Status: Y N U**Seismic Walkdown Checklist (SWC)**Equipment ID No. 1-1805-53-015 Equip. Class¹² ZEquipment Description 480V Switchgear 1AD15Location: Bldg. Aux/41 Floor El. 119'-3" Room, Area RD105

Seismic Walkdown Checklist (SWC)

Equipment Description 480V Switchgear IAB15

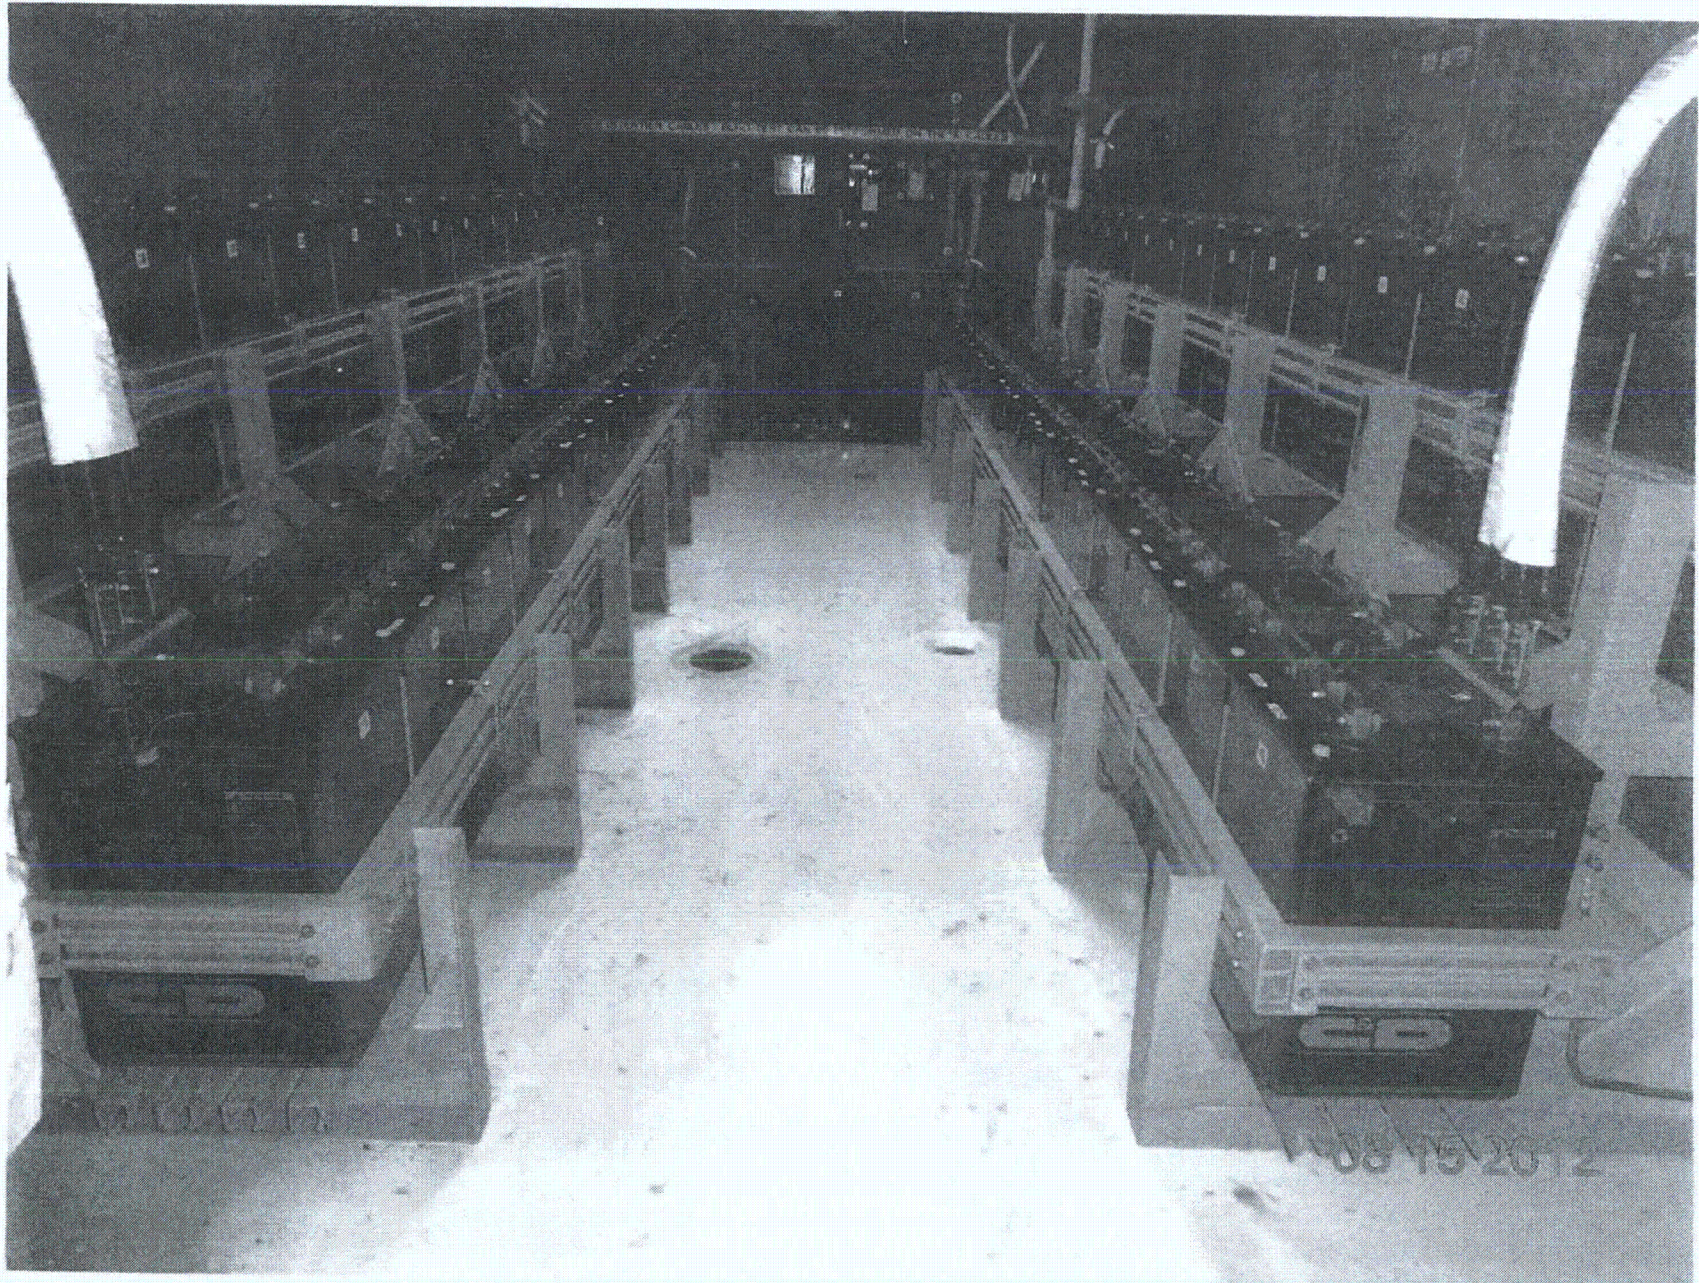
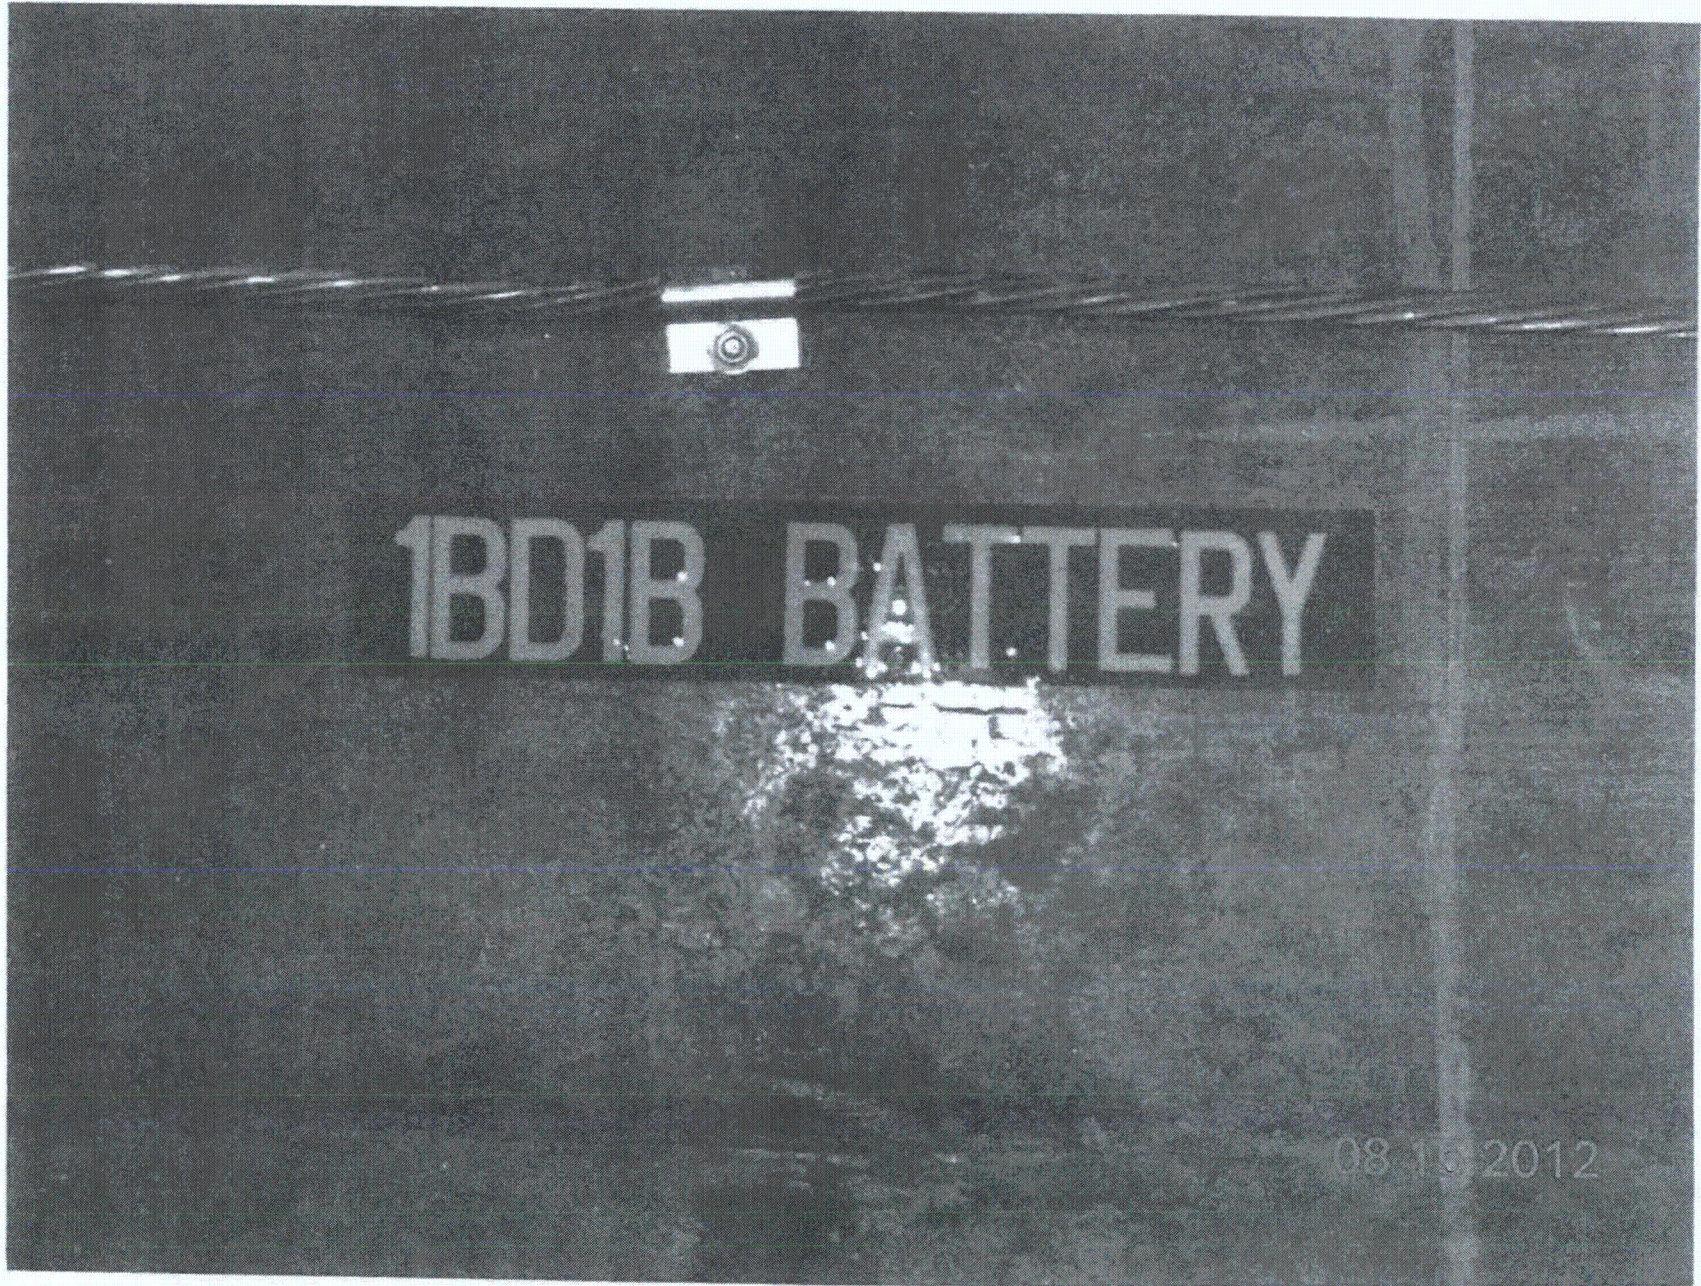
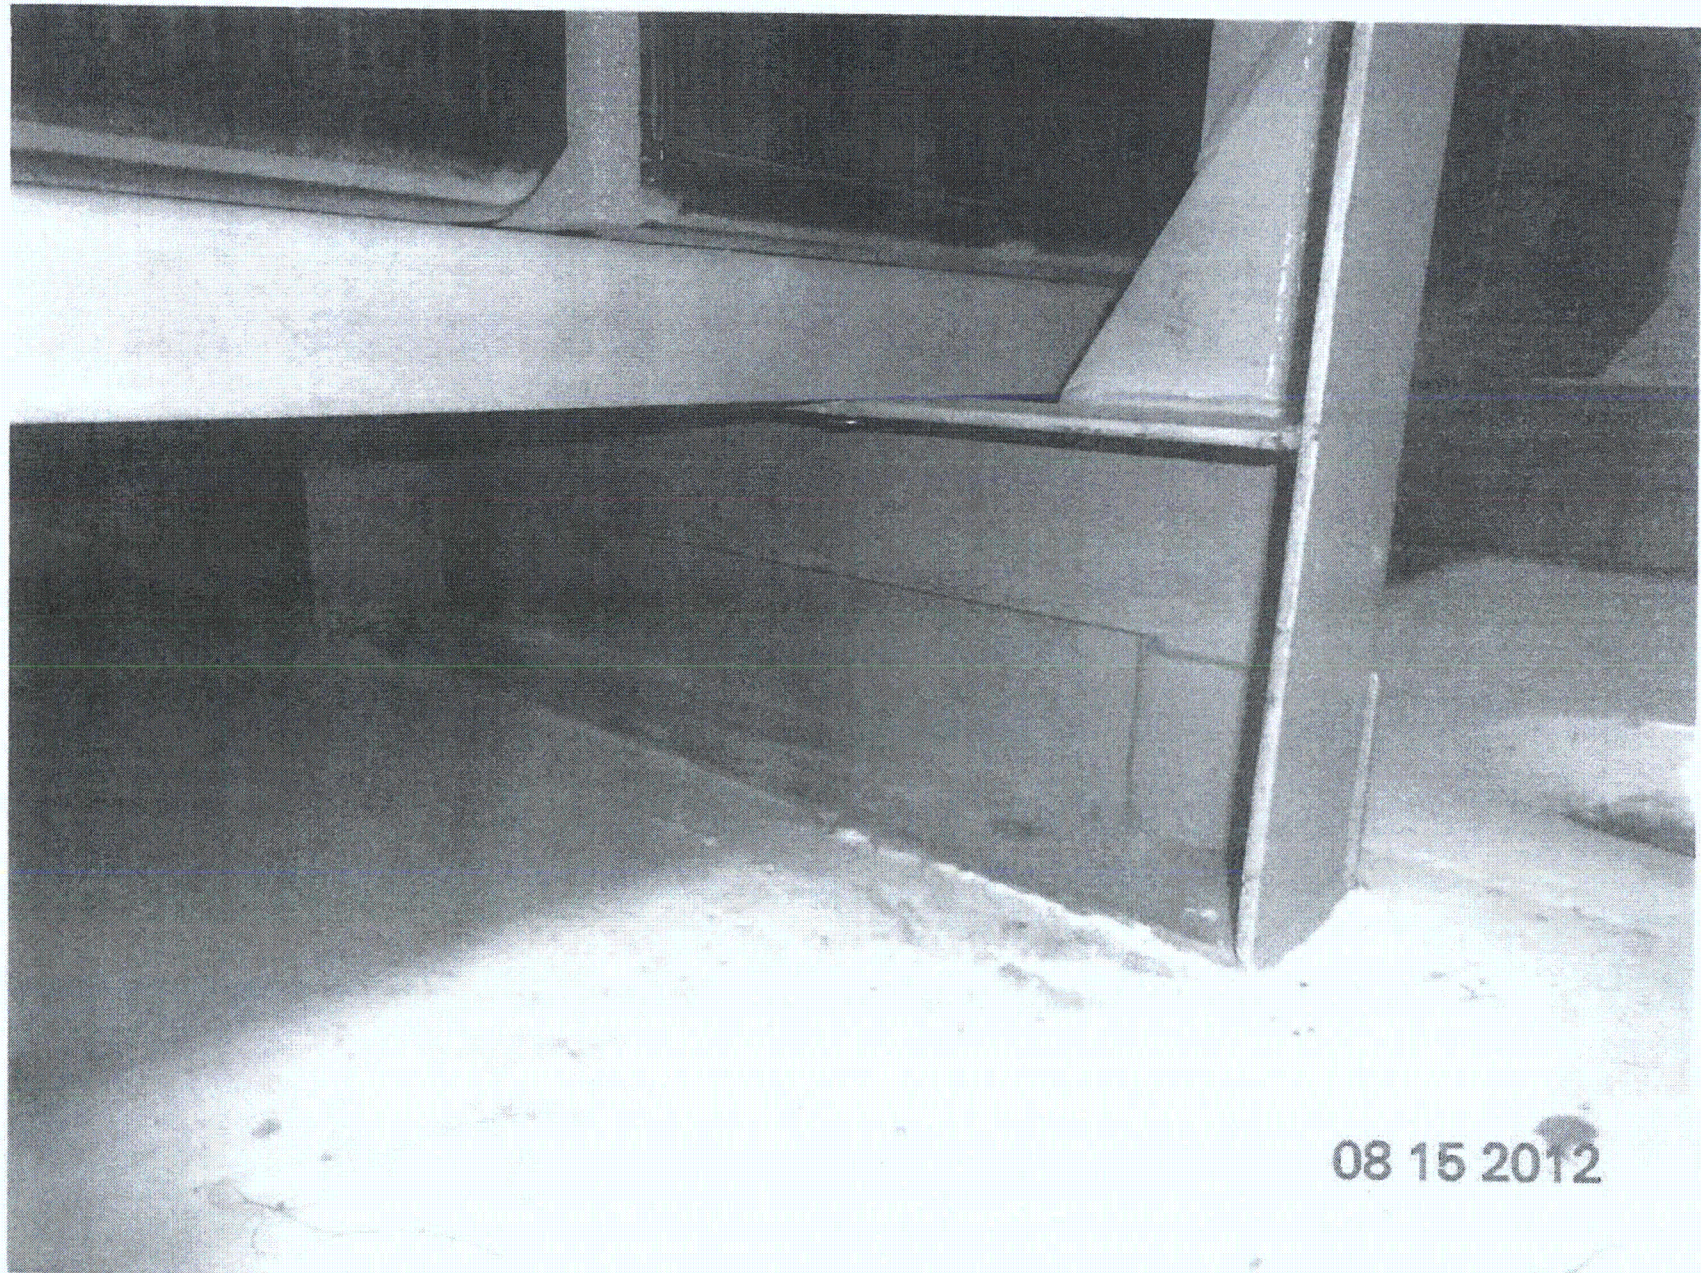
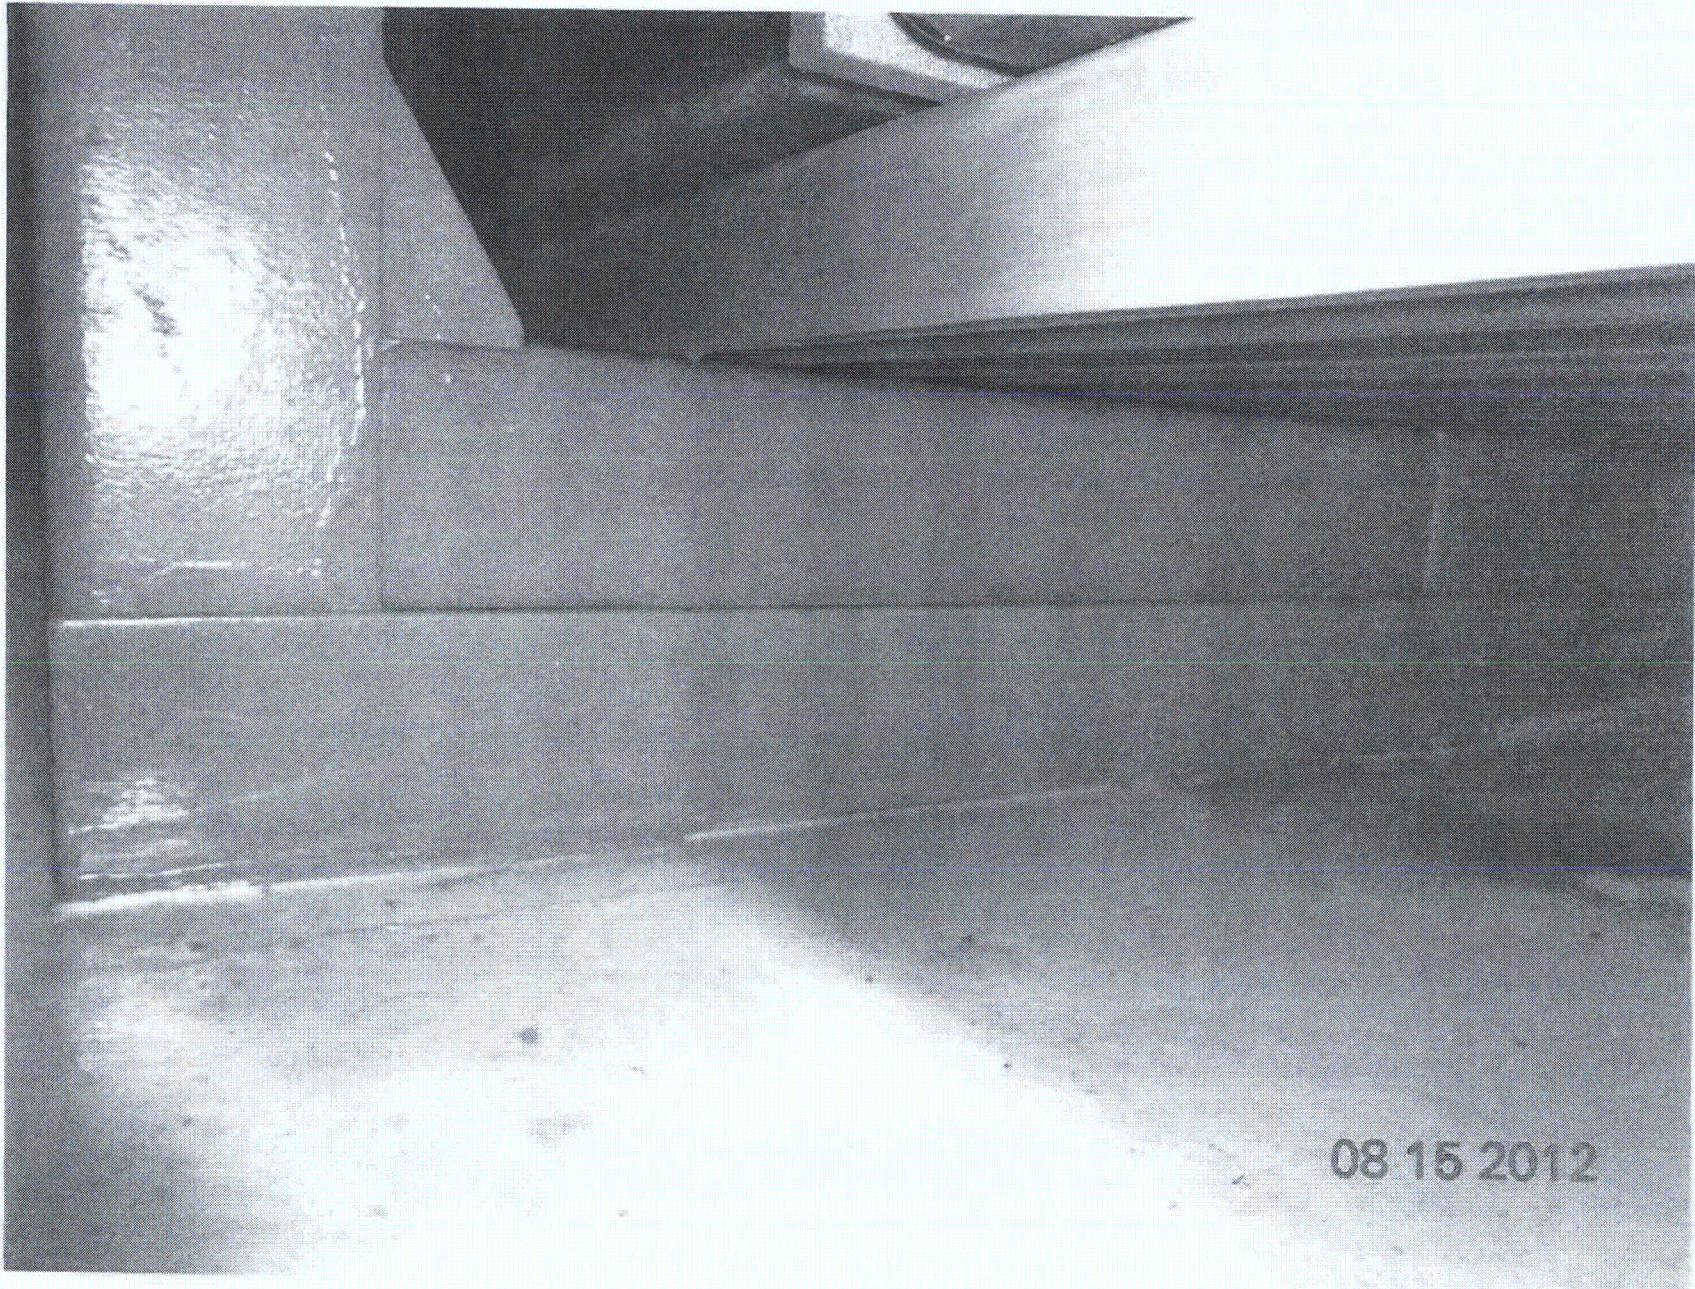
WELDED CONNECTION

(Note: This question only applies if the item is one of the 50% for which an anchorage configuration verification is required.)
WELD APPEARS TO BE UNDERSIZED AT FEW LOCATIONS. HOWEVER, CONSIDERING THE AMOUNT OF WELD AND WELD PATTERN, THE EXISTING WELDS ARE SUFFICIENT TO SUPPORT BATTERY RACK. REFER TO EQDP# X3AD01 REV.0 FOR WELD CONFIGURATION

LIGHT FIXTURES ARE PROPERLY SECURED WITH CLOSURE SCREWS

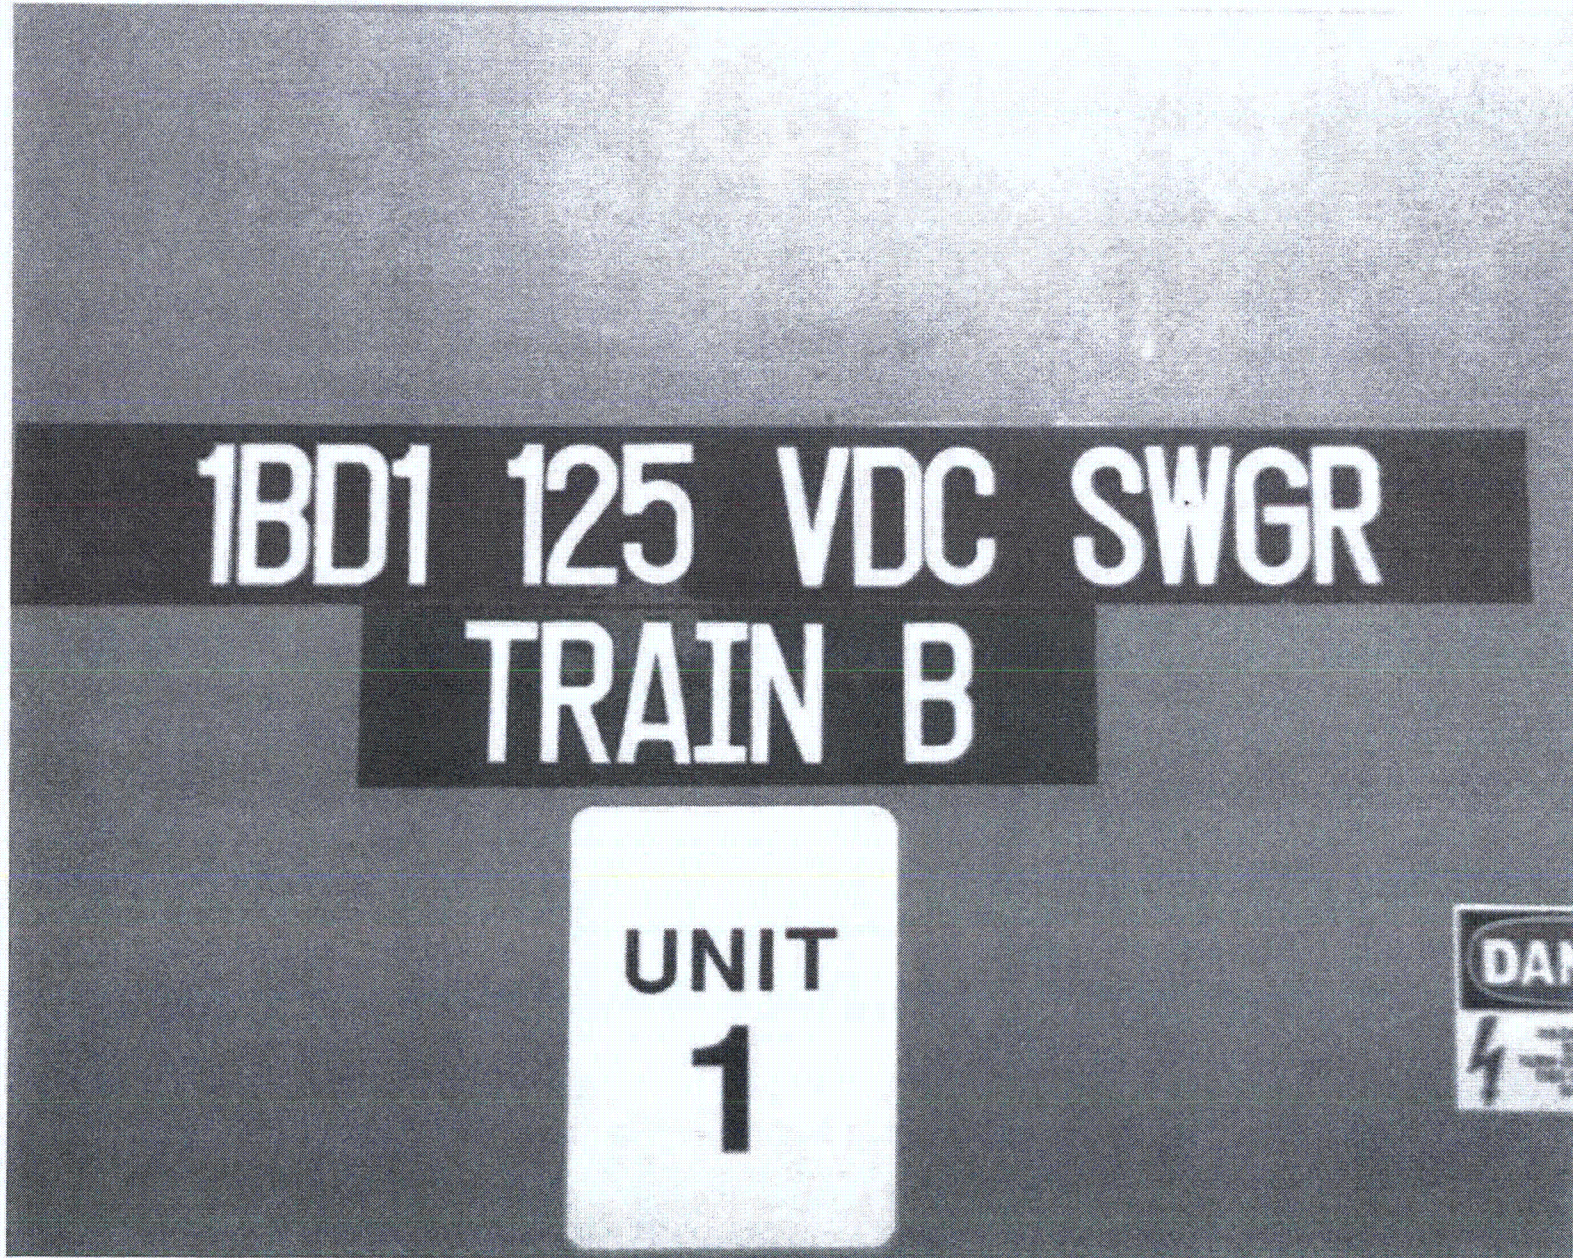
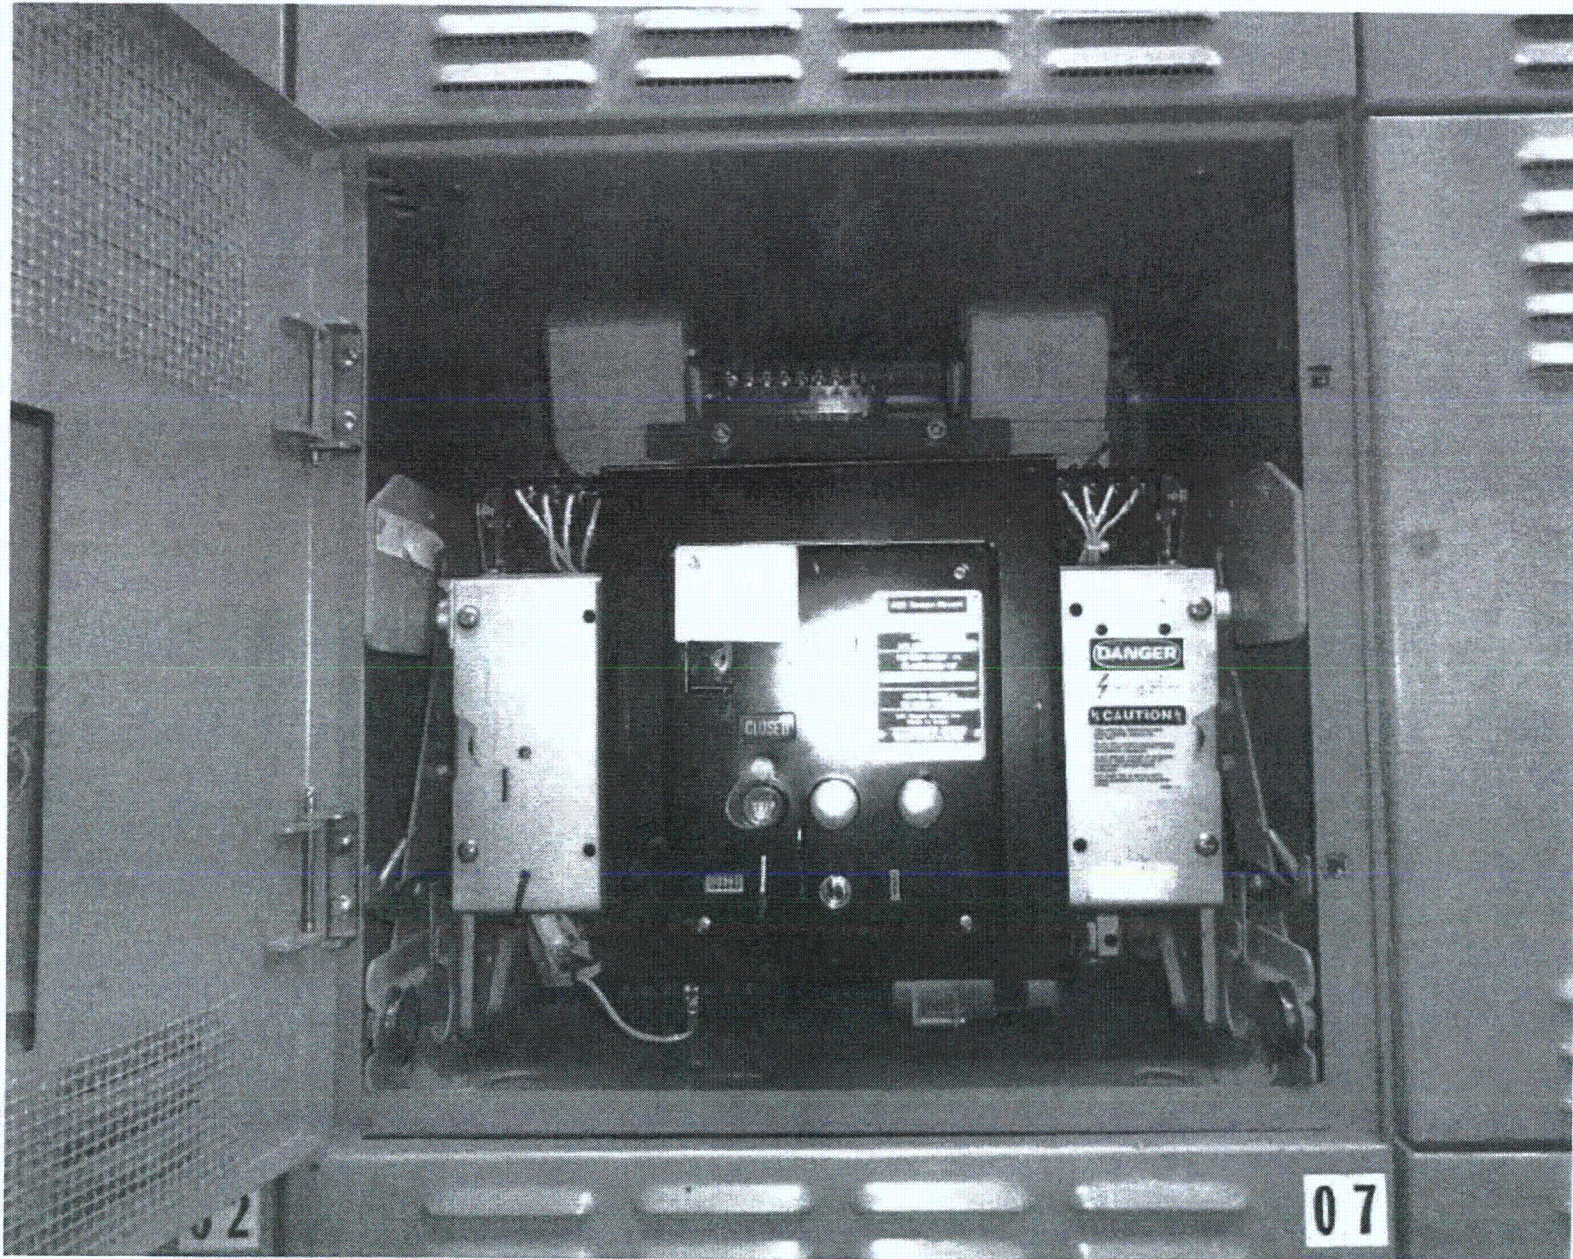
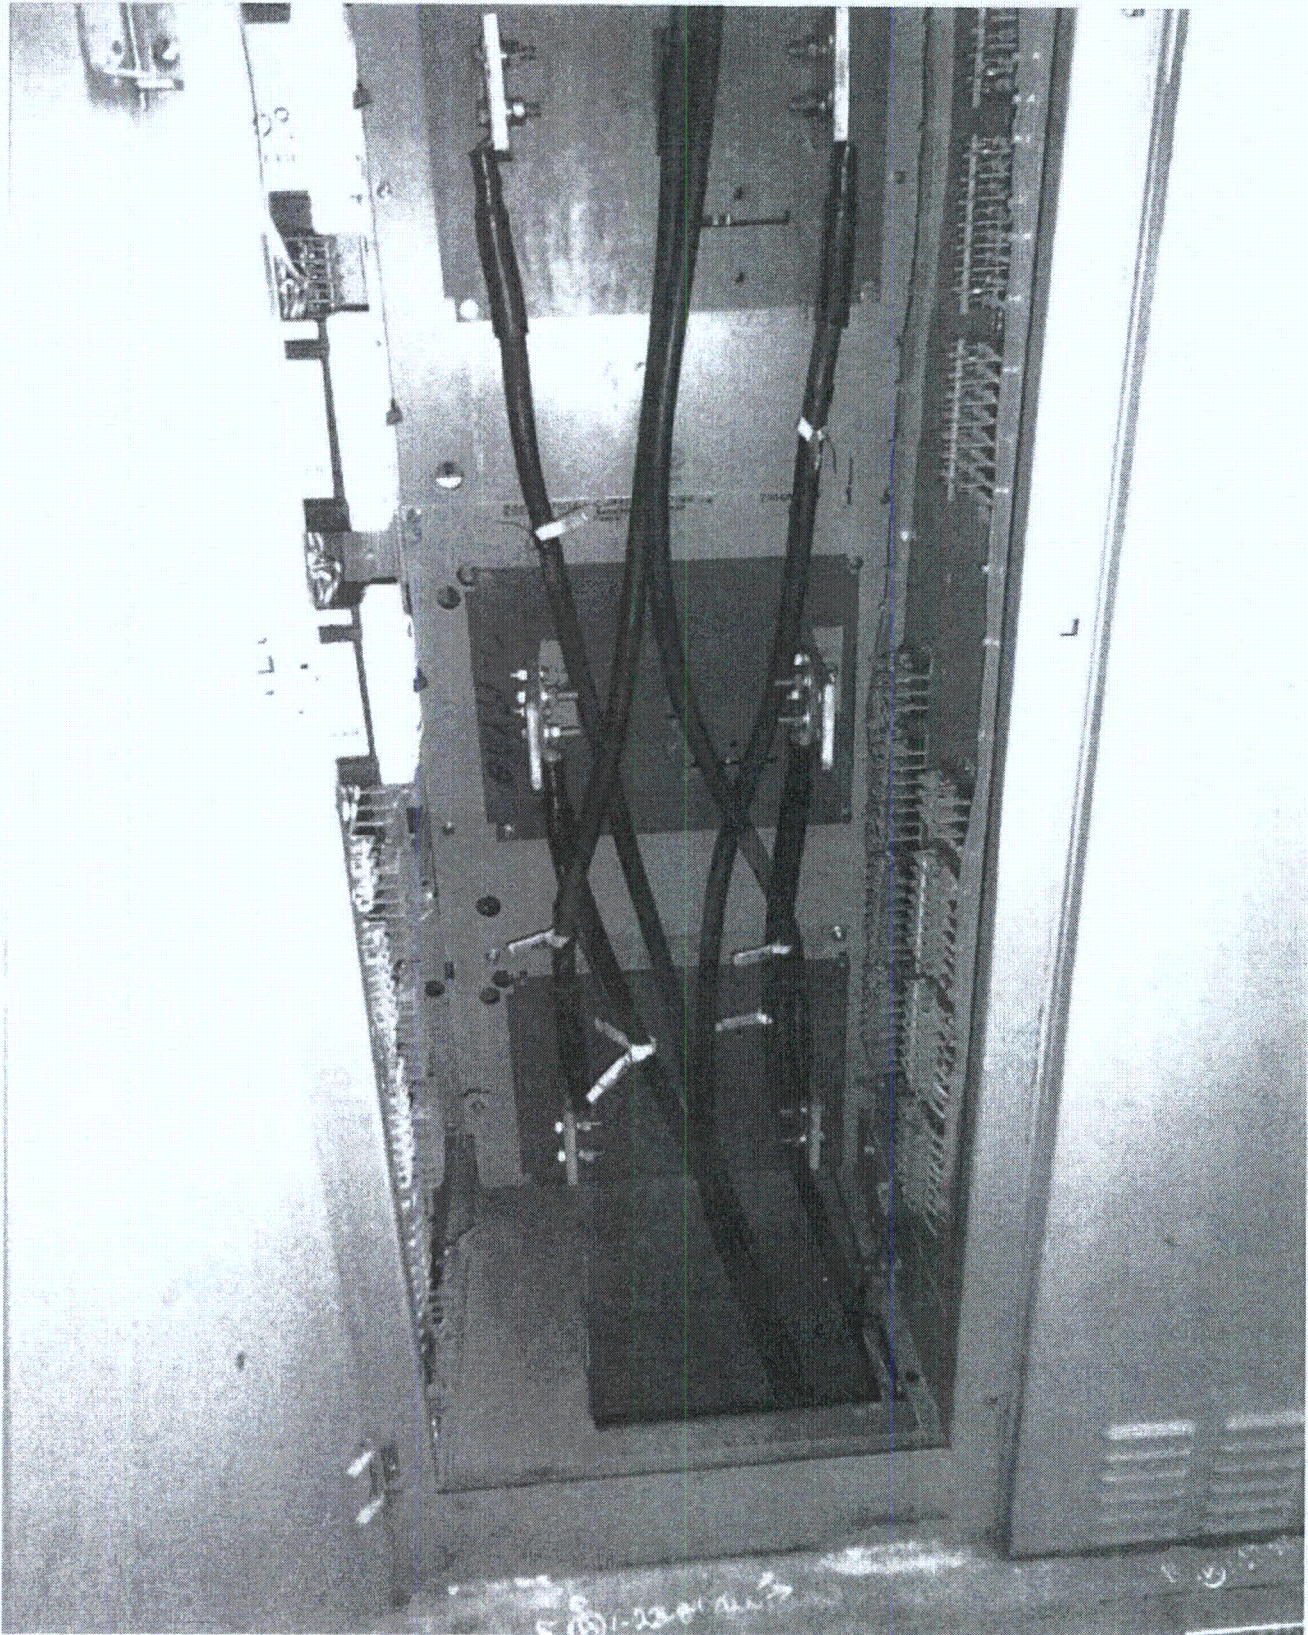
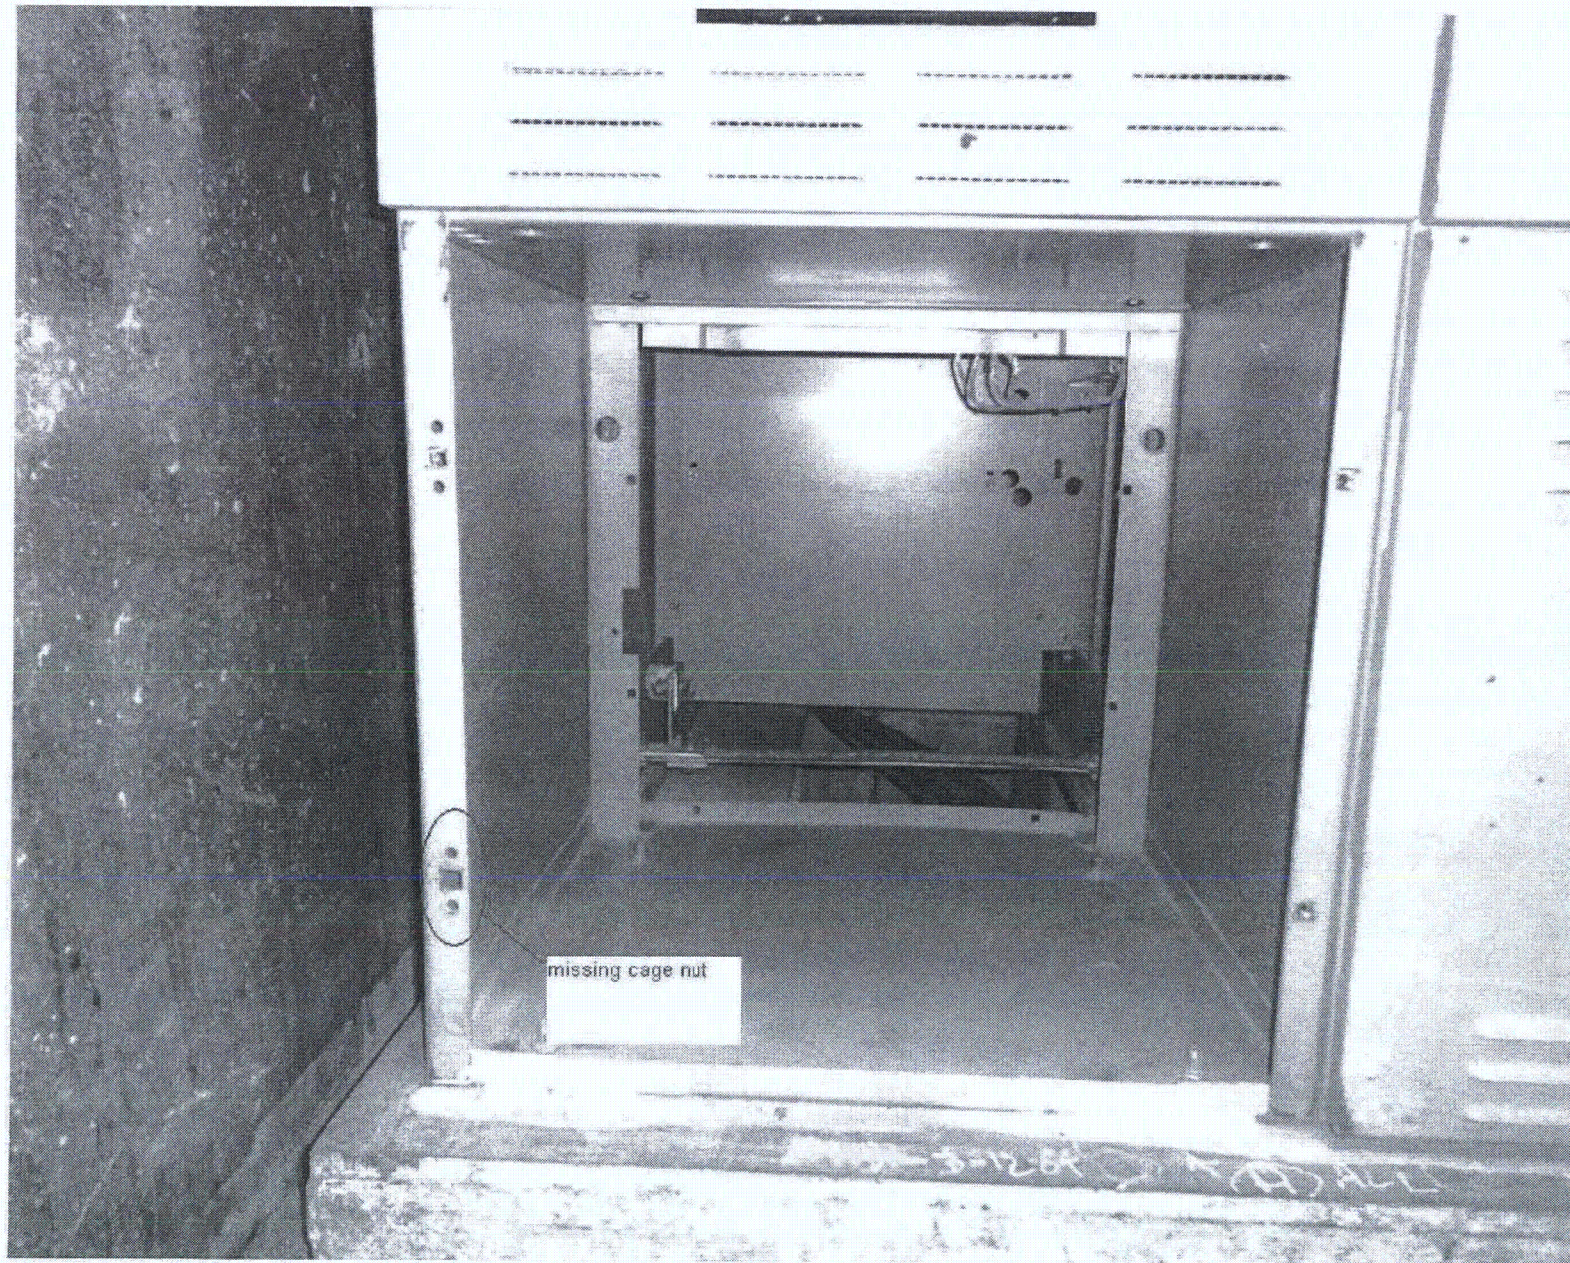
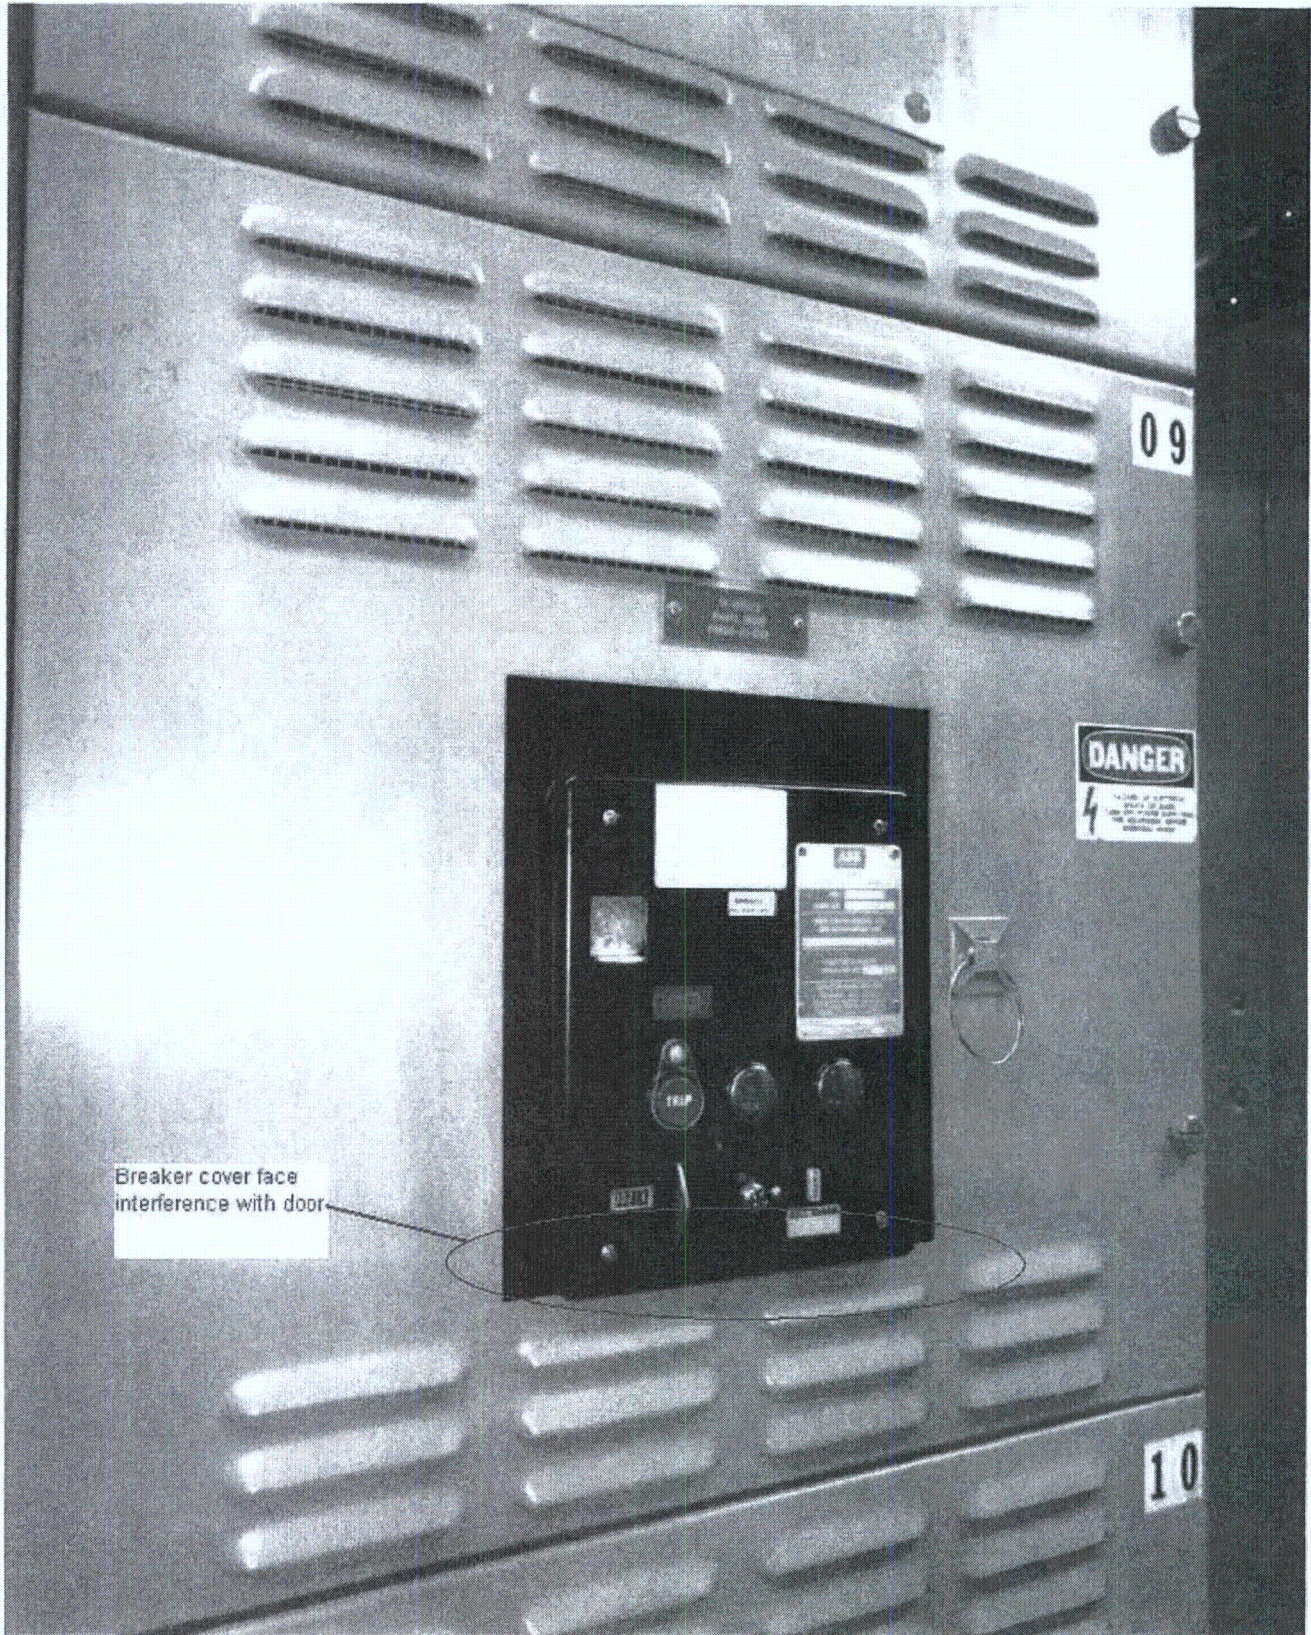
11. Have you looked for and found no other seismic conditions that could adversely affect the safety functions of the equipment? Y N U
A visual inspection of the internal components of this cabinet was performed to check for seismic adequacy to include any evidence of internal components not adequately secured, checked to ensure fasteners connecting adjacent cabinets were in place, and evidence of other adverse seismic conditions. No significant adverse conditions were found - some minor issues found are documented in the "Comments" section.

- Found the following minor issues:
 - ① One (1) cage nut used to secure the door closed missing.
 - ② One breaker door that could not be opened due to interference with the breaker face cover in bay 09.
- These issues were documented on the condition report 528389.
