**Seismic Walkdown Checklist (SWC)**

Equipment ID No. 1-1807-Q3-V15 Equip. Class<sup>12</sup> 14  
 Equipment Description 120 VAC VITAL OEST PANEL 1AY2A  
 Location: Bldg. AUX Floor El. 220'0" Room, Area R118  
 Manufacturer, Model, Etc. (optional but recommended) \_\_\_\_\_

Equipment ID No. 1-1807-Q3-VI3 Equip. Class<sup>12</sup> 14 (Distribution Panel)  
 Equipment Description 120 VAC, Vital Panel ICYIA  
 Location: Bldg. Control Floor El. 180' Room, Area RB55  
 Manufacturer, Model, Etc. (optional but recommended) Square D

Equipment ID No. 1-1807-Y3-IA11 Equip. Class<sup>12</sup> 16 (Battery Chargers and Inverters)  
 Equipment Description Vital AC Inverter 1AD111  
 Location: Bldg. Aux Floor El. 220' Room, Area R118  
 Manufacturer, Model, Etc. (optional but recommended) Ametek

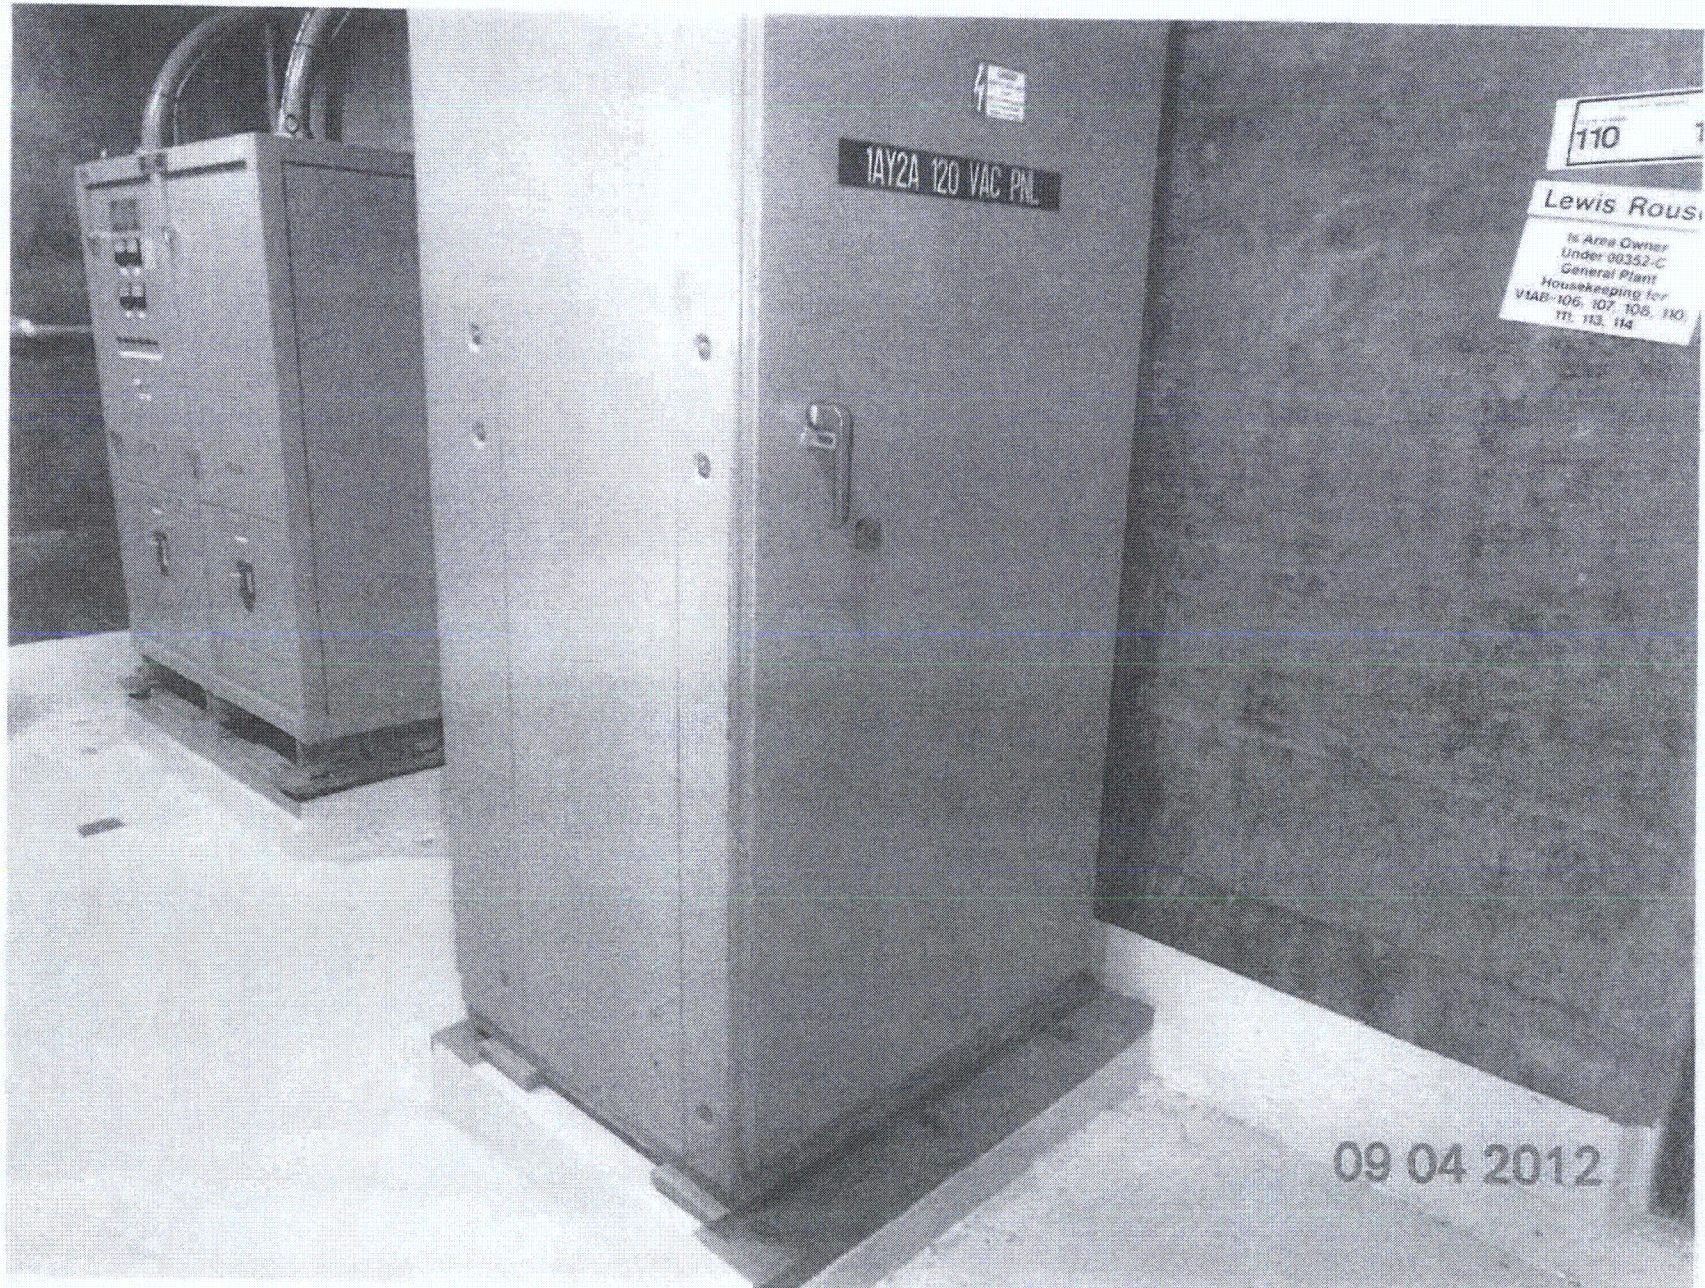
3/8" CLEAR TO WALL

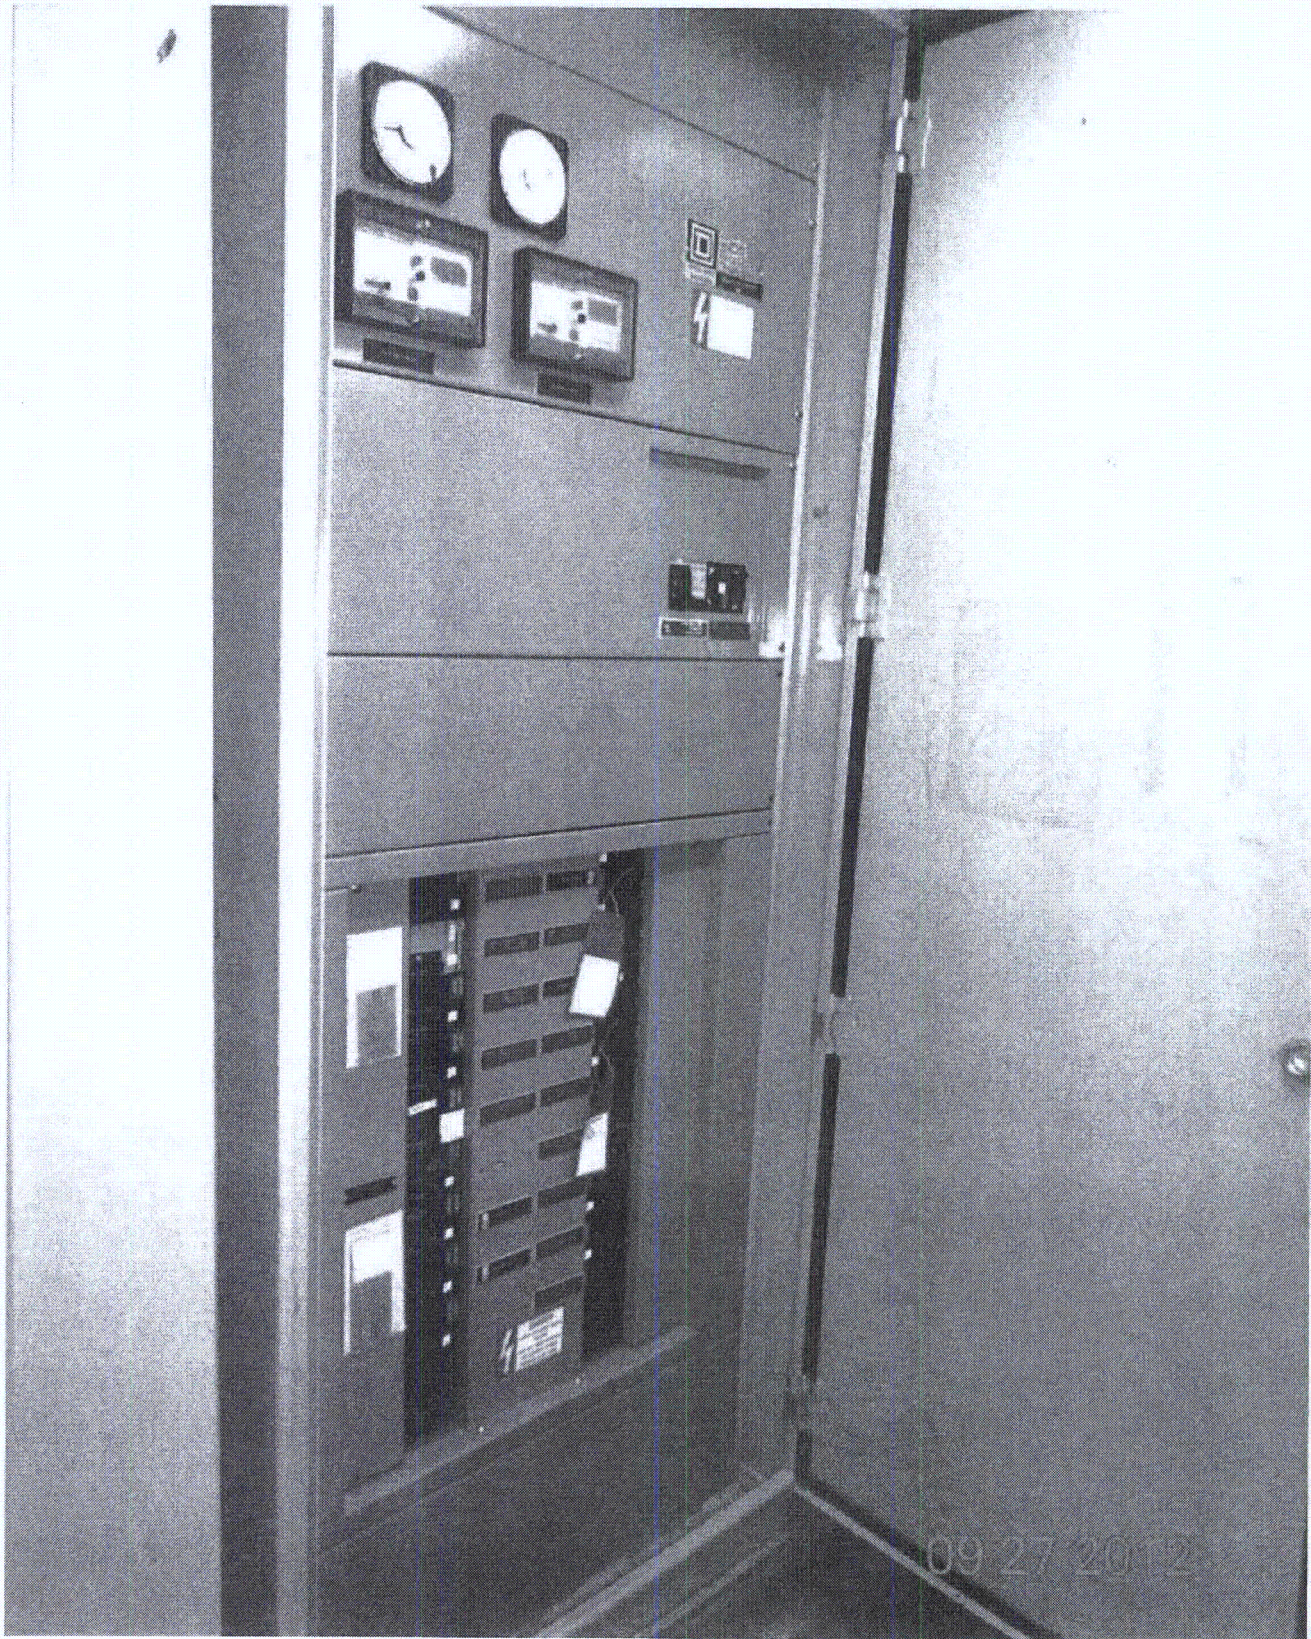
11. Have you looked for and found no other seismic conditions that could adversely affect the safety functions of the equipment? A visual inspection of the internal components of this cabinet was performed to check for seismic adequacy to include any evidence of internal components not adequately secured, checked to ensure fasteners connecting adjacent cabinets were in place, and evidence of other adverse seismic conditions. One (1) bolt that connects the inner frame with the cabinet is missing. See "Comments" section. Y  N  U

There was found one (1) bolt that connects the inner frame to be missing. An evaluation of this condition needs to be performed to determine seismic adequacy. Condition report 525039 was generated for this condition.

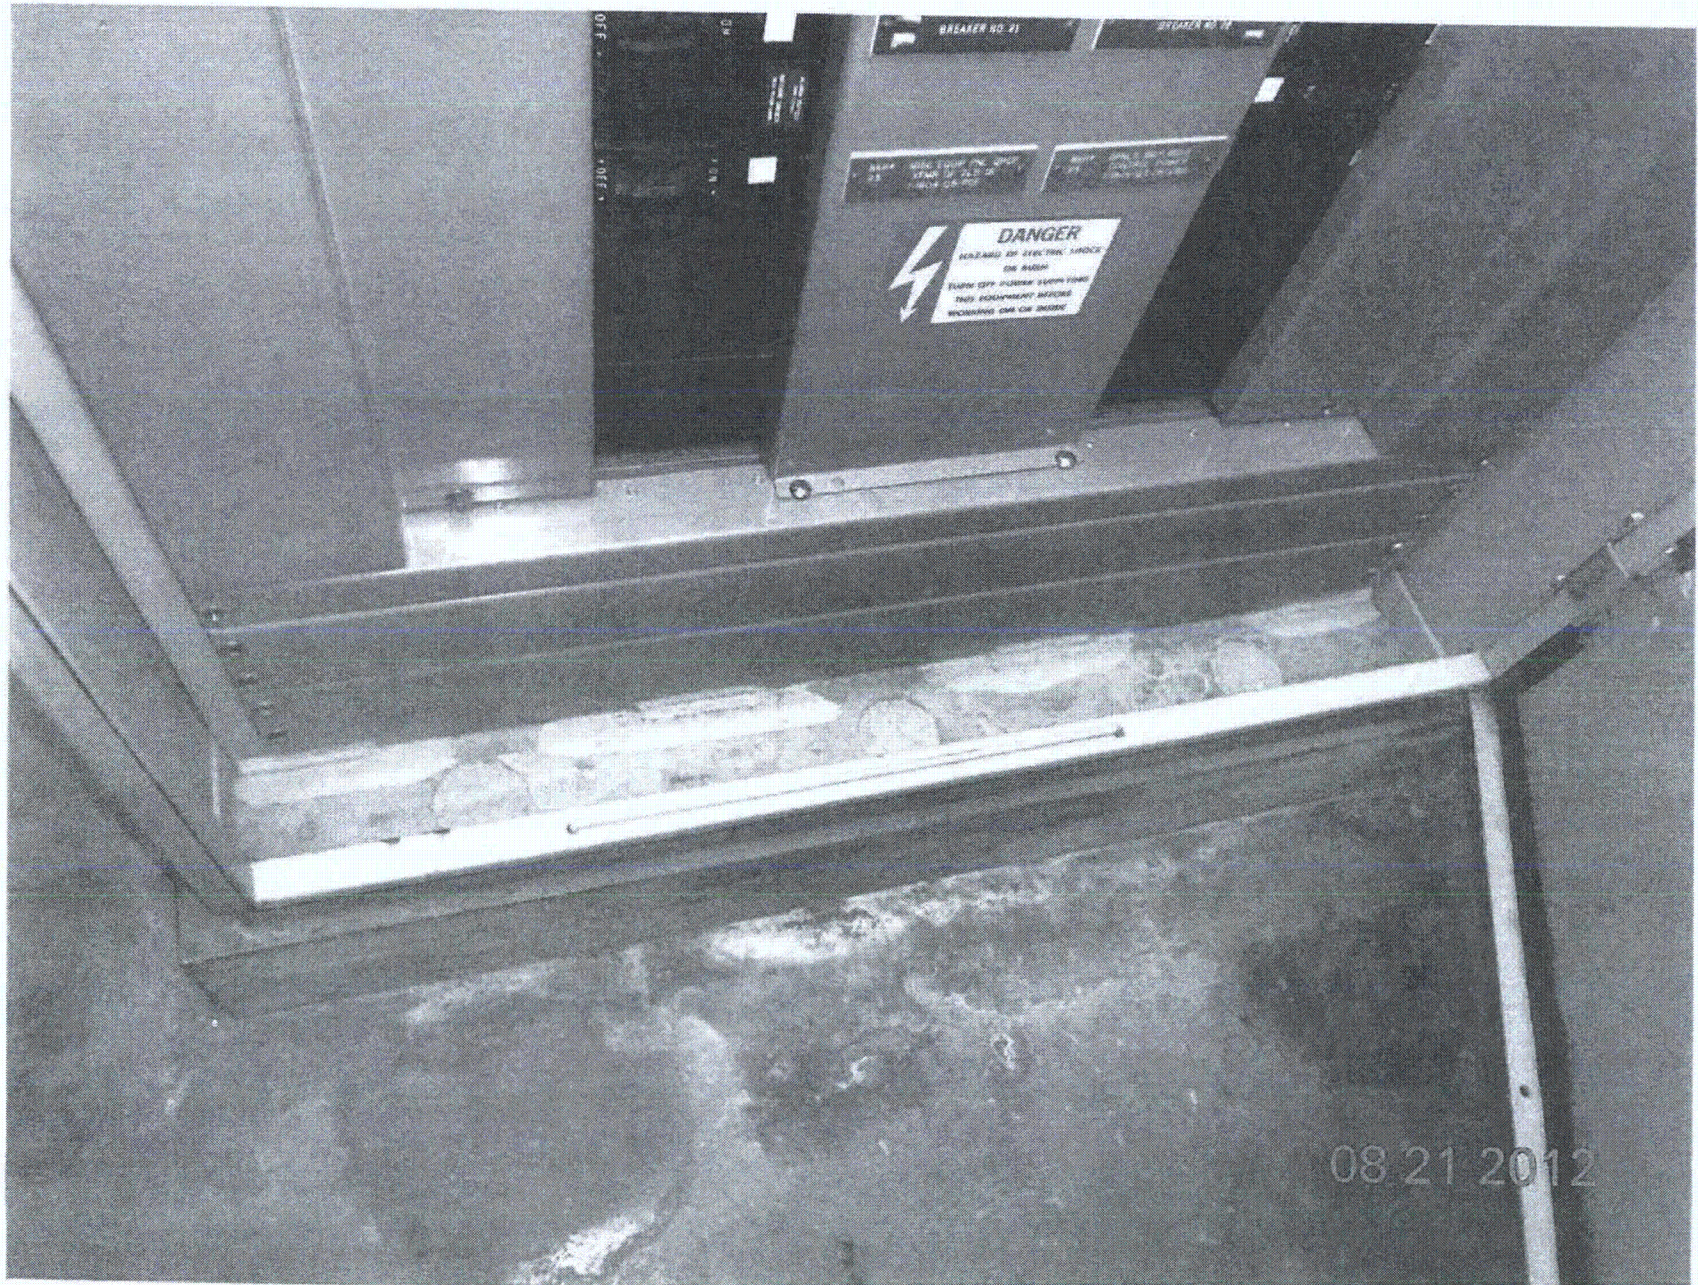
4. Is the anchorage free of visible cracks in the concrete near the anchors?  Y  N  U  N/A  
WELDED CONNECTION.

FOR AREA WALK-BY CHECKLIST, SEE 1-1806-S3-DSB.  
LIGHTING FIXTURES HAVE CLOSURE SCREWS

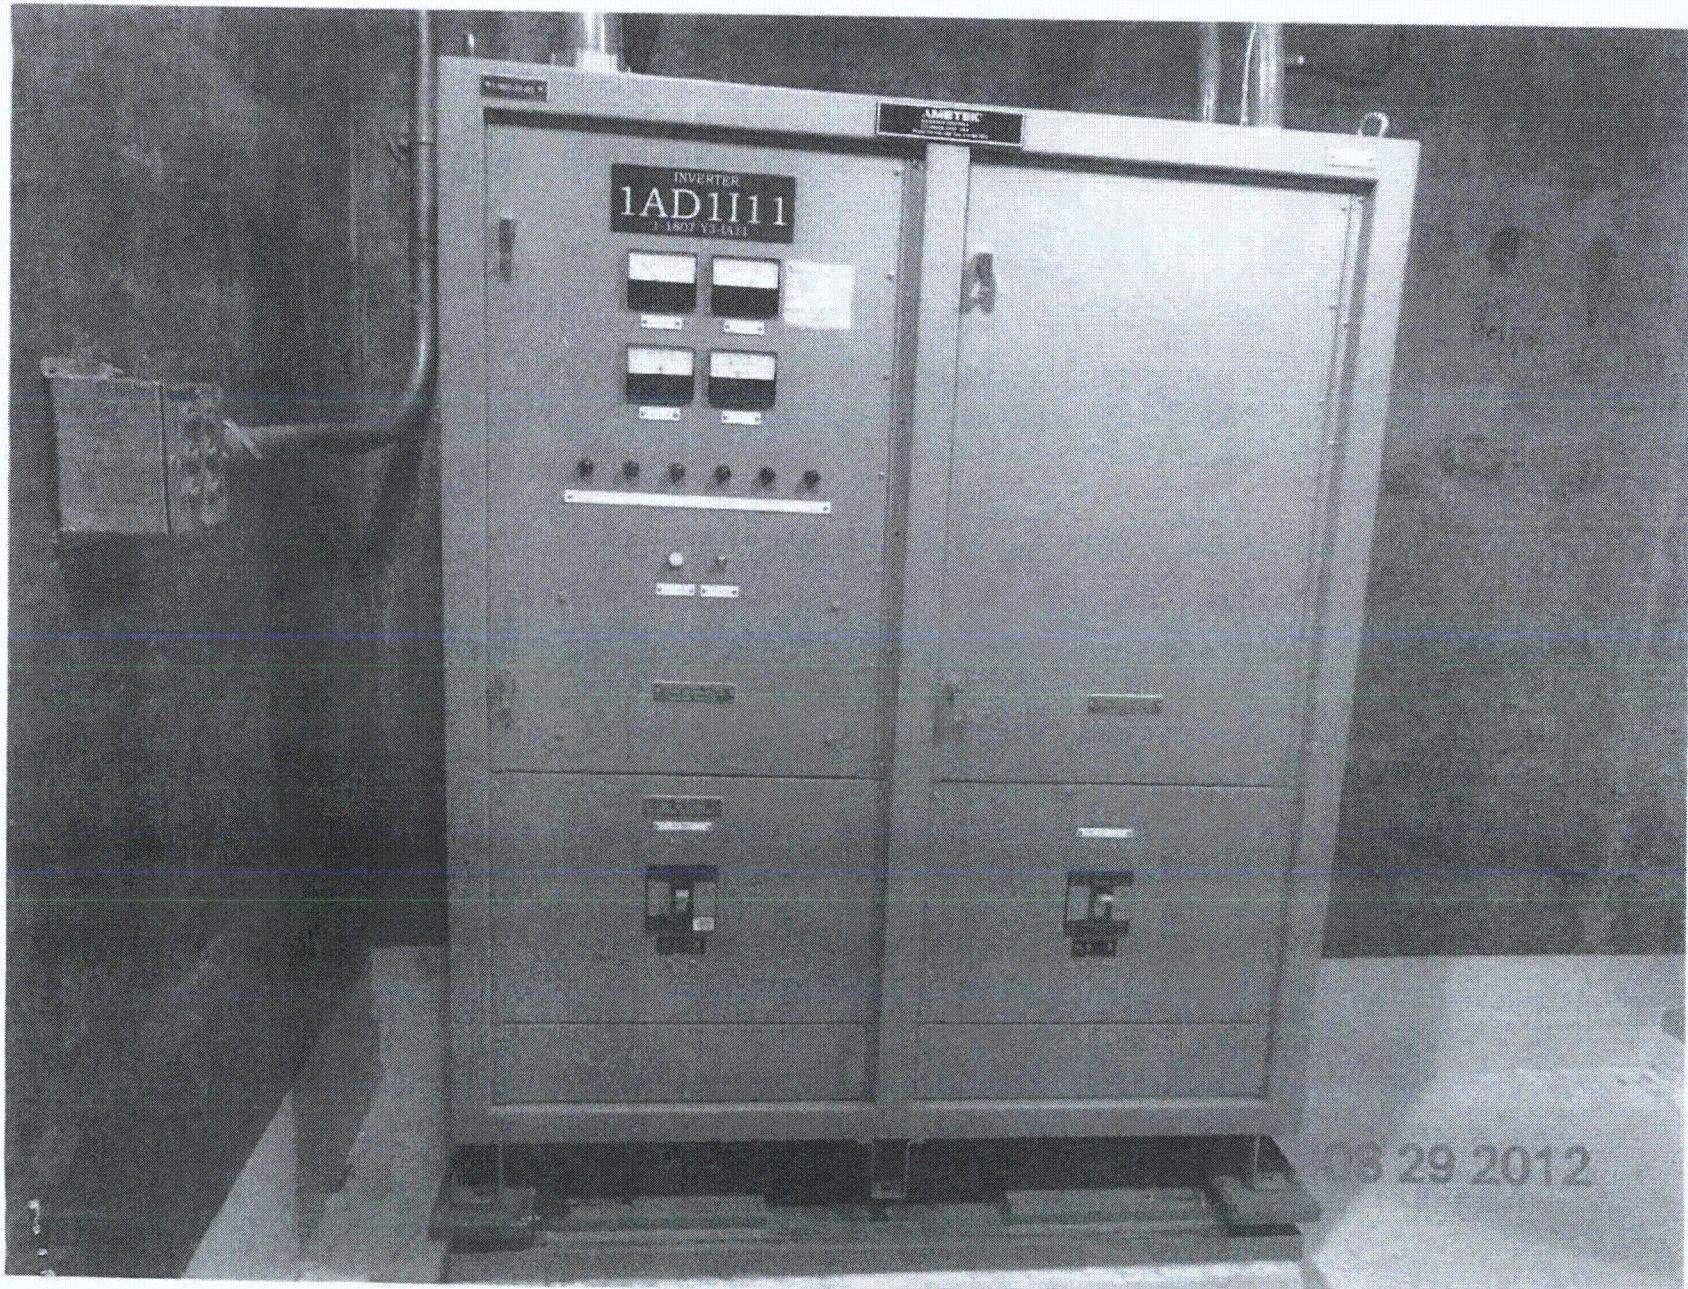
2. Is the anchorage free of bent, broken, missing or loose hardware?  Y  N  U  N/A  
*Fillet Welds are welded to the base.*

3. Is the anchorage free of corrosion that is more than mild surface oxidation?  Y  N  U  N/A  
*Welds are free of corrosion*

4. Is the anchorage free of visible cracks in the concrete near the anchors?  Y  N  U  N/A  
*Concrete is in good condition around welds*

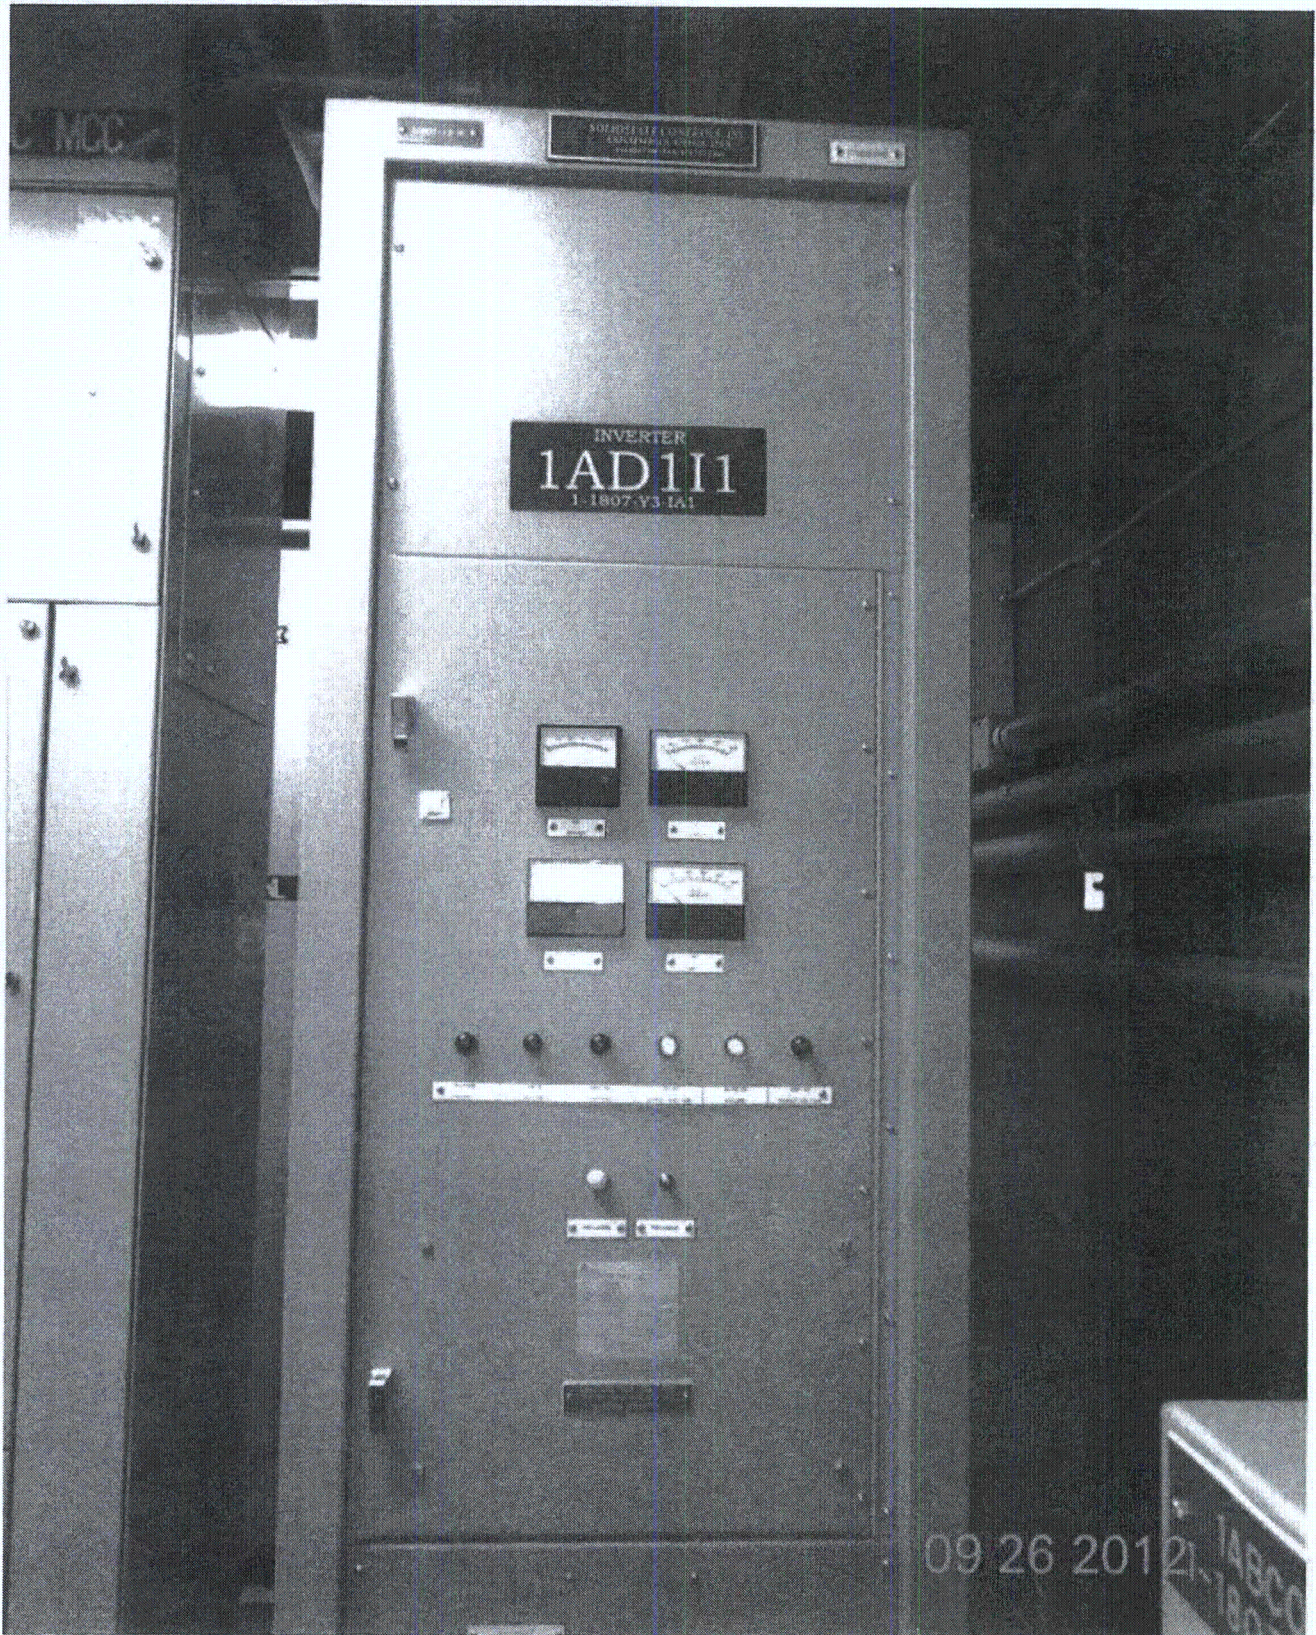
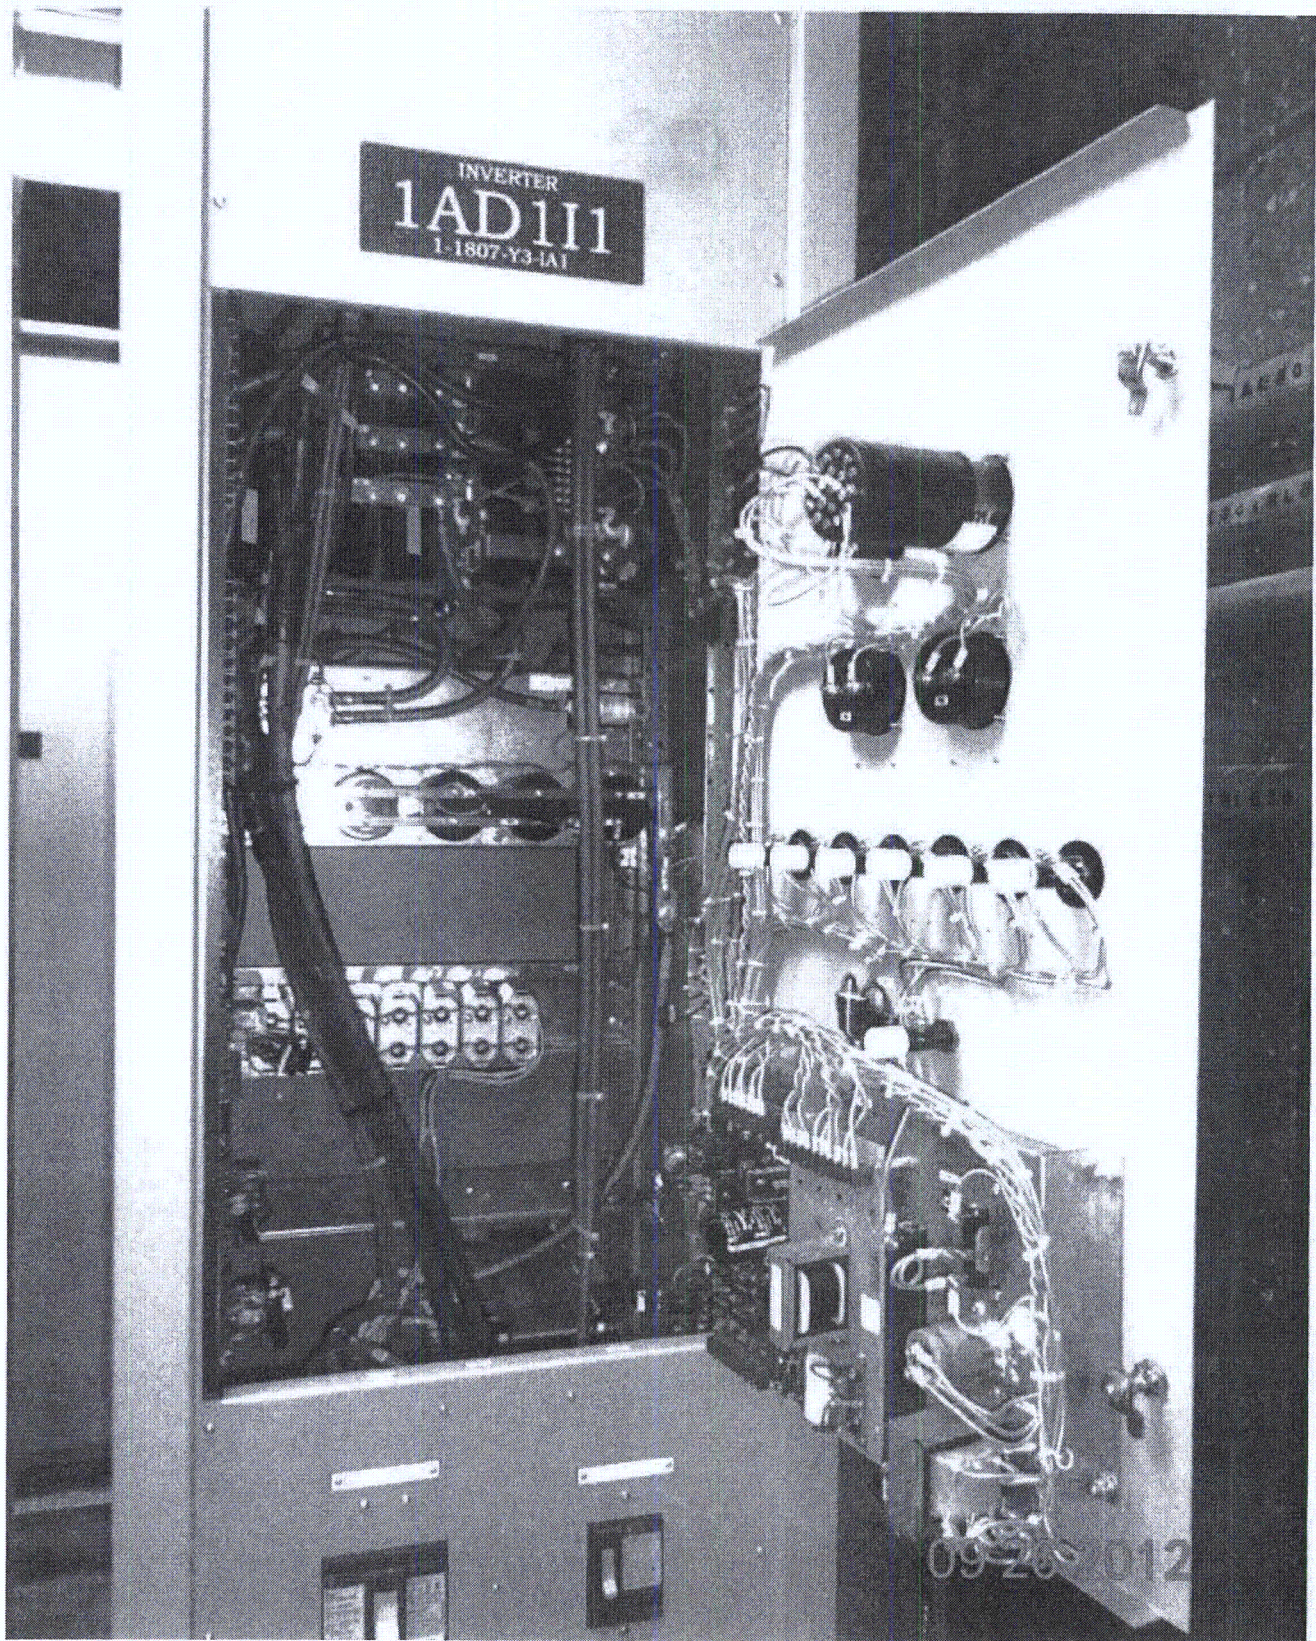
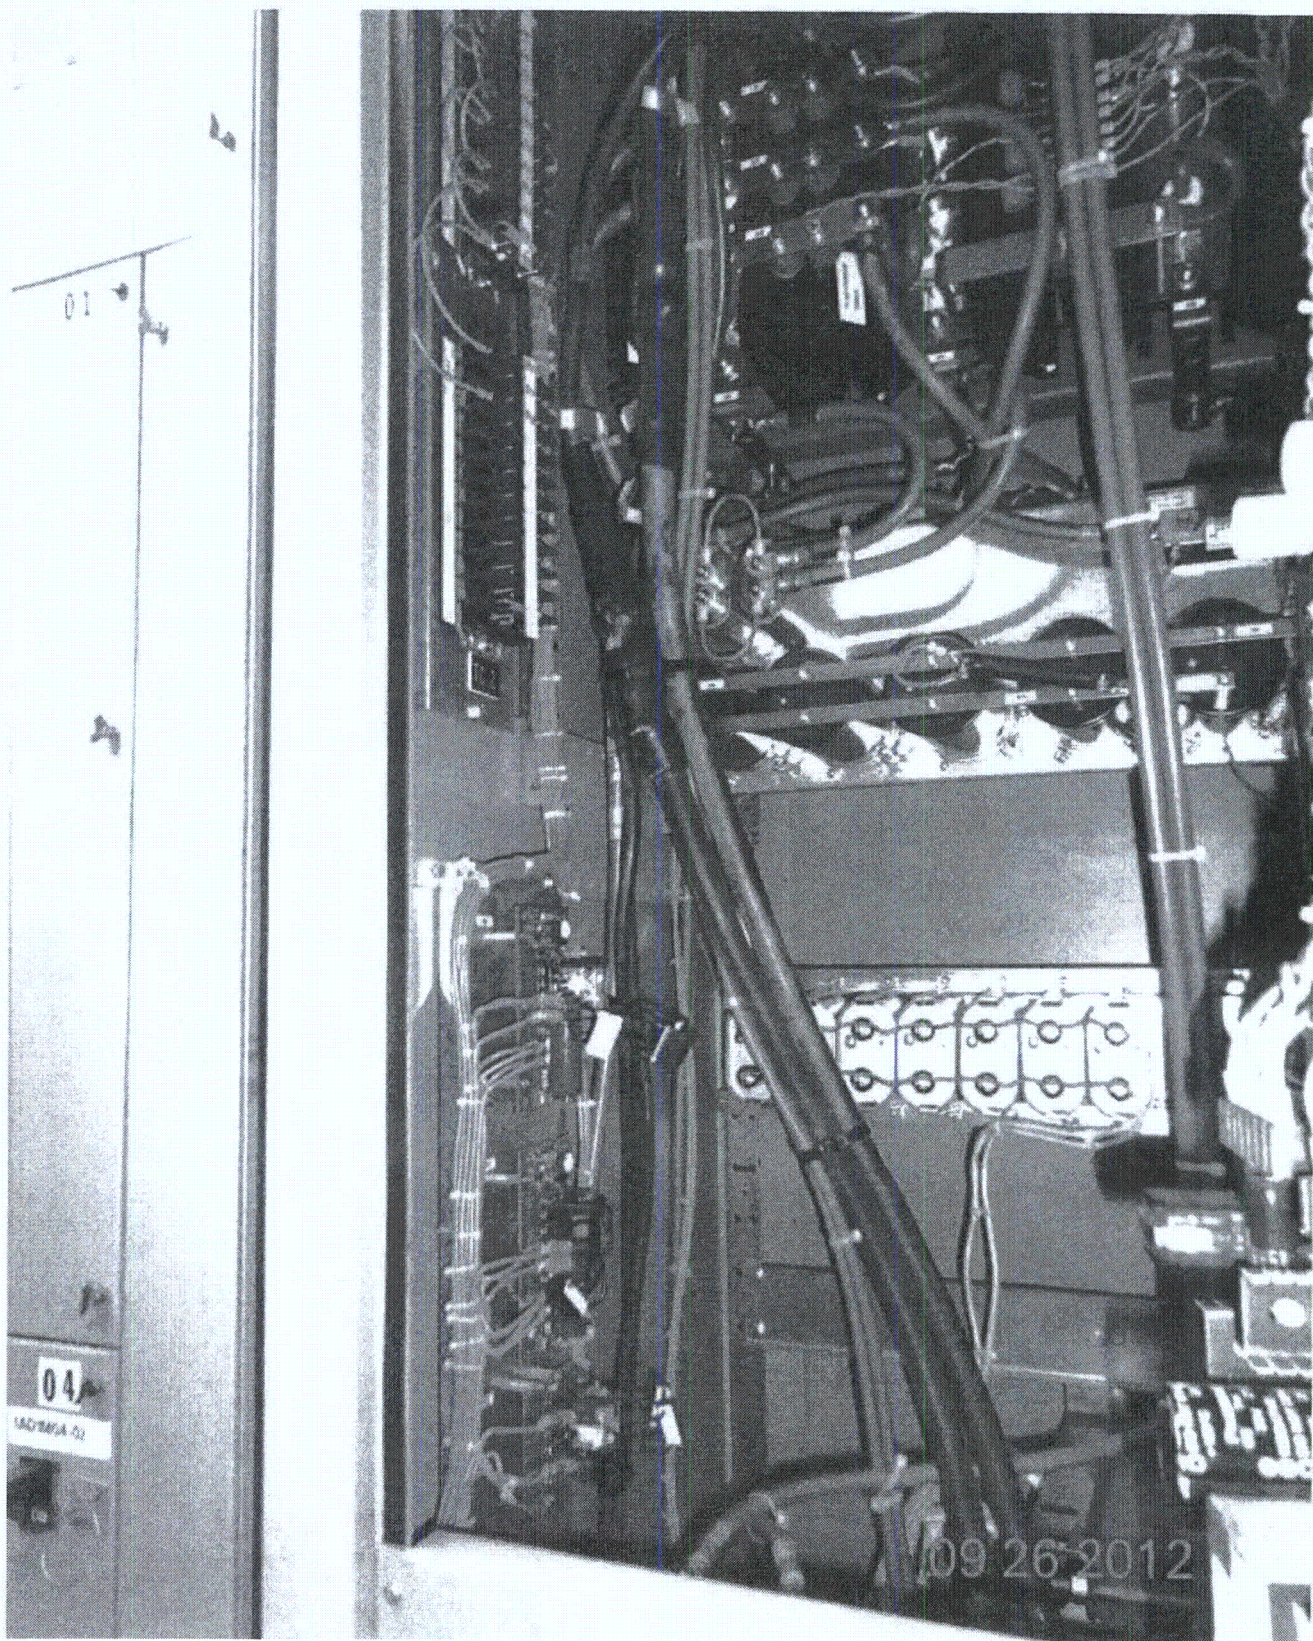
11. Have you looked for and found no other seismic conditions that could adversely affect the safety functions of the equipment? Y  N  U   
A visual inspection of the internal components of this cabinet was performed to check for seismic adequacy to include any evidence of internal components not adequately secured, checked to ensure fasteners connecting adjacent cabinets were in place, and evidence other adverse seismic conditions.  
No significant adverse conditions were found.
