Seismic Walkdown Checklist (SWC)

NO. SNCV061-RPT-01, VERSION 1.0

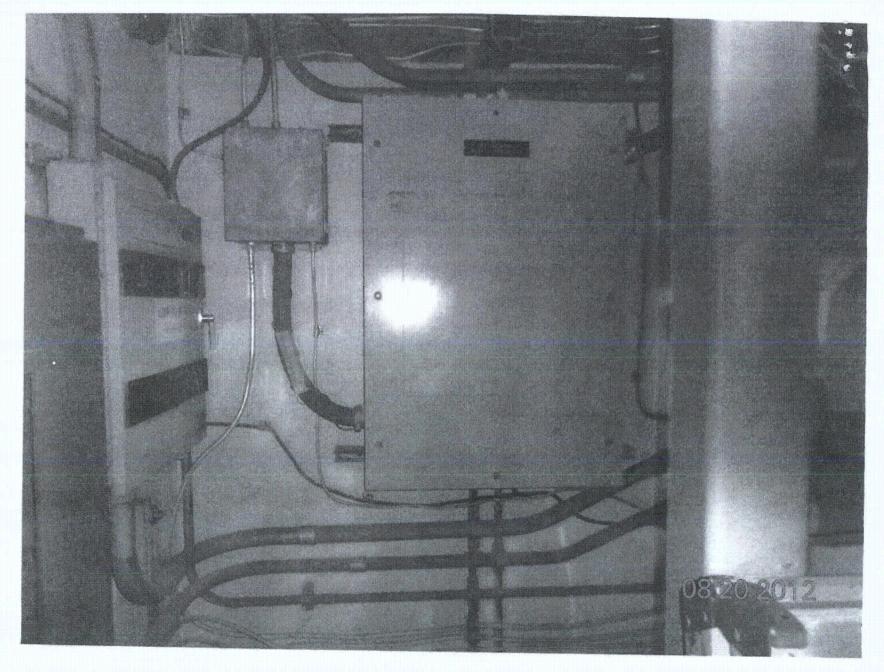
Seismic Walkdown Checklist (SWC)	
Equipment ID No. 1-1808-Q3-L47 Equip. Class ¹² [4	
Equipment Description Emergency Leg distribution panel	
Equipment Description <u>Emergenzy</u> <u>Leg distribution pane</u> <u>Diese</u> Location: Bldg. <u>Control All</u> Floor El <u>zro-o</u> Room, Area <u>R101</u>	
Manufacturer, Model, Etc. (optional but recommended)	<u> </u>
Instructions for Completing Checklist	
This checklist may be used to document the results of the Seismic Walkdown of SWEL. The space below each of the following questions may be used to record. findings. Additional space is provided at the end of this checklist for documenting the space of the space space.	the results of judgments and
Anchorage (See SWC dated 8/20/12)

A visual inspection of the internal components of this cabinet was performed to check for seismic adequacy to include any evidence of internal components not adequately seared, checked to ensure fosteners connecting adjacent cabinets were in place, and evidence of other adverse seismic conditions. No adverse conditions were found.

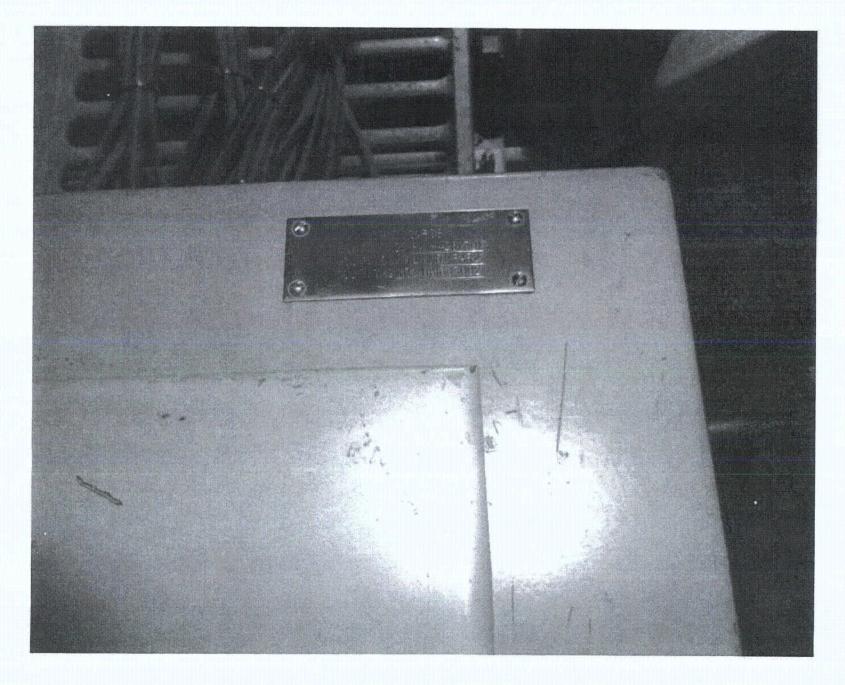
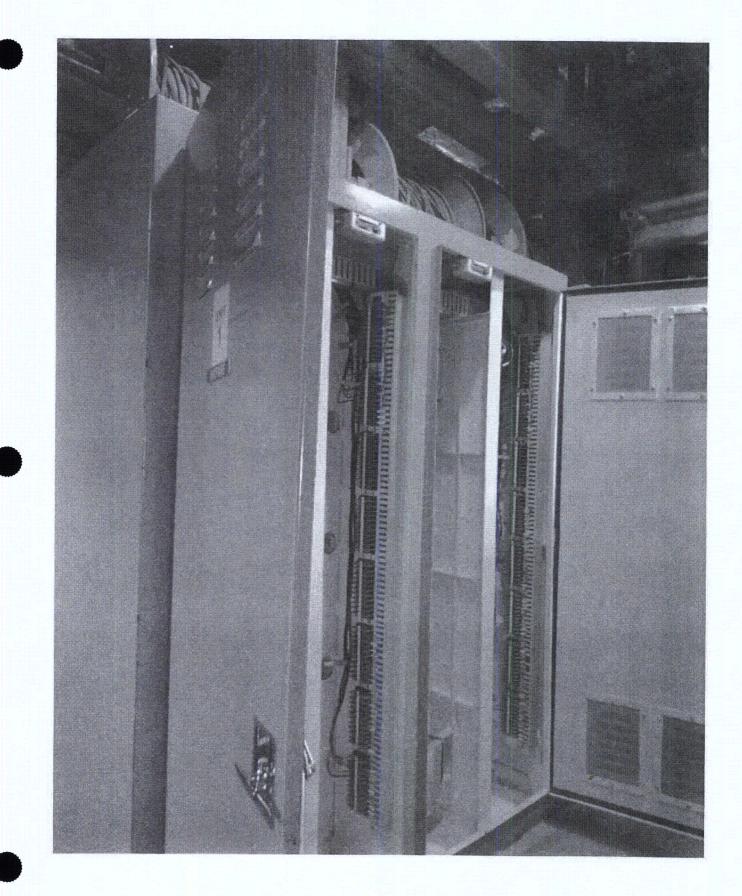
- Found screws missing used to scene terminal blocks and to scene a door atarm motide the cabinet. It was judged that this condition does not registent a seismic vulnerability or concern. Reterence condition report 327701

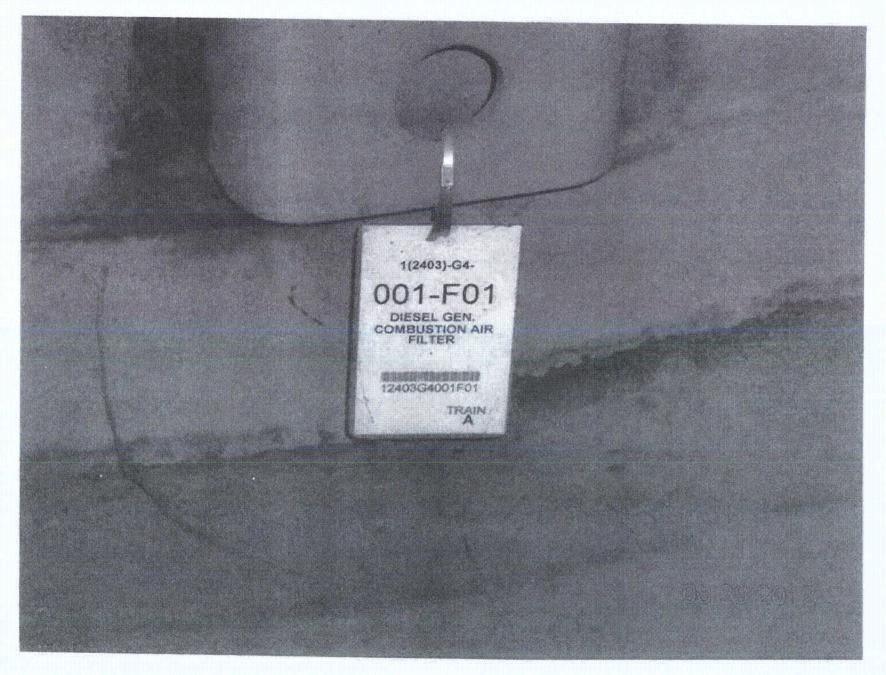
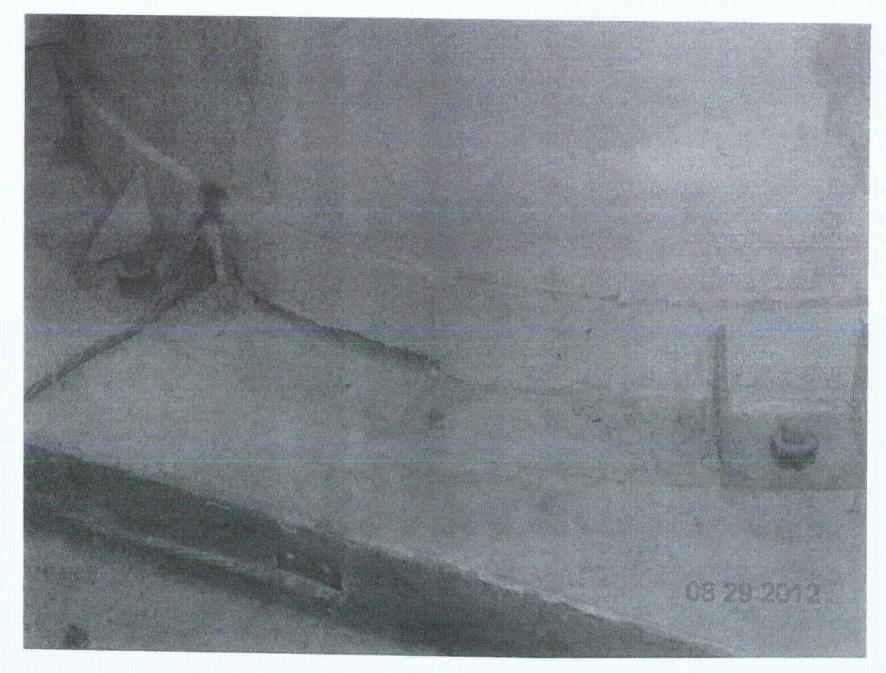
1. Is the anchorage configuration verification required (i.e., is the item one of the 50% of SWEL items requiring such verification)?	YX ND
2. Is the anchorage free of bent, broken, missing or loose hardware? 4 WASHERS MISSING NOT A SEISMIC ISSUE REE CR # 54
