**Seismic Walkdown Checklist (SWC)**

Equipment ID No: 1-1501-A7-004-000 Equip. Class<sup>1</sup> 10 - Air Handlers

Equipment Description CTB Cooling Unit & Motor

Location: Bldg. CTB Floor El. 220'±0" Room, Area 1401 Near Column #16

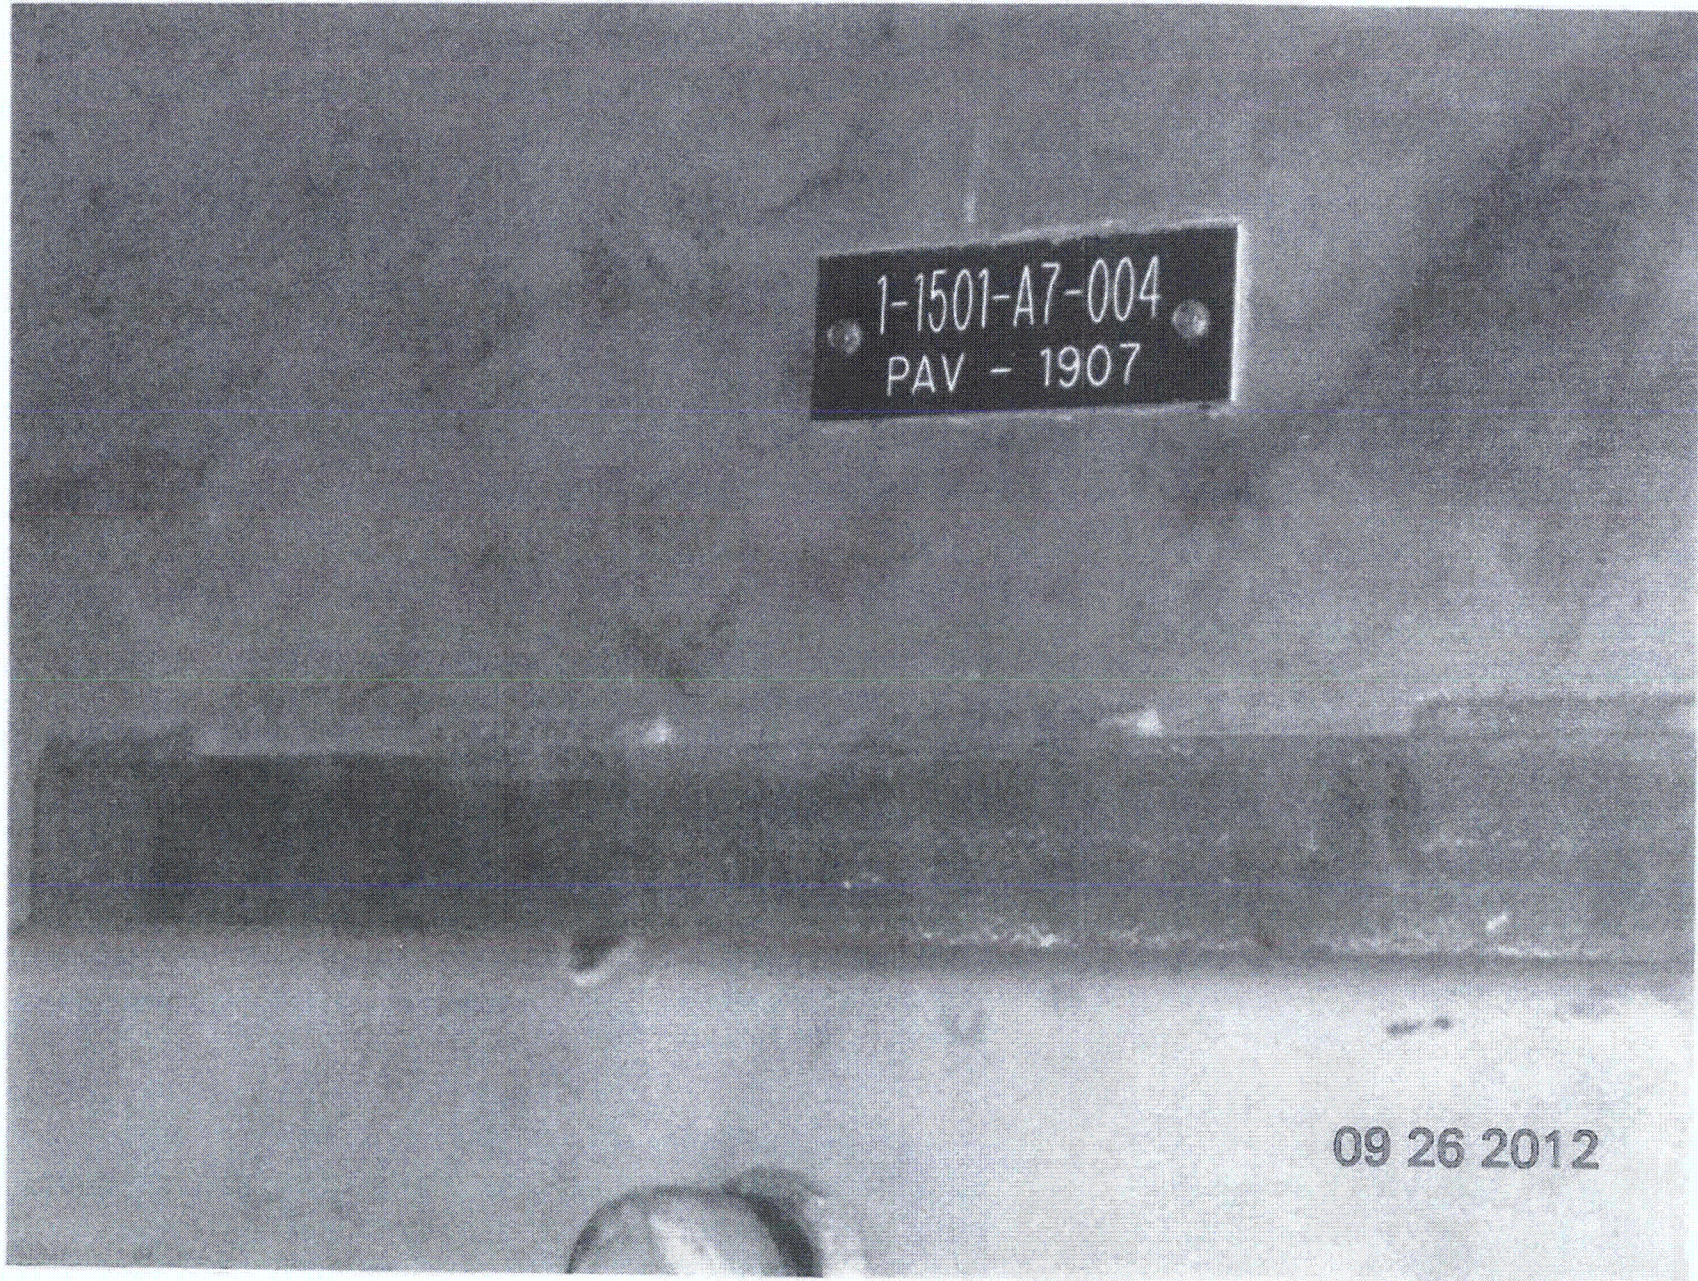
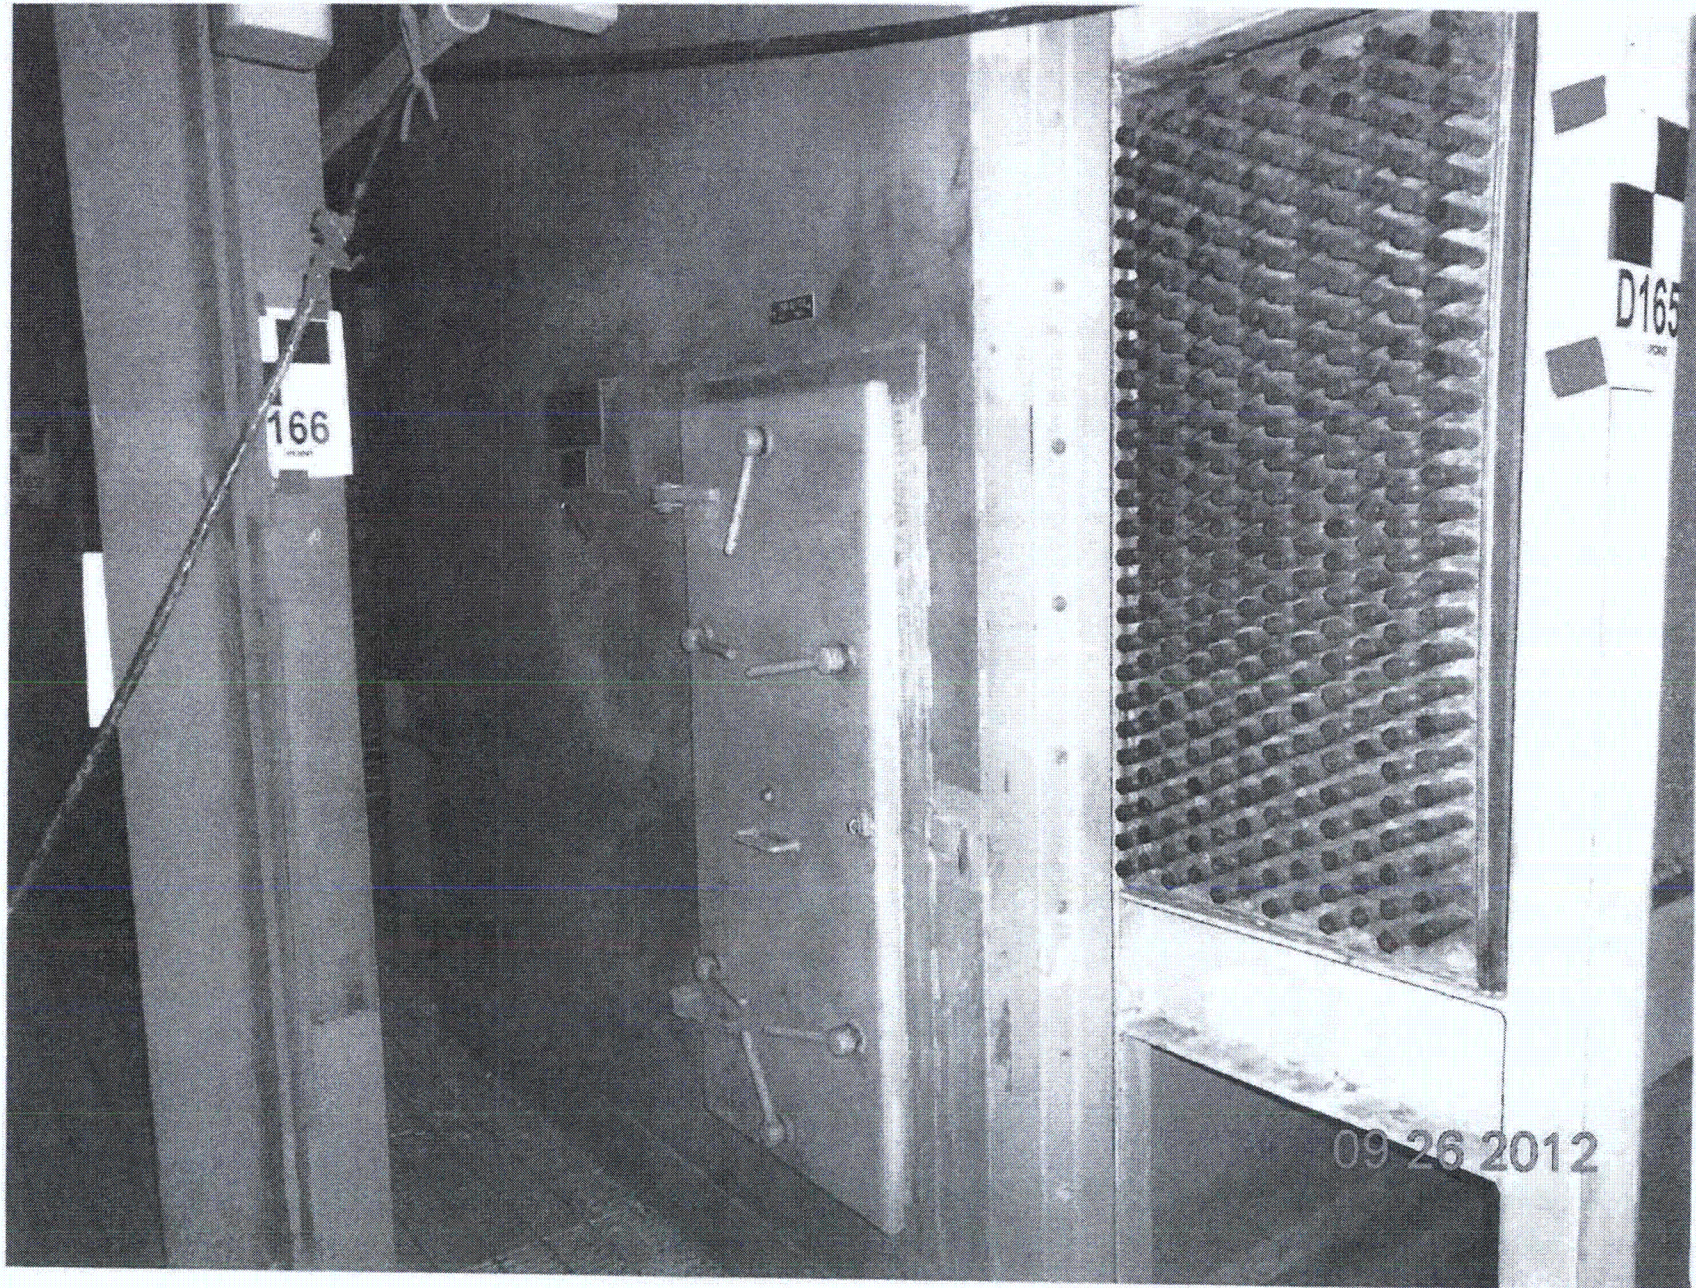
4. Is the anchorage free of visible cracks in the concrete near the anchors?  Y  N  U  N/A  
*Base are bolted to structural steel.*

9. Do attached lines have adequate flexibility to avoid damage?  Y  N  U  N/A  
*Mild oxidation found on u-bolt pipe support was judged to be acceptable.*

*One bolt on the upper flange of the fan was skew however the bolt head and nut were tight against the flange. Also, two screws which attach the grating cover of the fan were missing. These bolting conditions were judged to be acceptable based on the relatively low structural demand on*

**Comments** (Additional pages may be added as necessary) *The bolts and condition of the remaining bolts.*

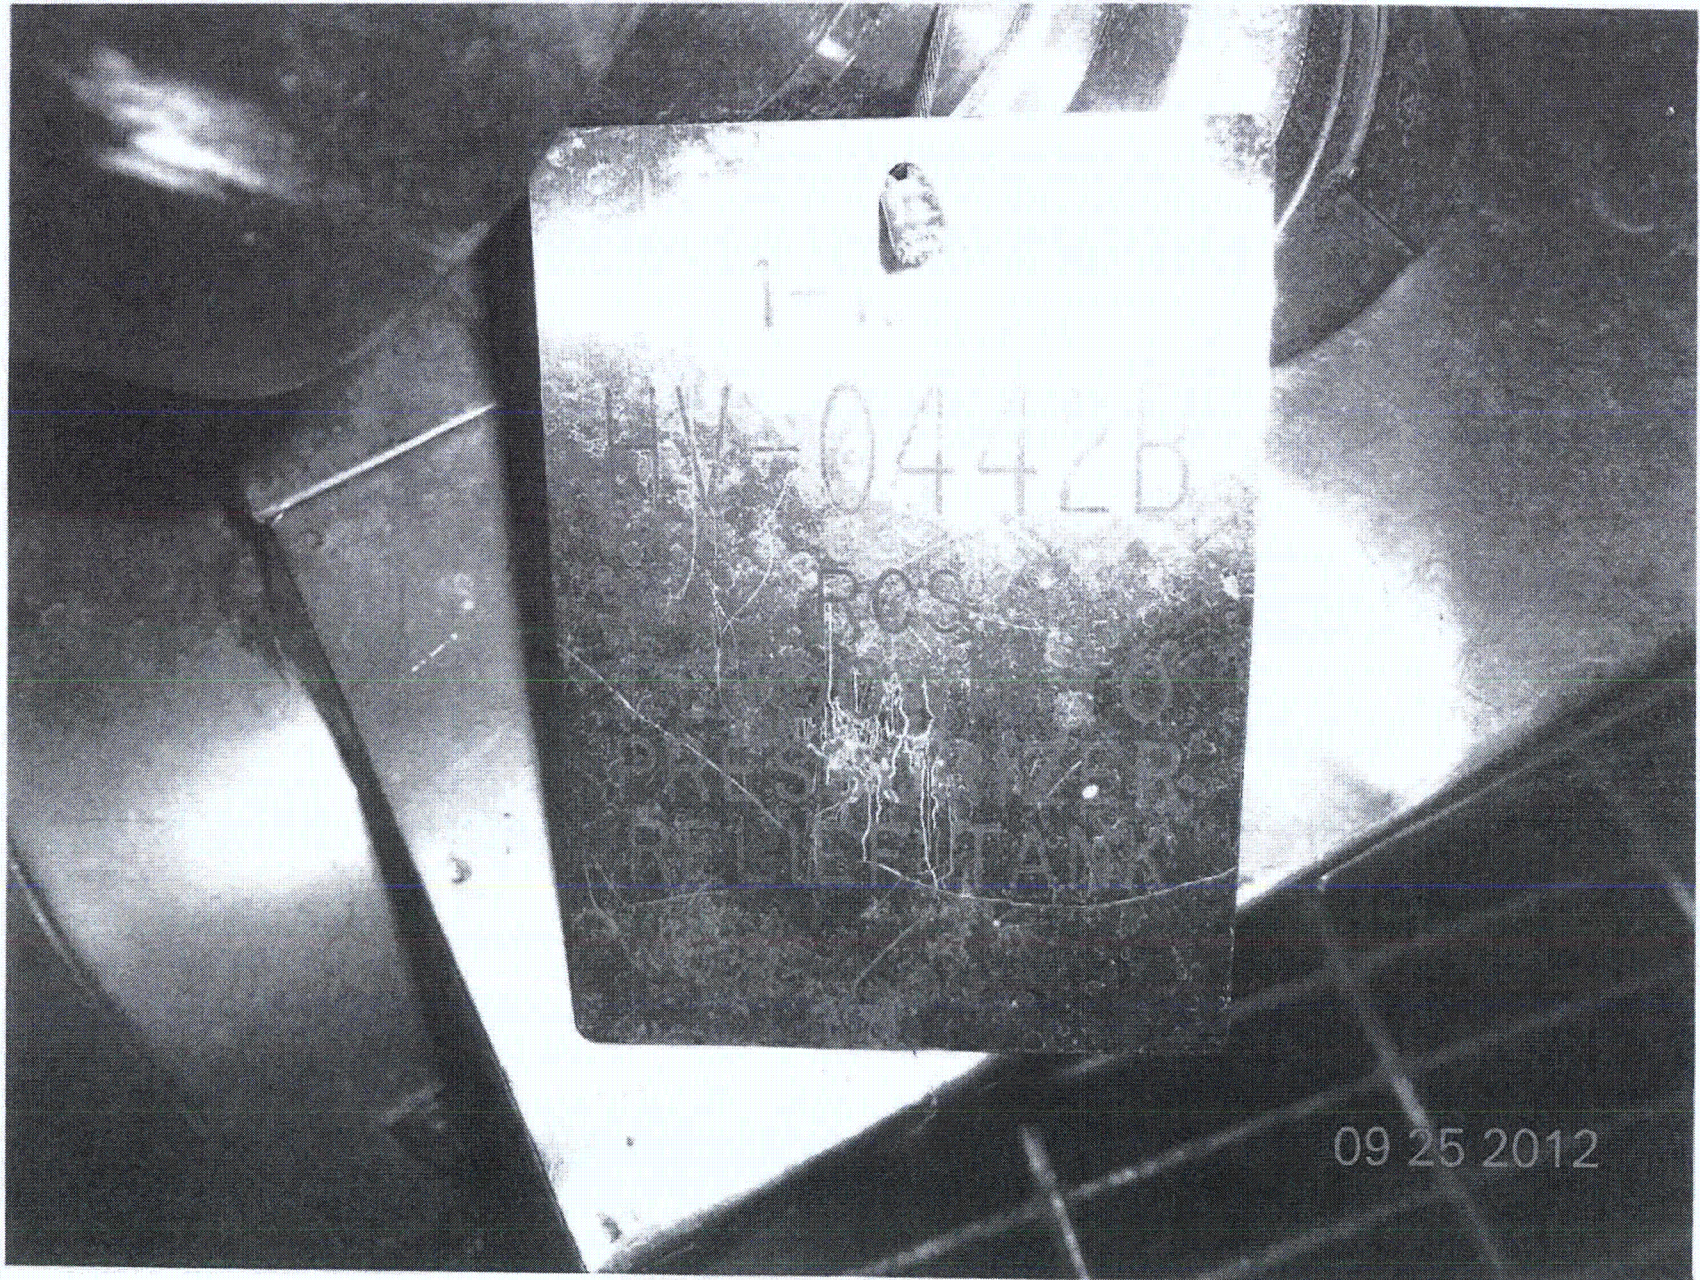
*Insulation is installed on the piping and valve. Welded joints connecting valve to piping (socket welds) are covered. However, this is not a seismic concern. The valve body is partially covered, but bonnet and operator is exposed. U.S. 9/25/12*

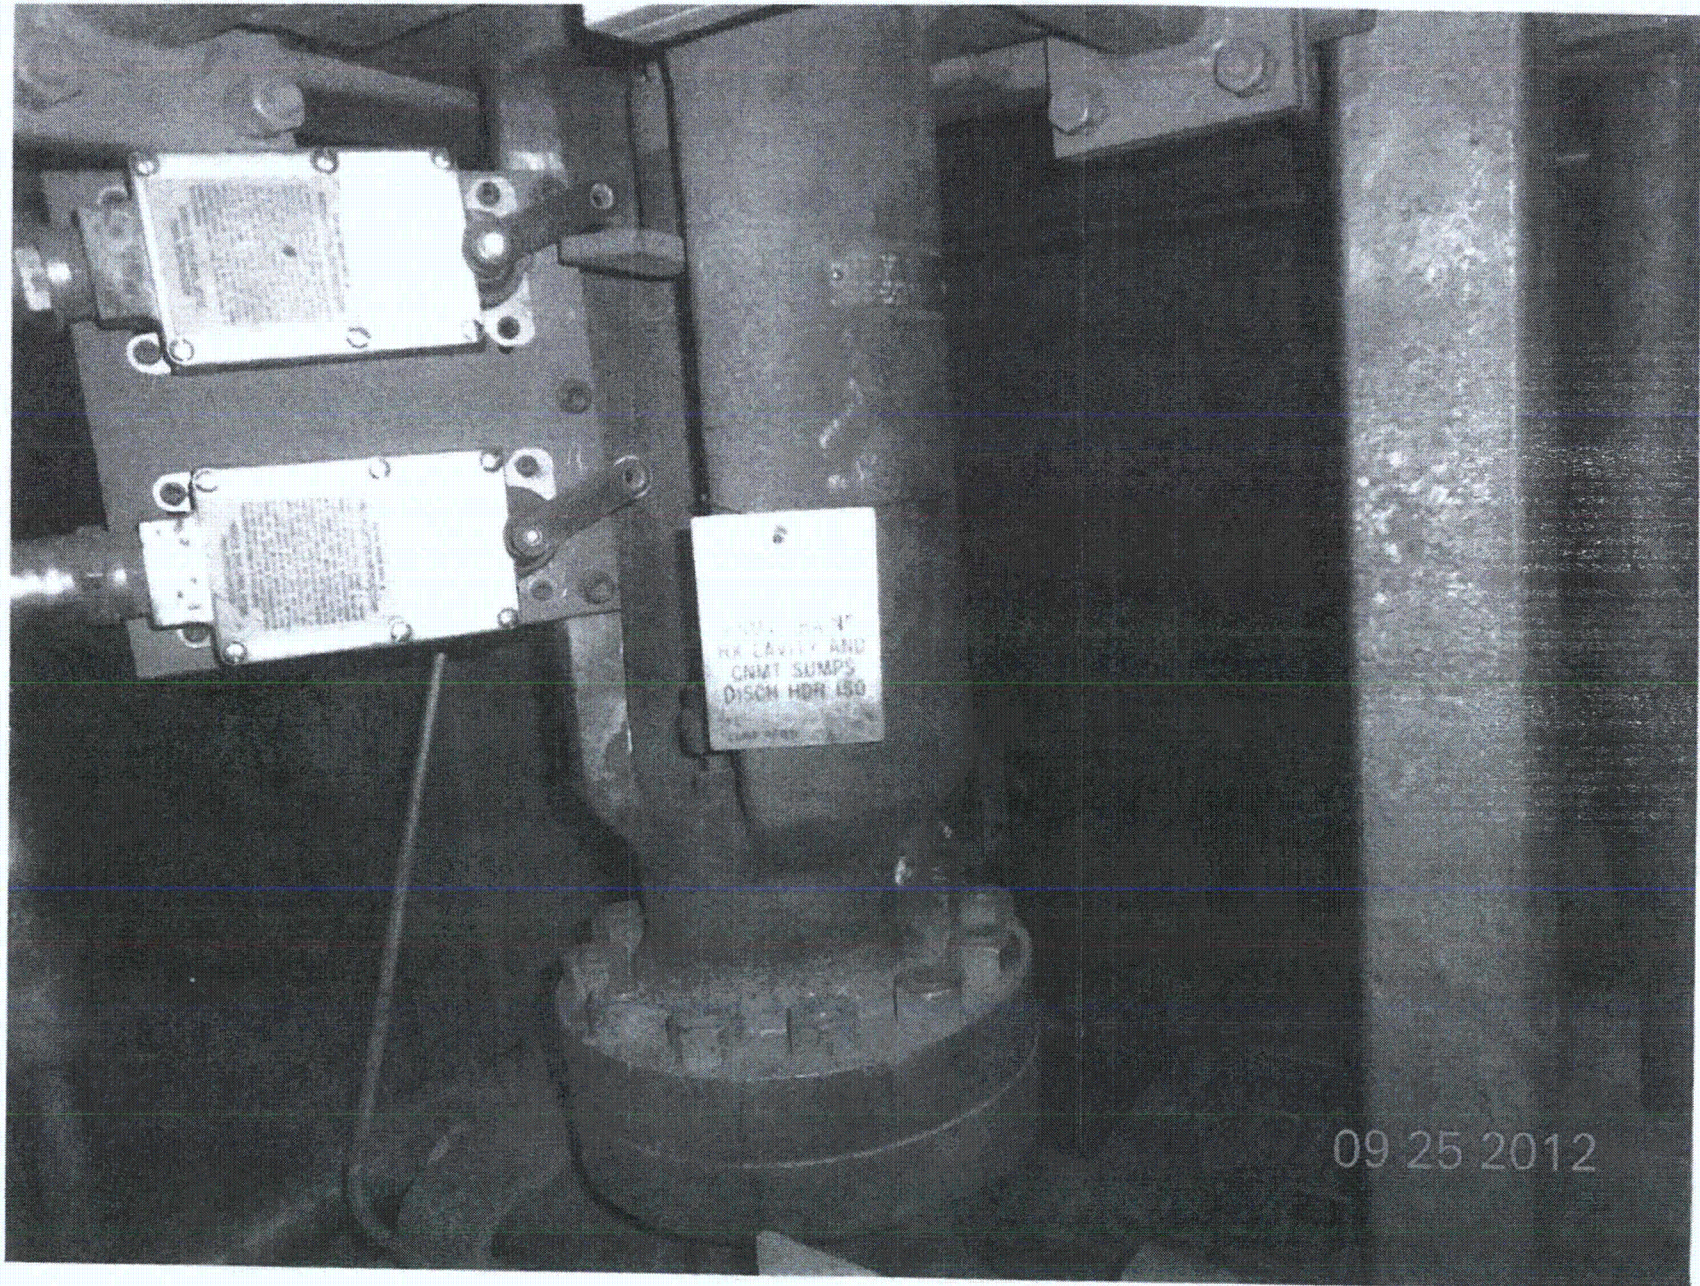
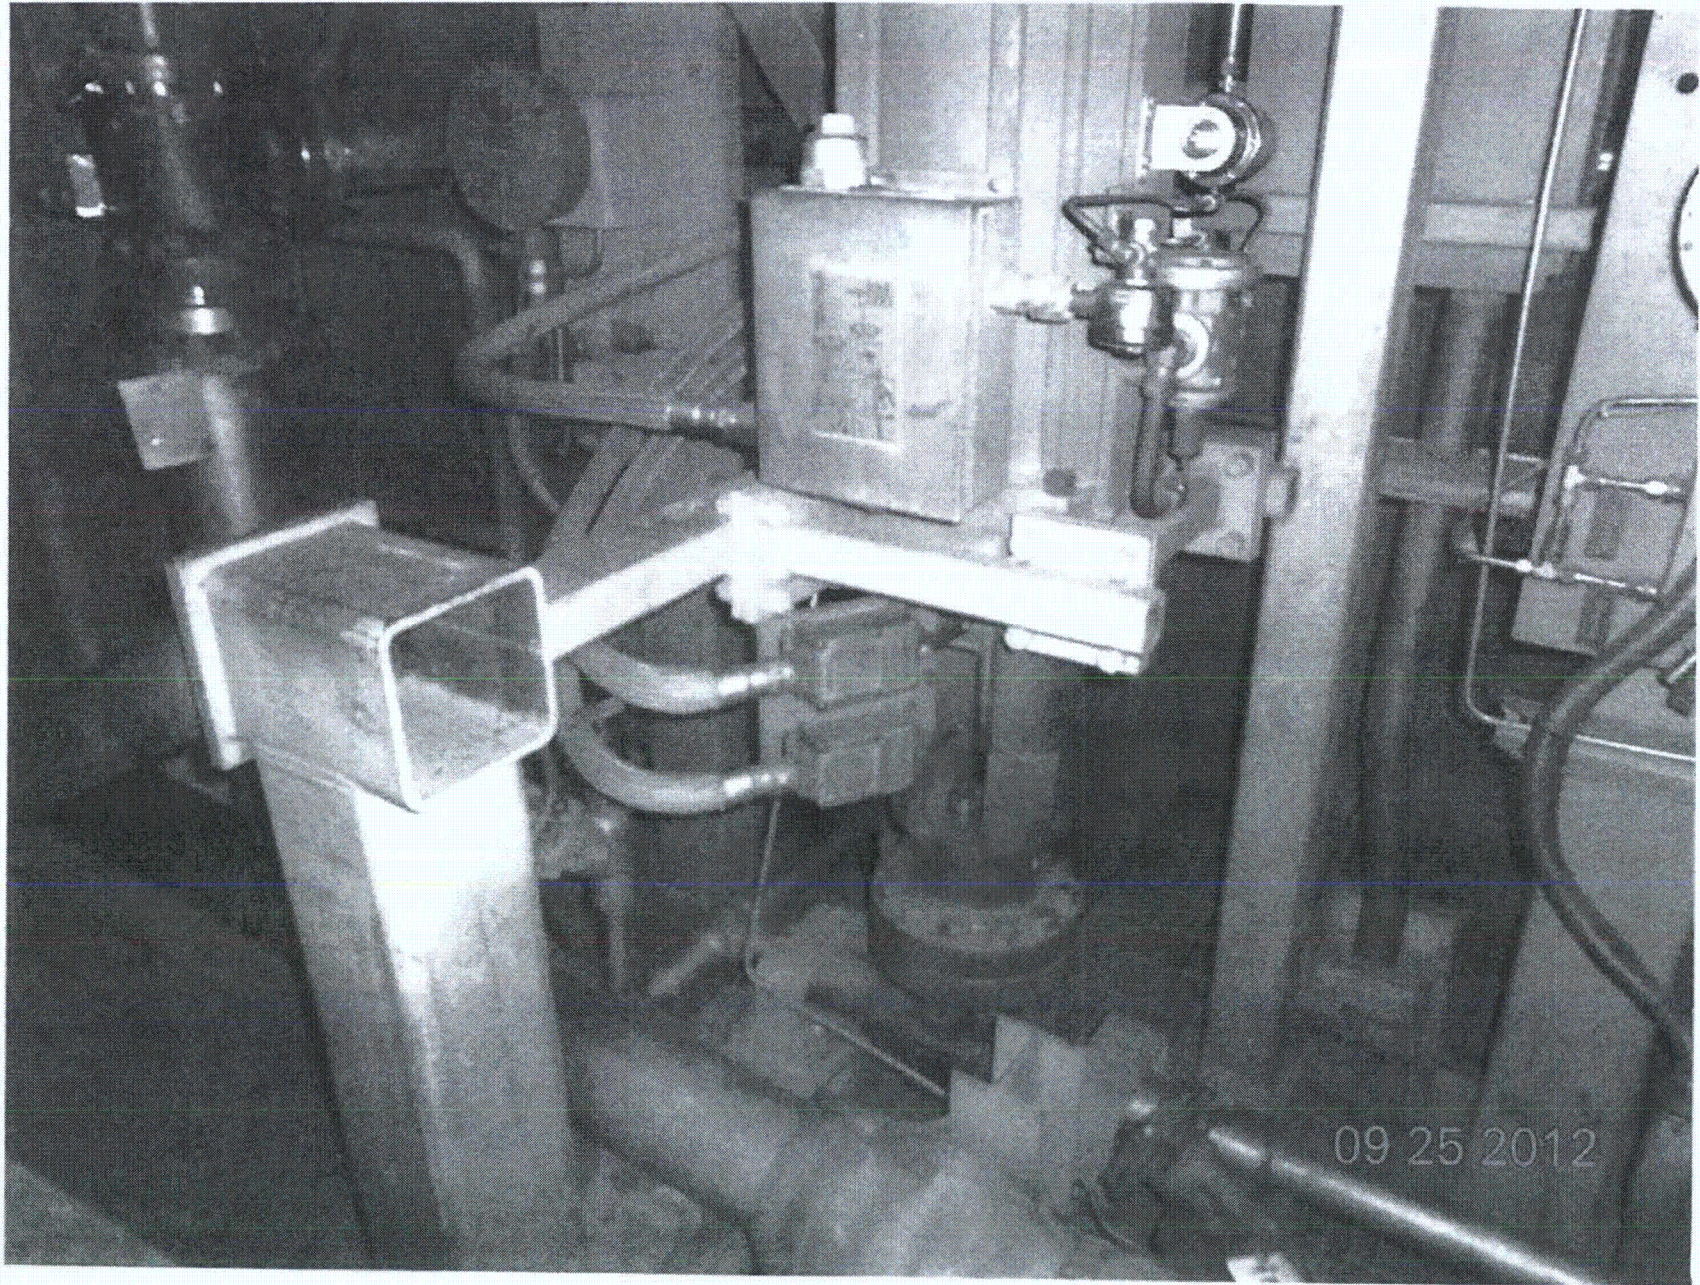
2. Is the anchorage free of bent, broken, missing or loose hardware?  Y  N  U  N/A  
*Inspected horizontal rigid frame which acts as a seismic restraint for the valve.*

4. Is the anchorage free of visible cracks in the concrete near the anchors?  Y  N  U  N/A  
*Welded to structural steel*

*Near by ext sign W.S. 9/25/12 sign has a loose cover. The cover is not a seismic concern to the valve or other components in the area due to the relatively small mass of the cover. RSP. CR 540127*

*Scaffolding installed near the valve was adequately restrained for seismic loads.*

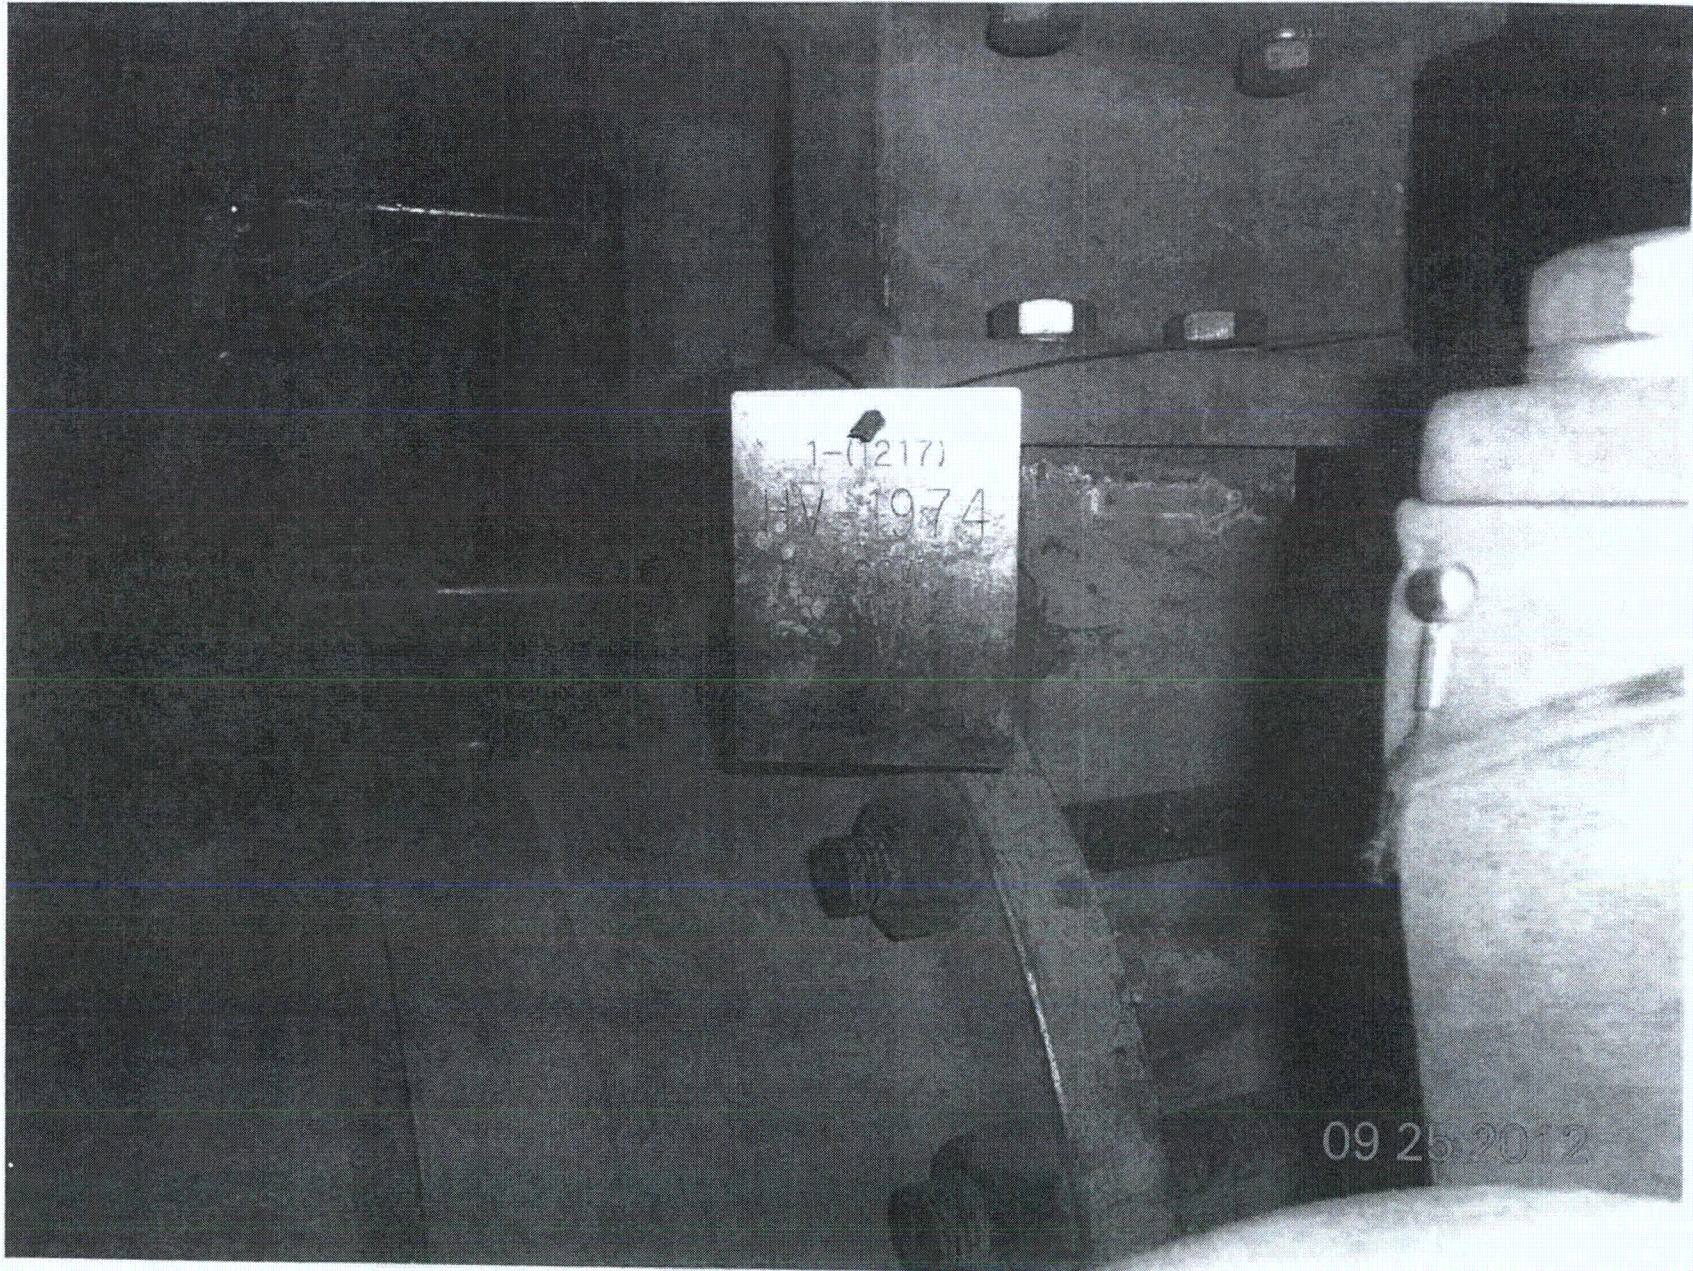
*Only structural steel and grating above - satisfactory installation.*

*Flexible conduits attached*

*Scaffolding around and near component is seismically installed - well supported.*

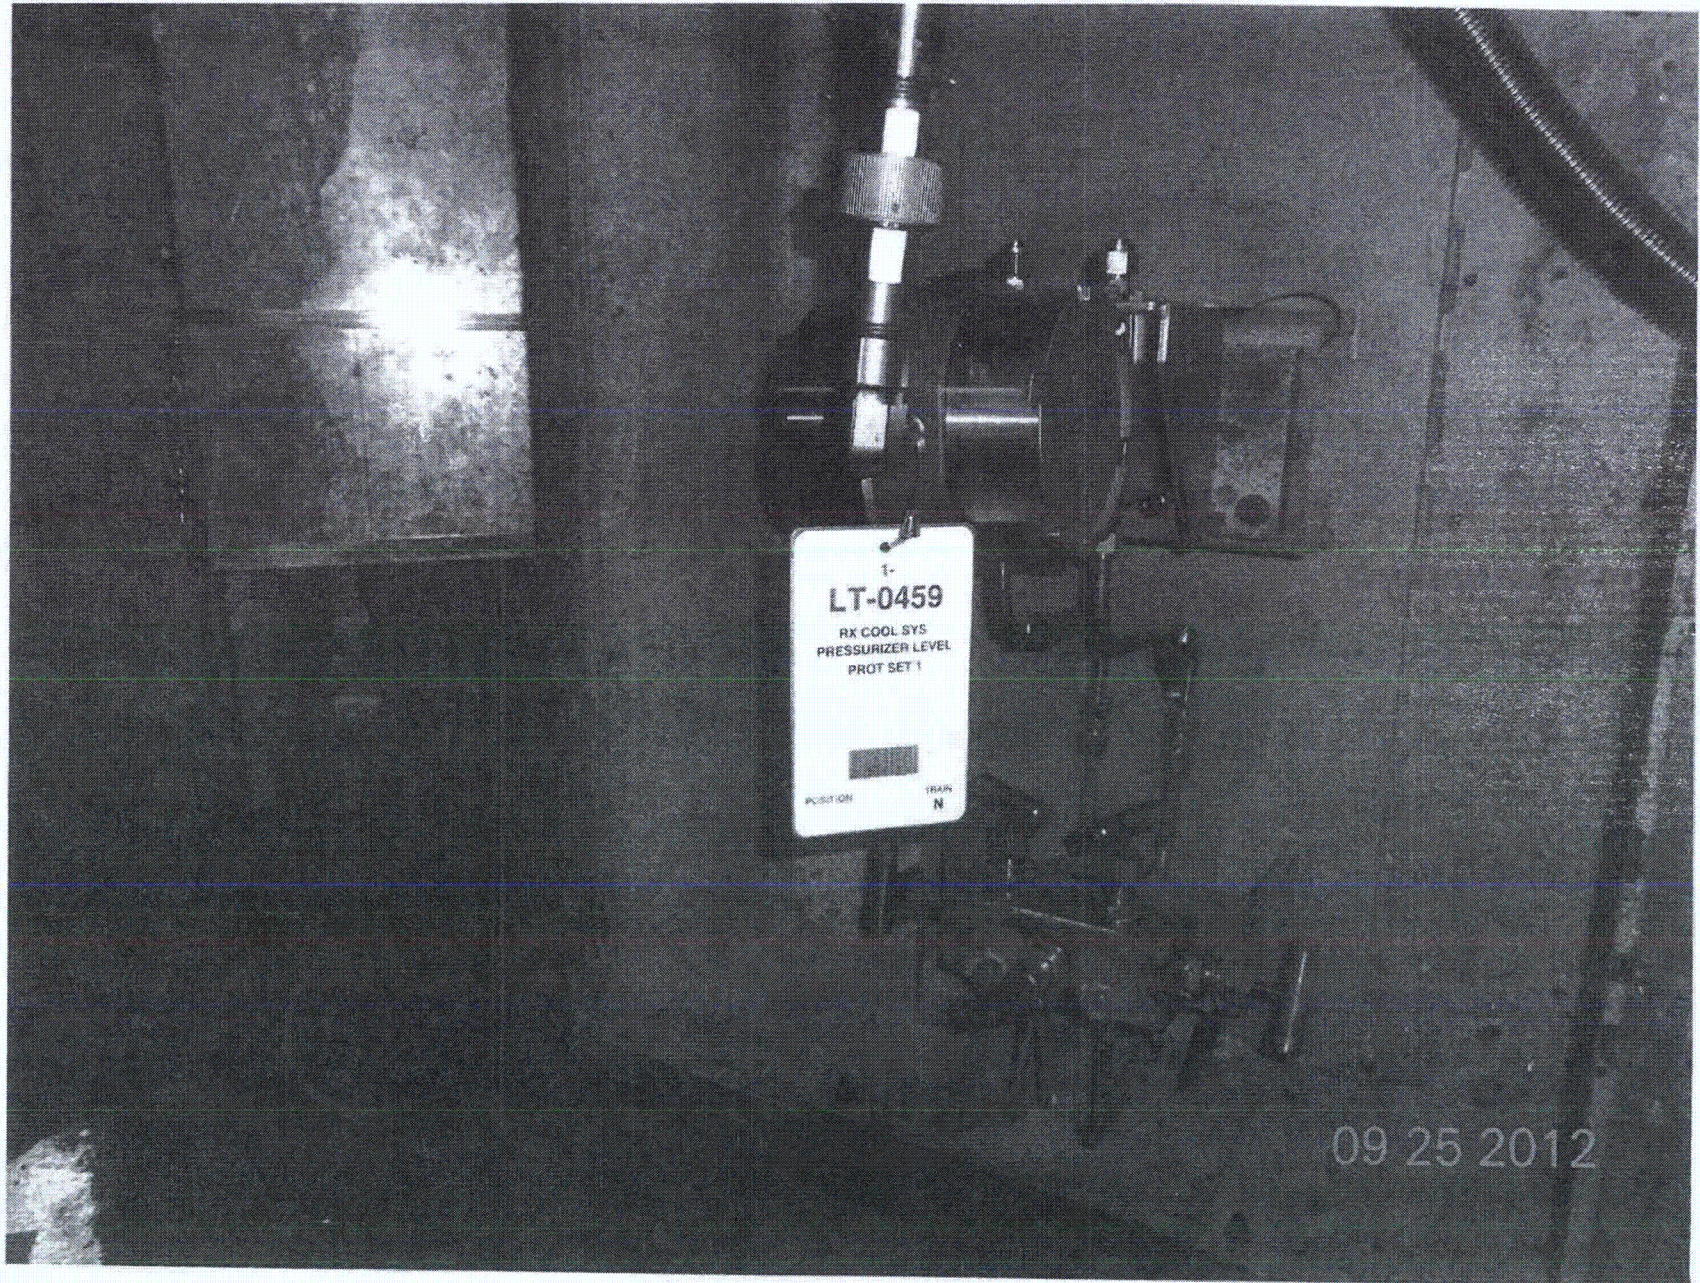
2. Is the anchorage free of bent, broken, missing or loose hardware?  Y  N  U  N/A  
*Welded to Base plate*

4. Is the anchorage free of visible cracks in the concrete near the anchors?  Y  N  U  N/A  
*Welded to steel plate*  
*for 9/25/12*

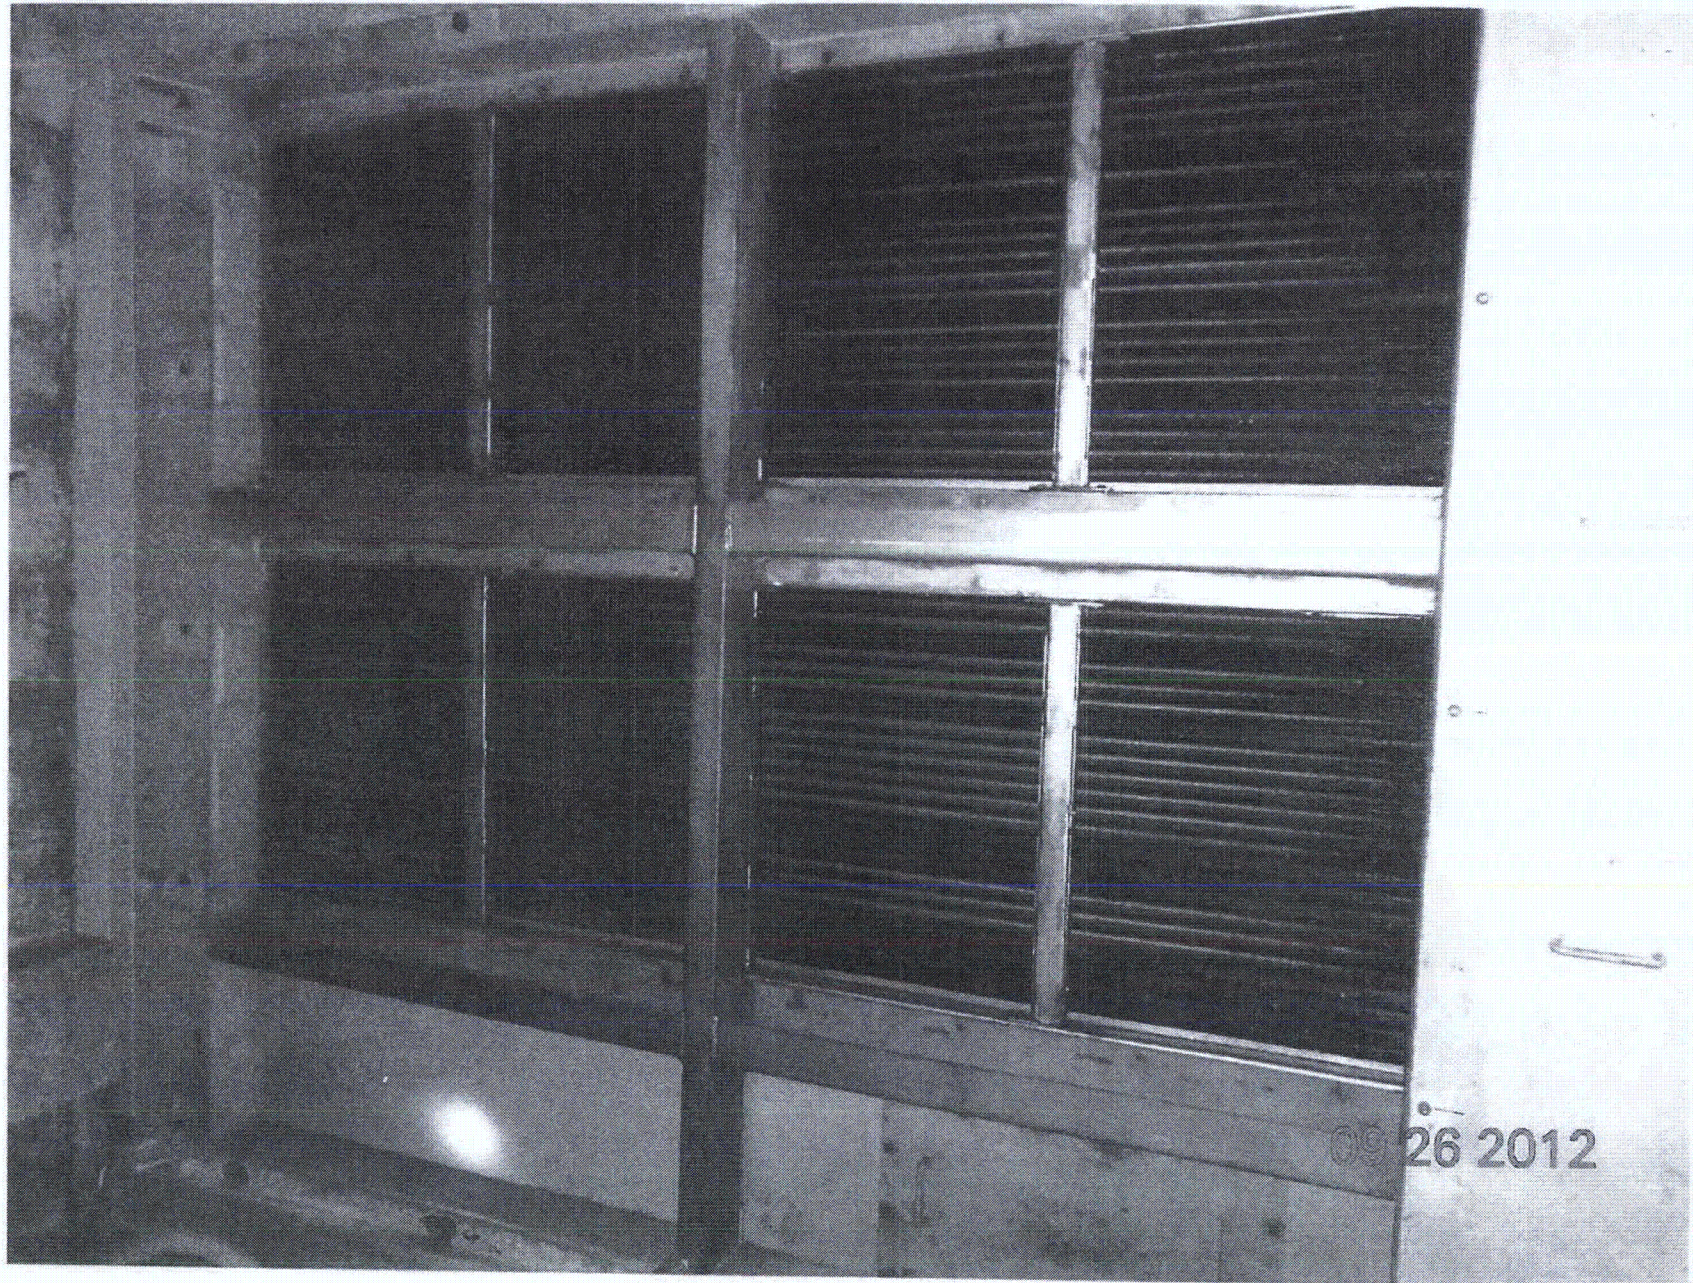
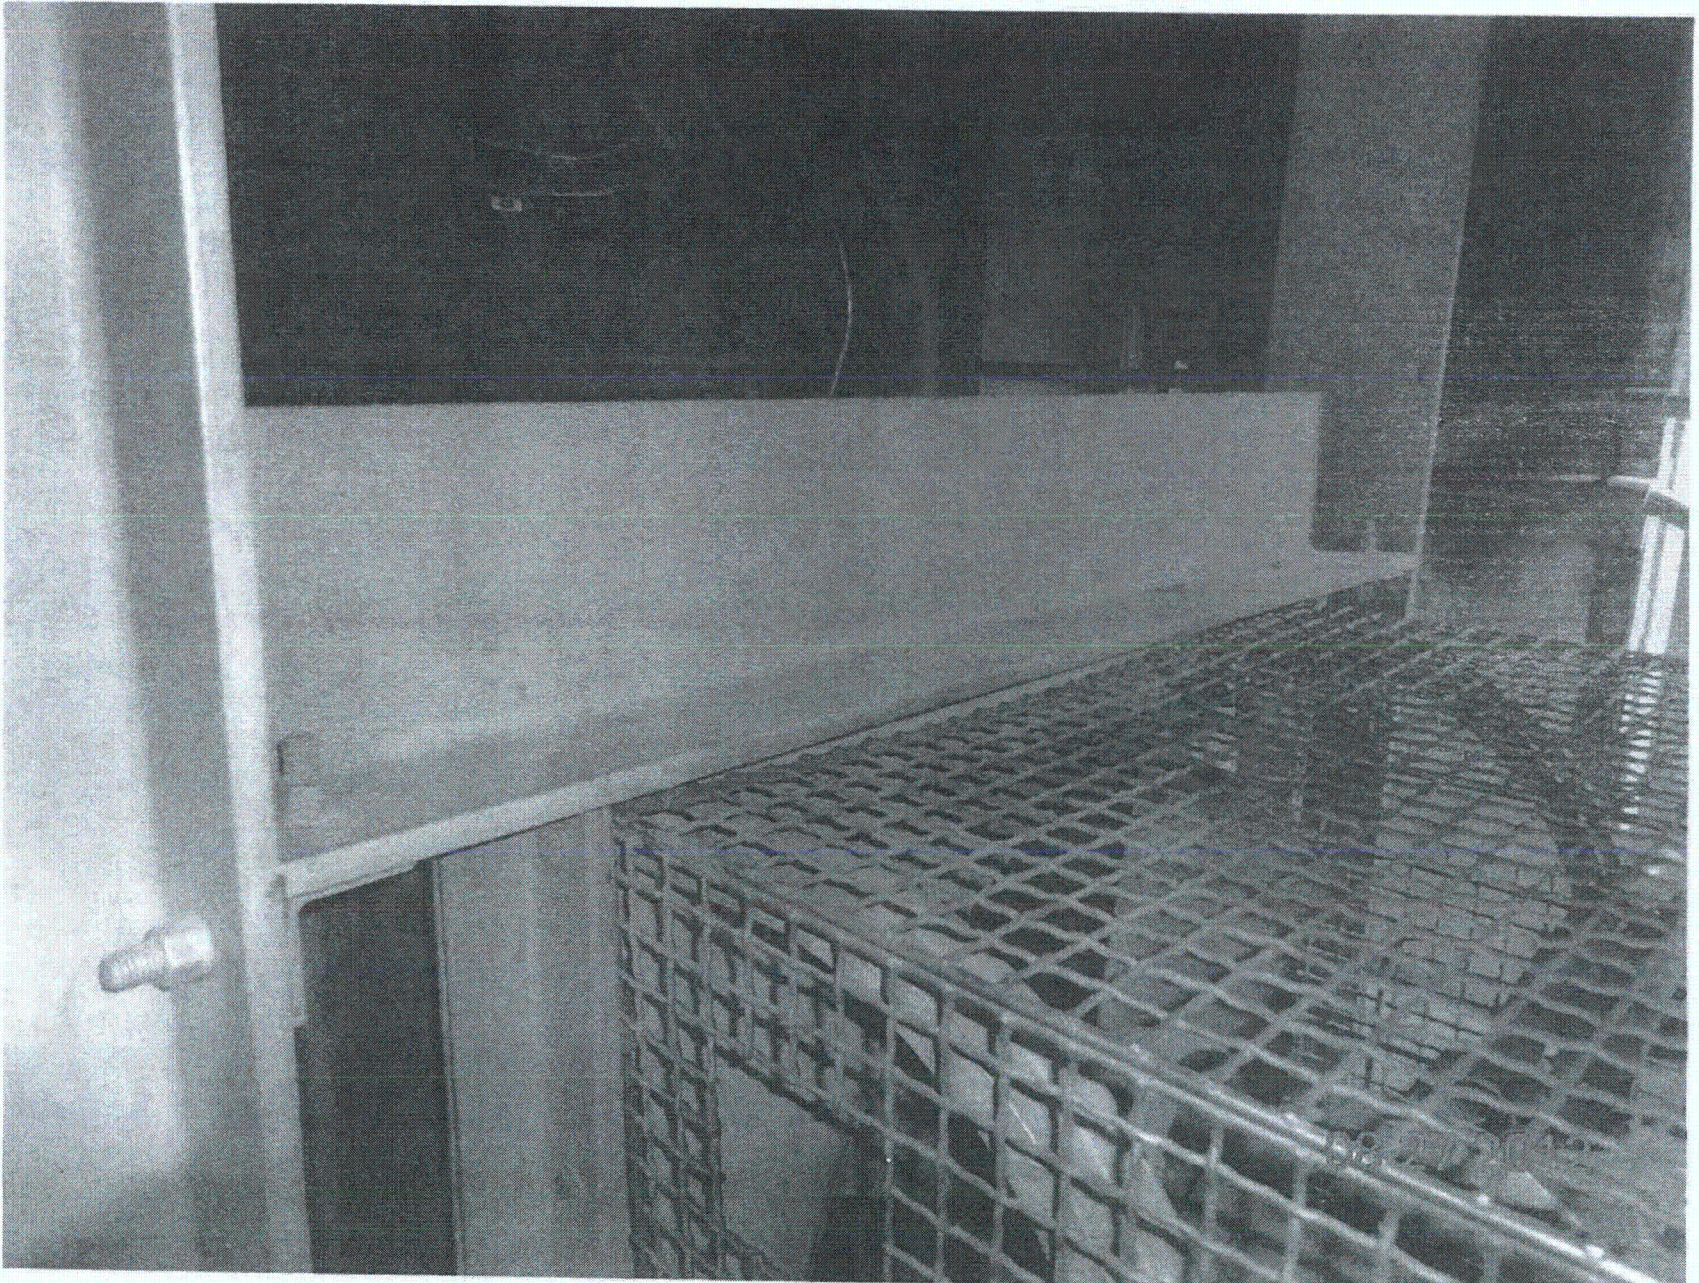
*Only mild surface oxidation was found on some anchor bolts. Therefore, the corrosion was judged to be acceptable.*

*Room is difficult to access - requires opening a heavy hatch cover at the top of a ladder.*
