**Seismic Walkdown Checklist (SWC)**

Equipment ID No: 1-1501-A7-004-000 Equip. Class<sup>1</sup> 10 - Air Handlers

Equipment Description CTB Cooling Unit & Motor

Location: Bldg. CTB Floor El. 220'±0" Room, Area 1401 Near Column #16

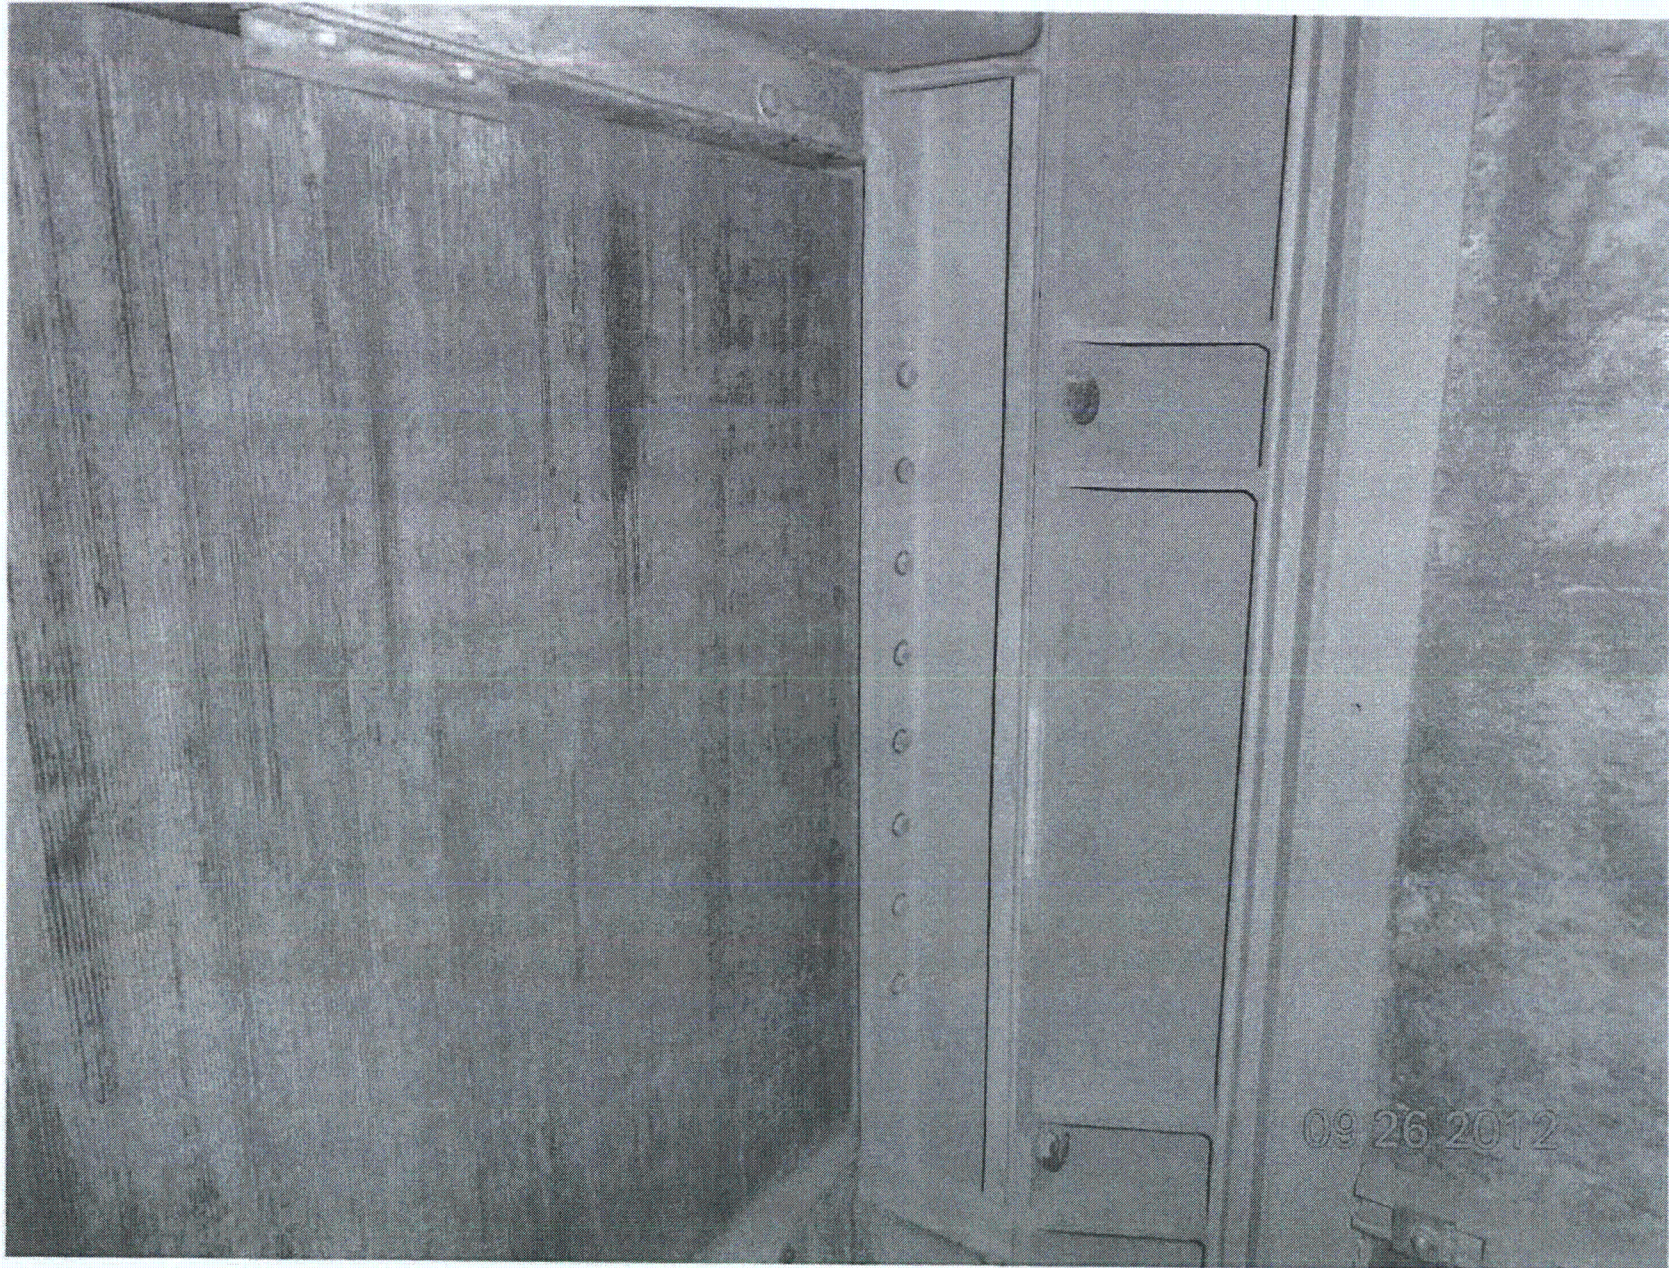
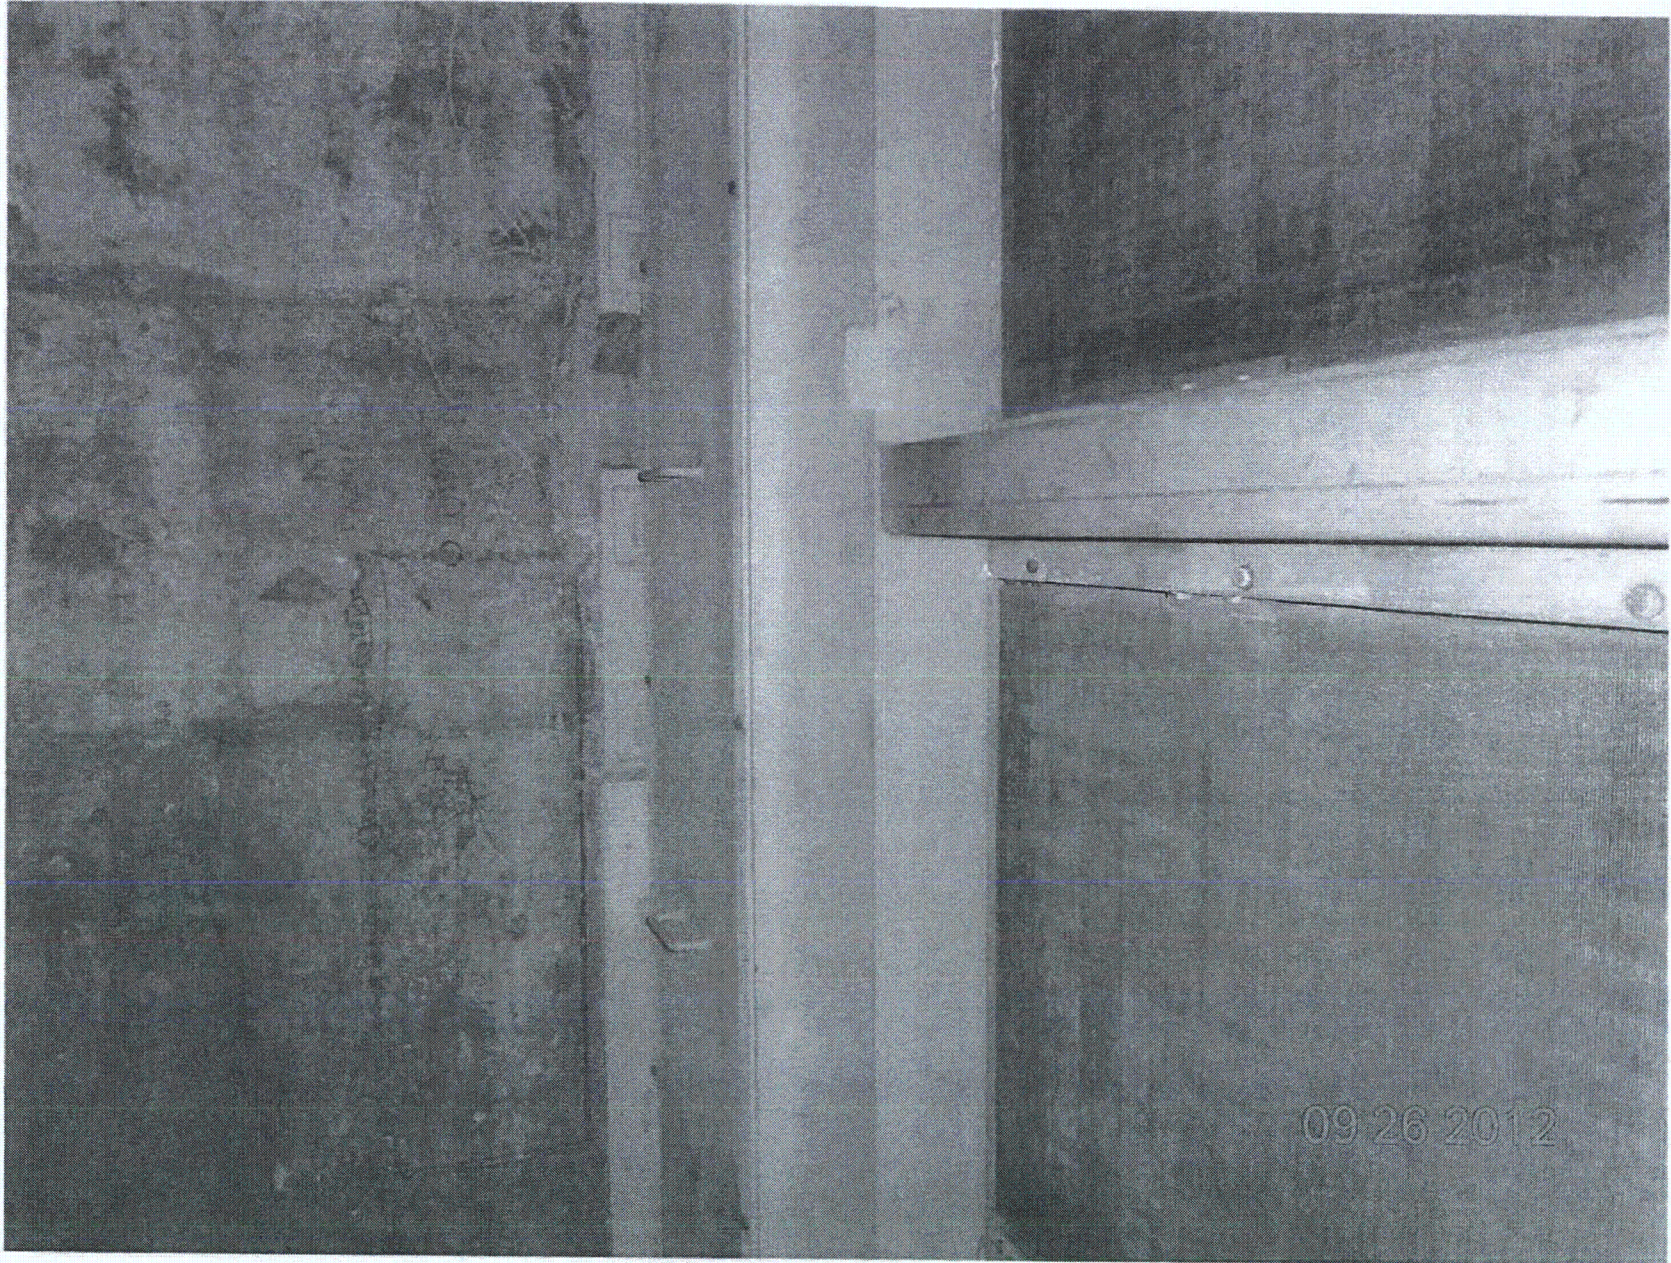
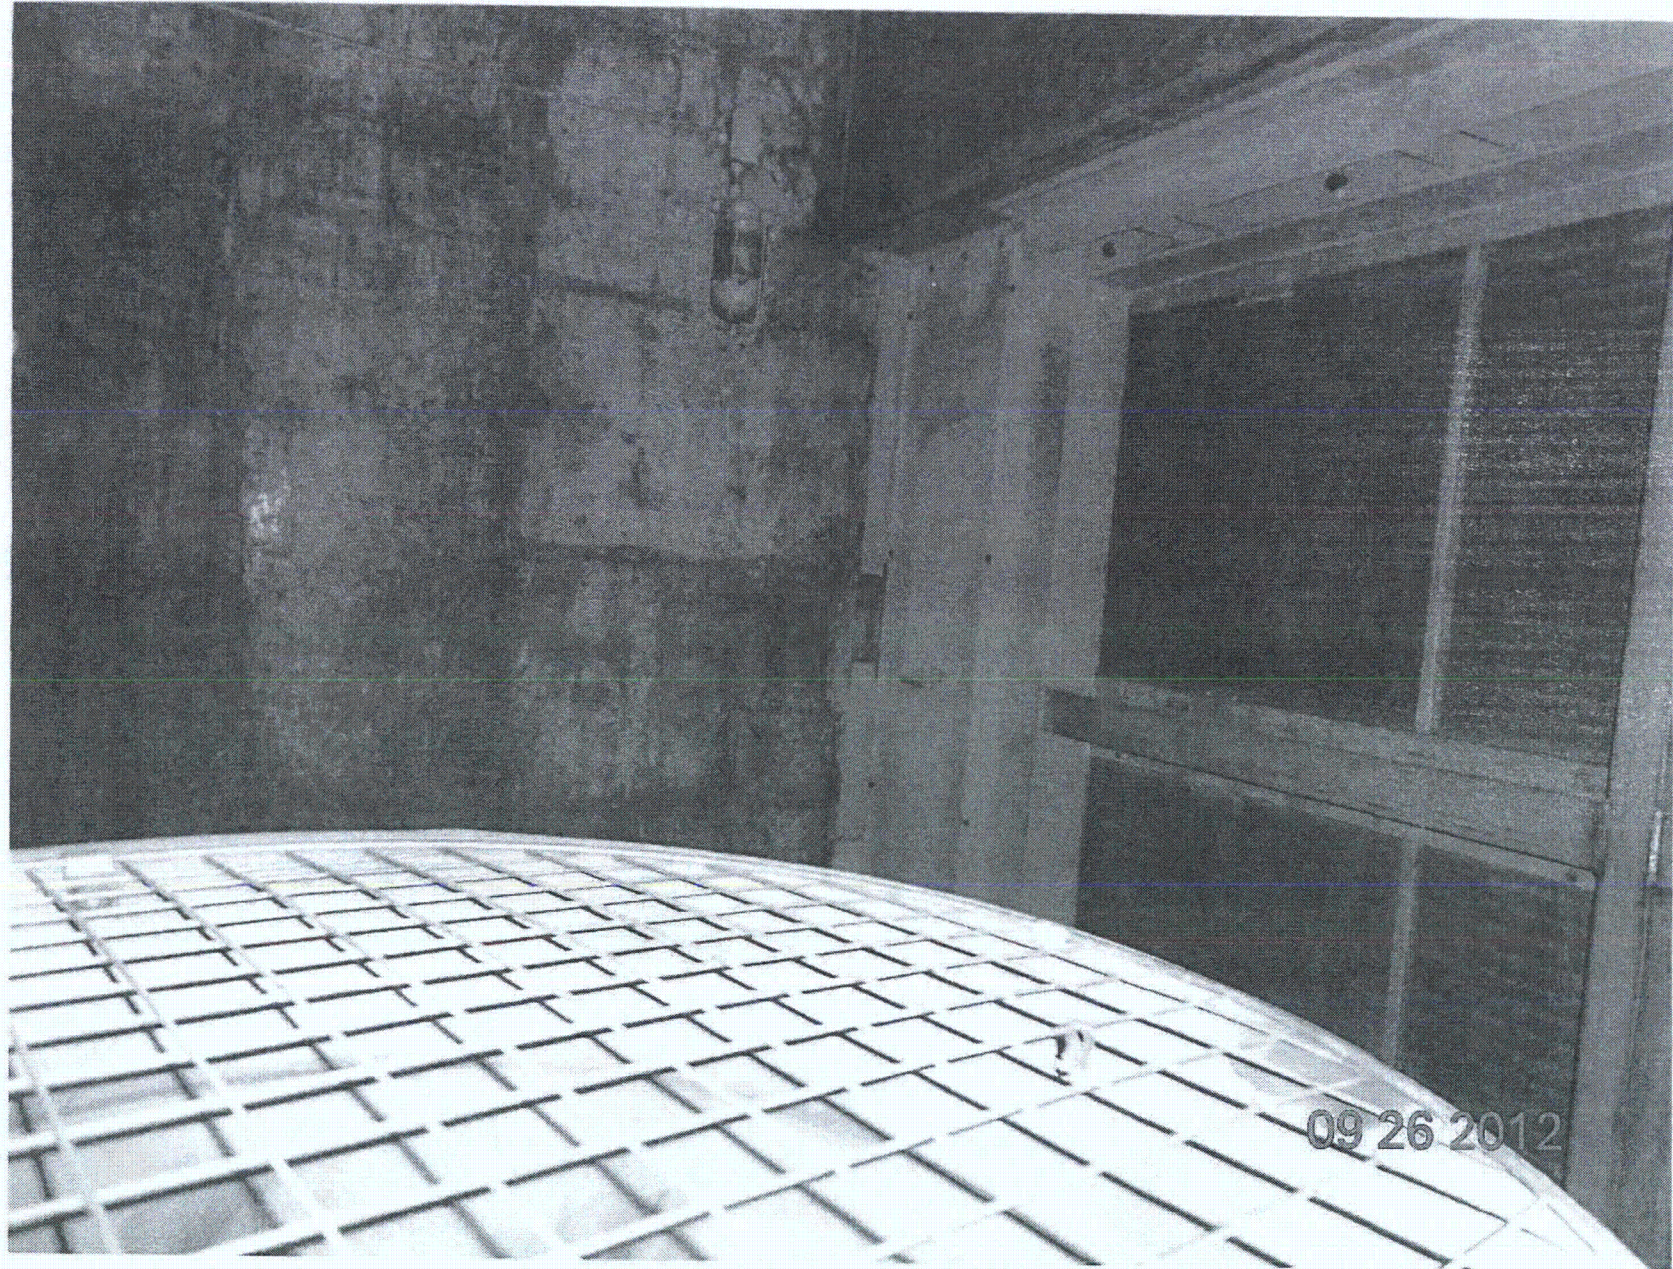
3. Is the anchorage free of corrosion that is more than mild surface oxidation?  Y  N  U  N/A  
*Only mild surface oxidation was found on some bolts. Therefore corrosion was judged to be acceptable.*
