ATTACHMENT 3: SEISMIC WALKDOWN CHECKLISTS

NO. SNCF164-RPT-02			
	Shee	tiof 2	TAM 11/13/2012
			-

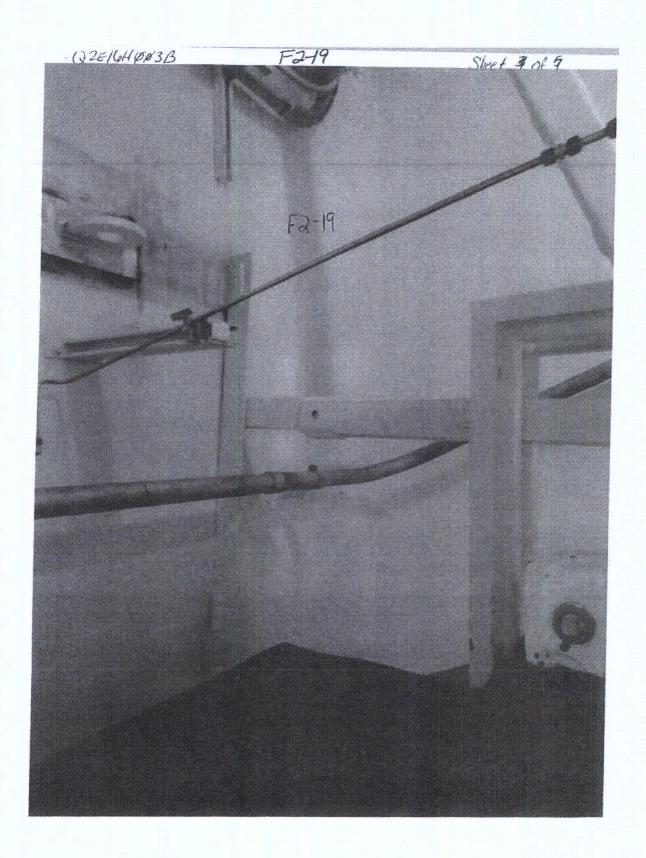
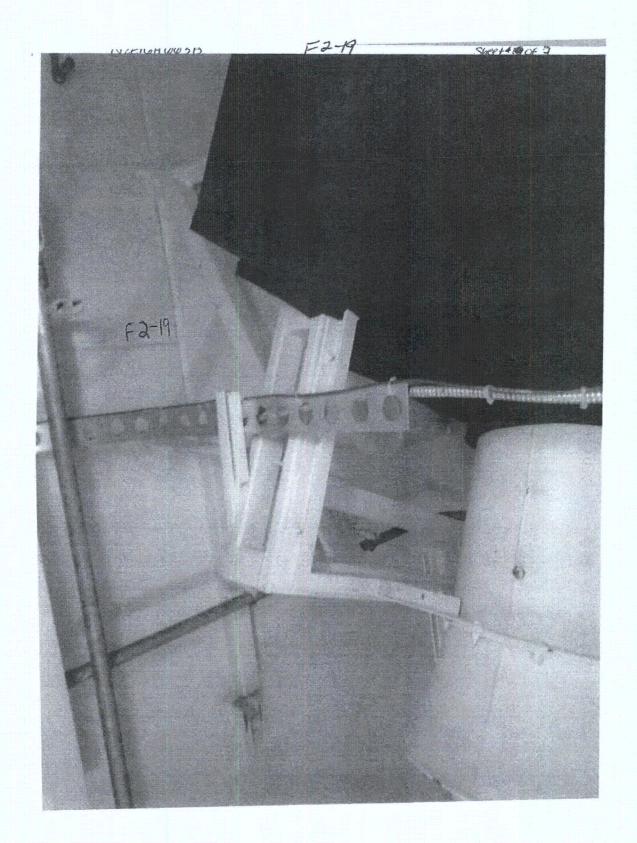
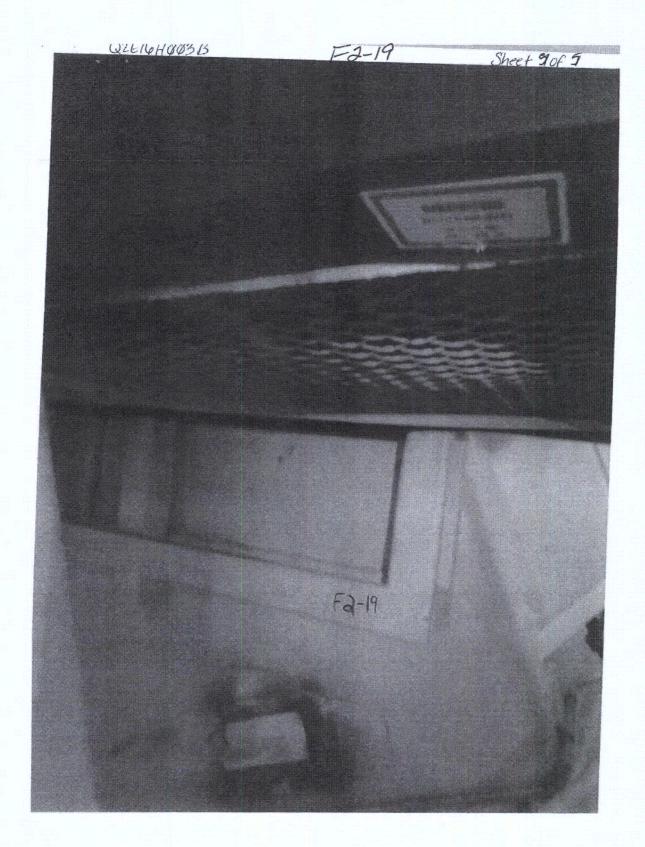
11. Have you looked for and found no other seismic conditions that could adversely affect the safety functions of the equipment?	
Comments (Additional pages may be added as necessary)	
Portions of anchorage covered (blocked by ) pased on Visible portions, anchorage judged Verse seismic conditions. Sufficient anch event this evaluation	to be the ot
Evaluated by: SLOT WALDEN fint Walden	Date: 8, 2- 3.2

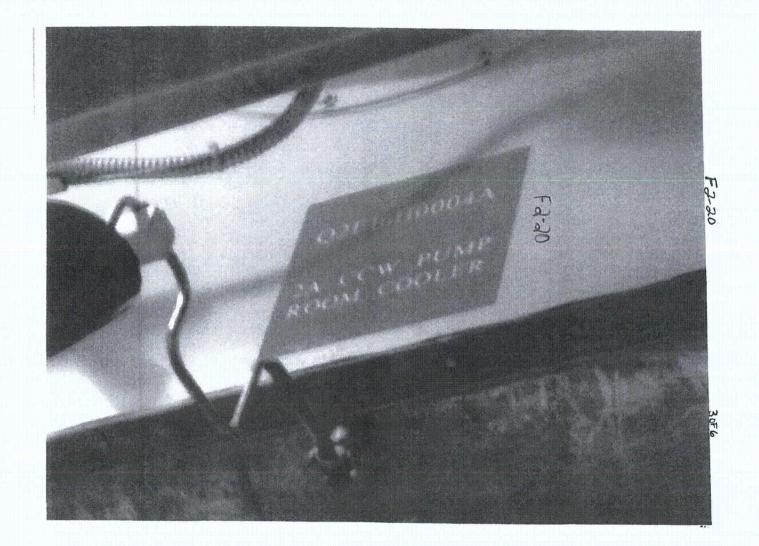
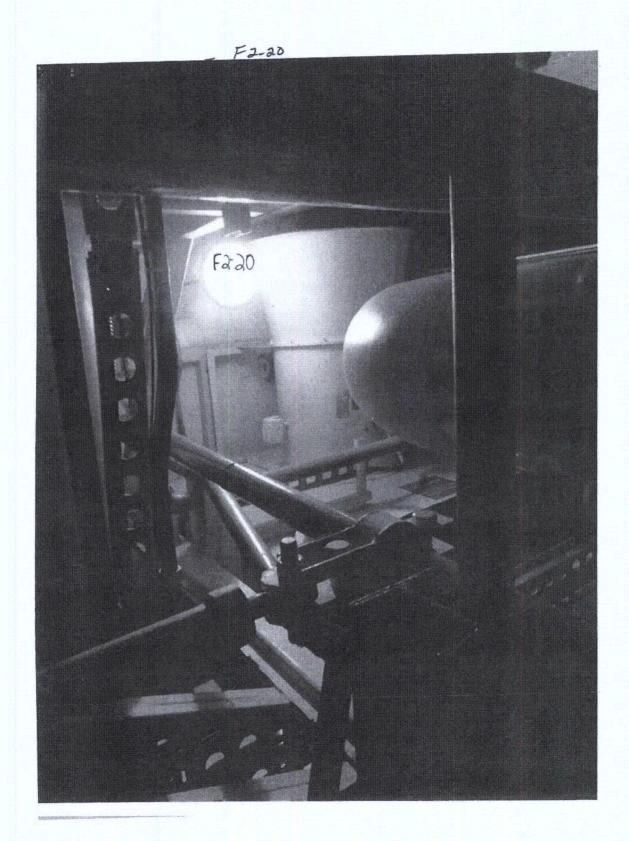
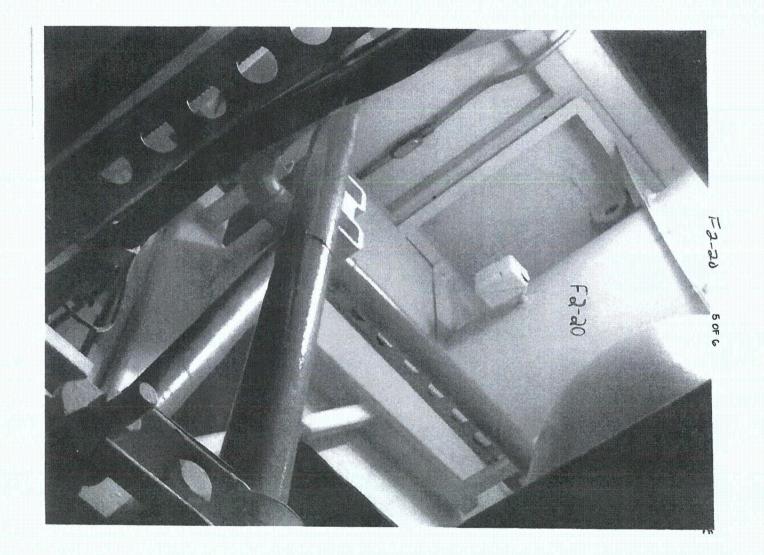
Seismic Walkdown Checklist (SWC)	
Equipment ID No. <u>Q2E16H004A</u> Equip. Class <sup>1</sup> <u>10</u>	
Equipment Description CCW PUMP ROOM COOLER TRAIN A	
Location: Bldg. <u>AUXILIARY</u> Floor El. <u>100</u> Room, Area <u>2185</u>	
Manufacturer, Model, Etc. (optional but recommended)	
Instructions for Completing Checklist This checklist may be used to document the results of the Seismic Walkdown of SWEL. The space below each of the following questions may be used to record findings. Additional space is provided at the end of this checklist for documentin	the results of judgments and
Anchorage	
<ol> <li>Is the anchorage configuration verification required (i.e., is the item one of the 50% of SWEL items requiring such verification)?</li> <li>COOLER IS MOUNTED TO CEILING AND IT IS NOT POSSIBLE TO VERIFY WELDS TO EMBEDDED STEEL IN CEILING</li> </ol>	Y□ N⊠

4. Is the anchorage free of visible cracks in the concrete near the anchors?	Y⊠ N□ U□ N/A□
the second se	
5. Is the anchorage configuration consistent with plant documentation? (Note: This question only applies if the item is one of the 50% for which an anchorage configuration verification is required.) U212563 REV 0 (9-26-03) - UNABLE TO VERIFY	Y□ N□, Ŭ□ N/A⊠

NO. SNCF164-RPT-02, VERSION 1.0 ATTACHMENT 3: SEISMIC WALKDOWN CHECKLISTS F2-20 Sheet 2 of g 11/13/202 Status: YX N U Seismic Walkdown Checklist (SWC) Equipment ID No. <u>Q2E16H004A</u> Equip. Class<sup>1</sup> 10 Equipment Description <u>CCW PUMP ROOM COOLER TRAIN A</u> Interaction Effects 7. Are soft targets free from impact by nearby equipment or structures? YX NO UO N/AO 8. Are overhead equipment, distribution systems, ceiling tiles and lighting,  $Y \boxtimes N \square U \square N/A \square$ and masonry block walls not likely to collapse onto the equipment? 9. Do attached lines have adequate flexibility to avoid damage? YX NO UO N/AO 10. Based on the above seismic interaction evaluations, is equipment free YX NO UO of potentially adverse seismic interaction effects? **Other Adverse Conditions** 11. Have you looked for and found no other seismic conditions that could YX ND UD adversely affect the safety functions of the equipment? **Comments** (Additional pages may be added as necessary) AREA WALK-BY FOR ROOM 2185 IS IN FOLDER F2-79 (Q2P17H001B)

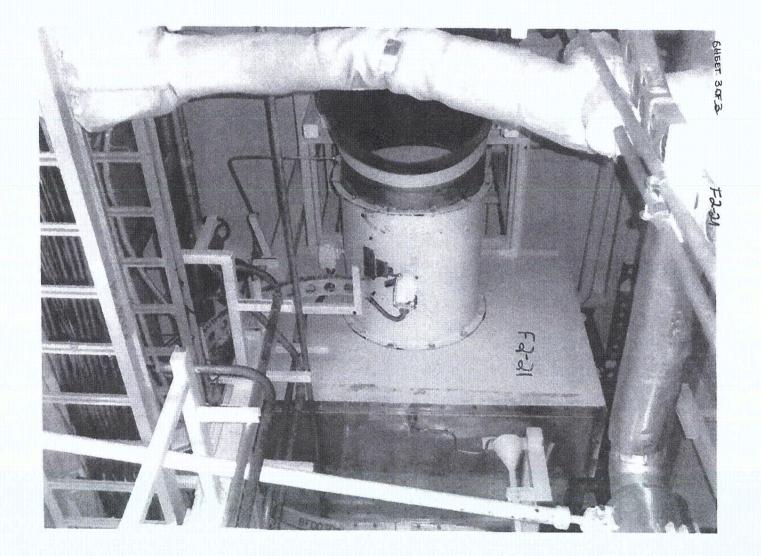
9. Do attached lines have adequate flexibility to avoid damage?	
Too high up to see everything but see No o that	the a sessie concentre
<ol> <li>Based on the above seismic interaction evaluations, is equipment free of potentially adverse seismic interaction effects?</li> </ol>	
Other Adverse Conditions	tigen in andreas of the second se
Other Adverse Conditions           11. Have you looked for and found no other seismic conditions that could adversely affect the safety functions of the equipment?

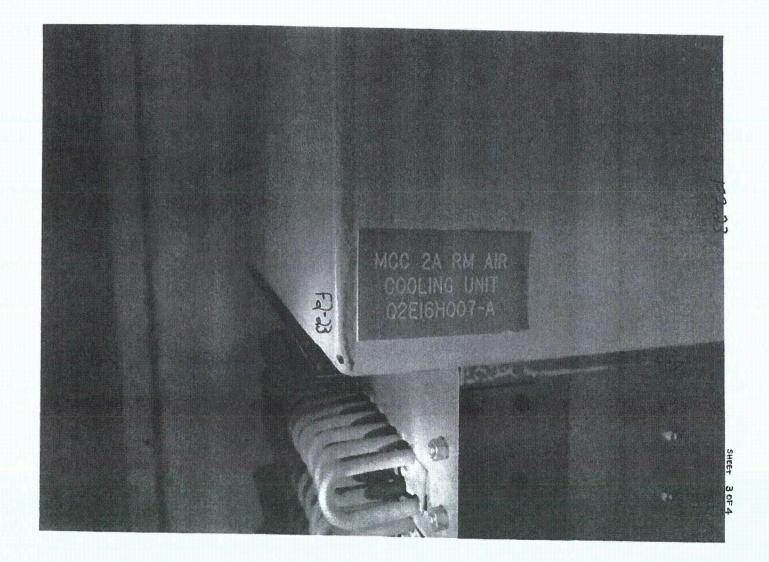
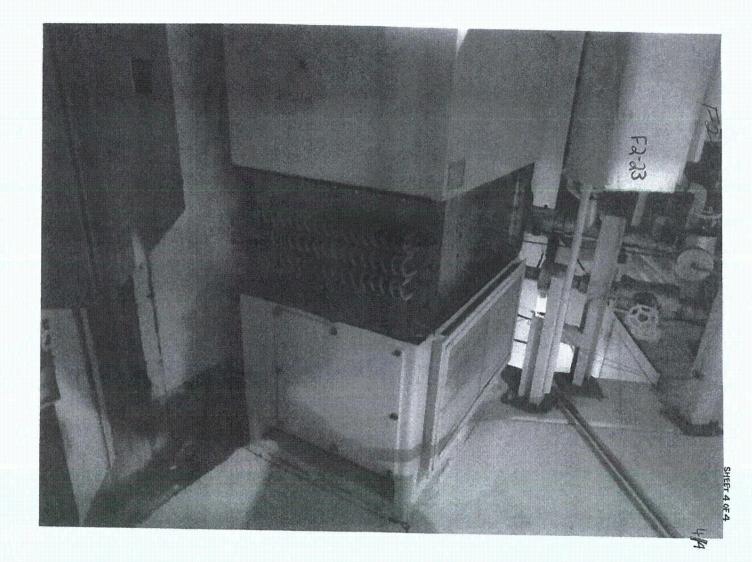
- 2 题	₩ 8 Sheet 1 of g 4 Status: YIT N U
Seismic Walkdown Checklist (SWC)	Status: Y ✓ N U
Equipment ID No. <u>Q2E16H007</u> Equip. Classi <u>10</u>	
Equipment Description MCC 2A ROOM COOLER	
Location: Bldg: AUXILIARY Floor El. 139 Room, Area 2332	
Manufacturer, Model, Etc. (optional but recommended)	
Instructions for Completing Checklist This checklist may be used to document the results of the Seismić Walkdown of SWEL. The space below each of the following questions may be used to recom- findings: Additional space is provided at the end of this checklist for document	the results of judgments and
Anchorage	y.
<ol> <li>Is the anchorage configuration verification required (i.e., is the item one of the 50% of SWEL items requiring such verification)?</li> <li>WELDED TO ENGEDDED STEEL.</li> </ol>	e yong
NELVED IF CREEDED SHEL

11. Have you looked for and found no other seismic conditions that could adversely affect the safety functions of the equipment?	YD/ND UD
<u>Comments (</u> Additional pages may be added as necessary) NoNE	<u></u>
AT DIA	D 10.
Evaluated by: <u>S. YUAN</u> <u>Alephen fun</u> P. MIKTUS Builtonill Tur	Date: <u>B:26-12</u> B-28-12-

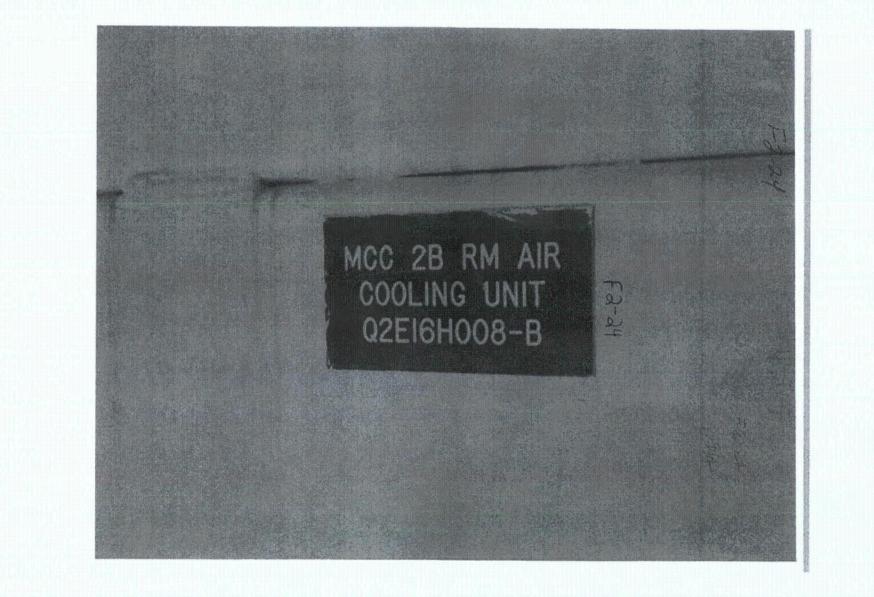
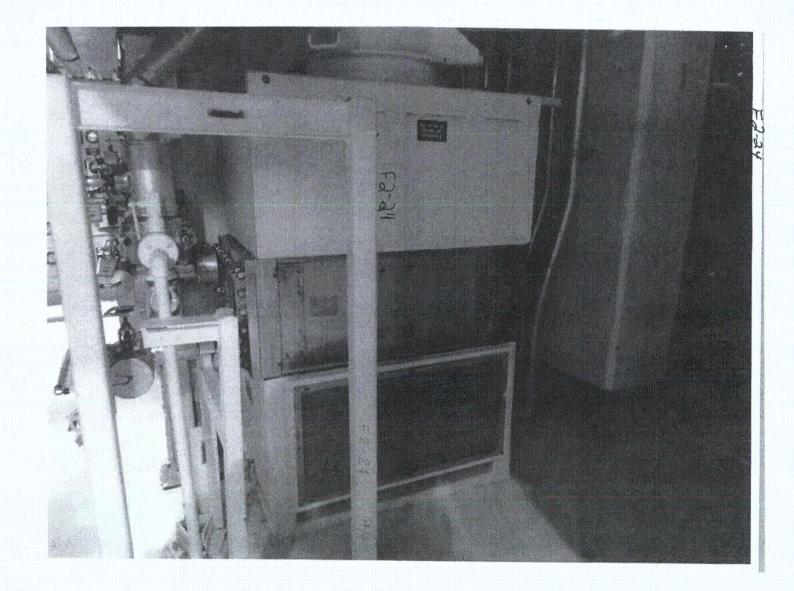
<ol> <li>Is the anchorage free of bent, broken, missing or loose hardware? Welded to embedded steel</li> </ol>	YX NO UO NAO
<ol> <li>Is the anchorage free of corrosion that is more than mild surface oxidation?</li> <li>Very minor surface corrosion and cracked paint observed. No degradation of weld observed. Condition has no adverse seismic impact.</li> </ol>	Y⊠ N⊡ Ü⊡ N/A⊡

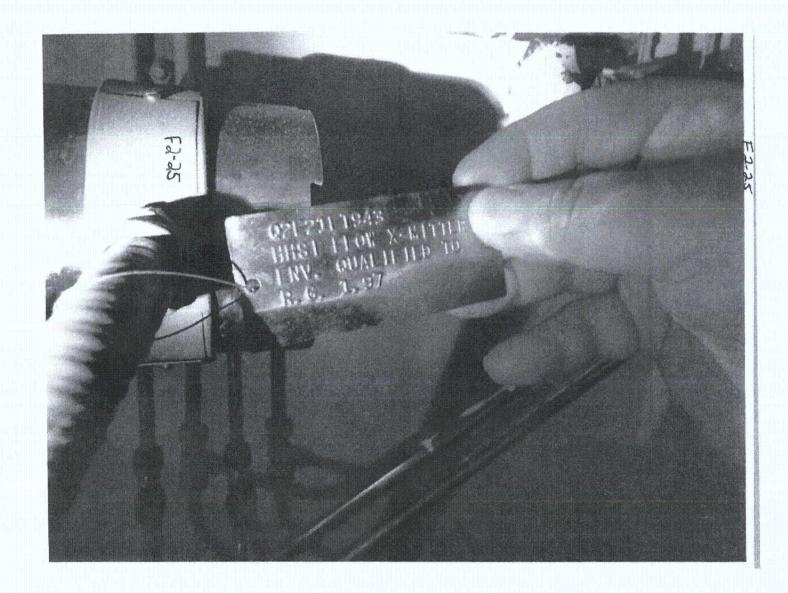
11. Have you looked for and found no other seismic conditions that could adversely affect the safety functions of the equipment?	
omments (Additional pages may be added as necessary)	
None	
valuated by: 3 YUAN Atert	Date: 8-27-12
P.MIKTUS Paul Concilitur	8-27-12

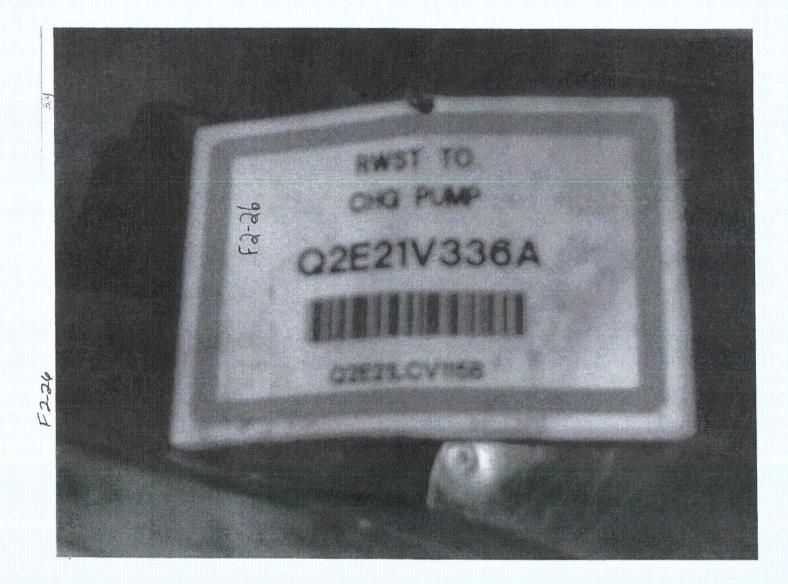
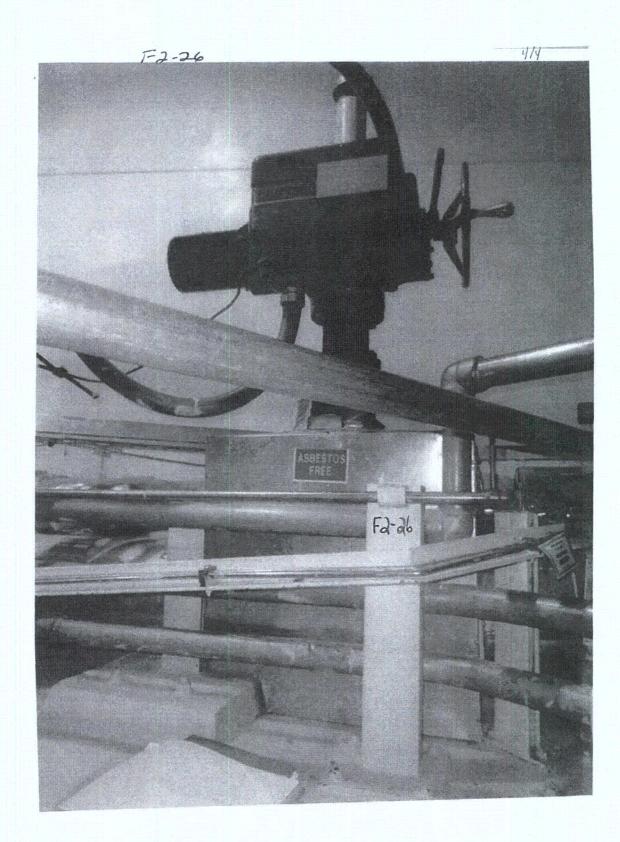
11. Have you looked for and found no other seismic conditions that could adversely affect the safety functions of the equipment?	
<u>Comments</u> (Additional pages may be added as necessary)	
cannot see behind valve w/o chiusing, but oppears	Seismically adequal 8/23/12
Evaluated by: Ezzy flow for / TEPRY A. MULLENIX Anna Maclay Laura Maciay.	Date: 8/22/2012-

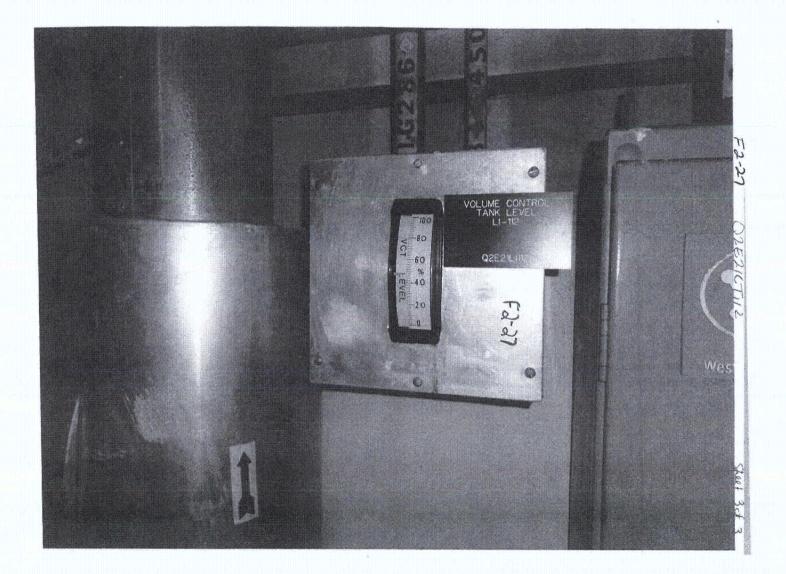
9. Do attached lines have adequate flexibility to avoid damage?	YEND UD NAD
Conduit affached to bax In rigid, however a s supports attached to same well as firmly attach BSth maje together during selectic event, N 10. Based on the above seismic interaction evaluations, is equipment free of potentially adverse seismic interaction effects?	o concern. OK ay YOUND UD
Other Adverse Conditions

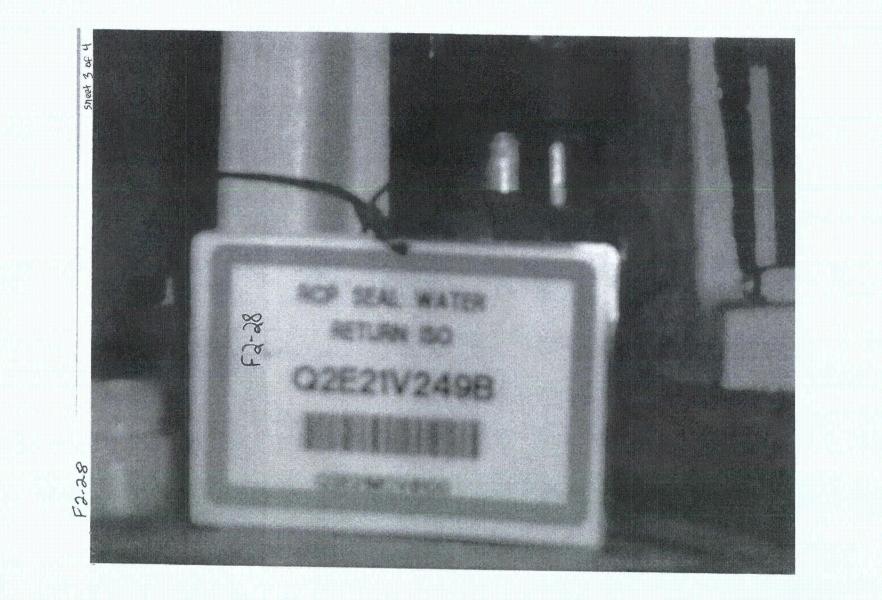
4. Is the anchorage free of visible cracks in the concrete near the anchors? Yi N $\square$ V $\square$ N/A $\square$ Y
	in-line component, no anchorage
	<ul> <li>5. Is the anchorage configuration consistent with plant documentation?</li> <li>Y□ N□ U□ N/AX</li> <li>(Note: This question only applies if the item is one of the 50% for which an anchorage configuration verification is required.)</li> </ul>
	<ol> <li>Based on the above anchorage evaluations, is the anchorage free of YZ N□ U□ potentially adverse seismic conditions?</li> </ol>
	Based on the above the component is free of
	adverse selsmic conditions.

9. Do attached lines have adequate flexibility to avoid damage? YZ N U	N/A
10. Based on the above seismic interaction evaluations, is equipment free Y N NU U of potentially adverse seismic interaction effects?	
Other Adverse Conditions         11. Have you looked for and found no other seismic conditions that could       YØ N□ U□ adversely affect the safety functions of the equipment?	<del>an ja s</del> a ng

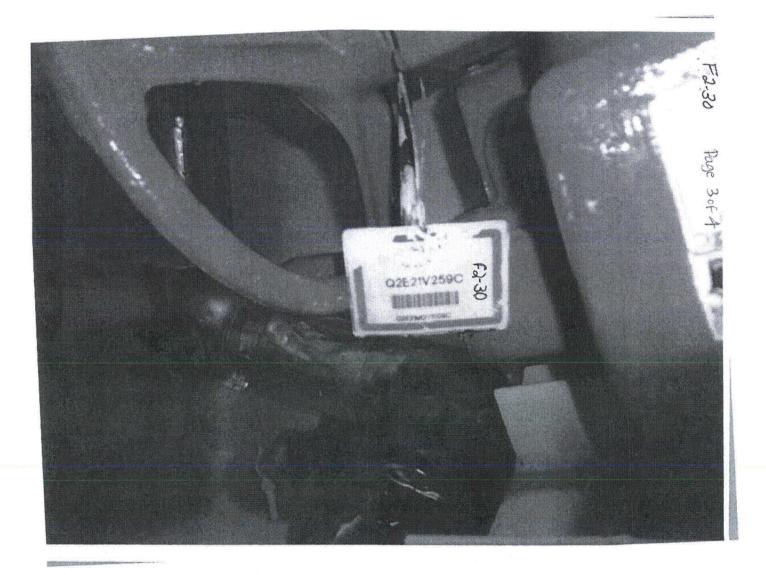
P2-30 Sheet 2 of 34 Status: YX NU UU Seismic Walkdown Checklist (SWC) Equipment ID No. <u>Q2E21MOV8109C</u> Equip. Class<sup>1</sup> 8 Equipment Description CHARGING PUMP P002C MINIFLOW VALVE **Interaction Effects** YOND UD NAD 7. Are soft targets free from impact by nearby equipment or structures? 8. Are overhead equipment, distribution systems, ceiling tiles and lighting, YXI NII UI N/AI and masonry block walls not likely to collapse onto the equipment? YOND UD N/AD 9. Do attached lines have adequate flexibility to avoid damage? YD NO UD 10. Based on the above seismic interaction evaluations, is equipment free of potentially adverse seismic interaction effects? Other Adverse Conditions YØ NO UD 11. Have you looked for and found no other seismic conditions that could adversely affect the safety functions of the equipment? Comments (Additional pages may be added as necessary) TERPHY A. MULLENIX 8/22/12 Laura Maday Evaluated by: KAMO

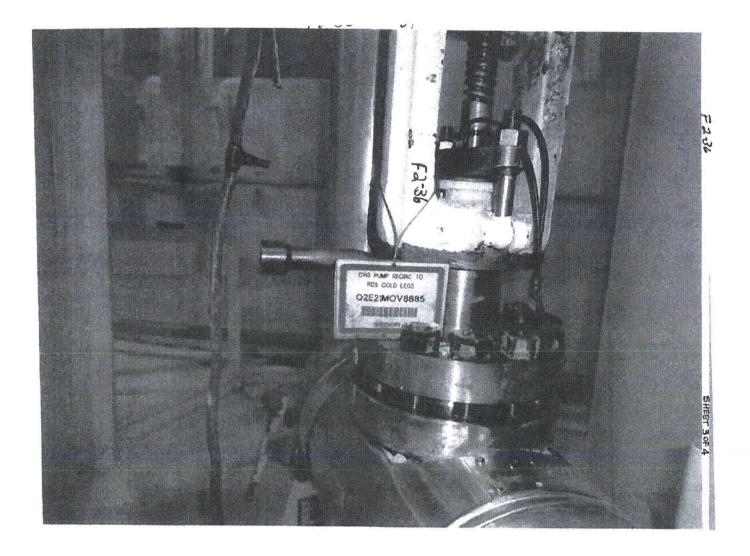
9. Do attached lines have adequate flexibility to avoid damage?	Yønd ut n/at
10. Based on the above seismic interaction evaluations, is equipment free of potentially adverse seismic interaction effects?	Y 52 NO UO
Other Adverse Conditions

11. Have you looked for and found no other seismic conditions that could adversely affect the safety functions of the equipment?	YDÛN U
Comments (Additional pages may be added as necessary)	
Evaluated by: fama Maday Lawa Mactay	Date: <u>8-22-12</u>
1224 Dalgo toppy A. MULLENIX	8/24/2012

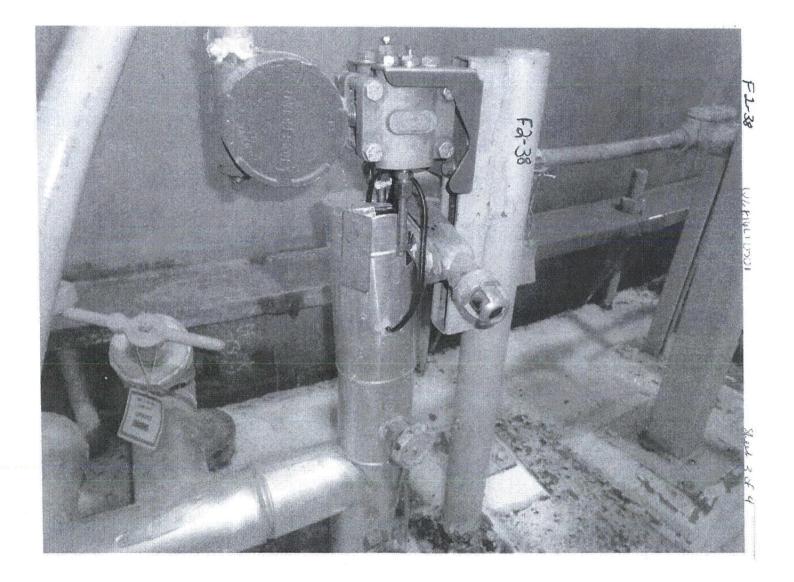
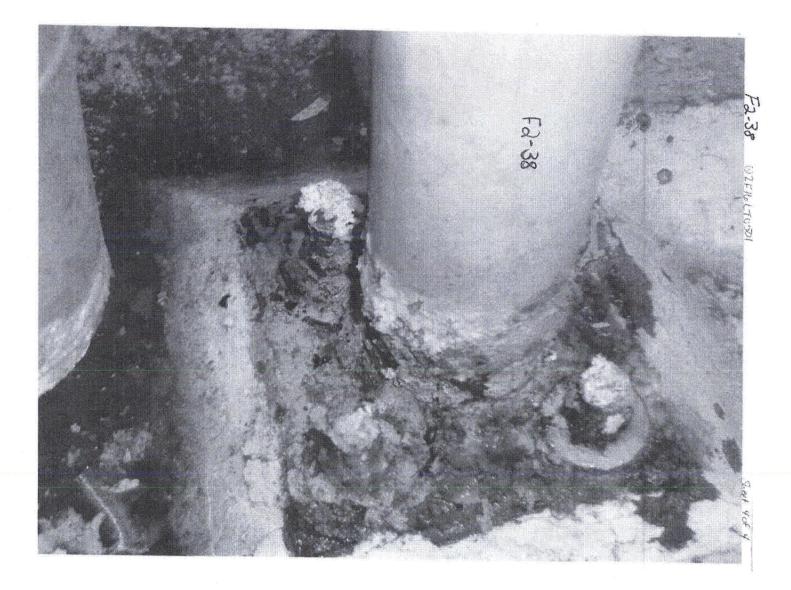
F2-38 Sheet 2 of 84200 Status: YT NO UD Seismic Walkdown Checklist (SWC) Equipment ID No. **Q2F16LT0501** \_ Equip. Class<sup>1</sup>\_18 Equipment Description RWSTLEVEL TRANSMITTER **Interaction Effects** YOND UD NAD 7. Are soft targets free from impact by nearby equipment or structures? YE NO VO NAO 8: Are overhead equipment, distribution systems, ceiling tiles and lighting. and masonry block walls not likely to collapse onto the equipment? 9. Do attached lines have adequate flexibility to avoid damage? NO UD NAD En of conduit on support nearby to Trans mitter touches the Transmitter. Both Transmitter and conduit 5 opport are attached to their which would act Together, No seismic interaction concern 10. Based on the above seismic interaction evaluations, is equipment free YE NO UD of potentially adverse seismic interaction effects? **Other Adverse Conditions** ם חים 11. Have you looked for and found no other seismic conditions that could adversely affect the safety functions of the equipment? Comments (Additional pages may be added as necessary) NONE Date: 8. 30. 2012 Evaluated by: rystal Lovelady 8/30/2012
