Seismic Walkdown Checklist (SWC)

Equipment ID No. Q2H21E505 Equip. Class¹ 20

Equipment Description 4.16KV SWITCHGEAR 2J LOCAL CONT PANEL

Location: Bldg. DIESEL Floor El. 155 Room, Area 56C

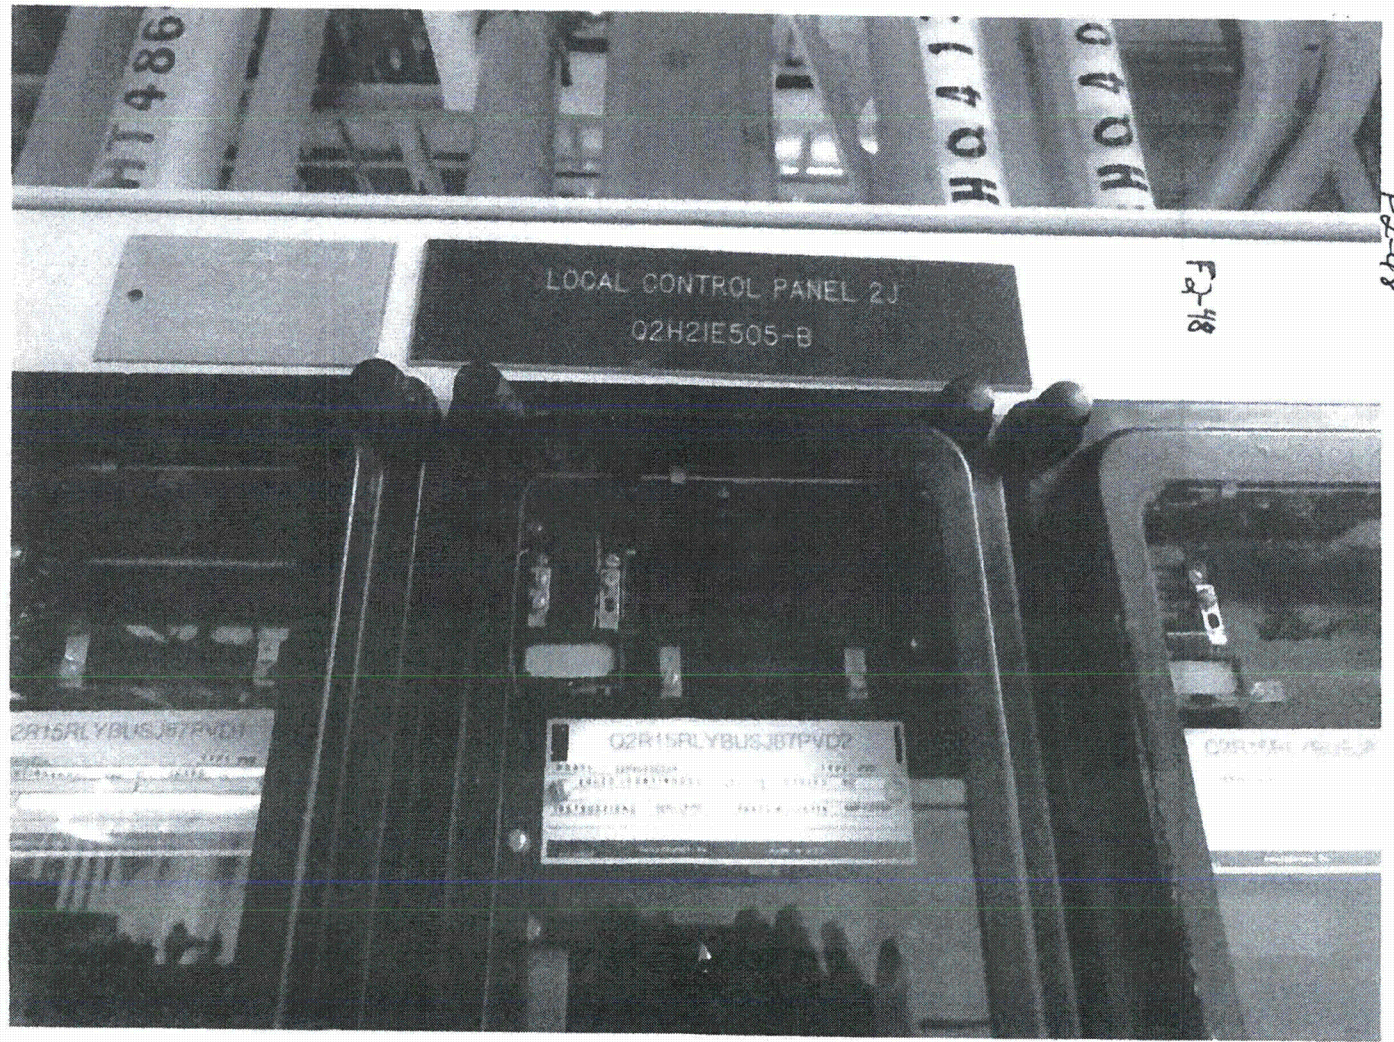
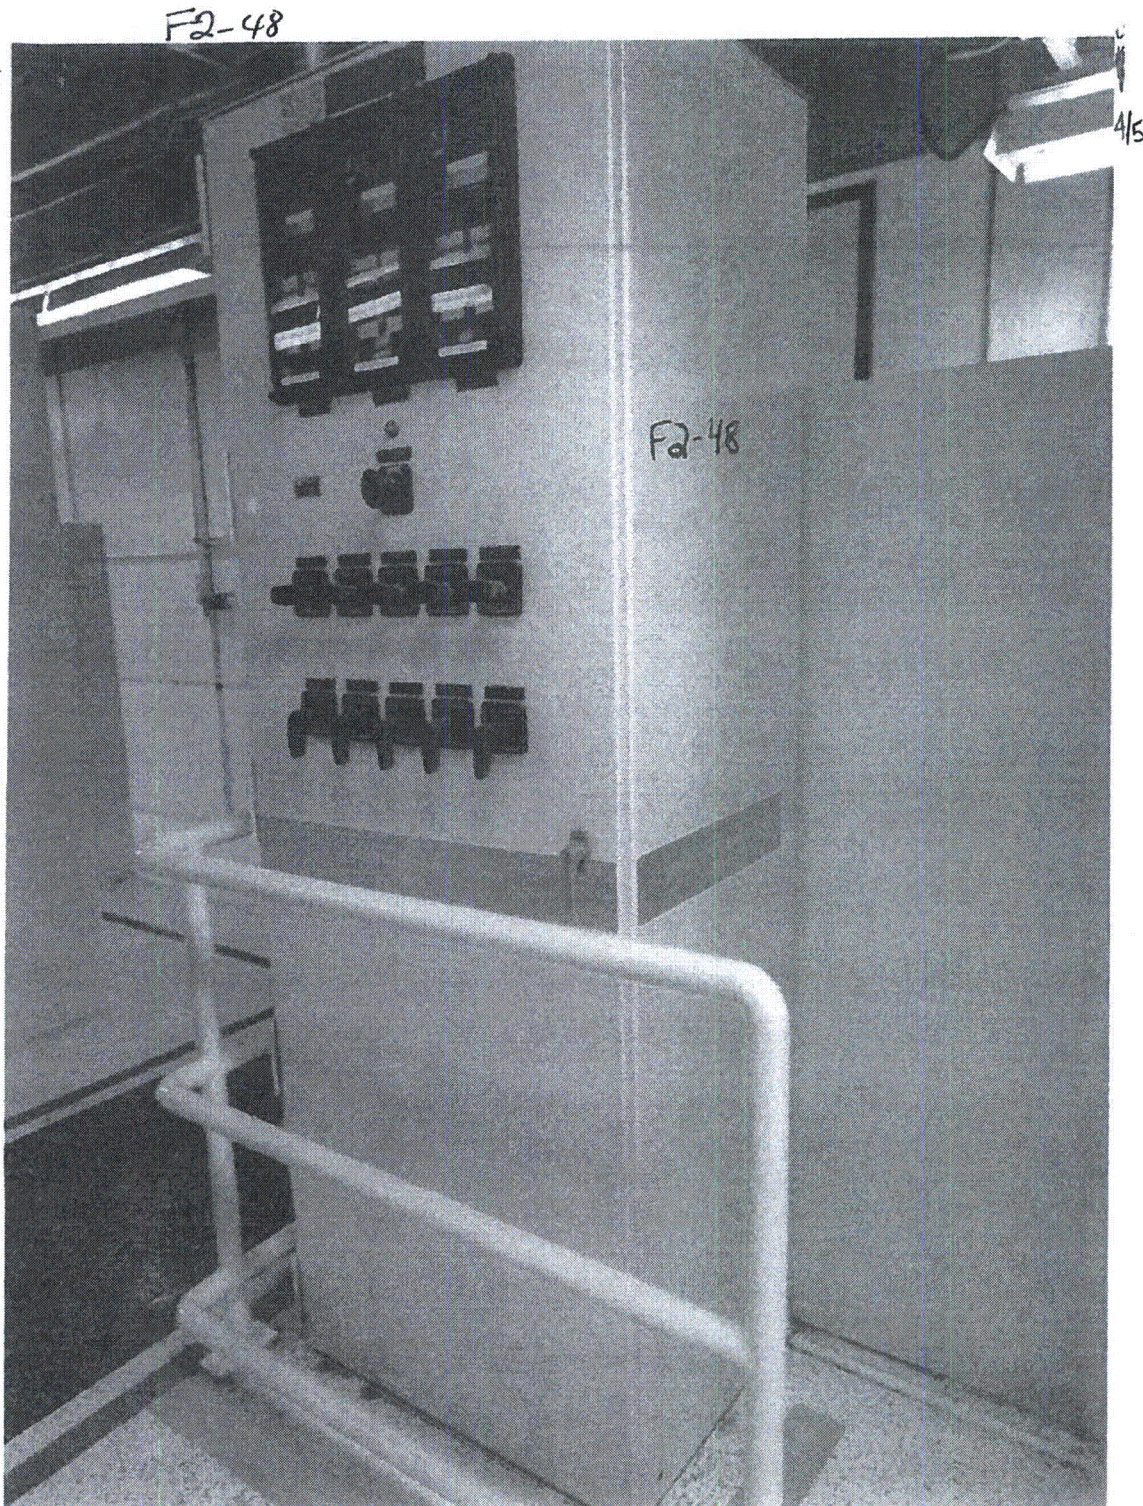
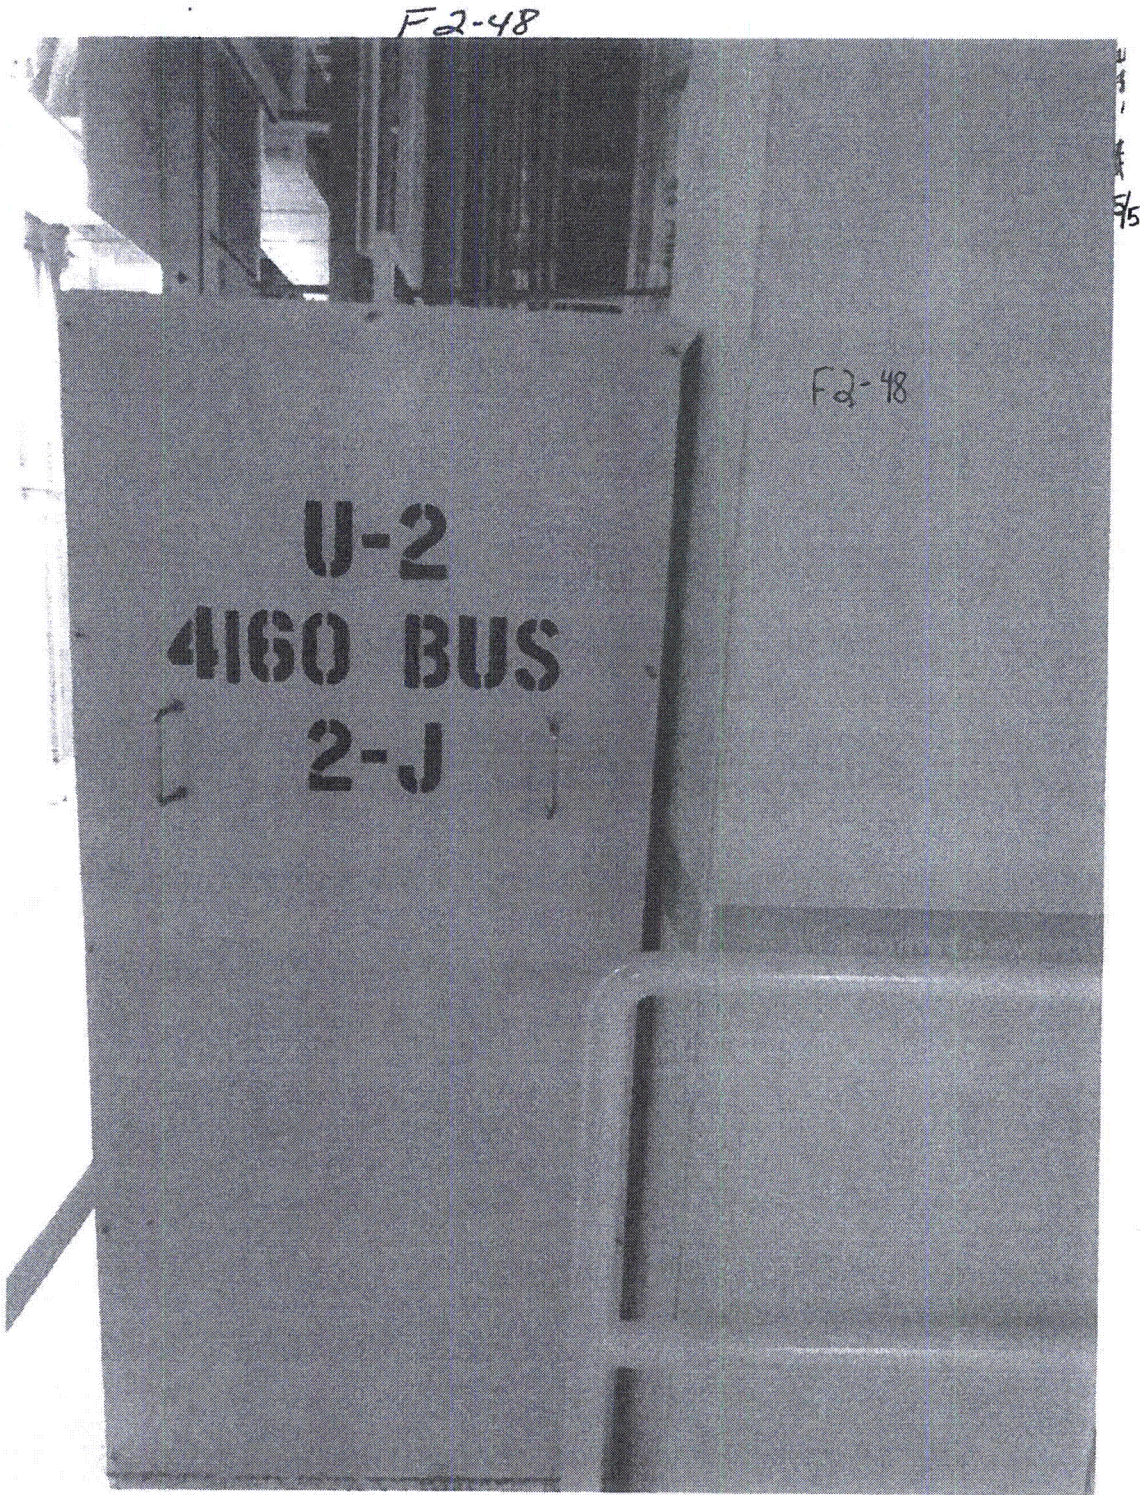
7. Are soft targets free from impact by nearby equipment or structures? YES NO U N/A
 1" gap b/t panel Q2H21E505 and U-2 4160 Bus 2J. Per Calculation SC 85-1-3347-001
 the panel is bolted at the four corners and is rigid with negligible deflections.
 The panel Q2H21E505 is also rigidly mounted with rigid conduit at the top. Therefore, 1" gap is acceptable.

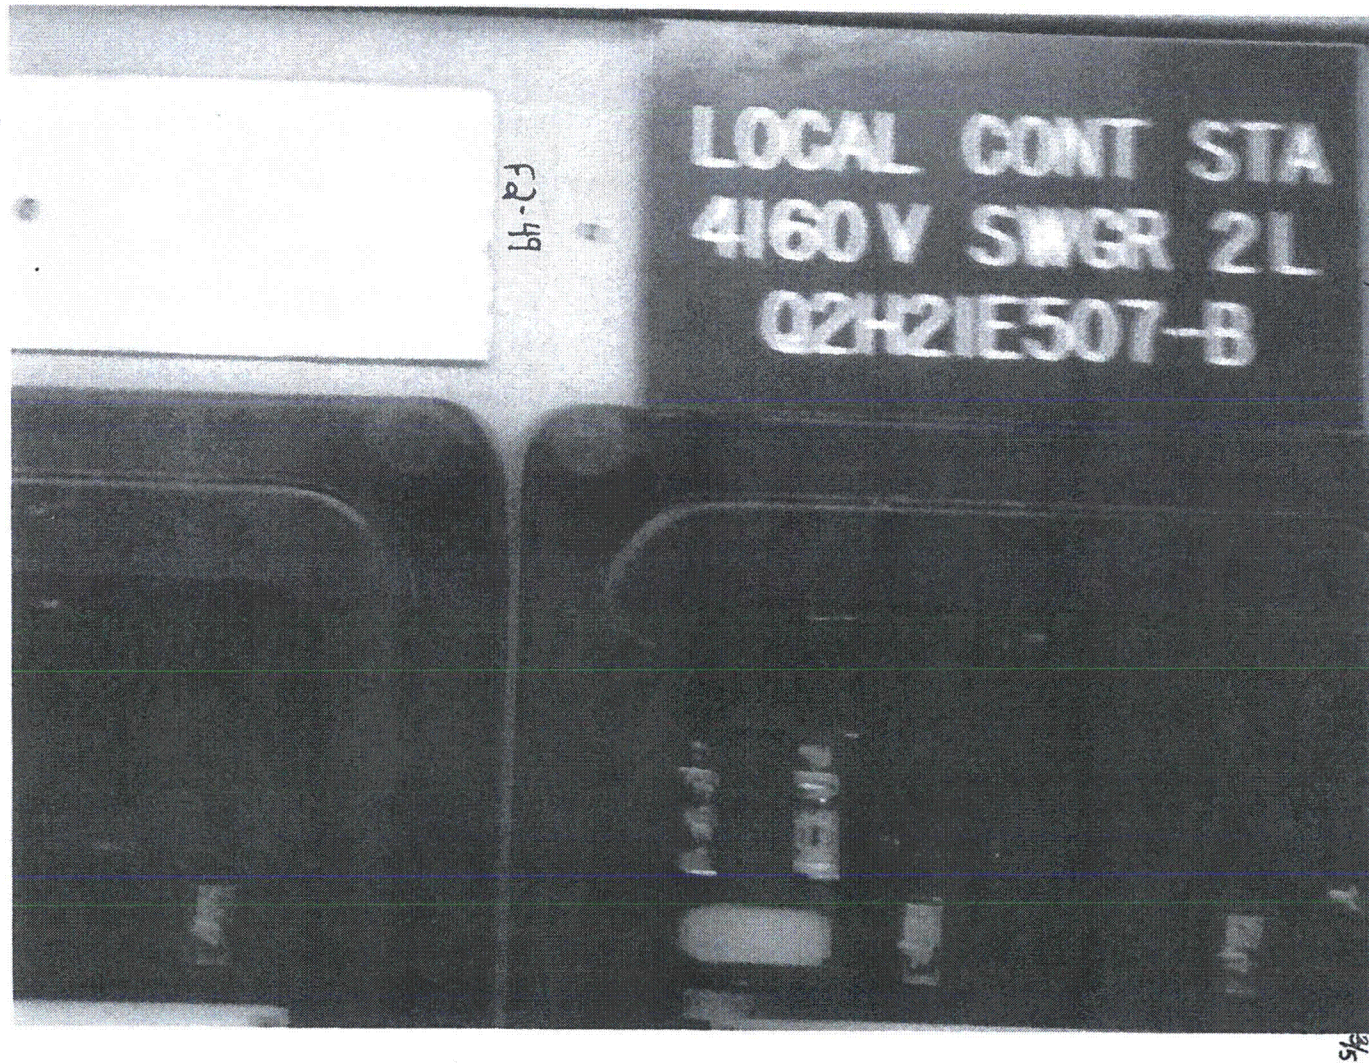
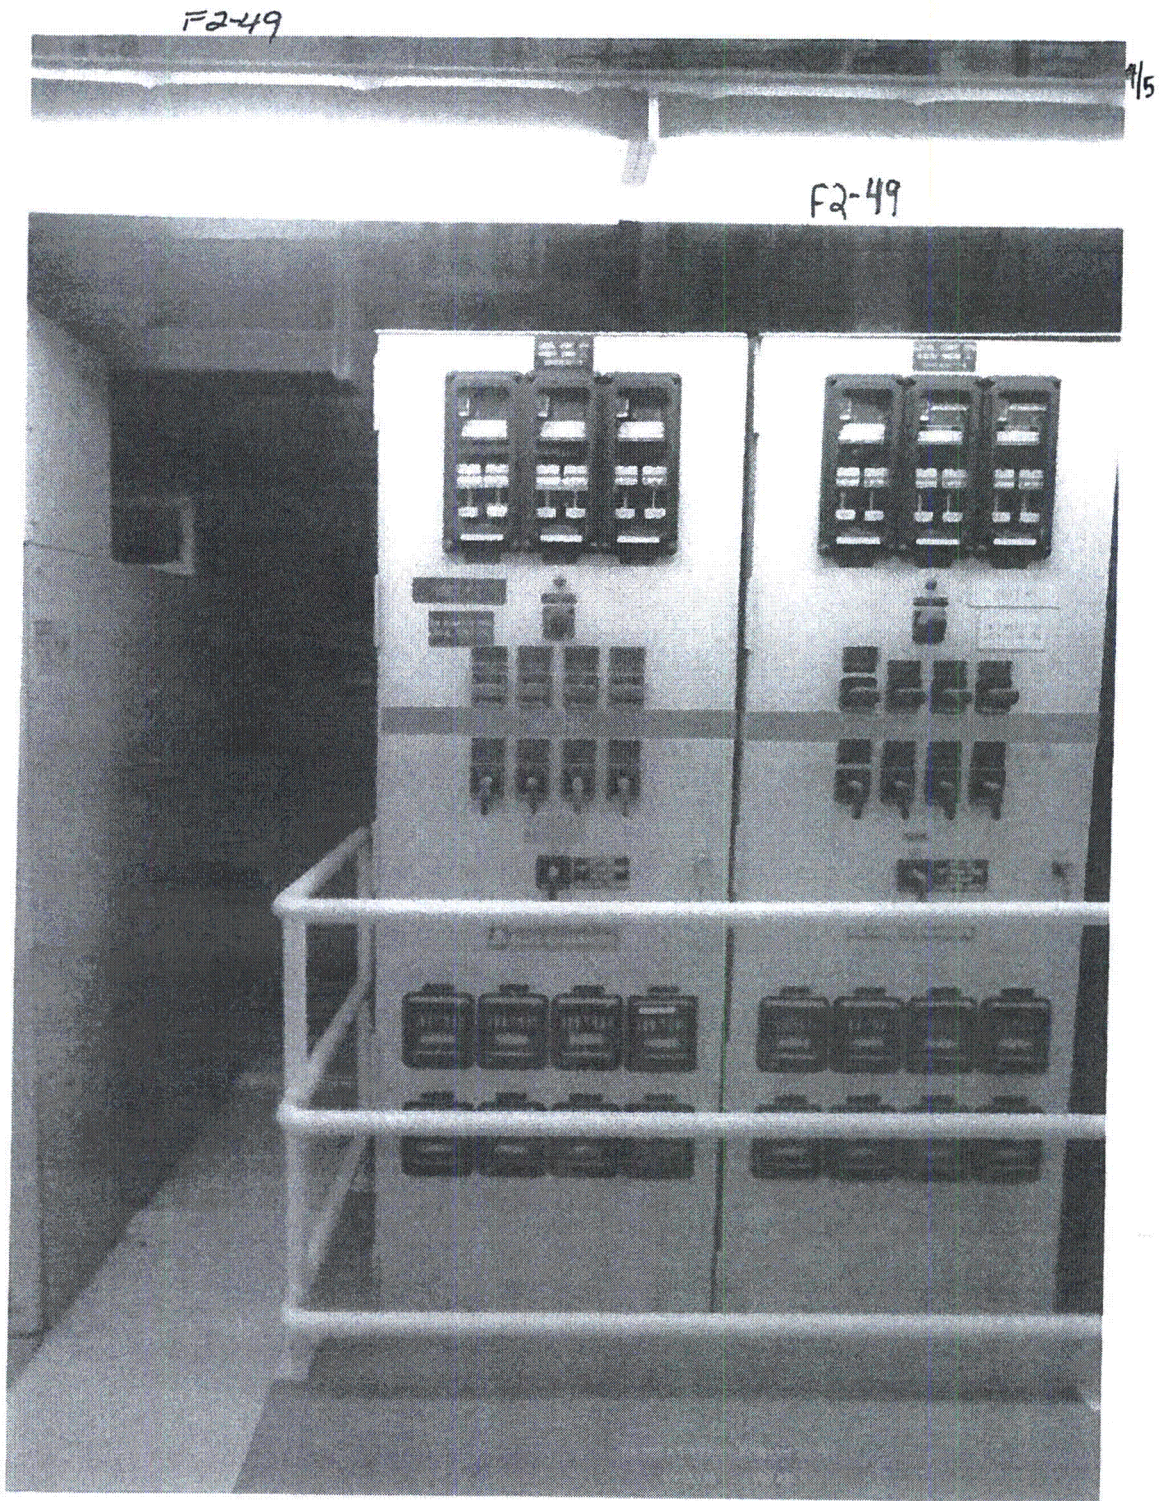
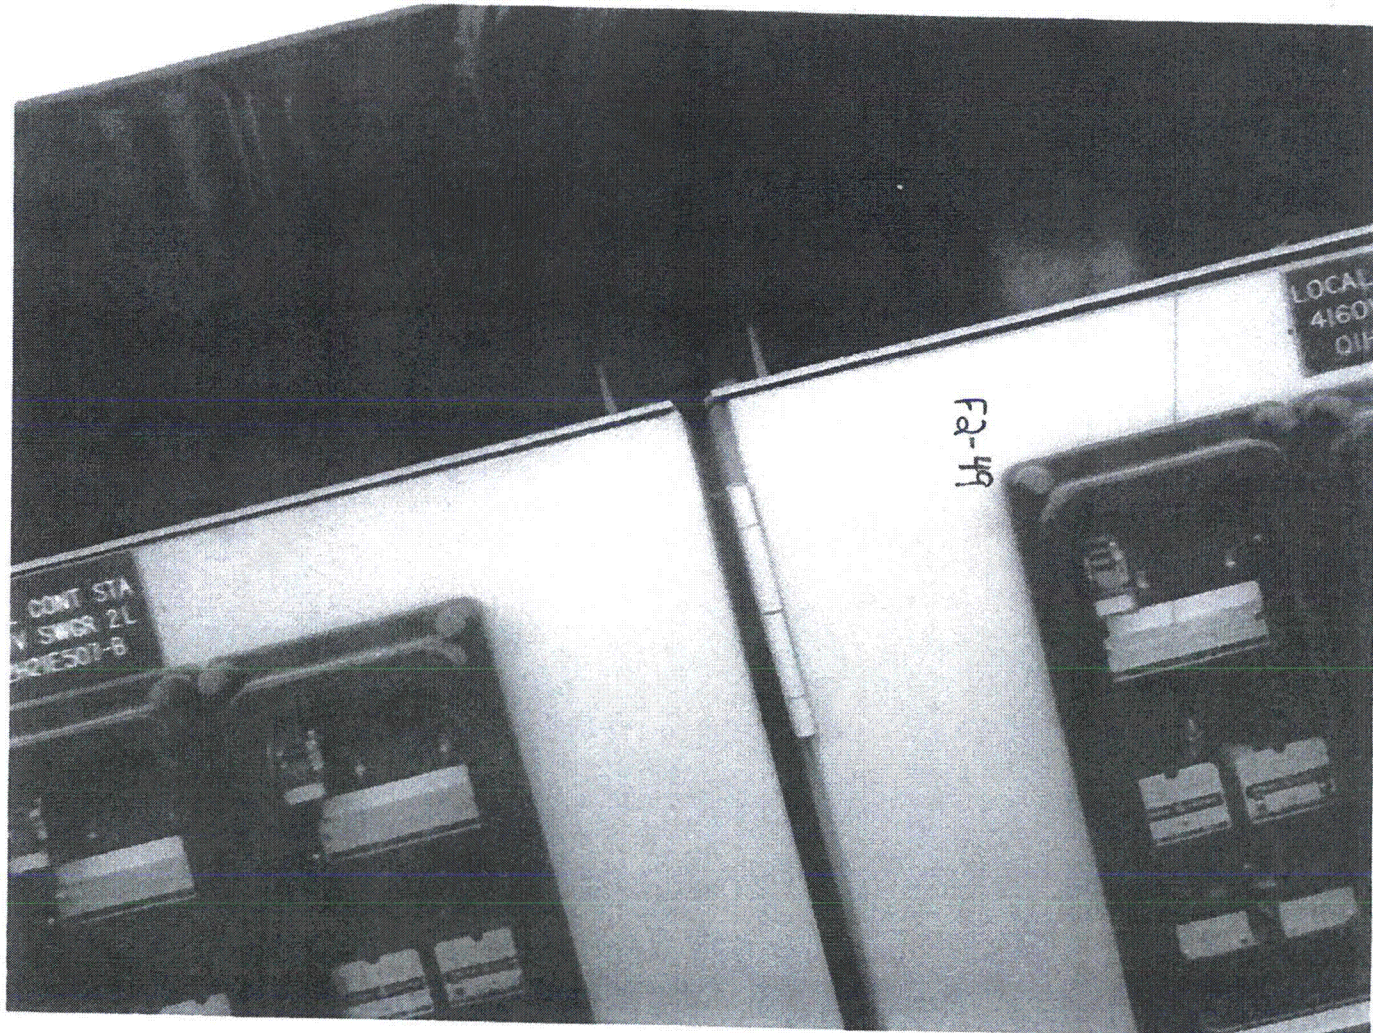
CONT STA
V SWGR 2L
201E507-6

2. Is the anchorage free of bent, broken, missing or loose hardware? Y N U N/A
Cannot open cabinet until outage.

IPEE: overhead light interaction, adjacent cabinets not bolted together, lighting is ^{now} restrained with wire ties and cabinets are bolted together at the top of panels.
 Interior mounting bolts could not be confirmed as cabinet could not be opened.

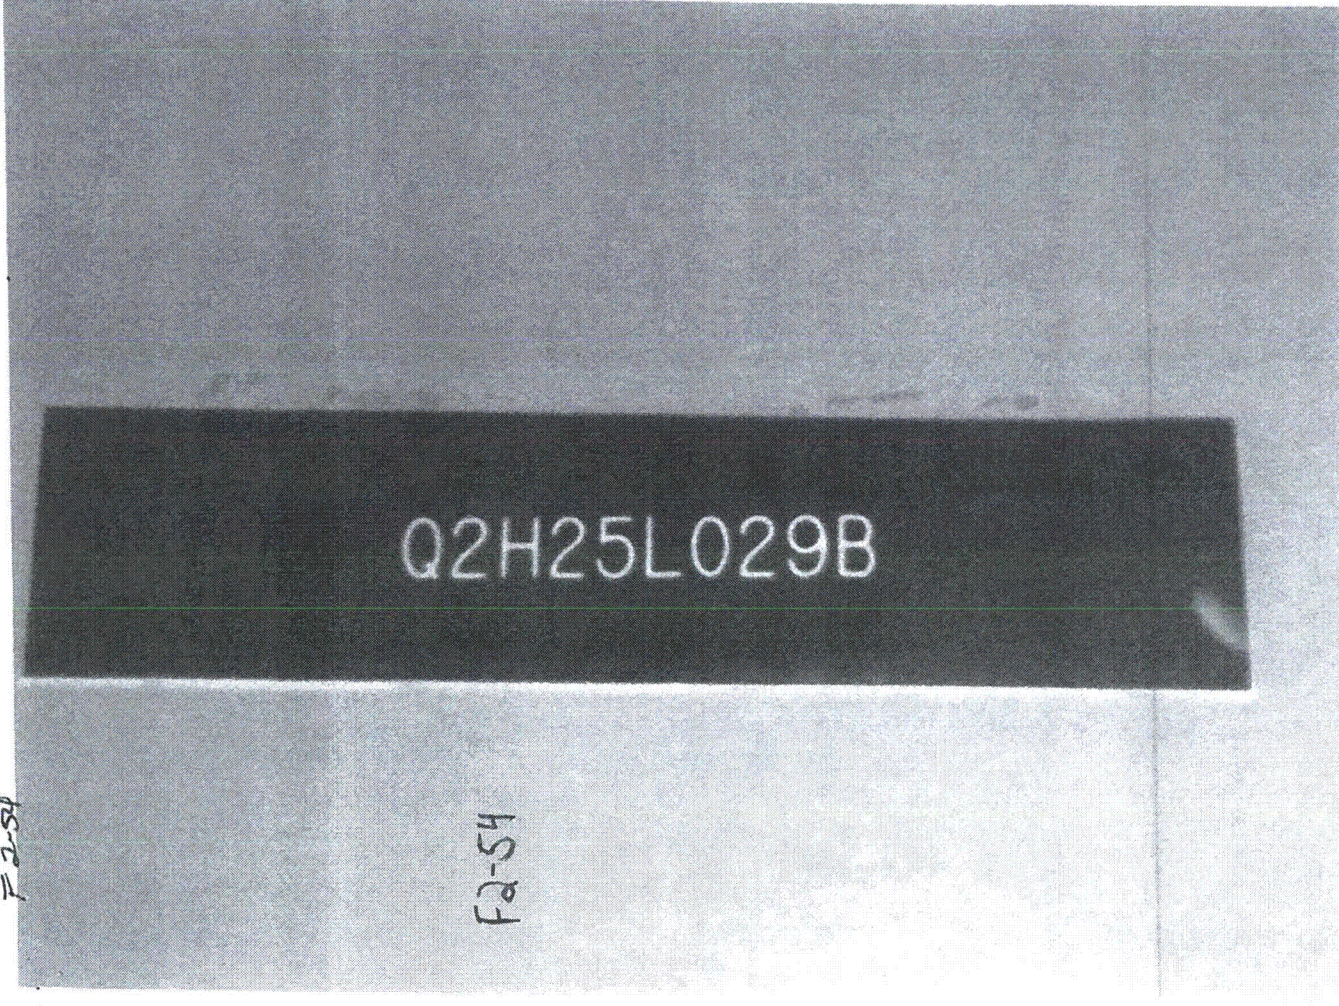
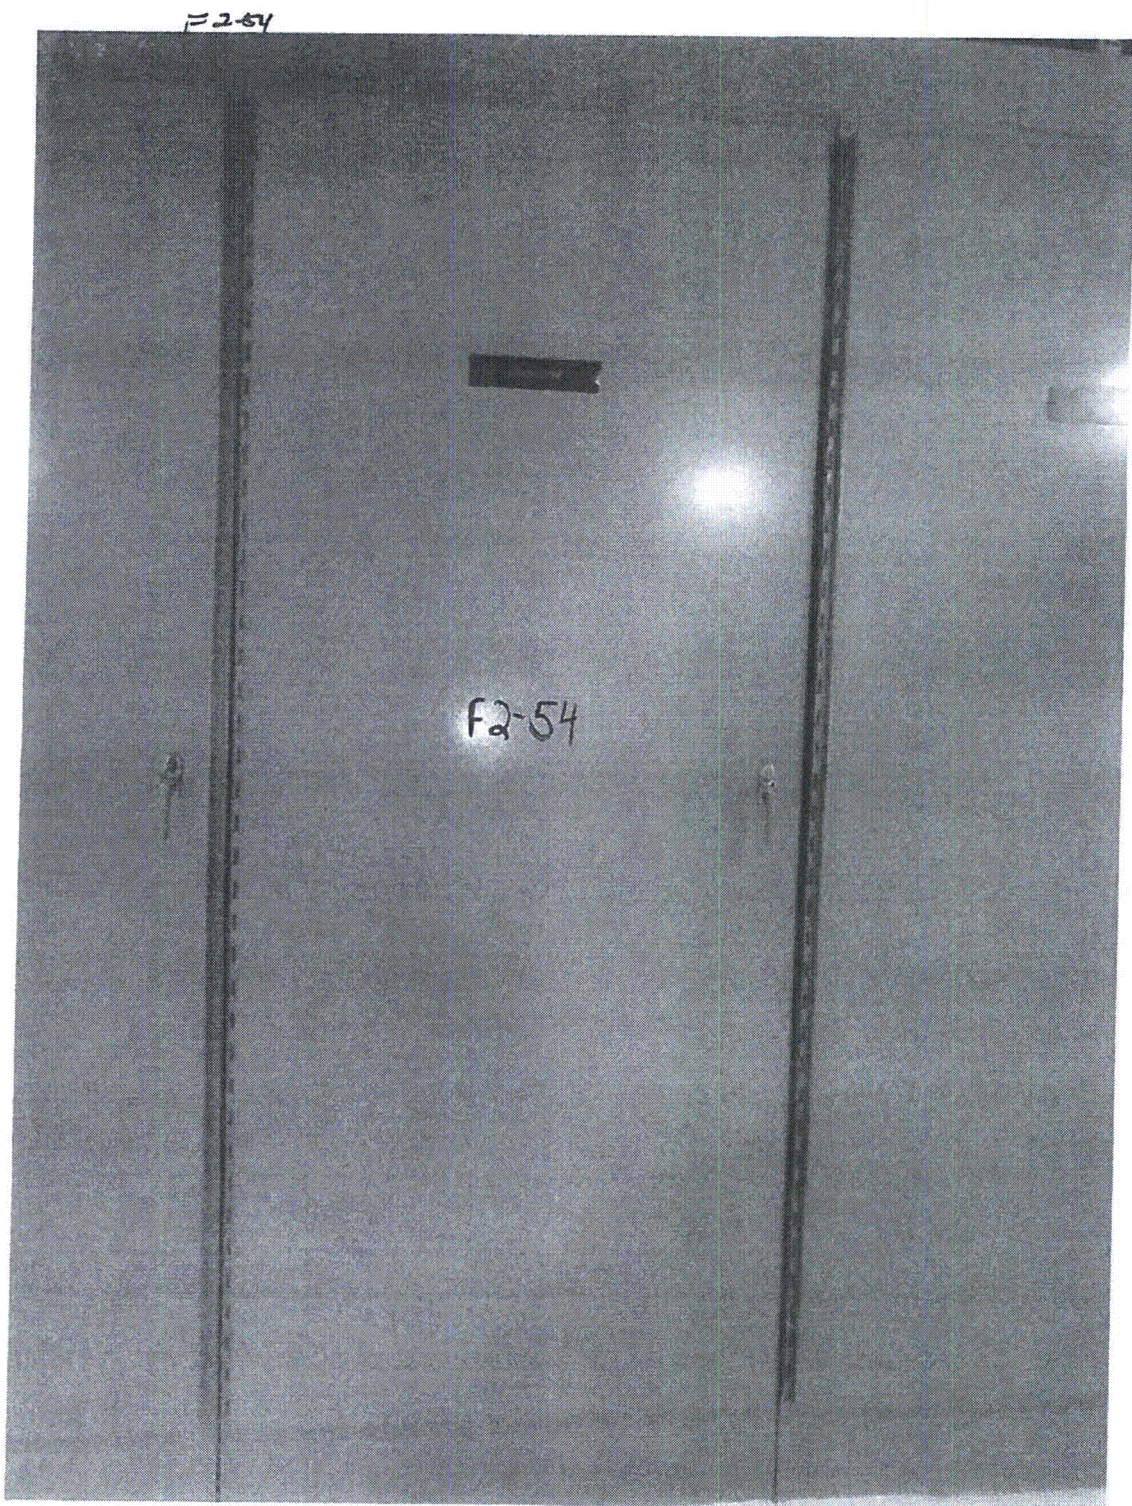
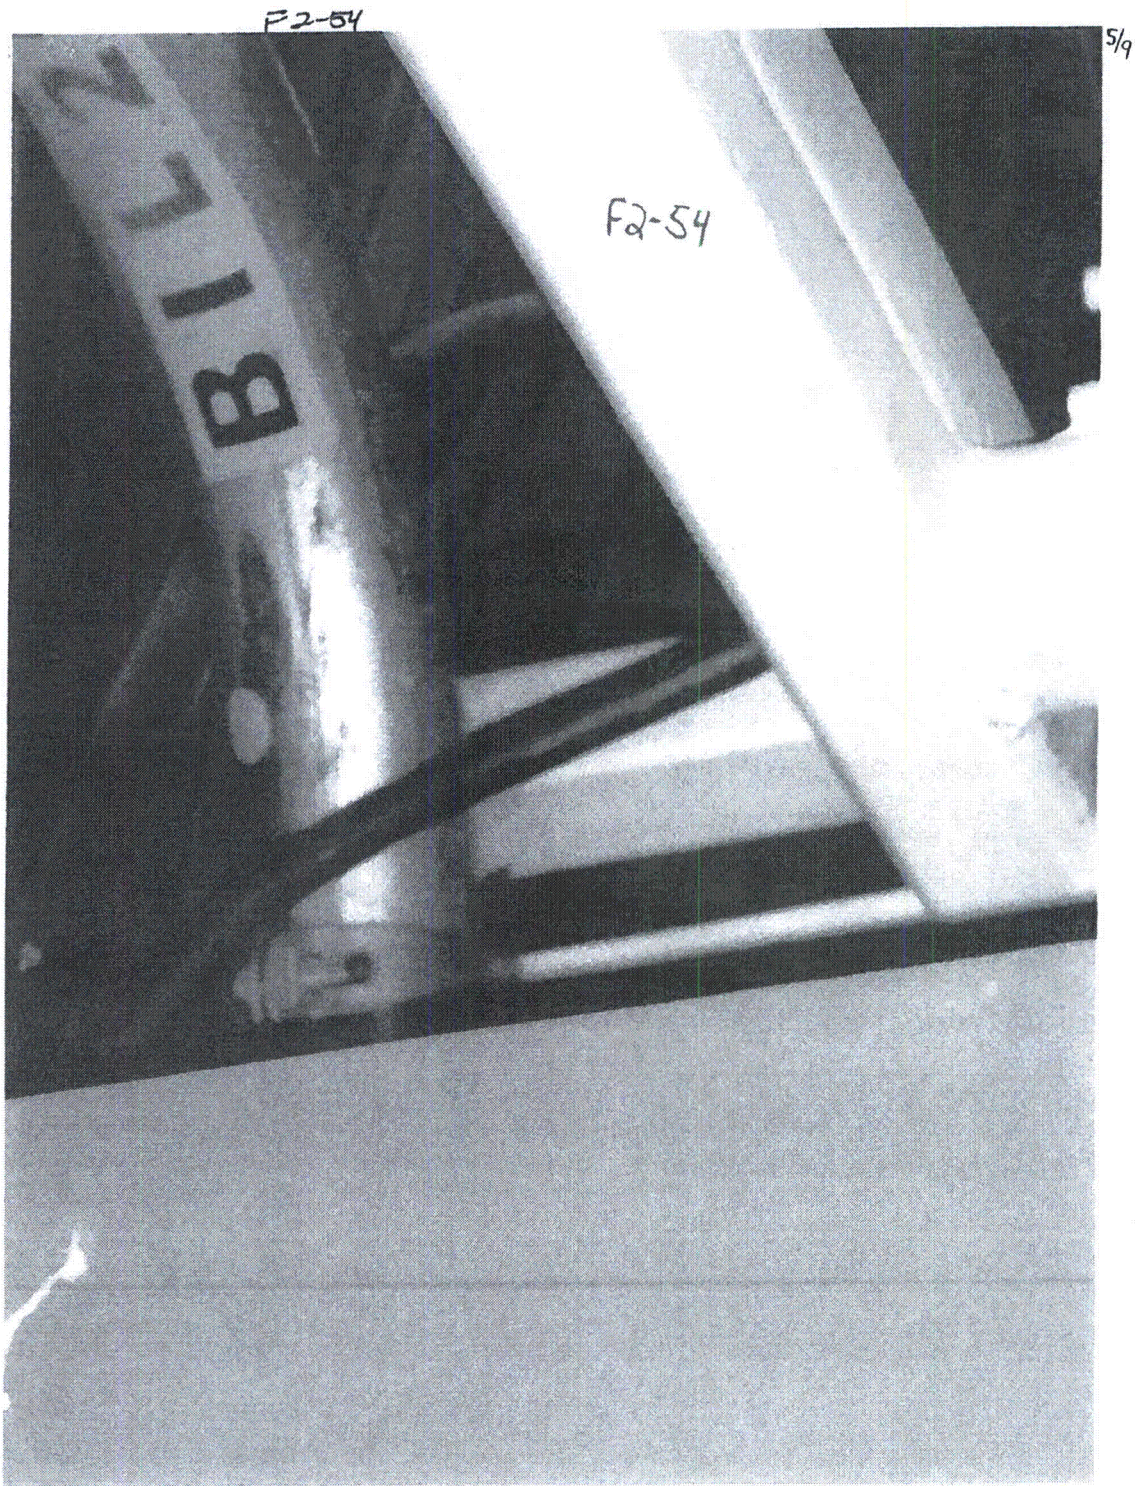
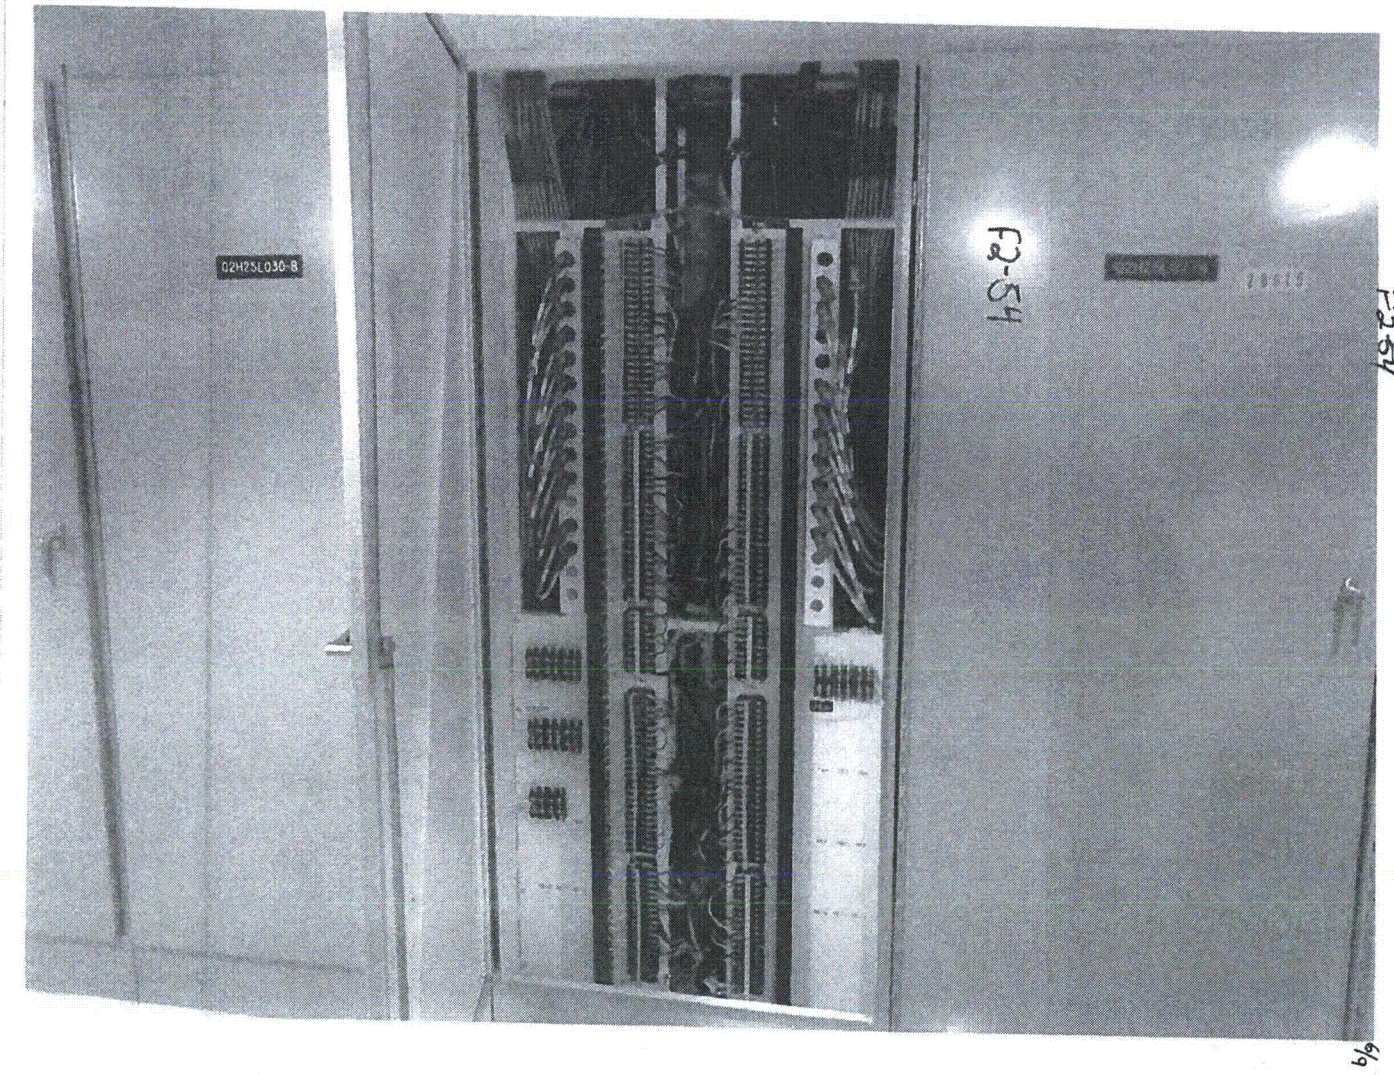
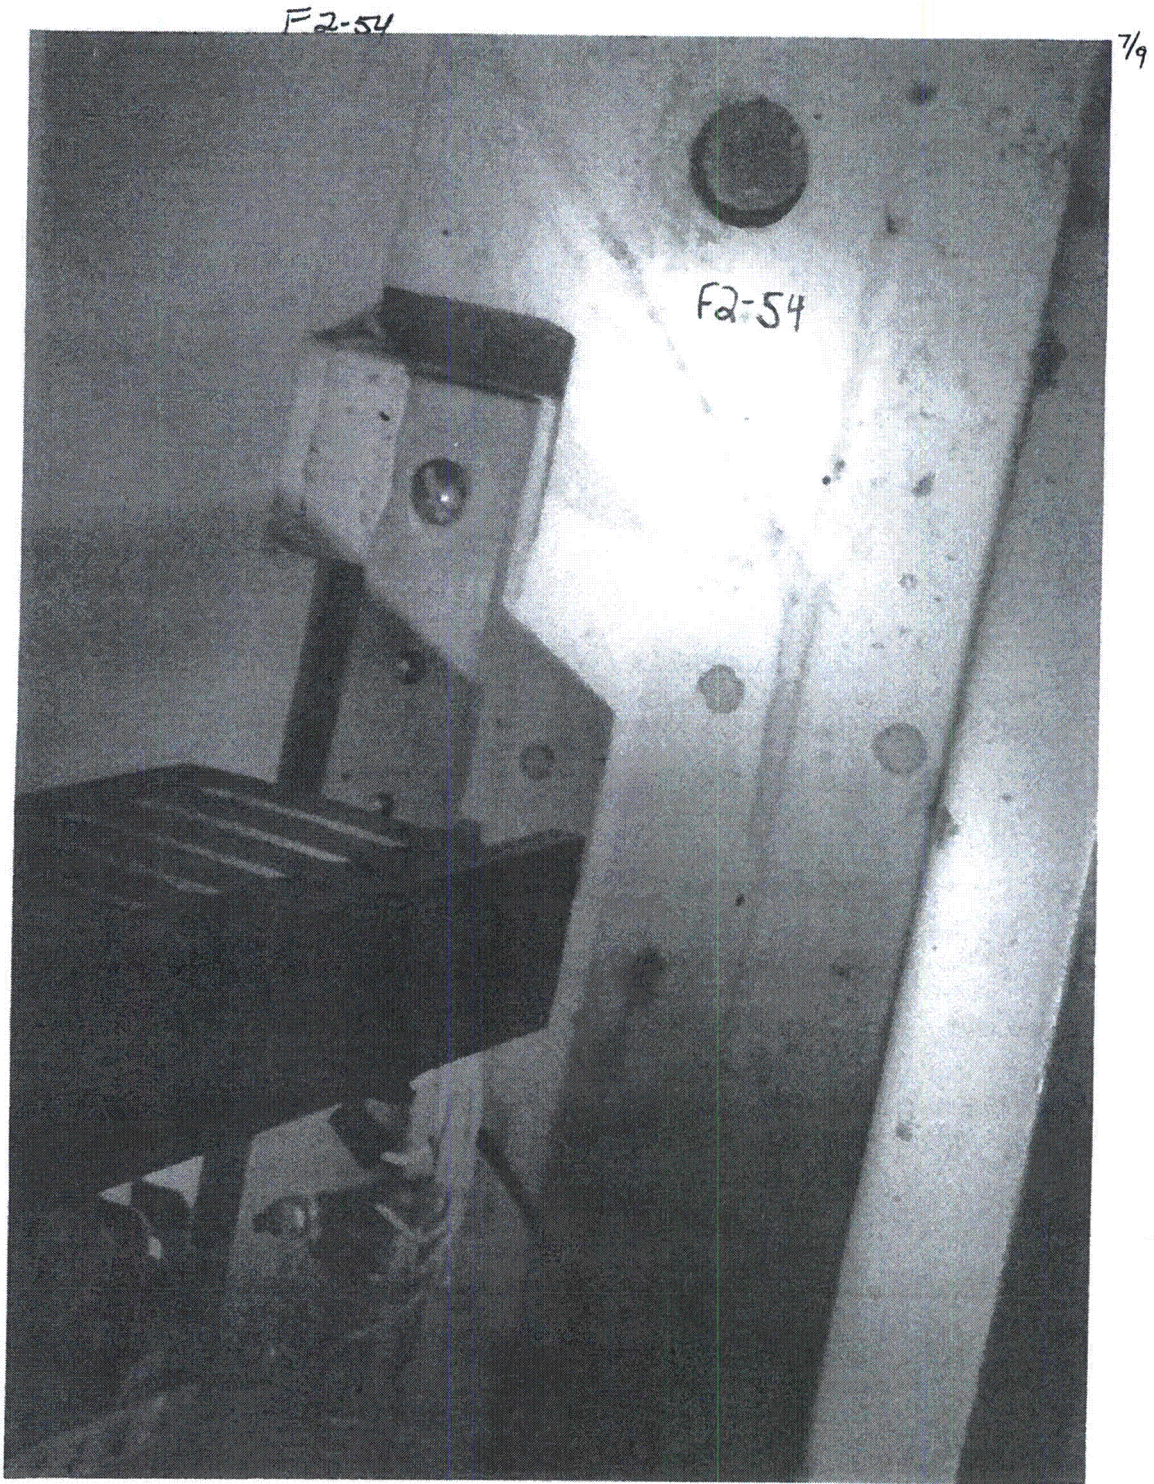
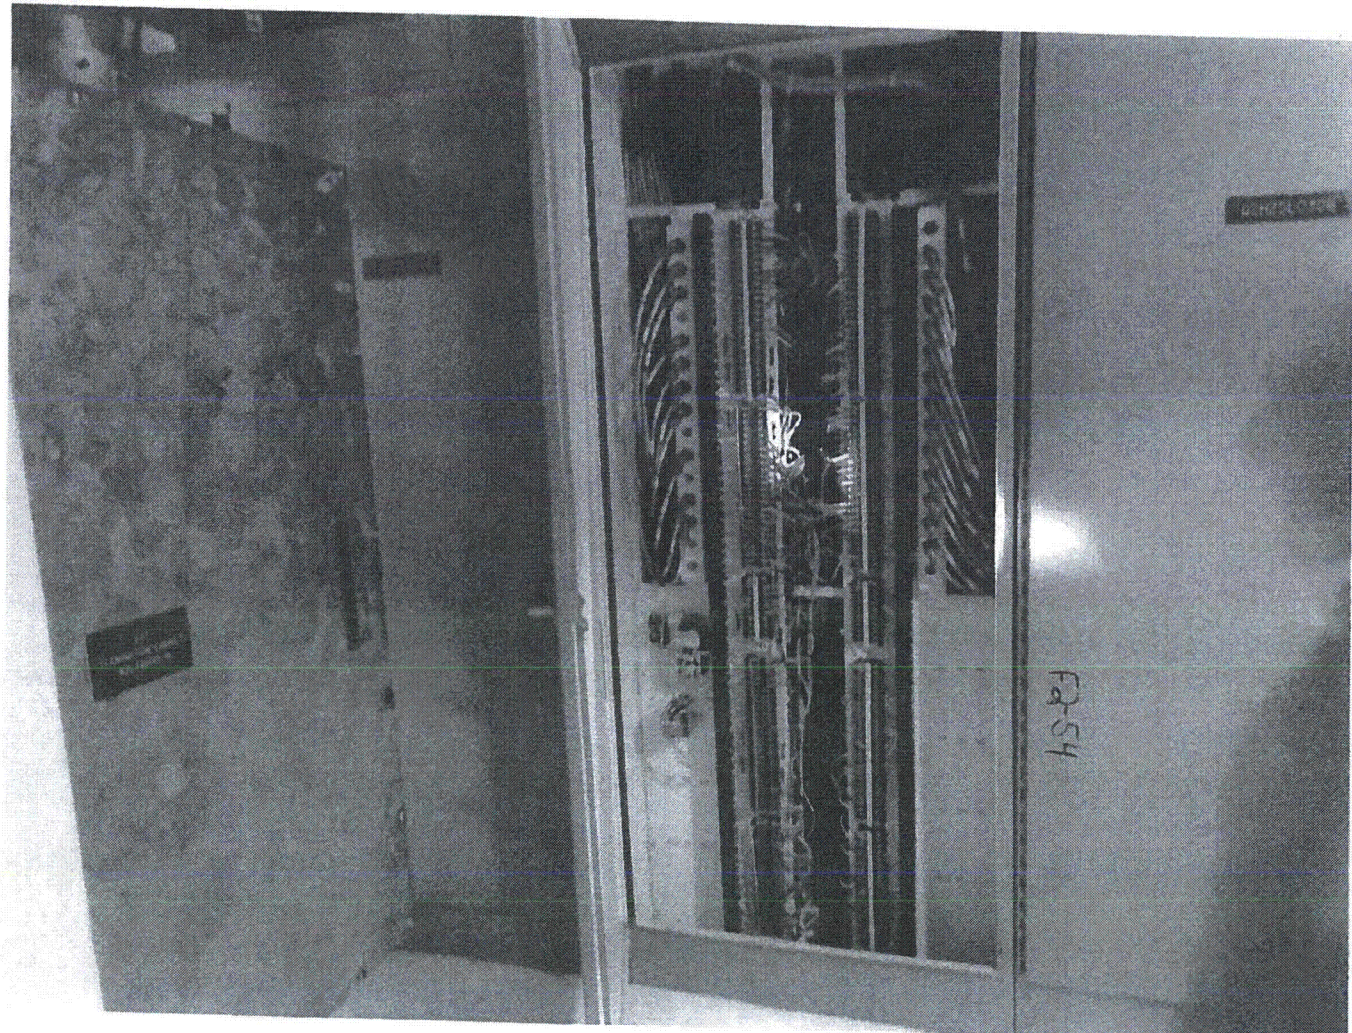
Observed a cable coming out of a cabinet and going to an overhead cable tray. The cable is positioned against the edge of a nearby conduit clamp. The clamp is observed to be free of sharp edges. SWES judged that there is no potential for edge of the clamp to penetrate to the outer

10. Based on the above seismic interaction evaluations, is equipment free of potentially adverse seismic interaction effects? Y N U N/A
cable insulation and cable has adequate flexibility.
