Seismic Walkdown Checklist (SWC)

Equipment ID No. 1E51B0002 Equip. Class 21. Tanks and Heat Exchangers

Equipment Description RCIC Lube Oil Cooler

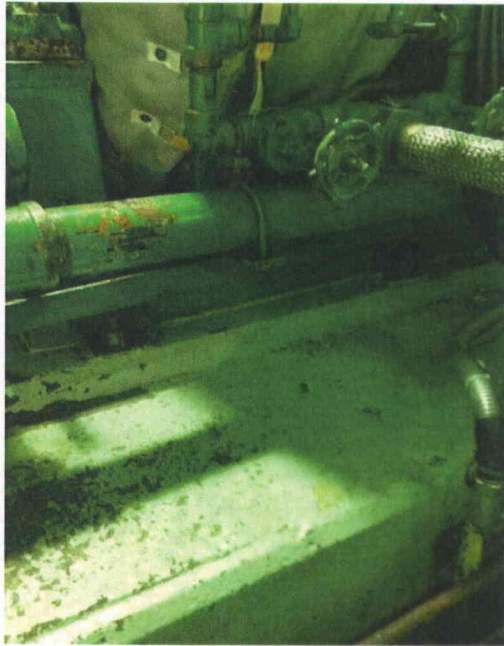
File Name: 2-63-2-4-18.jpeg
Description: View of anchorage configuration

Mounted rigidly on pump skid. Pump skid anchored with 6 - 1" diam anchor bolts. Motor anchored with 4 - 1 1/2" diam anchors.

Anchorage configuration confirmed with Drawing 25-0007-00002.

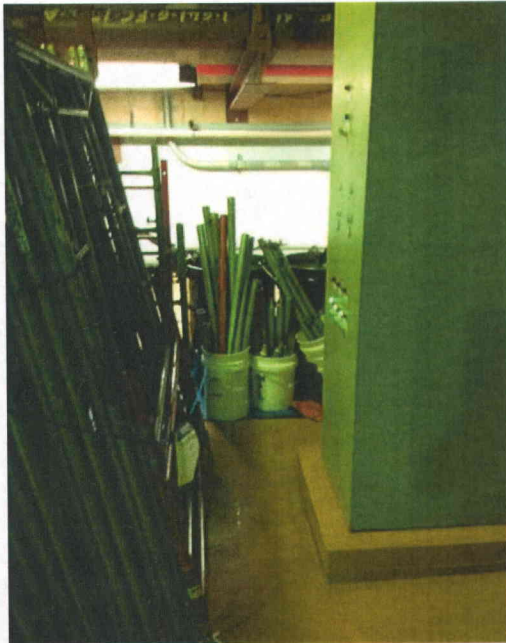
File Name: 2-63-2-4-22.jpeg
Description: Scaffolding staging area

7. Are soft targets free from impact by nearby equipment or structures?
Potential interaction from scaffolding staging near cabinet. Condition Report issued for this condition (CR-2012-12375).

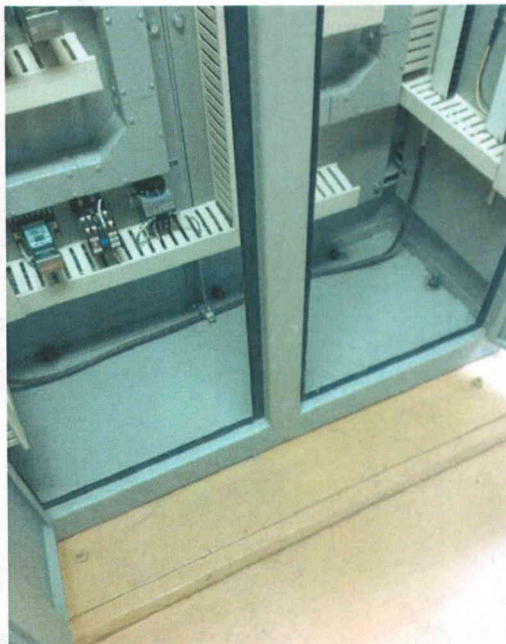
File Name: 2-64-15-4-06.jpeg
Description: General view of anchorage

Bolts found in good condition.

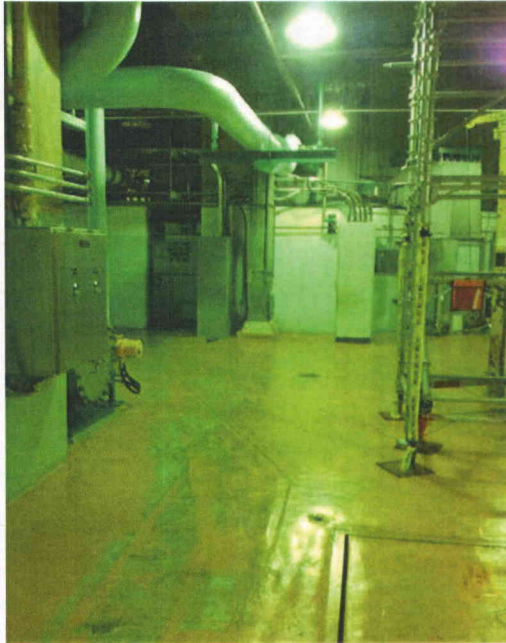
File Name: 2-73-3-4-22.jpeg
Description: Scaffolding located in the area

7. Are soft targets free from impact by nearby equipment or structures?
Scaffolding located in the area. Judged not an adverse condition due to distance and proper bracing of scaffold.
