# **Pacific Northwest National Laboratory Investigation of Stress Corrosion Cracking in Nickel-Base Alloys: Stress Corrosion Cracking of Cold Worked Alloy 690**

The report summarizes the results of a testing program to evaluate the effects of cold work, including rolling, forging, and tensile straining, on the primary water stress corrosion cracking (PWSCC) susceptibility of alloy 690. Alloy 690 is a high-chromium, nickel-base material used in reactor pressure vessel head penetration nozzles, steam generator divider plates, and other components. Prior testing indicated that an increase in the amount of cold work increases the crack growth rate in alloy 690, but the relationships between the degree of cold work, the material microstructure, and the cracking behavior were not systematically investigated. For this study, PWSCC growth rates were measured for a total of 37 different alloy 690 specimens in simulated primary water reactor environments. The alloy 690 test materials included six different heats of extruded control-rod-drive mechanism (CRDM) tubing and five plate/bar heats with variations in the degree of cold work, from no cold work to cold work greater than 30%. In additi

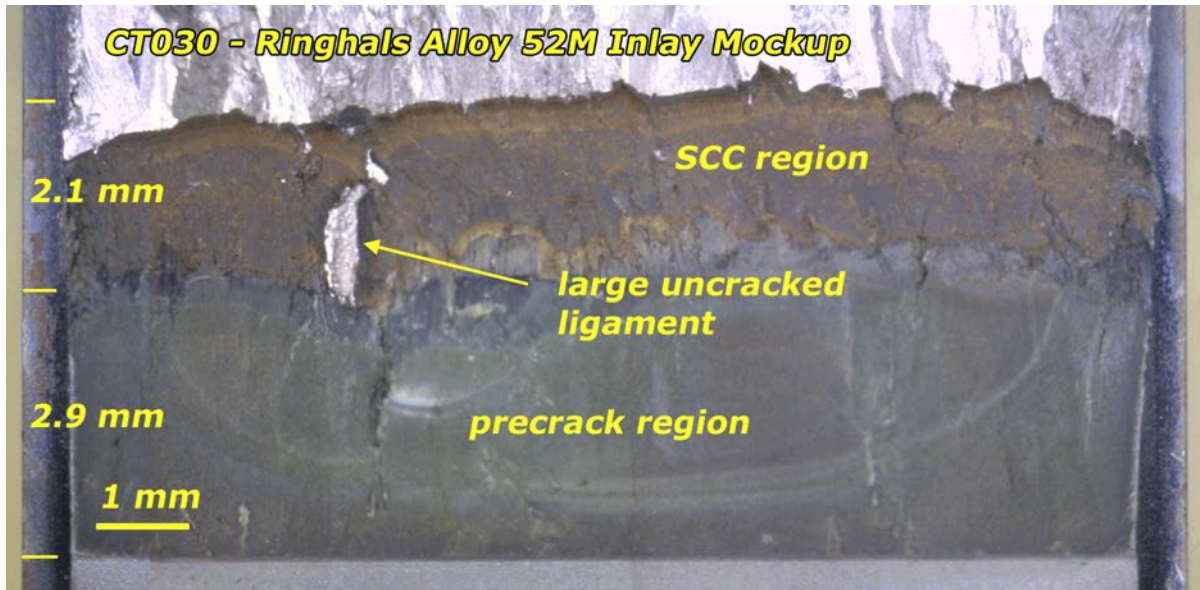
**Figure 2.5 Example of large uncracked ligament detected in the wake of a crack**

Another way exists to compensate for the effect that ligament/contact formation or uneven crack growth has on masking crack extension. During constant K assessments, the crack propagates without any fatigue cycling to break ligaments/contacts and keep the crack front straight. If ligaments/contacts are forming during this constant K crack extension, or if uneven crack extension is occurring, the CGR during load cycling immediately after the constant K observation will be accelerated as the fatigue cycling wipes out some or all of the ligaments/contacts and straightens the crack front. PNNL routinely applies the exact same cyclic loading conditions before and after a constant K observation to help account for untracked crack extension. When the crack front undergoes little or no shape change or when there is no ligament/contact formation, the propagation rates before and after constant K are very similar as shown in the test data in Figure 2.6. The test trace in Figure 2.7 shows much higher CGRs after constant K that point to untracked crack extension. The amount of untracked crack extension is determined by tracing a slope back from the point where the cycle+hold propagation rate stabilizes to a value that is close to the value observed before constant K. The distance that line sits above the DCPD test trace at the conclusion of the constant K observation is the estimated amount of untracked crack extension. An adjusted constant K CGR is then calculated using this value as shown in the plot.

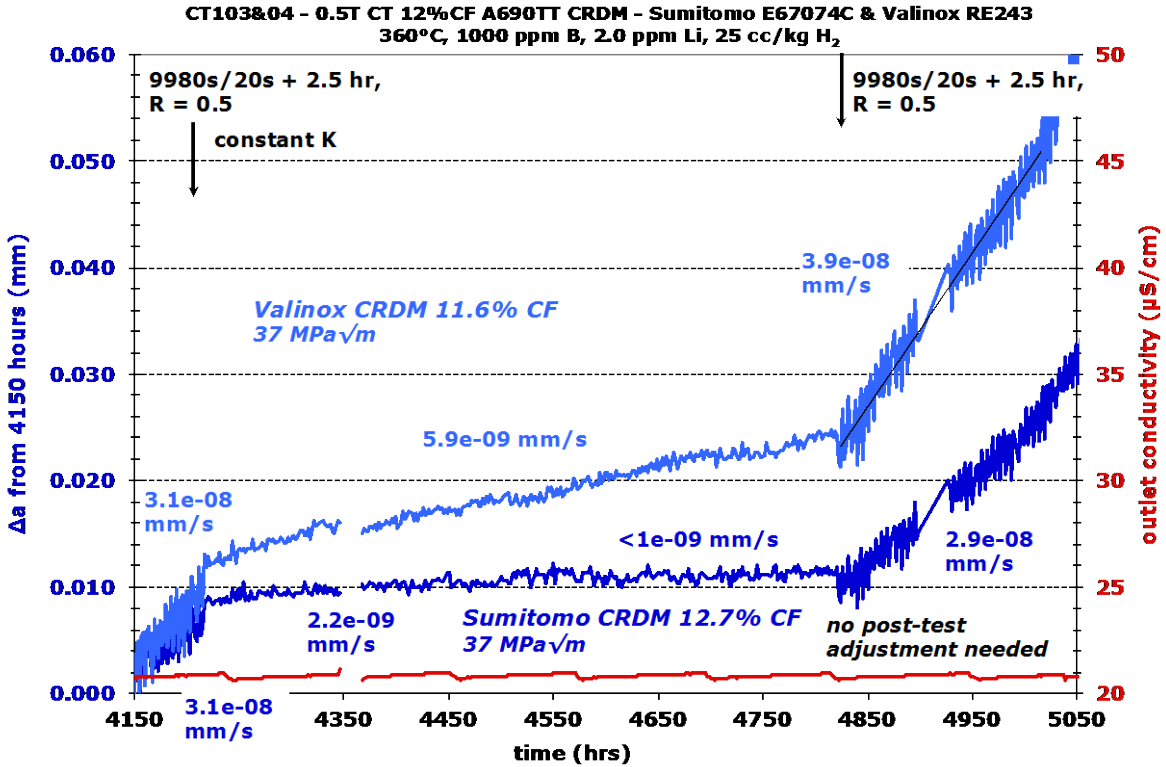
Figure 2.6 Two examples of when the same cyclic loading conditions before and after a constant K observation produce similar crack-growth rates

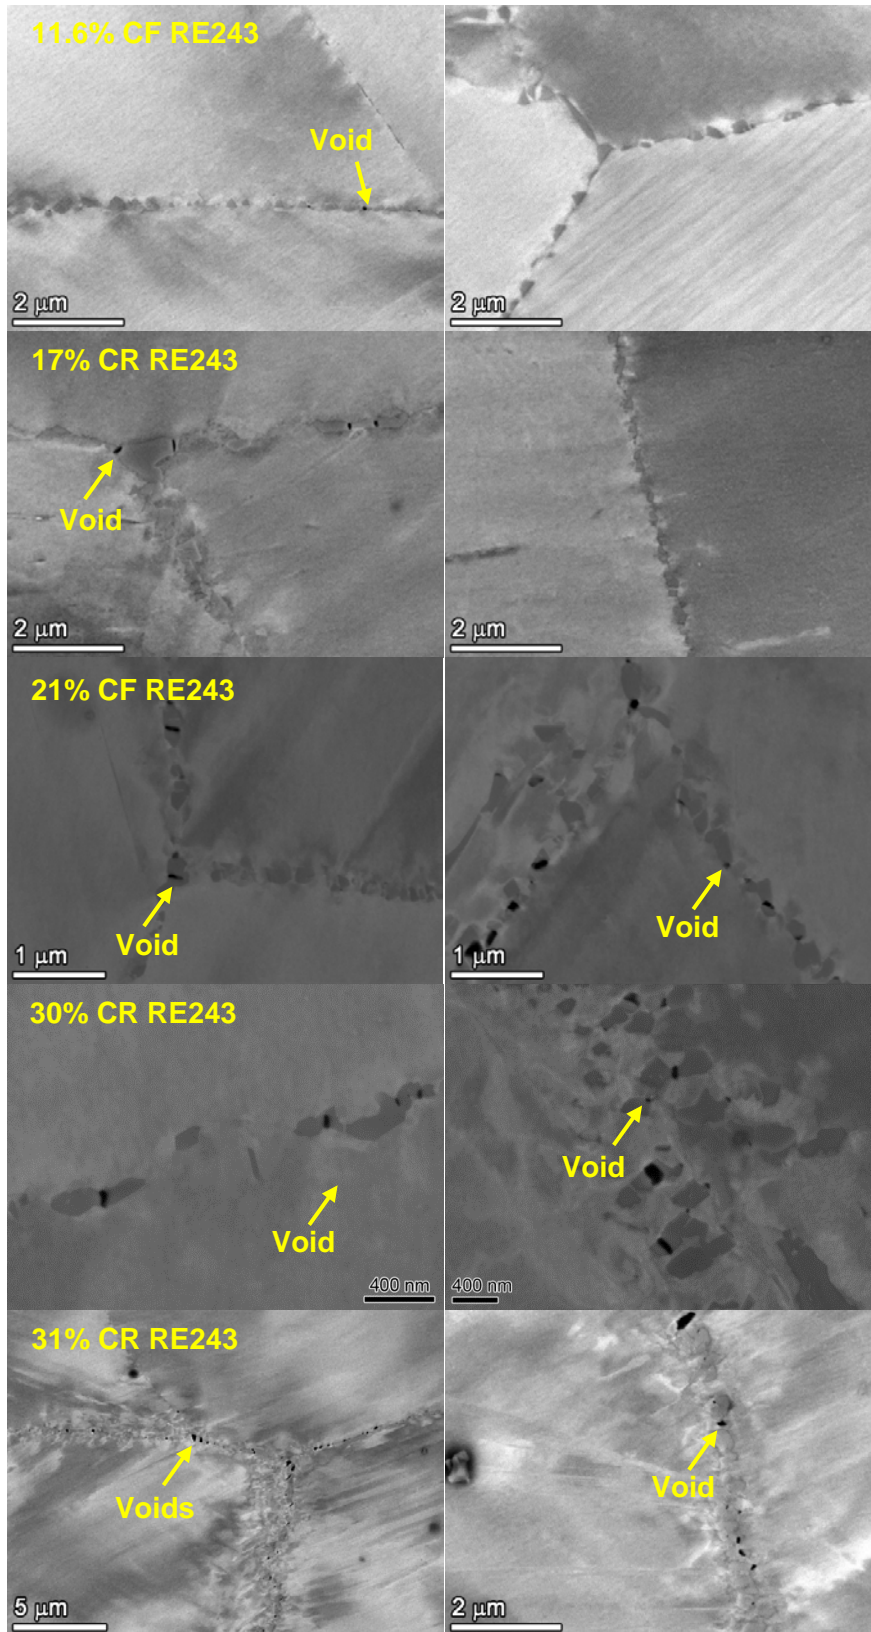
**Figure 3.11** High magnification SEM backscatter images showing the evolution in grain boundary damage with increasing cold work in alloy 690TT RE243

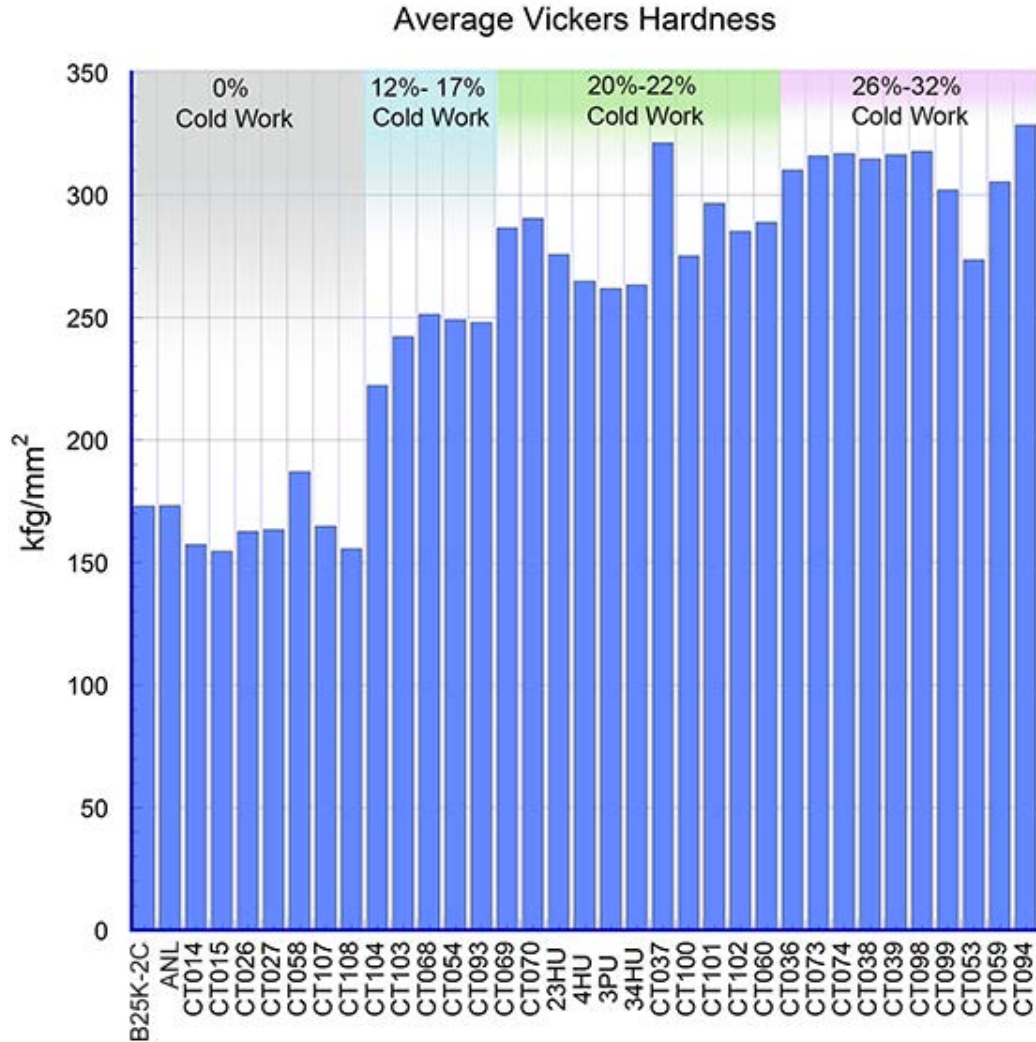
**Figure 3.15** Average hardness is plotted for the tested samples that are grouped according to increasing percent cold work

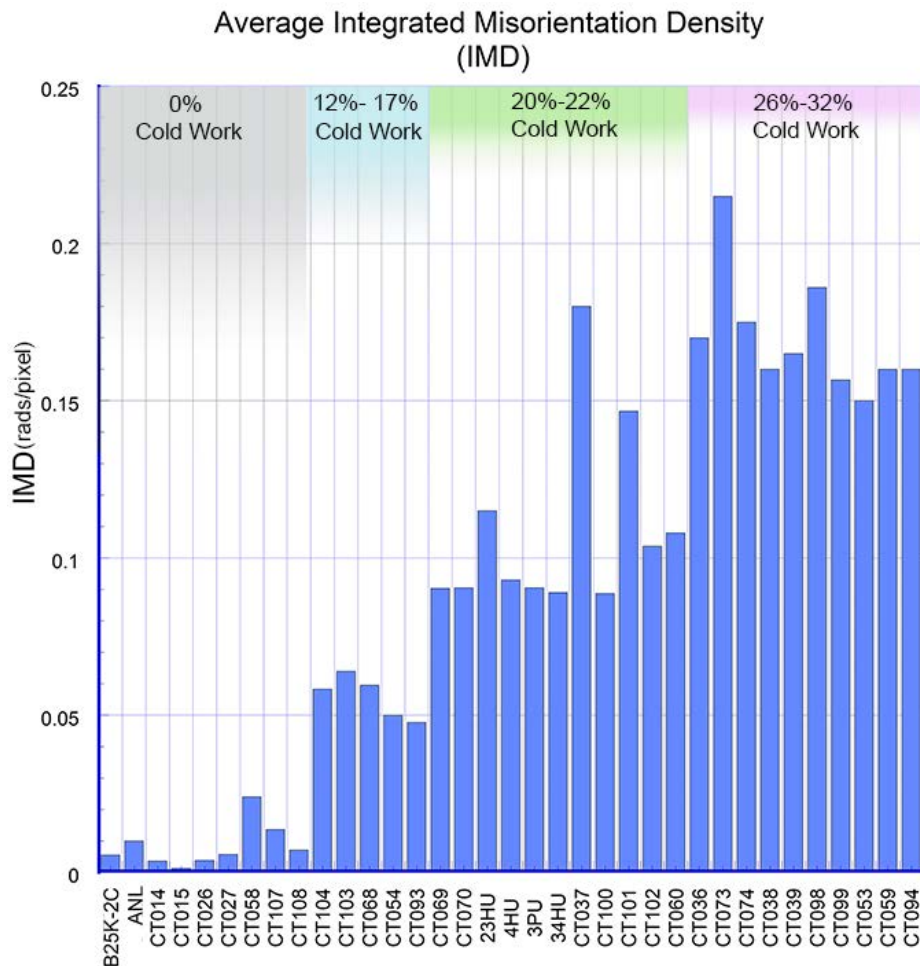
**Figure 3.16** Average IMD is plotted for the tested alloy 690 samples that are grouped according to increasing %CW

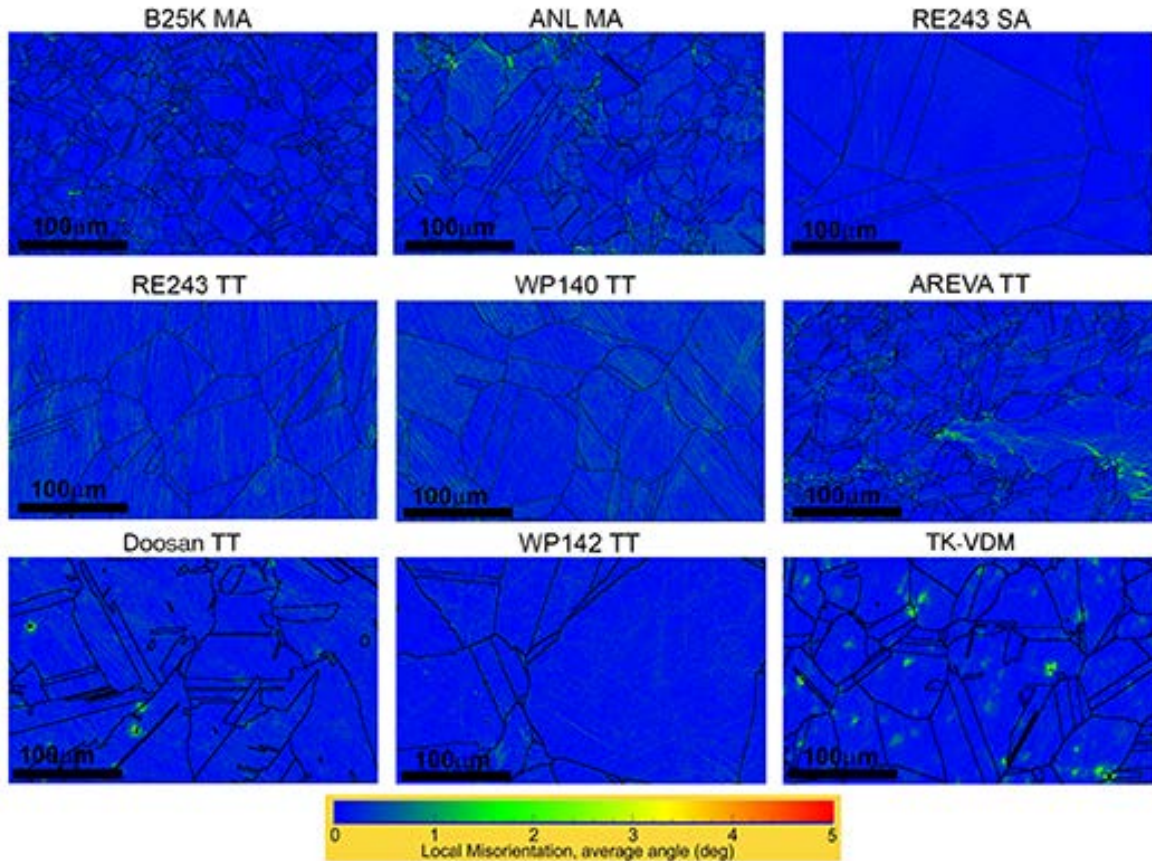
**Figure 3.21 EBSD local misorientation maps showing an overall low degree of misorientation present in the non-cold worked samples.**

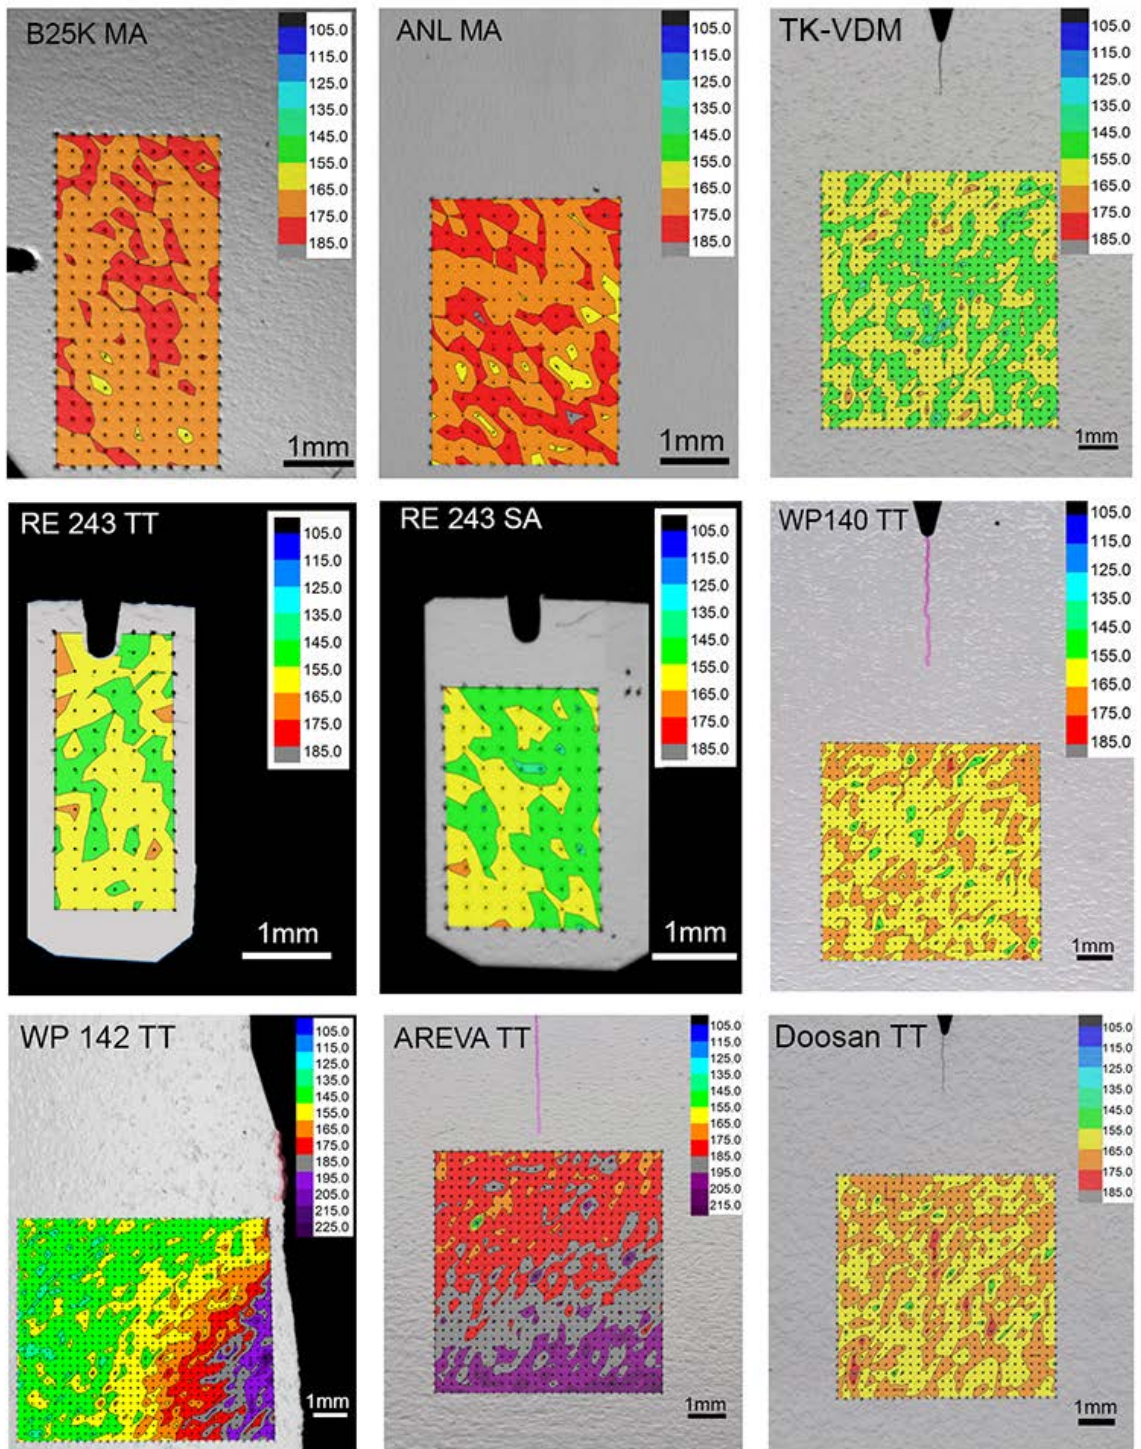
Figure 3.22 Hardness contour plots from the non-cold worked samples. MA conditions show similar hardness values. The thermally treated materials show more sample-to-sample variability.

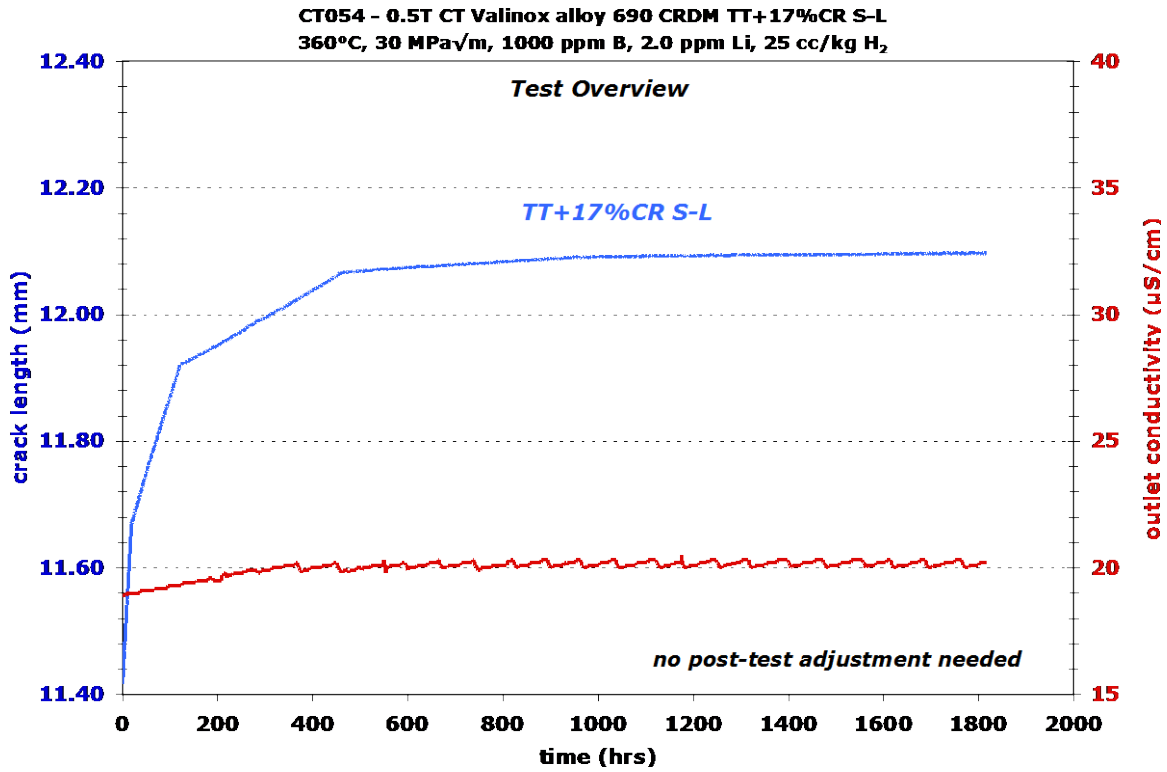
Figure 4.10 Overview of the entire SCC test on the 17%CR S-L Valinox RE243 specimen CT054

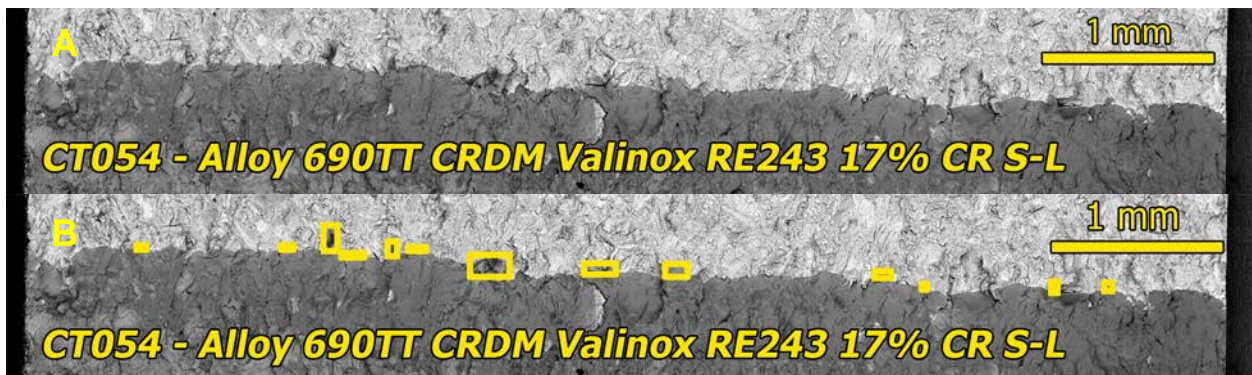
Figure 4.13 SEM-BSE image of the crack front for the 17%CR S-L Valinox RE243 specimen, CT054. (A) and (B) show the crack front with and without boxes that denote the location of IG protrusions along the crack front. Crack front was 18% engaged.

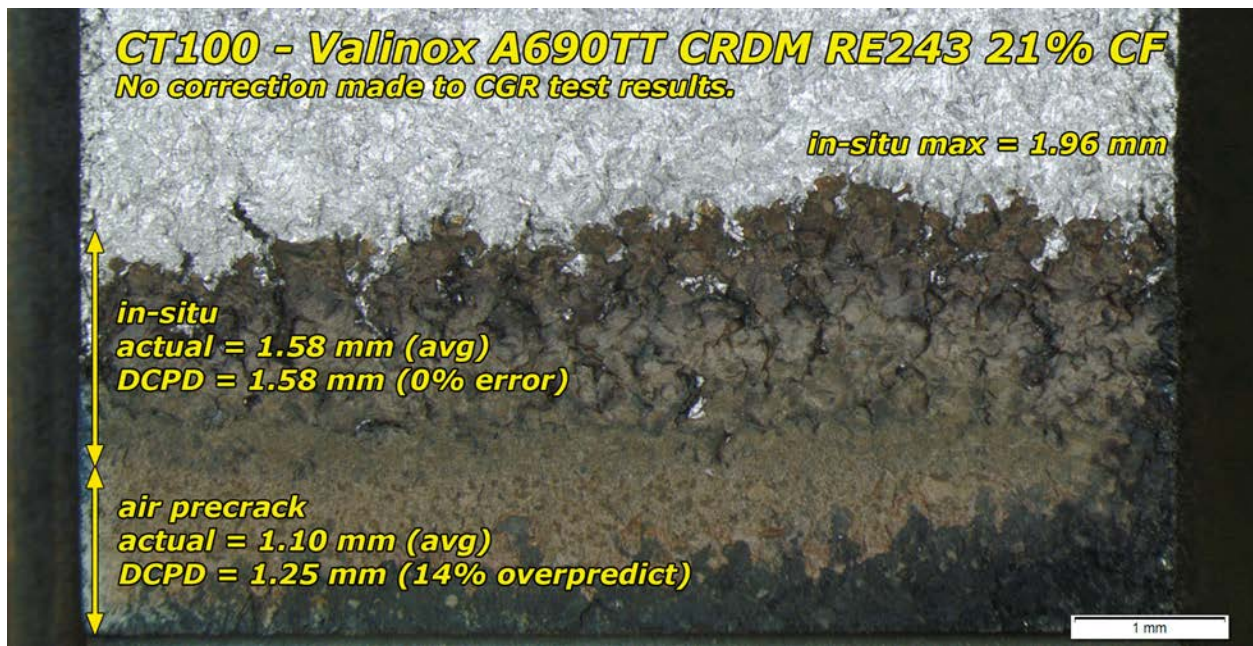
Figure 4.16 Optical image of the as-tested crack growth surface of the 21%CF S-L/S-T Valinox RE243 specimen CT100.

Post-test observations of the crack growth surface are shown in Figure 4.16 (optical) and Figure 4.17 (SEM). The variation in the in-situ extension ranged from ~1.4 to ~2 mm with an average across the crack front of ~1.6 mm. DCPD estimated in-situ extension was also ~1.6 mm, so no post-test corrections to the results was applied. As indicated in the SEM image, the crack front was measured to be 87% IG with IG cracking extending ~1.4 mm back from the final crack front. Even at the onset of IG cracking, the crack morphology is predominately IG, again with ~85% engagement. This indicates that the 980s/20s + 2.5-h hold loading that was used throughout the majority of the test was effective at maintaining IG engagement in this material. However as is evident in the optical and combined SEM BSE images, there were several unbroken ligaments, and some were more than 1 mm behind the final crack front. This indicates that a 980s/20s+2.5-h hold cyclic loading condition was insufficient to break these ligaments. It will be shown later that much more aggressive cycling (such as 0.1 Hz at R=0.5) has also proven to be ineffective in tests for other CW alloy 690 (CT099). There is substantial variability in the crack front shape, again suggesting that while cycle+hold is effective at maintaining the IG growth, it does allow some variability in crack length, both in the overall shape and the degree of jaggedness. Straightening of the jagged crack front in combination with breaking or reducing the size of some ligaments is thought to be the cause of the accelerated crack growth during cycle+hold after constant K exposures.

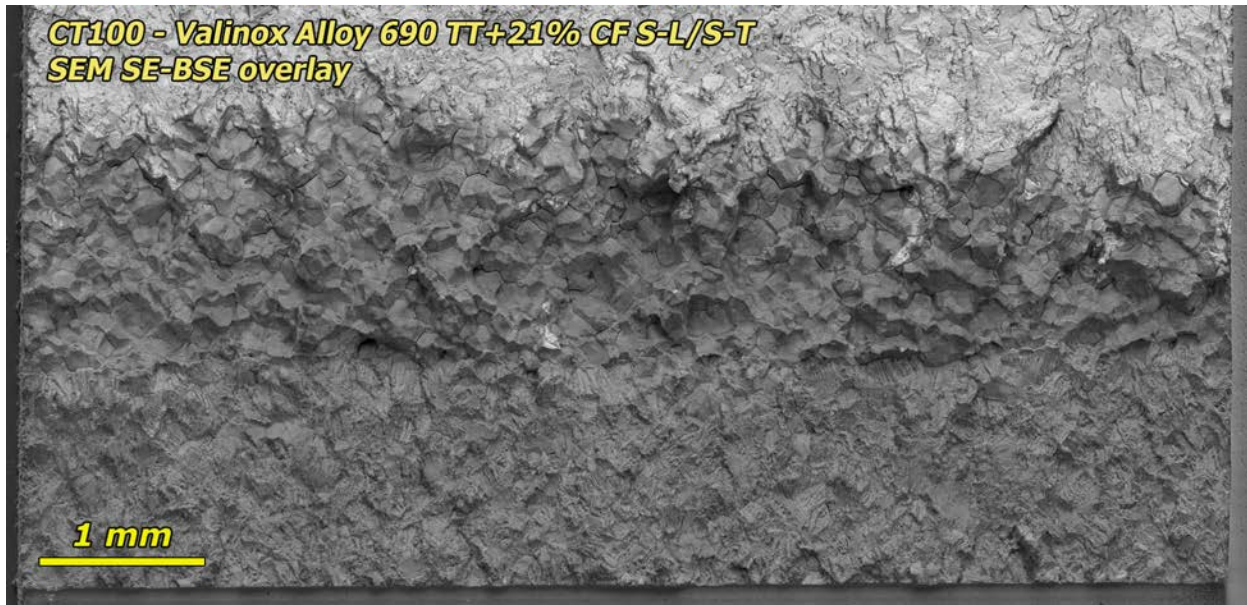
**Figure 4.17** SEM-BSE image of the crack front for the 21%CF S-L/S-T Valinox RE243 specimen CT100. The final crack front was 87% engaged.

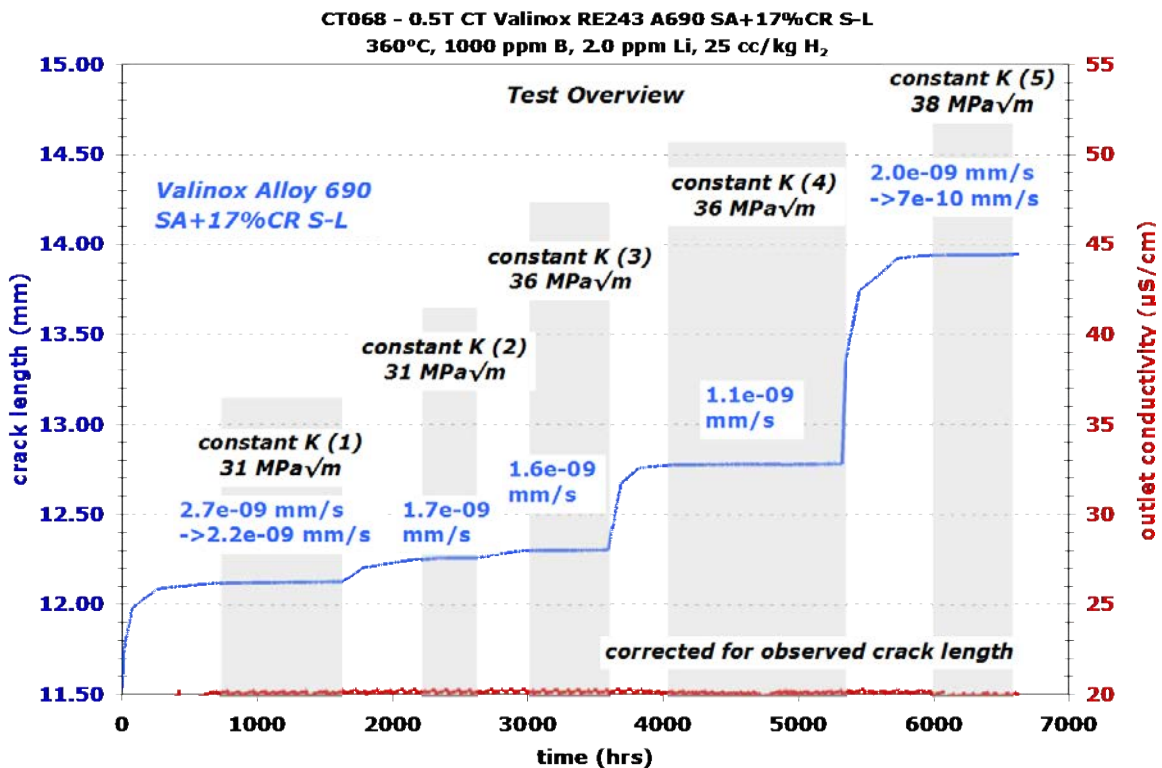
Figure 4.28 Overview of the entire SCC test on the SA+17%CR S-L Valinox alloy 690 CRDM RE243 specimen CT068

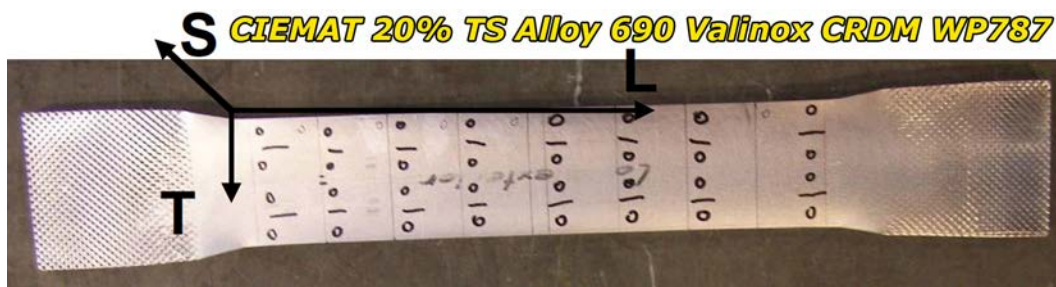
Figure 4.31 CIEMAT tensile strained alloy 690 CRDM WP787 used to produce CT093. Image courtesy of CIEMAT.

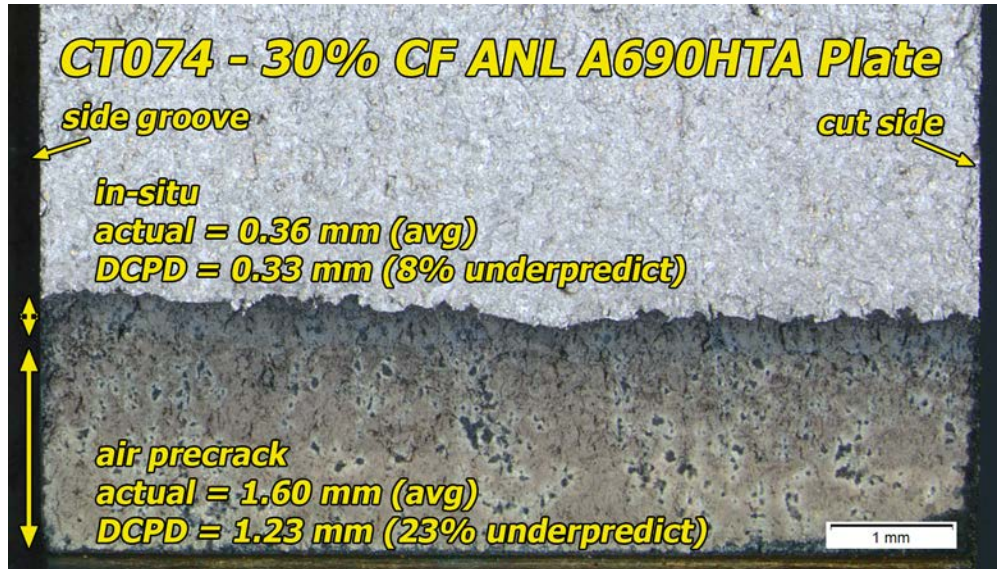
**Figure 5.13** Optical image of the as-tested crack growth surface of the 30%CF ANL alloy 690HTA CT specimen CT074

After completing the test, a slice was removed from each specimen for cross-section observation, and the remaining portion was fatigued open for crack surface observations. An optical image of the as-tested 30%CF MA crack surface in Figure 5.12 shows a relatively straight crack front in the central region, but near the side groove, lack of constraint reduced the K resulting in lower CGRs and a lower amount of crack extension. When using the central region of the crack front for determining the in-situ DCPD correction, it was found that DCPD underpredicted crack length by ~27%. This results in 27% higher CGRs while the increase in K varies with crack length. The in-situ portion of the crack surface shows the presence of ligaments as has been observed for other tests on CW materials. An optical image in Figure 5.13 of the as-tested crack growth surface of the 30%CF HTA specimen shows a much straighter crack front across the width of the specimen with no obvious ligaments. DCPD was found to underpredict crack length by 8% resulting in a proportionate increase in CGRs. Since K was not being controlled to this specimen, the corrected stress intensities are a function not only the DCPD correction to this specimen, but also the difference in crack length that developed between the two specimens during the test.
