International Agreement Report

Nuclear Regulatory Authority Experimental Program to Characterize and Understand High Energy Arcing Fault (HEAF) Phenomena

Prepared as part of
the Agreement between NRC and NRA in the Area of Fire-Related Research

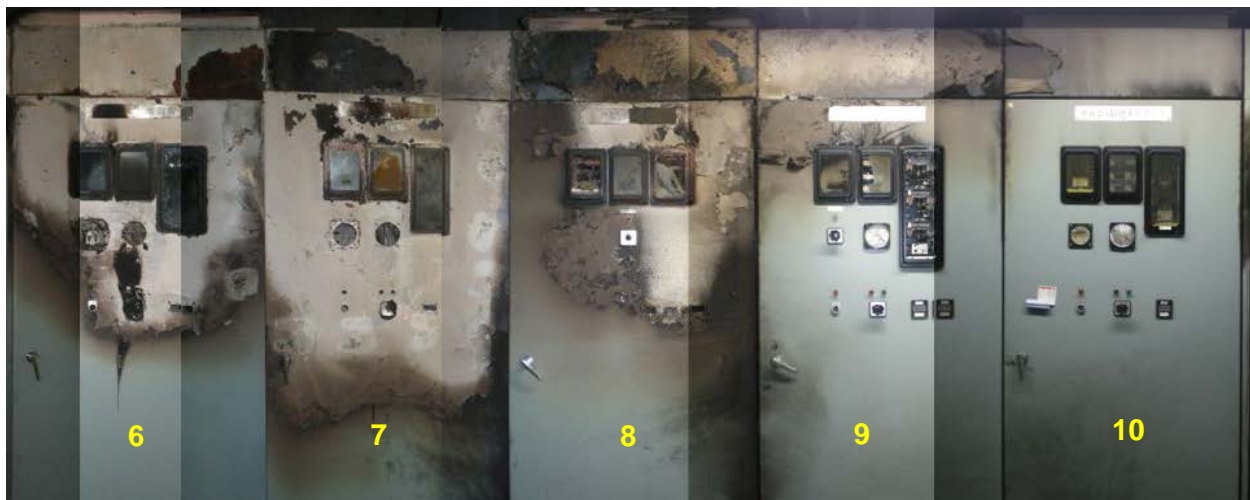
Figure 1.2-1. Damage in Onagawa HEAF Event

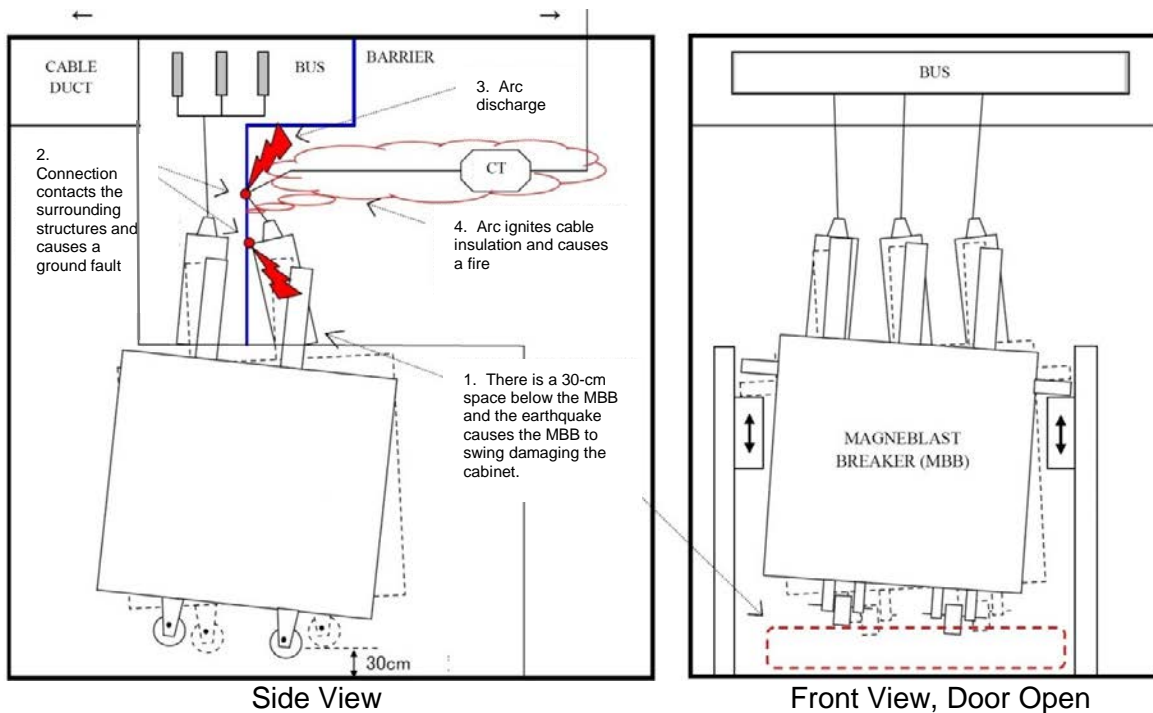
The main goal of the SWGR tests in this report was to simulate these arcs. The initial SWGR Tests 1 through 3 attempted to simulate the Cabinet 7 arc only. However, based on the initial test results, the SWGR tests were redesigned to provide two arcs in Tests 4 through 6 to better simulate the Onagawa event.

Figure 1.2-2. Onagawa Arching Scenario

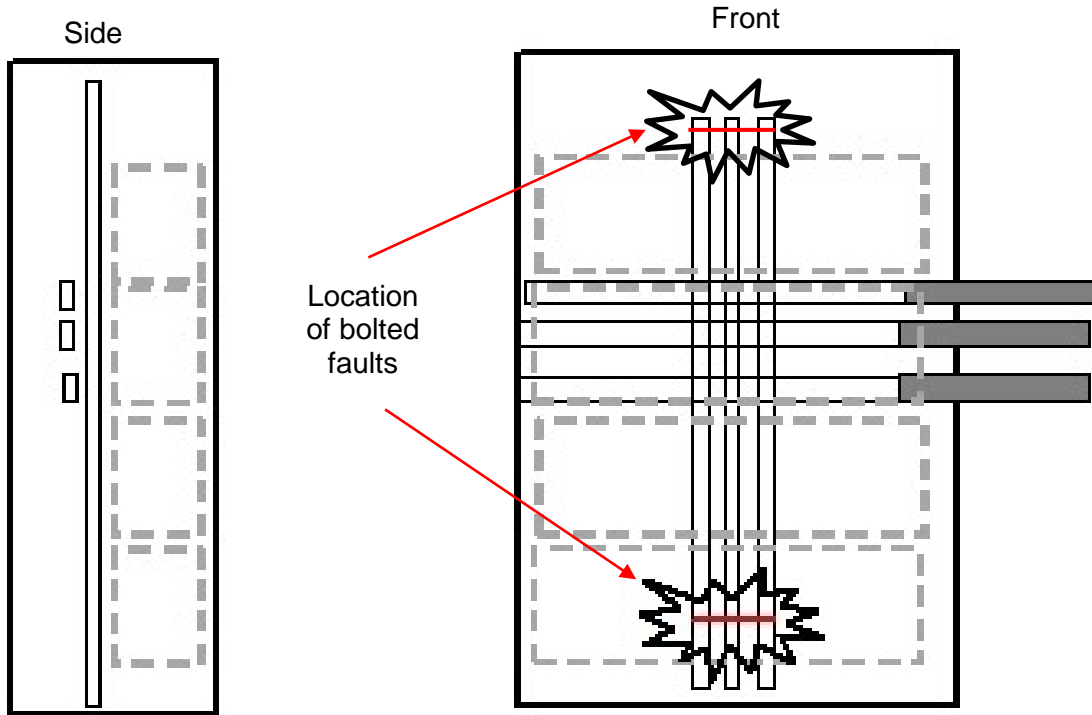
The GE APN-B DP has horizontal and vertical bus bars, as shown in Figure 2.3-1. The horizontal buses are extended outside the cabinet for KEMA to connect (gray). A wire to start the arc is connected to the buses inside (red lines). The breakers and components in the DP are the combustible load. An arc at the bottom below the combustibles should cause the largest fire in the cabinet. DP Tests 1 through 3 used an arc at the bottom of the cabinet. DP Tests 4 through 6 used an arc at the top of the cabinet.

Figure 2.3-1. DP Test Configuration

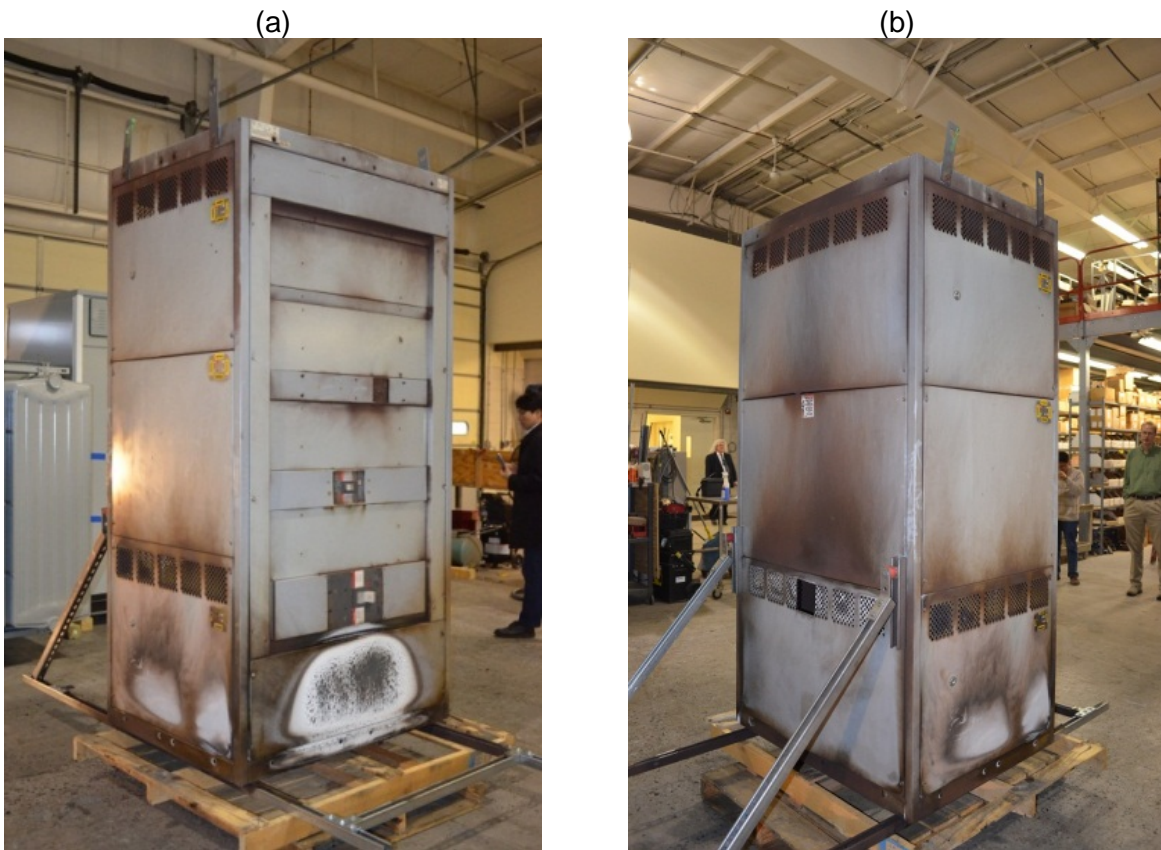
The cabinet front was heavily damaged by the arc. The sides and rear were damaged, as seen in Figure 2.9-2. The cabinet top had a deformation that occurred at about 0.022 seconds after the arc based on high speed images as shown in Figure 2.9-3.

Figure 2.9-2. DP Test 2 HEAF Exterior Damage

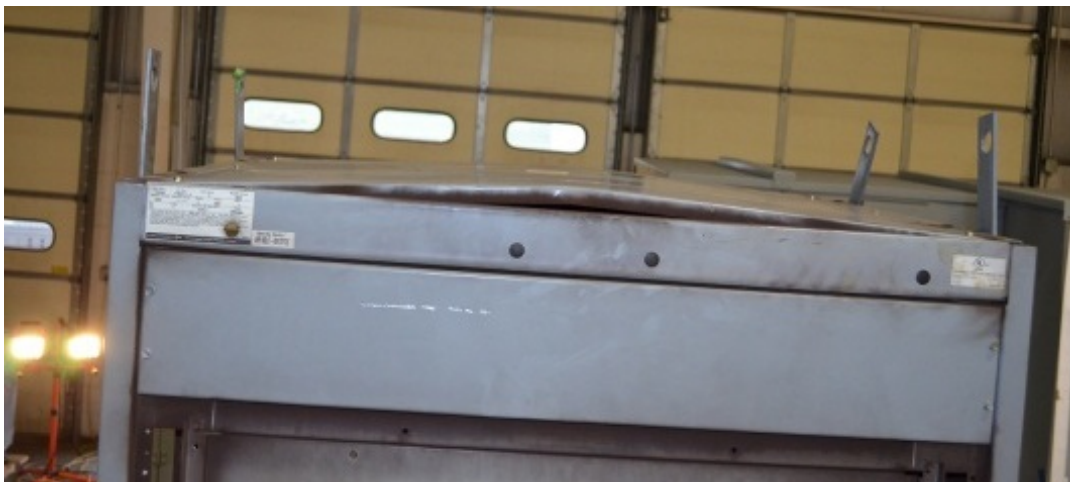
Figure 2.9-3. DP Test 2 Cabinet Top Deformation

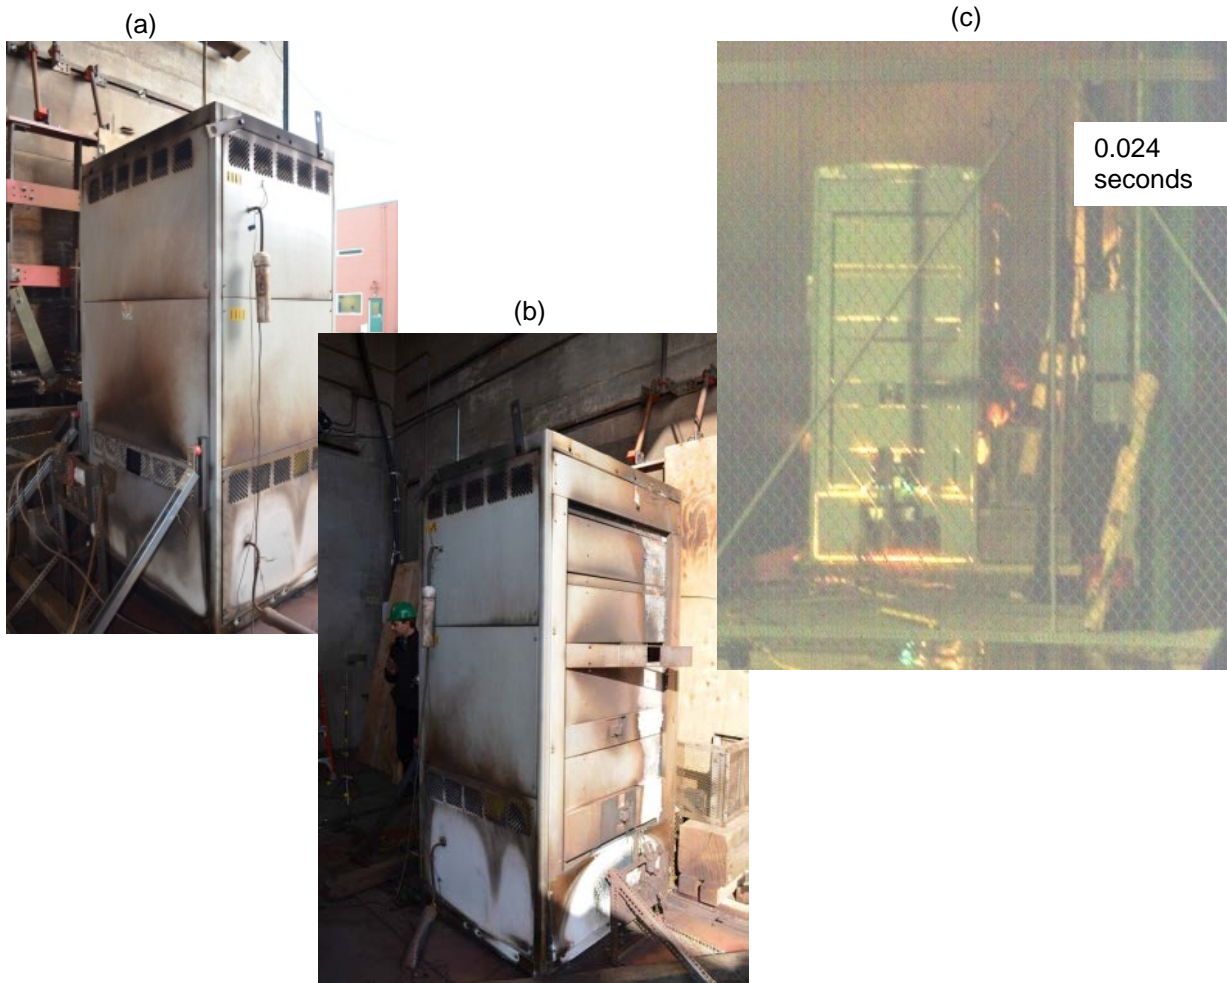
The front was heavily damaged by the arc and ensuing fire, as seen in Figure 2.10-3 through Figure 2.10-5. The sides and rear was also damaged. One panel opened from the high pressure at 0.024 seconds and roof deformation occurred at the same time, as seen in Figure 2.10-3(c). The roof deformation was smaller than Tests 1 and 2, probably because the pressure was relieved by the panel coming off during the test. The pressures seen in Test 3 were between those in Tests 1 and 2.

Figure 2.10-3. DP Test 3 Exterior Cabinet Damage

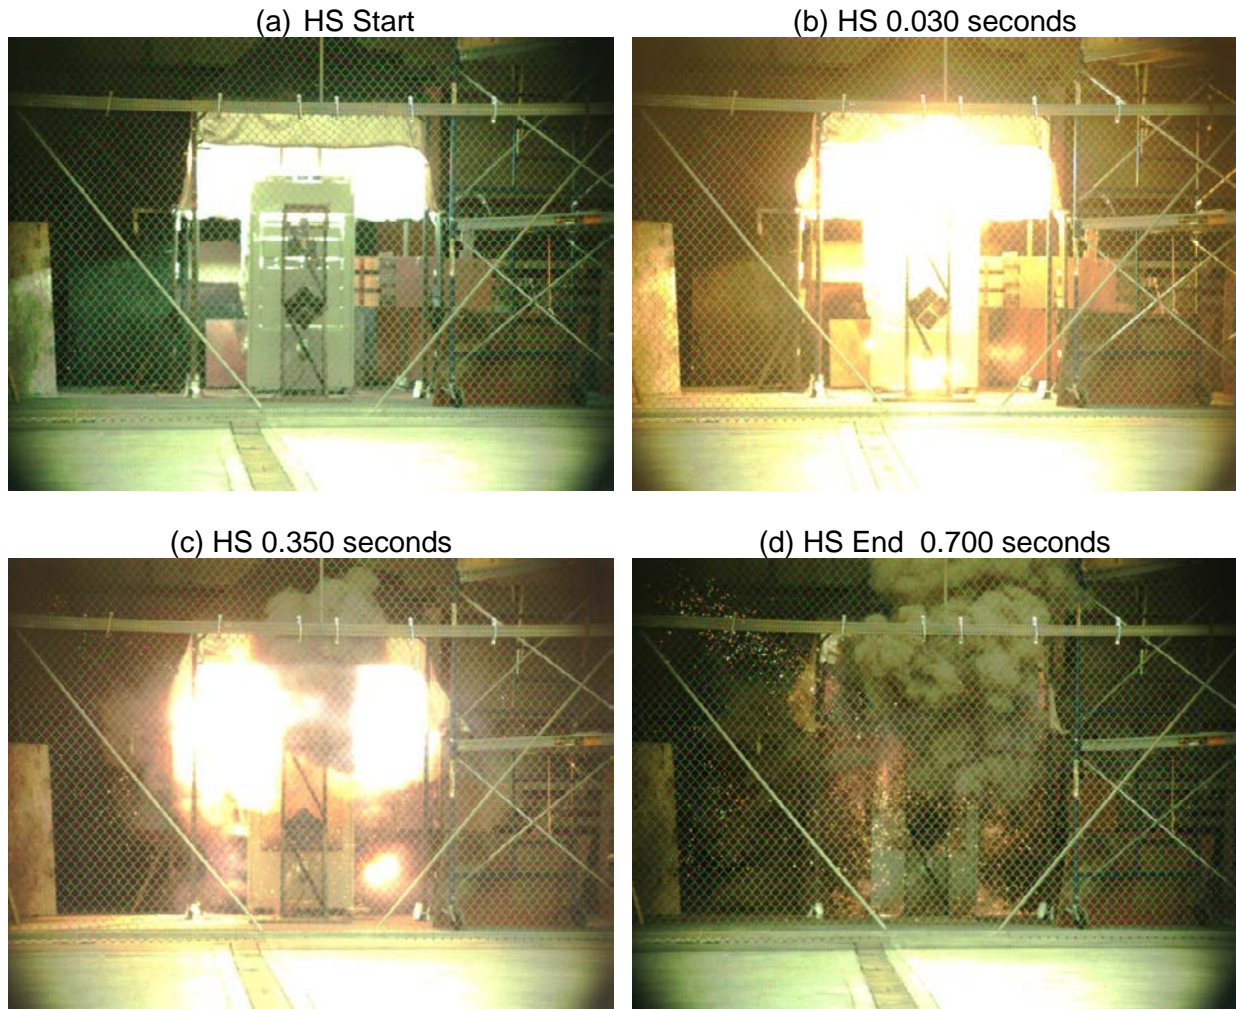
This cabinet test was initiated at 484 V and 50.3 kA, with a target duration of 2 seconds. The arc quenched at 0.698 seconds due to a ground failure. The total energy was 8.3 MJ. Figures 2.11-1 through 2.11-3 show the arc with High Speed (HS) camera, and High Definition (HD) camera, and Forward Looking Infrared (FLIR) camera. Note the arc flames extend to the postulated ZOI of 0.91m (3 ft) at 0.350 sec. There was no ensuing fire.

Figure 2.11-1. DP Test 4 Arc

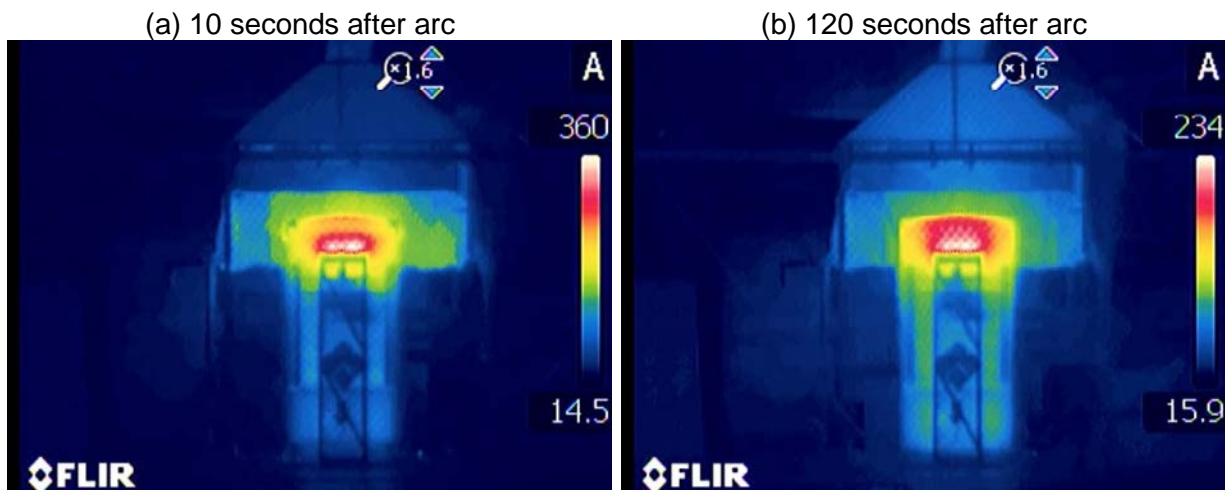
The FLIR camera indicated a maximum temperature of 350 °C at the top front “hot spot” that cooled 100 °C in 2 minutes, see Figure 2.11-3. The flux from this hot spot was detected by the slug calorimeter at the top front of the cabinet as discussed later. This hot spot on the panel near the arc was similar to previous DP tests in 2013. There was no ensuing fire.

Figure 2.11-3. DP Test 4 Thermal Images

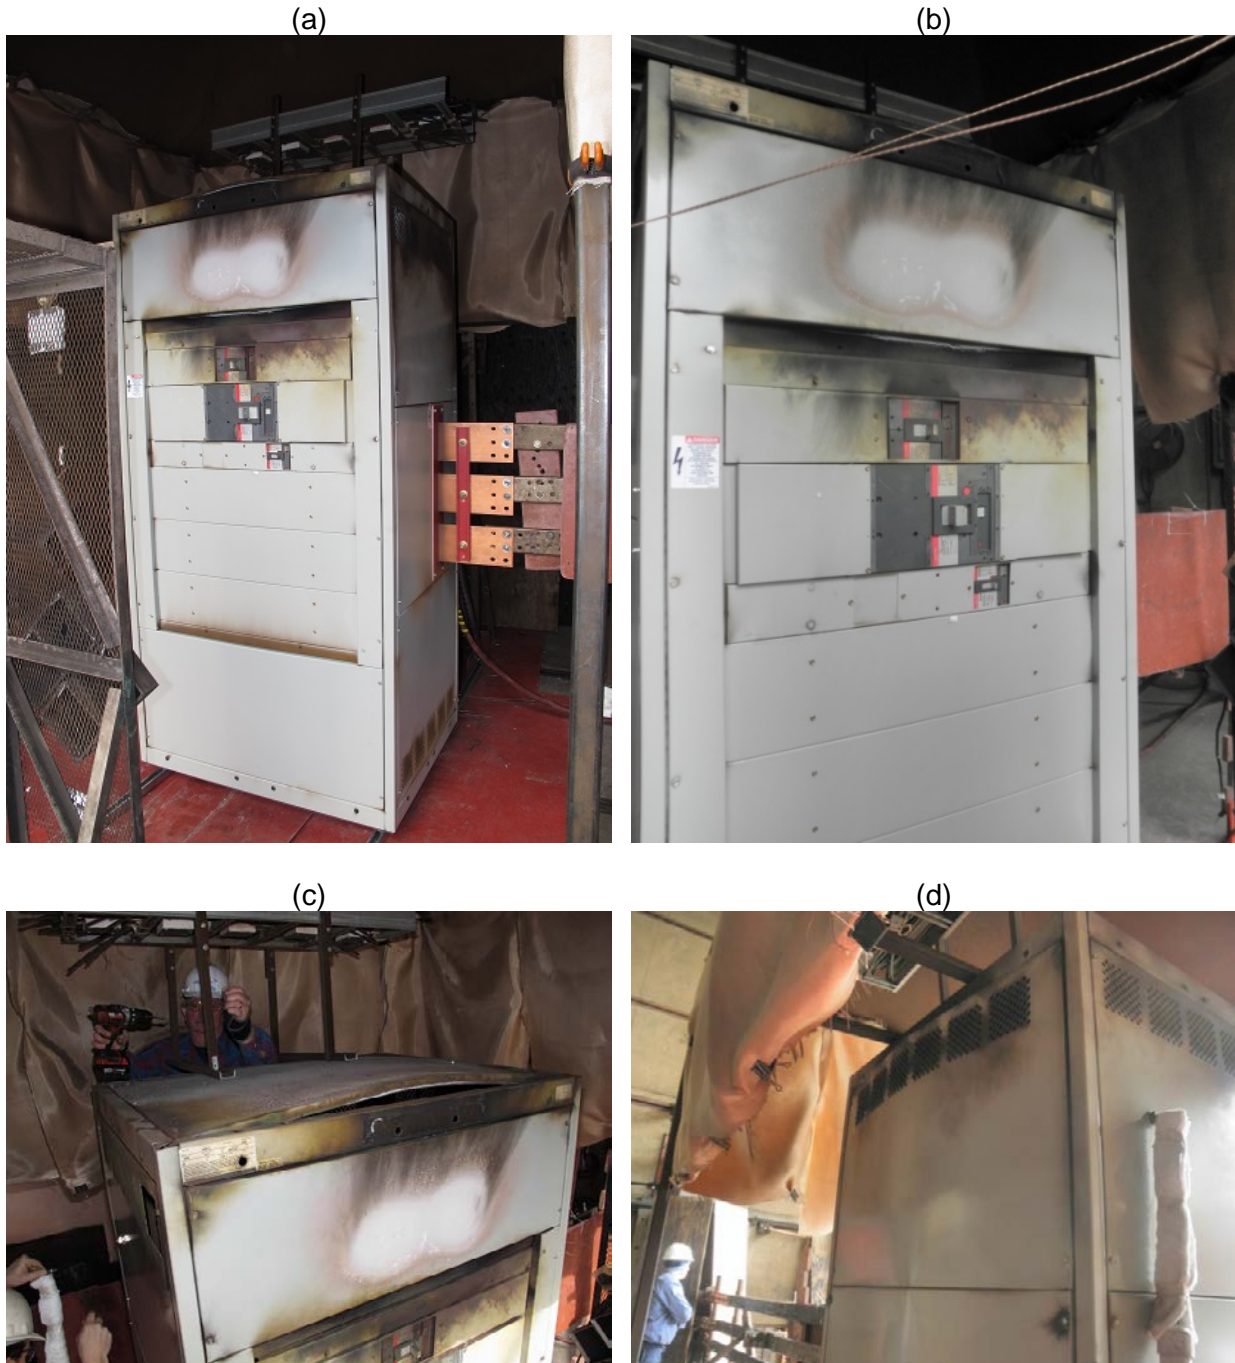
The damage is shown in Figure 2.11-4 through Figure 2.11-8. Figure 2.11-4 shows the exterior charring and discoloration on the top panel near the arc. There was minor deformation of the front and rear panels. The external cable tray showed no damage. The arc was shorter than planned because there was an external ground fault from a poor connection as shown in Figure 2.11-7. Figure 2.11-6 shows the interior damage with charring and copper plated on the surfaces but no major fire. Figure 2.11-8 shows the interior bus bar damage.

Figure 2.11-4. DP Test 4 Exterior Cabinet Damage

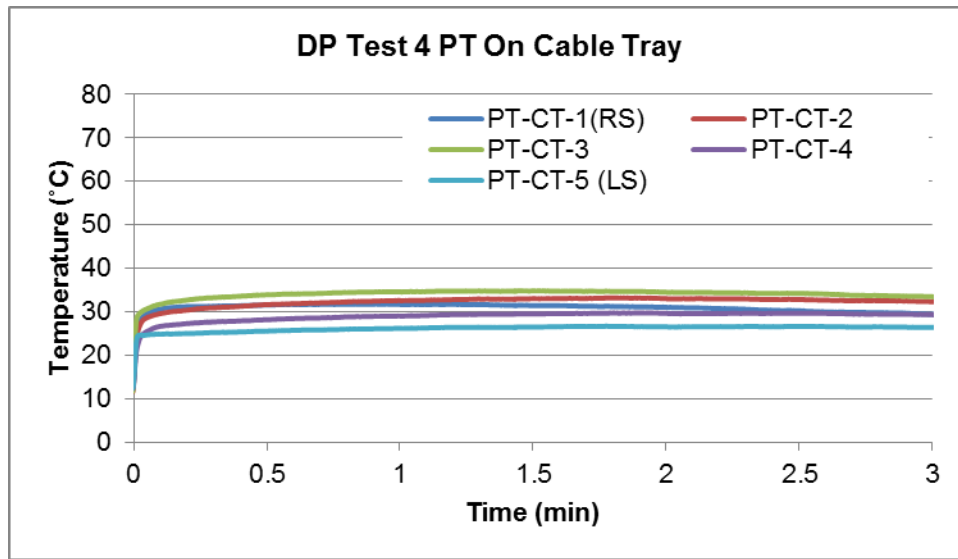
As expected, the temperature in the center of the cable tray was the highest but all temperatures were low, indicating the heat released through the top rear vents below the cable tray were low. These low temperatures were consistent with no cable damage, as shown earlier. The maximum temperatures occurred at about 1.5 minutes after the arc, indicating that heat escaped from the cabinet after the arc heating the PT.

Figure 2.11-10. DP Test 4 Cable Tray Plate Thermometer Data

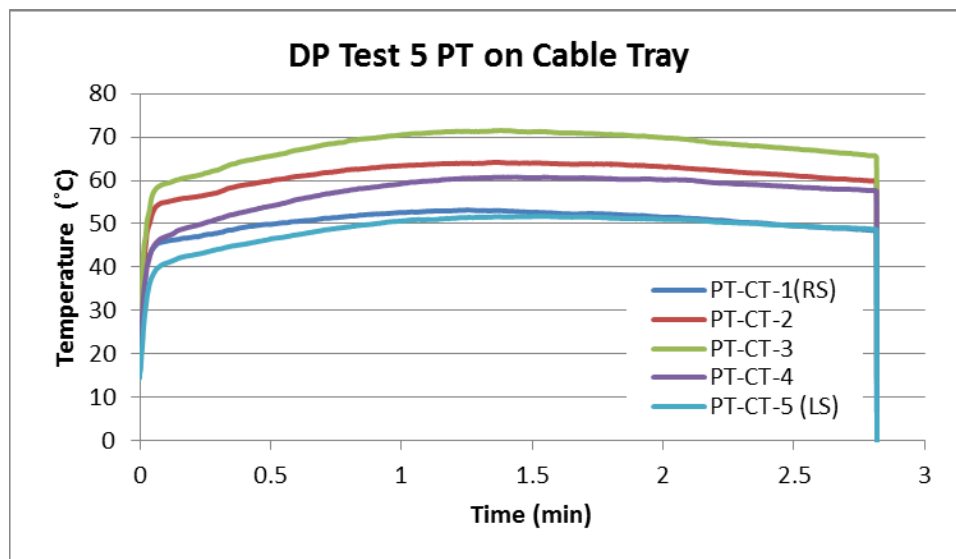
As expected, the temperature in the center of the cable tray was the highest but all temperatures were low indicating the heat released through the top rear vents below the cable tray was low. These low temperatures were consistent with no cable damage, as shown earlier. The maximum PT temperatures were higher than DP Test 4 because the duration was longer and there was more energy in Test 5. The maximum temperatures were about 1.5 minutes after the arc indicating that heat escaped from the cabinet after the arc heating the PT.

Figure 2.12-8. DP Test 5 Cable Tray Plate Thermometer Data

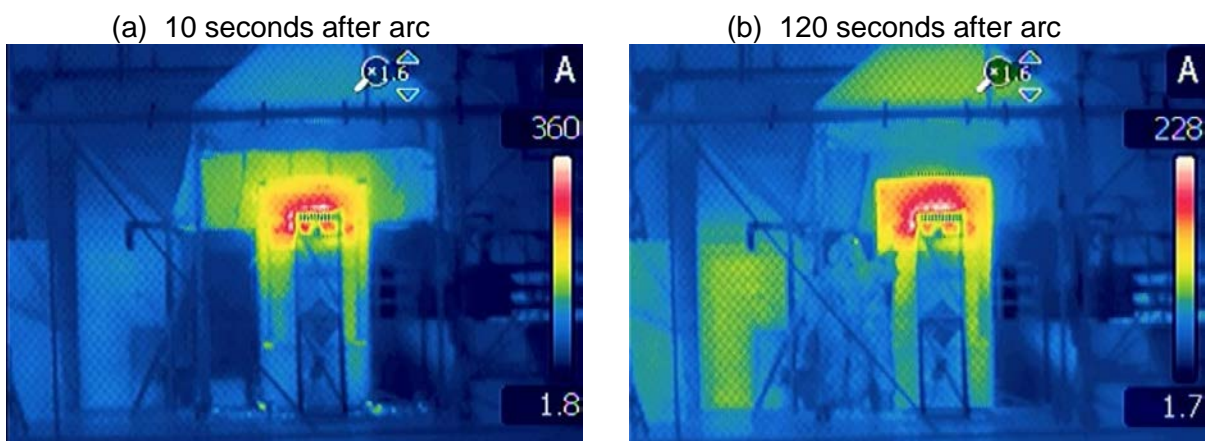
The FLIR camera indicated a maximum temperature of 360 °C at the top front “hot spot” that cooled by 140 °C in 2 minutes. The flux from this hot spot was detected by the slug calorimeter at the top front of the cabinet (see Figure 2.13-3). This hot spot was a little smaller than in Test 4, with a similar arc. There was no ensuing fire.

Figure 2.13-3. DP Test 6 Thermal Images

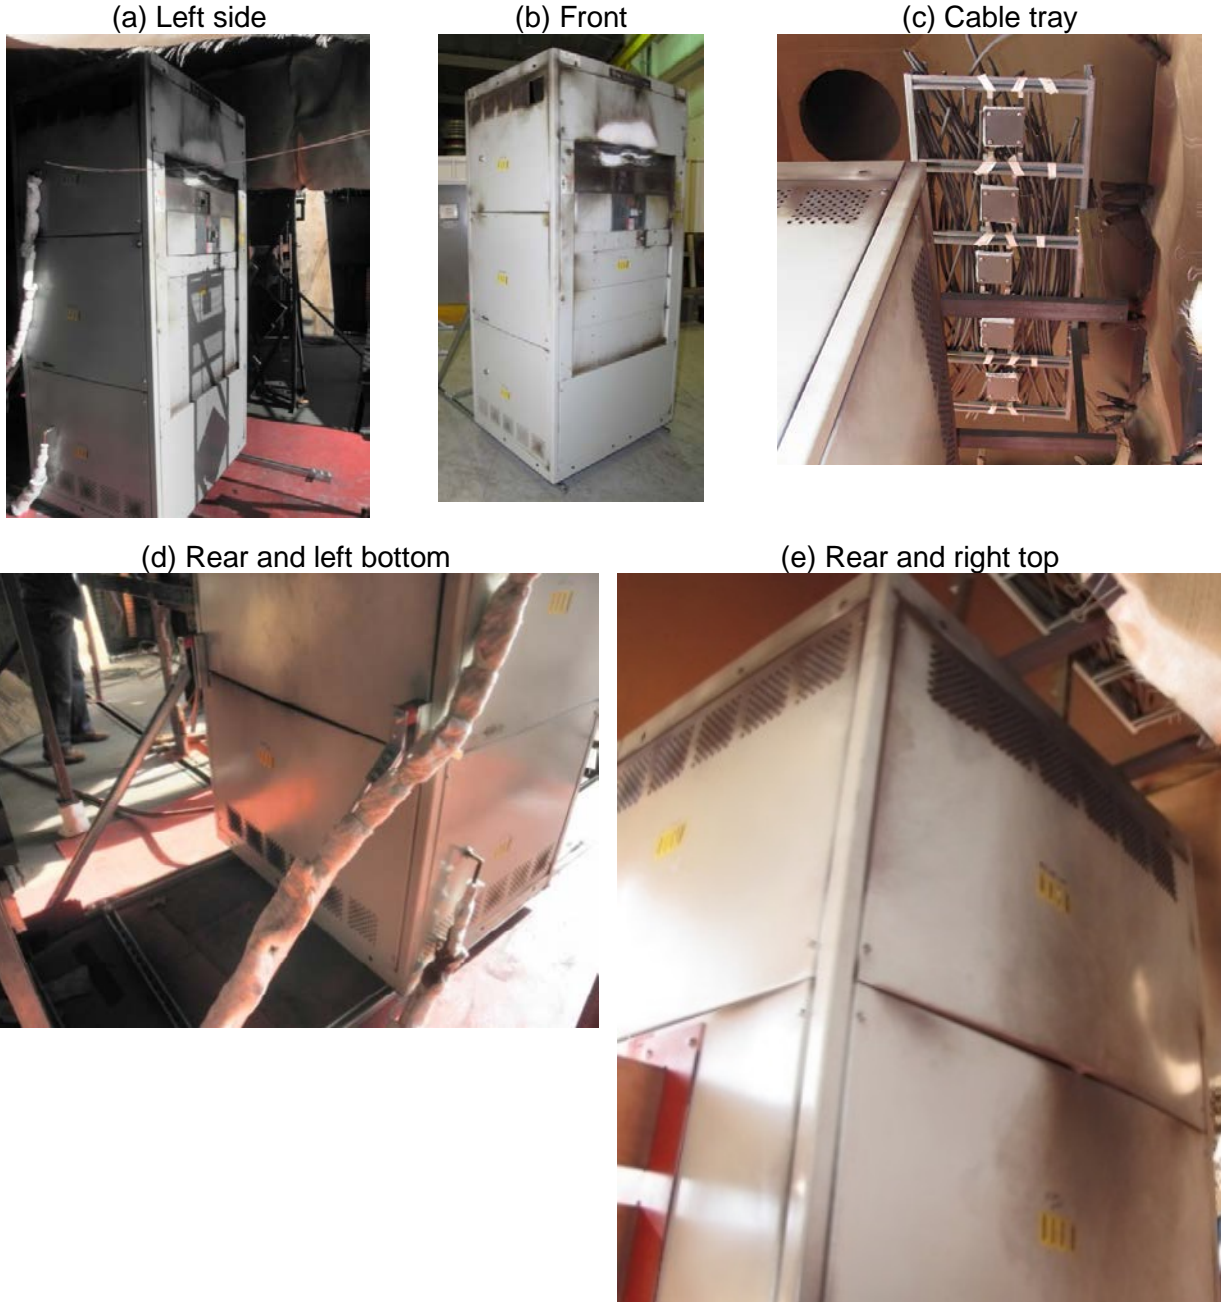
Figure 2.13-4 shows the exterior charring and discoloration on the top panel near the arc. There was minor deformation of the front and rear panels. The external cable tray showed no damage. Figure 2.13-5 shows the interior damage with minor charring of the cables and copper plated onto the surfaces but no major fire. Figure 2.13-6 shows the interior bus bar damage was only burning at the top of the bus bars.

Figure 2.13-4. DP Test 6 Exterior Damage

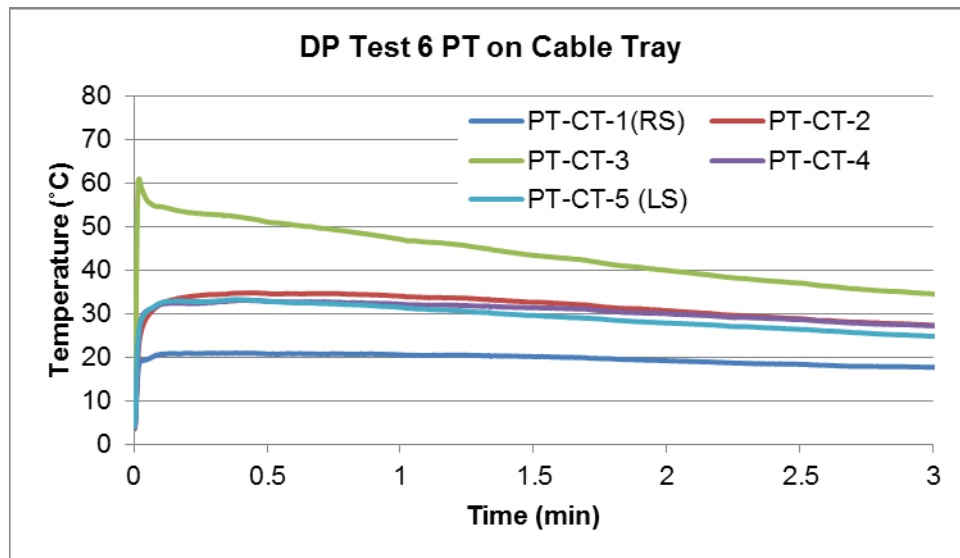
PTs were used in this test to measure temperature; TCs were not used based on experience in previous DP tests. The temperatures measured by the PTs on the CT are seen in Figure 2.13-9. Table 2.13-2 shows the maximum PT temperature during the test. The PTs indicated the maximum temperature a black-body, metal object 46 cm (18 in) above the cabinet rear could reach during the arc.

Figure 2.13-8. DP Test 6 Cable Tray Plate Thermometer Data

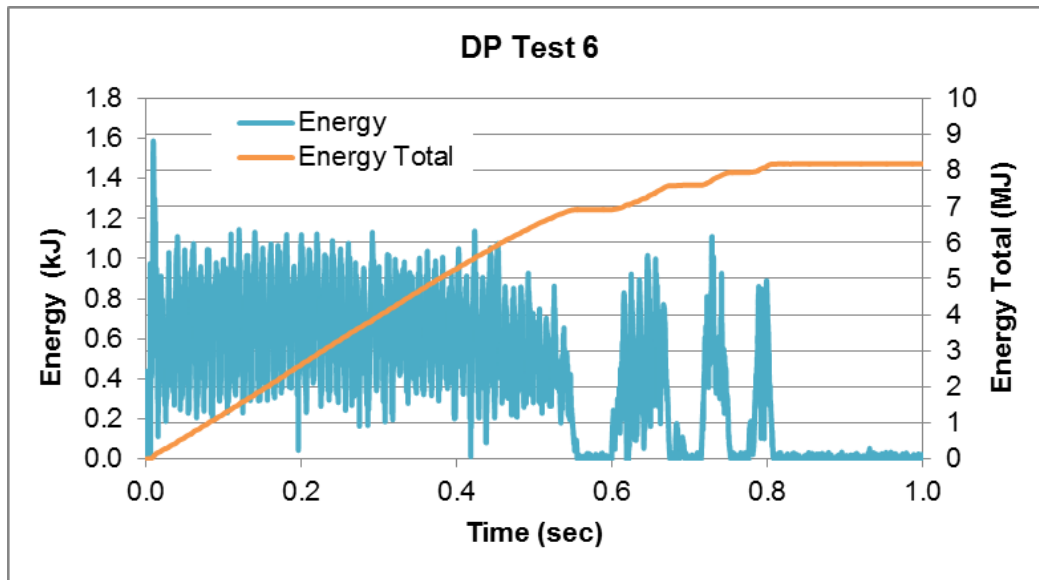
Figure 2.13-10 shows the initial arc was 0.55 seconds before the first extinction with a smooth and steady energy increase then there were several restrikes after the initial arc. The arc duration, including the restrikes was 0.781 seconds with total energy of 8.2 MJ. The energy analysis methods are in Appendix A. The “Energy” is calculated as volts multiplied current multiplied by the time step and each time step is shown. “Energy Total” is the cumulative sum of the energy in each time step.

Figure 2.13-10. DP Test 6 Arc Energy

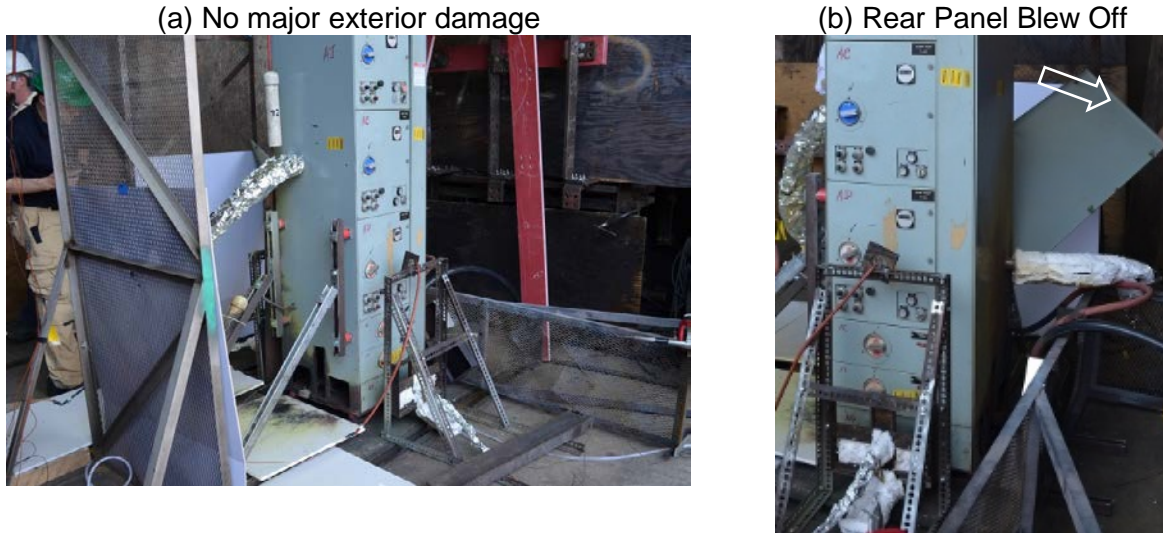
Damage was minor with only light charring and soot at the bottom of the cabinet and on a white external poster-board target, as seen in Figure 3.7-3(a). As shown in Figure 3.7-3(b) the top rear panel blew off during the arc; to avoid this in the future tests, steel bands were used to hold the cabinet panels in place.

Figure 3.7-3. MCC Test 1 Exterior Damage

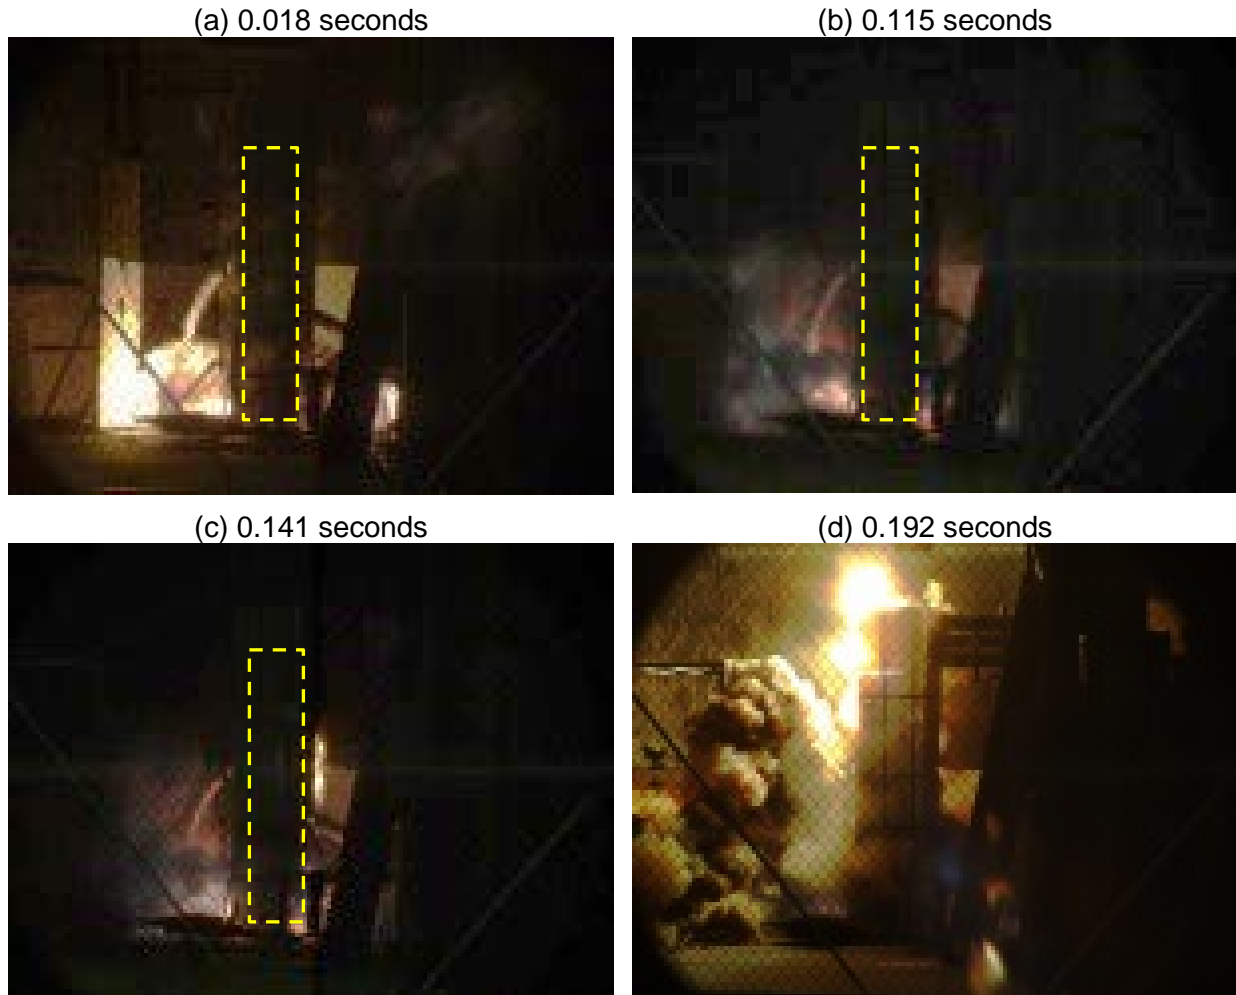
The arc sequence is shown in Figure 3.8-2: (a) the initial arc at 0.018 seconds, (b) the initial arc almost quenches and is not visible, (c) the hot gases traveled up the right side of the cabinet and some escaped out of the panels (at this point the gases are about half way up the cabinet), and (d) the hot gases caused the arc at the top horizontal bus bars. This is the only test where the arc quenched at the ignition point at the arc wire followed by the hot gases causing a second arc in a separate location.

Figure 3.8-2. MCC Test 2 Sequence for 2 Arcs
(the cabinet is outlined in yellow)

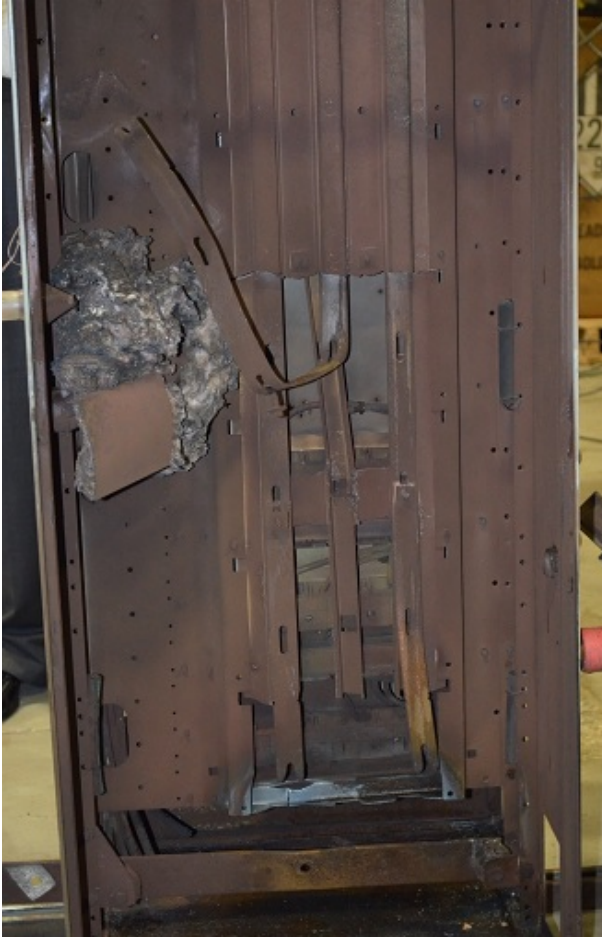
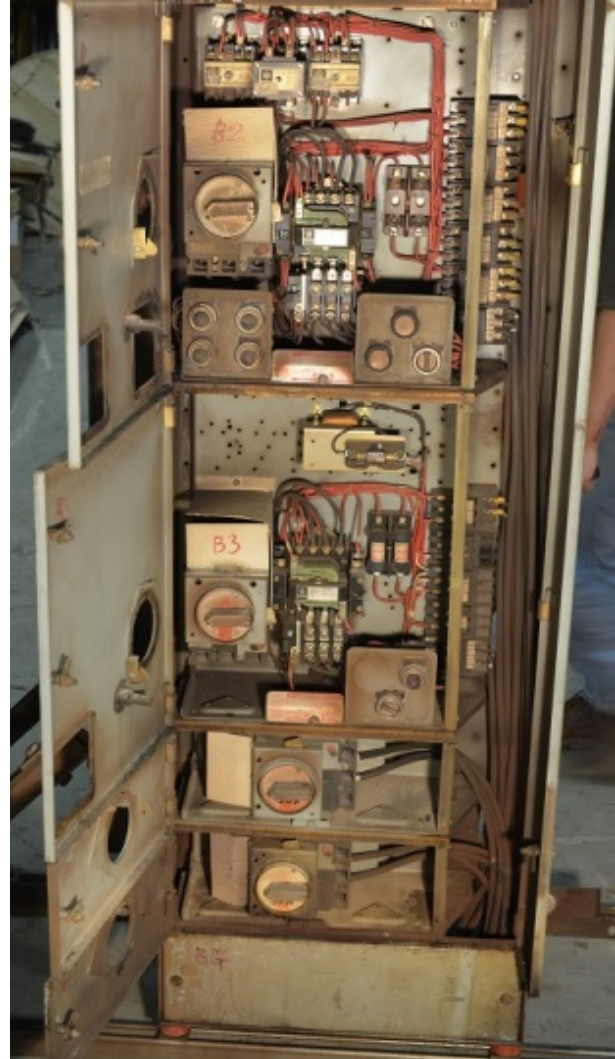
(a) Bottom Arc Damage

(b) No cable fire

Figure 3.8-5. MCC Test 2 Interior Damage

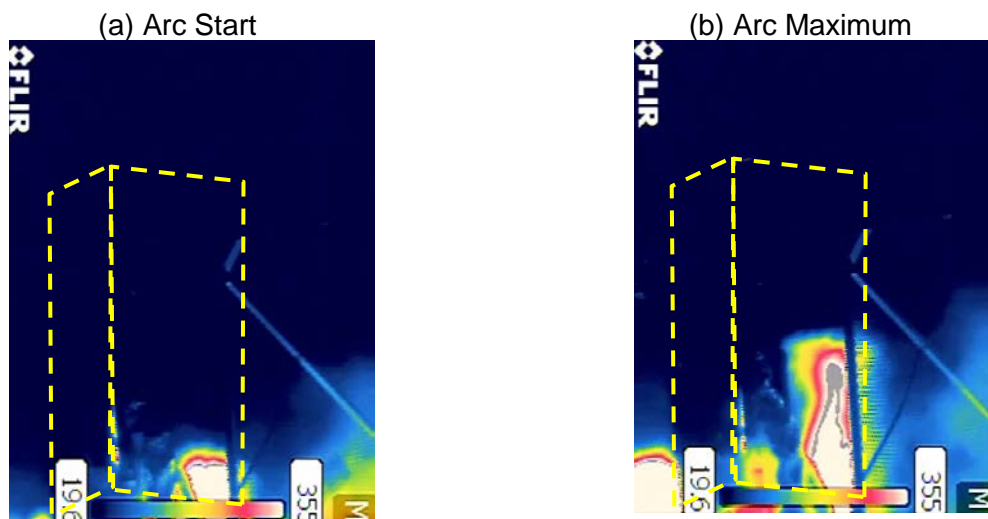
Figure 3.9-2 shows FLIR images from the rear, left corner of the tests cell (other videos are from the front) to get a close view if the arc moved to the top of the MCC. In these views the right side of the cabinet is on the left side and the camera was turned upward to view more of the MCC. The FLIR was set at a constant 355 °C (671 °F) maximum. Arc plasma and hot gases escaped the lower part of the cabinet during the arc. After the arc, there was no detectable indication of high temperatures on the exterior of the cabinet or of internal fires.

Figure 3.9-2. MCC Test 3 Thermal Images (Rear View)

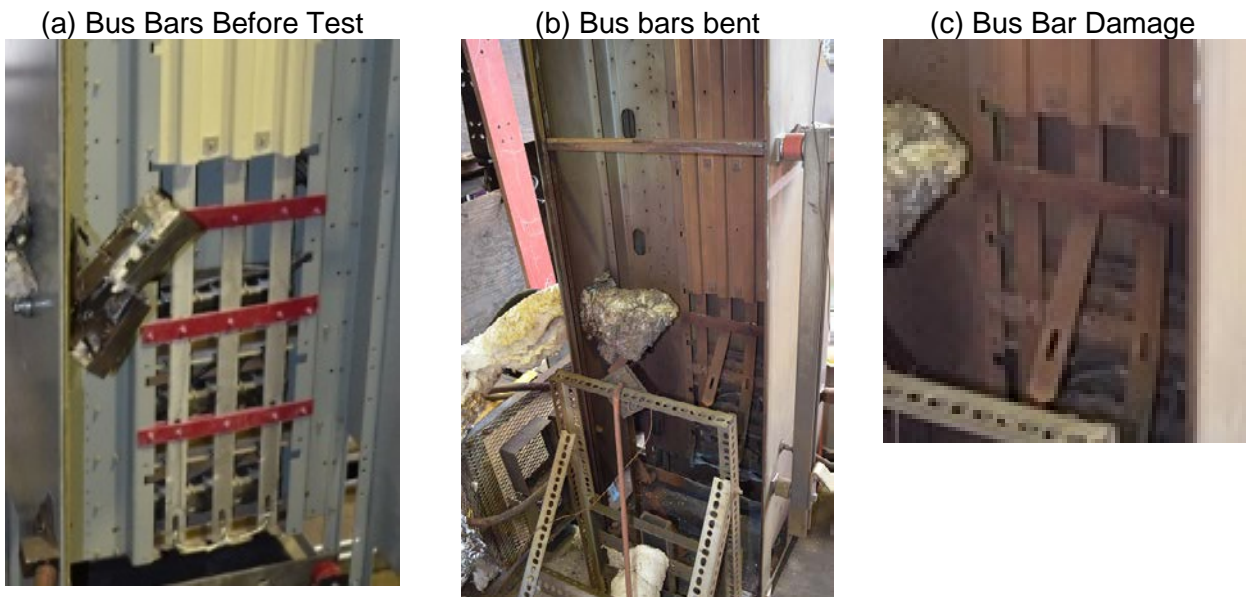
Figure 3.9-4 shows the lower bus bar damage for the arc position in Test 3. Figure 3.9-4(a) shows the bus bar configuration before the test. The thin, copper bus bars were held in place by three red boards (fiber-reinforced composite) at approximately 20.3 cm (8 in), 35.6 cm (14 in), and 50.8 cm (20 in) from the bottom as shown in Figure 3.9-4(a). Figure 3.9-4(b) and (c) shows that the bus bars bent despite the bands and caused the arc to quench.

Figure 3.9-4. MCC Test 3 Interior Damage

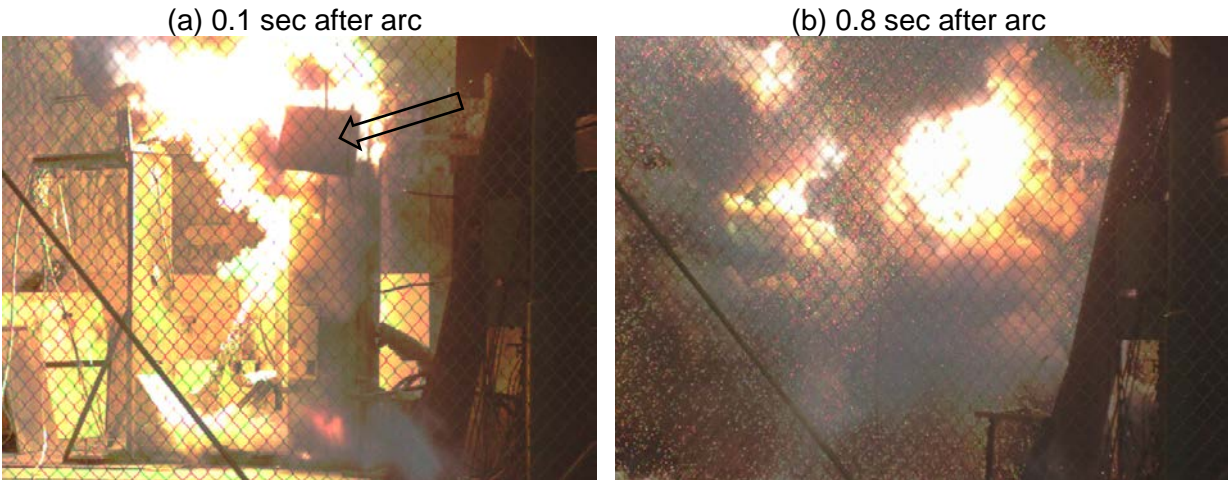
The cabinet from Test 3 was left in place and reused for Test 4 with the arc wire at the top bus bars to repeat the second arc that was observed in Test 2. This cabinet test was initiated at 492 V and 46.4 kA and a target duration of 2 seconds. The arc quenched at 0.922 seconds with a total energy of 17.6 MJ. Figure 3.10-1 shows the explosion at 0.1 sec and 0.8 sec after the arc. There was a small metal fire at the top bus bars for a few minutes but there was no major ensuing cable fire. The plasma escaped through the small cracks between the panels and burned through the steel bands. The top front panel was blown off and traveled about 3.66 m (12 ft) as shown in Figure 3.10-1(a).

Figure 3.10-1. MCC Test 4 Arc

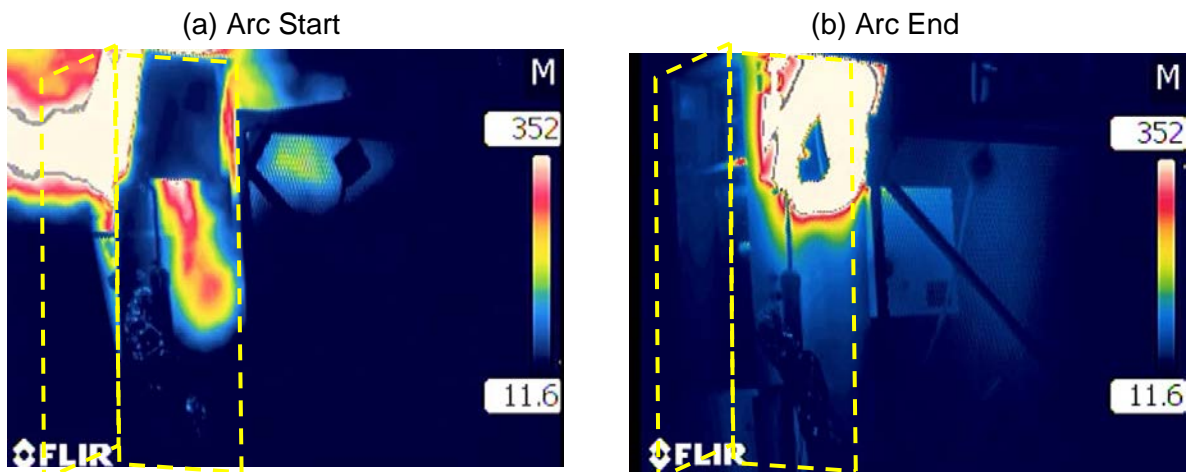
Figure 3.10-2 shows FLIR images (set at a constant 355 °C (671 °F) maximum) from the rear, left corner of the test cell. In these views the right side of the cabinet is on the left side of the view. Arc plasma and hot gases escaped the top part of the cabinet during the arc when the top and rear front panels blew off, and the top, left panel opened. After the arc, there was no detectable indication of high temperatures on the exterior of the cabinet or of internal fires.

Figure 3.10-2. MCC Test 4 Thermal Images (Rear View)

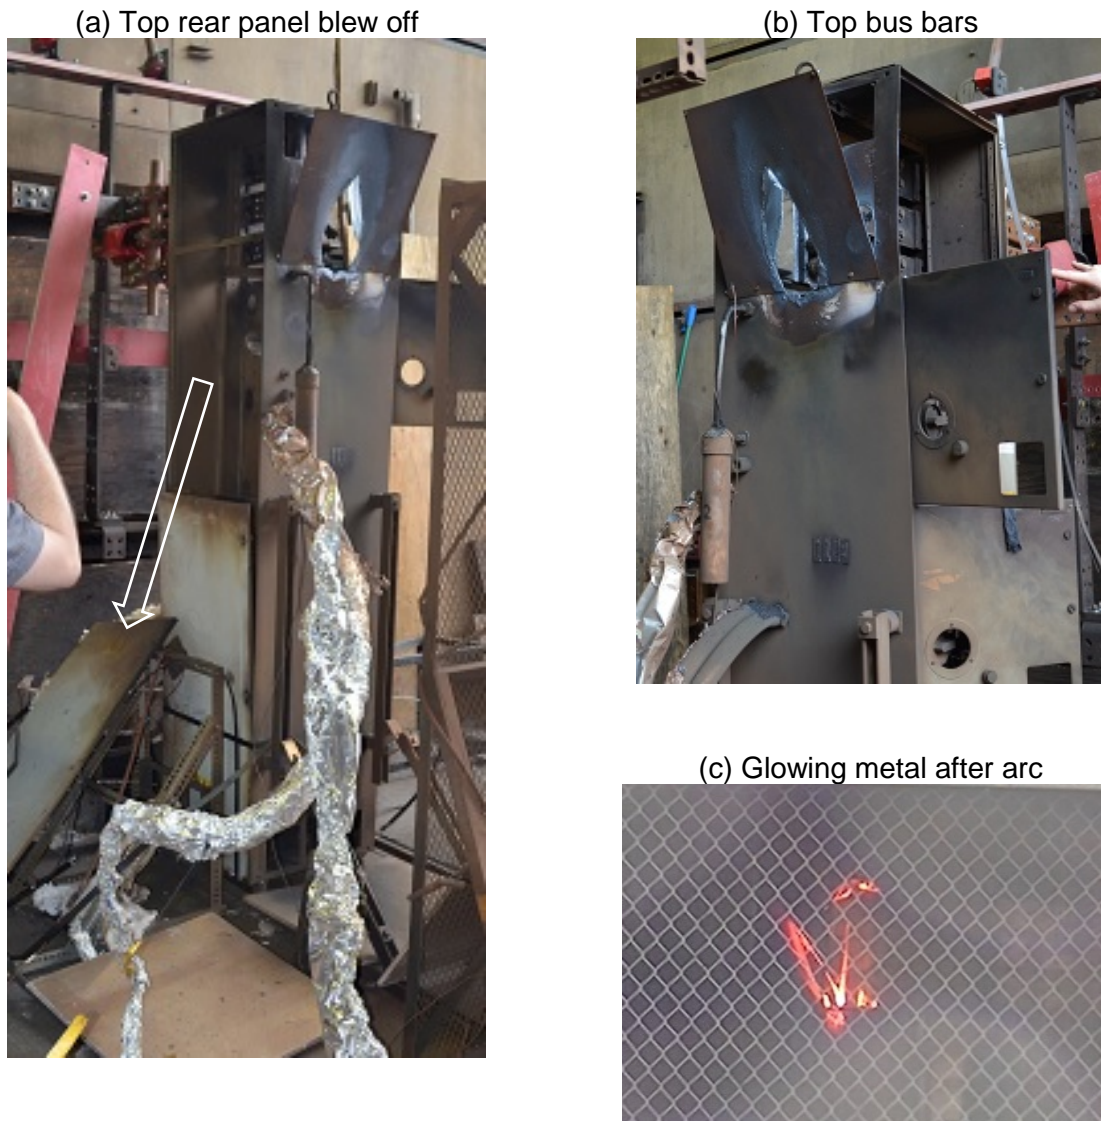
Figure 3.10-3(a) shows the damage caused by the arc was extensive at the top of the cabinet. The top rear panel blew off, as indicated by the white arrow, when the steel bands were burned through by plasma escaping the cabinet. Figure 3.10-3(b) shows that the arc burned through the top right panel, similar to MCC Test 2 and it almost detached from the cabinet. The exterior had charring, soot damage, and copper disposition and the MCCB panel on the front top also opened. The top front cover was blown off during the arc. The heat caused the metal in the area of the left top to glow for several minutes after the arc as seen from the front view in Figure 3.10-3(c).

Figure 3.10-3. MCC Test 4 Exterior Damage

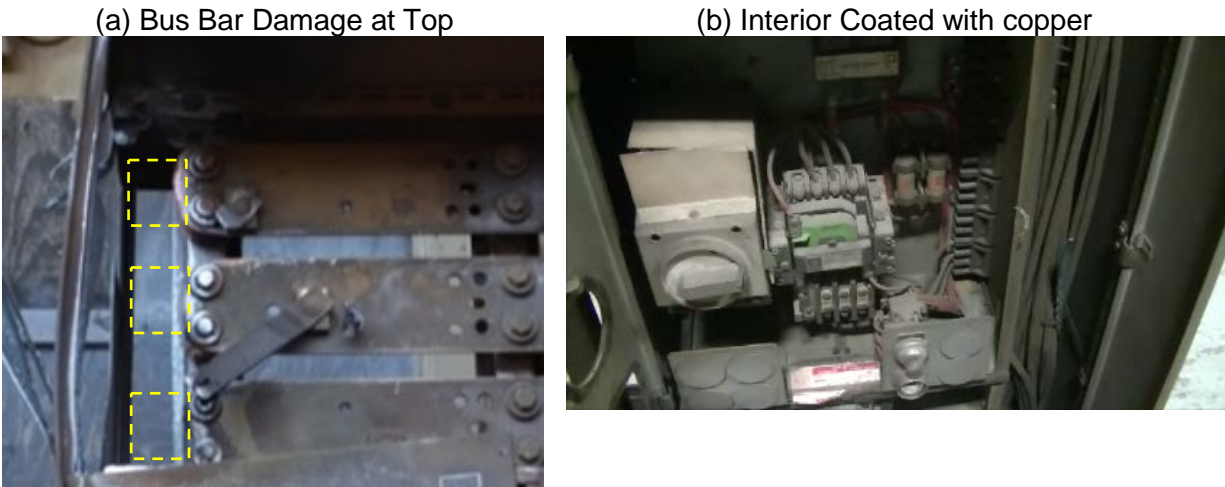
there was no ensuing cable fire. Most of the energy escaped through the open panels and did not build up inside the cabinet.

Figure 3.10-4. MCC Test 4 Interior Damage
