International Agreement Report

Nuclear Regulatory Authority Experimental Program to Characterize and Understand High Energy Arcing Fault (HEAF) Phenomena

Prepared as part of
the Agreement between NRC and NRA in the Area of Fire-Related Research

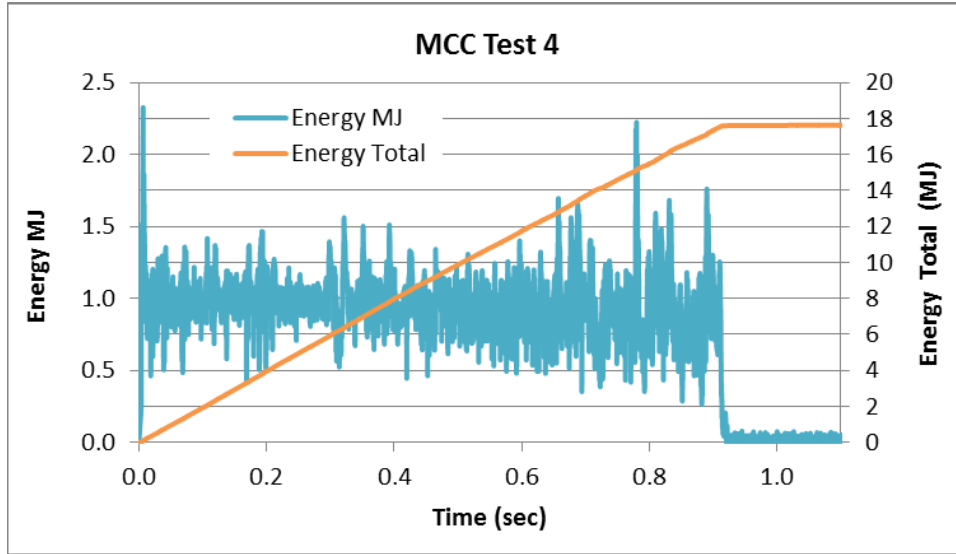
The arc duration was 0.922 seconds with total energy of 17.6 MJ, as seen in Figure 3.10-10. The energy analysis methods are in Appendix A. The “Energy” is calculated as volts multiplied current multiplied by the time step and each time step is shown. “Energy Total” is the cumulative sum of the energy in each time step.

Figure 3.10-8. MCC Test 4 Arc Energy

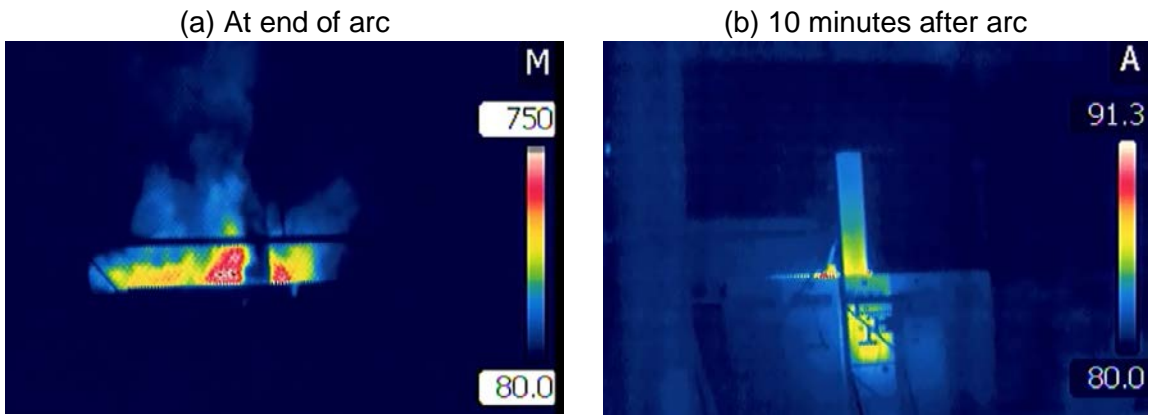
Figure 4.7-2. SWGR Test 1 Thermal Image at Arc Extinction

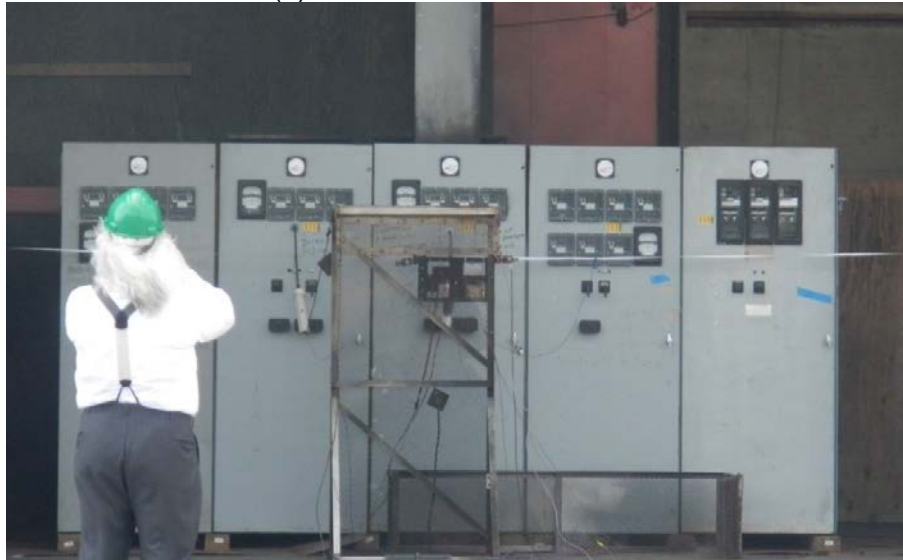
(a) Front View Cabinets 6-10

Figure 4.7-3. SWGR Test 1 Exterior Damage

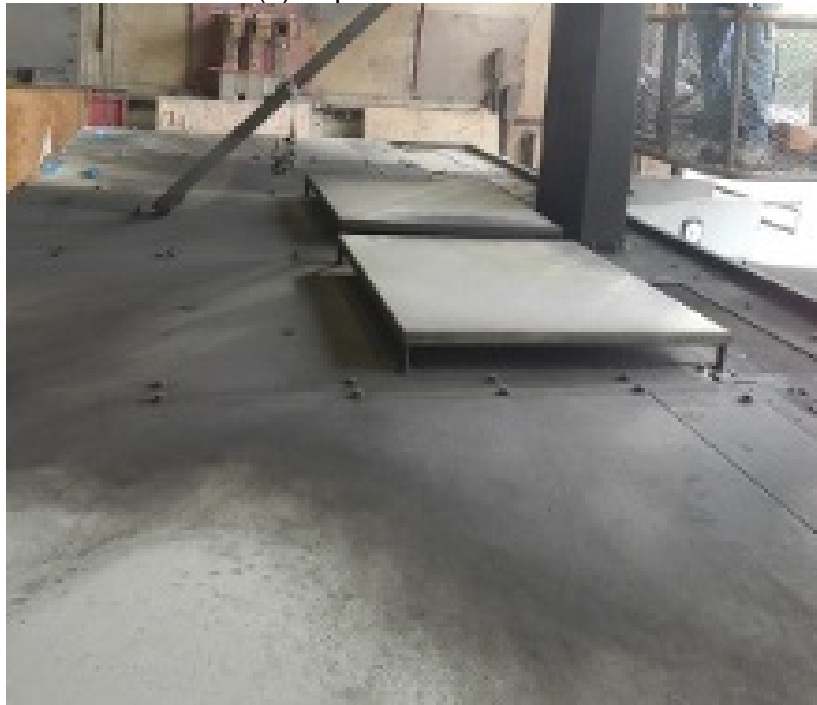
(b) Top of Cabinets 6-10

Figure 4.7-3. SWGR Test 1 Exterior Damage, continued

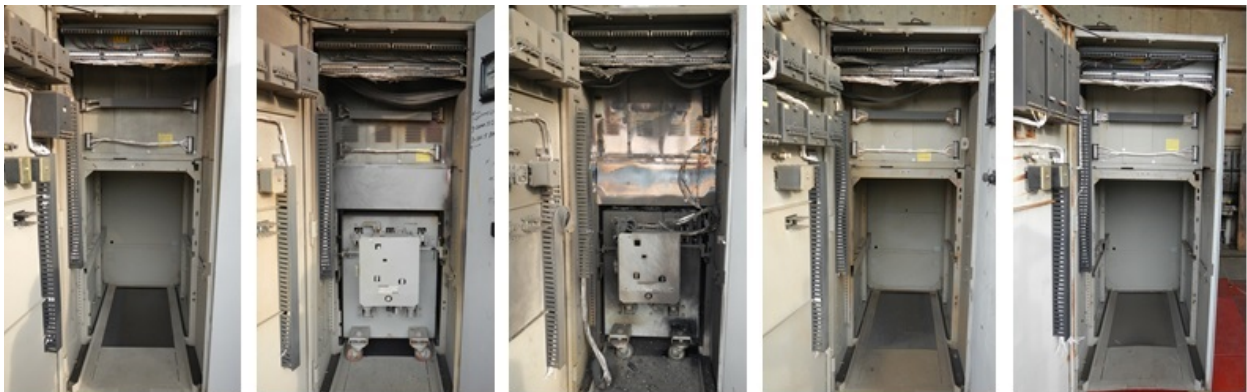
Figure 4.7-4. SWGR Test 1 Interior Damage

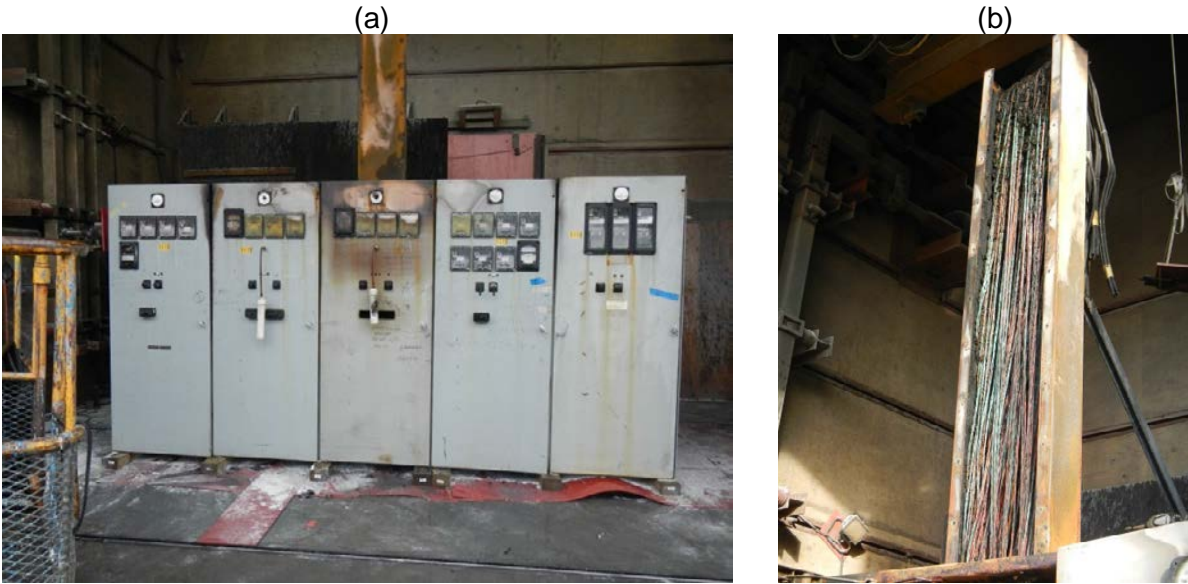
The SWGR cabinet outer walls did not have major deformation like the DP and MCC. The SWGR cabinet outer walls are thicker and the large vent allowed for pressure relief. The cabinet exteriors were slightly charred from the ensuing fire, but not as severely as at Onagawa which was not extinguished for 7 hours (see Chapter 6.10.4 for more detail). The vertical stack was heavily scorched and discolored from the intense stack fire. The orange color was also observed in the Onagawa event. The cables in the vertical duct (shown with cover removed) were completely burned.

Figure 4.9-1. SWGR Test 2 Exterior Damage

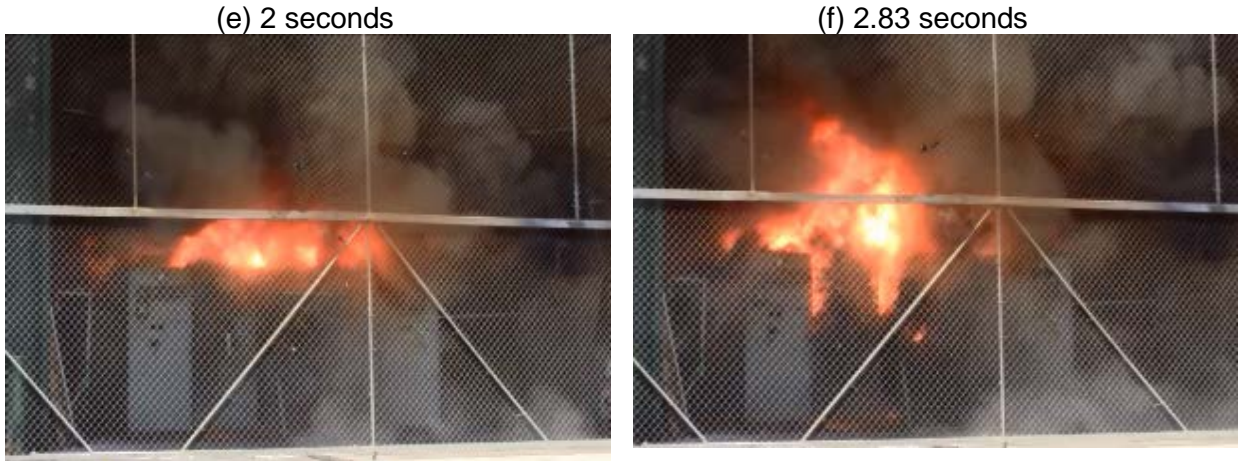
Figure 4.10-1. SWGR Test 3 Arc, continued

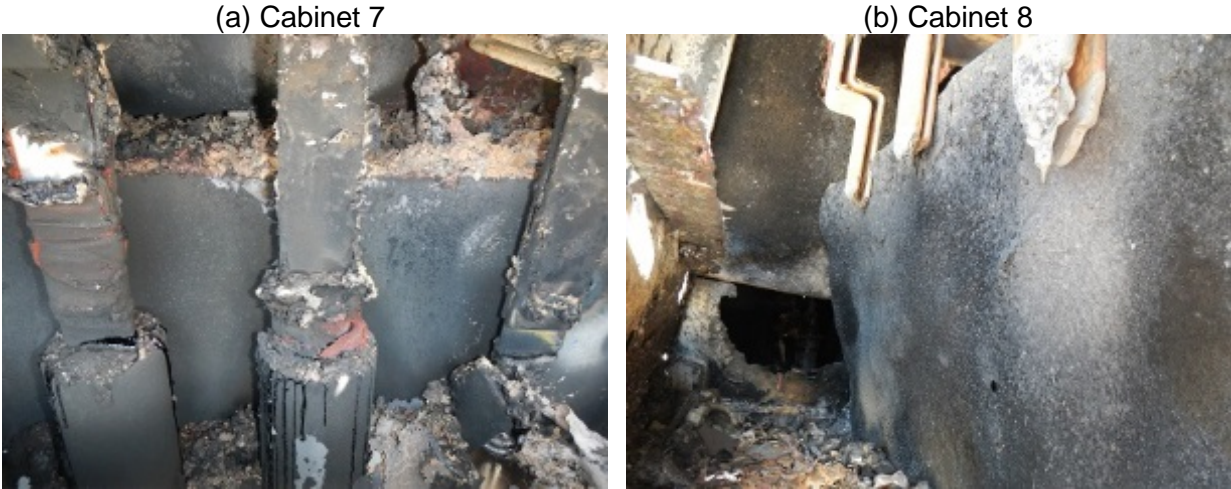
Figure 4.10-6. SWGR Test 3 Insulator and Bus Bar Damage

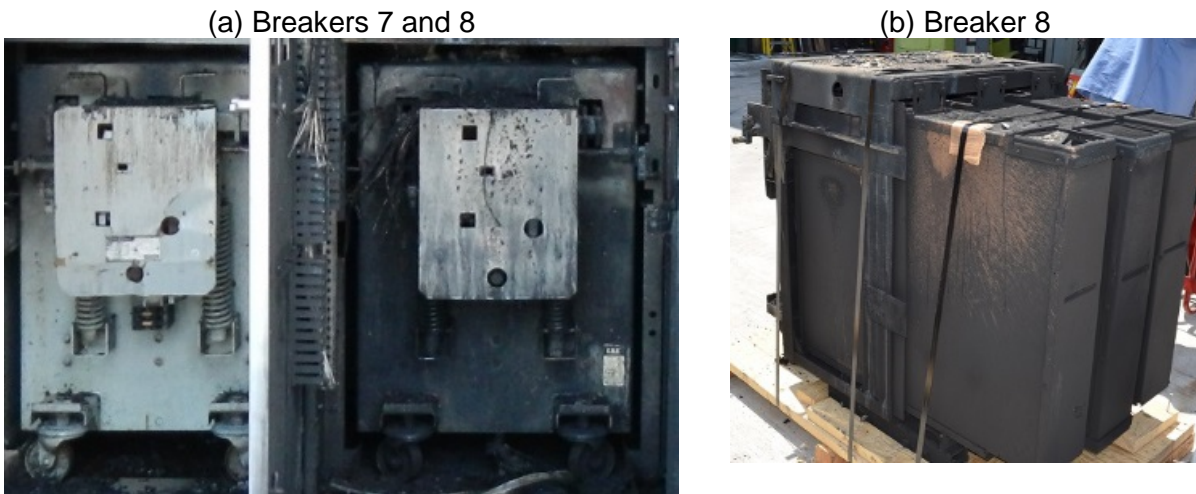
Figure 4.10-7. SWGR Test 3 Breaker Damage

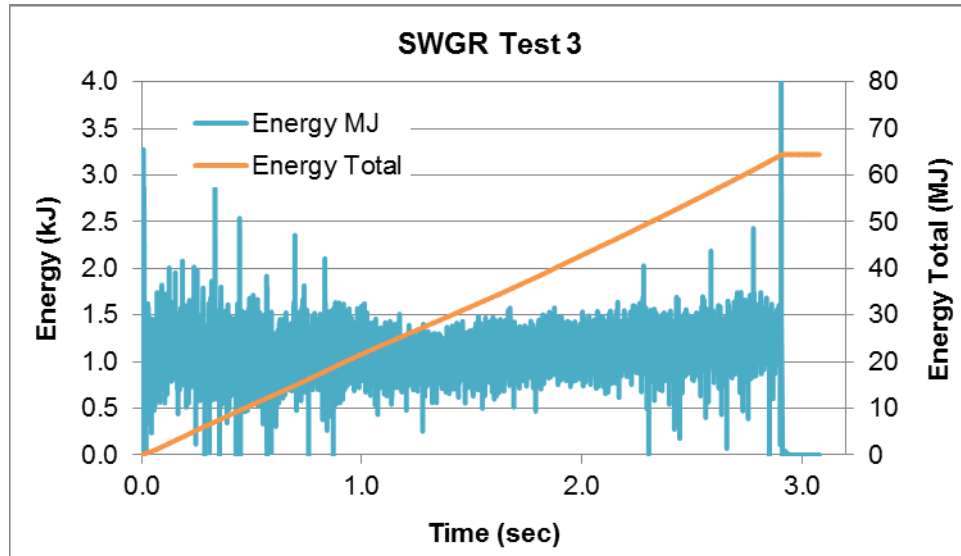
Figure 4.10-11. SWGR Test 3 Arc Energy

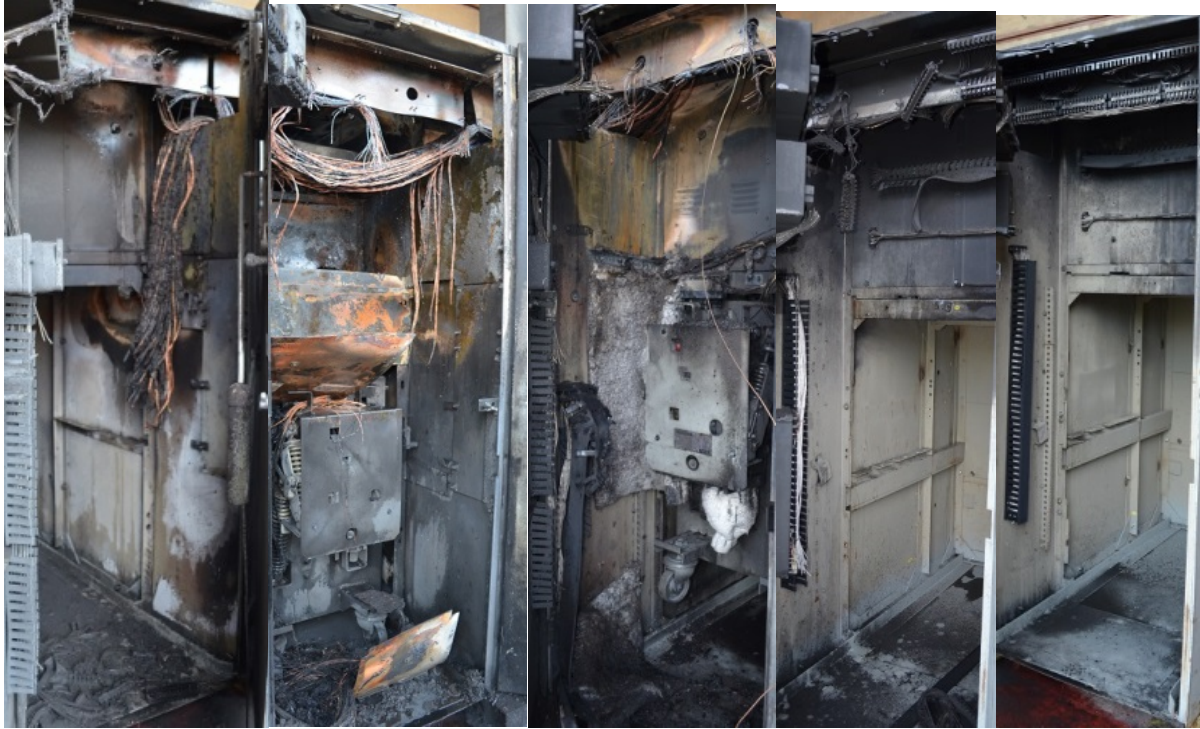
Figure 5.5-4. SWGR Test 4 Interior Damage

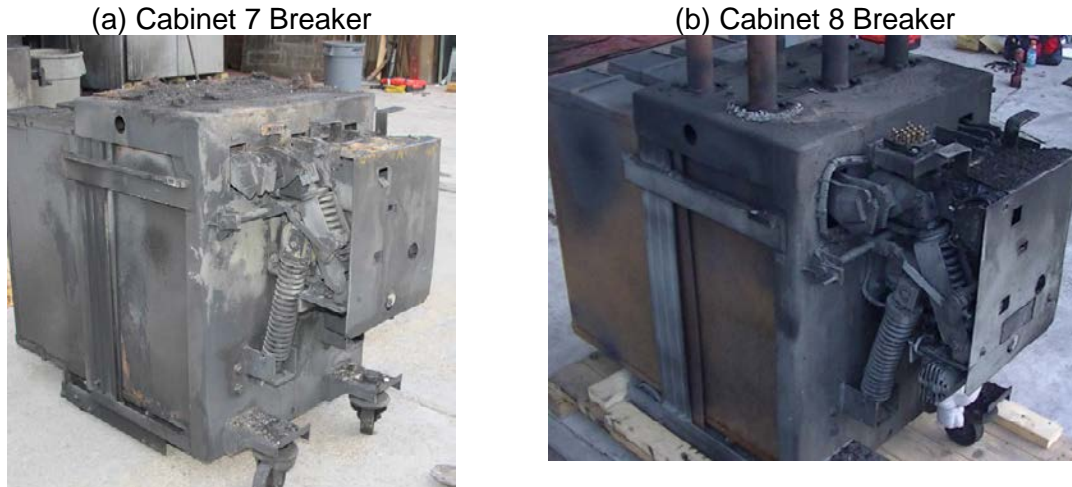
Figure 5.5-7. SWGR Test 4 Breaker Damage

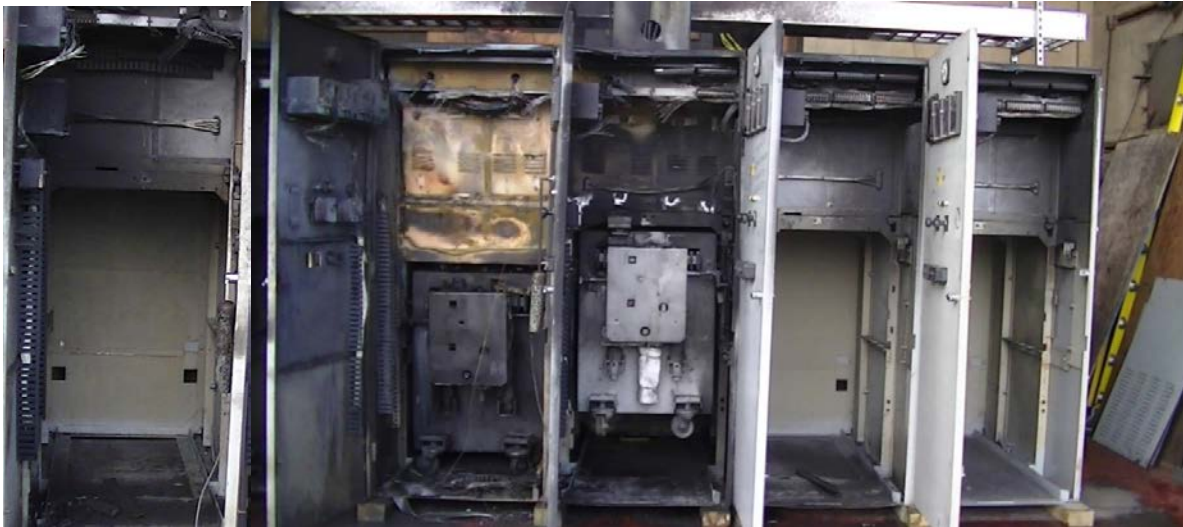
Figure 5.6-4. SWGR Test 5 Interior Damage

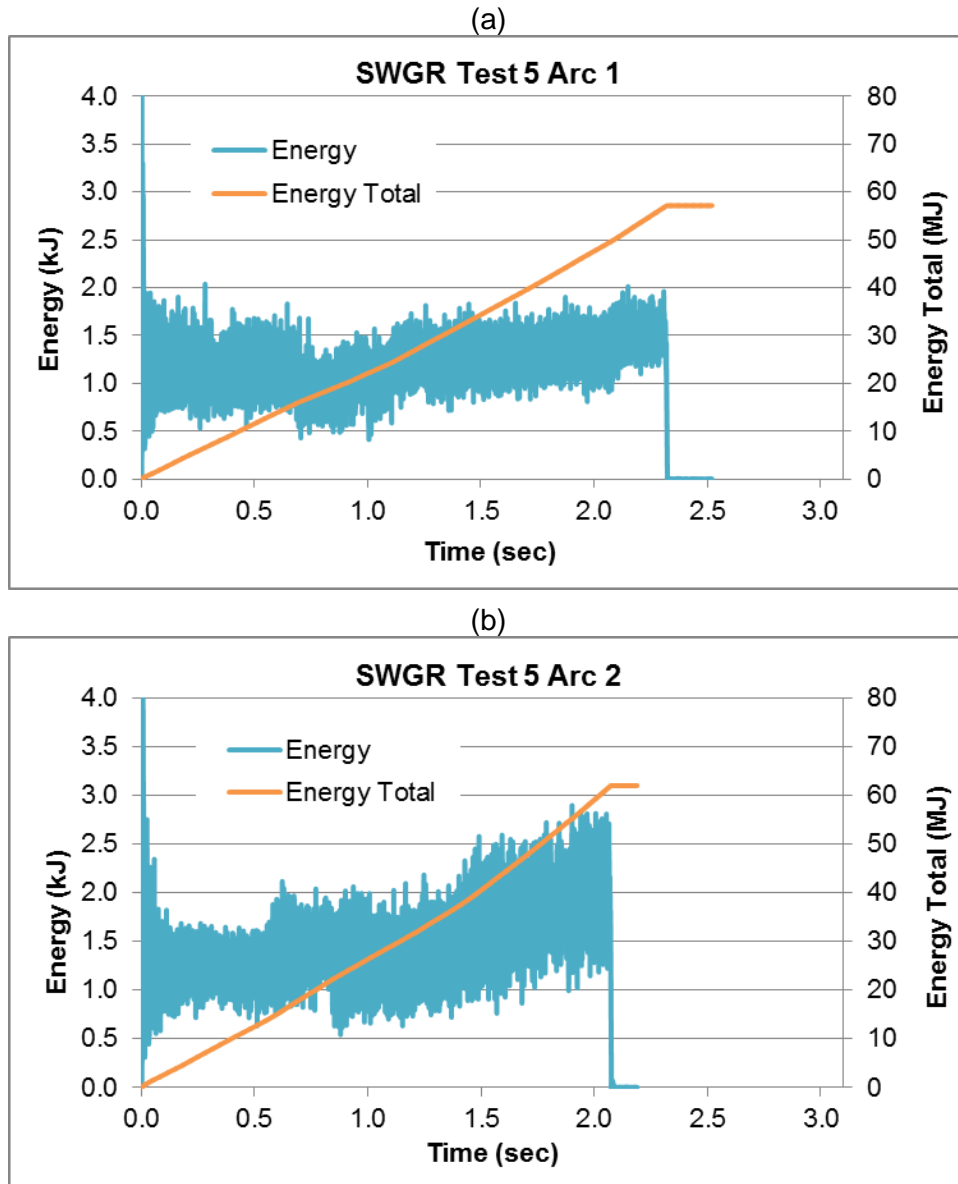
Figure 5.6-12. SWGR Test 5 Arc Energy (both arcs)

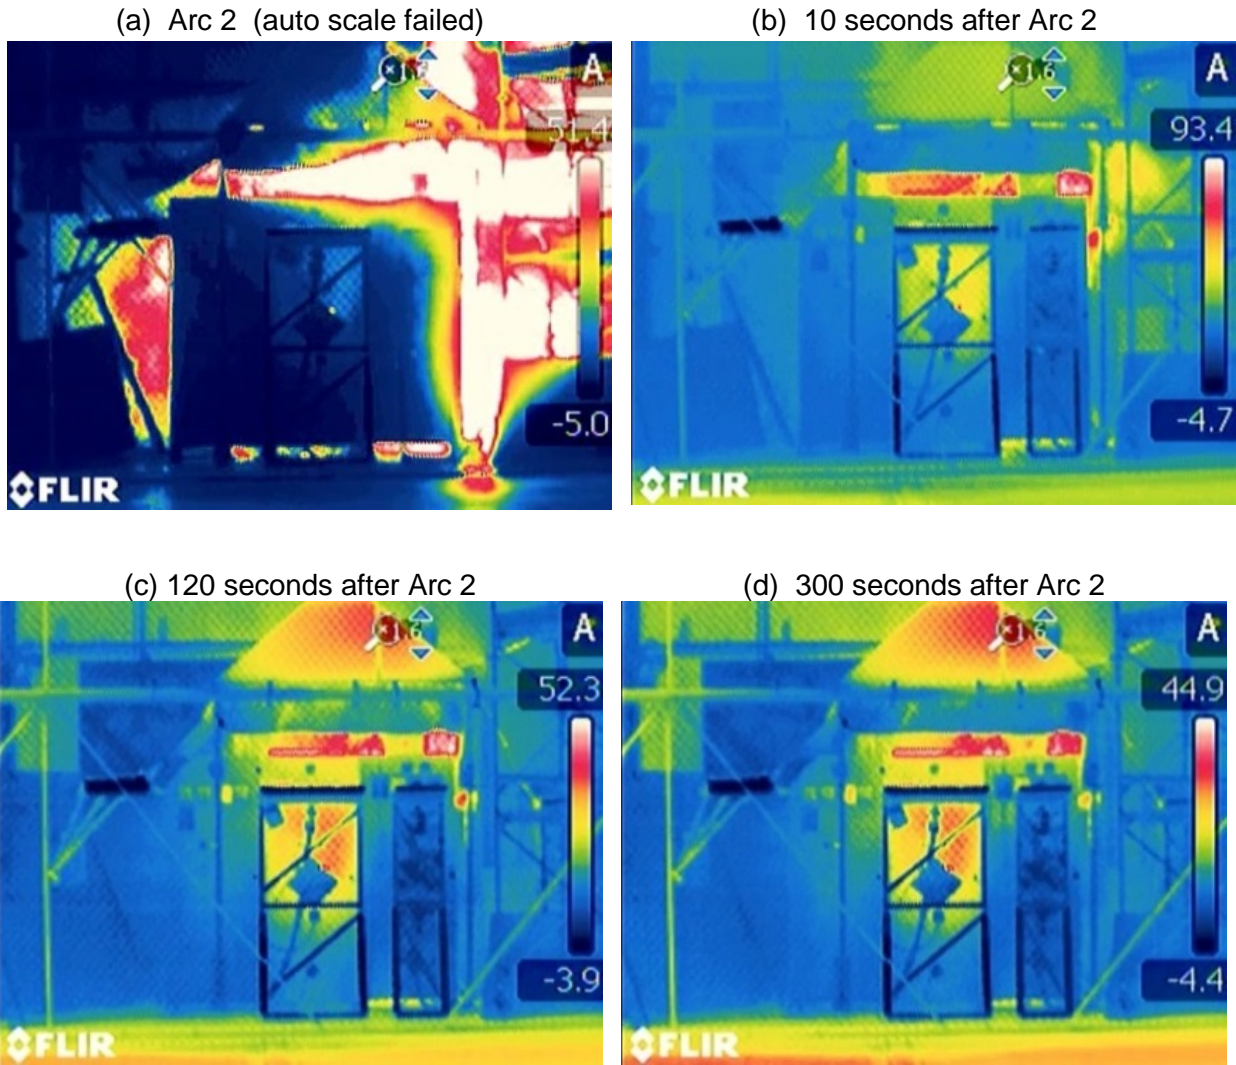
Figure 5.7-4. SWGR Test 6 Thermal Image, Arc 2

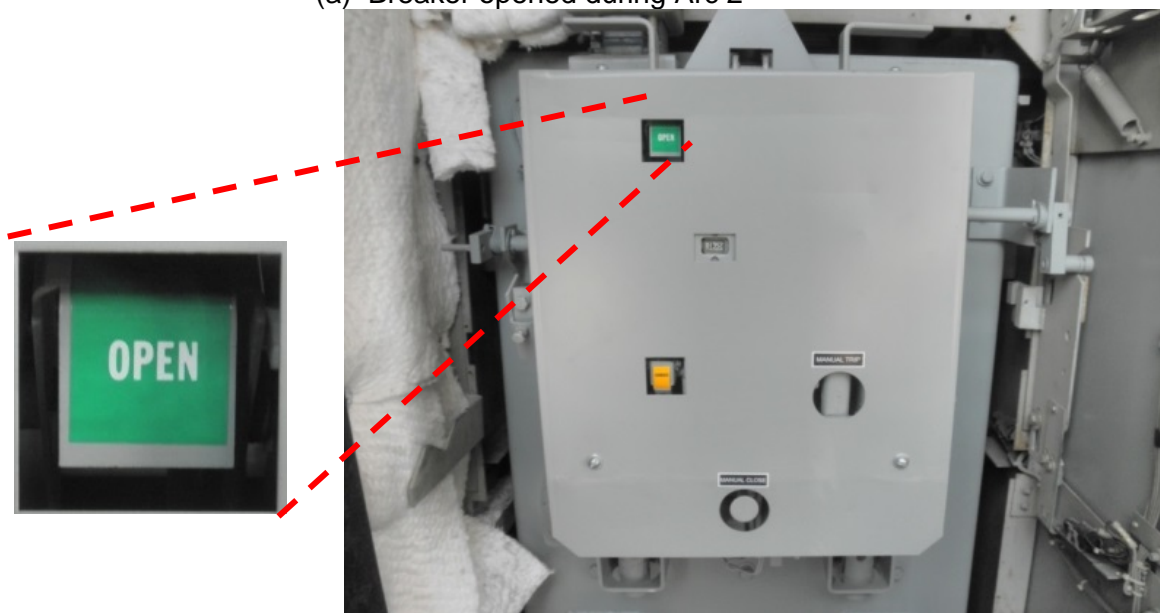
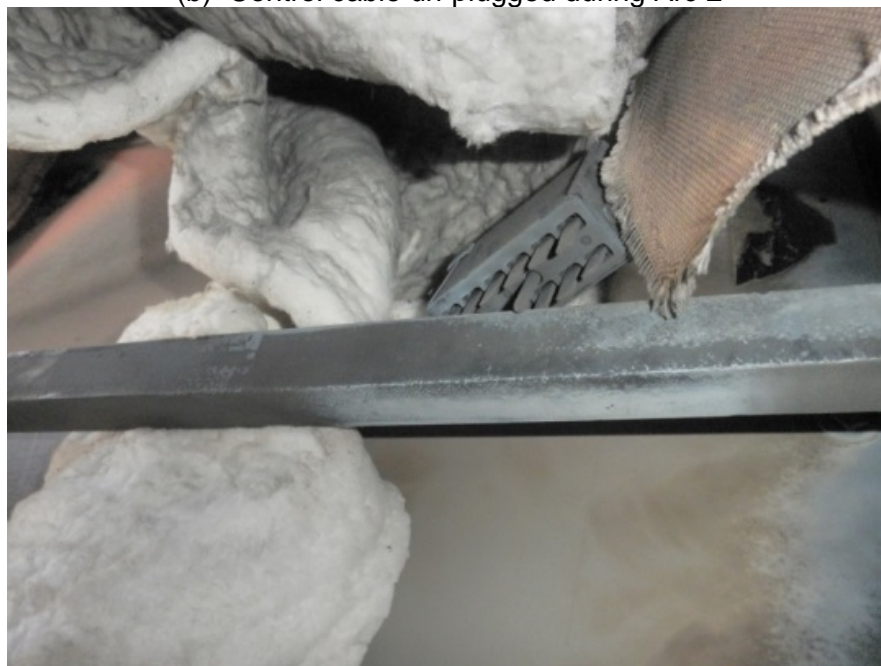
(a) Breaker opened during Arc 2

(b) Control cable un-plugged during Arc 2

Figure 5.7-5. SWGR Test 6 Breaker Opened in Arc 2

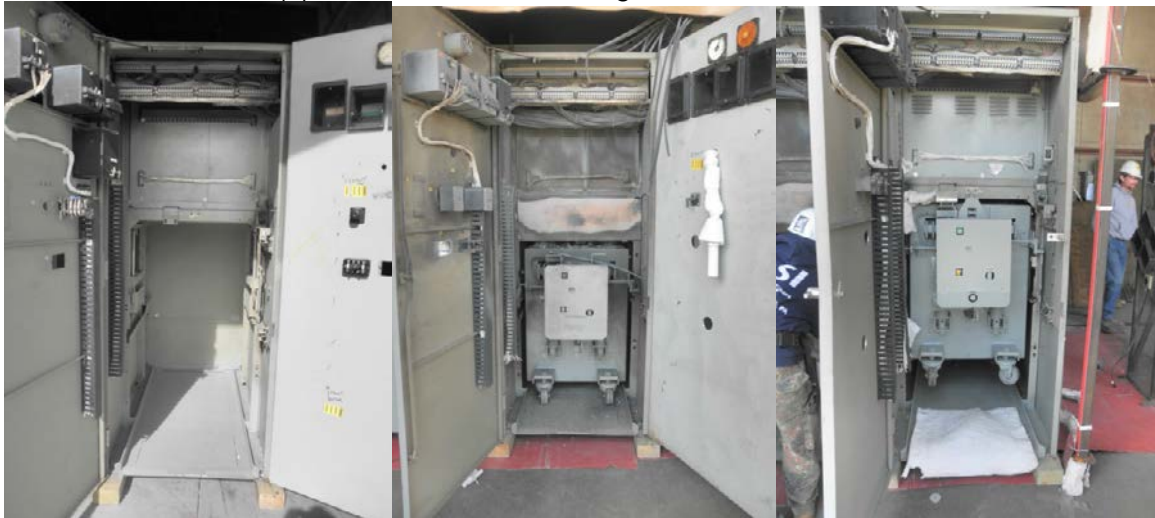
Figure 5.7-7. SWGR Test 6 Cabinet Interior Damage

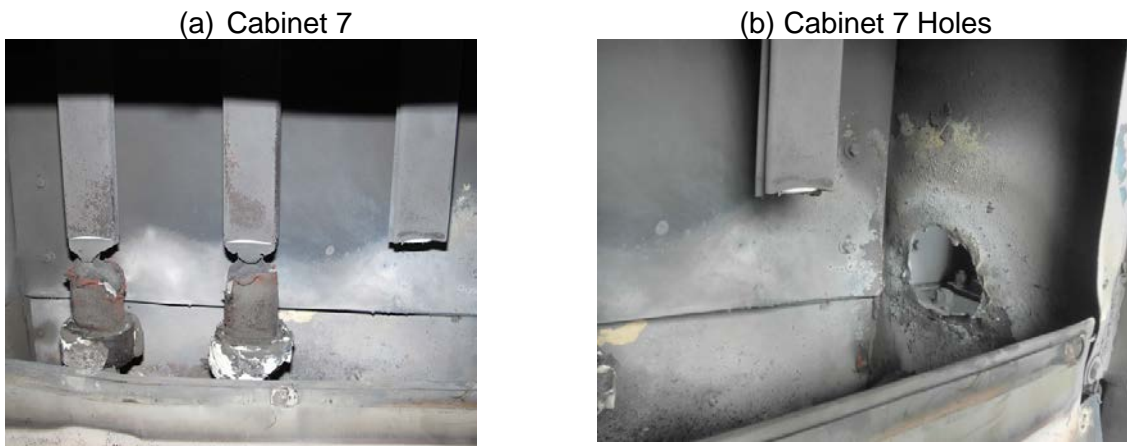
Figure 5.7-10. SWGR Test 6 Arc 1, Cabinet 7 Bus Bar Damage

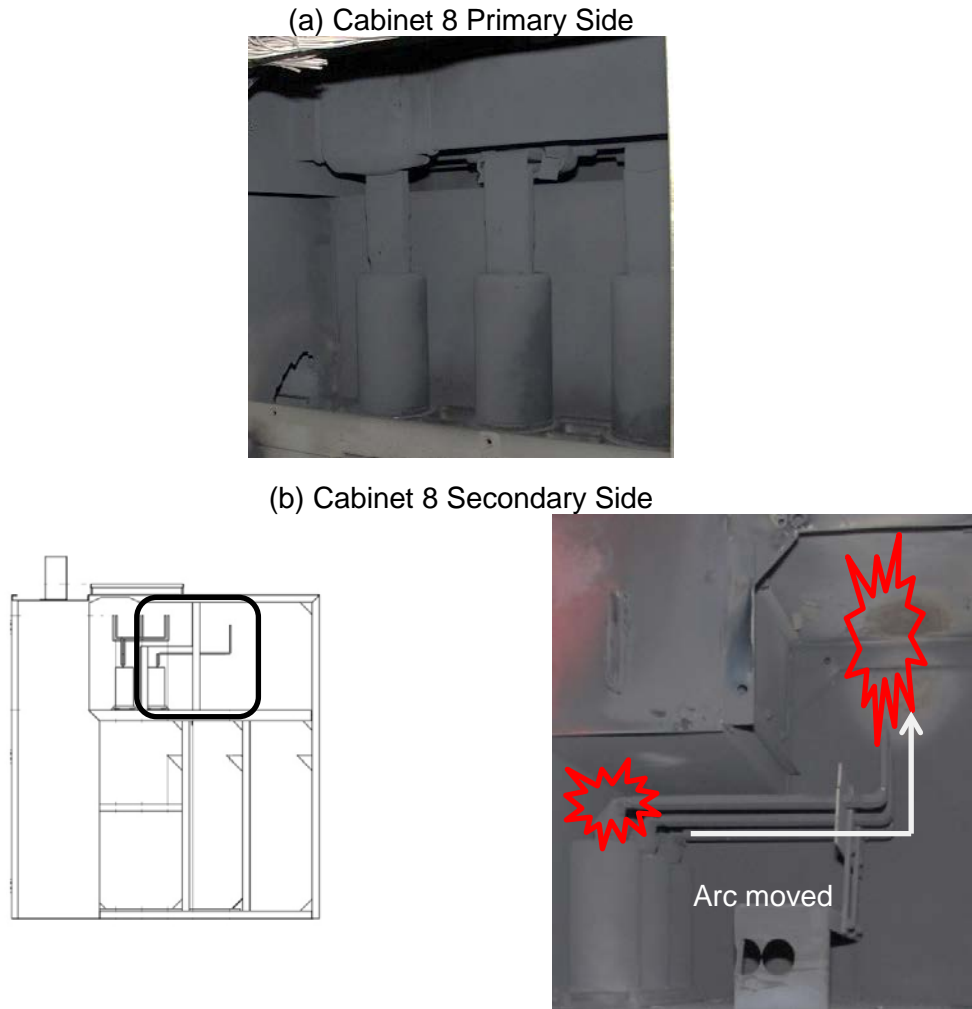
Figure 5.7-11. SWGR Test 6 Arc 2 on Cabinet 8 Damage.

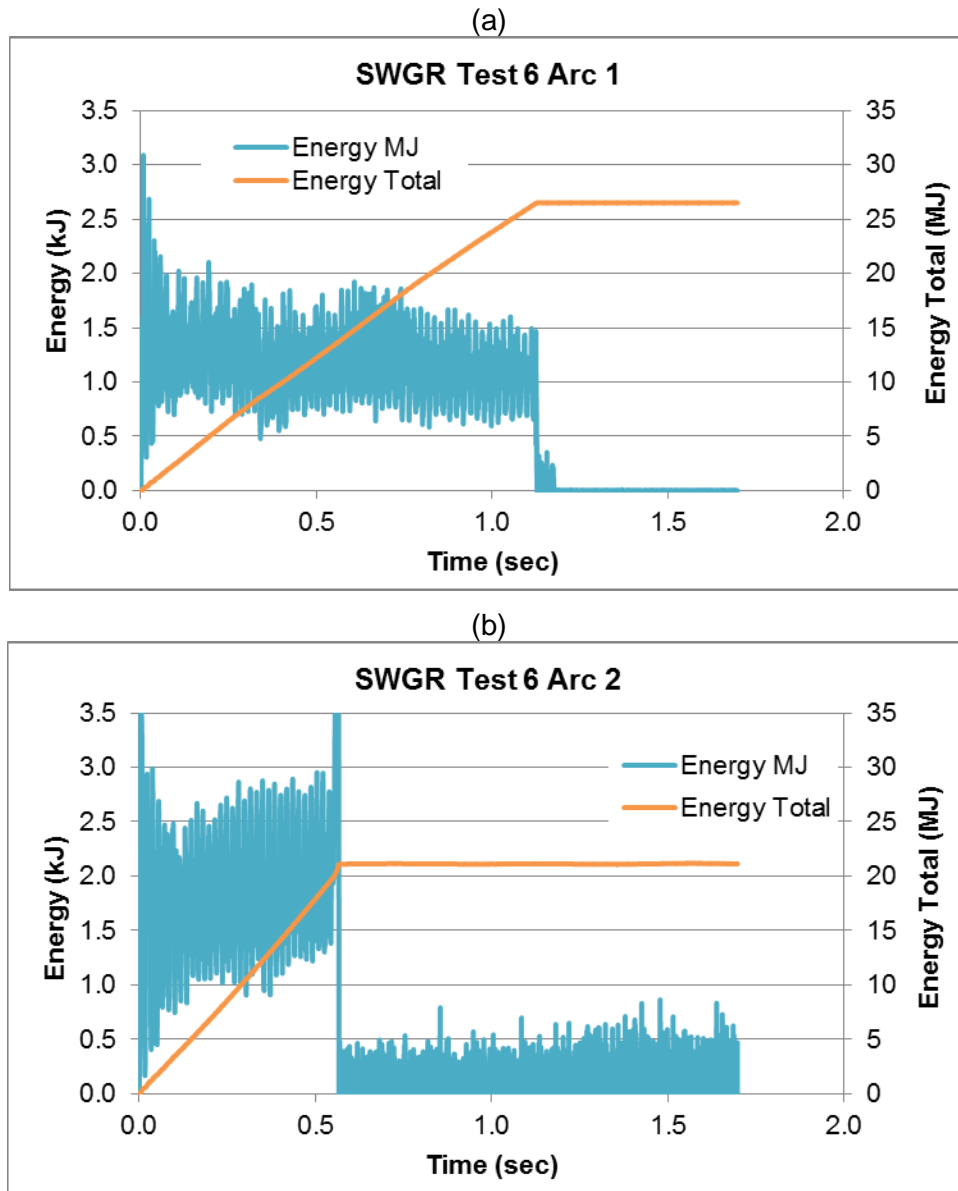
Figure 5.7-18. SWGR Test 6 Arc Energy (both arcs)

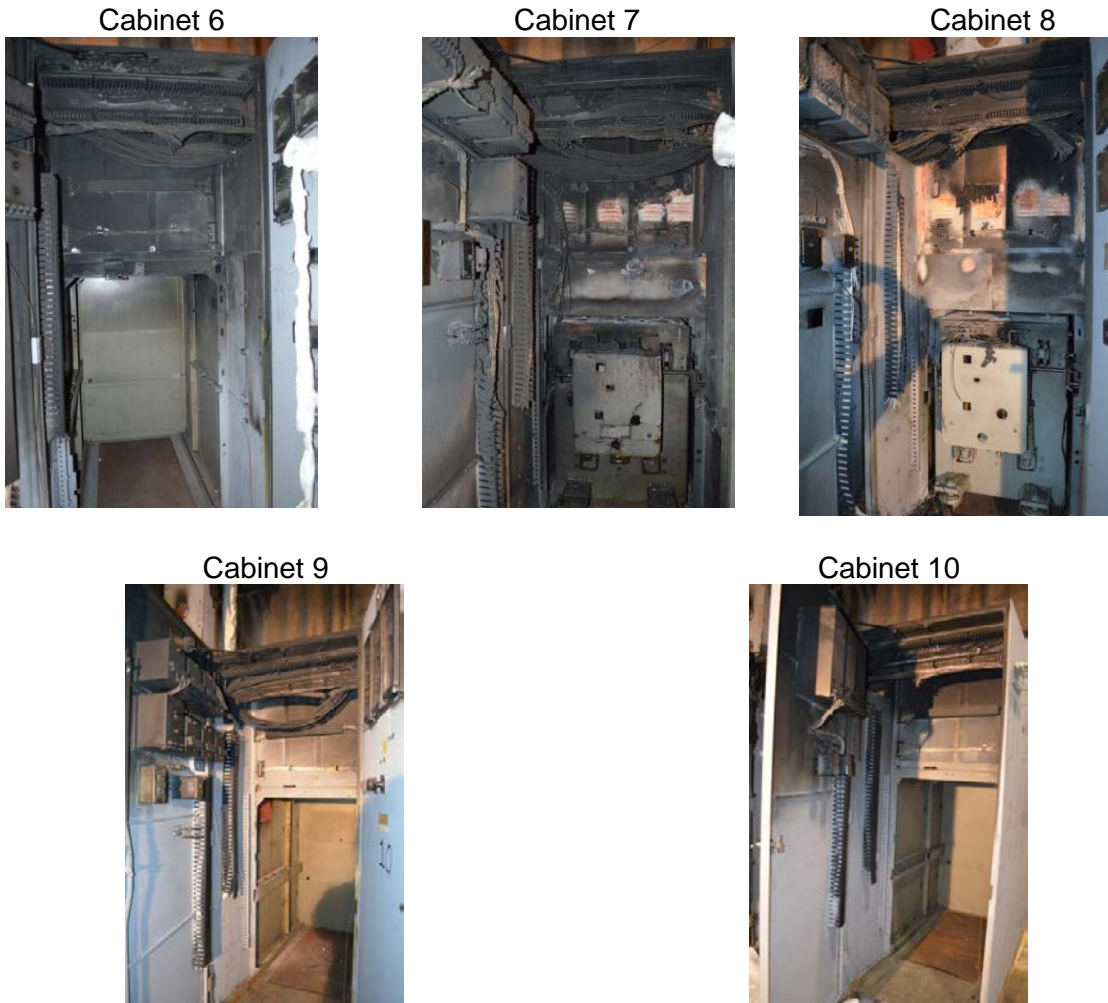
Figure 6.9-3. Test 1 Interior Cabinet Damage

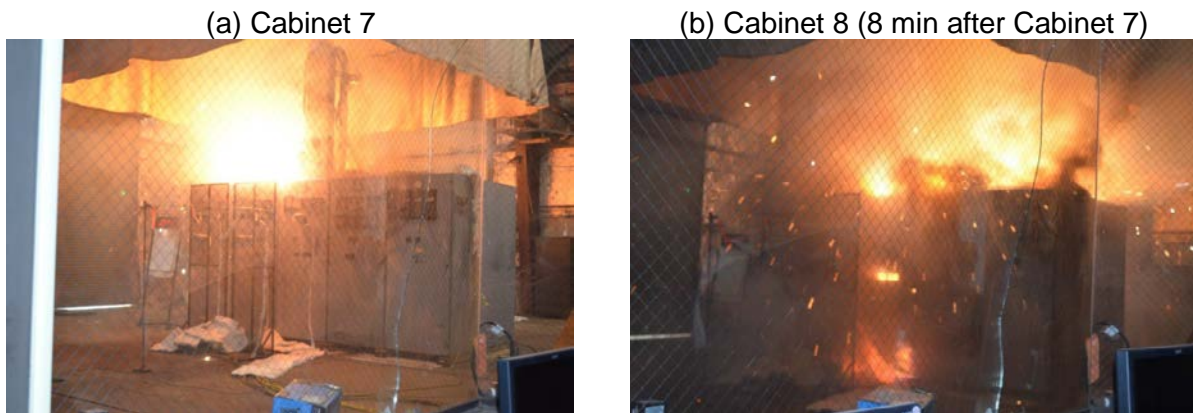
Figure 6.10-1. RFAS Test 2 Events

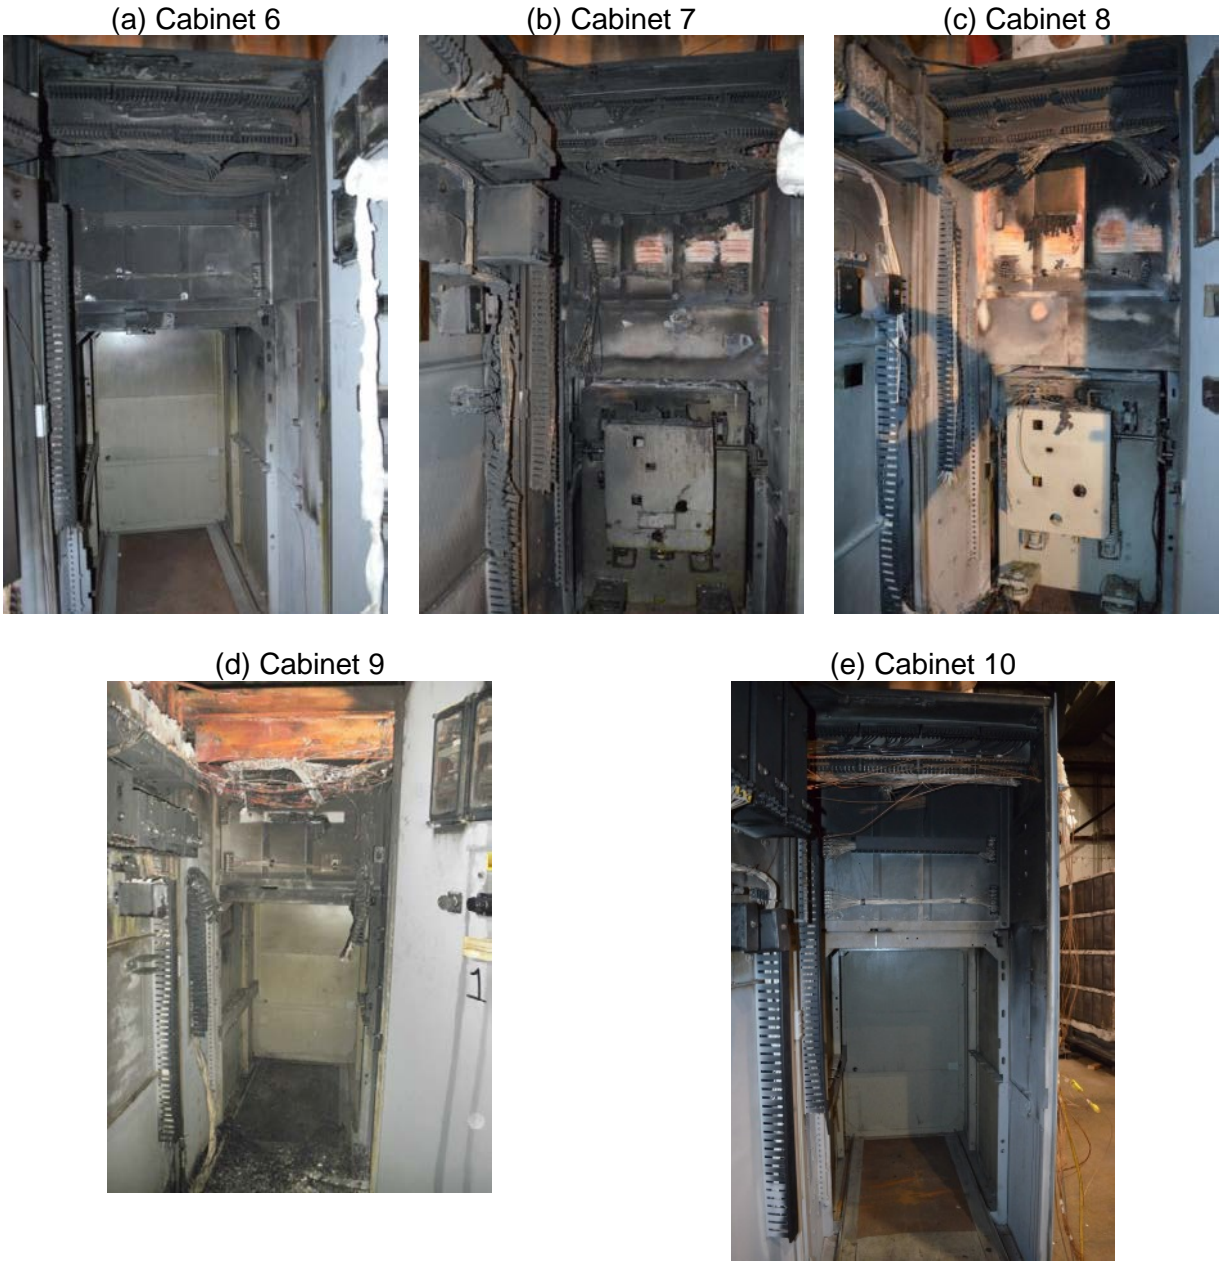
Figure 6.10-3. Test 2 Interior Cabinet Damage

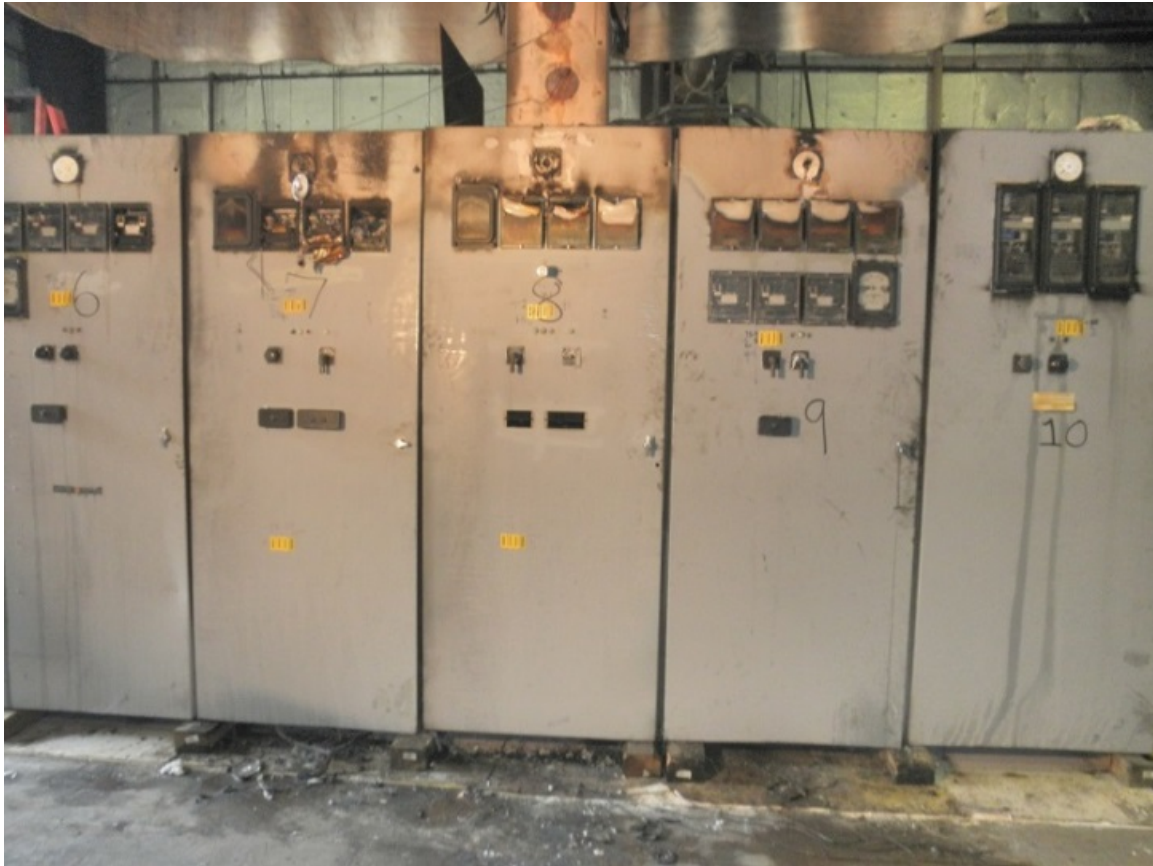
Figure 6.10-4. Test 2 Exterior Cabinets Damage

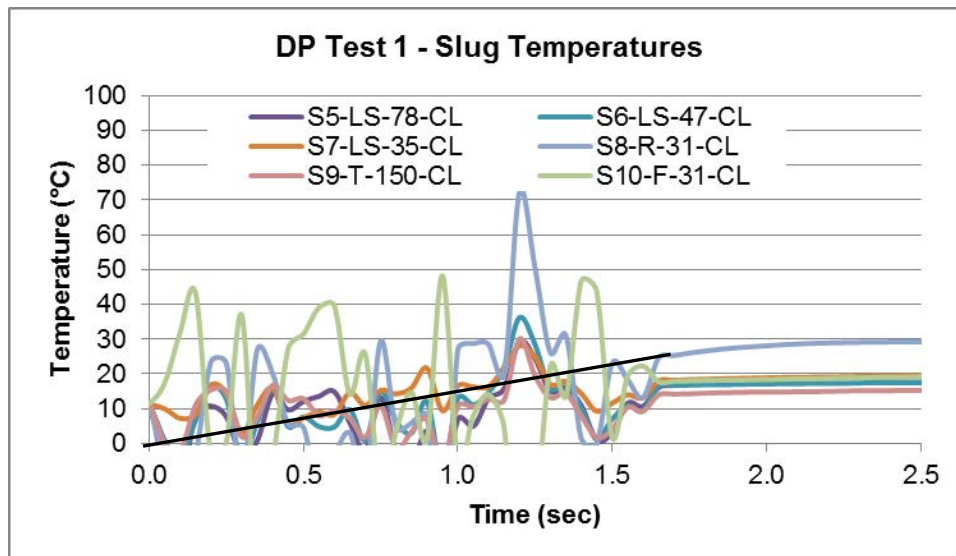
Figure A.1-2. Typical Slug Calorimeter Temperature Results
