Mechanical Fatigue Testing of High-Burnup Fuel for Transportation Applications

Testing was conducted at Oak Ridge National Laboratory (ORNL) to determine the ability of high burnup (HBU) (>45 GWd/MTU) spent nuclear fuel (SNF) to maintain its integrity under conditions relevant to storage and transport. The cyclic integrated reversible-bending fatigue tester (CIRFT) is an innovative system used in these tests. The CIRFT can impose pure bending loads on SNF test specimens and can measure the in situ curvature of the fuel rod during bending. *Pure bending* is a condition of stress in which a bending moment is applied to a beam without the simultaneous presence of axial, shear, or torsional forces. The CIRFT is composed of a U-frame equipped with load cells. A setup with three linear variable differential transformers (LVDTs) was used.

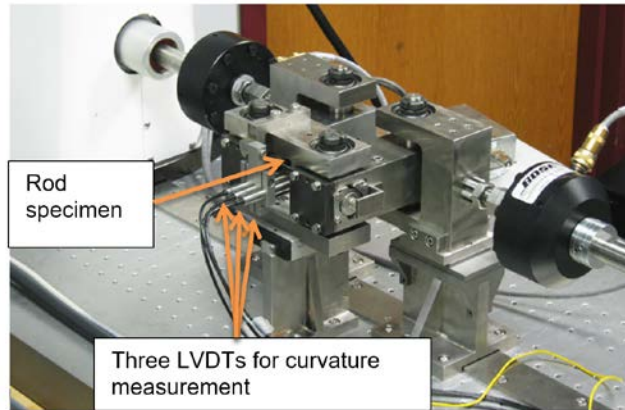
Figure 1 The cyclic integrated reversible-bending fatigue tester developed by ORNL

The cyclic integrated reversible-bending fatigue tester (CIRFT) shown in Figure 1 is the test hardware developed by ORNL.^{4,5,6,7,8,9,10,11,12} Test protocols were designed to oscillate short segments of HBU SNF until fatigue failure occurred. The results of these tests were evaluated to gain a better understanding of the expected fatigue lifetime of SNF during NCT and the potential effects of phenomena such as HR.

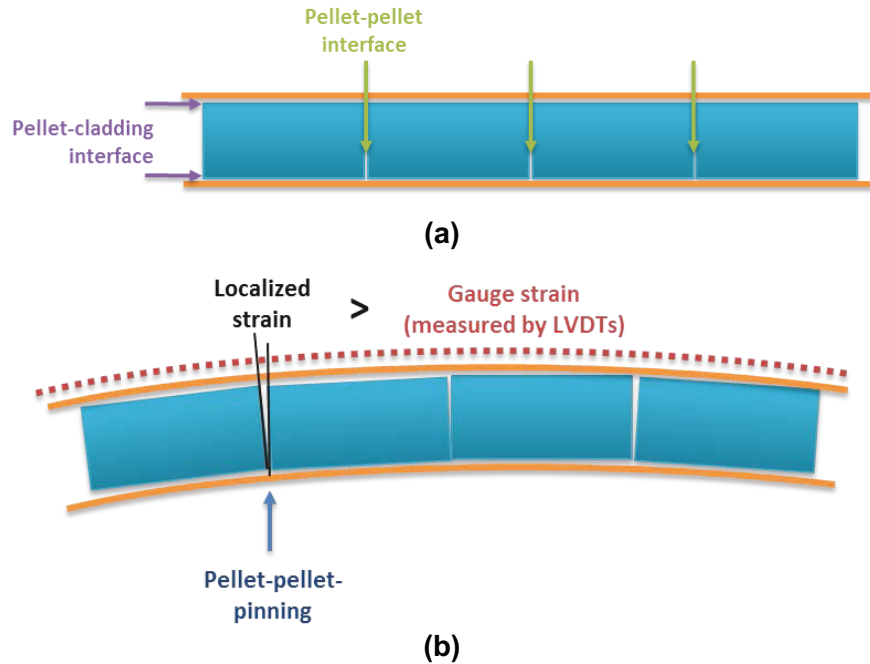
Figure 3 Key fuel and cladding features and fuel rod phenomena of (a) an unloaded fuel rod, and (b) a fuel rod under a bending load

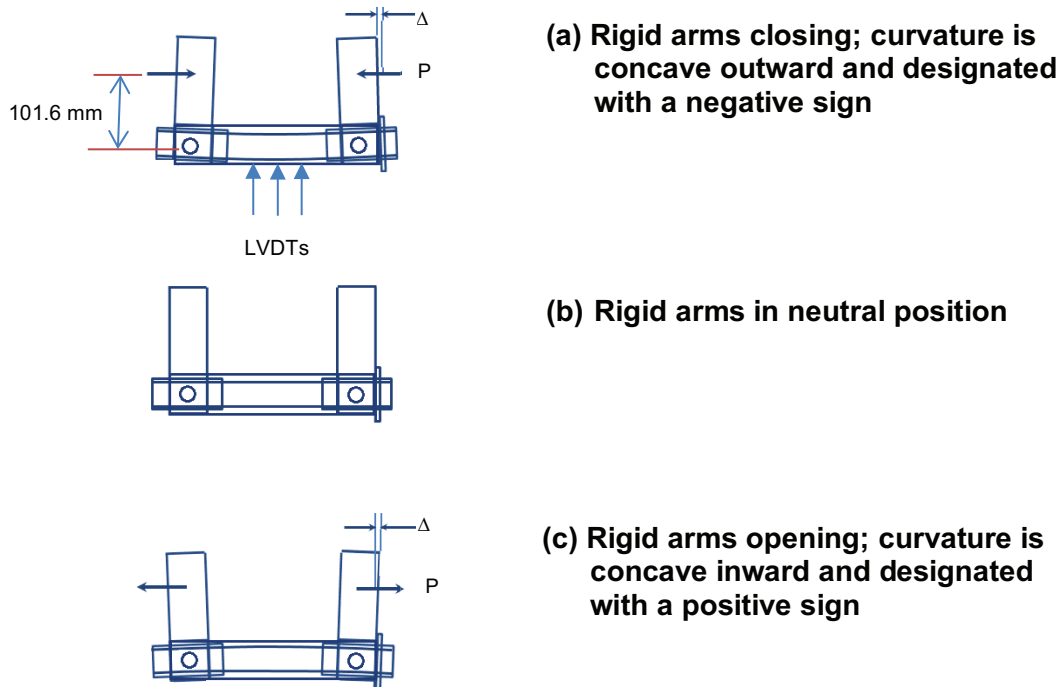
Figure 5 Schematic drawings of U-frame setup for reversal bending when rigid arms are (a) closing, (b) neutral, and (c) opening. Δ is the rigid rod end displacement at the loading joint

Bending is imposed through a U-frame with dual driving points and a 101.60 mm loading arm. Under a pair of forces or displacements that face outward, the rigid arms are opened, and bending moments force the rod to deflect outward, away from the operator, as shown in Figure 5.

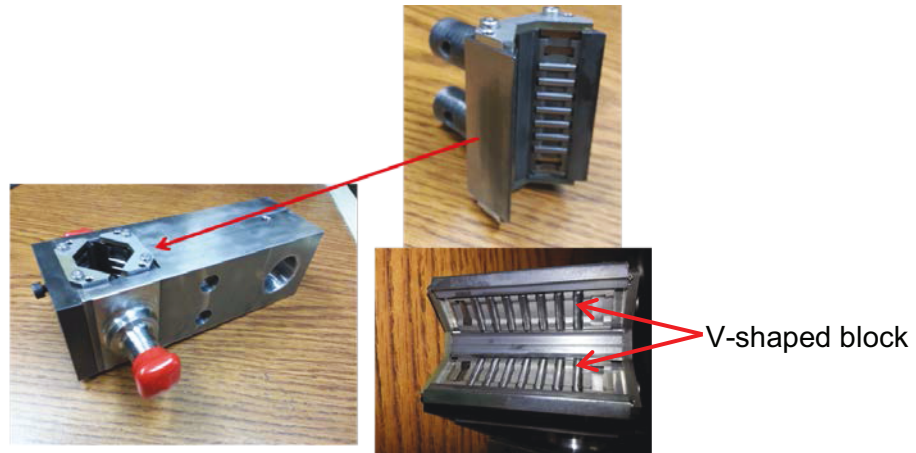
Figure 6 Assembled grip blocks (left) and two views (right) of detached grip body

Each grip consists of a V-shaped block integrated into the rigid arm of the U-frame and a V-shaped end block (Figure 6). The surfaces of the blocks serve as contacts to the specimen assembly and are equipped with embedded linear roller bearing sets to ensure free axial movement of the specimen when the force is being transferred. The rod specimen is secured by opening and closing the end blocks in two grips.^{5,6,7,8}

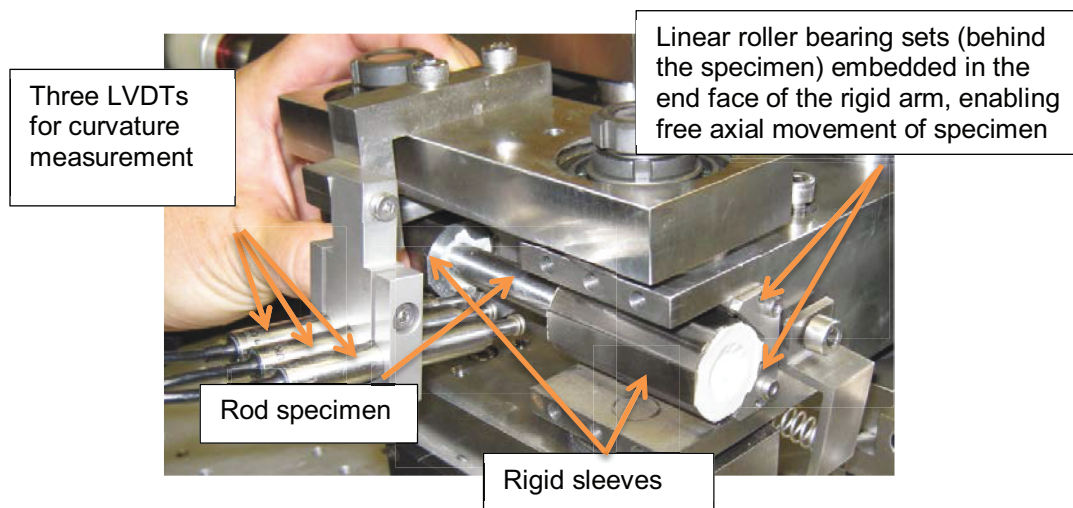
Figure 7 Image showing the grip design of CIRFT with one end-block removed

Figure 7 shows an exposed view of one end of the specimen with the end block removed. The specimen has a pair of rigid sleeves over both holding areas to protect the specimen from any contact damage through a compliant layer between the specimen and sleeves. The rigid sleeves also enable the specimen to move freely in the axial direction while being set against the embedded linear roller bearing sets. The free axial movement of the specimen is a critical requirement in pure bending⁴ for cases in which the stress condition of a tested rod under the applied bending moment does not have the simultaneous presence of axial, shear, or torsional forces.

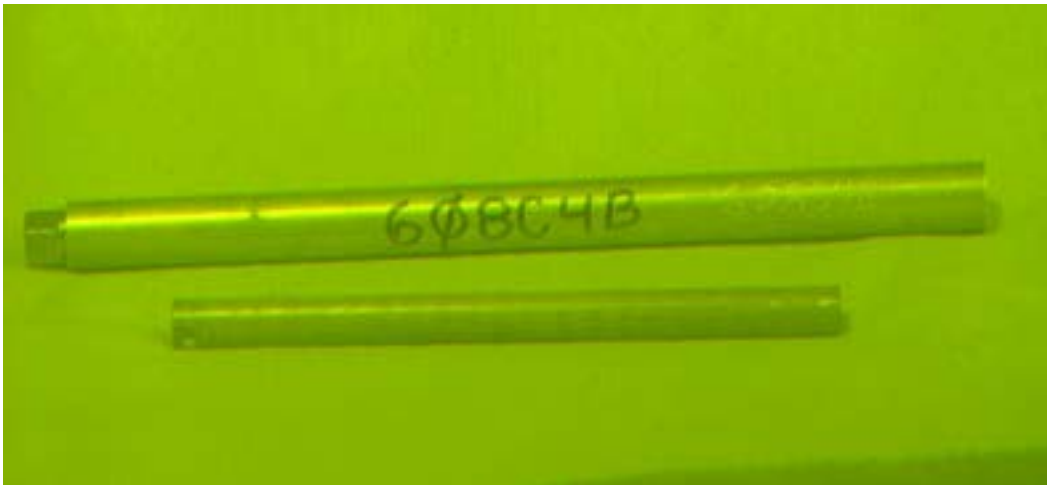
Figure 13 Segment 608C4B for DL2 taken from rod G10, with the storage tube

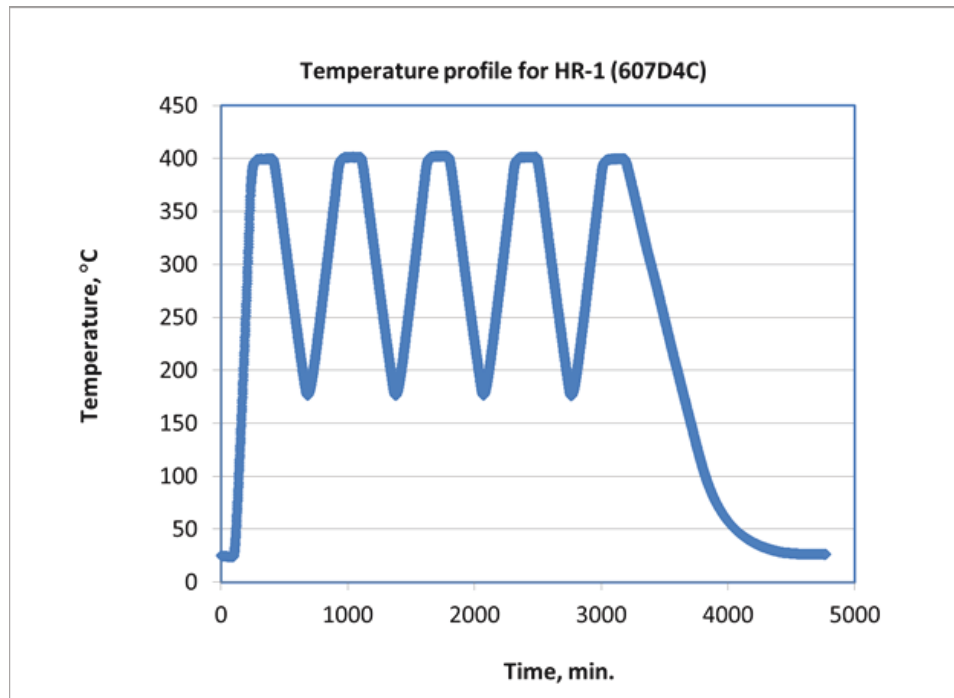
Figure 14 Sample temperature as a function of time for HR1

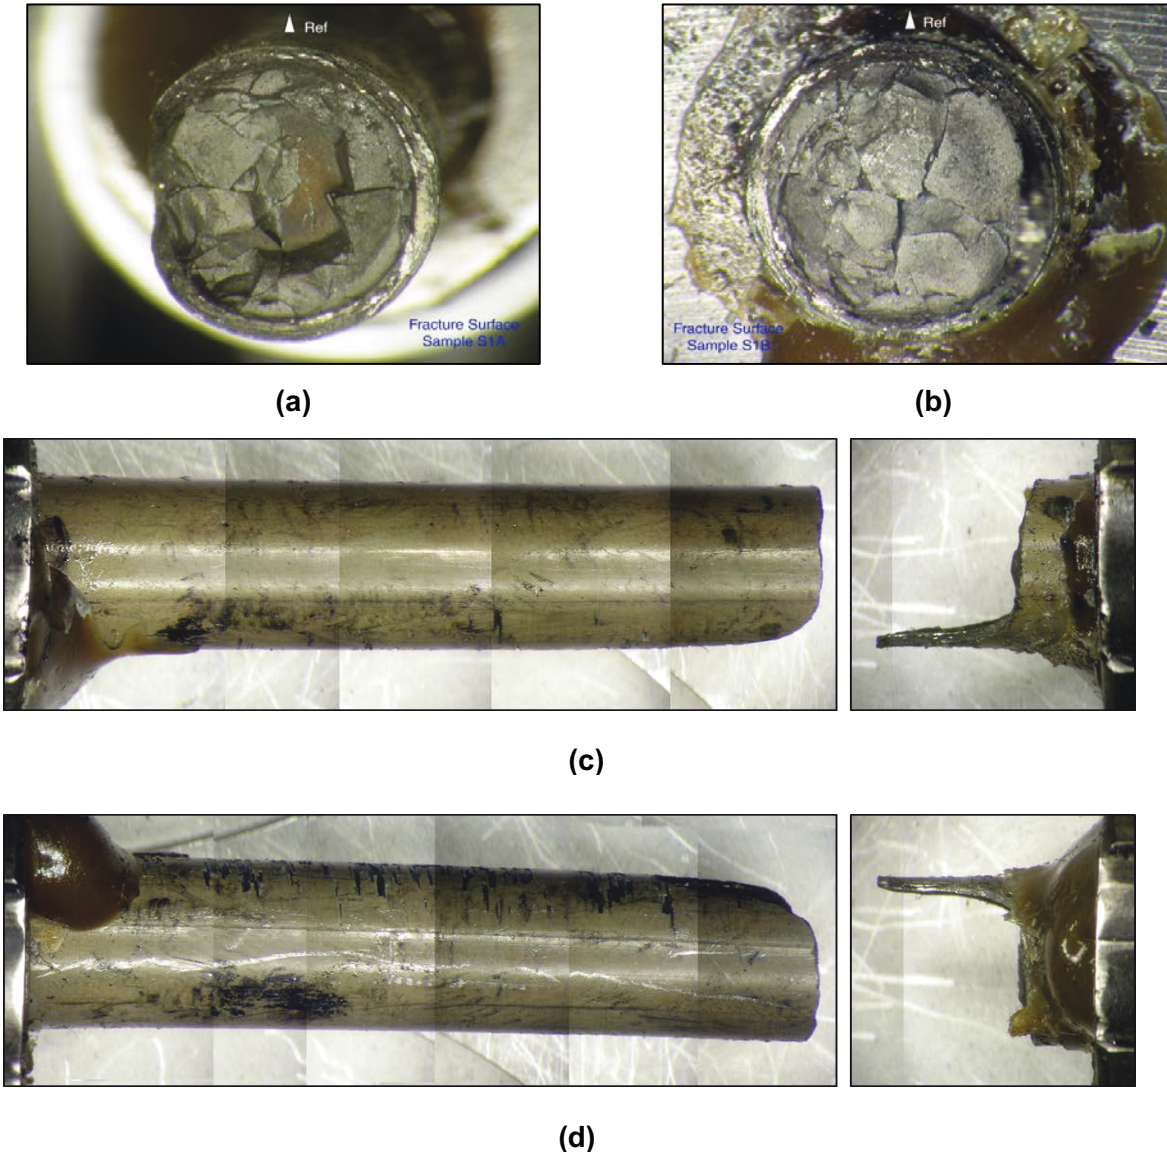
Figure 19 Mating fracture surfaces (a) and (b); lateral sides near the neutral axis of the bending rod for S1 (606C3C) (c) and (d)

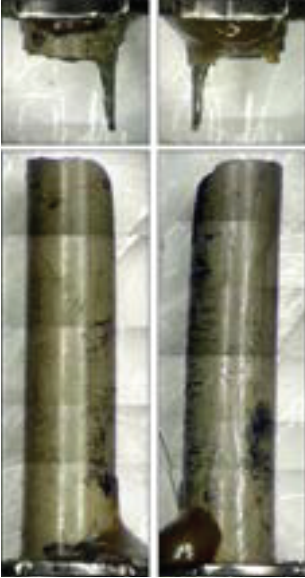
Specimen ID	Specimen burnup	Testing condition and result	Fracture surfaces	Side view of fractured specimens
S1, 606C3C	66.8 GWd/MTU	Four static cycles to 24 mm maximum relative displacement, 85.5 N·m maximum moment without failure, followed by post-static dynamic test to induce failure. 0.9 g fuel fragments were collected when the sample failed.

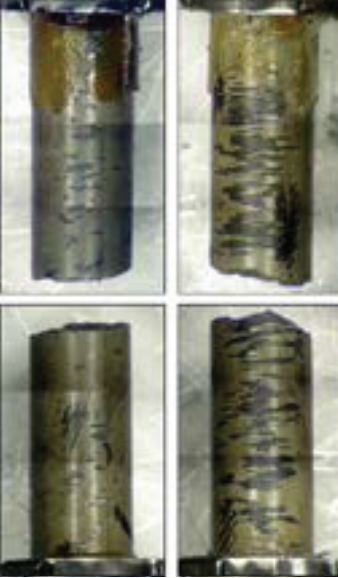
S3, 609C5	66.5 GWd/MTU	Three static cycles to 24 mm maximum relative displacement, 85.8 N·m maximum moment without failure, followed by post-static dynamic test to induce failure. 0.2 g fuel particles were collected when the sample failed.

The end faces of the two neighboring pellets were essentially clean. Both stressed cylinder surfaces of the rod were found covered with equally spaced circumferential cracks throughout the gauge section. Spalling only occurred on the local area near the fracture. The degree of damage shown on both stressed cylinder surfaces of specimen D1 is different from the damage in test specimens undergoing only unidirectional bending. The large deformation arising from the unidirectional bending can produce a greater extent of damage or spalling on one side of the test specimen, with much less spalling on the other side of the specimen (e.g., S3 [609C5] in Table 3).

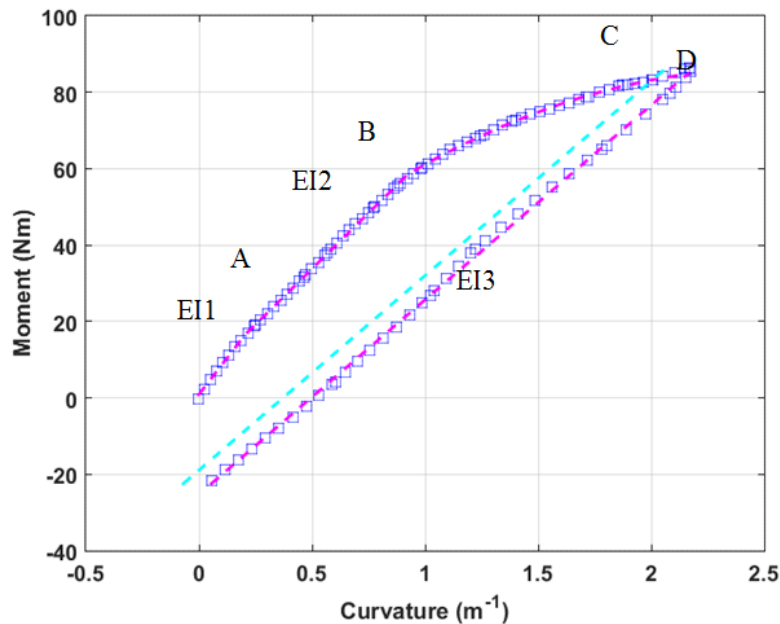
Figure 21 Characteristic points of moment-curvature curve.

The moment-curvature responses of the four HBU SNF as-irradiated specimens were similar. They are characterized by two distinct linear responses, EI1 and EI2, followed by a nonlinear response during the loading and a linear response upon unloading, EI3. It was observed that when reloaded, the moment-curvature response of the rod followed the same slope of the linear unloading curve and proceeded with nonlinear response after passing the previous maximum load. Such loading/unloading/reloading responses can be found in many mechanical systems where irreversible changes occur during loading.⁸ An effort was made to characterize the moment-curvature response based on characteristic points to facilitate understanding of the test results. The values for EI1, EI2, and EI3 were obtained, corresponding to the slopes of the first and second linear regions and of the unloading region, by using curve fitting with the first order polynomial (Figure 21).

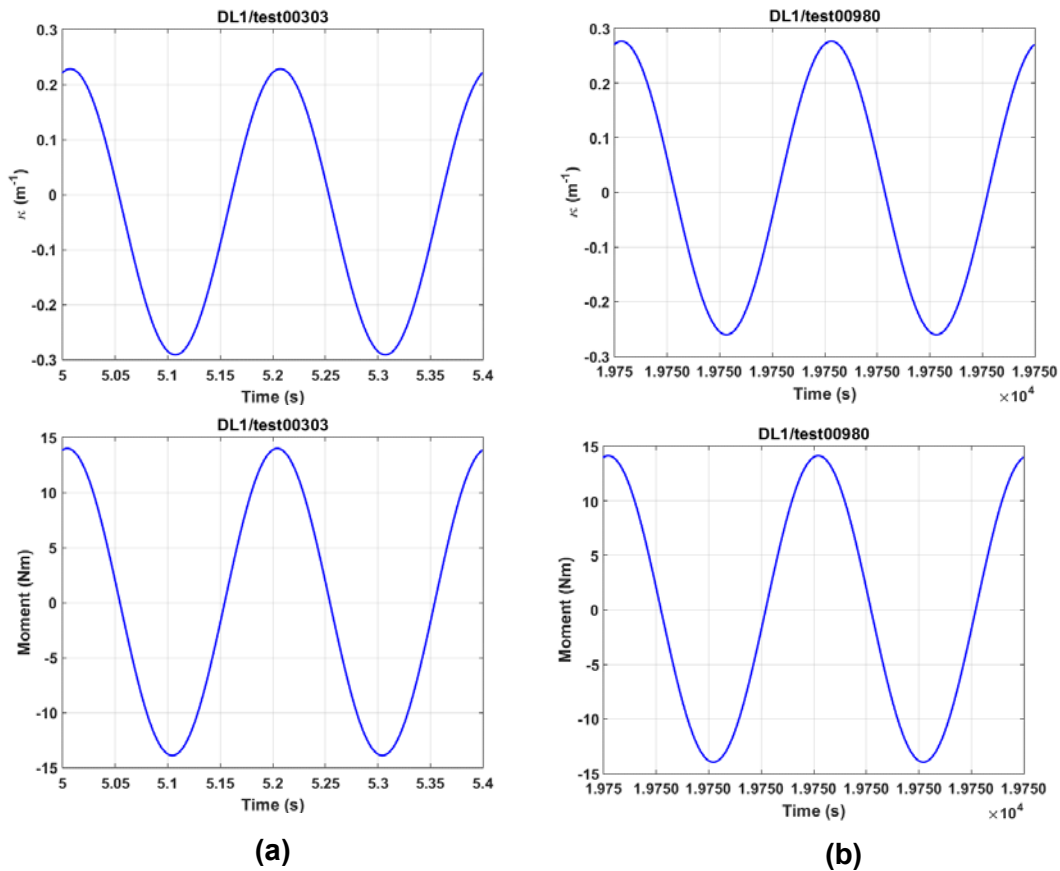
Figure 27 Moment and curvature as a function of time at (a) 26 and (b) 1.10×10^5 cycles; results based on online monitoring; the initial unsymmetrical curvature deformation mode of the tested rod was stabilized and replaced with a symmetrical curvature deformation mode at higher cycles

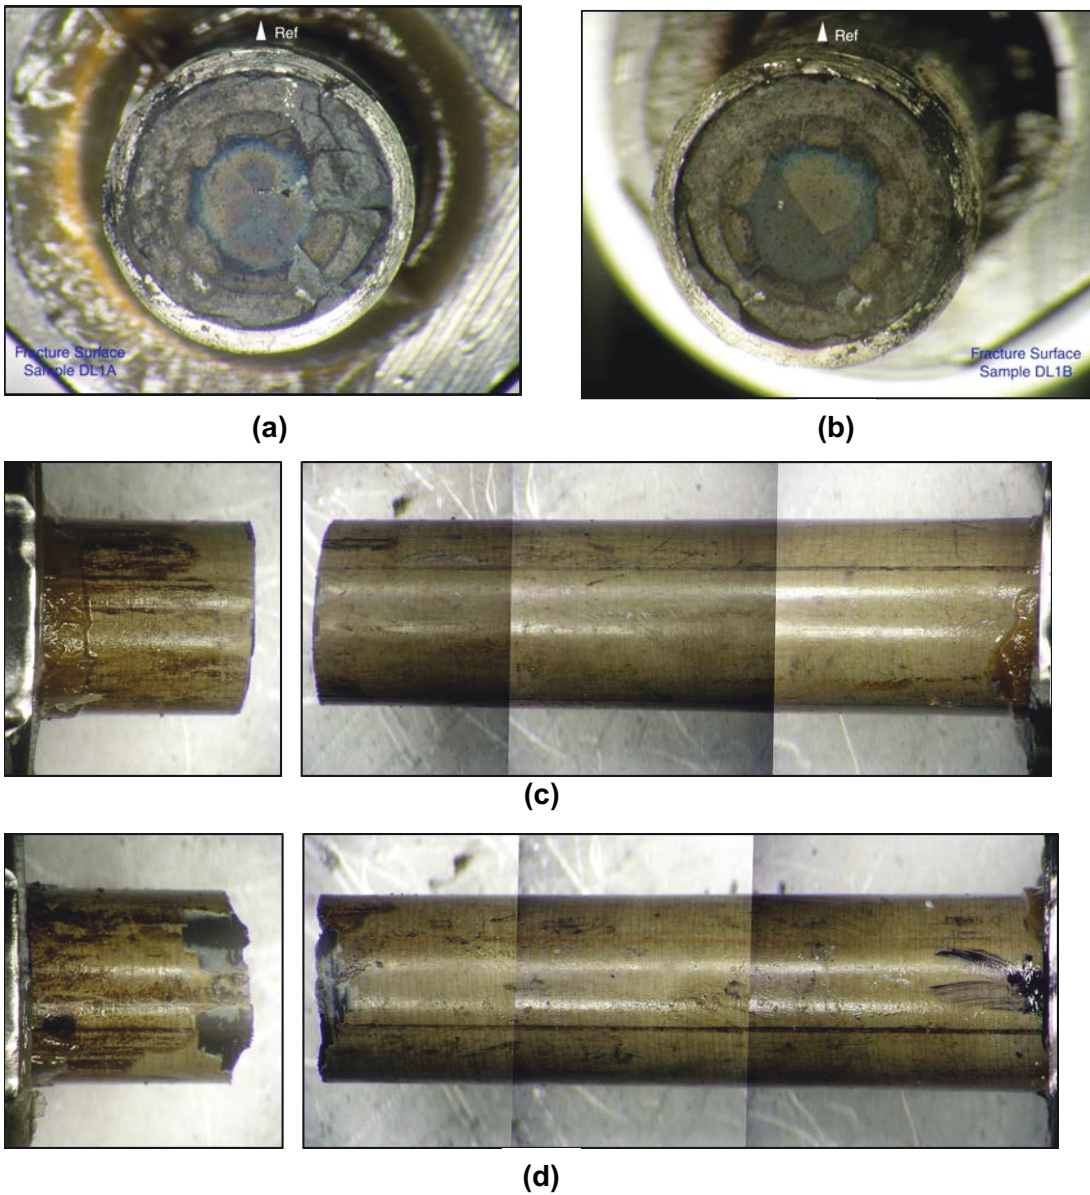
Figure 28 (a) and (b) mating fracture surfaces, (c) front and (d) back sides for D1 (607C4B), $N_f = 1.1 \times 10^5$ cycles under ± 15.24 N·m, 5 Hz; fuel particles collected < 1.0 g

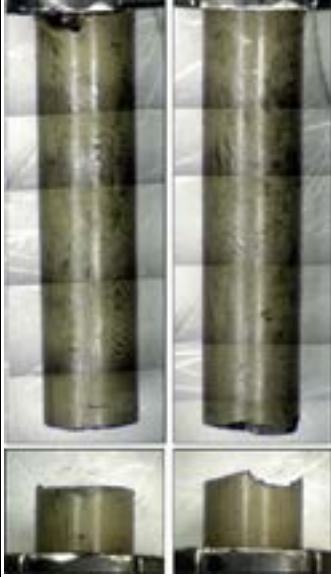
Spec label	Applied moment amplitude		Average curvature (κ_a)	Number of cycles to failure	Cross section	Lateral view
	N·m	m^{-1}				
D0, 605D1F	24.068	0.439	2.50×10^4

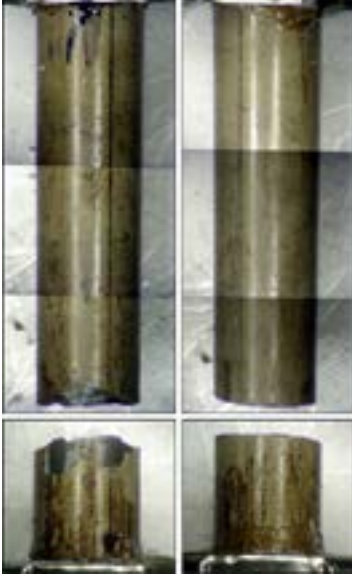
D1, 607C4B	14.107	0.215	1.10×10^5

The test on D1 (607C4B, 63.8 GWd/MTU burnup, 70–100 μm oxide layer) was conducted under ± 15.24 N·m, 5 Hz. A fatigue life of 1.1×10^5 cycles was obtained, and less than 1 g of fuel fragments was collected at the failure site.

The failure in test D1 was observed in the gauge section near motor 2 (left side of the U-frame setup). The failure occurred at the pellet-to-pellet interface, as illustrated in Figure 28.

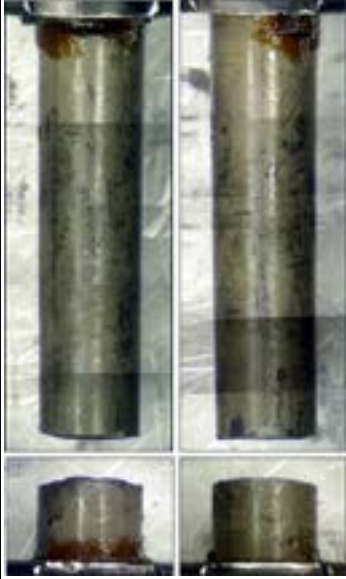
D3, 605C10A	9.170	0.125	1.00 × 10 ⁶

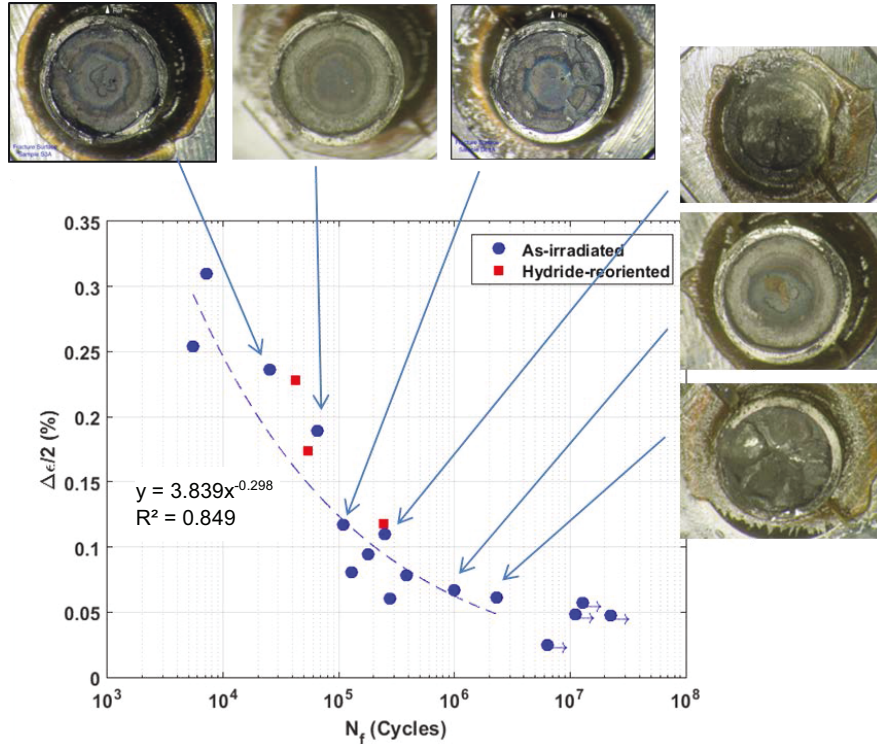
Figure 29 Equivalent strain amplitudes ($\Delta\epsilon/2$) as a function of the number of cycles to failure. Markers with arrows indicate that the tests stopped without failure.

- The gauge strain amplitudes (ϵ_a , half of strain range $\Delta\epsilon / 2$) of as-irradiated fuel rods are shown in Figure 29 as a function of the number of failure cycles, along with those which were subject to HRT. For as-irradiated specimens that failed during the tests, the fatigue life decreases with increasing strain amplitude according to a well-defined ϵ -N curve. The data points can be fit by using the power function $y = 3.839 \cdot x^{-0.298}$ with an R^2 value as high as 0.849, where x is the number of cycles to failure, and y is the strain amplitude (%).

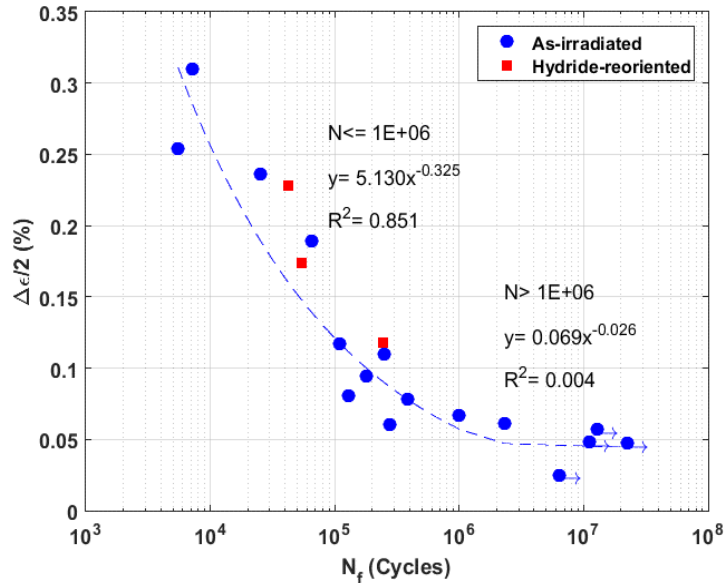
Figure 30 Equivalent strain amplitudes ($\Delta\epsilon/2$) as a function of number of cycles to failure with curve fitting extended to include data points without failure; markers with arrows indicate that tests stopped without failure

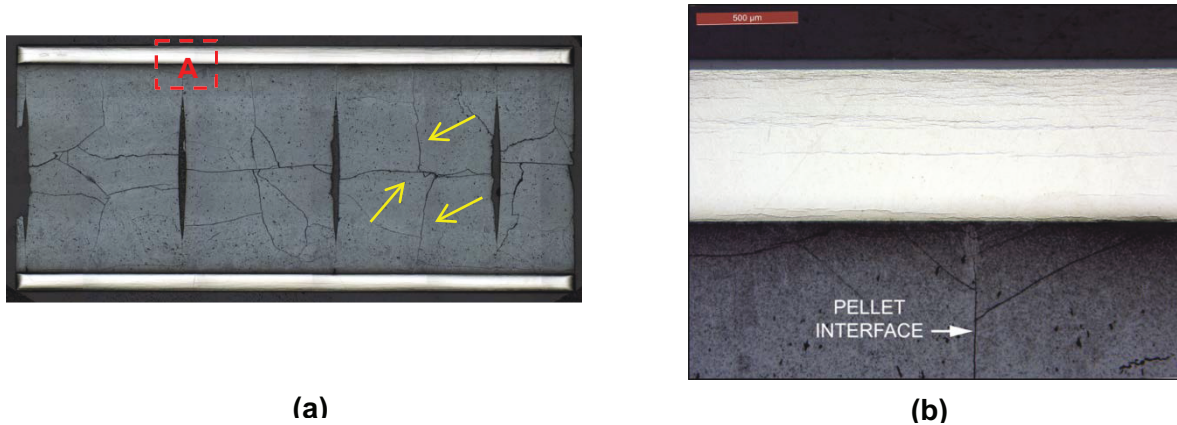
Figure 33 Images of untested segment 605D1D for (a) overall axial cross section and (b) enlarged area A

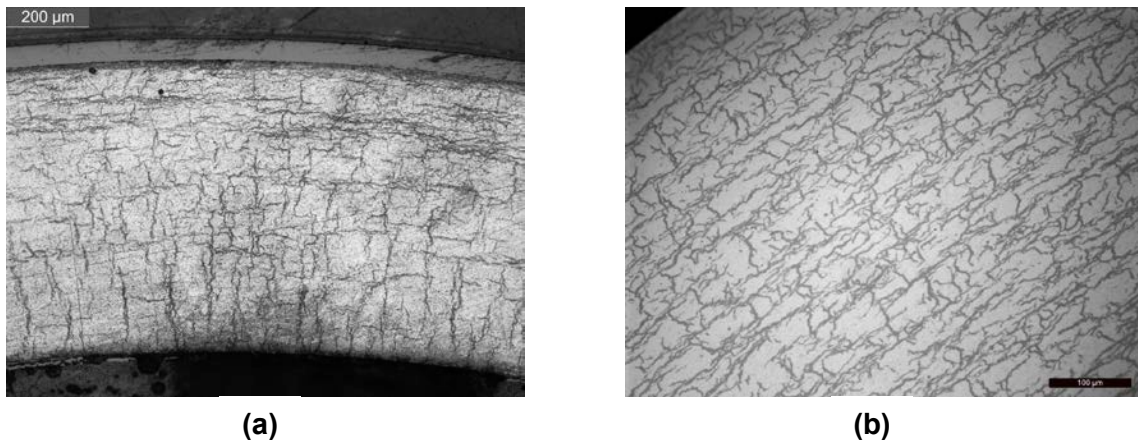
Figure 35 (a) High magnification micrograph showing radial hydrides of Sample HR-1 ($H \approx 360\text{--}400$ ppm); the HBU HBR specimen was pressurized to 140 MPa at 400 °C with five thermal cycles; (b) high magnification micrograph showing radial hydrides of a sample of unirradiated, hydrogen charged zircaloy-4 ($H \approx 286 \pm 20$ ppm); the specimen was sectioned at the mid-plane of a sample that was 6 inches long

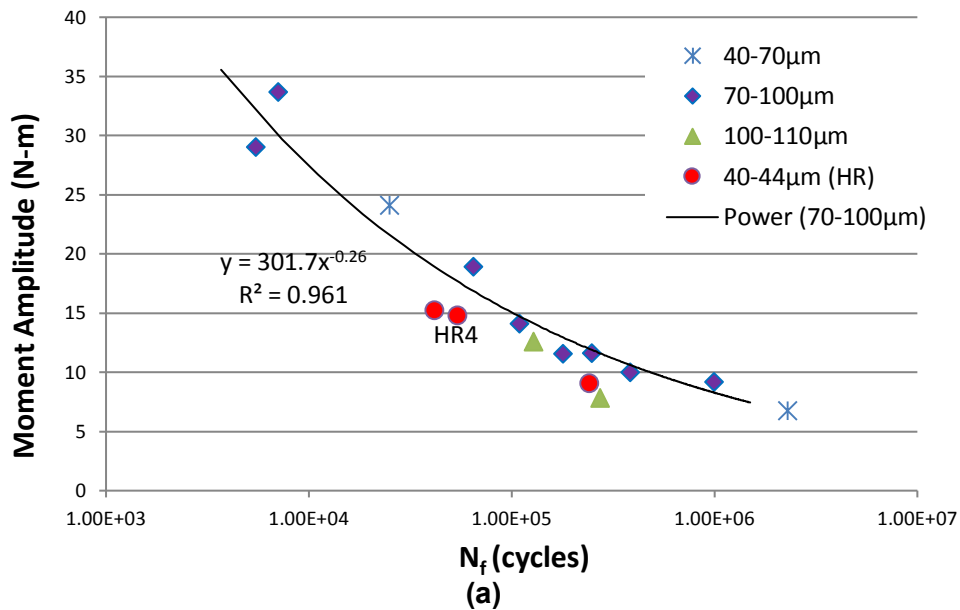
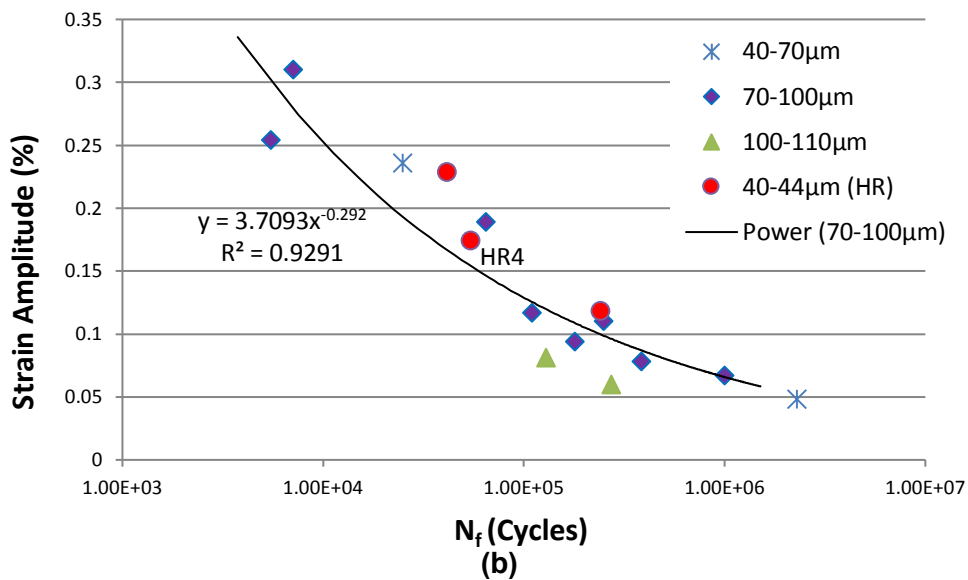
Figure 36 (a) Moment amplitude vs. number of failure cycles, (b) strain amplitude vs. number of failure cycles, as function of clad oxide thickness; HR4 only has thermal annealing treatment without pressurization applied

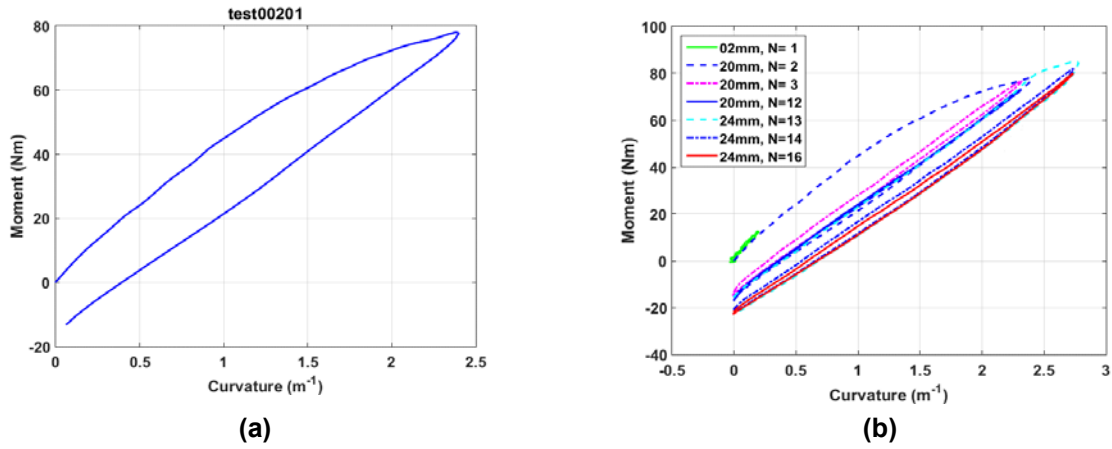
Figure C.1 (a) Curve of moment versus curvature with maximum relative displacement of 20 mm, and (b) moment versus curvature in the subsequent repeats of static tests with relative displacement of 20 or 24 mm for Demo1 (606B2).

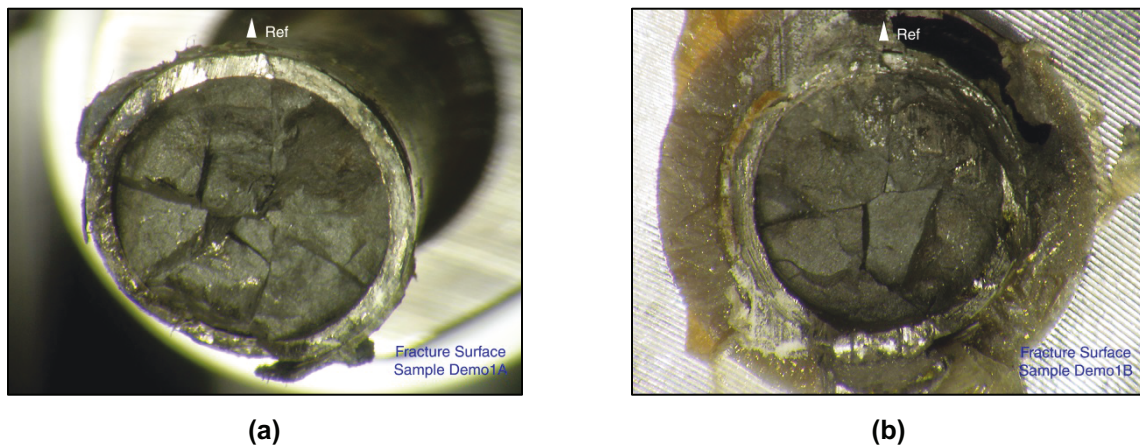
Figure C.3 Mating fracture surfaces of Demo1 (606B2); the reference marker indicates the frontal maximum stress line (facing the operator); $N_f = 3.96 \times 10^3$ cycles under ± 30.48 N·m 5 Hz.

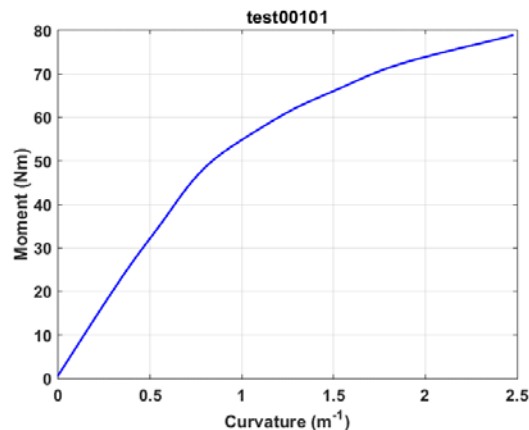
Figure C.4 Moment-curvature curve for Scal1/ Demo2 (606B3B) with a rate of 0.1 mm/sec at the U-frame loading points/ the rod broke at peak moment = 83 N·m

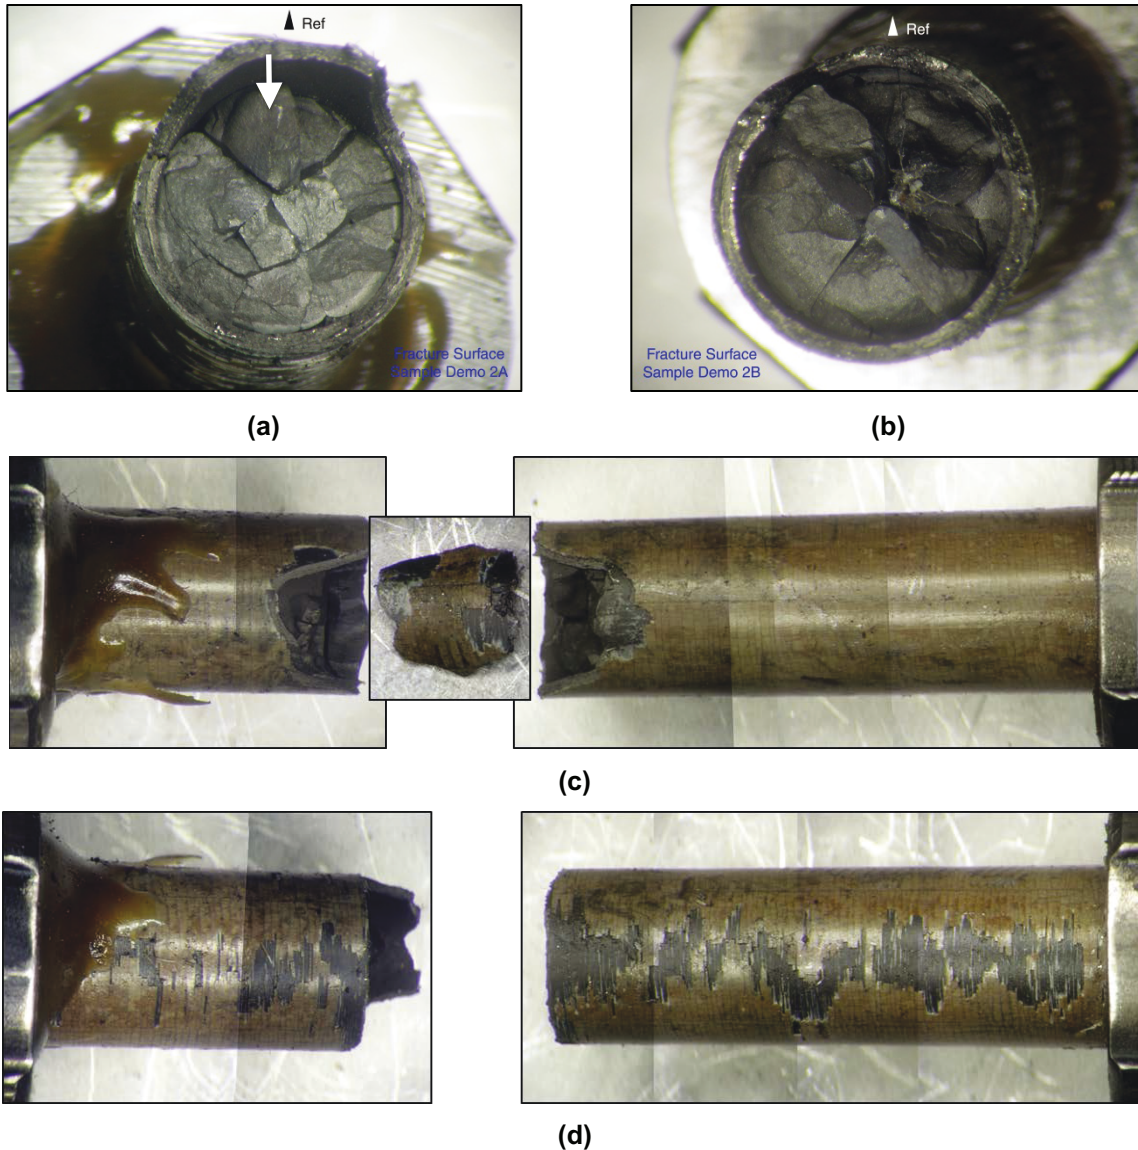
Figure C.5 (a, b) Mating fracture surfaces, (c) front side (compressive), and (d) back side (tensile) of Scal1/ Demo2 (606B3B). The rate was 0.1 mm/sec at the U-frame loading points. The rod broke at peak moment = 78.2 N·m.

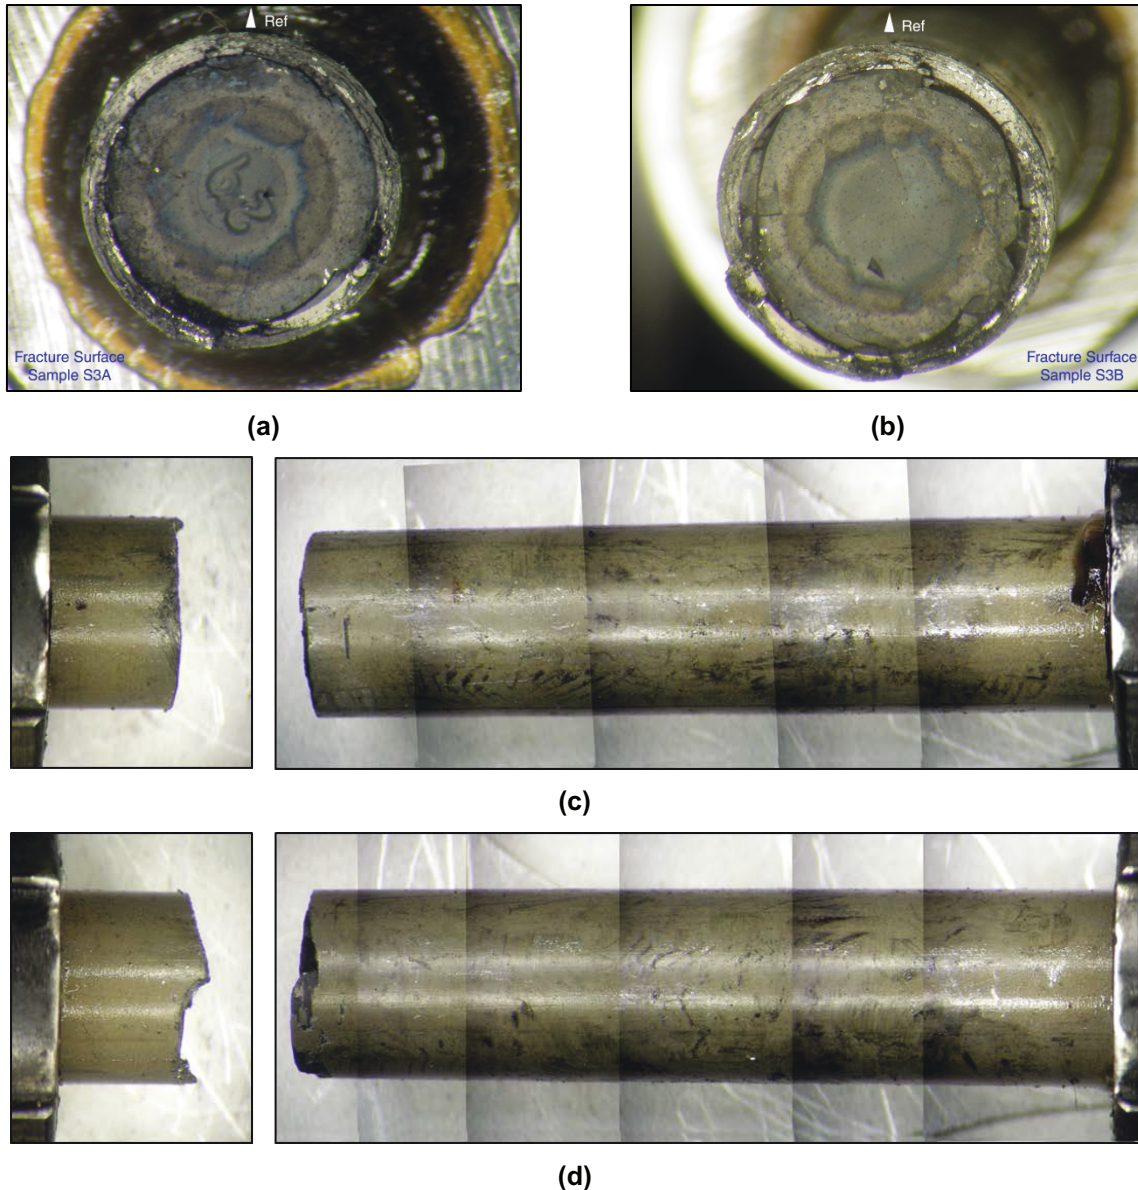
Figure C.9 (a, b) Mating fracture surfaces, (c) front side, and (d) back side of Dcal/ S3 (605D1F); $N_f = 2.5 \times 10^4$ cycles under ± 25.40 N·m 5 Hz

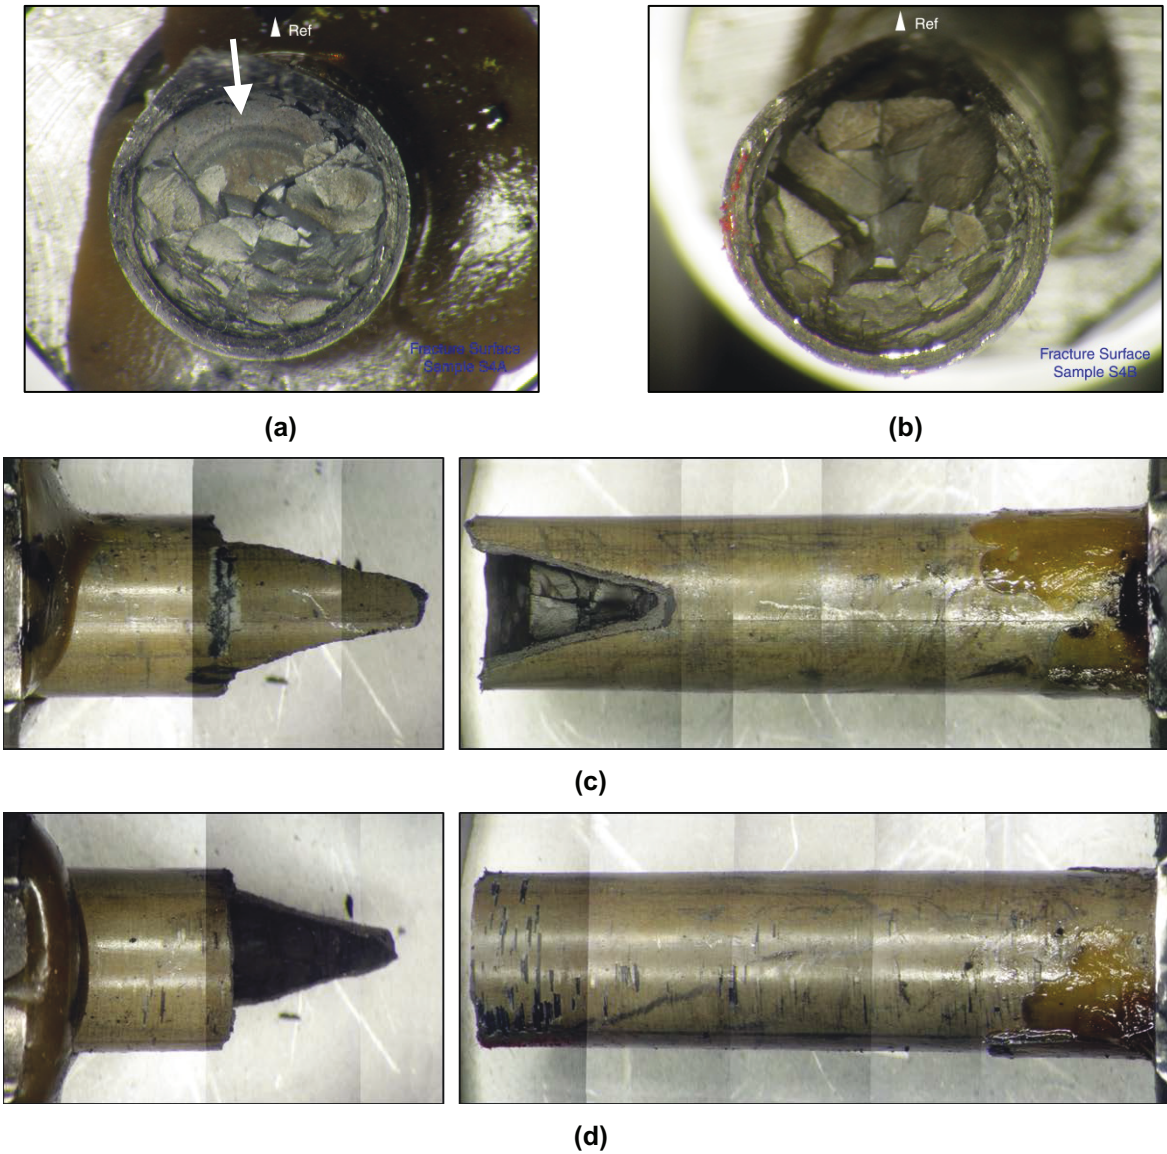
Figure C.10 (a, b) Mating fracture surfaces, (c) front (compressive) side, and (d) back (tensile) side of Scal2/ S4 (606C3B).

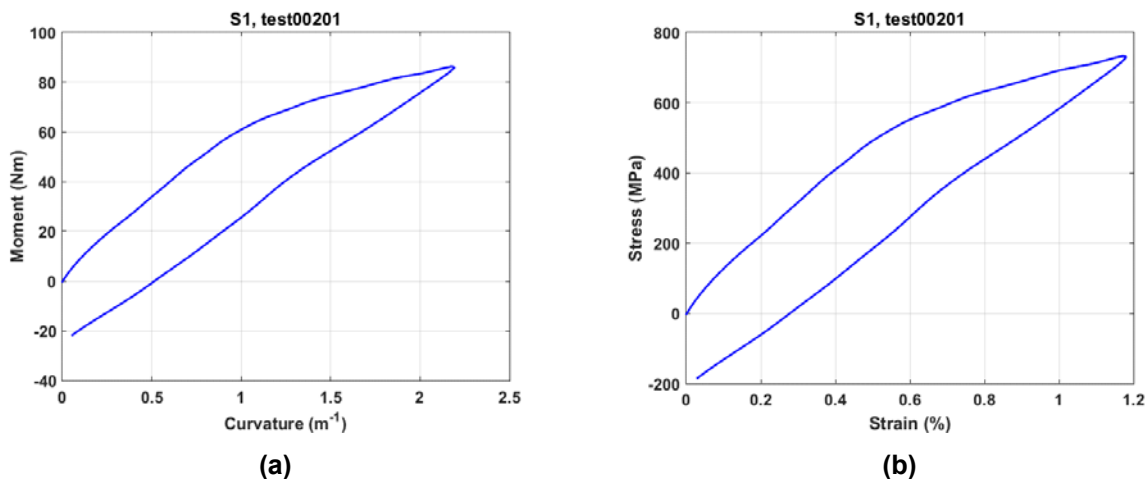
Figure D.1 (a) Curve of moment versus curvature, and (b) equivalent strain–stress curve for S1 (606C3C), based on static loading cycle in which the maximum relative displacement was 24 mm and the rate at the U-frame loading points was set at 0.1 and 0.2 mm/s in loading and unloading, respectively

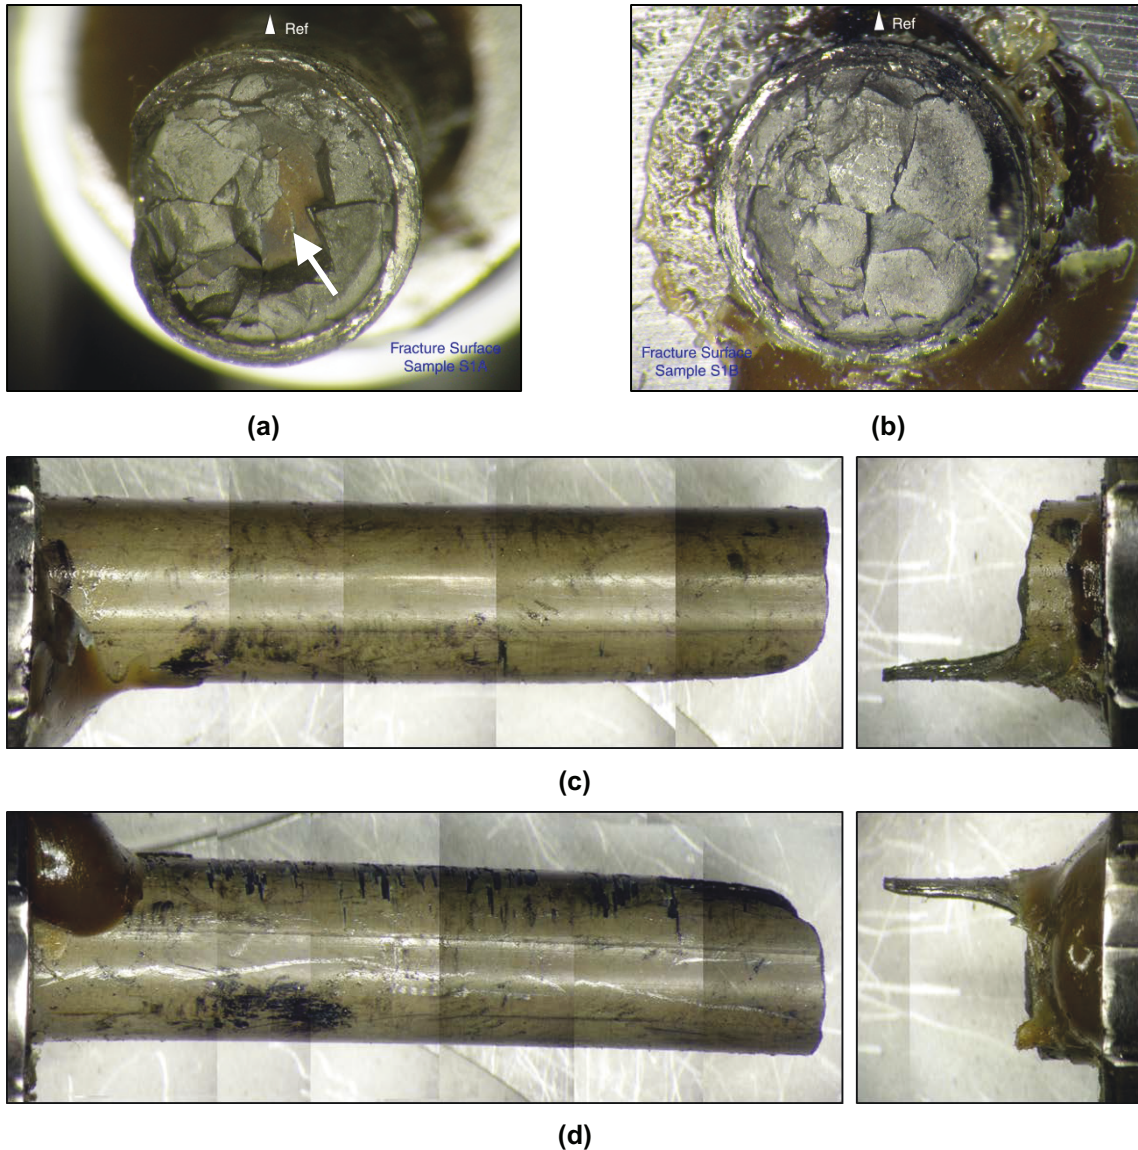
Figure D.2 (a, b) Mating fracture surfaces and (c, d) lateral sides near the rod's neutral axis of bending for S1 (606C3C), which was subjected to four repeated static cycles to 24 mm maximum relative displacement followed by dynamic cyclic loading ± 25.40 to 30.48 N·m 5 Hz; 1.4×10^4 failure cycles, 0.9 gram of fuel particles collected

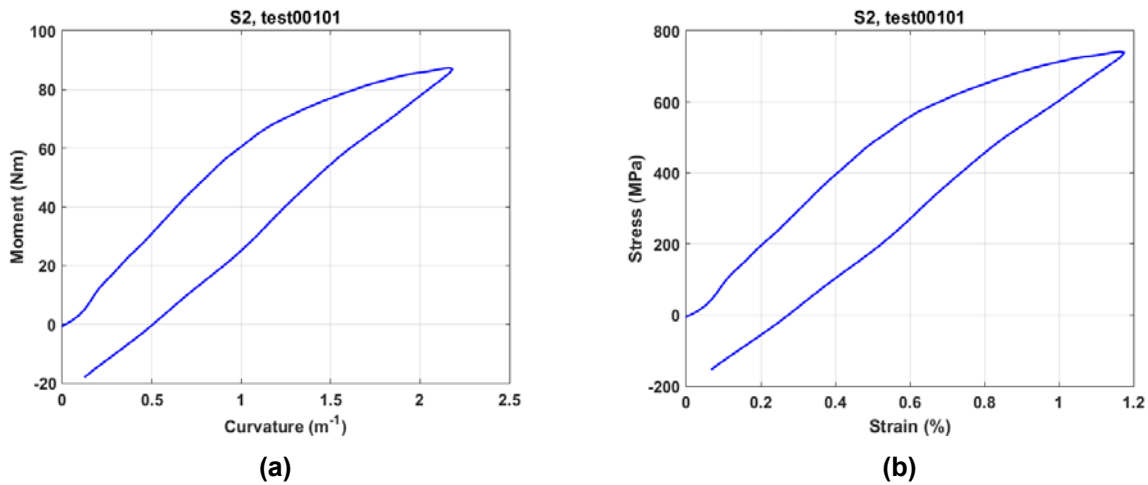
Figure D.3 (a) Curve of moment versus curvature and (b) equivalent strain-stress curve for S2 (605D1E), based on static loading cycle in which maximum relative displacement was 24 mm and the rate at the U-frame loading points was set at 0.1 and 0.2 mm/s in loading and unloading, respectively
