Mechanical Fatigue Testing of High-Burnup Fuel for Transportation Applications

Testing was conducted at Oak Ridge National Laboratory (ORNL) to determine the ability of high burnup (HBU) (>45 GWd/MTU) spent nuclear fuel (SNF) to maintain its integrity under conditions relevant to storage and transport. The cyclic integrated reversible-bending fatigue tester (CIRFT) is an innovative system used in these tests. The CIRFT can impose pure bending loads on SNF test specimens and can measure the in situ curvature of the fuel rod during bending. *Pure bending* is a condition of stress in which a bending moment is applied to a beam without the simultaneous presence of axial, shear, or torsional forces. The CIRFT is composed of a U-frame equipped with load cells. A setup with three linear variable differential transformers (LVDTs) was used.

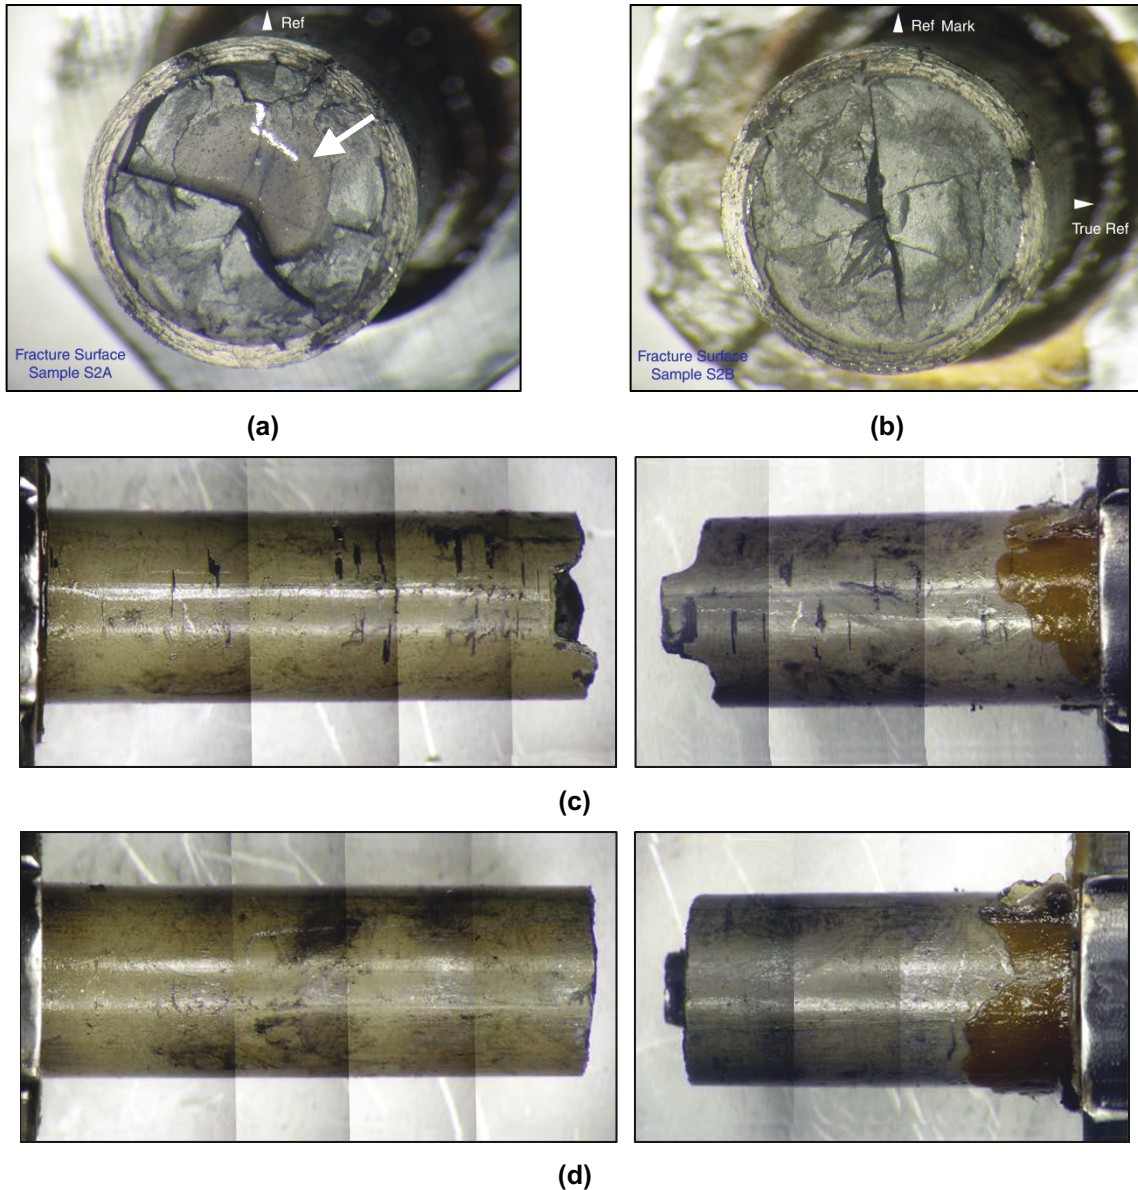
Figure D.4 (a, b) Mating fracture surfaces, (c) front side, and (d) back side of S2 (605D1E), which was subjected to three repeated static cycles to 24 mm maximum relative displacement followed by dynamic cyclic loading ± 30.48 N·m 5 Hz; 7.2×10^3 failure cycles, 0.6 gram of fuel particles collected

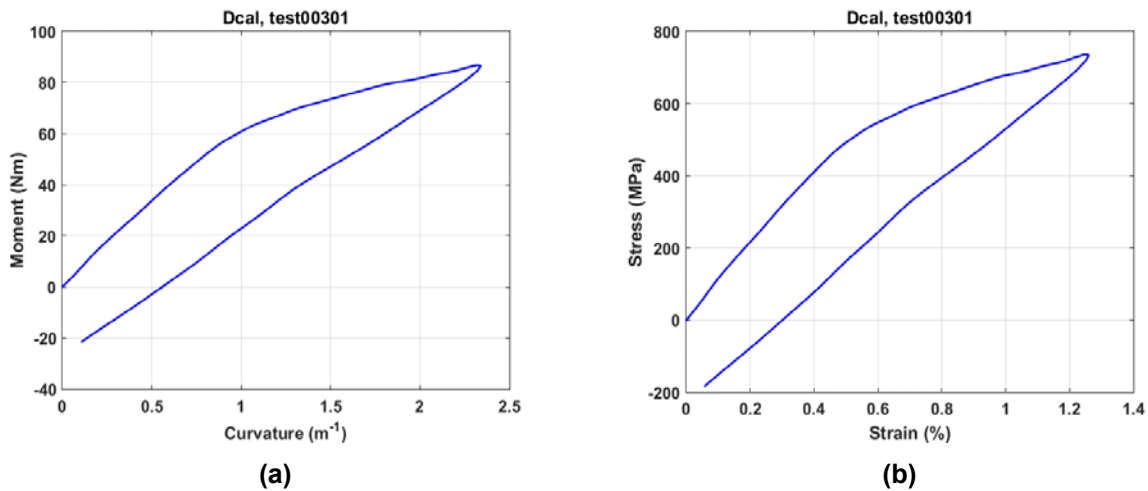
Figure D.5 (a) Curve of moment versus curvature and (b) equivalent strain-stress curve for S3/ Dcal (609C5), based on a static loading cycle in which maximum relative displacement was 24 mm and the rate at the U-frame loading points was set at 0.1 and 0.2 mm/s in loading and unloading, respectively

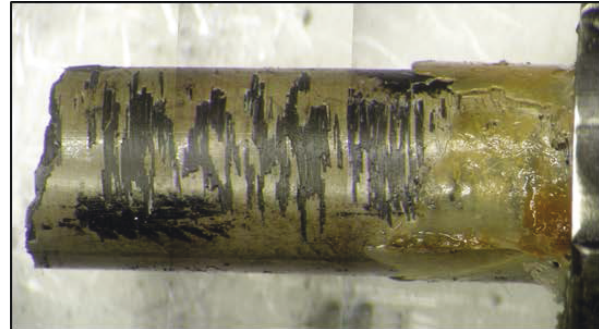
Figure D.6 (a, b) Mating fracture surfaces, (c) front side, and (d) back side of S3/ Dca1 (609C5), which was subjected to three repeated static loadings to 24 mm maximum relative displacement followed by dynamic loading: ± 30.48 N·m 5 Hz; 9.6×10^3 failure cycles, 0.2 gram of fuel particles collected

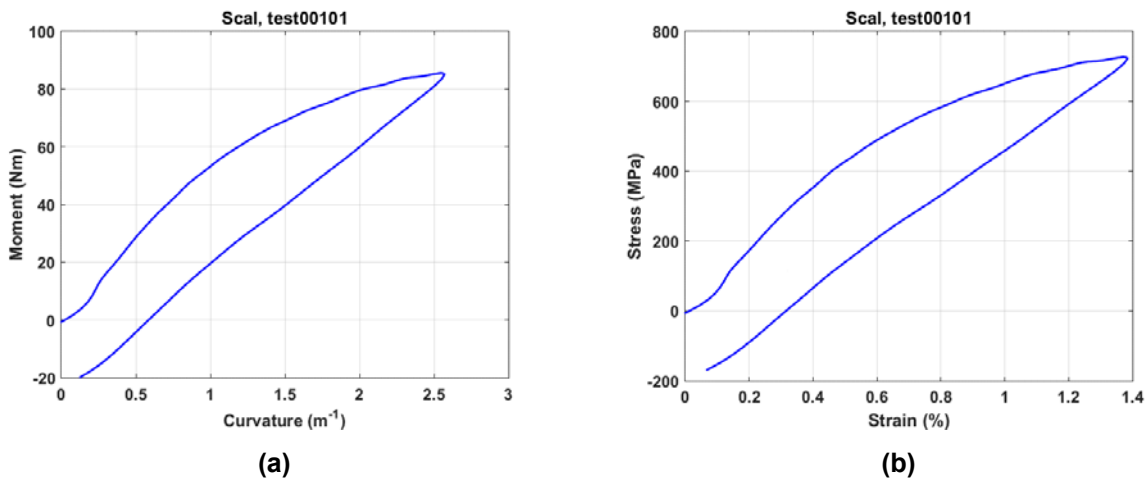
Figure D.7 (a) Curve of moment versus curvature and (b) equivalent strain-stress curve for S4/ Scal (609C6), based on static loading cycle in which maximum relative displacement was 24 mm and the rate at the U-frame loading points was set at 0.1 and 0.2 mm/s in loading and unloading, respectively

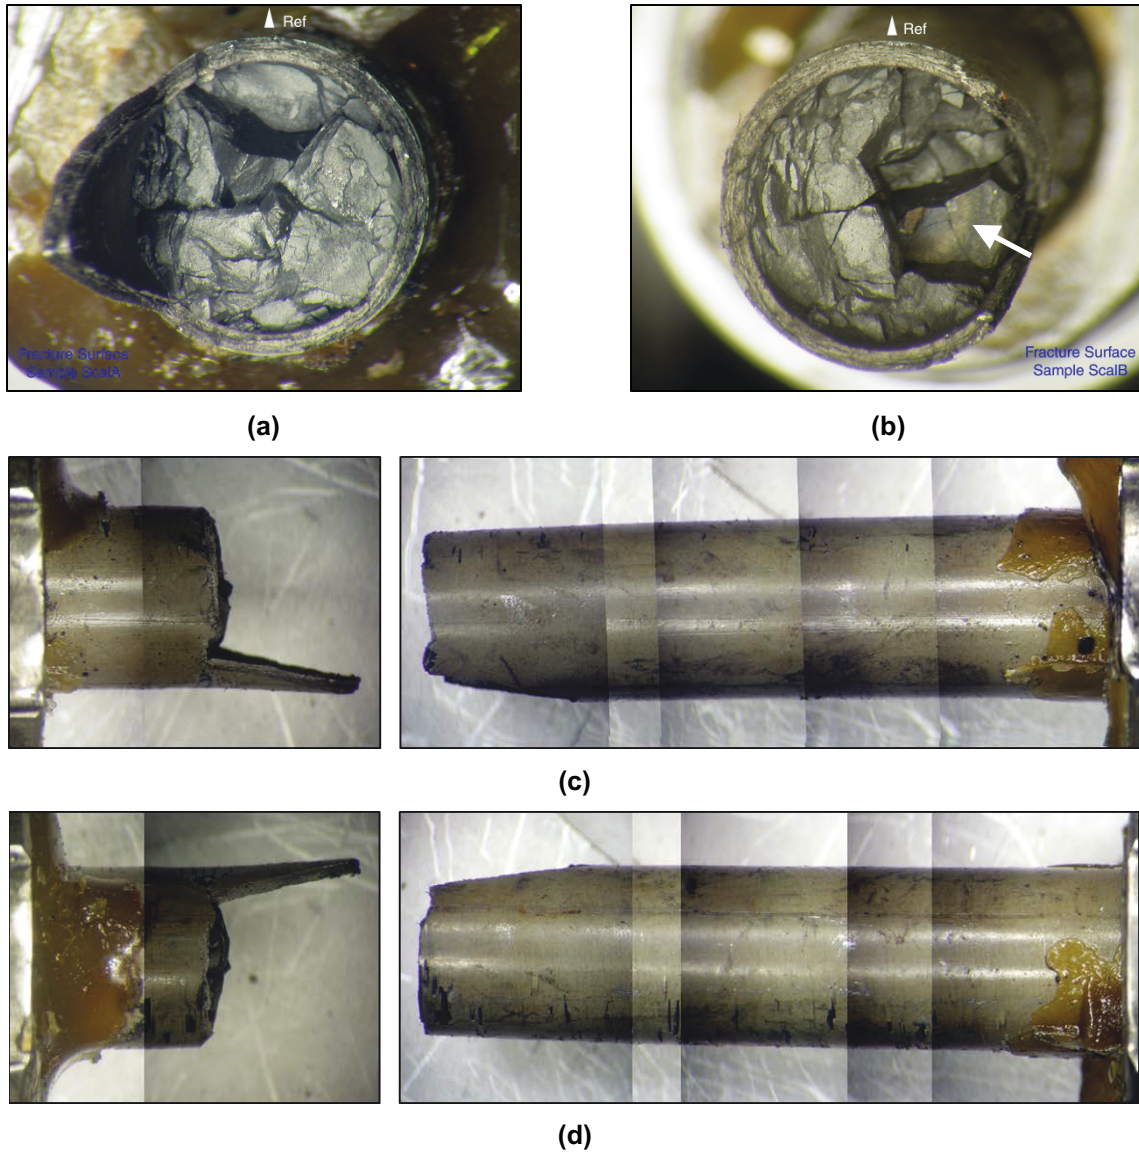
Figure D.8 (a, b) Mating fracture surfaces and (c, d) lateral sides near the rod's neutral axis of bending for S4/ Scal (609C6), which was subjected to repeated static loading to 24 mm maximum relative displacement and failed at 86.1 N-m in the 4th cycle; 1.3 grams of fuel particles collected

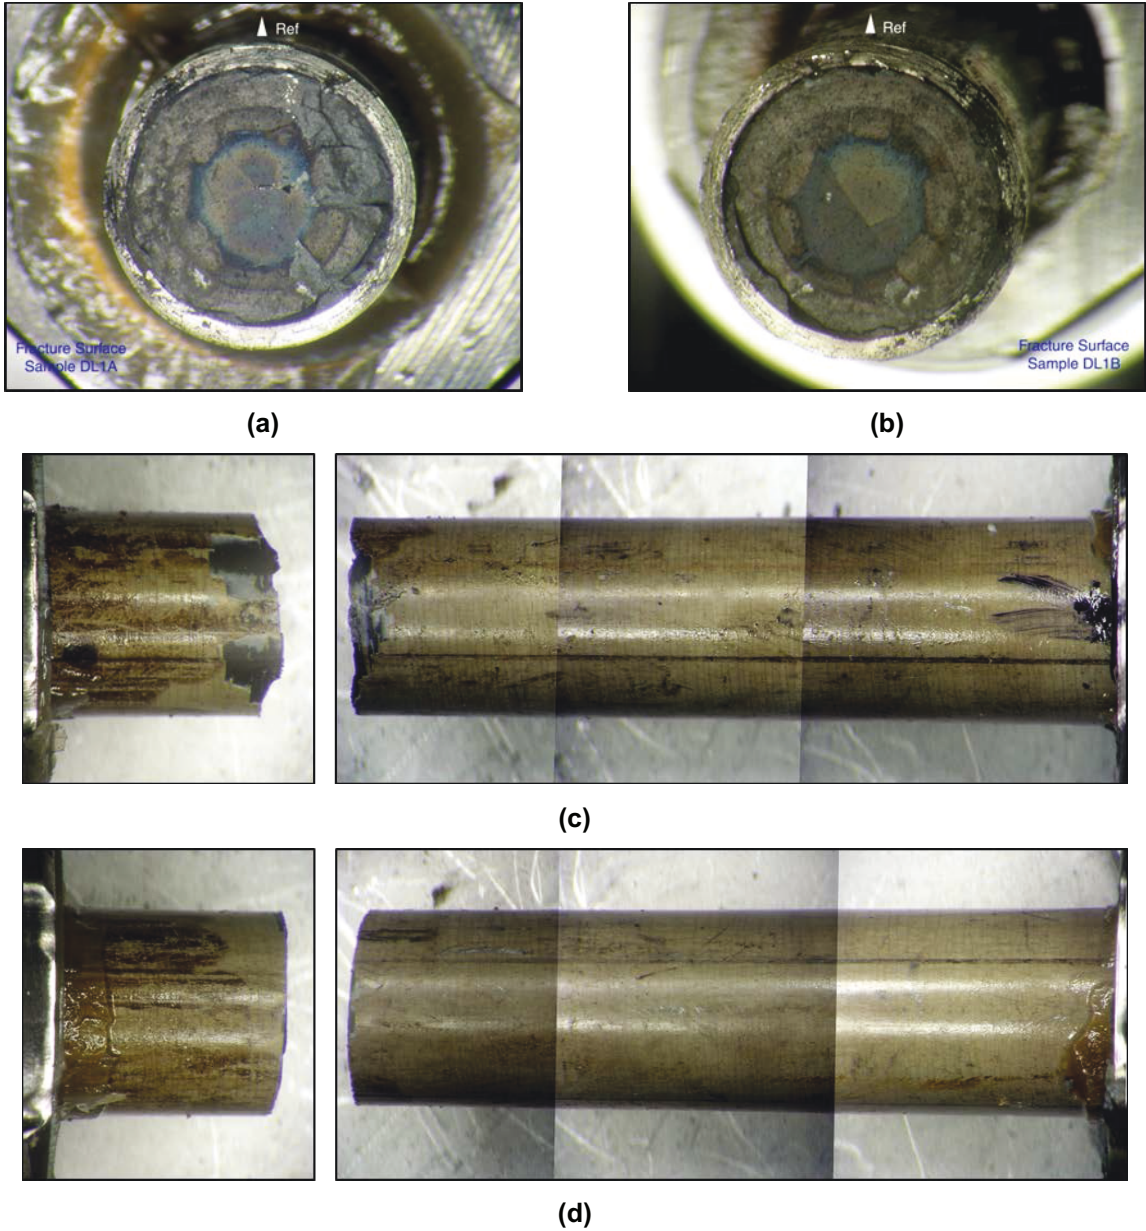
Figure E.5 (a, b) Mating fracture surfaces, (c) front side, and (d) back side of D1/ DL1 (607C4B), $N_f = 1.1 \times 10^5$ cycles under ± 15.24 N·m 5 Hz; fuel particles collected < 1.0 gram

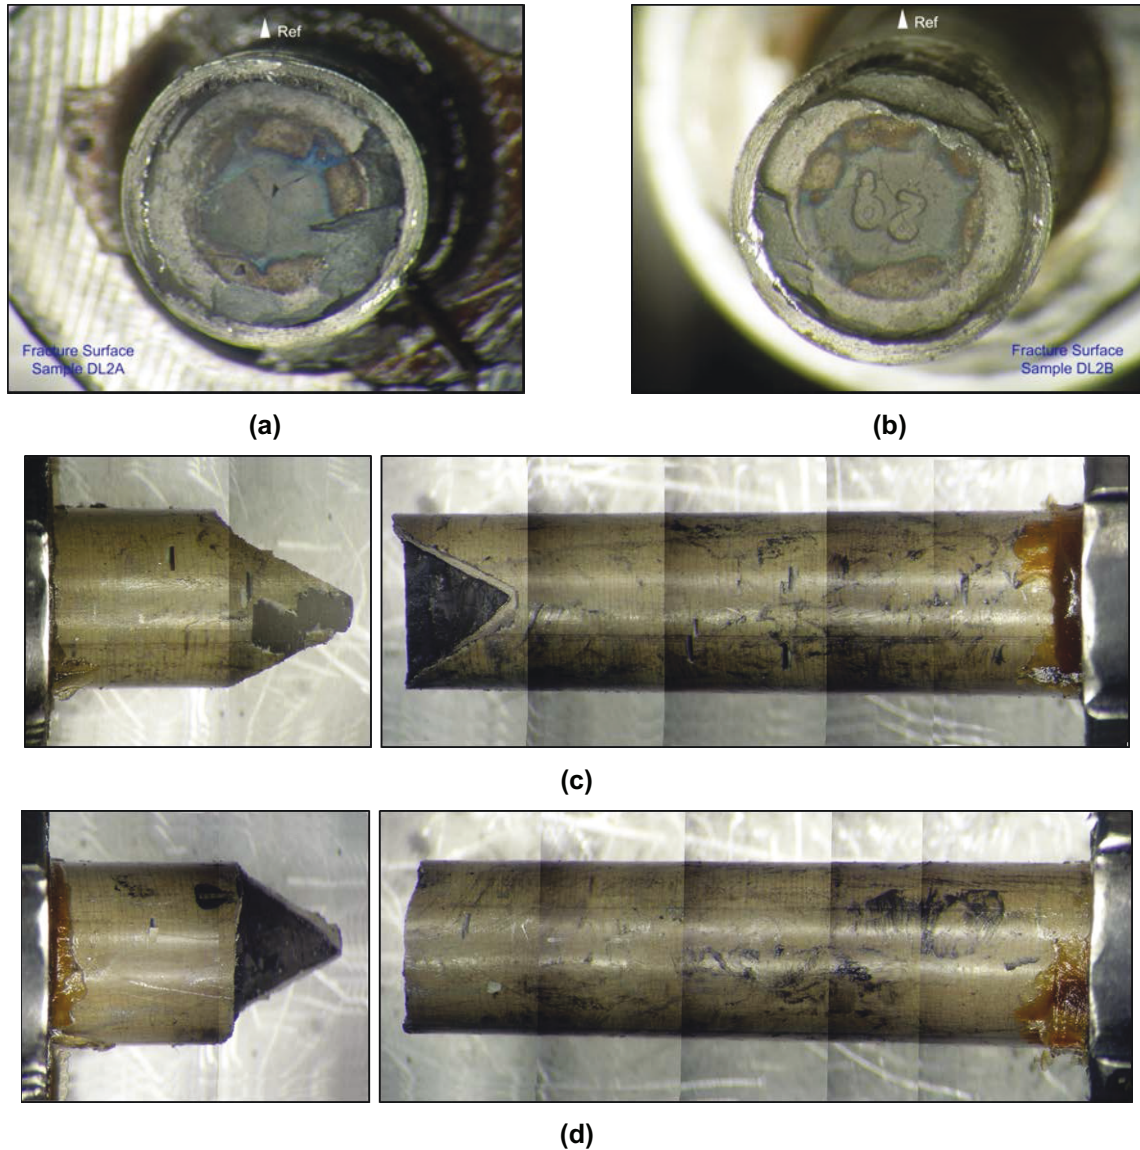
Figure E.8 (a, b) Mating fracture surfaces, (c) front side, and (d) back side of D2/ DL2 (608C4B); follow-up test was conducted with increased amplitude ± 35.56 N·m 5 Hz with $N_f = 1.8 \times 10^3$ cycles

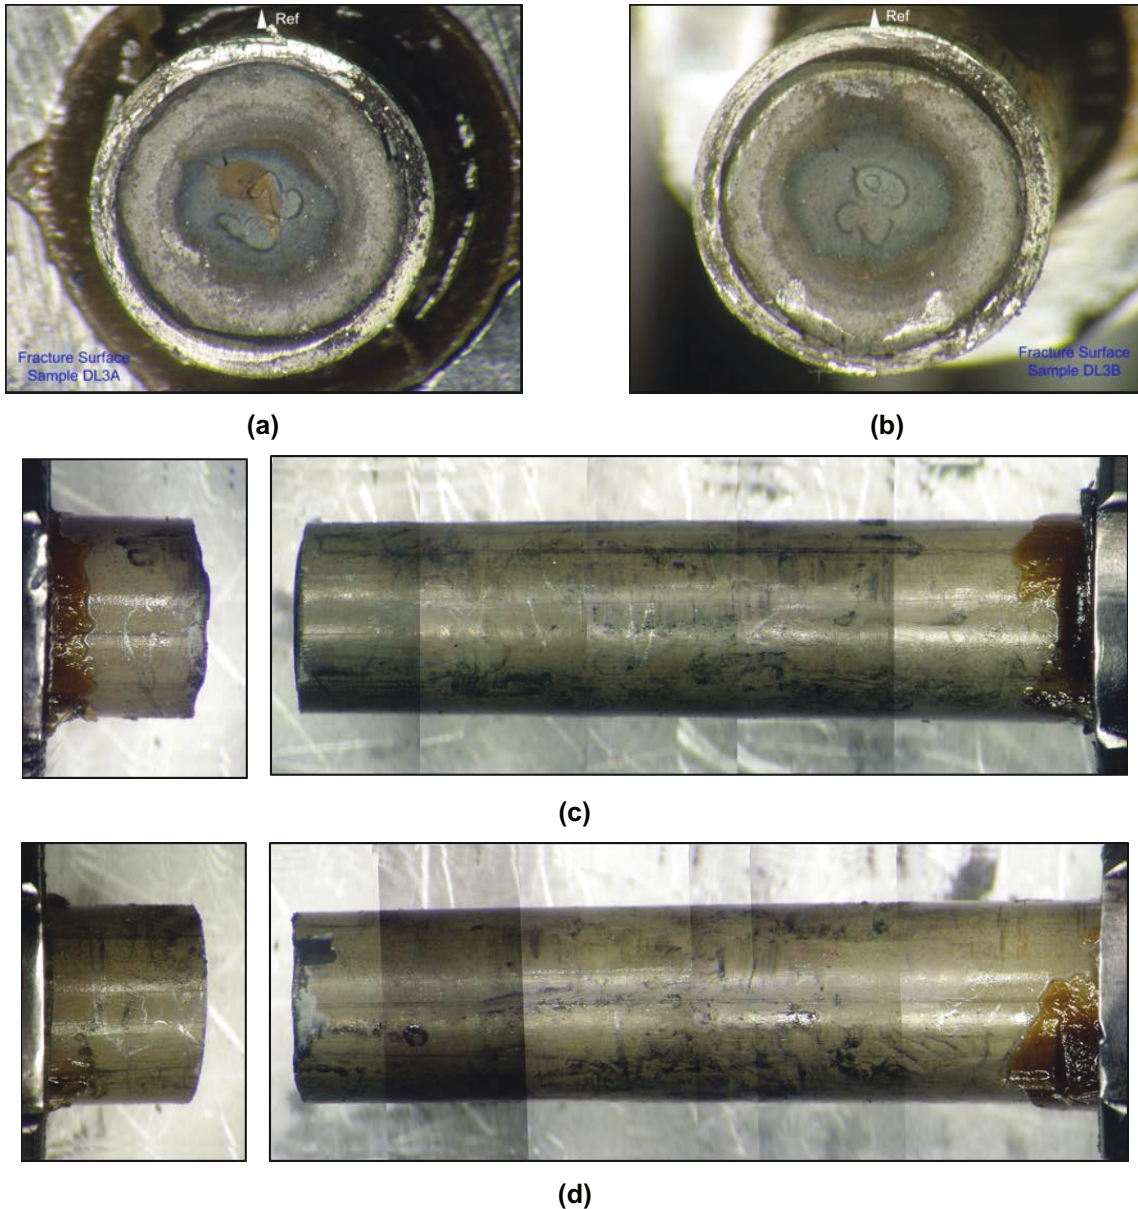
Figure E.11 (a, b) Mating fracture surfaces, (c) front side, and (d) back side of D3/ DL3 (605C10A); $N_f = 1.0 \times 10^6$ cycles under ± 10.16 N·m 5 Hz

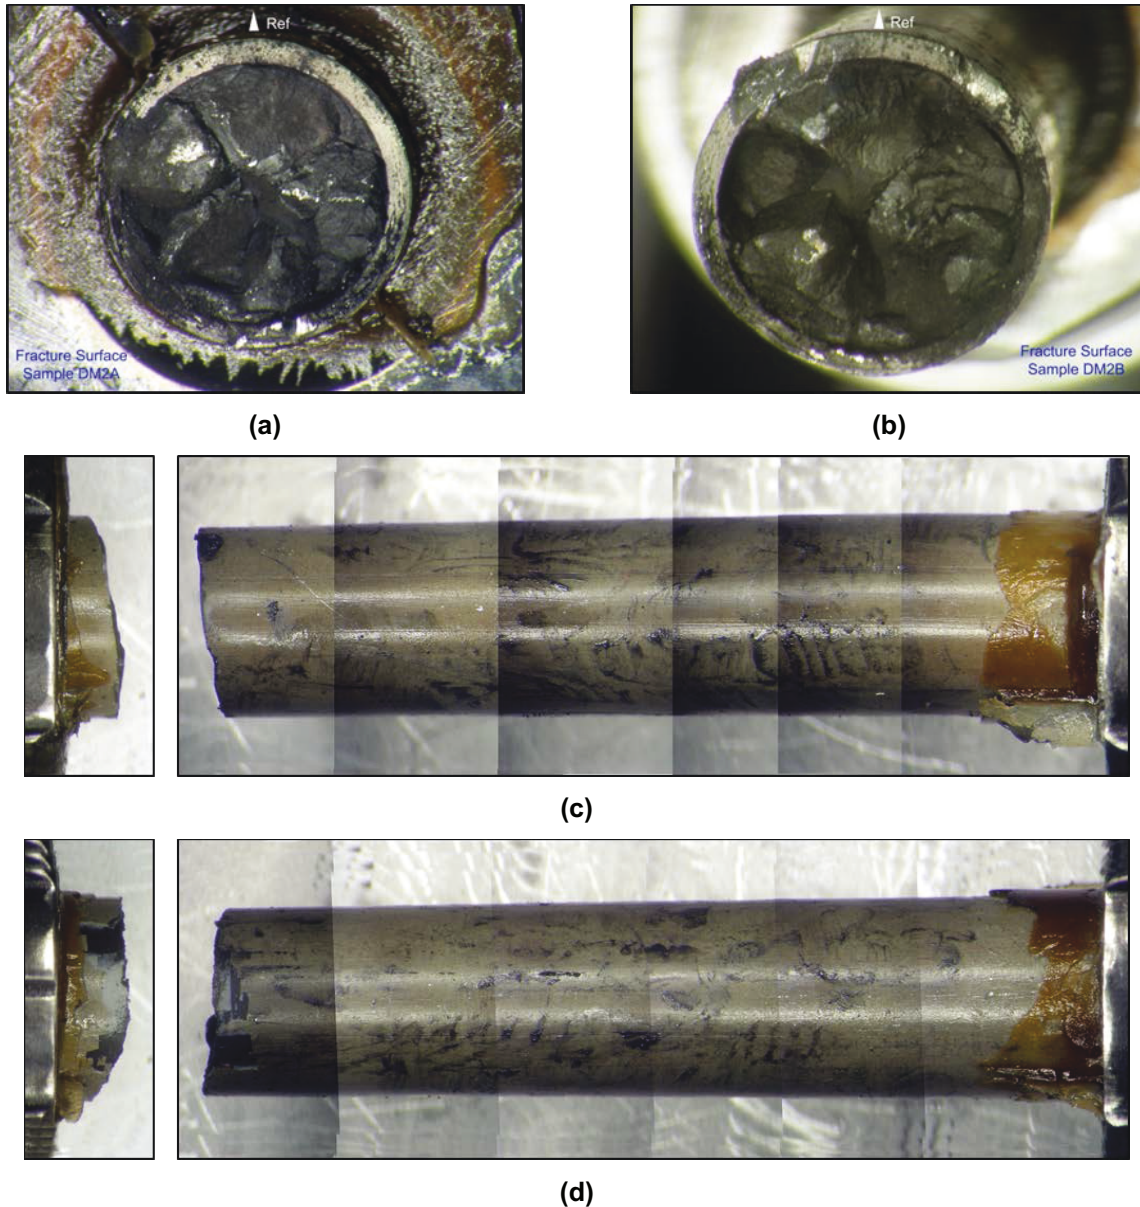
Figure E.16 (a, b) Mating fracture surfaces, (c) front side, and (d) back side of D5/ DM2 (605D1B); $N_f = 2.3 \times 10^6$ cycles under ± 9.14 N·m 5 Hz.

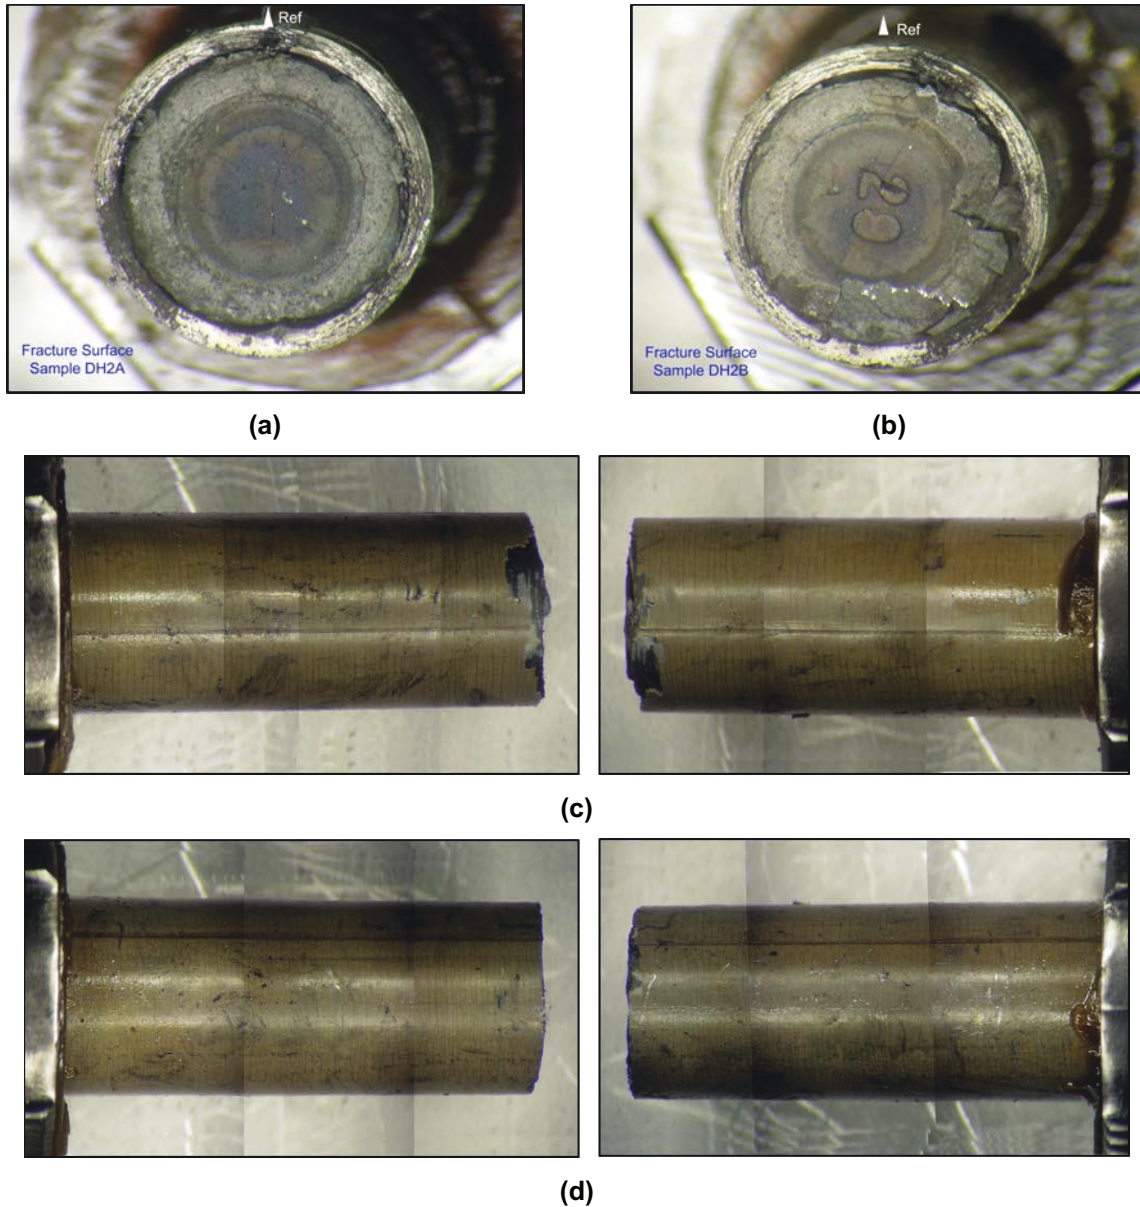
Figure E.22 (a, b) Mating fracture surfaces, (c) front side, and (d) back side of D7/DH2 (609C3); $N_f = 6.5 \times 10^4$ cycles under $\pm 20.32 \text{ N}\cdot\text{m}$ 5 Hz

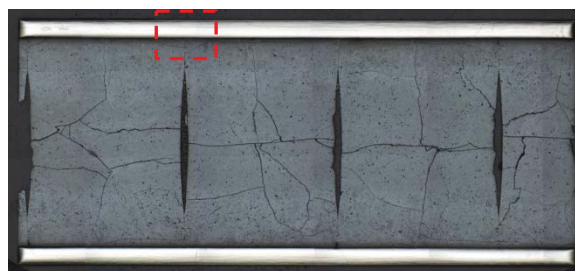
(a)

The parallel axial hydride layers can also be seen clearly over the whole thickness. The axial hydrides are widely spaced in the large middle part of wall. The density of hydrides becomes much higher toward the outside of clad and in the clad-pellet interface area. The axial hydride layers are sizable, and in the middle of clad wall, the layers can be over 1000 μm .

The outside surface of clad is covered with a continuous thin oxide layer that is measured at about 75 μm .

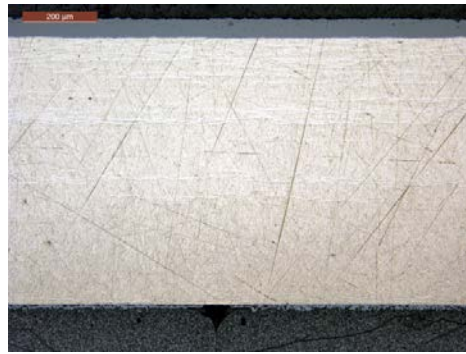
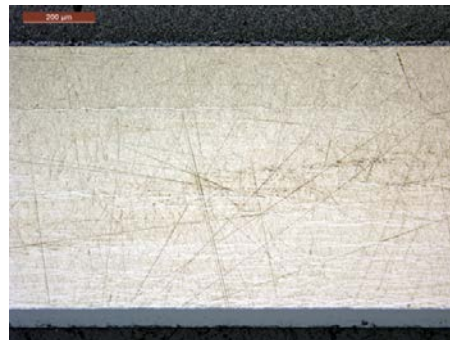
Figure F.3 (a) Axial cross section of DM1/605D1C, (b) back side of rod, and (c) front side of rod

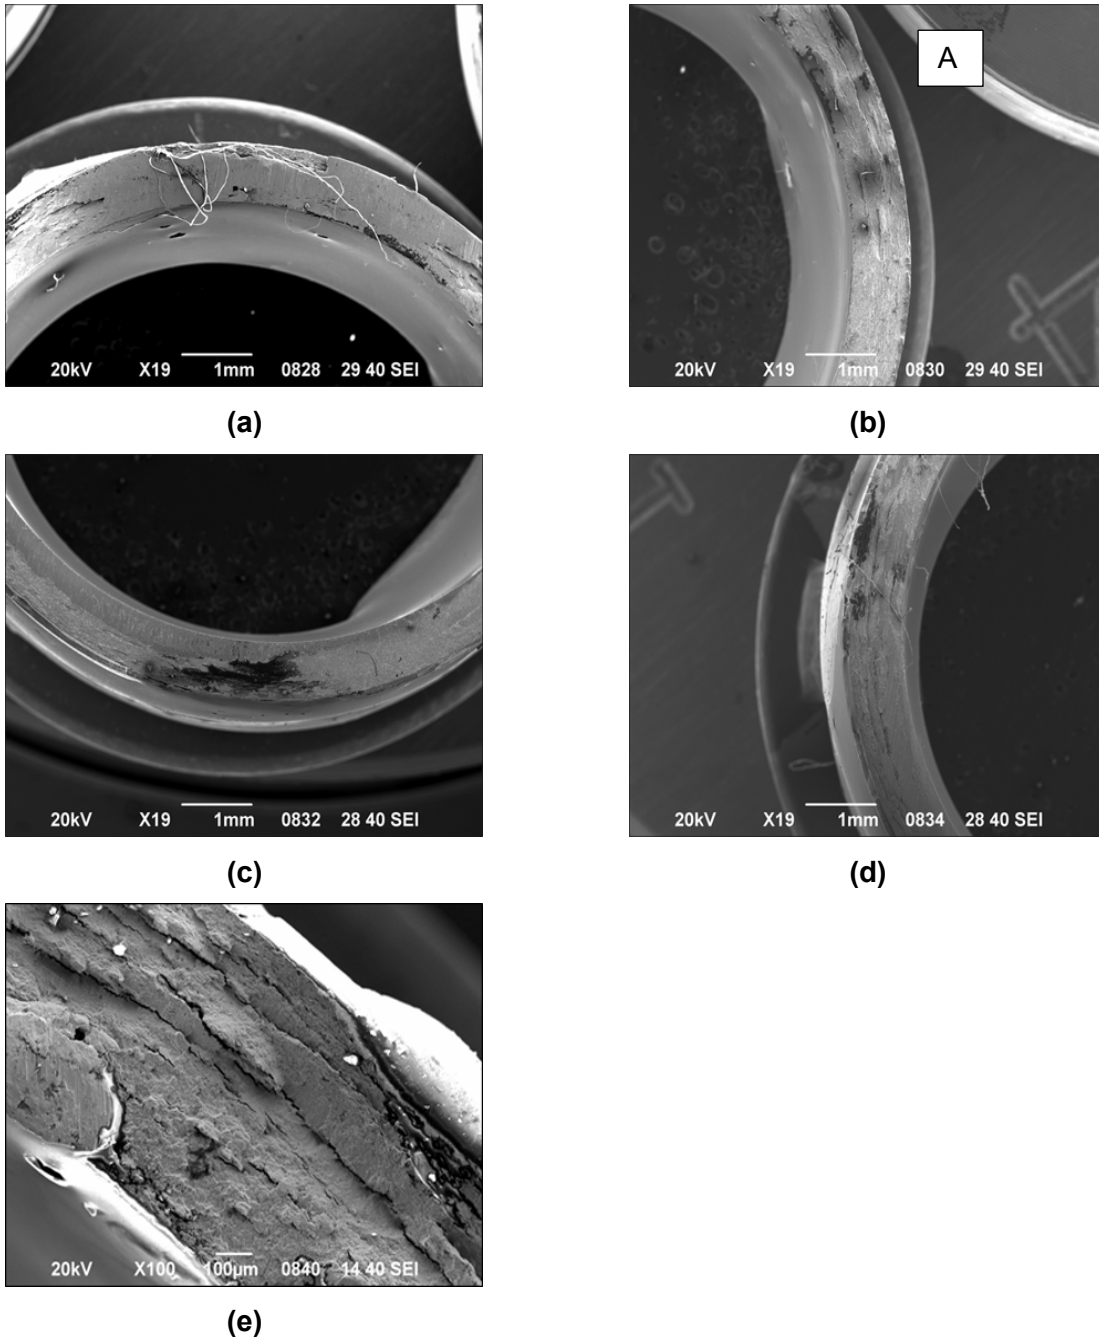
**Figure F.5 SEM images of clad cross section based on the defueled D3:
(a) 12 o'clock (reference mark), (b) 3 o'clock, (c) 6 o'clock, (d) 9 o'clock, and
(e) enlarged area (labeled A)**

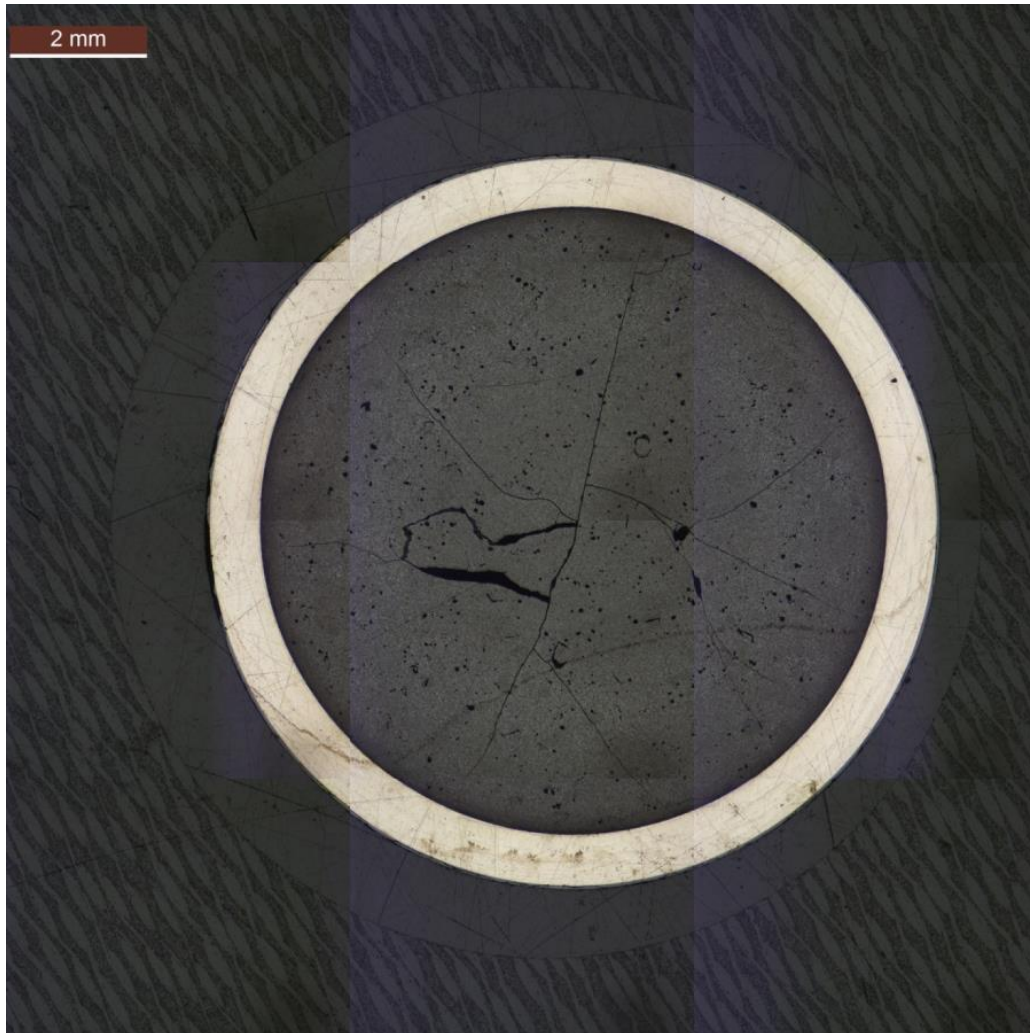
Figure H.1 HBU HBR fuel morphology for Sample 607D4A.

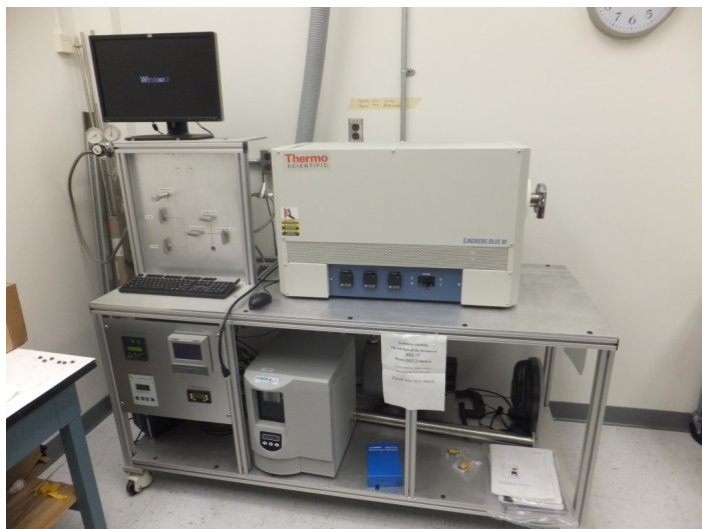
Figure H.2 Hydrogen charging apparatus

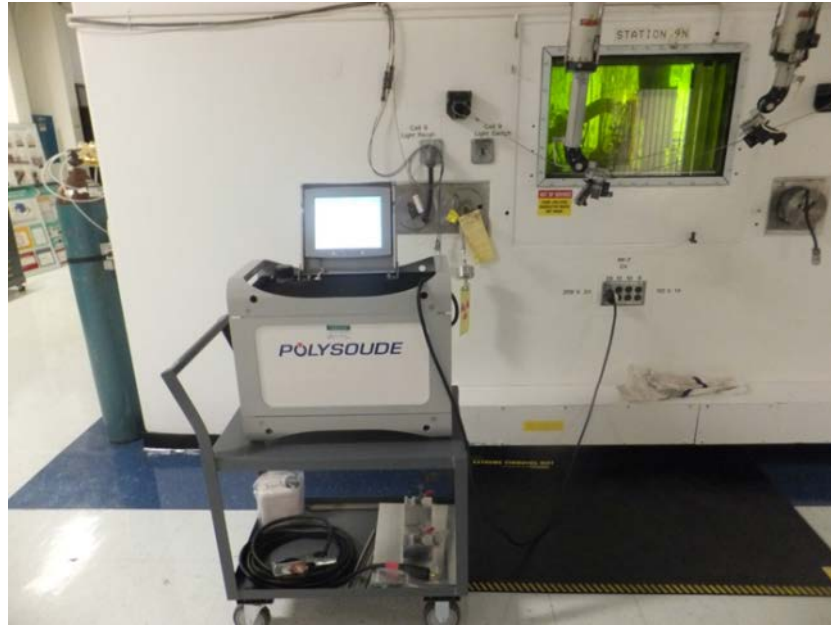
An Astro Arc Polysoude welder (see Figure H.4) was used for automatic orbital welding of the cladding. A circular movement of the welding torch/electrode around fuel cladding, controlled by the welder power source, creates an orbital weld. This welder can be operated remotely with manipulators in a hot cell.

Figure H.4 An Astro Arc Polysoude tubing welder

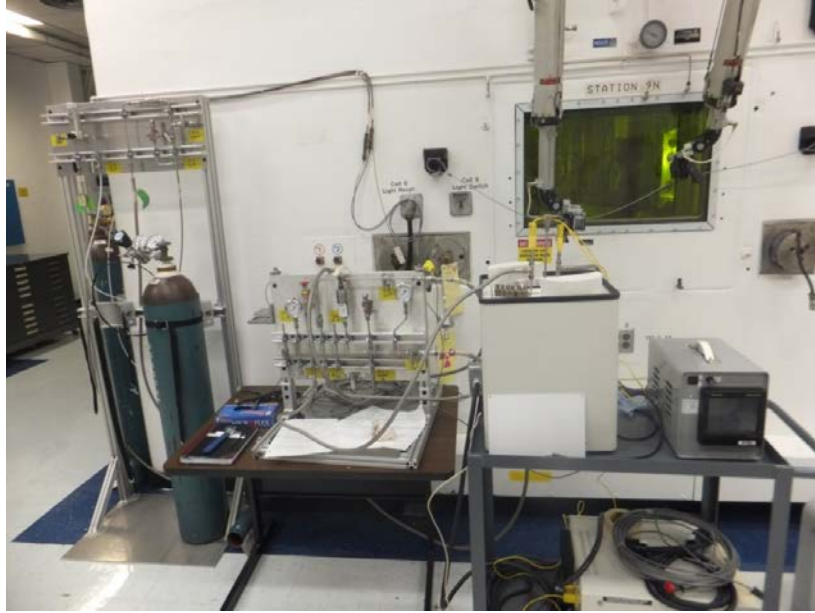
(a)

The reorientation system consists of a high pressure piping system and test chamber within a programmable crucible furnace (see Figure H.5). The system was installed into the hot cell in FY16. Calibrations and benchmark tests were performed with unirradiated materials. For each experiment, a specimen 6 inches in length was welded with two end plugs, with one end sealed and the other end connected to the high-pressure piping system within the test chamber. The test chamber was purged with pure argon gas to remove air and moisture contents, and then the sample was internally pressurized to cause a hoop stress ranging from 0–150 MPa [5]. Pressurized samples were subjected to a preprogrammed temperature profile for up to five cycles, with each cycle being heated to 400 °C, held for 2 hours, and slow-cooled/heated (1 °C/min) to 170 °C; the final cycle cooled from 170 °C to room temperature (RT). Hoop stress was calculated using values $r = 4.62$ mm for inner radius and $t = 0.76$ mm for the wall thickness of the HBR Zircaloy-4 cladding.

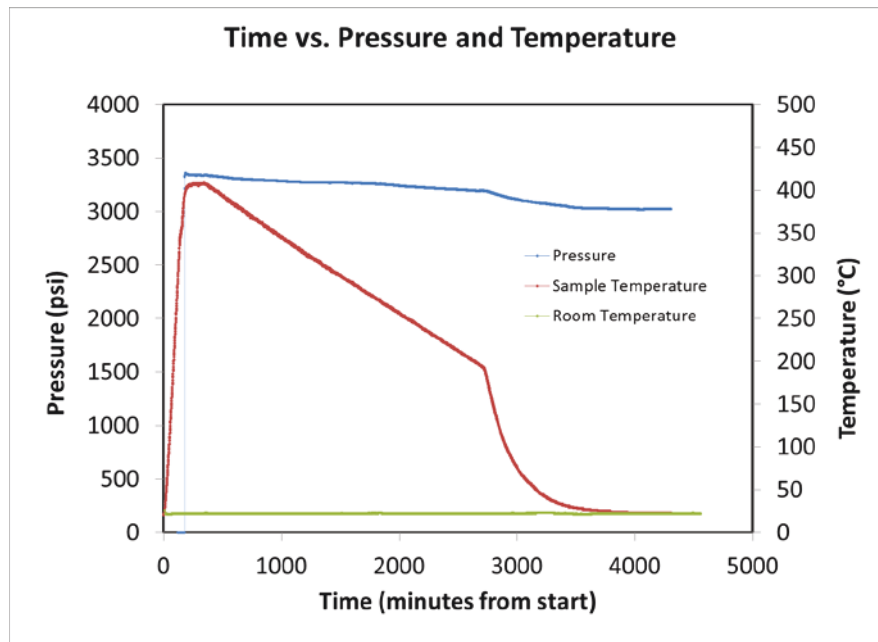
Figure H.7 Pressure and sample temperature as a function of time for Test HR-HBR#1

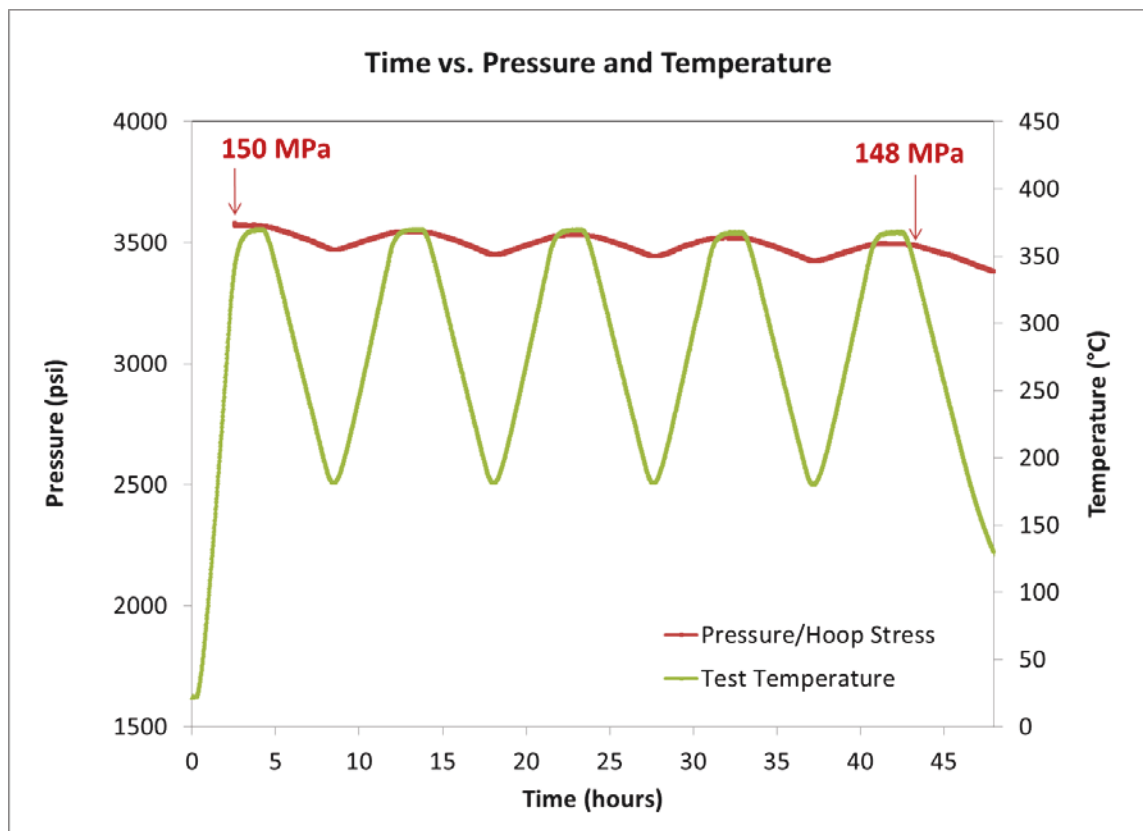
Figure H.10 Pressure and sample temperature as a function of time for Test HR-HBR#2

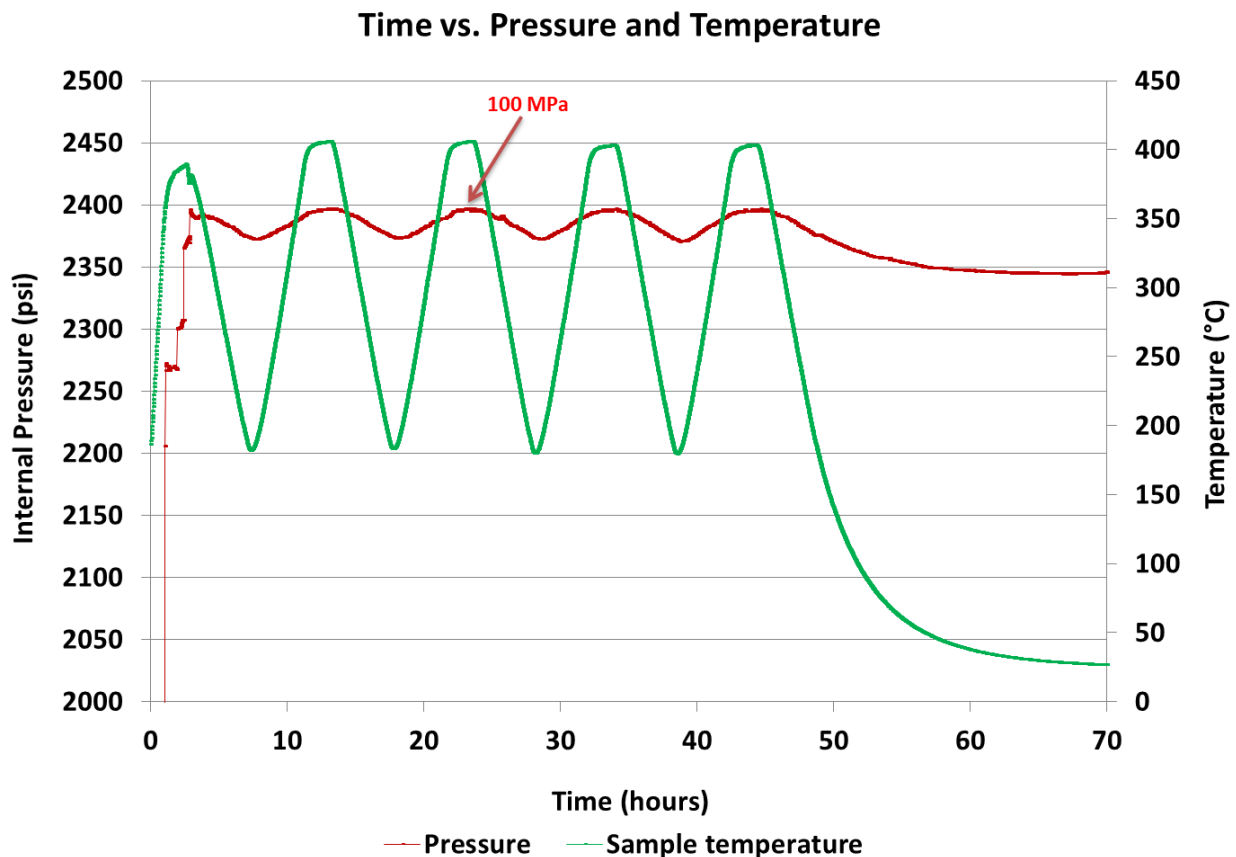
Figure H.13 Pressure and sample temperature as a function of time for Test HR-HBR#3

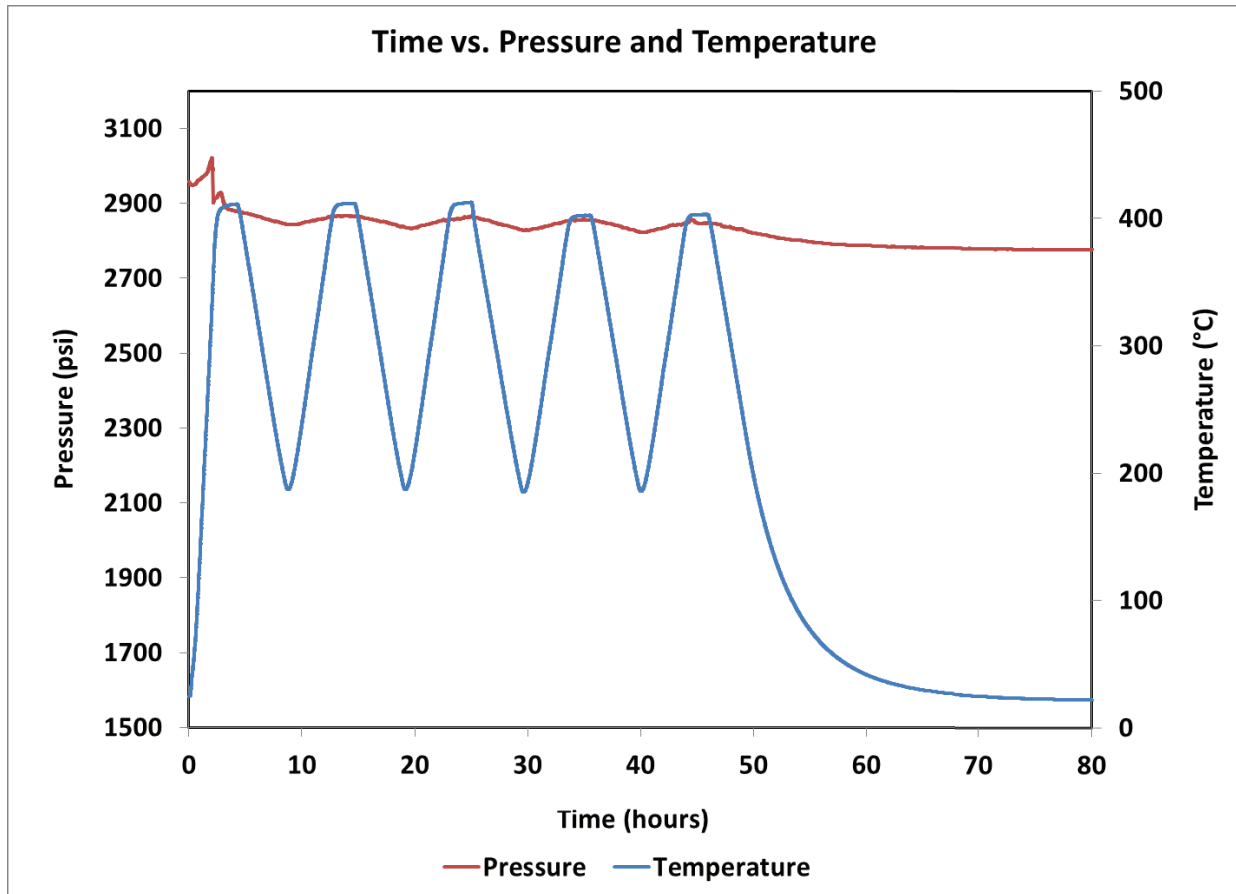
Figure H.16 Pressure and sample temperature as a function of time for Test HR-HBR#4

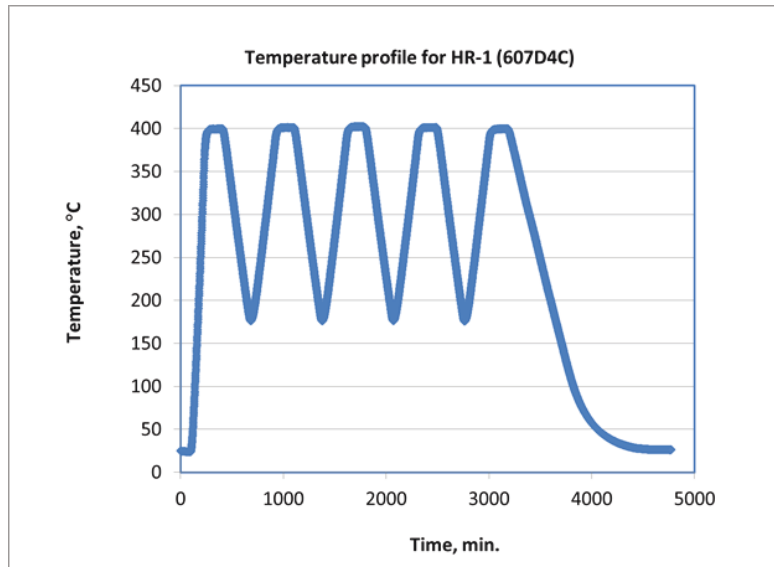
Figure H.19 Sample temperature as a function of time for in-cell HR test HR-1.
