International Agreement Report

Nuclear Regulatory Authority Experimental Program to Characterize and Understand High Energy Arcing Fault (HEAF) Phenomena

Basic Arc Test Experimental Data

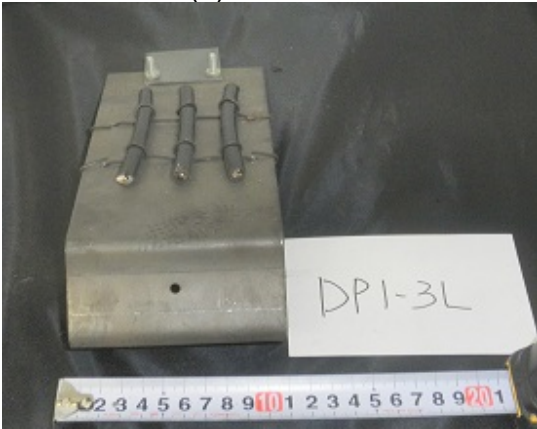
(a) 1 – None

Identifier	Damage Description	Types of Damage
1	None	No damage; cable and plastic the same as installed and can be reused. Usually low temperatures. May look slightly brown from minor copper minor deposition. No smoke soot. May be reused.
2	Sooted	No damage to cable or plastic. Soot from smoke from other combustibles or copper covers the cable. The cable jacket color is dull and the letters on the cable are hard to see.
3	Minor damage	Light charring or discoloration of the target and cables, minor charring.
4	Medium damage	Charring of cables; plastic bent slightly.
5	Heavy damage	Deep charring of cable. Cables may be missing; plastic samples may be missing. This usually occurs for targets within 50 to 100 cm of arc. Plastic is bent over metal target mount. Orange steel after cool down indicates high heat.
6	Destroyed	Cable or plastic samples are no longer attached. This usually occurs for targets within 40 cm of the arcs, on long duration arcs. Bright orange steel indicates very high heat.

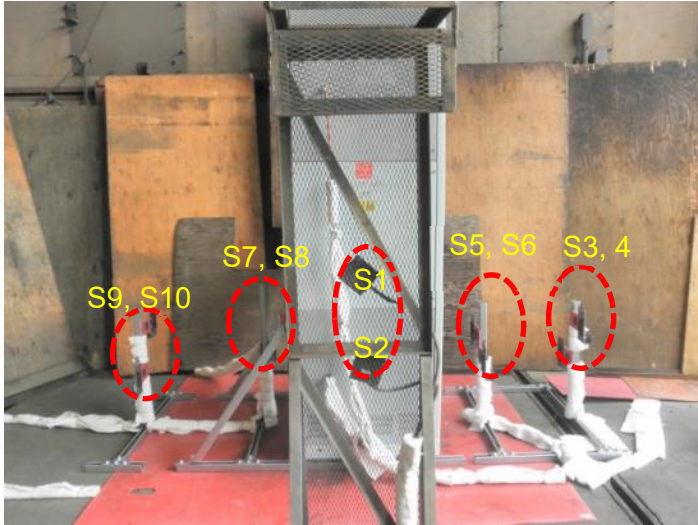
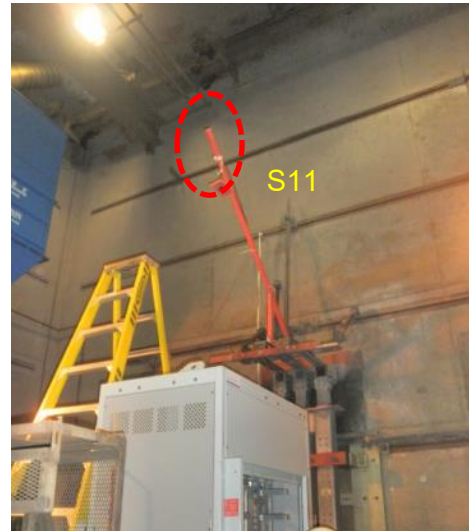
Figure 2.6-1 DP Calorimeter and External Target Locations

The external targets are co-located with the slug calorimeters. External targets are placed with calorimeters S3 through S10, and are numbered to match the slug number, e.g., the PVC target located with S3 is named “E3”. Targets are mounted at different angles, but all face directly toward the center of the arcs. Temperature measurements on the target surfaces are taken with temperature labels (see Appendix A.3 for details). For confirmation of readings on the labels, TC are also placed on targets E7 through E10. Figure 2.6-1, Table 2-2 and Table 2-3 show the external slug calorimeter locations at nominal positions. Note the slightly different slug locations for DP Test 9 and therefore different external target locations.

(a) Side view, external slugs (S3 to S10)

(b) Top slug (S11)

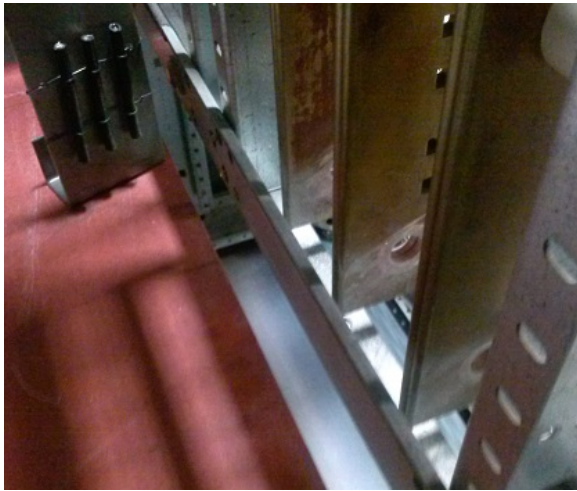
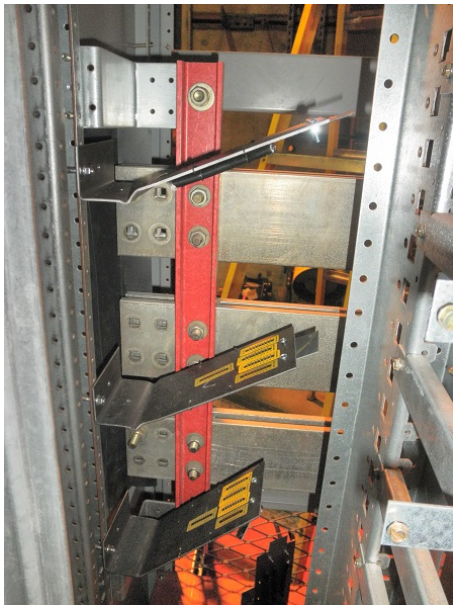
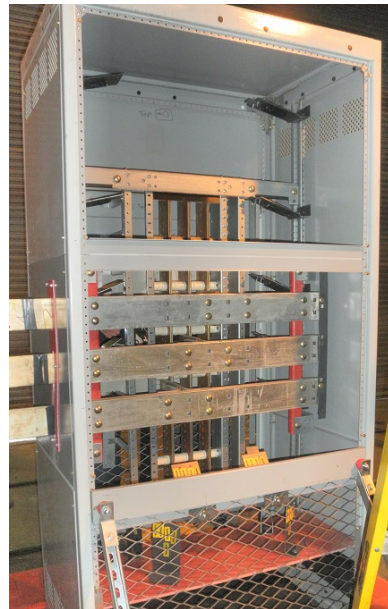
Figure 2.6-2 DP Target Interior Locations

Targets were placed inside the cabinets in view of the arc to capture the maximum radiative heat flux. The targets closer to the arc do not block the view of the targets further from the arc. Targets are at different angles to face directly toward the center of the arcs. However, there are internal bus bars and other obstructions that partially block the view directly to the arc. In these cases, the targets view the plasma around the arc, which also results in high radiative heat transfer. The locations for the internal targets are shown in Table 2-4 and Figure 2.6-2.

(b) Target T1L

(c) Targets T4L, T5L and T6L (from rear)

(d) All targets
Targets T7 and T8 at the top, from rear

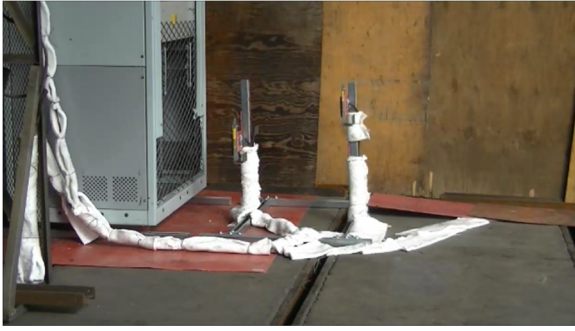
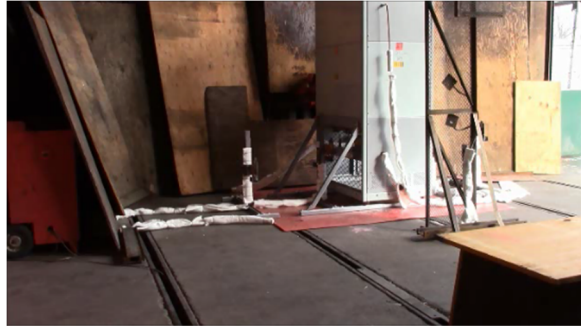
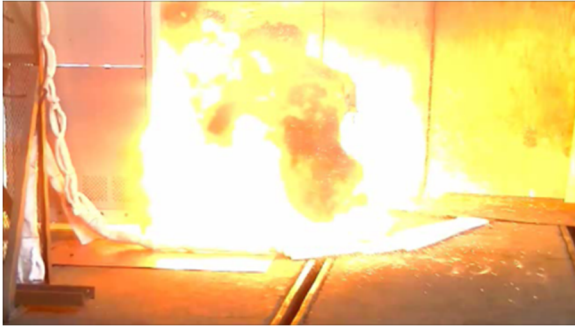
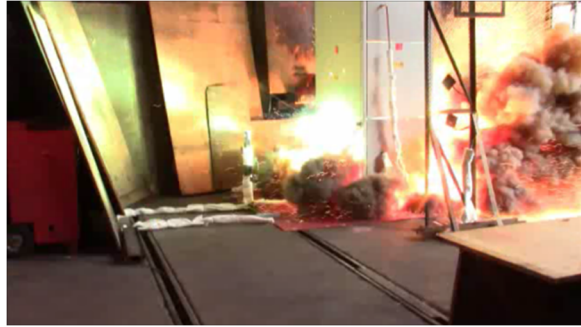
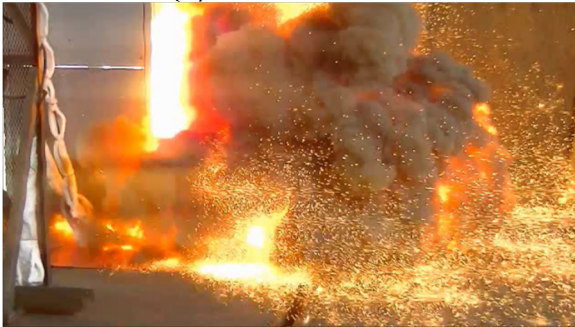
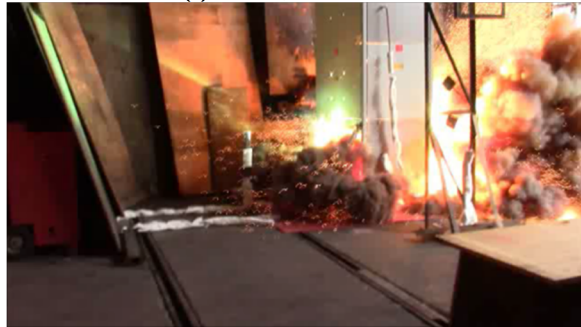
Figure 2.8-3 DP Test 7 Flames during Arc

Photos from the HD cameras, Figure 2.8-3 and Figure 2.8-4, inside the test cell can be used to determine the distance the flames traveled, and if the flames made contact with the slugs during the tests. Note the flames extended out of the front and rear cabinet openings past the postulated NUREG 6850 ZOI of 0.91m. See Section 4.1.

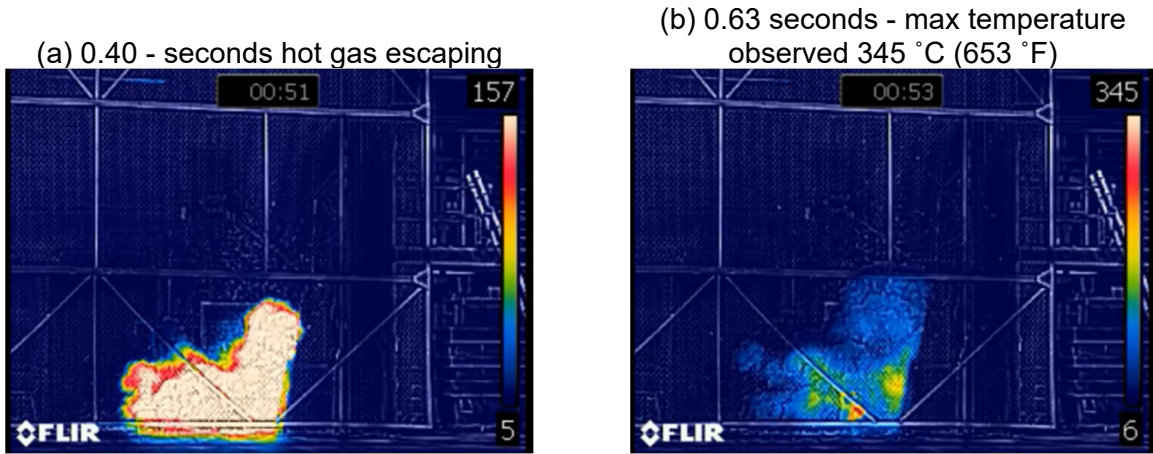
Figure 2.8-5 and Figure 2.8-6 show IR camera images. The IR camera was on auto-scale and indicated low maximum temperatures. Past tests showed that arcs typically result in temperatures greater than 650 °C (1202 °F), however, in these tests, the temperatures did not exceed 345 °C (653 °F).

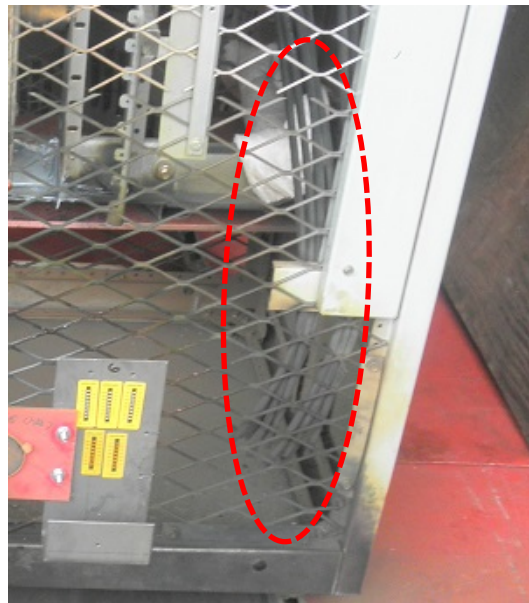
Figure 2.8-8 DP Test 7 Interior Cable Bundle Damage

Interior cable damage is shown in Figure 2.8-8. The damage was “minor” within about 15 cm of the ends near the arc. Soot deposits from the copper vaporization were seen higher up the cables. Resistance measurements after the tests showed that none of the CV-2 cables failed by conductor-to-conductor shorting. Additional discussion is in Section 4.2.

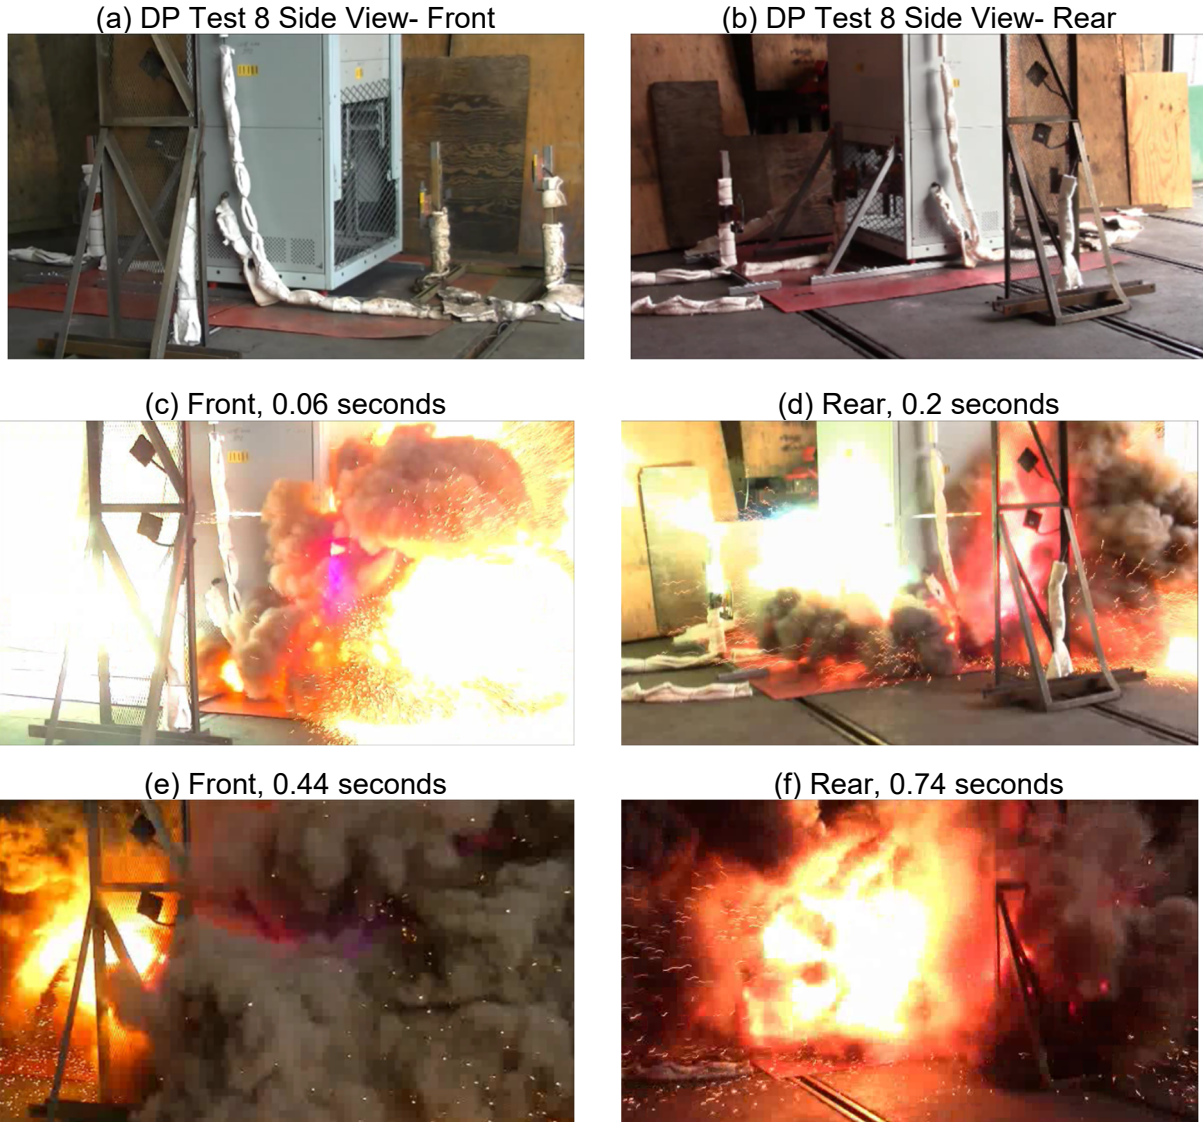
Figure 2.9-2 DP Test 8 Flames during the Arc

Photos from HD cameras inside the test cell, seen in Figure 2.9-2, indicate the distance the flames traveled, and if the flames made contact with the slugs during the tests. Note the flames during the arc reached past the instrumentation stands, which are 0.91 m in front of and rear of cabinet openings. Flame contact with front S3 through S6 are shown in Figure 2.9-2(c). Flames contacting with S7 through S10 are shown in Figure 2.9-2(d), (e), and (f).

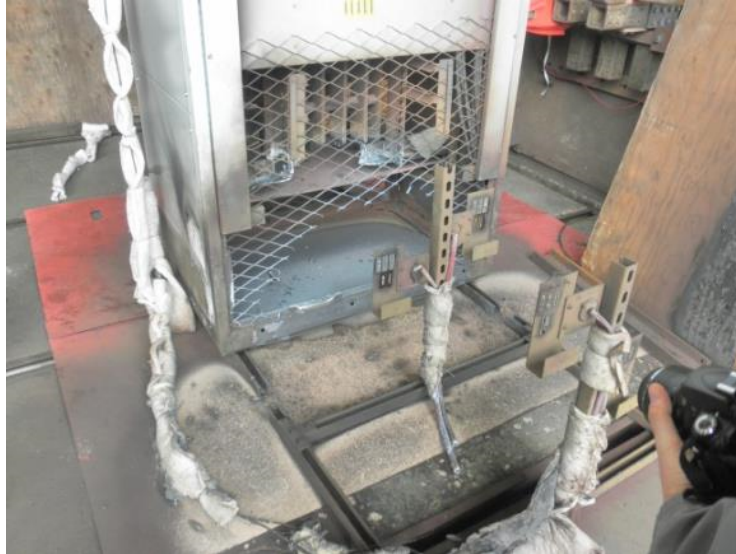
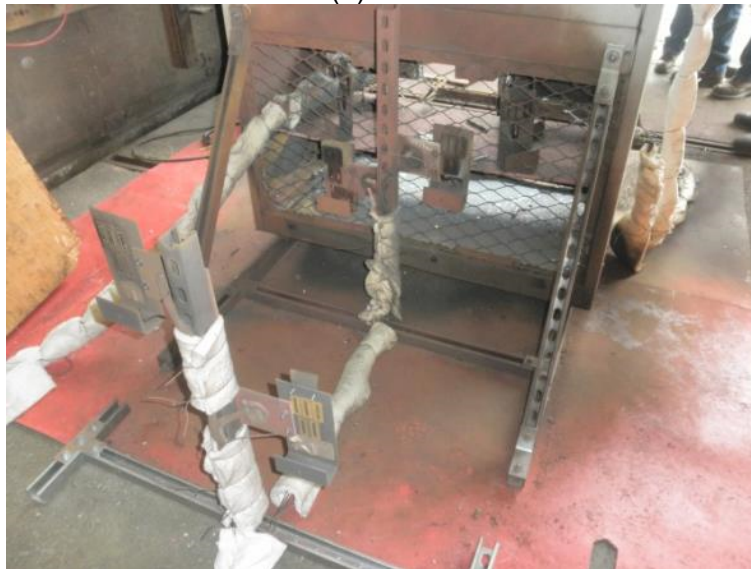
Figure 2.9-4 DP Test 8 Exterior Damage

The exterior damage to the cabinet is shown in Figure 2.9-4. The flames burned through the front screens (closest to the arc). There was charring on the cabinet around the openings and soot deposited above the openings. There were no holes burned in the cabinet.

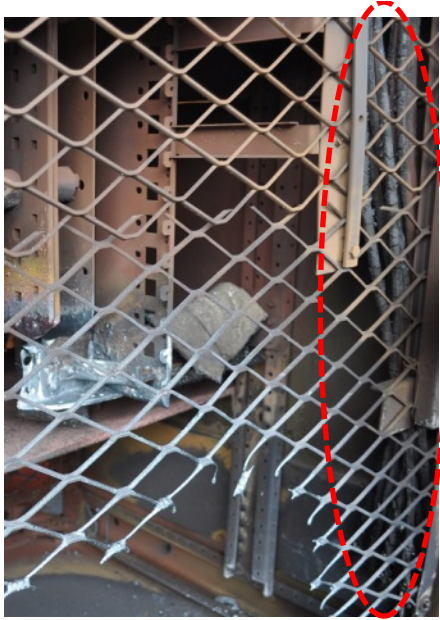
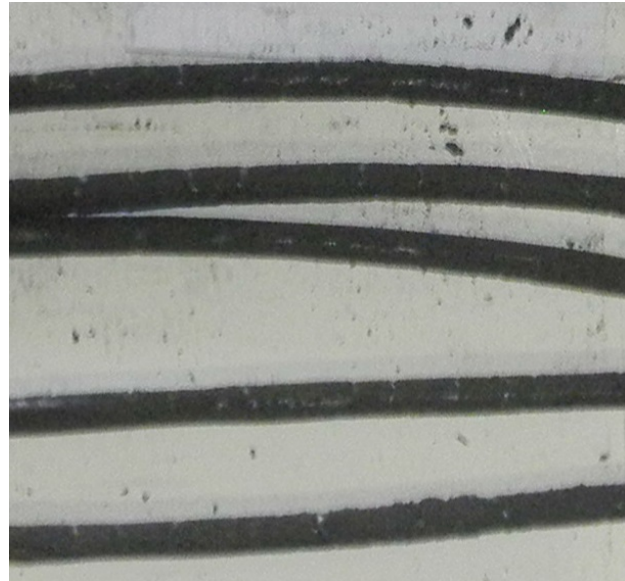
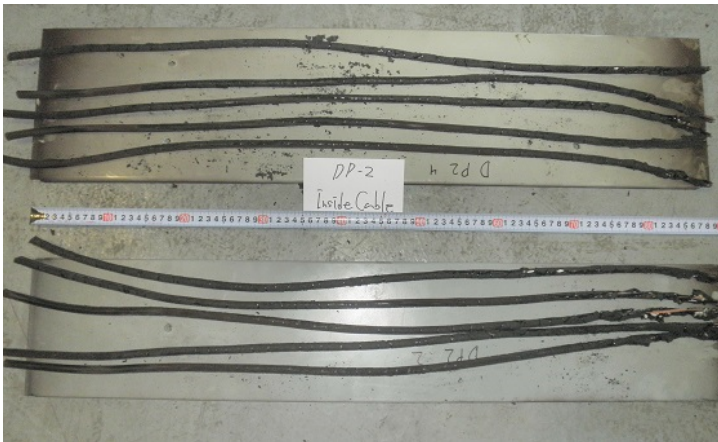
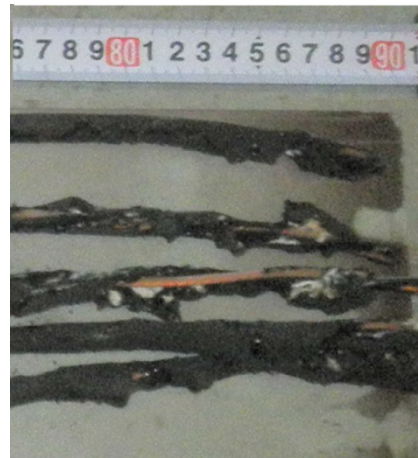
Figure 2.9-5 DP Test 8 Interior Cable Damage

The damage to the cables is shown in Figure 2.9-5. The 15 cm of the cables near the arc is characterized as “destroyed.” The remaining cable section is characterized as, “medium.” Post-test resistance measurements were not made because the cable was assumed to be failed by conductor-to-conductor shorting at the ends. Additional discussion is in Section 4.2.

(a) In-situ damage

(b) Detail above end: “medium” damage

(c) 15-20 cm near the ends: “destroyed”

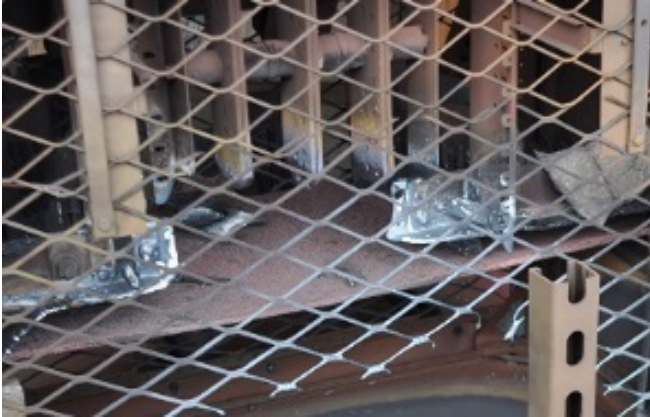
(a) Front View

The damage to the vertical bus bars is shown in Figure 2.9-6. About 7 to 10 cm of copper bus bar were burned and the steel angle bracket was burned. The mass loss of the copper bus bars was 2.668 kg. The mass loss calculations are detailed in Appendix G.

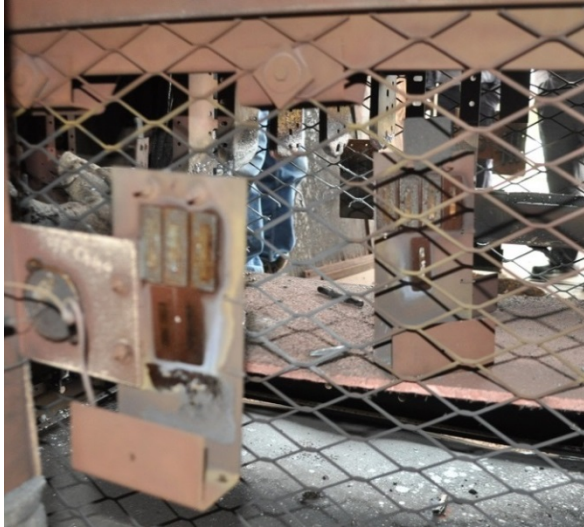
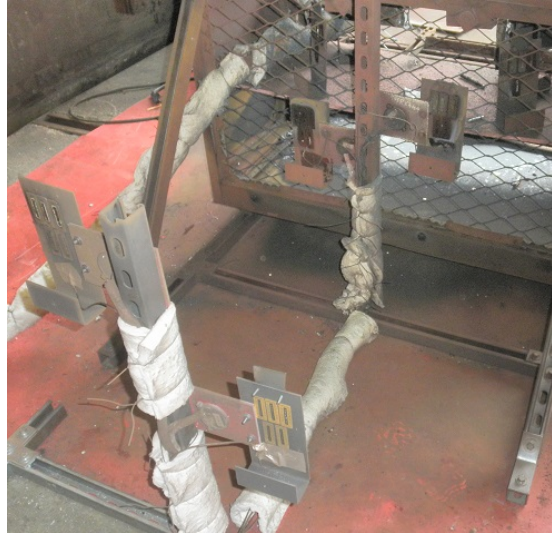
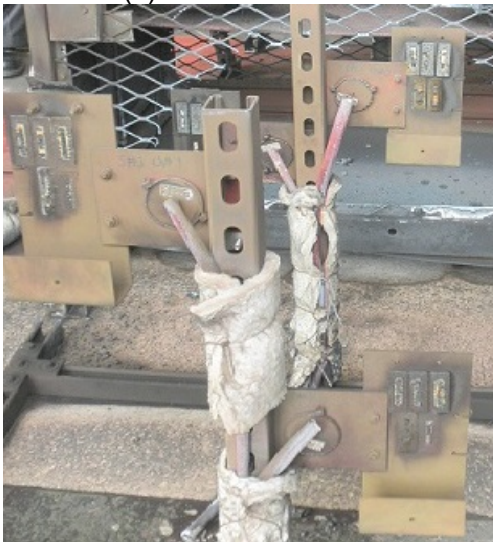
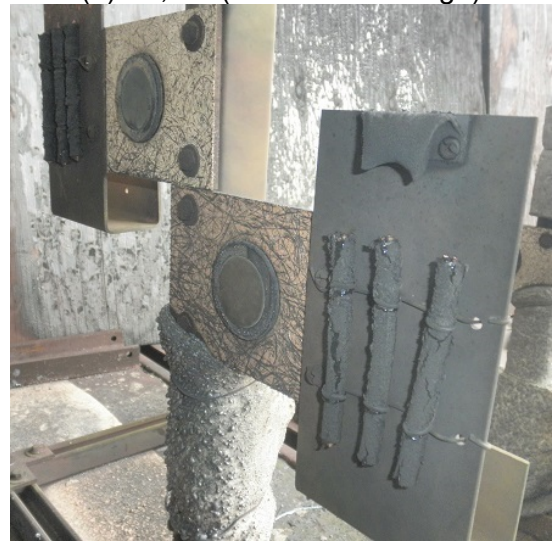
Figure 2.9-7 DP Test 8 Target Damage and Target Numbers

- Gray heavy metal coating on T1 and T2 that is the steel bar where the arc attached.
- External metal coating out to E8 (62 cm), heavy metal coating internally out to 48 cm at arc level.

(a) Target T1, T2, and E8 from rear

(b) E7-E10 From Rear

(c) E3-E6 from front

(d) E5, E6 (Maximum damage)

The results are shown in Figure 2.9-7 and Table 2-10. See Figure 2.6-4 for target locations. Detailed photographs of the target damage are in Appendix F.

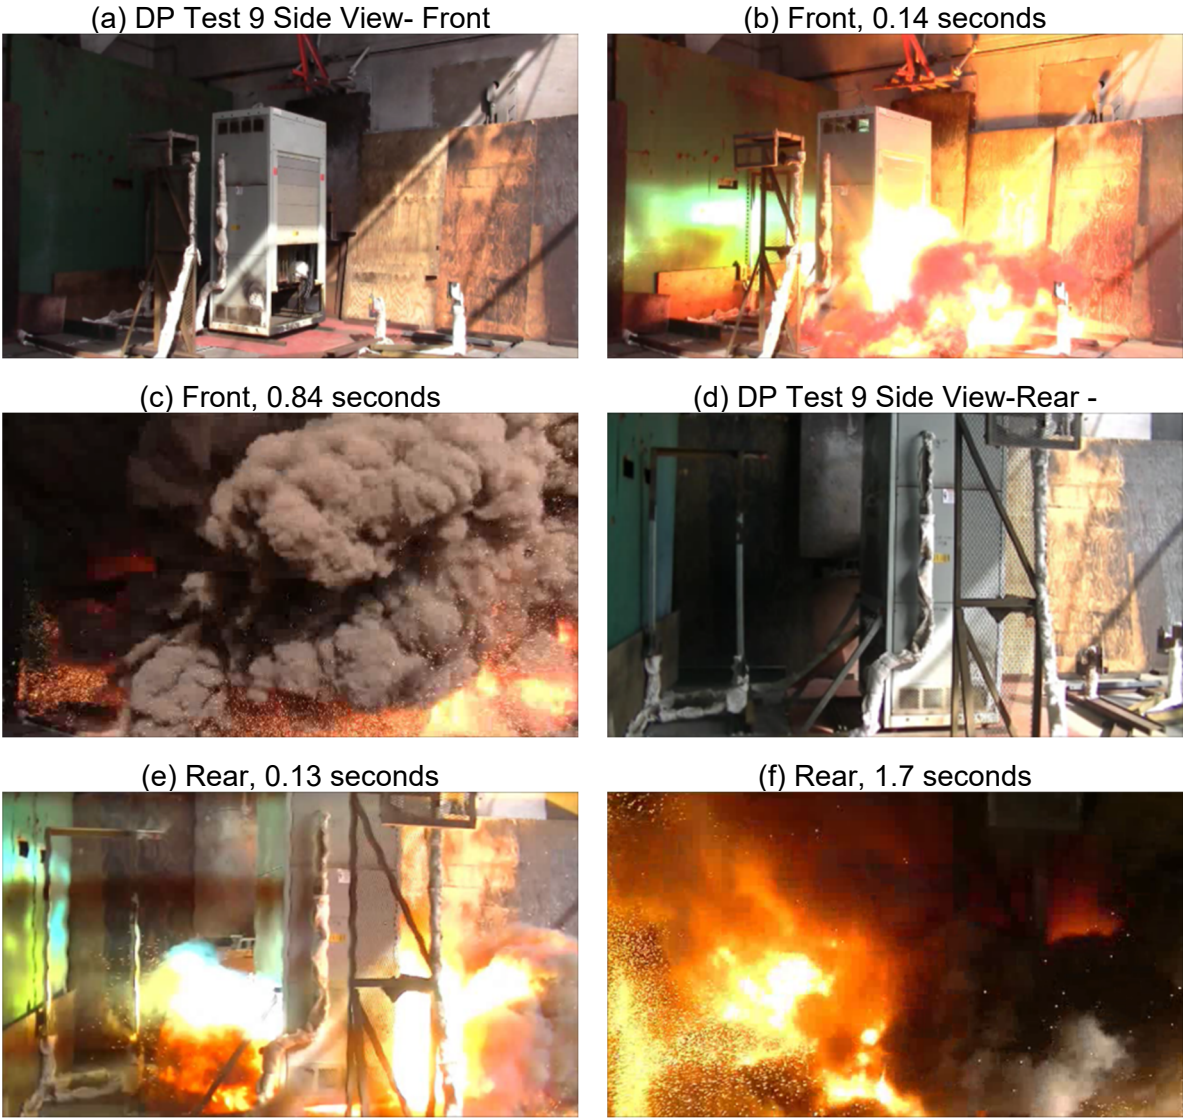
Figure 2.11-2 DP Test 9 Flames During Arc

Photos from HD cameras inside the test cell, seen in Figure 2.11-2, indicate the distance the flames traveled and if the flames made contact with the slugs during the tests. Note the flames during the arc reached past the instrumentation stands, which are located 0.91 m in front of and rear of cabinet openings. See Section 4.1 for more discussion. Flames made contacted with S3 through S10.

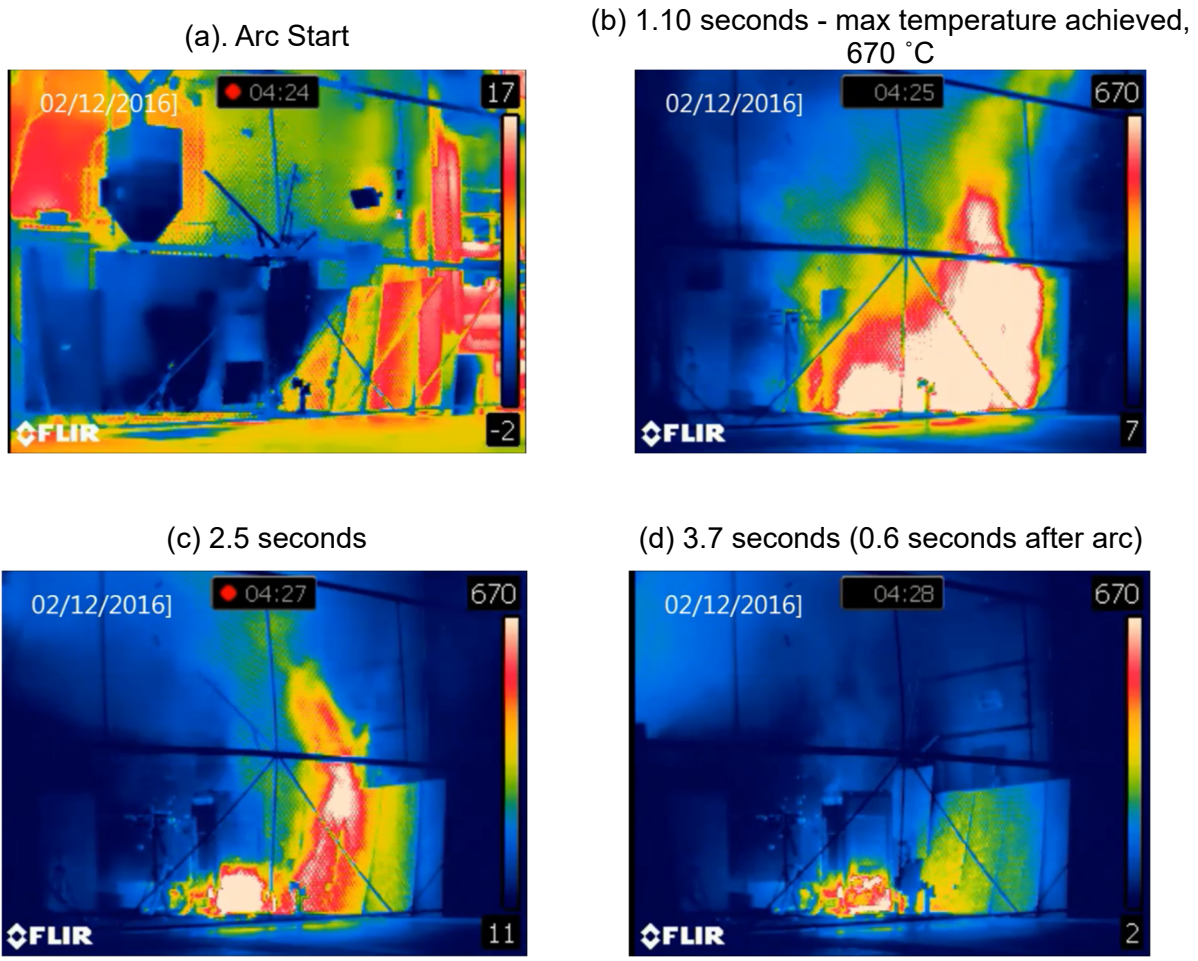
Figure 2.11-3 DP Test 9 Thermal Images

Images from the IR camera are shown in Figure 2.11-3. The FLIR camera was on auto-scale and the maximum temperature that could be detected (670 °C) was within about 1 second that is typical for previous arc tests.

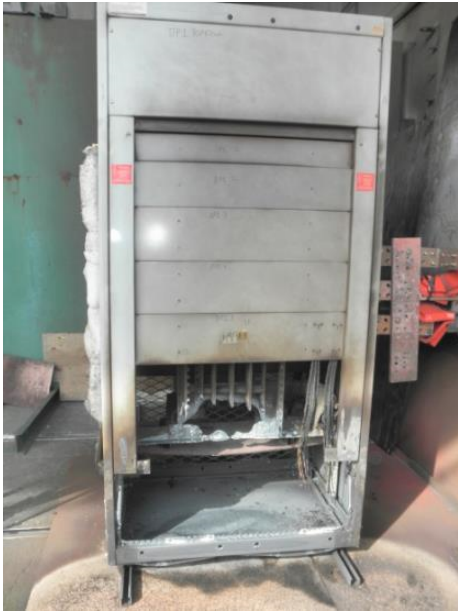
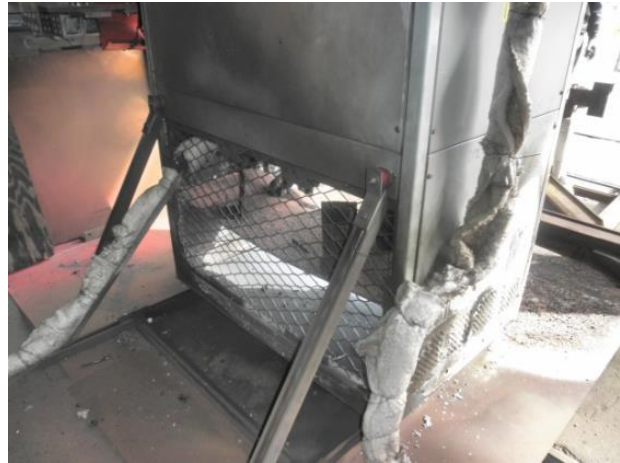
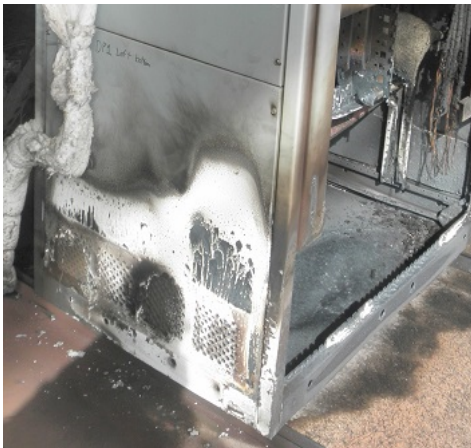
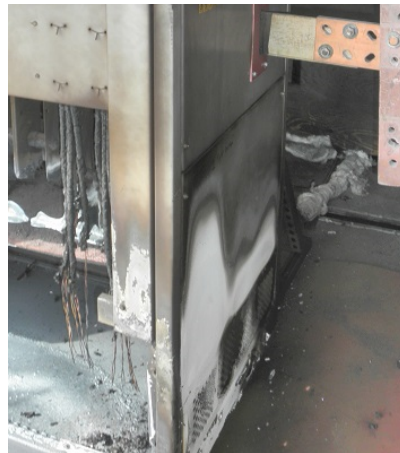
Figure 2.11-4 DP Test 9 Exterior Cabinet Damage

Figure 2.11-4 shows the exterior cabinet damage; unlike previous tests, the test was run without a front screen. There was charring on the cabinet around the openings and soot deposits above the openings. The soot and discoloration were heavy on the rear panel at the location of Target T3R. The lower sides, near the arc, showed discoloration from high temperatures and almost burned through. The panels were deformed, allowing for flames to escape, as shown in Figure 2.11-2(f). The panels were discolored and showed soot deposits on the exterior, as well as metal spatter on the front panel.

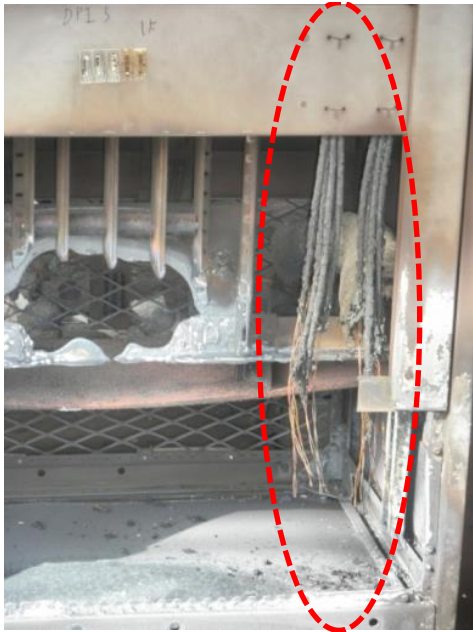
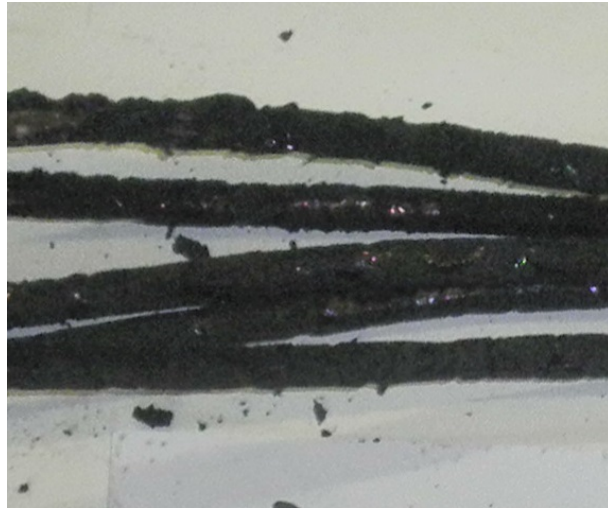
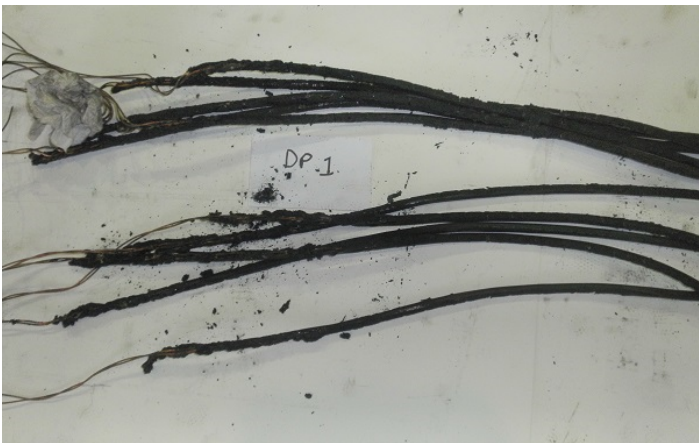
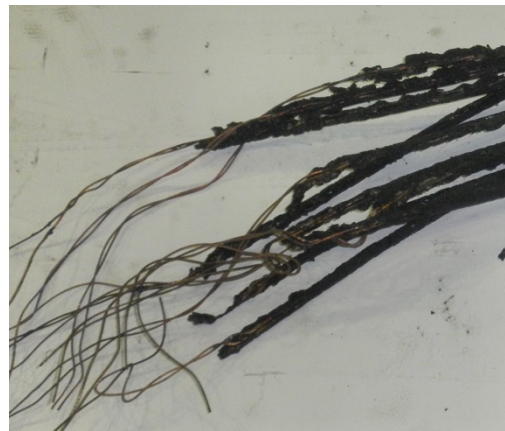
Figure 2.11-5 DP Test 9 Interior Cable Damage

The damage to the cables is shown in Figure 2.11-5. The bottom 40 to 50 cm of cable near the arc showed a damage state of “destroyed” and “heavy” higher up based on the damage criteria in Table 1-3 Target Damage Descriptions. The insulation was completely consumed in the destroyed part of the cables. Since no ensuing fire was observed, this damage likely occurred during the arc as the arc flames forcefully impacted the cables and stripped the cables. The upper parts of the cables did not burn, suggesting the open panel allowed the arc heat to escape instead of sustaining a cable fire. Resistance measurements were not made after the test because the cable was assumed to have failed by conductor-to-conductor shorting. Additional discussion is in Section 4.2.

(a) In-situ damage

(b) Detail above ends: "heavy" damage

(c) 40-50 cm of cable, at the ends: "destroyed"

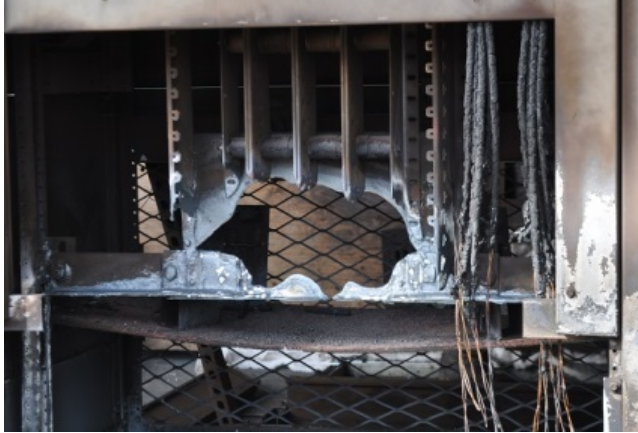
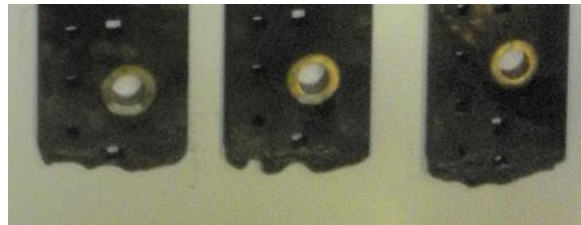
Figure 2.11-6 DP Test 9 Bus Bar Damage

DP Test 9 had more vertical bus bar loss than other DP tests in this series and almost burned to the first large hole for the insulator as shown in Figure 2.11-6(b). The damage to the bus bars and plate are shown in Figure 2.11-6. The ends of the copper bus bar were consumed and the steel plate where the arc connected was nearly consumed. The steel from the plates coated several targets and the Unistrut supporting S5 and S6, in front of the cabinet. The mass loss of the copper bus bars was of 4.74 kg and the lengths changed 13-17 cm. The calculation details of the mass loss are in Appendix G.

(a) Rear View Shows Plate Damage

(b) Bus Bar Ends with Insulator Holes

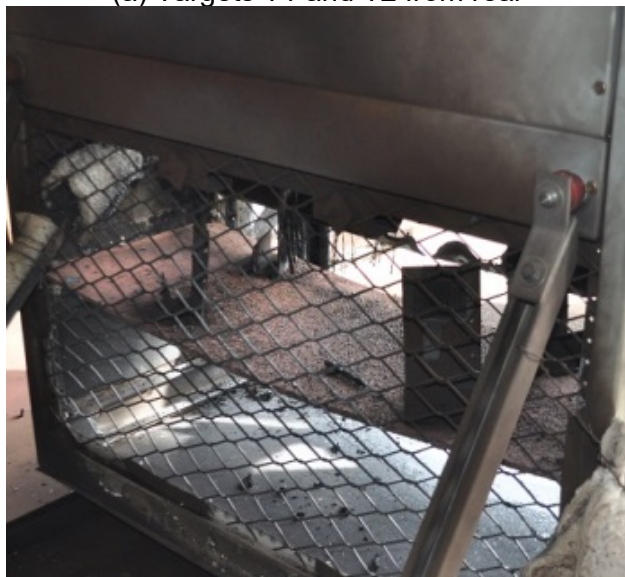
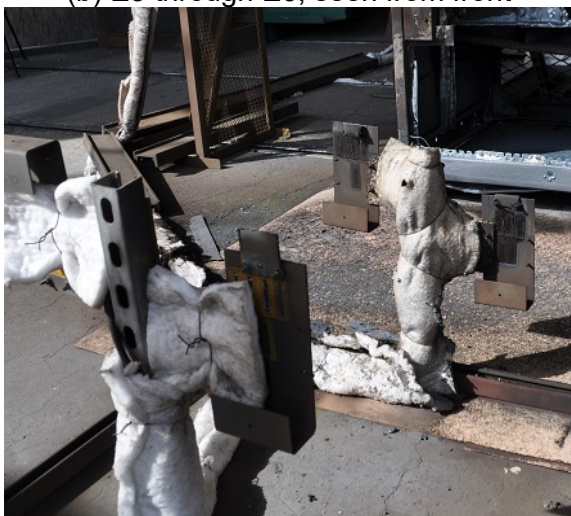
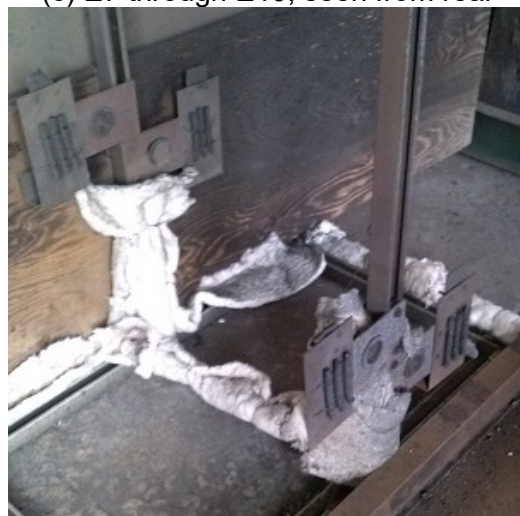
Figure 2.11-7 DP Test 9 Target Damage and Target Numbers

- Internal cable damage up to T6 (96 cm) similar to Test DP-8. Sooting on other internal targets > 96 cm.
- External cable damage at all targets out to E10 (202 cm) but cables except E3 passed resistance tests.
- A cable on Target E3 failed the resistance check and indicated conductor-to-conductor shorting- a failure. This was the only target cable tested that failed. However, E3 is 167 cm from the arc and also showed low temperature on the label.

- Internal medium plastic damage out to T5 (75 cm). More damage than Test DP-8 perhaps from longer arc time and more energy.
- External heavy damage out to E7 (144 cm) so more damage than Test DP-8.

- Metal coating out to E6 (122 cm), Extern E8 (62 cm) also had some coating. Heavy metal coating internally out to 48 cm at arc level.

(a) Targets T1 and T2 from rear

(b) E3 through E6, seen from front

(c) E7 through E10, seen from rear

The results are shown in Figure 2.11-7 and Table 2-11. See Figure 2.6-4 for target locations. Detailed photographs of the target damage are in Appendix F.

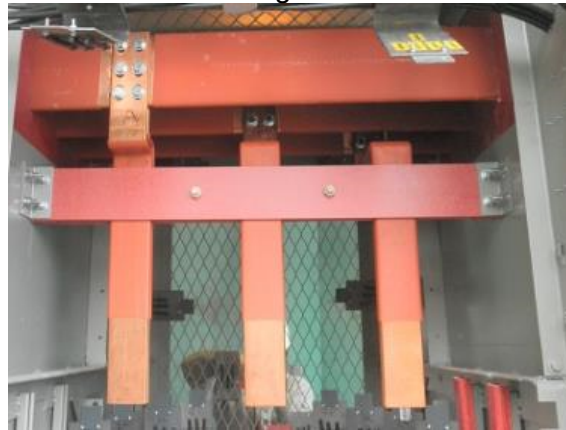
Figure 3.4-2 SWGR Bus Bar and Top Vent Configuration

The SWGR bus bar configuration is shown in Figure 3.4-2. Each phase has two copper bus bars that are called “front” and “rear” and have a 0.375-inch space between them. The phases are A, B and C from left to right. The bus bars are 6.35 mm thick and 76.2 mm wide. Bus bars did not need to be supported by bus bar insulators/bushings. The bus bars have polymer insulation on them but this was removed before weighing after the test. The bus bar weight from the manufacturer was measured before the polymer insulation was installed.

© Looking from front

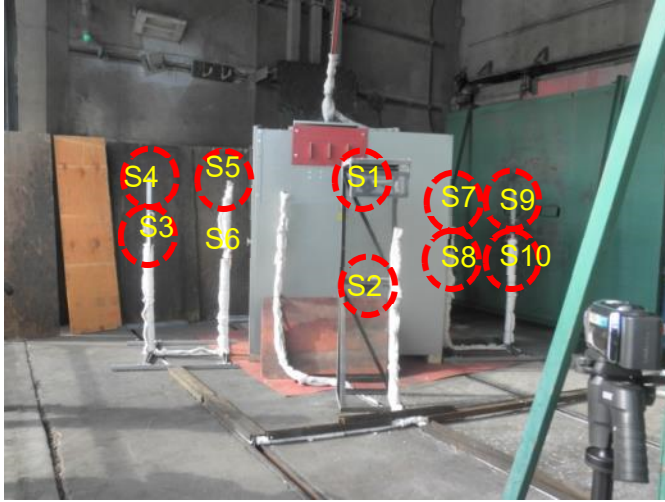
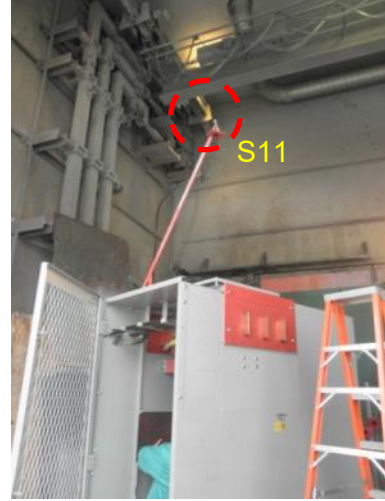
Figure 3.5-2 SWGR Tests 7 through 10 Slug Calorimeter (and External Target) Locations

Figure 3.5-2 shows the slug calorimeter locations at the nominal positions. Slug calorimeters 3 through 6 were moved to the right to provide a view for the HS camera to view the arc. Some adjustments were also made for SWGR Tests 9 and 10.

(a) Right Side Slugs

(b) Top Slug, S11

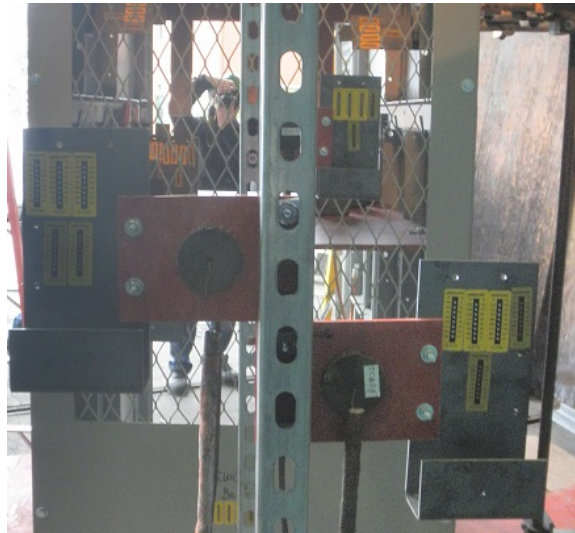
Figure 3.6-1 SWGR Tests Exterior Target Details

The external targets are co-located with the slug calorimeters. External targets, denoted by “E#,” are co-located with calorimeters S3 through S10, and are numbered to match the slug number, e.g., the target located with S3 is named “E3.” Targets are mounted at different angles, but all face directly toward the center of the arcs. Temperature measurements on the target surfaces are taken with temperature labels (see 1.1.1.1.1 Appendix A for details). For confirmation of readings on the labels, thermocouples (TC) are also placed on targets E7 through E10. Figure 3.5-2, Figure 3.6-1, and Table 3-3 show the external slug calorimeter locations at nominal positions. The calorimeter positions in the front and rear of the cabinet also have cable/plastic targets.

(b) E7 through E8 Rear (Looking rear to front)

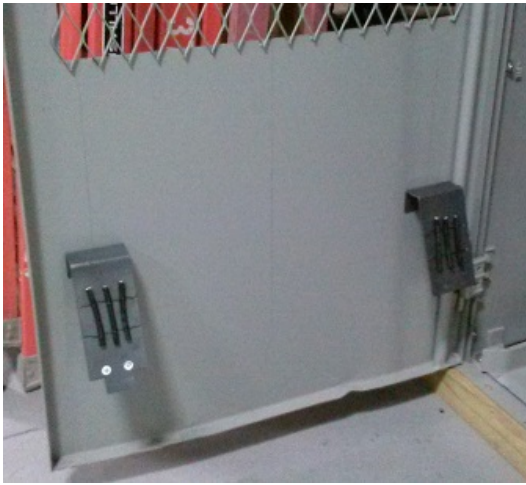
(a) T1 on inside of door

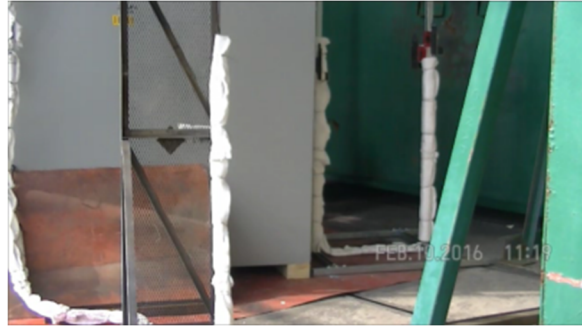
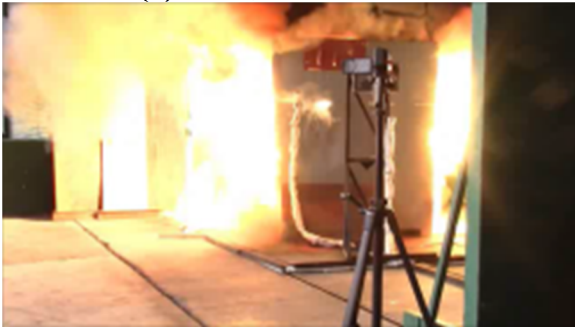
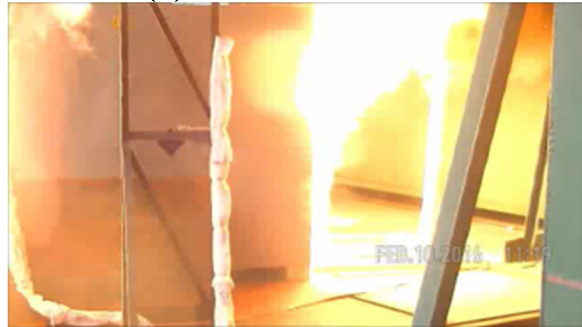
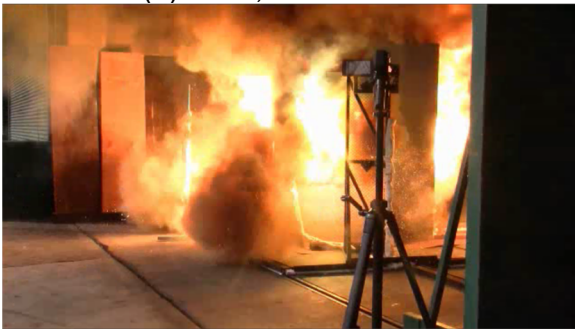
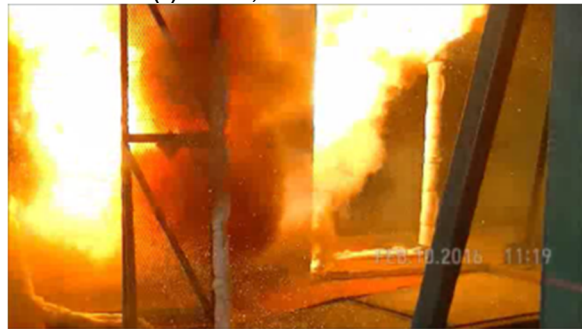
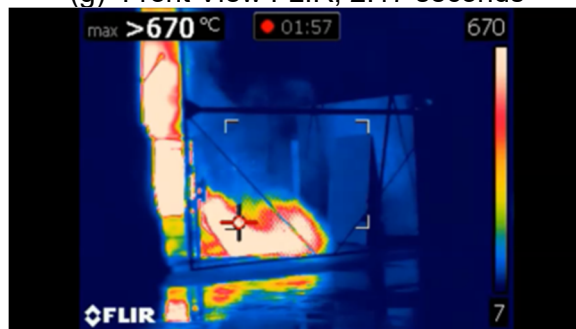
Figure 3.8-2 SWGR Test 7 Flames during Arc

(b) Test 7 Side View- Rear

(c) Front, 0.53 seconds

(d) Rear, 0.40 seconds

(e) Front, 1.14 seconds

(f) Rear, 1.44 seconds

(g) Front View FLIR, 2.17 seconds

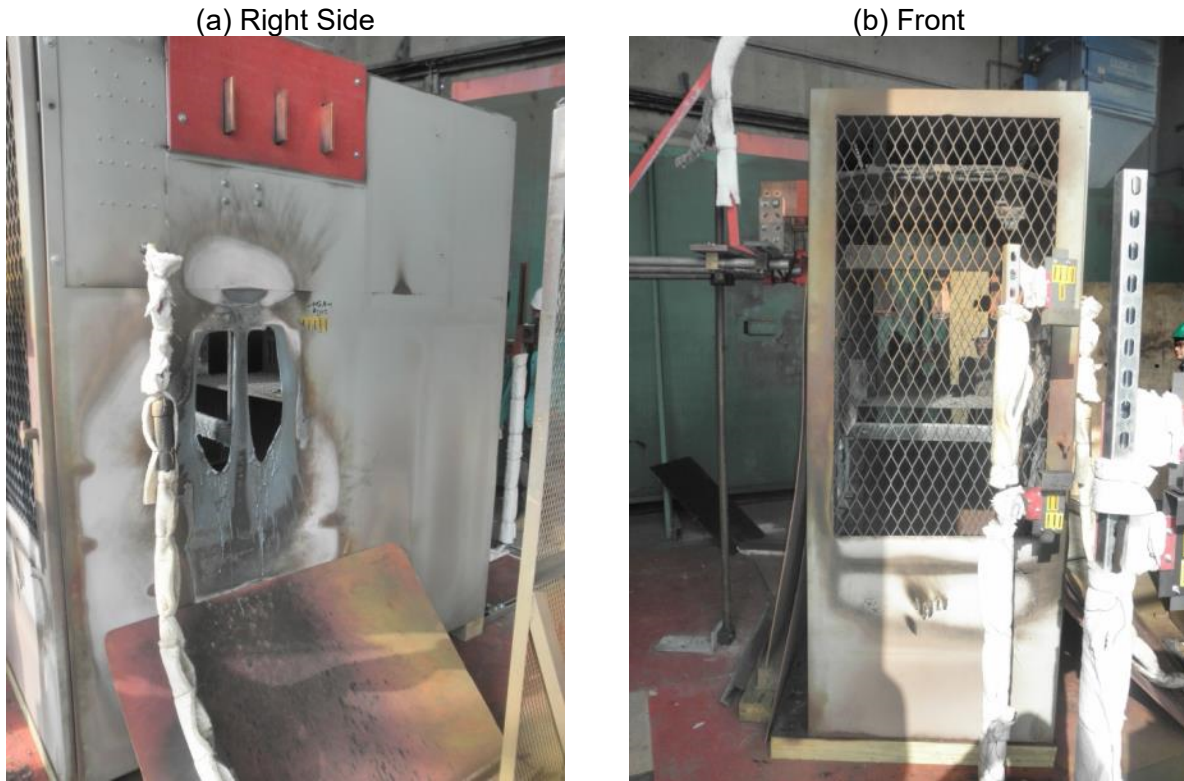
Figure 3.8-4 SWGR Test 7 Exterior Damage

Figure 3.8-4 shows the exterior cabinet damage. The arc attached to the cabinet panels, creating holes through the exterior panels as it burned through as shown in Figure 3.8-4(a). Charring of the panels was also seen on the exterior of the cabinet in many areas, such as the bottom panel of the front door as shown in Figure 3.8-4(b). Soot deposited on the external surfaces where smoke leaked through cracks and openings. The screens on the front and rear did not melt or fail from the flames passing through them.

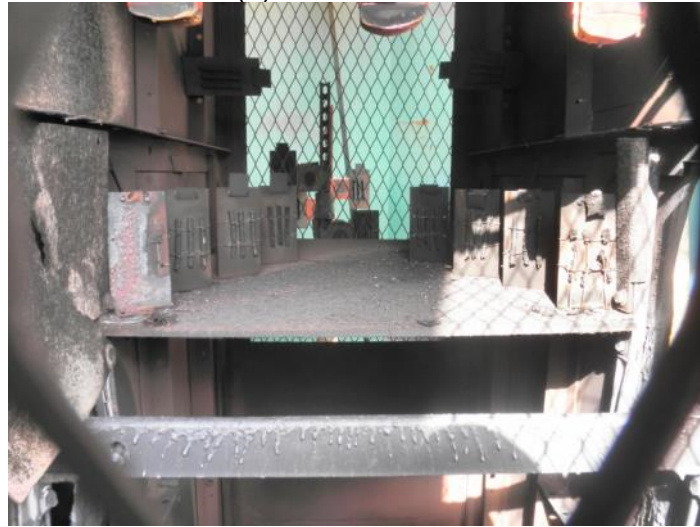
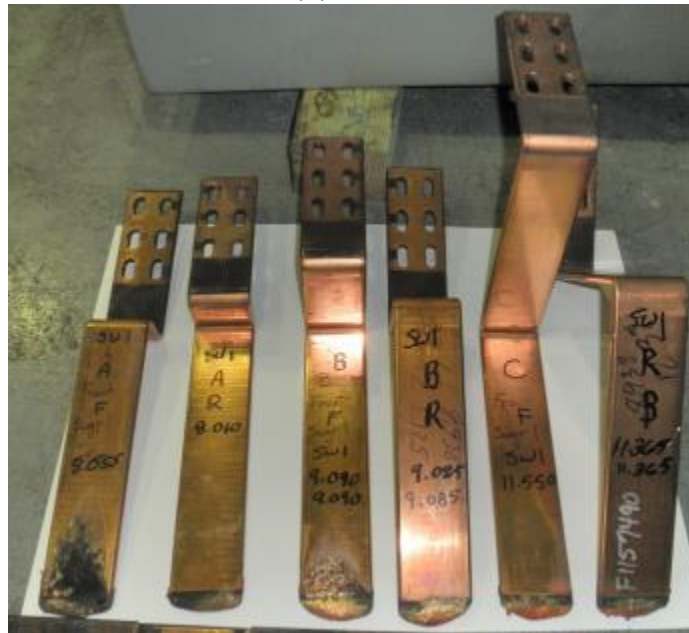
As observed in previous tests, the bus bars do not burn evenly and Phase A has slightly more mass loss than Phases B and C. The ground bar loss is about 11% of the total copper bus bar loss. Ground bus bar losses were more than 20% in the other SWGR tests in this report and this probably indicates that the arc was attaching to the cabinet more in this test than other tests and less energy was applied to the ground bar.

(a) View from Front

(b) Bus Bars
