International Agreement Report

Nuclear Regulatory Authority Experimental Program to Characterize and Understand High Energy Arcing Fault (HEAF) Phenomena

Basic Arc Test Experimental Data

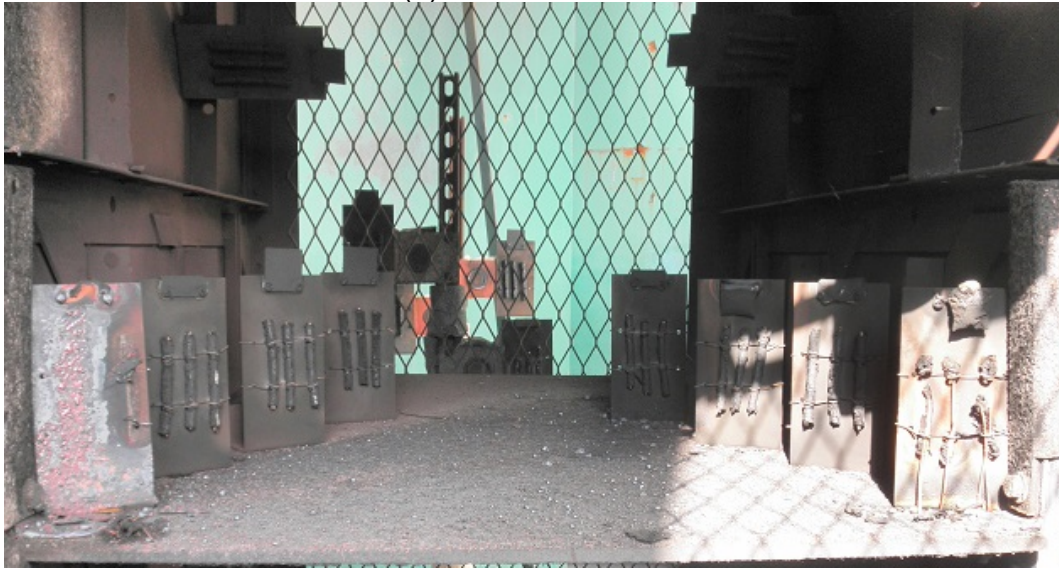
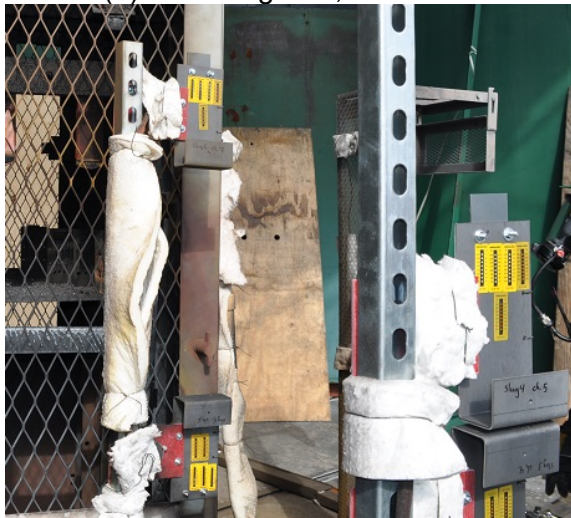
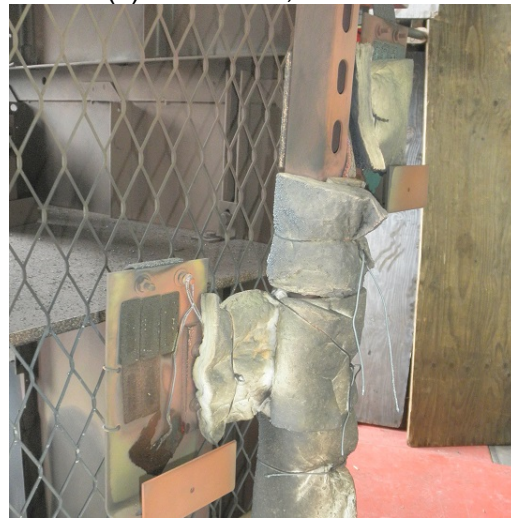
Figure 3.8-7 SWGR Test 7 Target Damage

- There was metal coating on T3L (48 cm) in contact with the plasma similar to metal coating in the DP tests but not as severe.

(a) T3-T7 from Front

(b) E3 through E6, from front

(c) E7 and E8, from rear

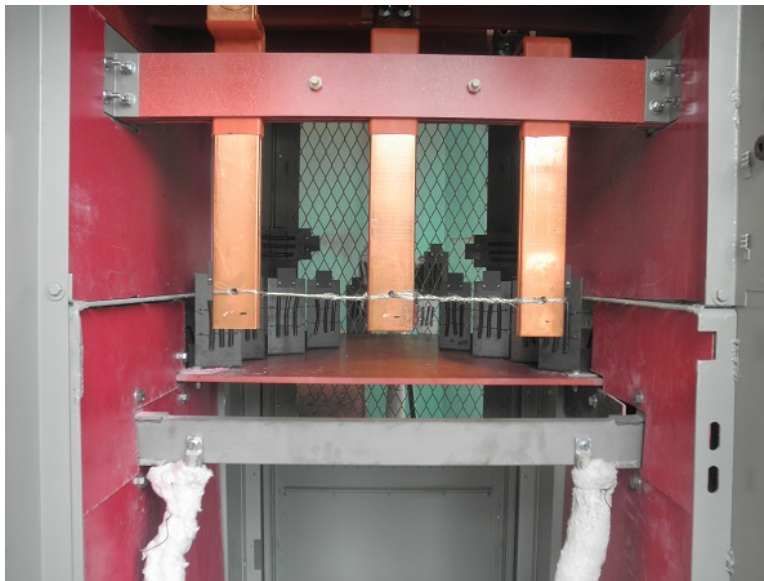
Figure 3.9-1 Red Board Added for SWGR Test 8, 9, 10

For SWGR Test 8, the ground bar was set 15 cm from the ends of the bus bars as a one-off test, as shown in Figure 3.9-1. See Section 3.3 for more discussion. As expected, the arc voltage was lower than the other SWGR tests in this report, which had 30 cm gaps. However, SWGR Test 7 cannot be directly compared because it was arcing to the sidewall that was closer than the ground bar.

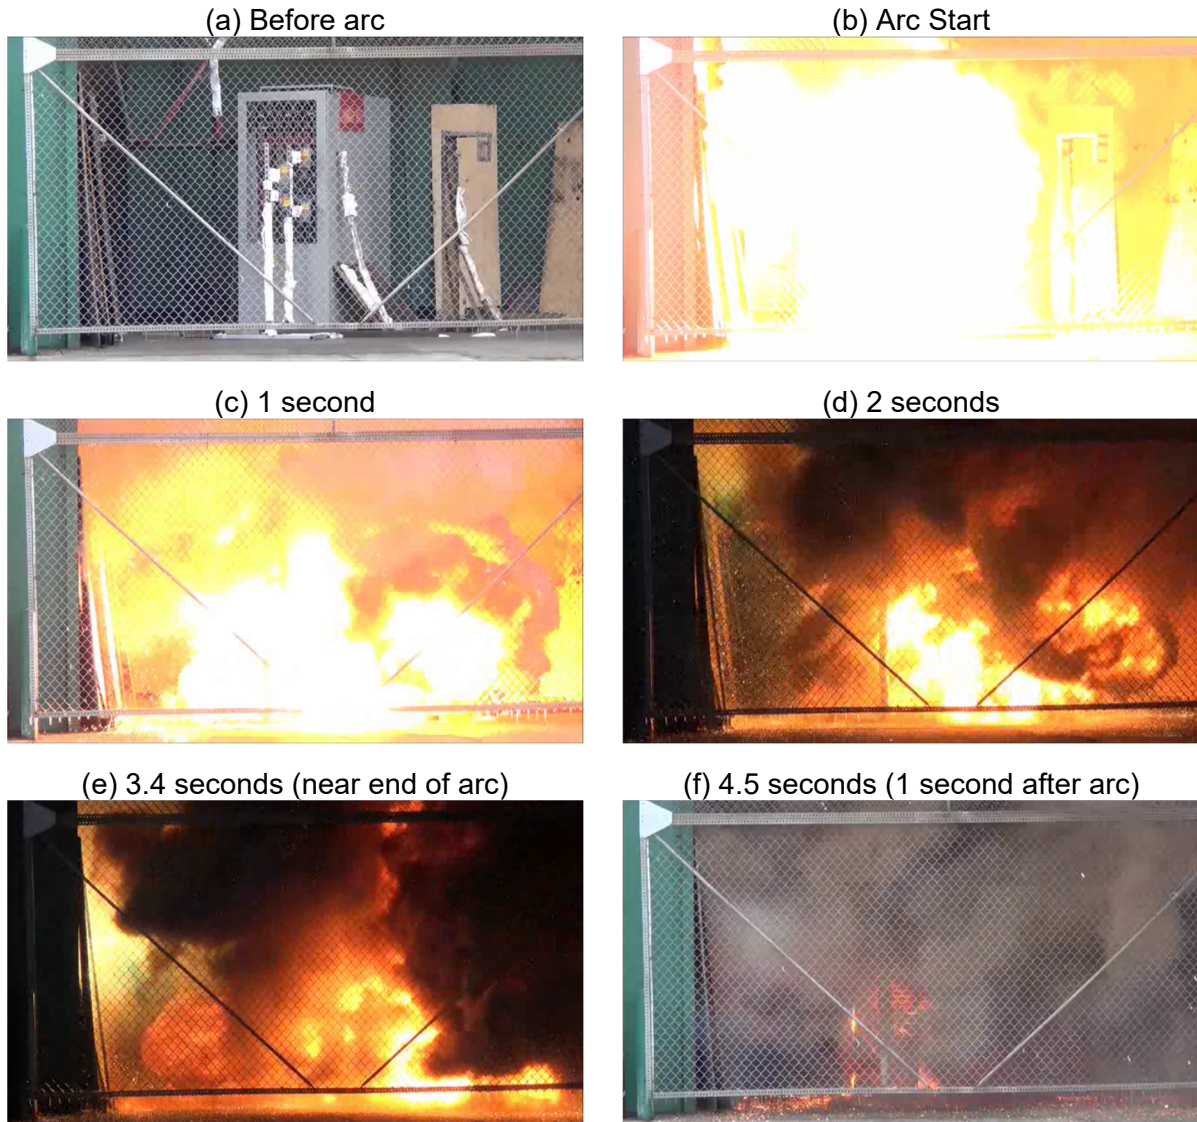
Figure 3.10-1 SWGR Test 8 Arc

This test was initiated at 7.1 kV and 29.5kA, with a target duration of 3.5 seconds with a total energy of 89.1 MJ, and power of 22 to 32 MW. The arc voltage was 816 V. Figure 3.10 -1 shows the observed arc sequence.

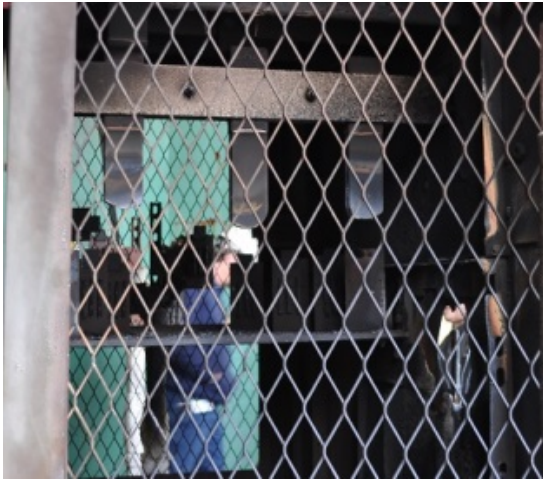
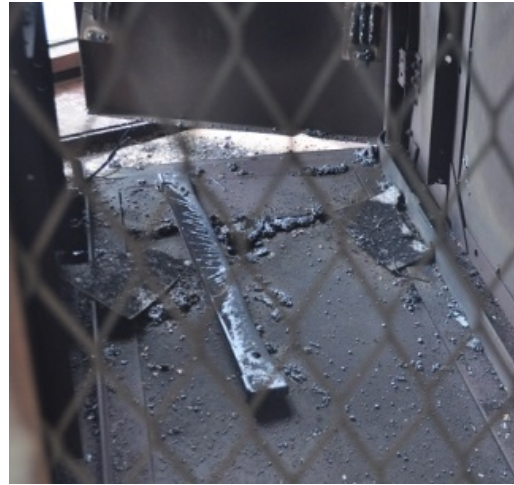
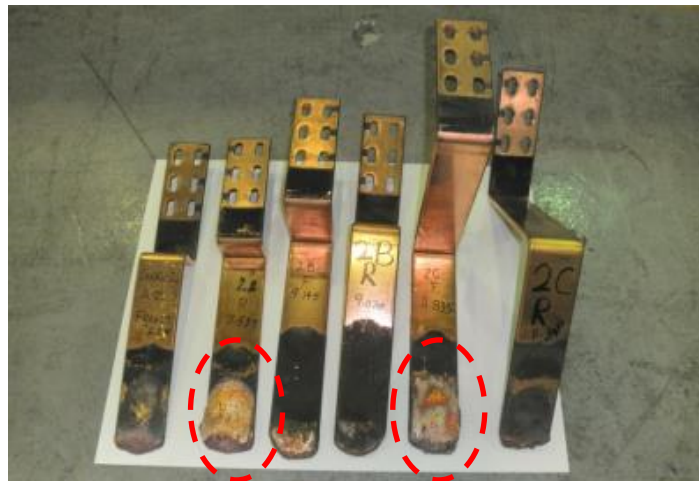
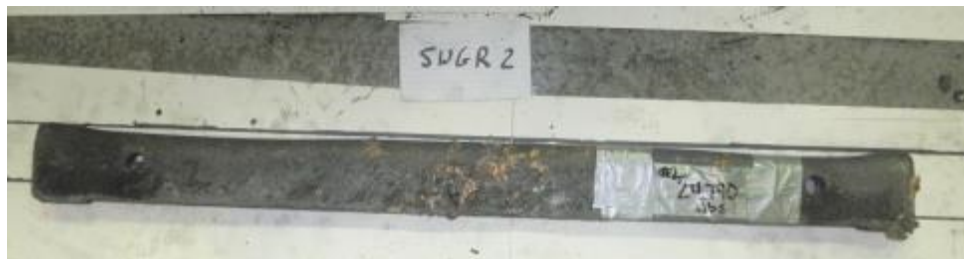
Figure 3.10-6 SWGR Test 8 Bus Bar and Ground Bar Damage

The ground bar lost about 36% of the total copper bus bar loss.

(a) Bus Bars and Targets

(b) Detached Ground Bar

(c) Bus bars (large melted slugs circled in red)

(d) Ground Bar

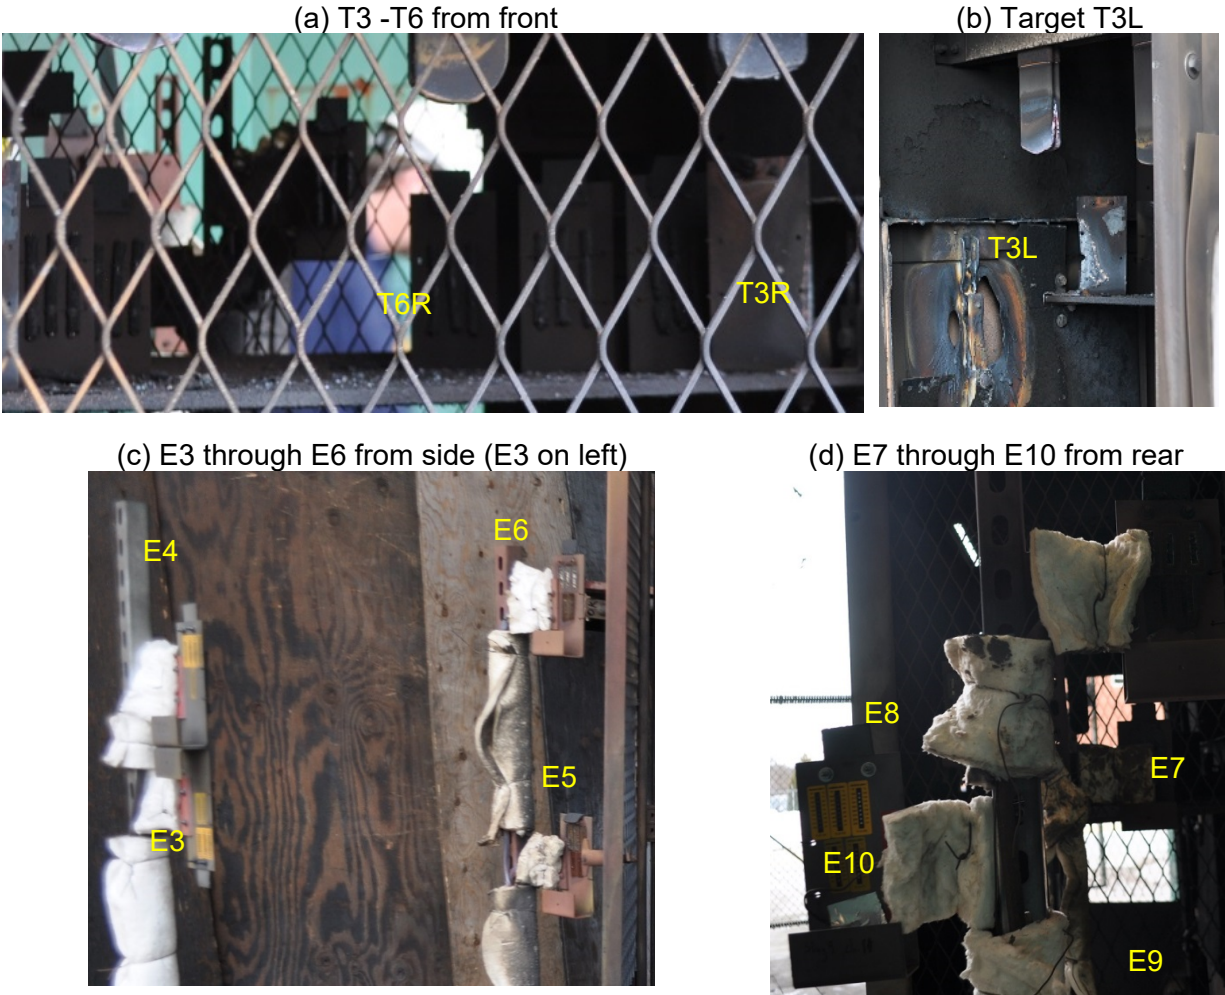
Figure 3.10-7 SWGR Test 8 Target Results and Target Numbers: Observations

- There was minor metal coating on T3L (48 cm) in contact with the plasma similar to metal coating in the SWGR Test 7 but not as severe. See Figure 3.10-7(b).

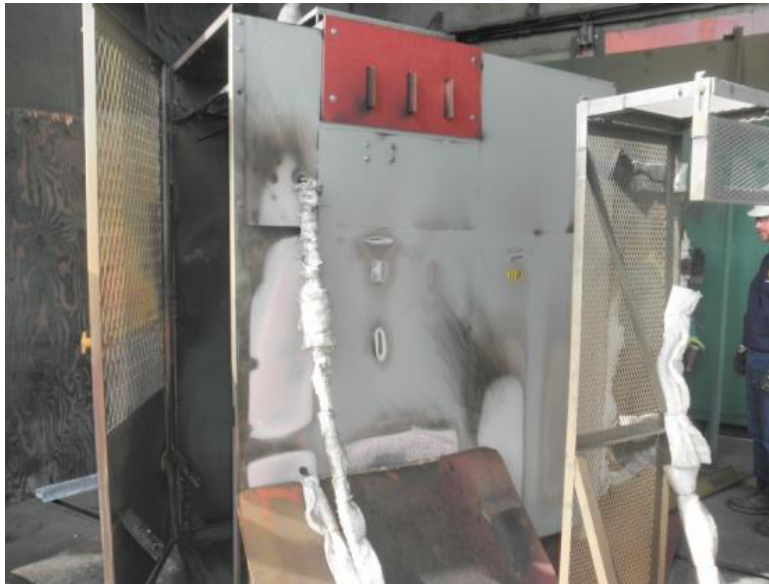
Figure 3.11-4 SWGR Test 9 Exterior Damage

The exterior panel damage consisted of holes in the panels where the arc attached and burned through, as shown in Figure 3.11-4. The damage was less than in SWGR Test 8, even though the arc duration and the energy were much higher in SWGR Test 9 (137 MJ vs. 89 MJ). This indicates that the additional red board enhancements in SWGR Test 9 were effective in preventing the arc from attaching to the interior side of the panel. There was charring on the exterior sides of the panels in many areas, such as the bottom panels of the front door as shown in Figure 3.11-4. There were various soot deposits on the external surfaces where smoke leaked through cracks and openings. The screens on the front and rear did not melt or fail from the flames passing through them.

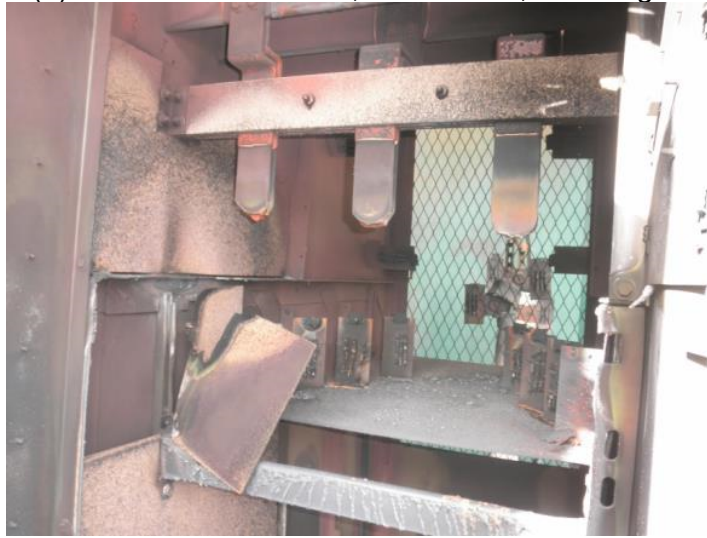
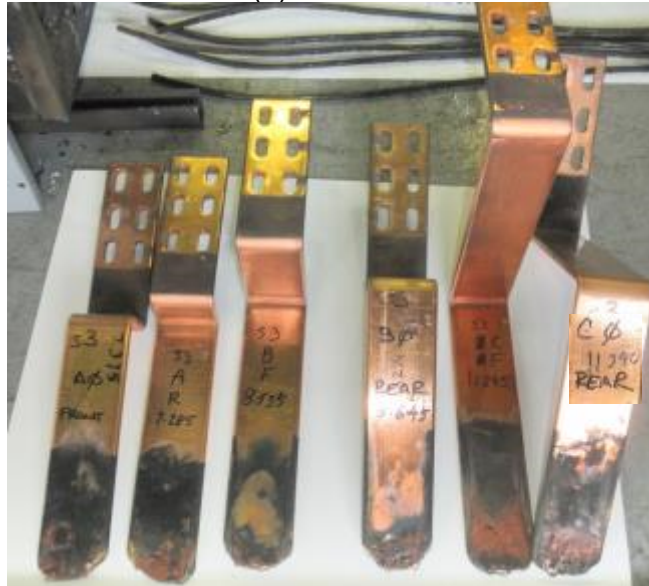
Figure 3.11-6 shows the interior damage to the bus bars, targets on the platform, and the ground bar. The mass loss for the copper bus bars was 6.78 kg, and the lengths changed 16-36 cm. As described earlier, the ground bar was at 30 cm from the ends of the vertical bus bars. The ground bar remained intact with severe melting on the top surface – indicating that the arc attached to the ground bar, as planned. Some of the red board peeled back but appeared to be effective protecting the cabinet sidewalls during the arc. The ground bar lost 1.27 kg of steel, which is about 20% of the copper bus bars. These losses were less than in SWGR Test 8 that had a lower energy because the ground bar in SWGR Test 8 was much closer to the bus bars. Mass loss calculations are detailed in Appendix G.

(a) Front View: Bus Bars, Ground Bar, and Targets

(b) Bus Bars

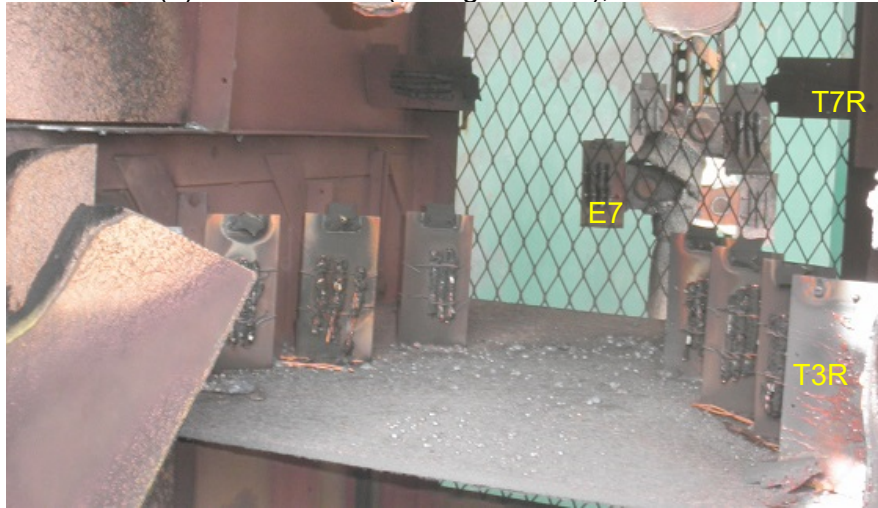
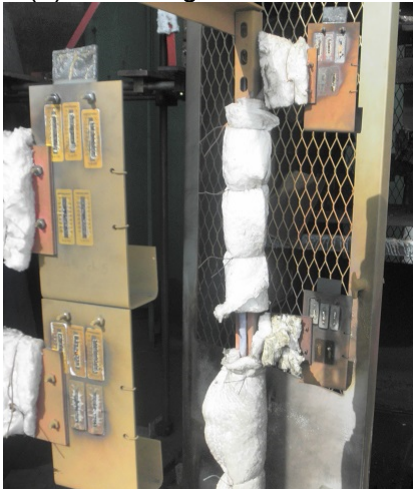
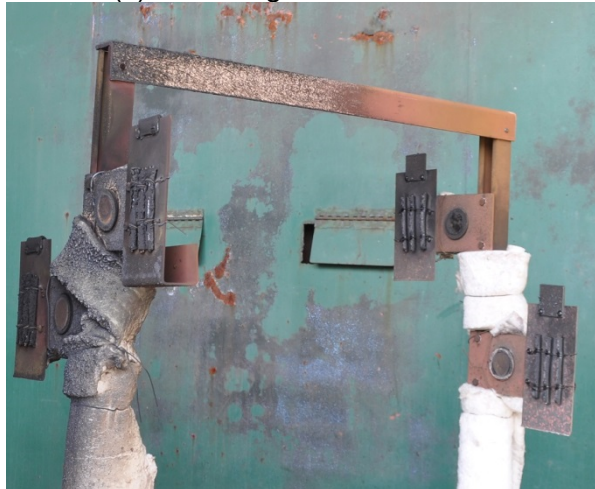
Figure 3.11-7 SWGR Test 9 Target Damage and Target Numbers: Observations

- There was metal coating on T3L (48 cm) in contact with the plasma similar to metal coating in the SWGR-7 and SWGR-8 but a little more severe. Some of the T3L steel was also destroyed from the high energy. Targets E7 and E8 (211 cm) also had metal coating.
- E10 had some red dots that appear to be red epoxy from the horizontal red board bar above the targets that had a burned spot caused by the flames.

(a) T3-T7E7-E10 (through screen), from front

(b) E3 through E6 from front

(c) E7 through E10 from front

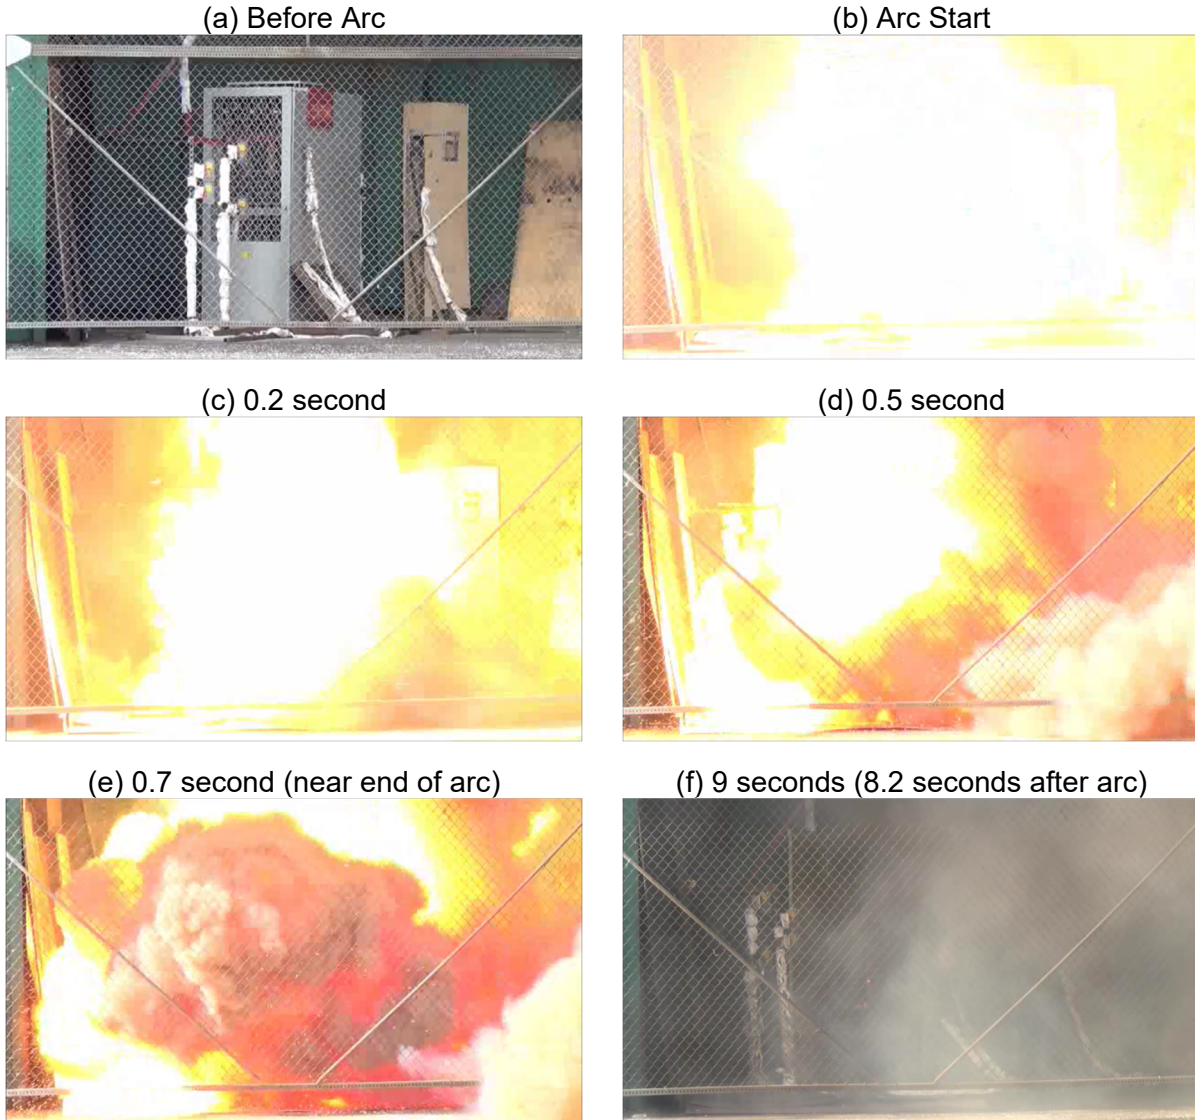
Figure 3.12-1 SWGR Test 10 Arc

This test was initiated at 7.1 kV and 29.5 kA and a target arc duration of 0.8 seconds with a total energy of 24.02 MJ and a power of 30 MW. The arc voltage was 949 V for the 30 cm gap. The arc sequence is shown in Figure 3.12-1.

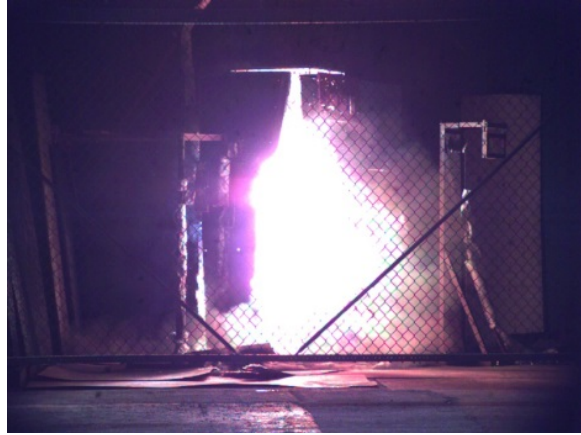
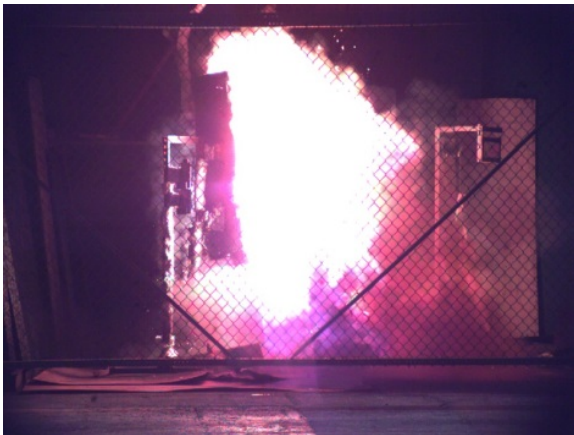
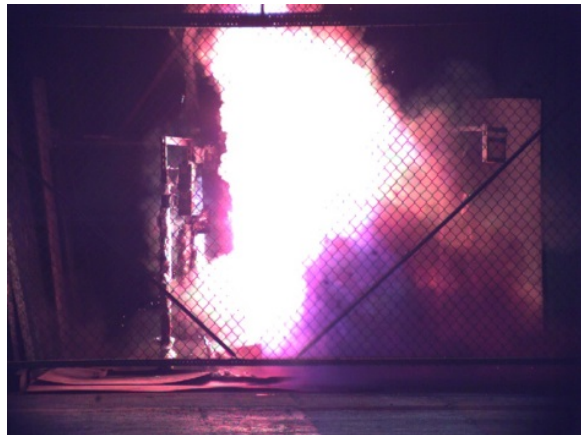
Figure 3.12-3 SWGR Test 10 High Speed Images of Door Opening

(b) 0.073 sec bolt holding top right corner

(c) 0.138 second door hits S5 and S6

(d) 0.175 second door open S5 and S6

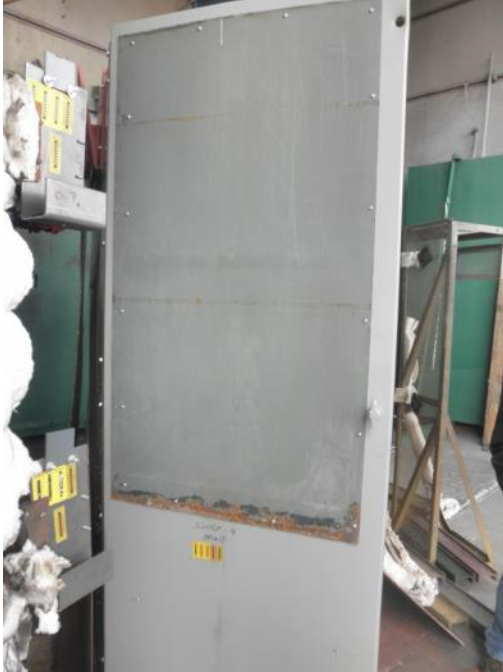
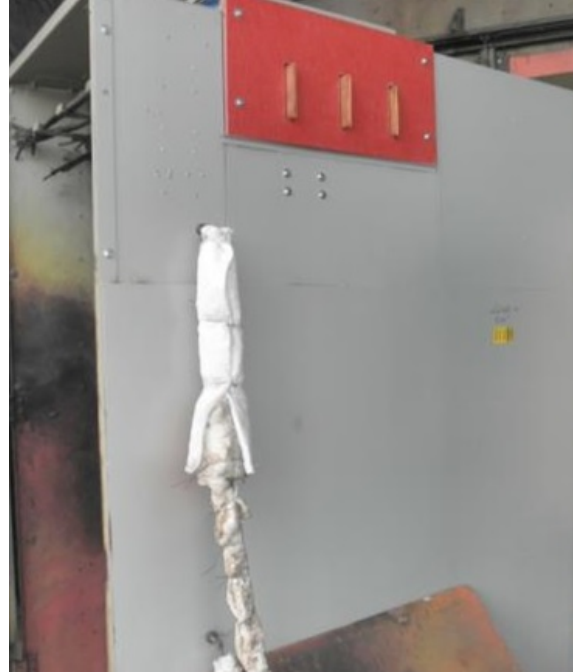
Figure 3.12-5 SWGR Test 10 Exterior Damage

There was no burn through the door or the side panels for the tests, as shown in Figure 3.12-5. The test was both a low duration and low energy output.

(a) Front Door

(b) Right Side

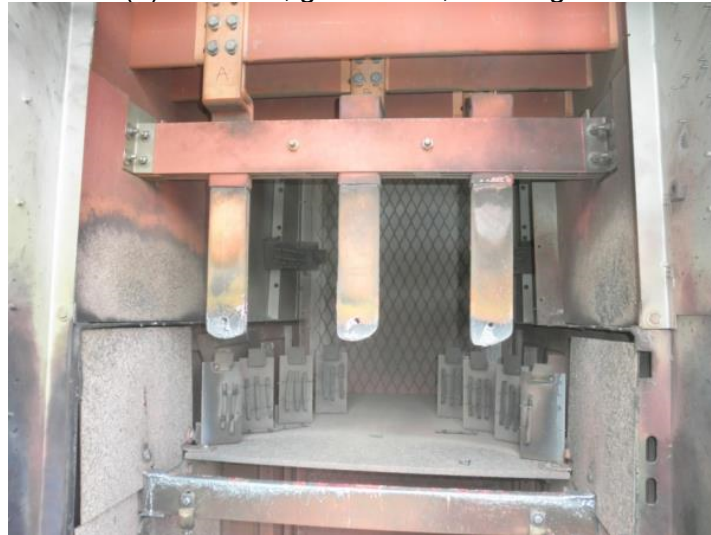
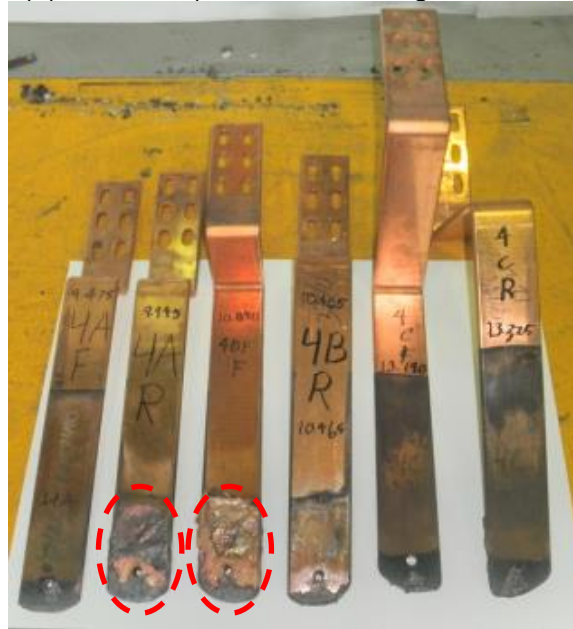
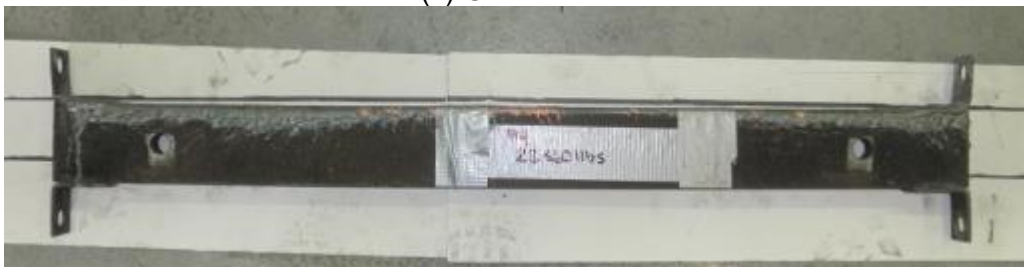
Figure 3.12-7 SWGR Test 10 Bus Bar and Ground Bar Damage

The damage to the bus bars is shown in Figure 3.12-7. The mass loss of the copper bus bars was 0.672 kg and the lengths changed 3-6 cm. The ground bar, which was located 30 cm from the ends of the vertical bus bars, remained in place but had minor melting because the arc duration was short. All of the interior red board remained intact. The mass loss of the steel ground bar was 0.173 kg, which is about 16% of the copper bus bar loss.

The conditions were similar to SWGR Test 9, but Test 10 was a shorter arc with less energy. The shorter duration arc explains why the mass loss was less for this test than SWGR Tests 7 through 9. See Appendix G for details on the calculations.

(a) Bus bars, ground bar, and targets

(b) Bus bars (melted metal slugs circled in red)

(c) Ground Bar

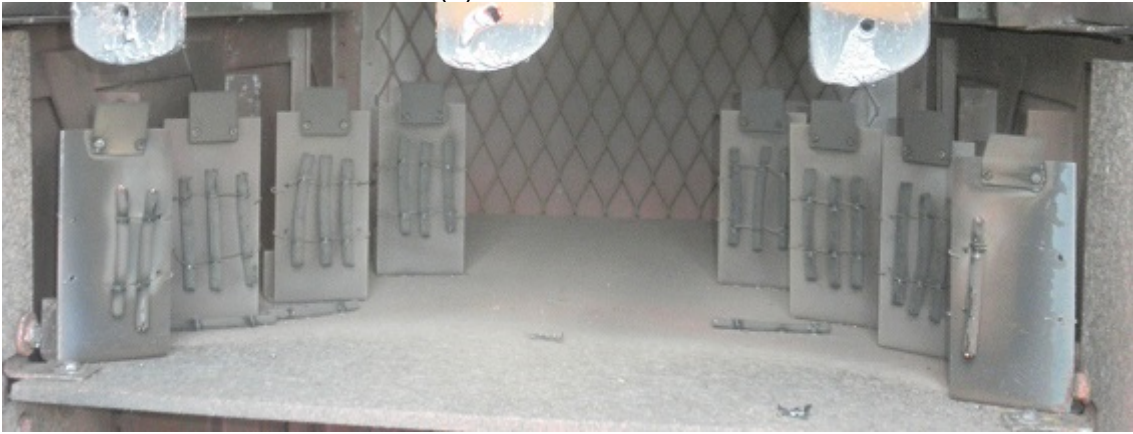
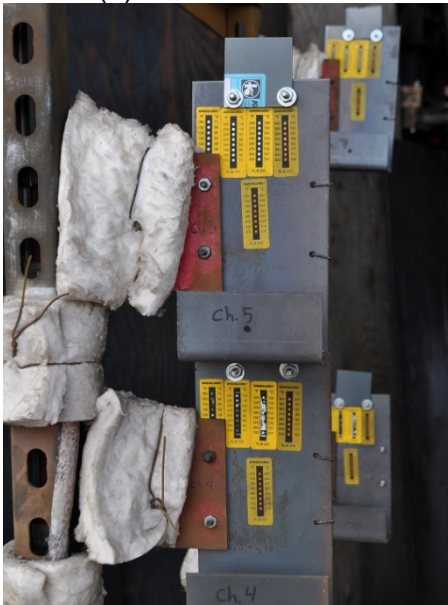
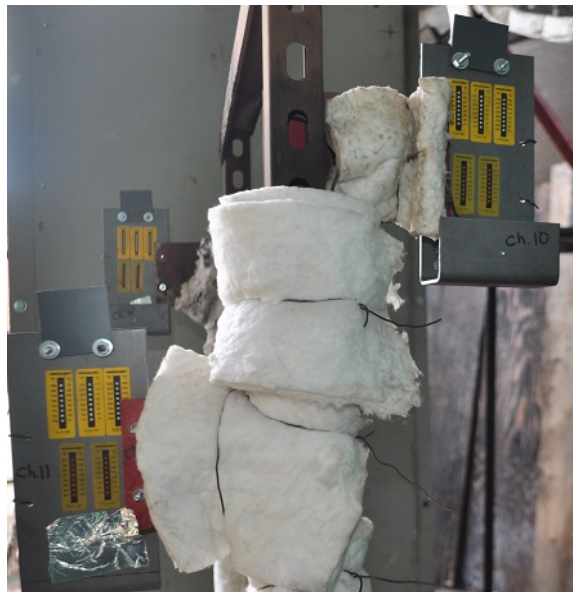
Figure 3.12-8 SWGR Test 10 Target Results and Target Numbers: Observations

The results are shown in Figure 3.12-8 and Table 3-14. See Figure 3.6-5 for target locations. Detailed photographs of the target damage are in Appendix F.

SWGR Test 10 was a “closed cabinet” with no openings in the front or rear. However, the front door opened at the start of the arc. The energy was intentionally much lower than the other SWGR tests. Damage is less than SWGR Tests 7 through 9 because the arc energy is much lower. The observations are in Table 4.4-6. The summary observations are:

(a) T3- T6 from front

(b) E3-E6 from front

(c) E7-E10 from rear (no damage)

Target (cm)		Damage Description		Label Temp. (°C)	Note
		Cable	Plastic		
T1 86	L	3. minor damage	No data	burnt	plastic is missing
	R	3. minor damage	3. minor damage	burnt	
T2 48	L	3. minor damage	3. minor damage	116-121	
	R	3. minor damage	3. minor damage	77-82	
T3 48	L	6. destroyed	4. medium damage	burnt	1 cable is gone, minor metal coating
	R	6. destroyed	4. medium damage	burnt	2 cables are gone, minor metal coating
T4 55	L	4. medium damage	3. minor damage	burnt	
	R	3. minor damage	3. minor damage	burnt	
T5 64	L	4. medium damage	3. minor damage	burnt	
	R	4. medium damage	3. minor damage	burnt	
T6 80	L	3. minor damage	3. minor damage	>260	
	R	4. medium damage	3. minor damage	>260	
T7 100	L	3. minor damage	3. minor damage	143-149	
	R	3. minor damage	3. minor damage	154-160	
T8 120	L	3. minor damage	2. sooted	77-82	
	R	3. minor damage	2. sooted	88-93	
T9 200	L	2. sooted	2. sooted	<41	
	R	2. sooted	2. sooted	<41

E3 150		3. minor damage	2. sooted	160-166	
E4 150		1. none	1. none	<41	
E5 86		2. sooted	2. sooted	160-166	
E6 86		1. none	1. none	<41	
E7 211		1. none	1. none	<41	
E8 211		1. none	1. none	<41	
E9 287		1. none	1. none	<41	
E10 287		1. none	1. none	<41

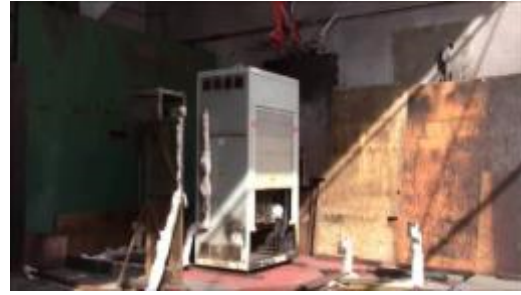
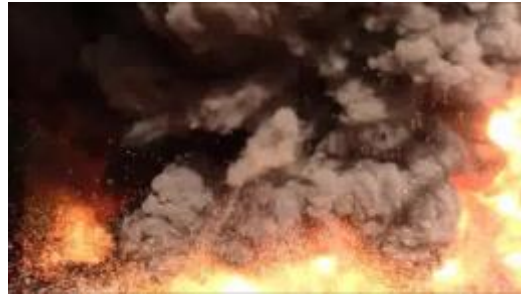
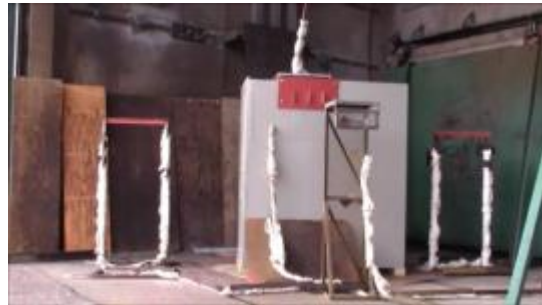
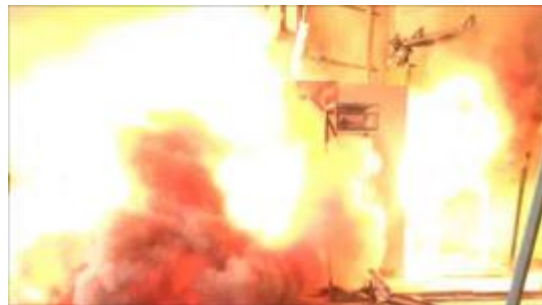
Figure 4.1-1 Maximum Flame Distance

(a) DP Test 9 Maximum flame

(b) SWGR Test 9 Maximum flame

- The “Maximum. Slug Temperature” shows the maximum temperature achieved by the slug calorimeter as a bounding temperature that may be achieved by an object at that distance.
- The “Maximum Flame Distance” is the maximum distance the flames extended from the cabinet openings based on the photos in Figure 4.1-1. Since the arc was close to the front of the cabinet, flames extended furthest in this direction. In both tests the flames extended further than 0.91 m).
- The “Maximum. Metal Sputter Distance” is the maximum distance from the arc where metal coating was observed on a cable/plastic target. Hot metal and embers can cause external fires or other damage. See Section 4.5.

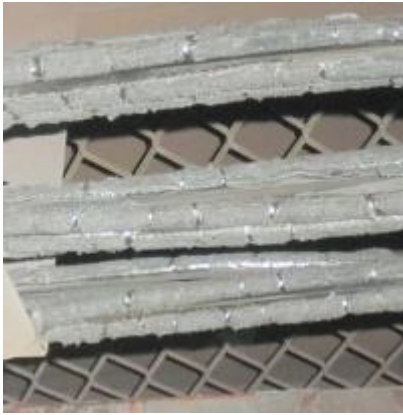
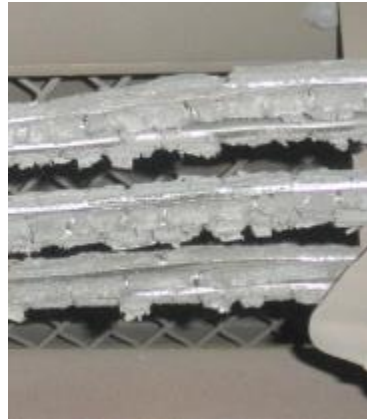
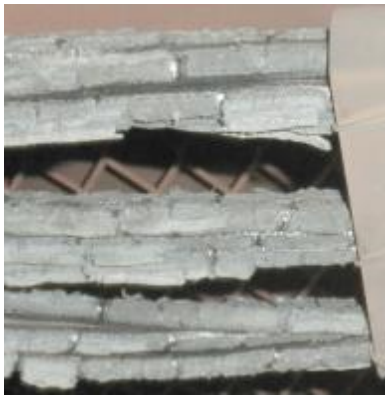
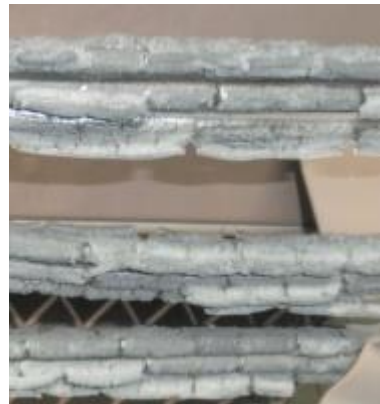
Figure 4.2-1 SWGR Test Interior Cable Bundle Damage

(a) SWGR Test 7: 88.2 MJ, medium damage (b) SWGR Test 8: 89.1 MJ, medium damage

(c) SWGR Test 9: 137.3 MJ, medium damage

(d) SWGR Test 10: 24.0 MJ, medium damage

The interior cable bundles inside the SWGR cabinets (see Figure 4.2-1) had 0 failures for the 70 cables tested that had minor to heavy damage. Photographs of the interior cable damage are in the “Interior Damage” subsection for each test in Chapters 2 and 3. It is interesting that all of the internal cables had similar damage for arc energies ranging from 24-137 MJ as shown in Figure 4.5-1. Like the internal cables, damage for both the T2 targets at the internal cable location was also “medium” for all the SWGR Tests except SWGR Test 9, T2L was “heavy”. The reason that the damage was the same for all arc energies is not clear. Perhaps the flux at this position above the arc is very low for all tests because the heat and flames are projected downward from the ends of the bus bars as discussed in Section 4.4.

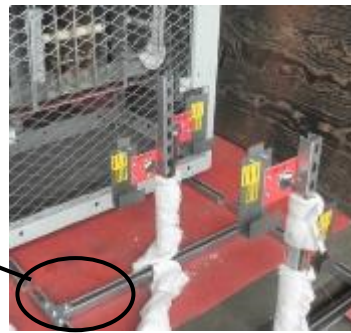
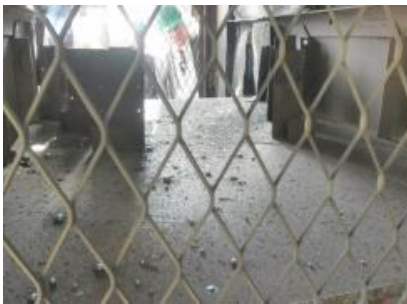
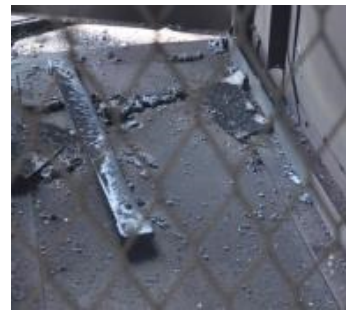
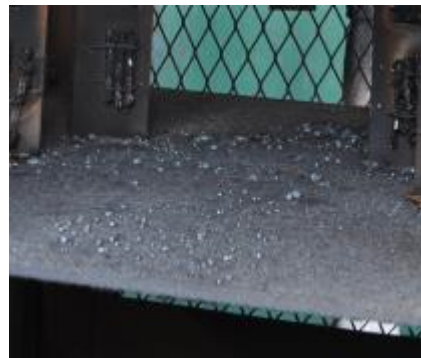
Figure 4.5-1 Metal Sputtering and Coating

(d) Coating Outside DP Test 9

(e) SWGR Test 7 (from rear)

(f) SWGR Test 8 Metal on floor (from rear)

(g) Metal sputter SWGR Test 9 (from front)

- Figure 4.5-1d shows metal that coated the lower Unistrut mount in front of the cabinet in DP Test 9. The metal coating had been removed from the Unistrut surface and placed on the concrete floor for the photograph.

- Figure 4.5-1e through 4.5-1f show the sputter inside of the cabinets that is composed of small droplets of molten metal up to about 4 mm diameter that are scattered on the inner surfaces.

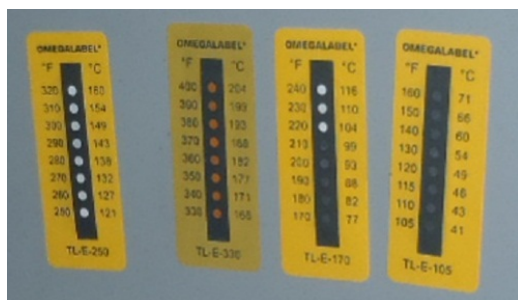
Figure A-3 Passive Temperature Label Set

Irreversible passive temperature indicators (called "temperature labels" or "labels"), Omega Engineering, Model No. TL-E-****-30, where **** is the temperature range) are placed on the sides of the cabinets for each test. The indicators show the maximum temperature measured by a permanent color change. In some cases, near the arc high temperatures will destroy the gauges. The labels are shown in Figure A-3 have a range from room temperature to >204 °C in 6 °C increments.

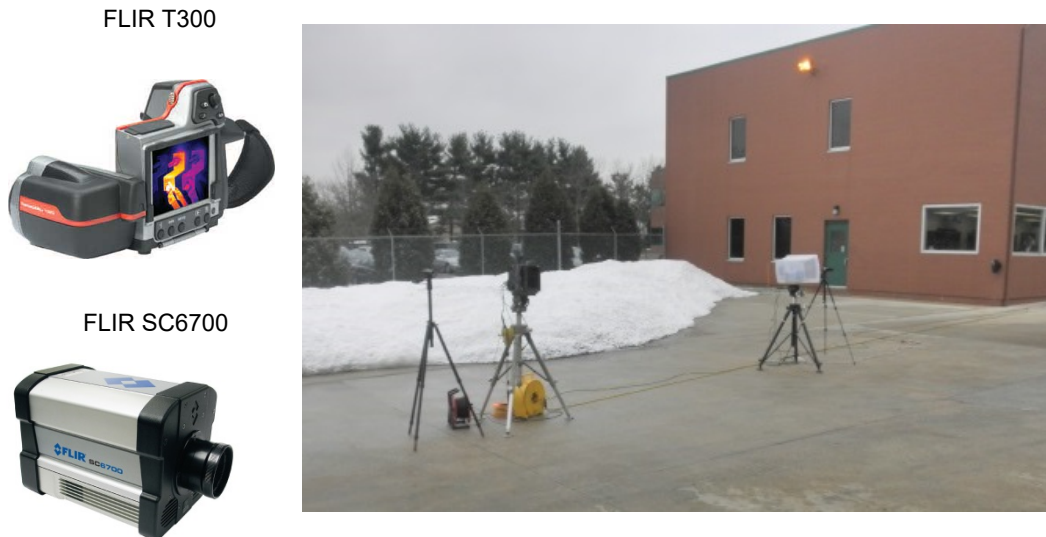
Figure A-10 Thermal and High-Speed Cameras

Various cameras were used for video and photography by KEMA, SwRI, and by NRC. NRC used a FLIR SC6700 IR camera and SwRI used a FLIR T300 camera. Video cameras were in front of the test cell looking toward the test cell as shown in Figure A-10. The KEMA High-Speed (HS) Phantom V7.3 camera at 500 – 1200 frames per second was also used. Videos and photographs were provided separately on DVD. Several cameras are in a line to view the front of the cabinets. Other cameras are in the test cell at the front and rear of the cabinets.

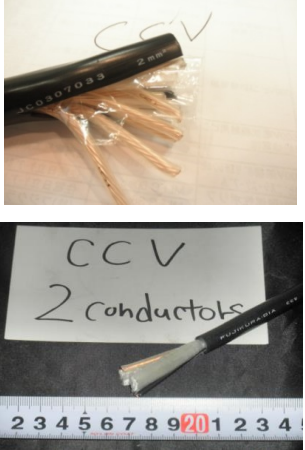
Figure C-1 Cable Materials

<p>CCV - for Cable/Plastic targets</p> <p>Sheath: Heat Resistant Vinyl (PVC)</p> <p>First Wrapping: Thin, Clear, Cellophane-Like Plastic</p> <p>Shield: None</p> <p>Fill: None</p> <p>Insulation: Cross-Linked Polyethylene (XLPE, clear)</p> <p>Conductor: Stranded</p>

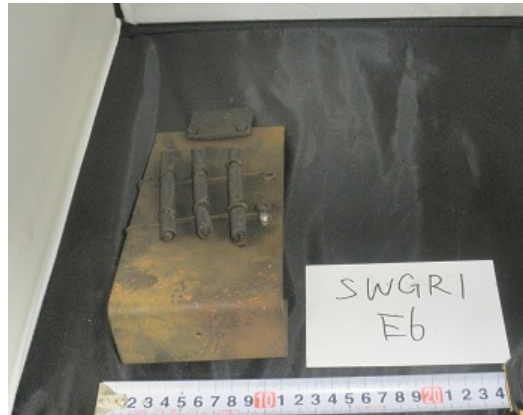
E3 No damage- reused E4 No damage reused

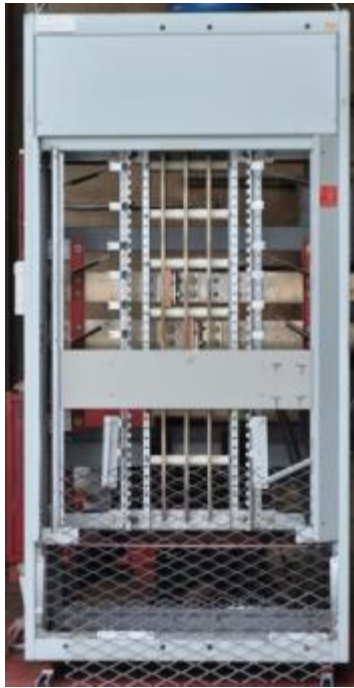
Figure G-1 DP Bus Bar Configuration

(a) Front View with panels removed

This section discusses the mass losses for the vertical bus bars for the DP tests. The photos of the damage are in the internal damage section in the main text for each test. The photos show the DP bus bars marked as DP Cabinet 1 or Cabinet 2. Cabinet 1 was used for DP Tests 7, 7A, and 9 and Cabinet 2 was used for Test 8. DP Tests 7 and 7A had short arcs with minor damage and Cabinet 1 was re-used for Test 9. The copper mass loss in Tests 7 and 7A (to use as the starting mass for Test 9) was estimated by calculation because the bus bars were not removed and weighed after DP Tests 7 and 7A.

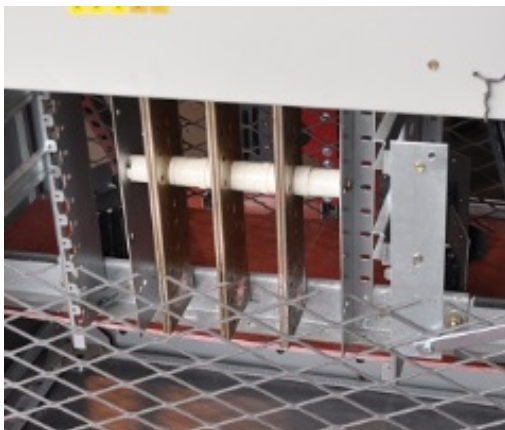
(b) Arc position front view

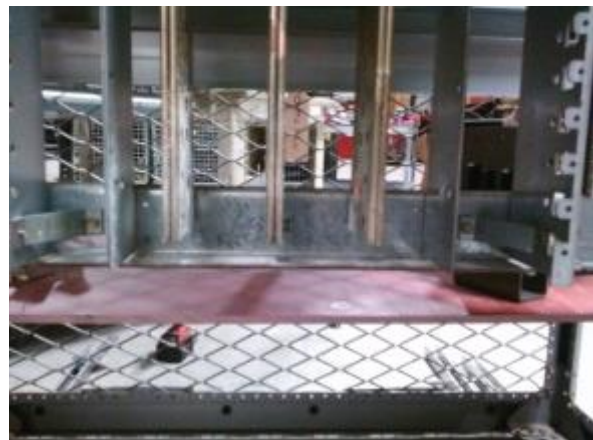
(c) Arc position rear view

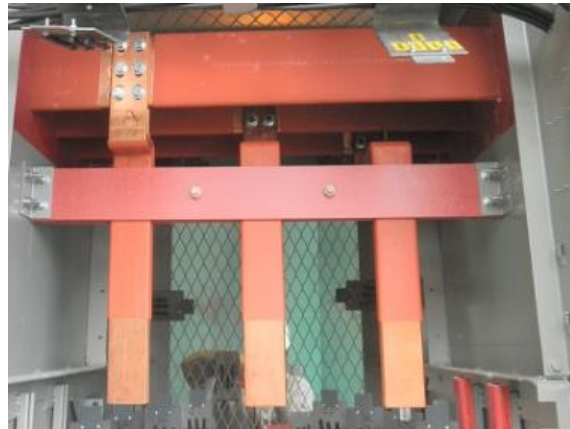
Figure G-2 SWGR Bus Bar Configuration

- a. Most of the uncertainty is because the check using the 65 g/cm assumes that the only copper mass lost is from the rectangle shown in Figure G-2. This rectangle is based on the width of the bus bar and the length that was lost based on the length before the arc minus the length after the arc. After the arc, the longest bus bar length is recorded as shown in Figure G-2. However, this simple rectangle does not account for the material lost because the bus bar does not burn evenly. For example, in Figure G-2, the triangle shape of material lost is not included in the 65 g/cm check. This uncertainty also applies to any material lost above the rectangle like the irregular shapes at the end of the bus bars.

These measurement uncertainties can cause the check to 65 g/cm to be uncertain by 10% or so. For tests where the total mass loss is large like SWGR Tests 7-9, the uncertainties above will usually be within the 10%. However, when the mass loss is small the uncertainties above may exceed 10%. For example, in Figure G-2 for Test 10, the triangle mass is about 21% of the total mass loss and this must be included in the check.
