# Aging of Post-tensioned Concrete Containment Vessels with Emphasis on Concrete Creep and Creep Rupture

Manuscript Completed: August 2021  
Date Published: March 2022

J. Hogancamp<sup>1</sup>  
C. Jones<sup>2</sup>  
M. Sircar<sup>3</sup>  
R. Gascot<sup>3</sup>  
B. Dameron<sup>4</sup>  
P. Chang<sup>4</sup>  
E. Kjolsing<sup>5</sup>  
R. James<sup>6</sup>

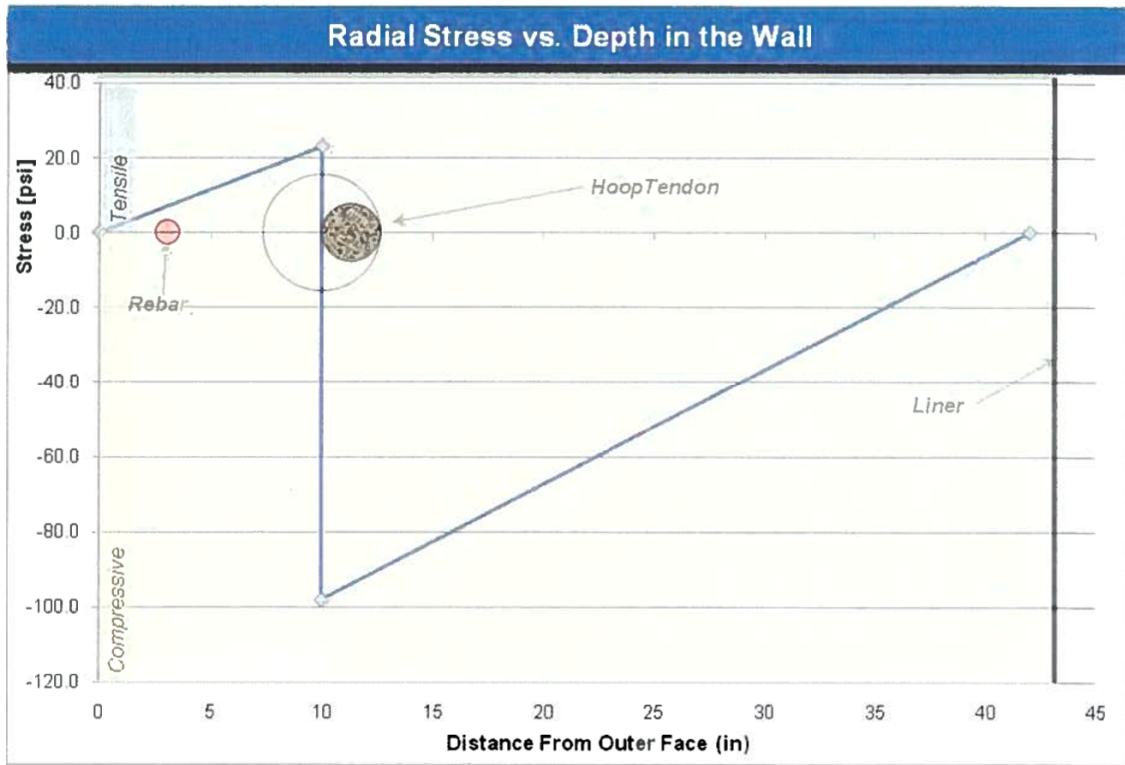
**Figure 2-1** Tensile and compressive stresses in concrete wall cross-section due to horizontal hoop tendons. (US Nuclear Regulatory Commission, 2010)

4. Radial stresses caused by prestress are even higher in domes than in cylinders.
5. The ASME BPVC required radial reinforcement in concrete structures with double curvature (e.g., domes).

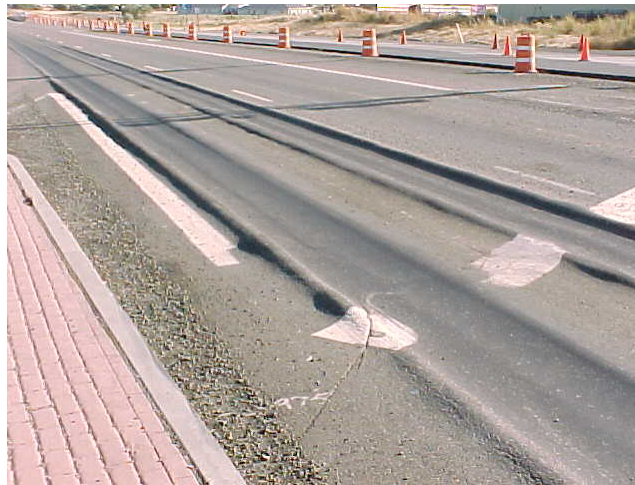
**Figure 2-3 Asphalt pavement rutting on a primary highway. (Pavement Tools Consortium, n.d.)**

One prominent example of long-term deformations from sustained or repeated loads is rutting in asphalt<sup>2</sup> pavements. As heavy vehicles such as cargo trucks or aircraft repeatedly traverse the same area of pavement, the pavement under the highest stresses slowly deforms as shown in Figure 2-3.

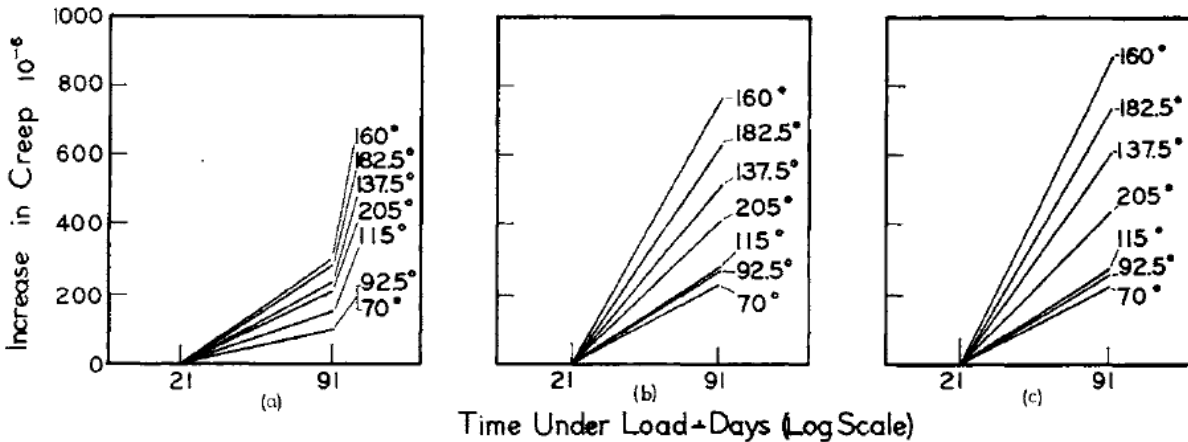
**Figure 2-14 Increase in creep above the 21-day creep for different temperatures and stress-strength ratios of (a) 35%; (b) 60%; and (c) 70%. Temperature is in °F. (Nasser & Neville, 1966)**

creates a complicated creep strain response. At temperatures up to 160°F (71°C), concrete creep increases by a factor of ~3.5 (compared to creep at 70°F). Above 160°F (71°C), Nasser & Neville suggest that moisture evaporation from the cement gel pores increases the capillary suction effect in the cementitious matrix, causing a reduction in creep to a factor of ~1.7 (Figure 2-14, (Nasser & Neville, 1966)).

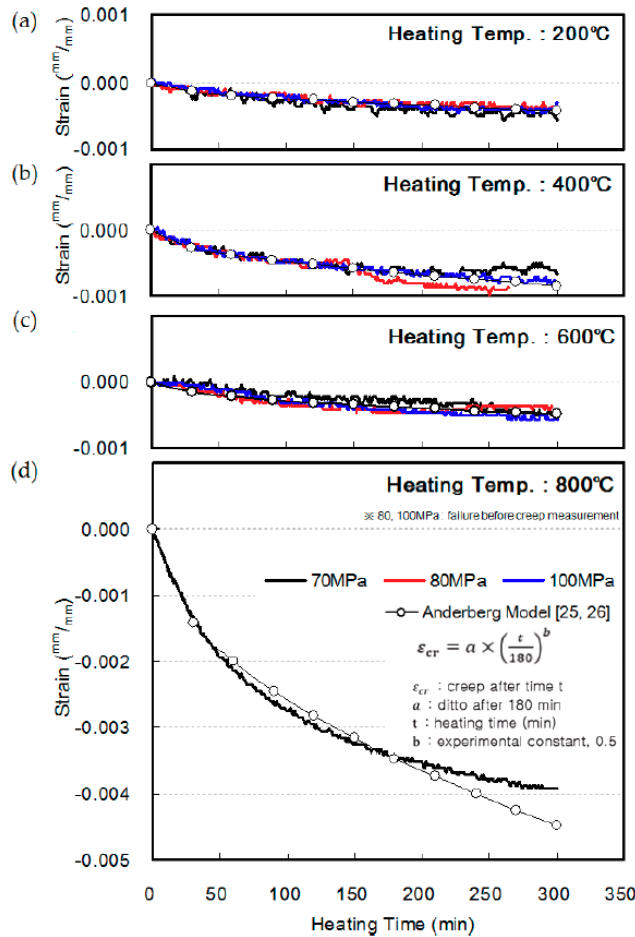
Figure 2-16 Creep of high-strength concrete at elevated temperature: (a) 200°C (392°F); (b) 400°C (752°F); (c) 600°C (1112°F); (d) 800°C (1472°F). Test specimens with  $f_c$  of 80 MPa and 100 MPa at 800°C fractured before creep could be measured. (Yoon, et al., 2017)

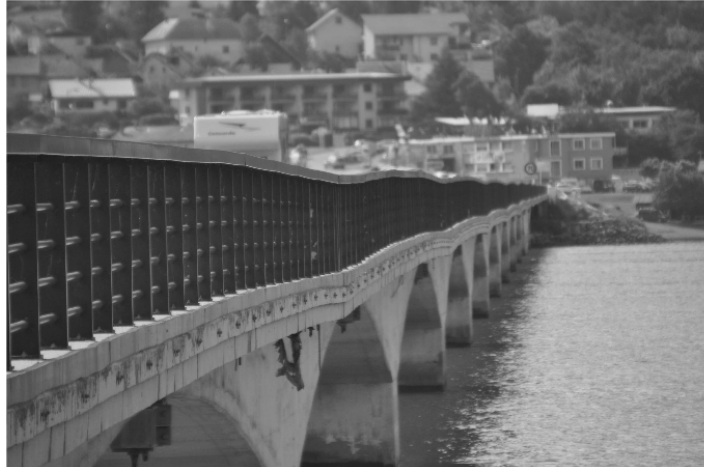
**Figure 2-18 Present-day view of the Savines Bridge in France. (Sellin, Barthélémy, Bondonet, & Cauvin, 2015)**

As an example of the severity of excess deformations, Figure 2-18 shows creep effects visible to the naked eye on the Savines Bridge in France (Sellin, Barthélémy, Bondonet, & Cauvin, 2015). Built in 1960, the Savines Bridge was one of the first post-tensioned concrete bridges constructed in France. At 40 years, Eurocode Standard EN1992-1-1 predicted a maximum deflection of ~50 mm while EN1992-2 without silica fume predicted a maximum deflection of ~90 mm. The actual deflections of the bridge measured from 120-170 mm (Sellin, Barthélémy, Bondonet, & Cauvin, 2015).

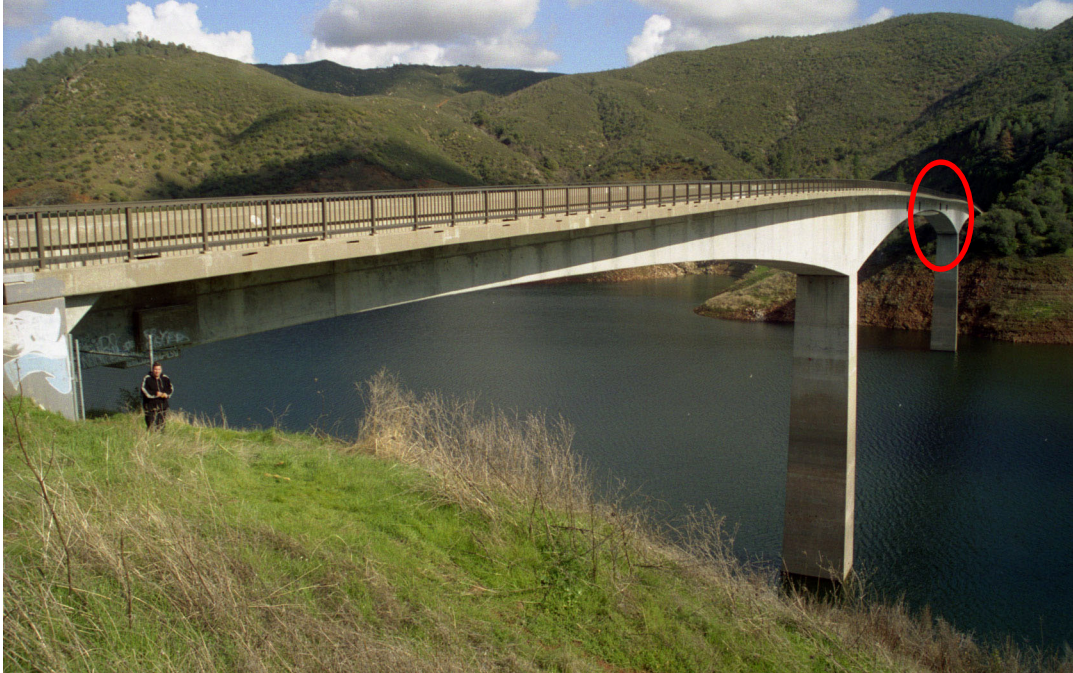
**Figure 2-21 Parrotts Ferry Bridge showing deflection at midspan (inside the red circle). (HighestBridges.com, 2009)**

The Parrotts Ferry Bridge in California, USA, was built between 1976 and 1979 and is a three-span prestressed concrete continuous rigid frame bridge that is experiencing excessive deflections from creep at midspan. At 195 m (640 ft), the main span is one of the longest prestressed concrete beam bridges ever built in the United States. The central span sagged nearly 30 cm (12 in) five months after opening and up to 63.5 cm (25 in) as of 2015 (HighestBridges.com, 2009) (Chen, Yang, & Liu, 2015).

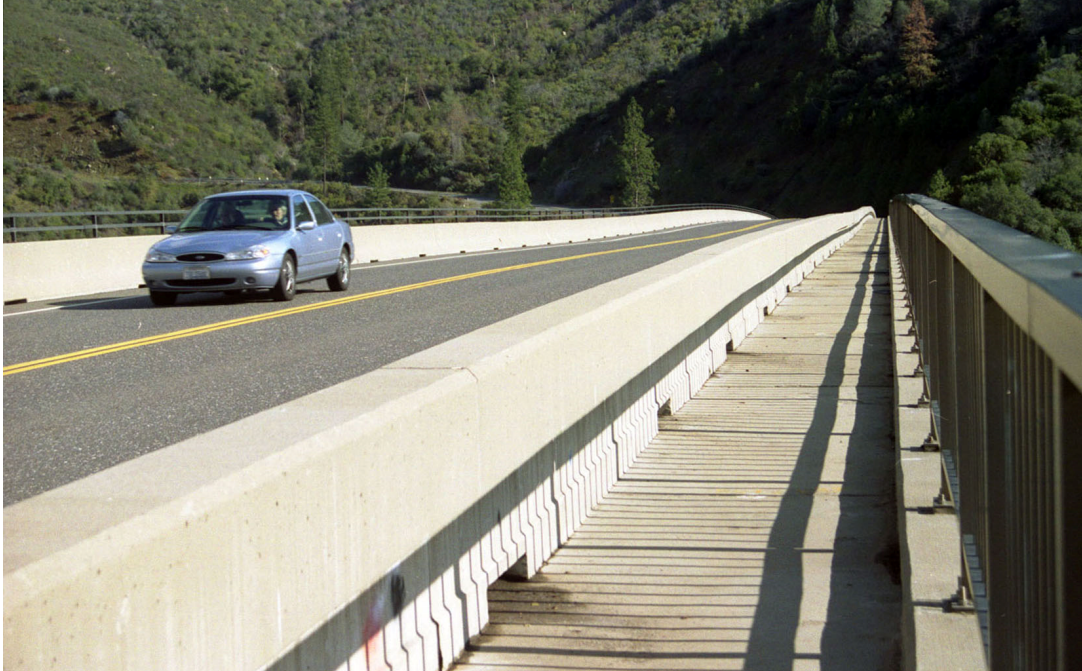
**Figure 2-22** Parrotts Ferry Bridge with a nearly 2-foot (61 cm) sag in the center. (HighestBridges.com, 2009)

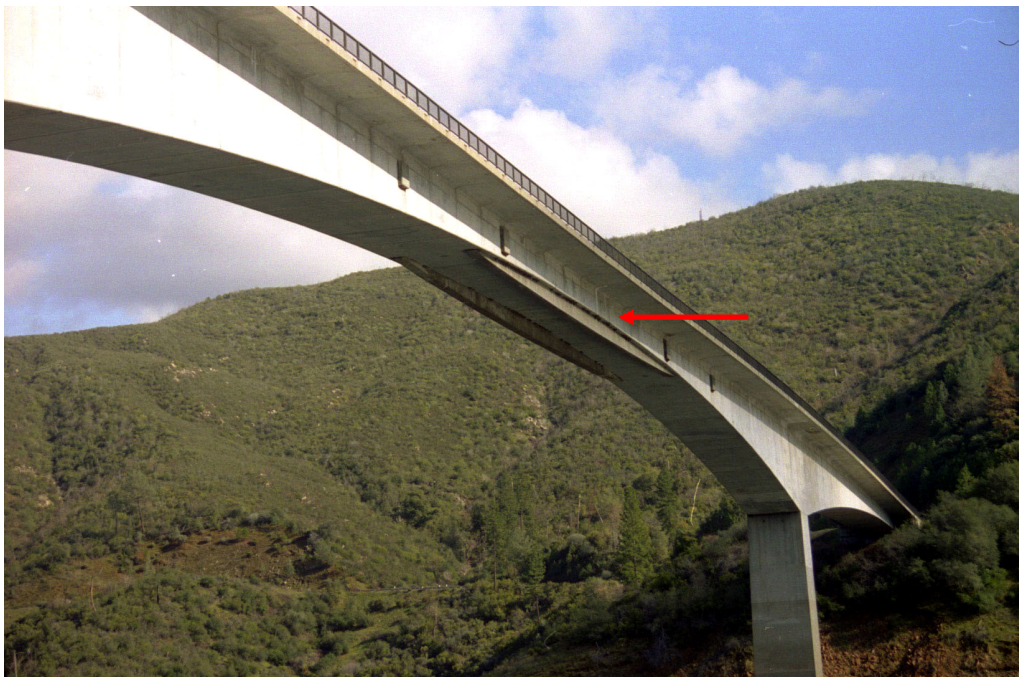
**Figure 2-23** Brace installed on Parrotts Ferry Bridge (indicated by arrow) more than 10 years after construction to support the center. (HighestBridges.com, 2009)

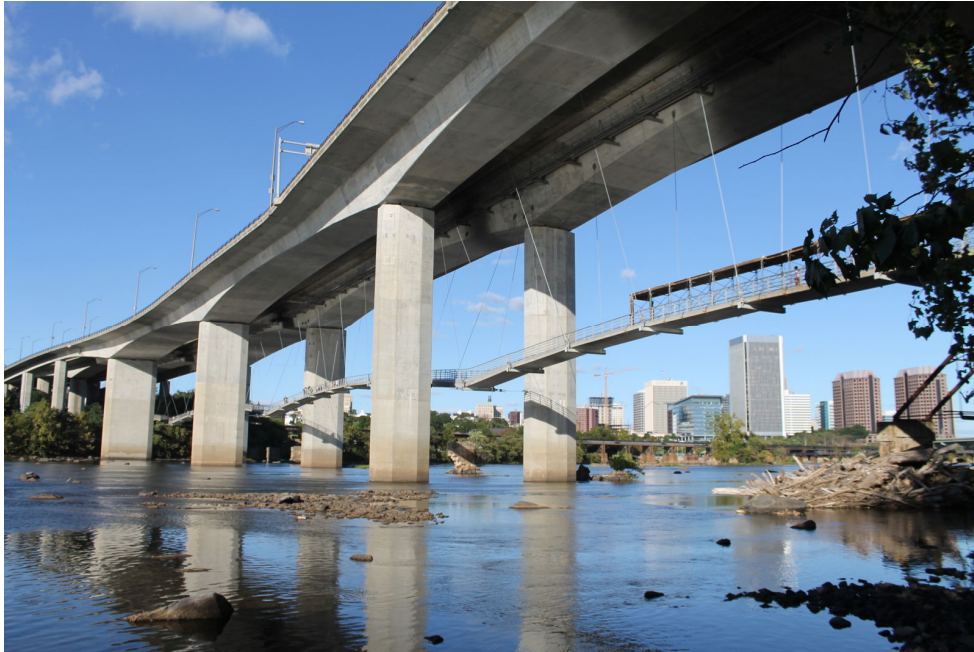
**Figure 2-24** Robert E. Lee Memorial Bridge in Richmond, VA. Photograph shows the piers, underside, and pedestrian suspension bridge. (BridgeHunter.com, 2017)

Another U.S. bridge that is experiencing excessive creep deformations is the Robert E. Lee Memorial Bridge in Richmond, VA. This precast concrete stringer bridge was completed in 1989, provides six (6) lanes of vehicular traffic, and includes an underslung pedestrian suspension bridge as shown in Figure 2-24. Figure 2-25 shows the effect of creep between Pier 8 and Pier 9. As of 2011, the bridge span at the expansion joint had sagged a total of 25 cm (0.82 ft) since its construction, bringing the expansion joint 14 cm (0.46 ft) below the reference line (Theryo, 2011).

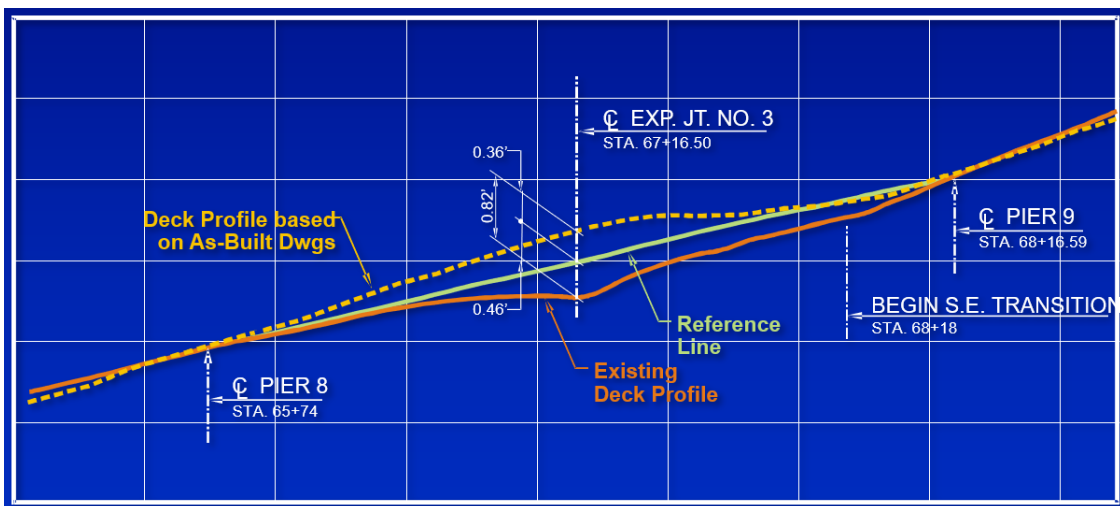
**Figure 2-25** Robert E. Lee Memorial Bridge deck profile on the east face of the curb showing the as-built and existing deck profiles relative to the reference line. (Theryo, 2011)

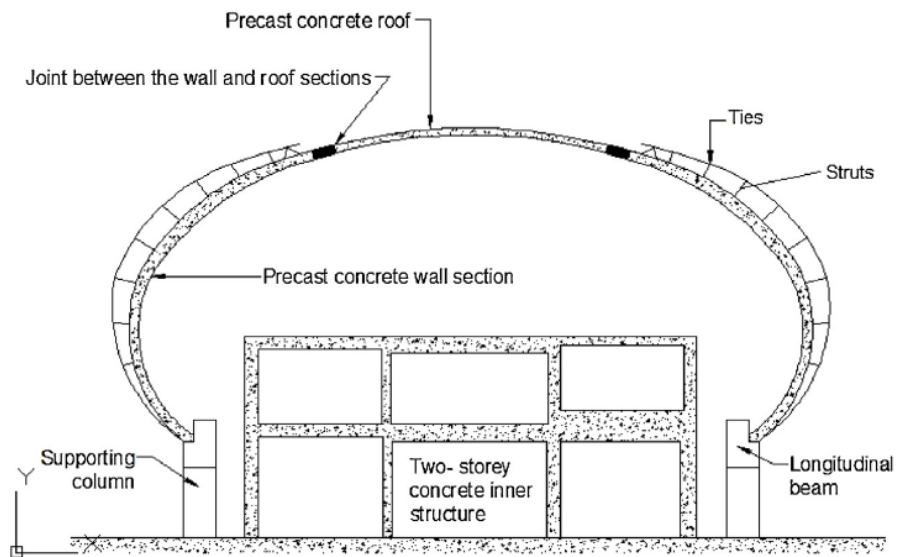
**Figure 2-26** Typical section of boarding area of a terminal at Roissy-CDG airport. (Daou, Salha, Raphael, & Chateauneuf, 2019)

- The stresses and efforts calculated in the design phase were inaccurate; the load applied at the ultimate limit state was 4.5 times greater than the maximum permissible load.
- Hasty construction practices lacked appropriate monitoring techniques.
- Long-term concrete creep caused excessive unpredicted deformations that resulted in excessive forces in the struts that led to shear punching in the shell.
- The maximum deflection occurred in the local area where the crash occurred.
- Excessive deformation was a major cause of the structural damage, and thus, led to the terminal failure.

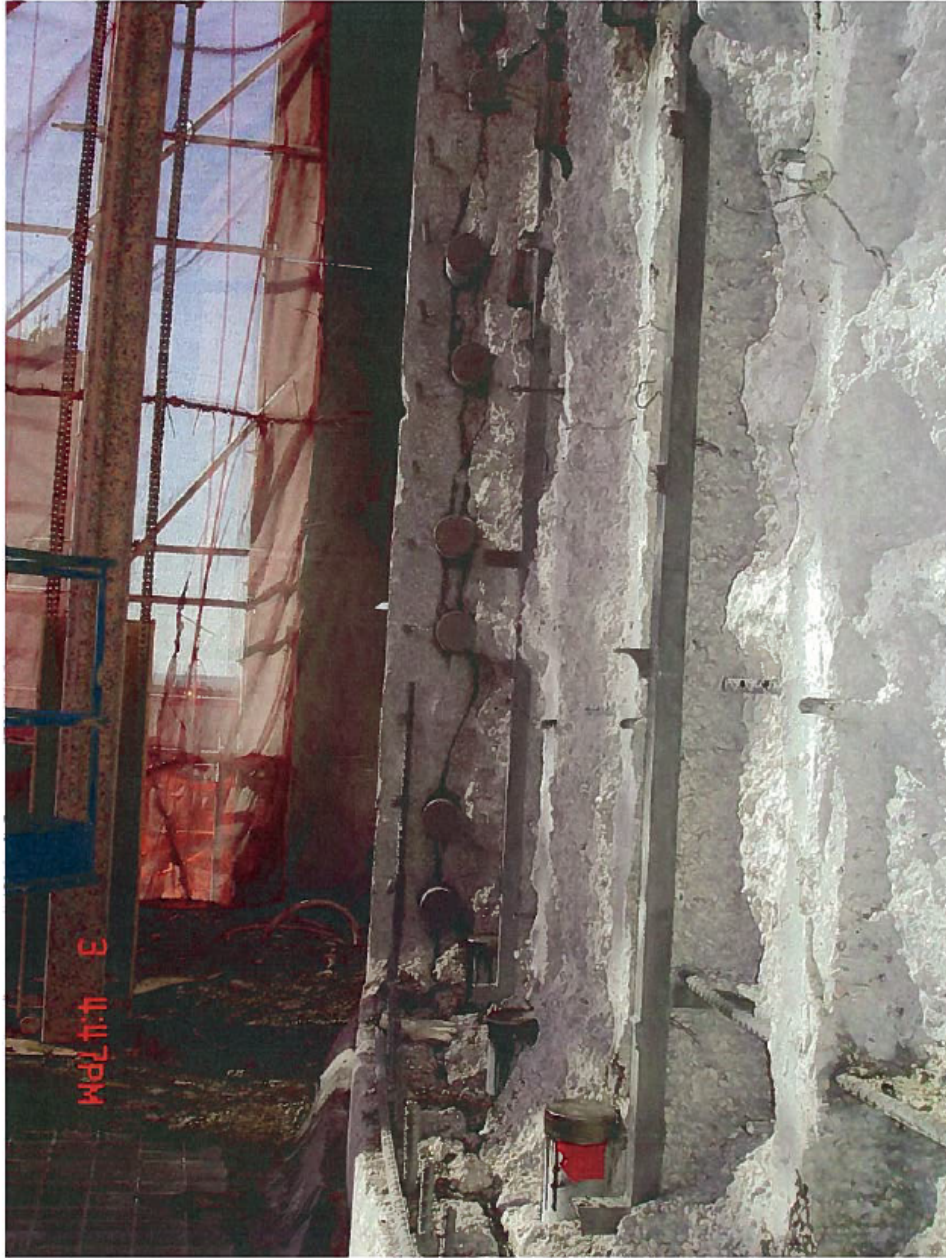
**Figure 2-27** Photograph of delamination crack running from horizontal tendon to horizontal tendon, parallel to the wall surface, approximately 10 inches from the exterior surface of the concrete. (US Nuclear Regulatory Commission, 2010)

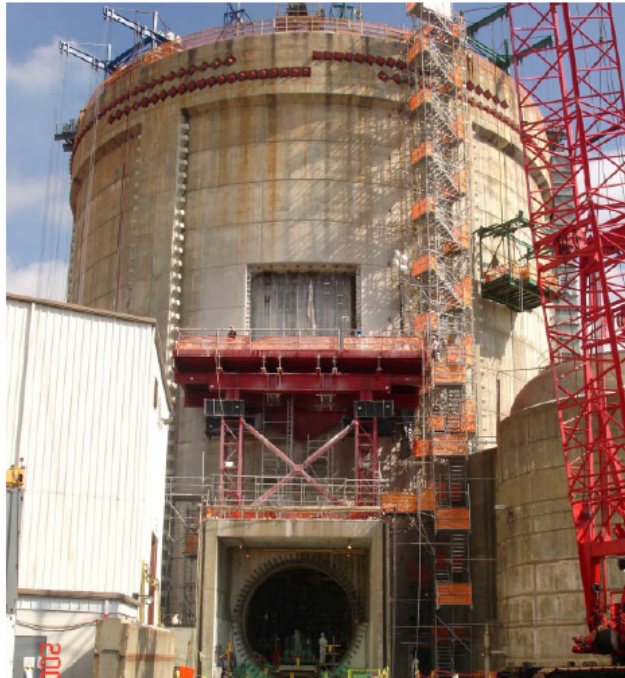
Figure 2-28 Crystal River structure (top) and extent of delamination (bottom). (US Nuclear Regulatory Commission, 2010)

A delamination failure at Crystal River Nuclear Power Plant in 2009 indicated that creep may be an issue in long-term PCCV operations (US Nuclear Regulatory Commission, 2010). During a planned shutdown and after tendon detensioning, an opening was cut in the PCCV to replace a steam generator. While creating this opening, workers saw that there was a gap, or separation, affecting the outer layer of concrete in the building wall. This gap or separation in concrete is commonly referred to as a delamination. The delamination occurred on the plane formed by the post-tensioning tendon ducts, see Figure 2-27. The delamination occurred in an hourglass shape across the structure as presented in Figure 2-28. This plane is an area where the concrete stress state changes from pure compression to a state involving tension (US Nuclear Regulatory Commission, 2015). The delamination is a source for discontinuities in the cross-section of the PCCV wall, effectively decoupling the in-plane compressive forces from the PT with the interior portions of the wall, thereby allowing for a multitude of problems to occur that could damage and failure to an extent requiring decommissioning of the PCCV. While several issues contributed to the delamination event, the importance of creep could not be determined.

- The radial strain profile after detensioning is significantly different if creep is included in the analysis (Case A1 vs A2, Figure 3-73 and Figure 3-74 respectively), and the profile with creep better resembles the hourglass shape found in the delamination cracking pattern at Crystal River (see Figure 2-28 for the hourglass delamination shape).

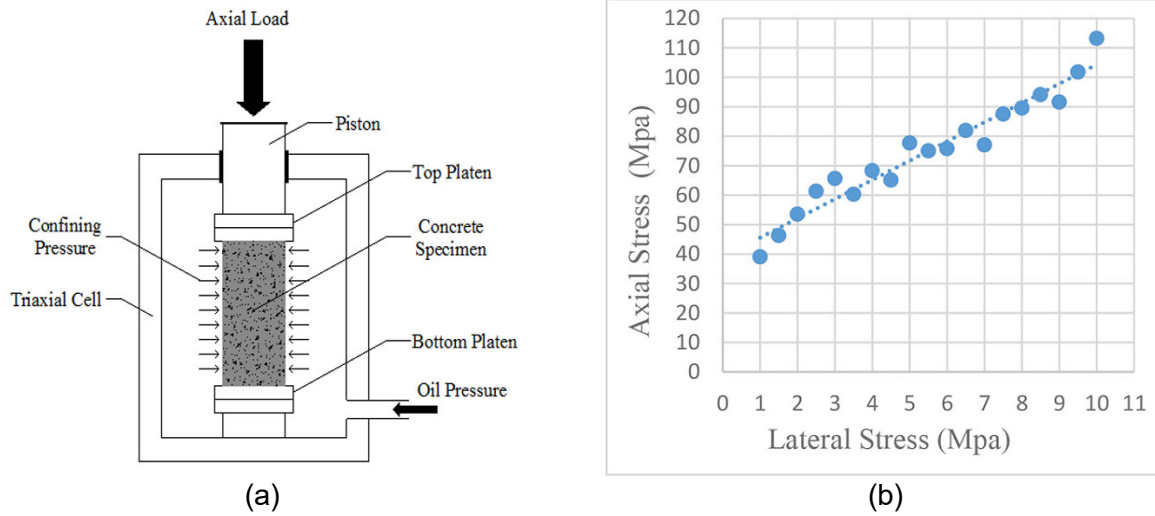
Figure 2-29 (a) Example concrete cylinder triaxial stress compressive test; (b) Ultimate axial stress vs applied lateral stress. (Javanmardi, 2020)

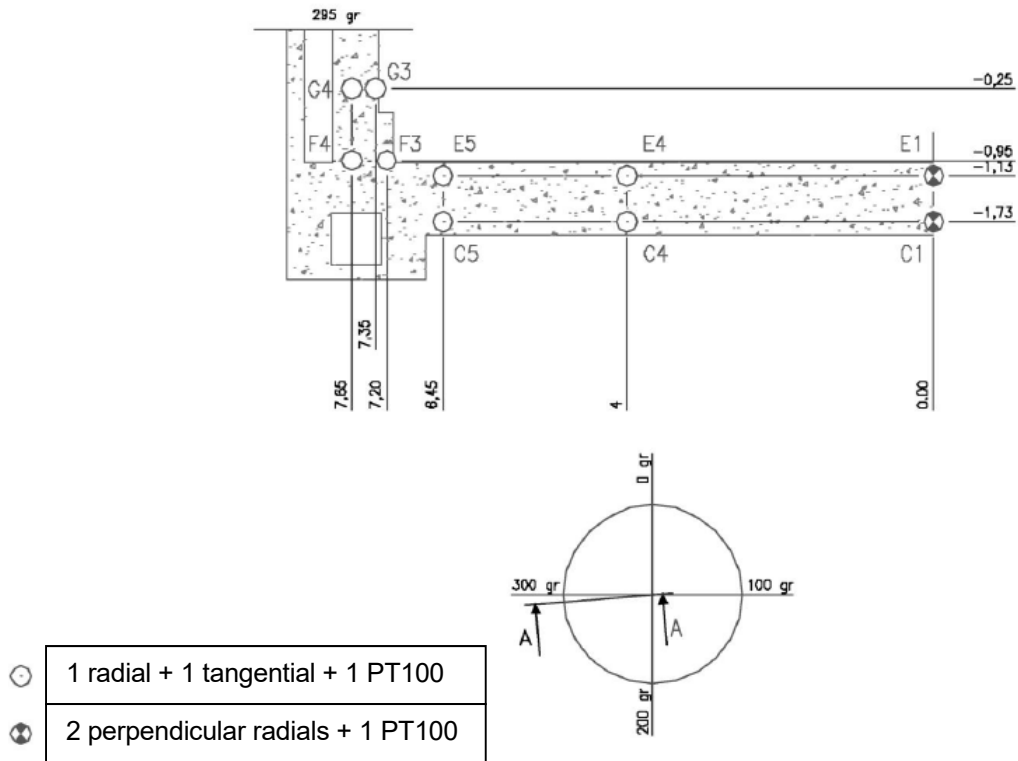
**Figure 3-5** Strain gauges and thermometers in the base slab. The shape of the base slab is given as an indication. There is no gallery in the base slab of the mockup. Please see Figure 3-4 for the real shape of the base slab. (Électricité de France, 2018)

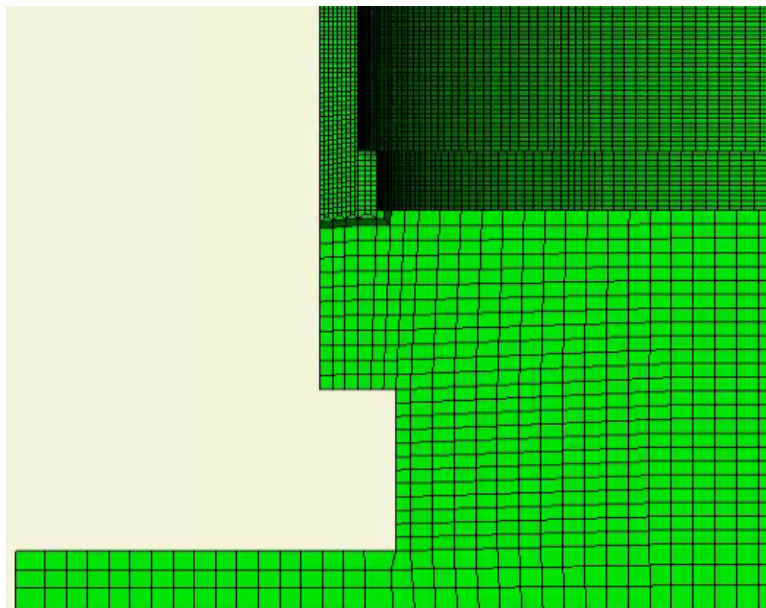
**Figure 3-16** Cut view of the PCCV with 'fine' mesh showing the transition between coarse elements (in the basemat) and fine elements (in walls and dome).

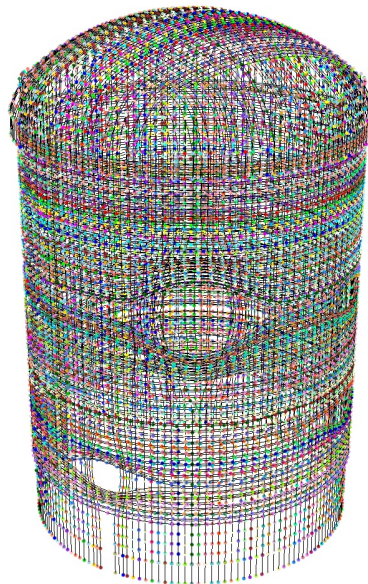
**Figure 3-20** VeRCoRs tendon geometry and mesh.

The PT tendons geometry and mesh is shown in Figure 3-20. The tendons mesh contains 44,466 2-noded beam elements with each element approximately 0.5 m long. The hoop tendons encircle the entire cylinder and are tensioned using protruding elements (not shown). Hoop tendons alternate on which side of the cylinder the strands protrude to evenly distribute PT forces. The vertical tendons and dome tendons in the CV are separated into three different groups: vertical tendons, dome tendons, and combined J tendons. Vertical tendons range from the bottom of the CV to the top of the cylinder. Dome tendons range across the dome and do not extend into the cylinder wall. Combined J tendons as shown in Figure 3-21 range from the base of the cylinder wall up and across the dome.

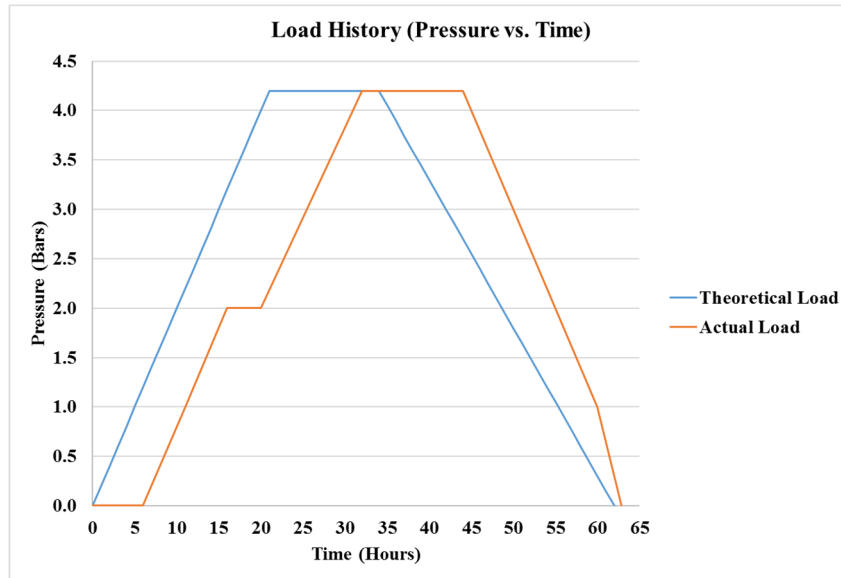
**Figure 3-23 VeRCoRs pressurization curves. The Actual Load has a delayed start, a pressure hold at 2.0 bars relative, and a steeper decline post-4.2 bars relative.**

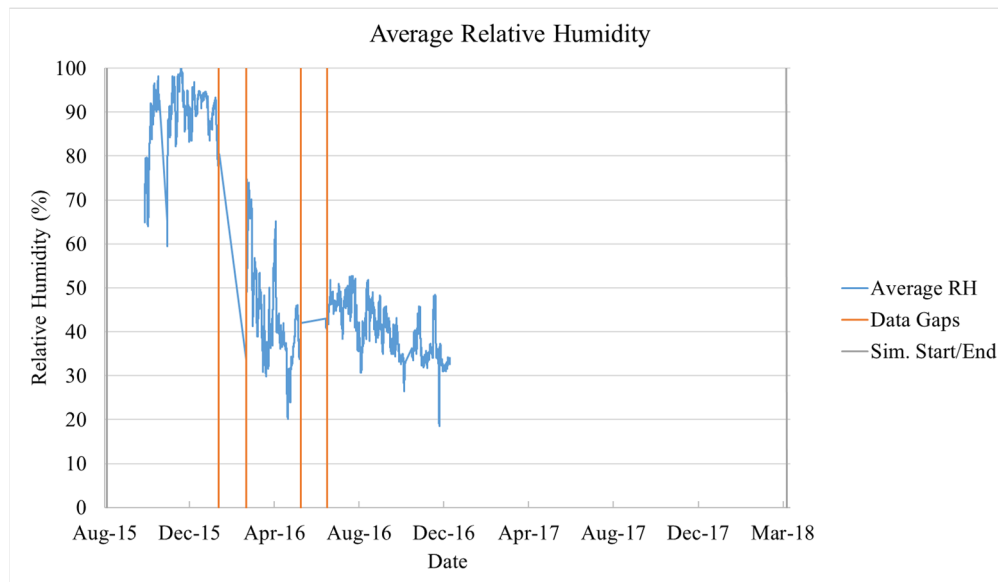
**Figure 3-24 Average relative humidity in contact with the VeRCoRs concrete. Gaps in data are shown between vertical lines. Dates are listed as Month-Year.**

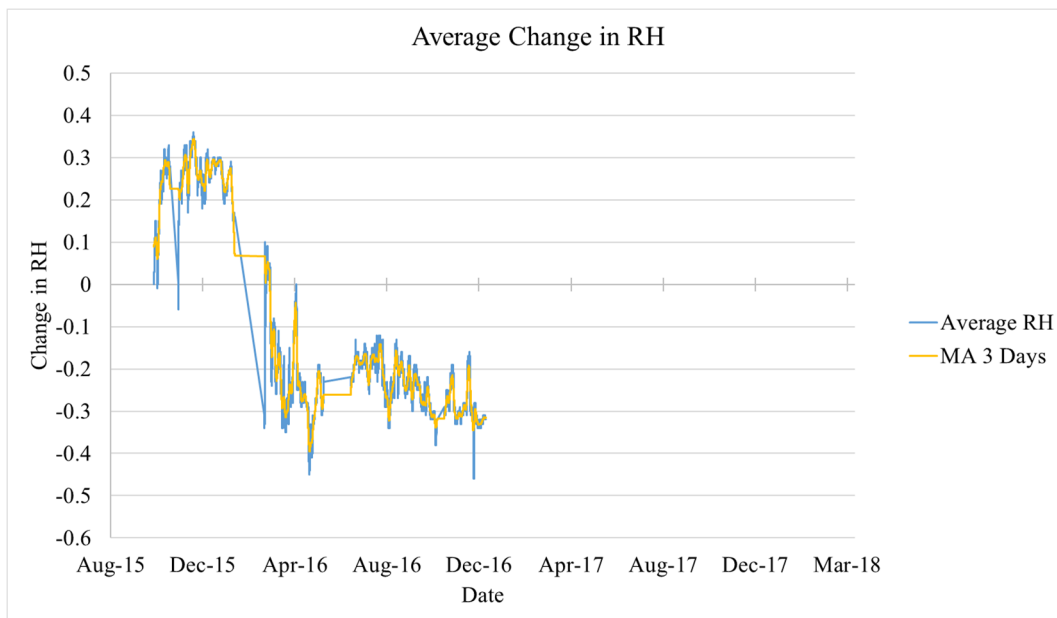
**Figure 3-25** Change in relative humidity inputs for ABAQUS. A moving average (MA) of 3 days of data was utilized to smooth the experimental data. Dates are listed as Month-Year.

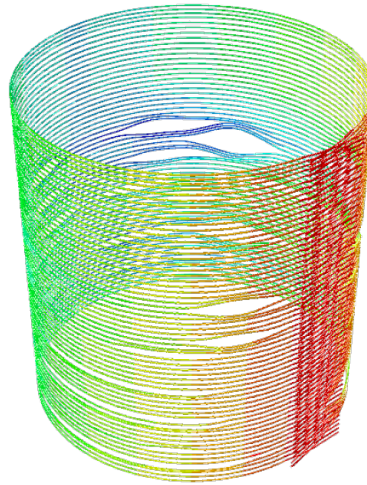
Figure 3-26 Set 1 of 2 hoop tendon stress after jacking.

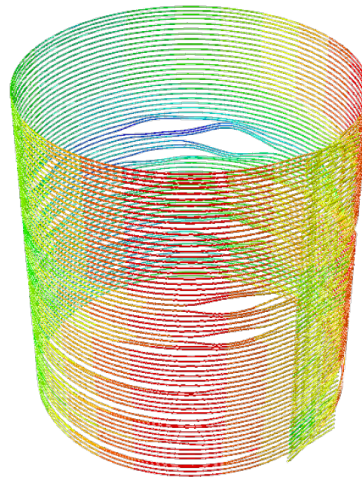
Figure 3-27 Set 1 of 2 hoop tendon stress after anchor set.

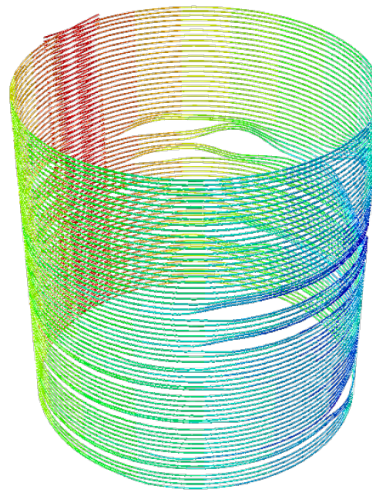
Figure 3-28 Set 2 of 2 hoop tendon stress after jacking.

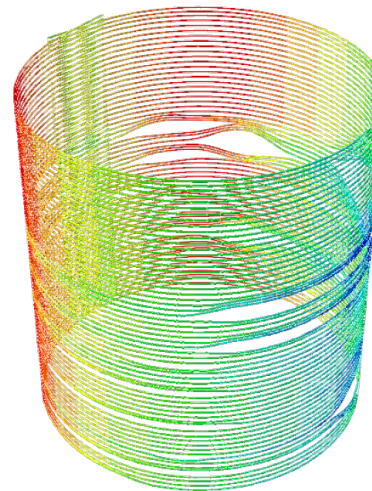
Figure 3-29 Set 2 of 2 hoop tendon stress after anchor set.

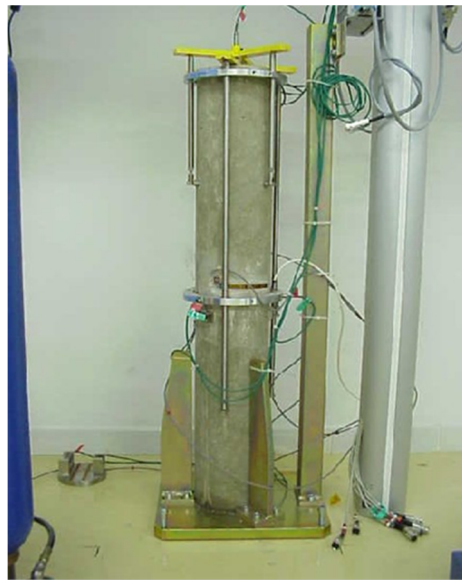
**Figure 3-37** Drying shrinkage concrete cylinder specimen.

A cylinder of concrete was cast, cured for 28 days, and then exposed to a dry environment of 50% RH for 762 days by EDF for the VeRCorRs experiment (Corbin, 2018). See Figure 3-37 and Figure 3-38. The experimental data and the ABAQUS simulation results are presented in Figure 3-39. The ABAQUS simulation geometry and mesh is presented in Figure 3-40. The material properties used in the simulation were as follows:

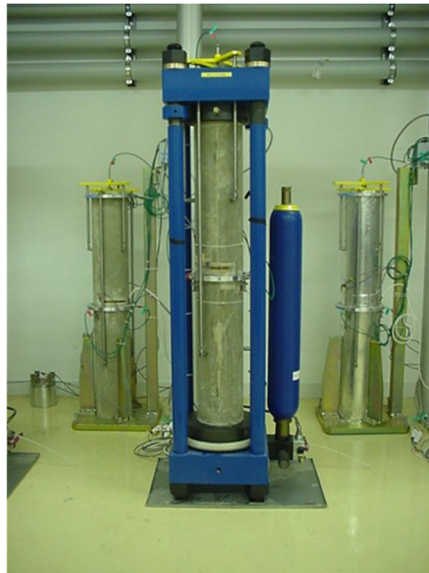
**Figure 3-41** EDF creep test configuration. Specimen is 0.16 m diameter and 1 m tall.

The EDF drying creep test experimental setup is shown in Figure 3-41 and Figure 3-42. The EDF basic creep test experimental setup is identical to the drying creep test except that the basic creep test specimen was sealed to prevent drying. The data for both experiments is presented in Figure 3-43.

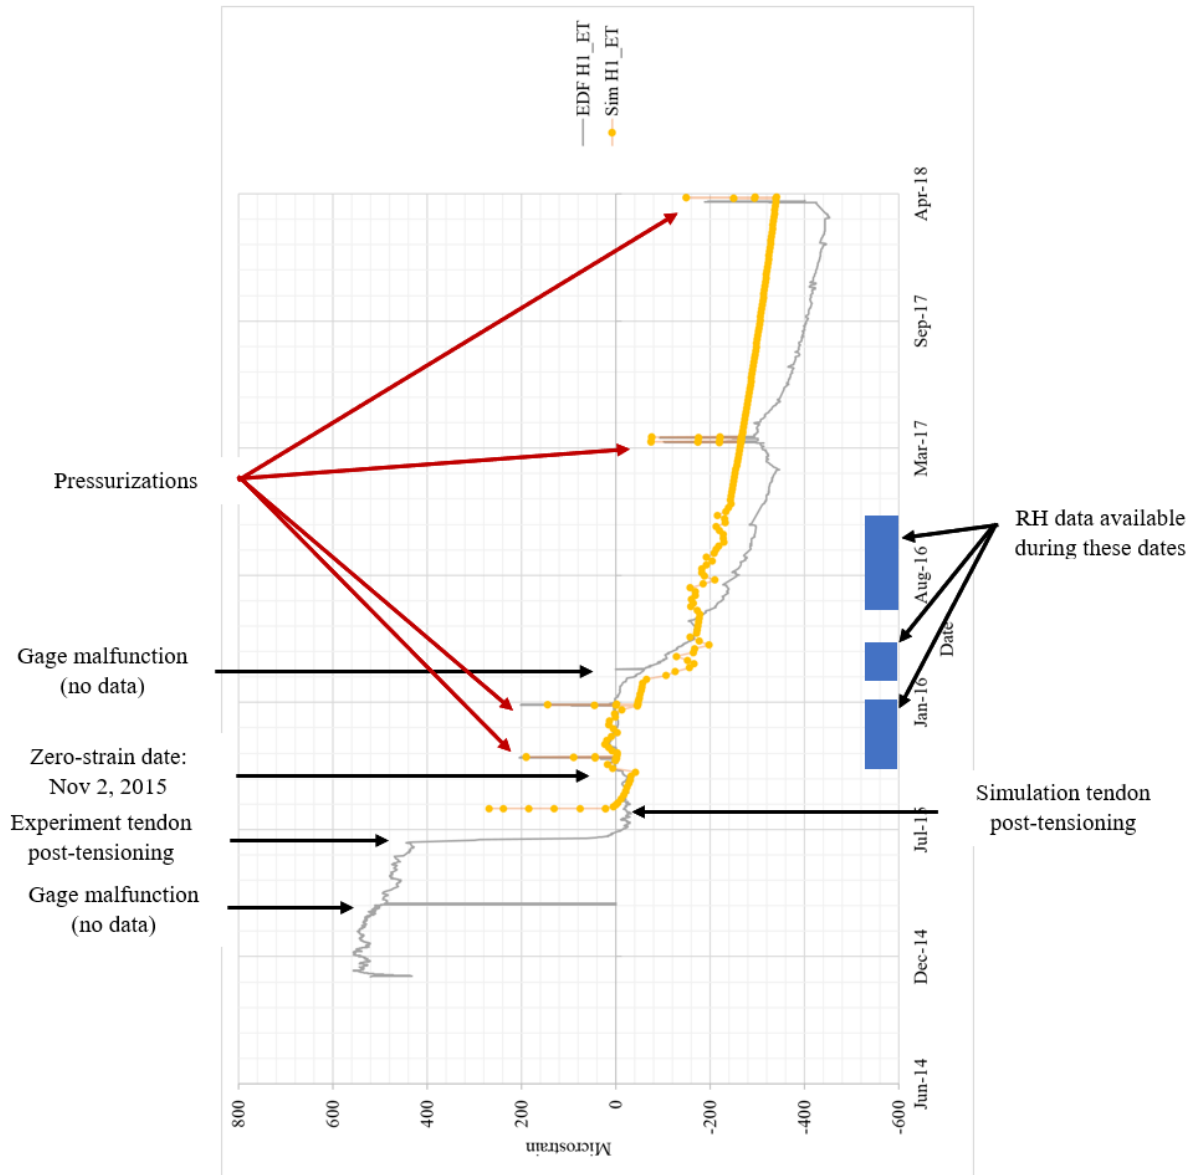
**Figure 3-50 VeRCoRs strain gage data comparing experimental data with simulation results.**

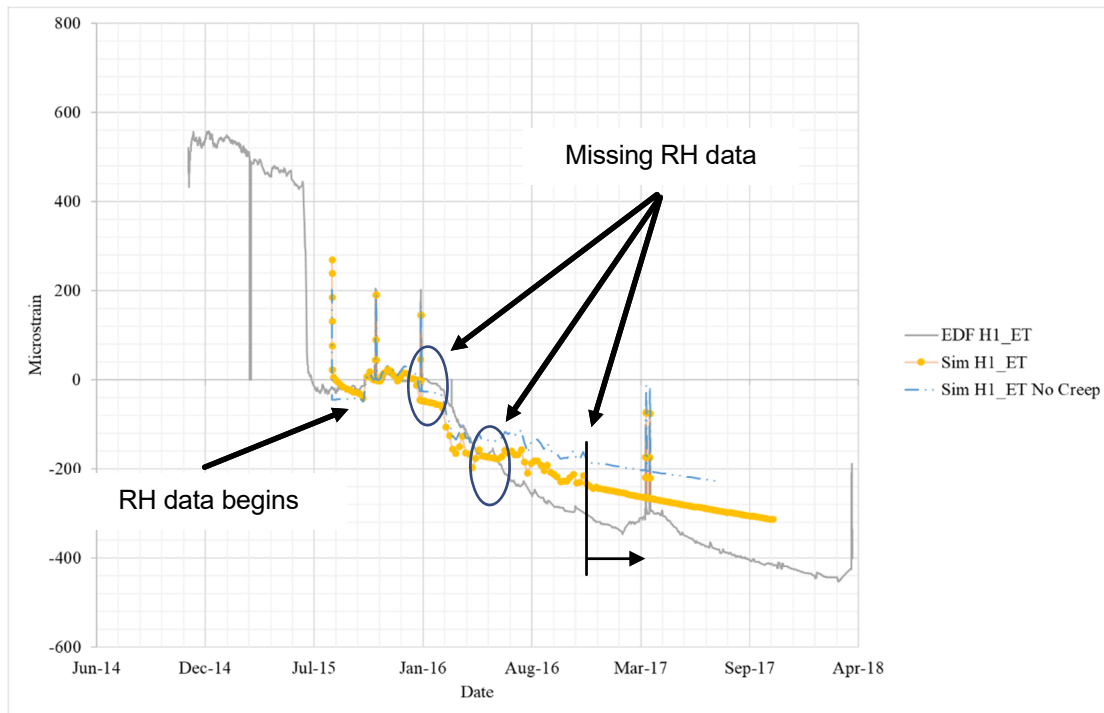
**Figure 3-53** Time history of gage H1ET showing EDF experimental data, the simulation results, and the simulation results excluding creep effects.

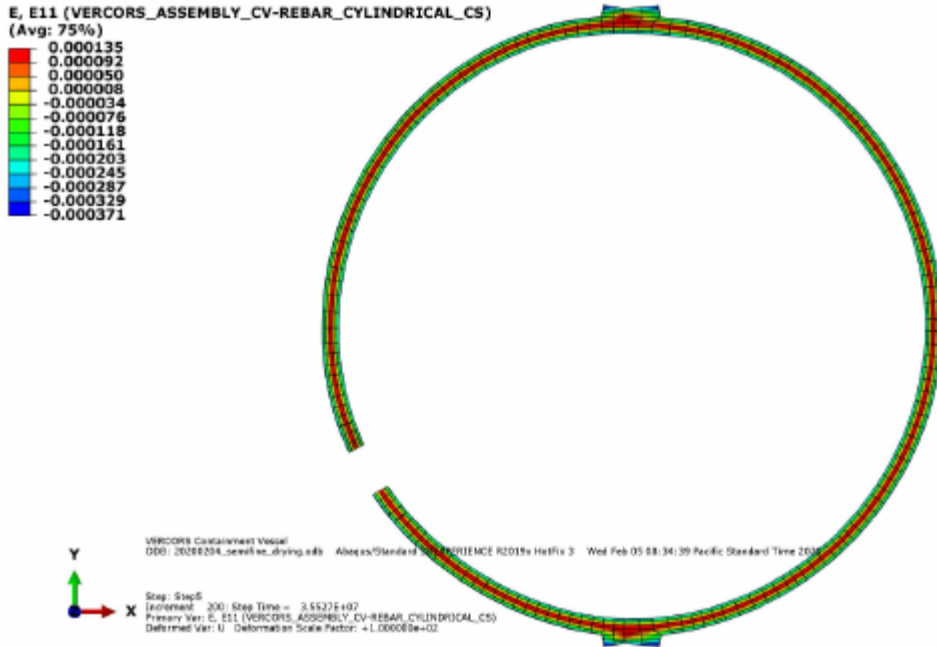
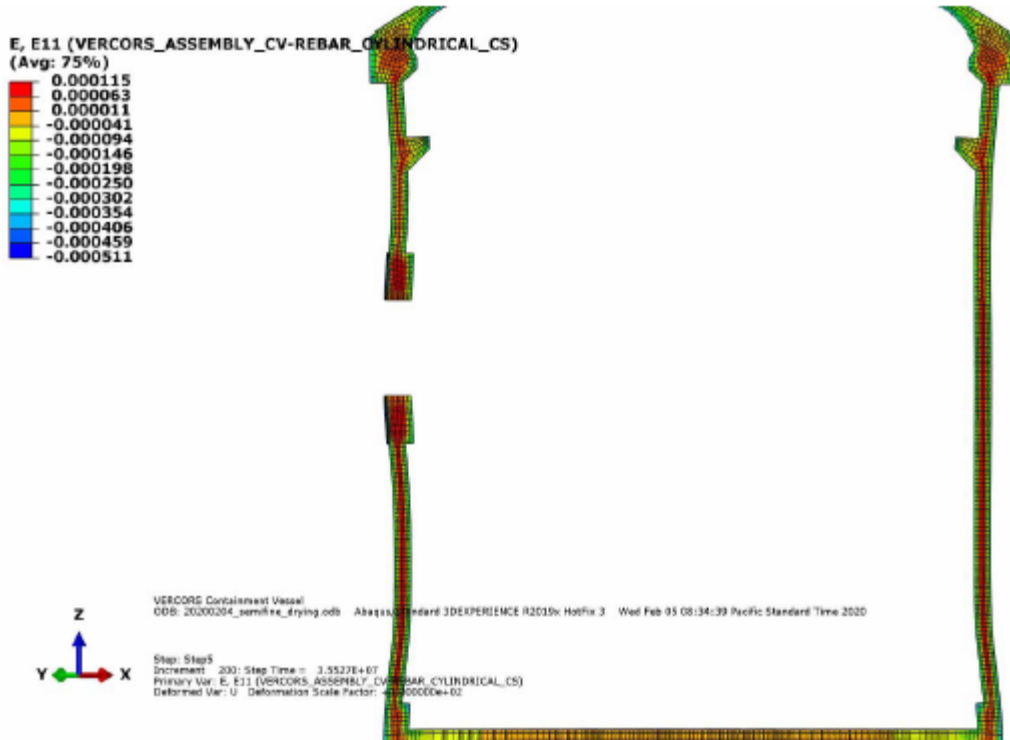
**Figure 3-55 Moffat & Nichol ABAQUS plots of tensile "radial" strains in the containment vessel.**

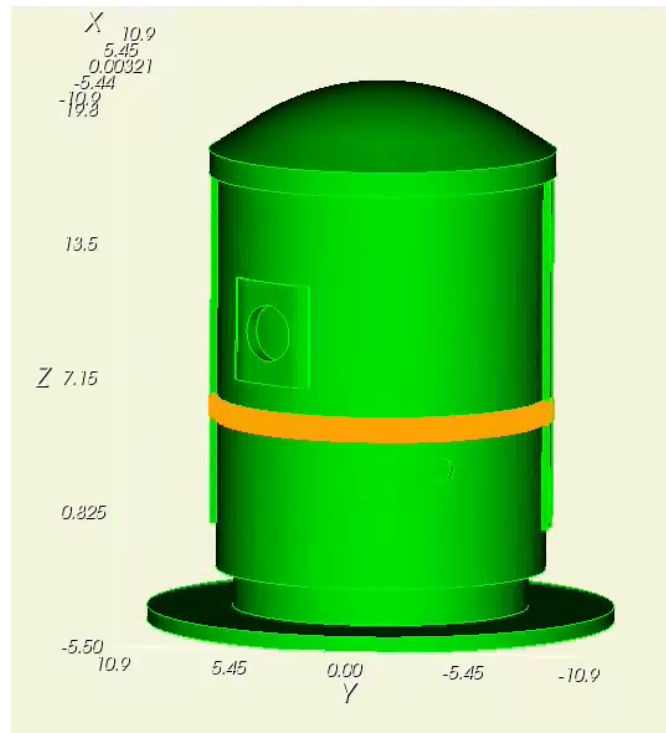
**Figure 3-56 Thin-slice section of the VeRCoRs PCCV selected for fine mesh analysis.**

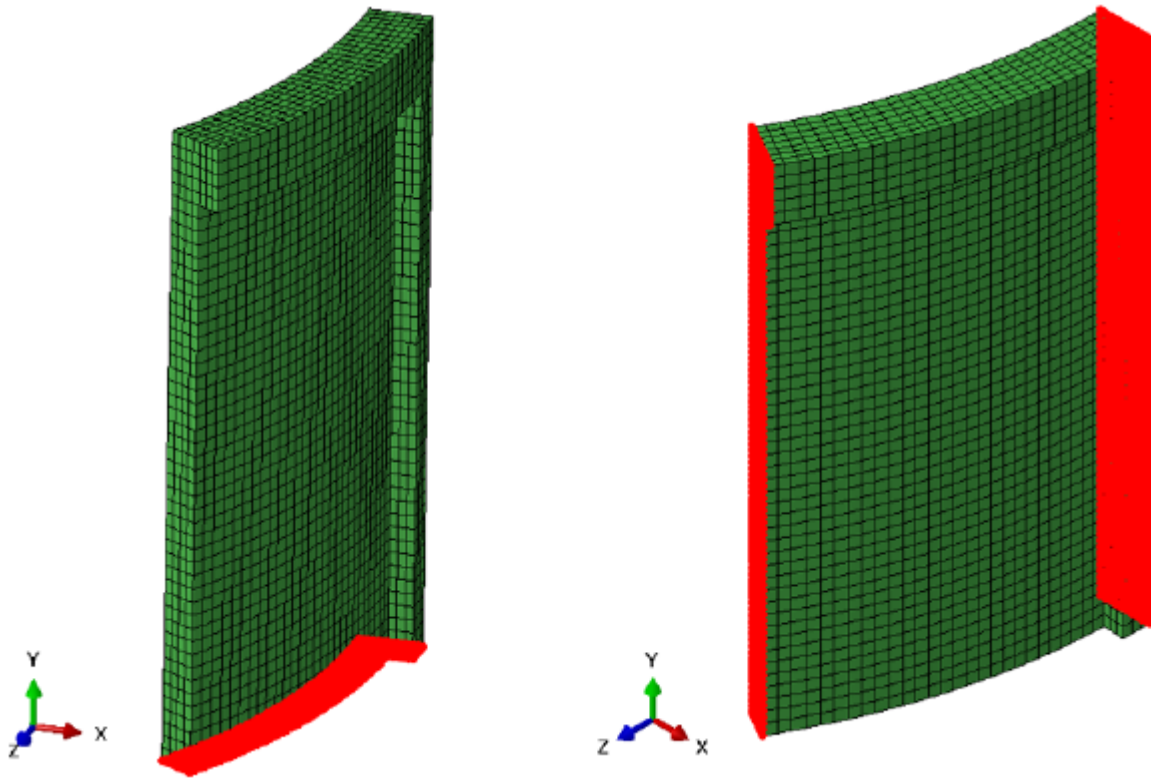
**Figure 3-70 FEM - Vertical (left) and circumferential (right) boundary conditions.**

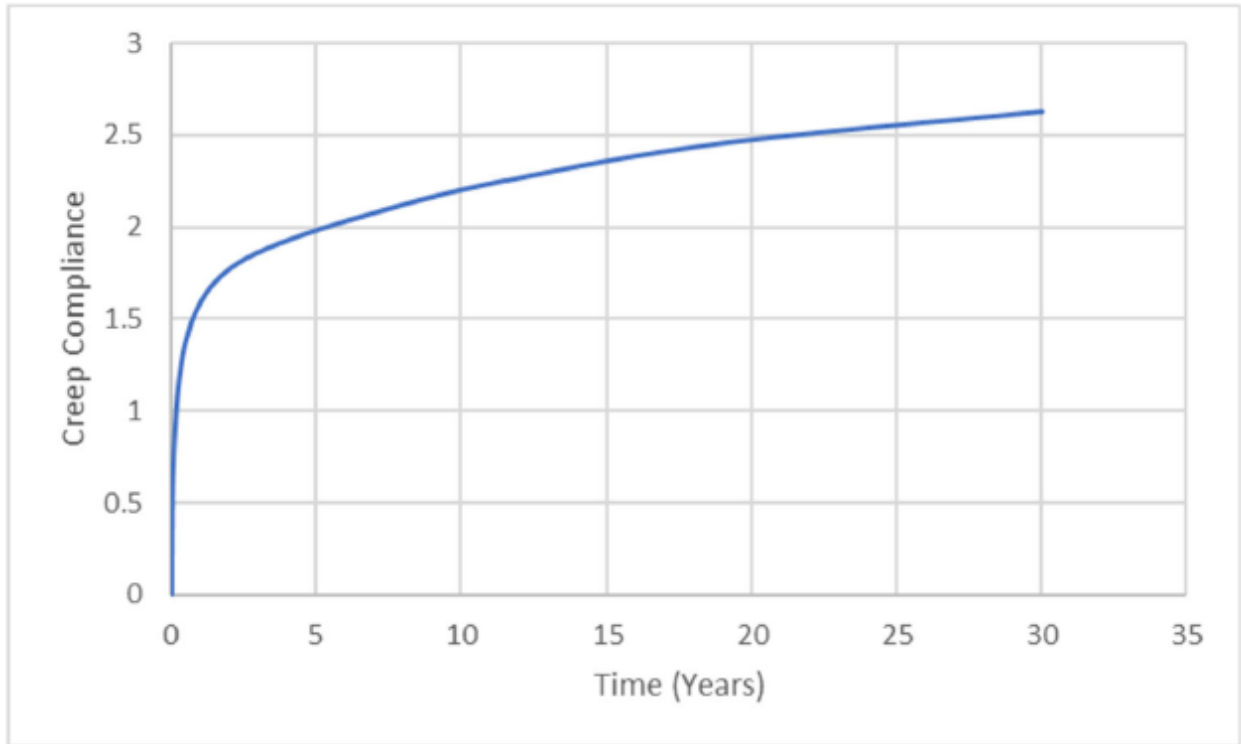
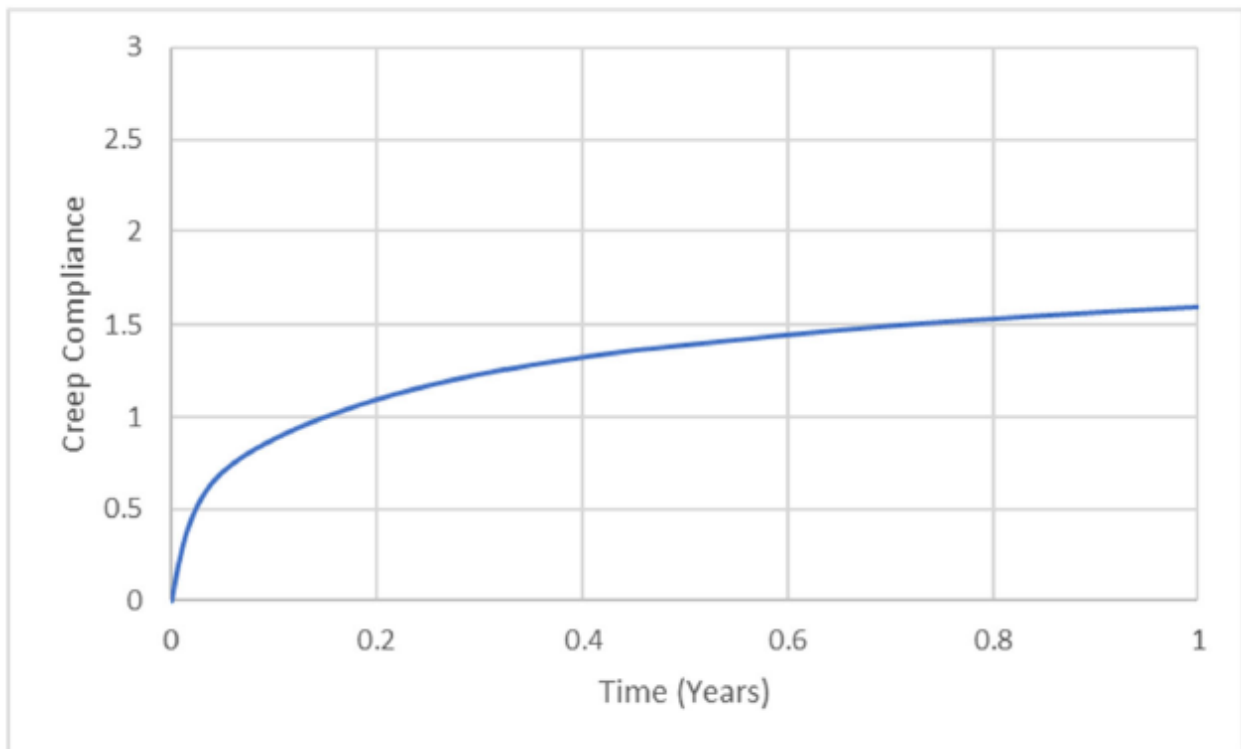
Figure 3-71 FEM—Creep compliance (Top = 30 year, Bottom = 1 year).
