# Aging of Post-tensioned Concrete Containment Vessels with Emphasis on Concrete Creep and Creep Rupture

Manuscript Completed: August 2021  
Date Published: March 2022

J. Hogancamp<sup>1</sup>  
C. Jones<sup>2</sup>  
M. Sircar<sup>3</sup>  
R. Gascot<sup>3</sup>  
B. Dameron<sup>4</sup>  
P. Chang<sup>4</sup>  
E. Kjolsing<sup>5</sup>  
R. James<sup>6</sup>

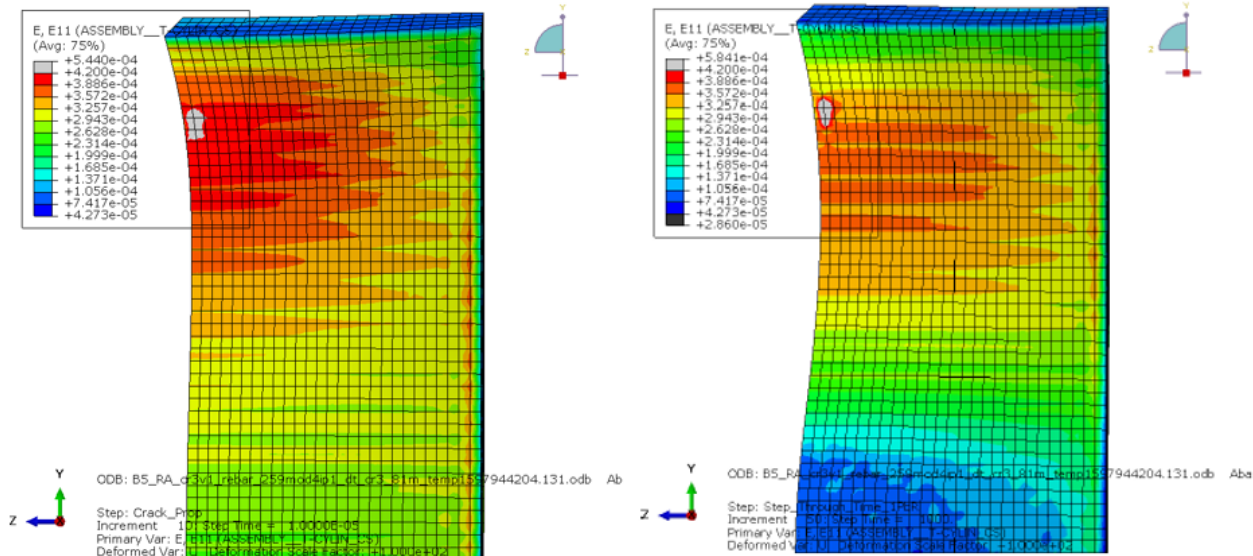
**Figure 3-78 Case B5—Radial strain after introduction of local defect (left) and 1250 hrs after detensioning (right).**

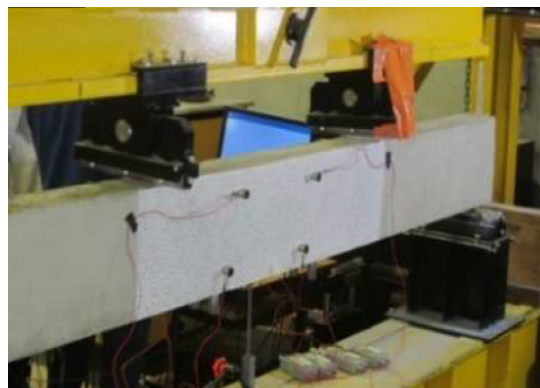
**Figure 4-4** 3-point bending test of concrete specimen monitored with acoustic emission. (Garnier, et al., 2018)

Three-point bend tests were monitored using acoustic emission as shown in Figure 4-4. Each incident was recorded, and the data was combined into a crack location image as shown in Figure 4-5. Acoustic emission techniques were found to be useful for estimating position and dimension of a crack so long as the monitoring system was active prior to acoustic energy release.

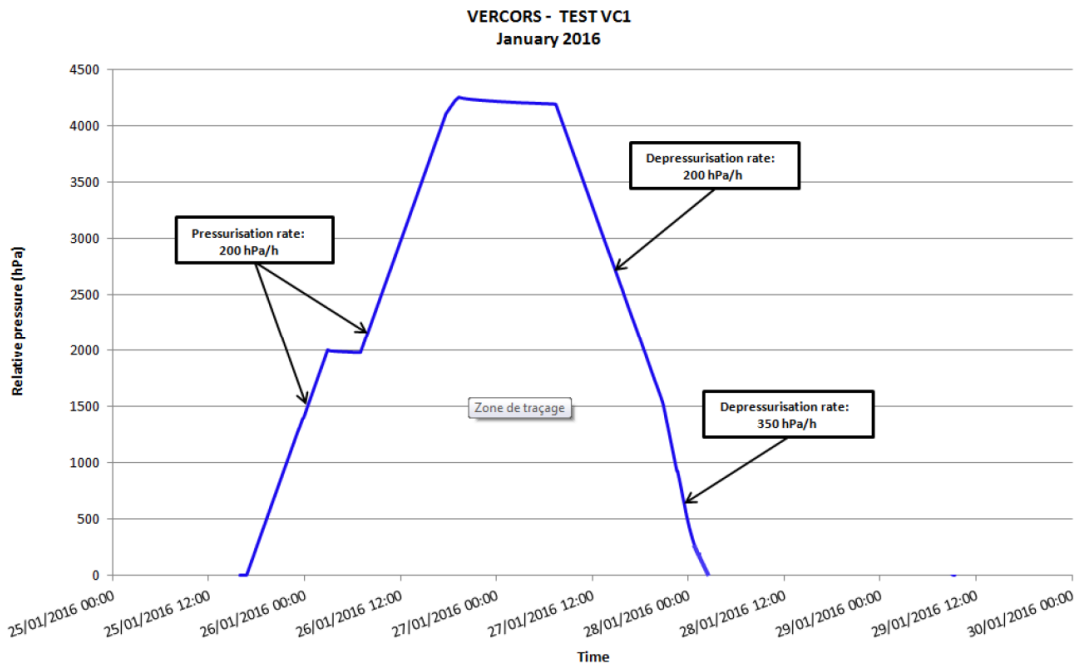
**Figure 4-9 Pressure cycle for VeRCoRs pressurization test VC1. (Henault, et al., 2018)**

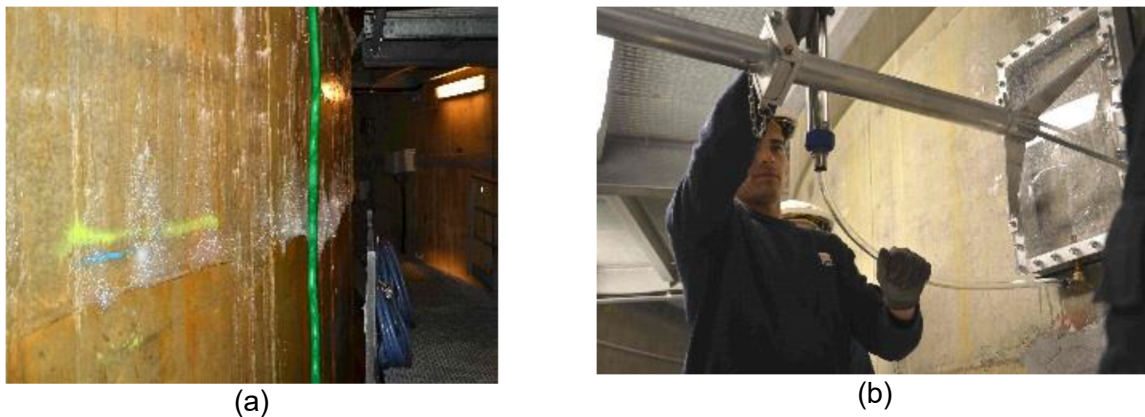
**Figure 4-11 (a) Leaking zones revealed by soap bubbling. (b) Flow rate measurement with collecting box and flowmeter. (Henault, et al., 2018)**

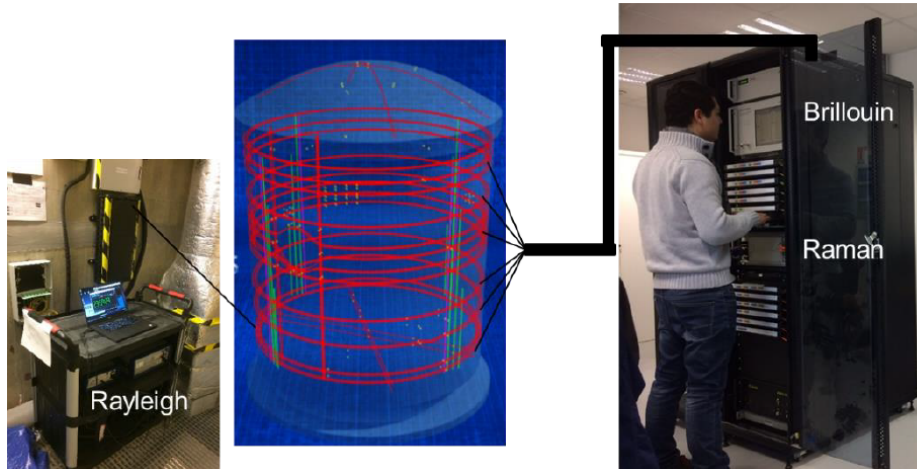
**Figure 4-13 (Left) Rayleigh measurement DAQ. (Center) Fiber optic installations in VeRCoRs. (Right) Temperature and strain DAQs. (Henault, et al., 2018)**

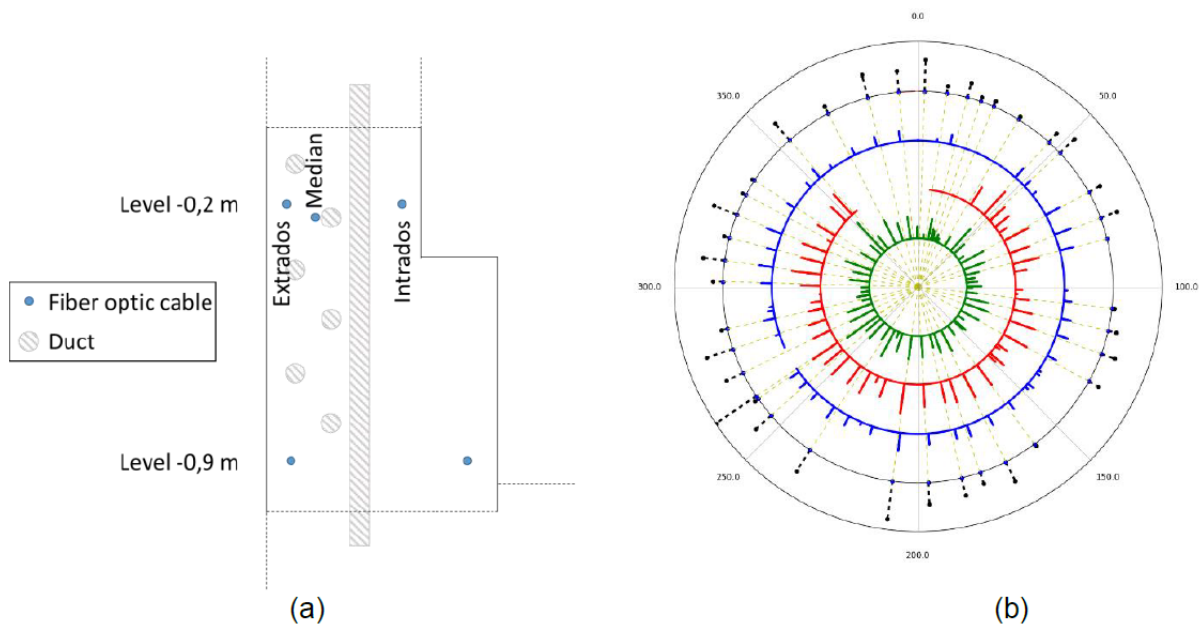
**Figure 4-14 (a) Localization of the outer (extrados), middle (median), and inner (intrados) fiber optic cables in the gusset zone as presented by EDF. (b) Radial map of cracks obtained with Rayleigh measurements at level - 0.2m at 3 different depths. (Henault, et al., 2018)**

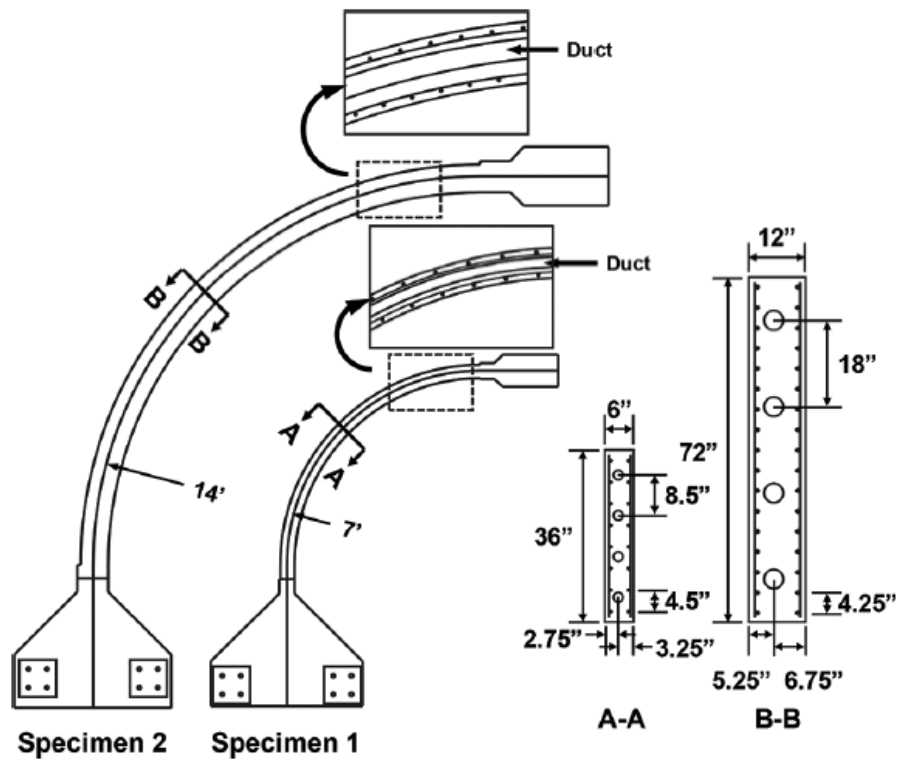
Figure 5-2 Summary of dimensions and reinforcement details. Duct numbering starts from the top duct (e.g., Duct 1 is the top duct). (Choi, Woods, Hrynyk, & Bayrak, 2017)

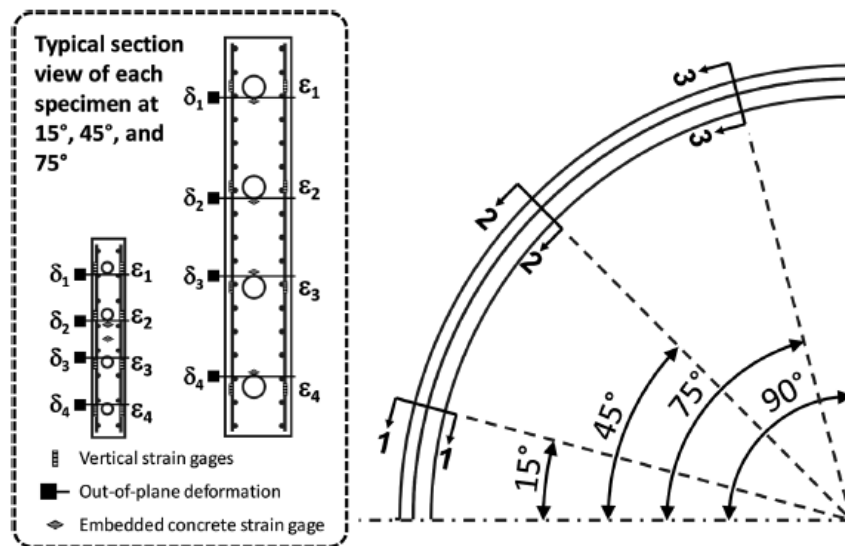
Figure 5-3 Summary of mechanical instrumentation plan including strain gages on the vertical reinforcement, out-of-plane deformation sensors, and embedded concrete strain gages. (Choi, Woods, Hrynyk, & Bayrak, 2017)

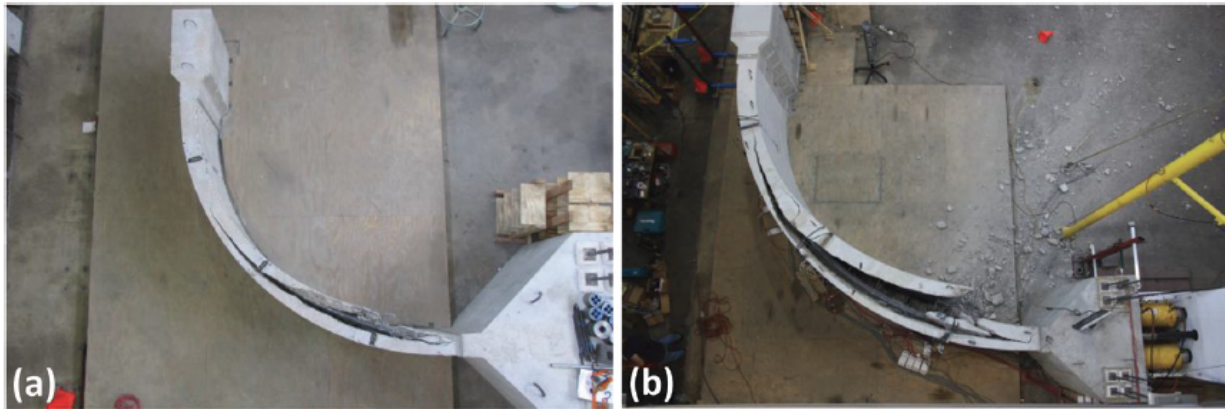
**Figure 5-4** Specimens after delamination failure: (a) Specimen 1—delamination crack formed from 0° to 68°; (b) Specimen 2—delamination crack formed from 0° to 78°. (Choi, Woods, Hrynyk, & Bayrak, 2017)

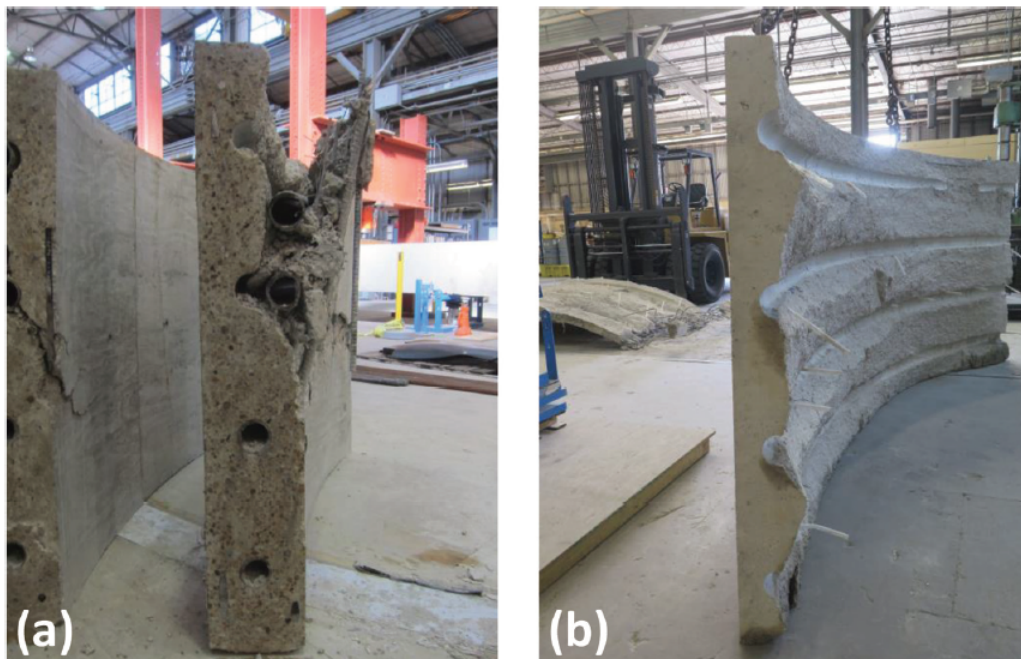
**Figure 5-5** Typical sectional crack pattern: (a) Specimen 1 at 15° location; and (b) Specimen 2 at 8° location. (Choi, Woods, Hrynyk, & Bayrak, 2017)

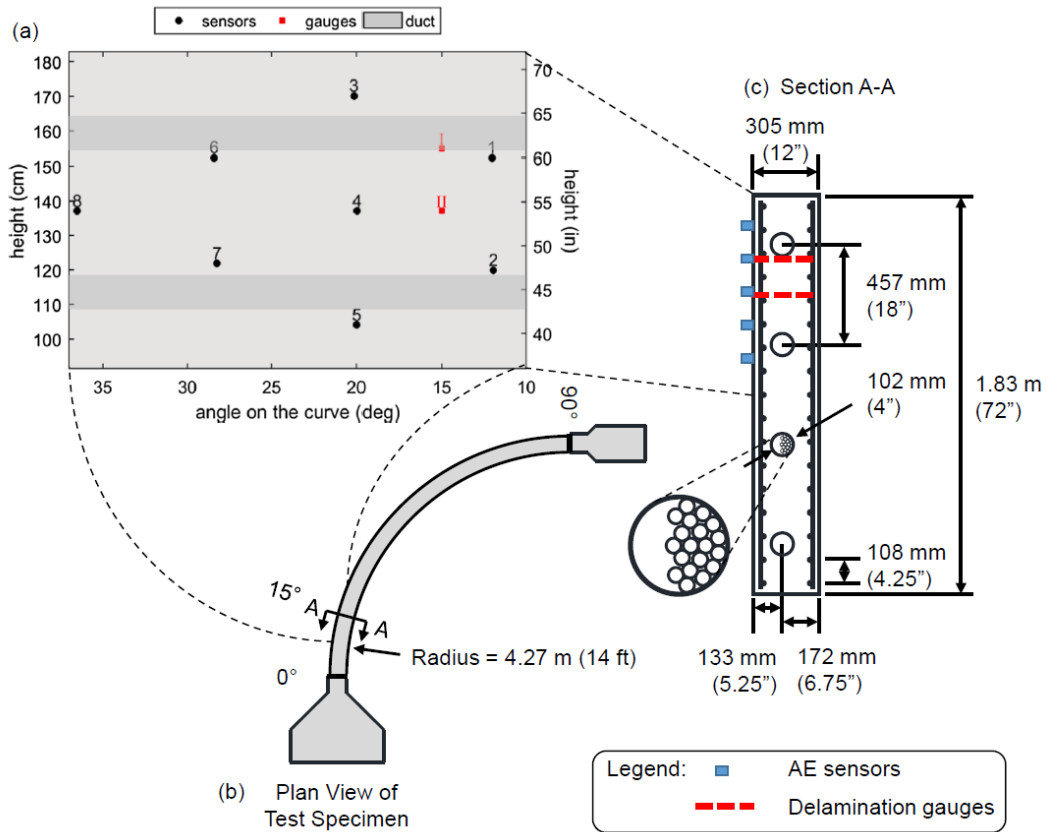
**Figure 5-7 Acoustic monitoring plan and section view of Specimen 2. (Ebrahimkhanlou, Choi, Hrynyk, Salamone, & Bayrak, 2019)**

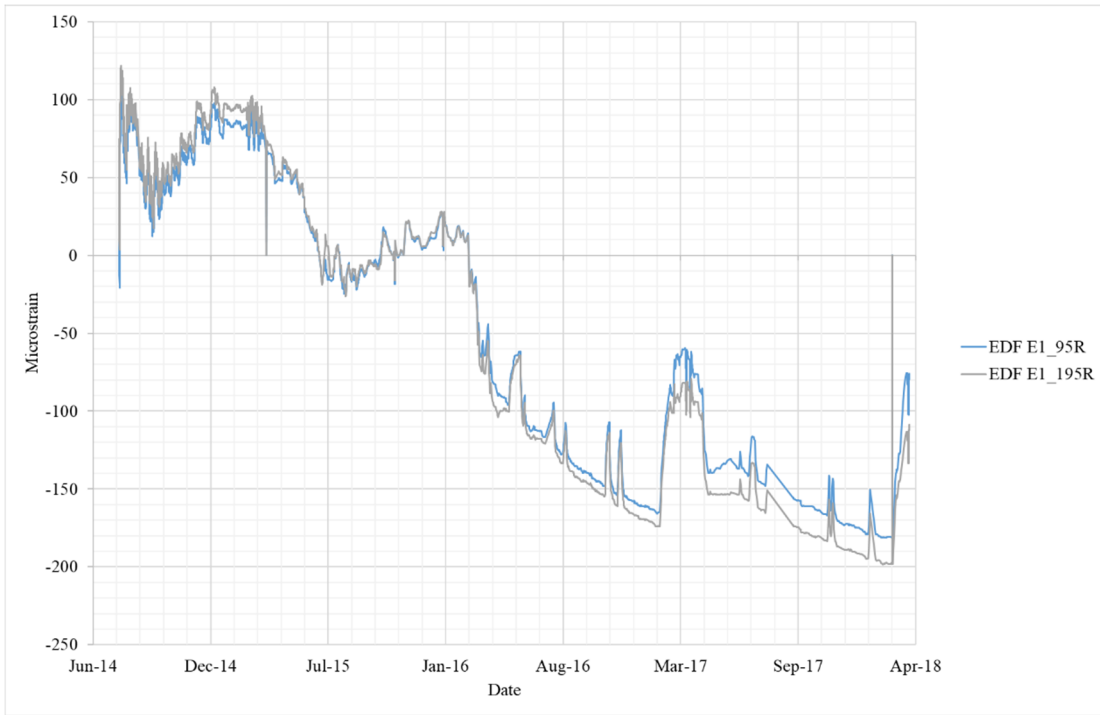
**Figure A-2 EDF strain gage data for E95R and E195R.**

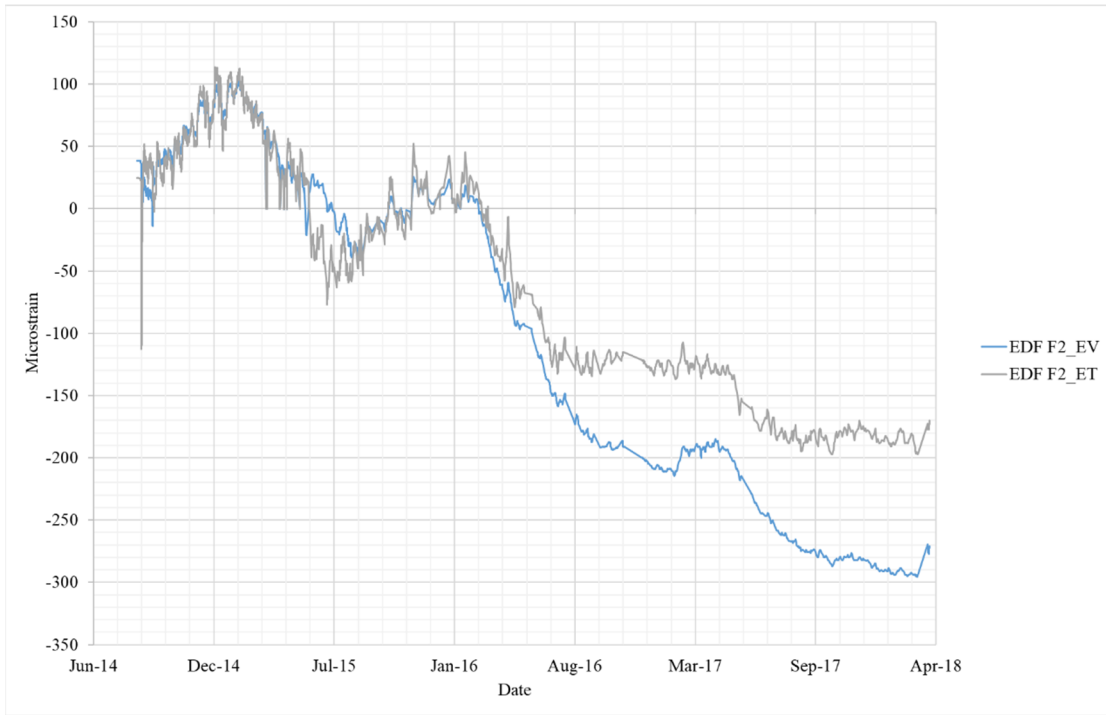
**Figure A-6 EDF strain gage data for F2EV and F2ET.**

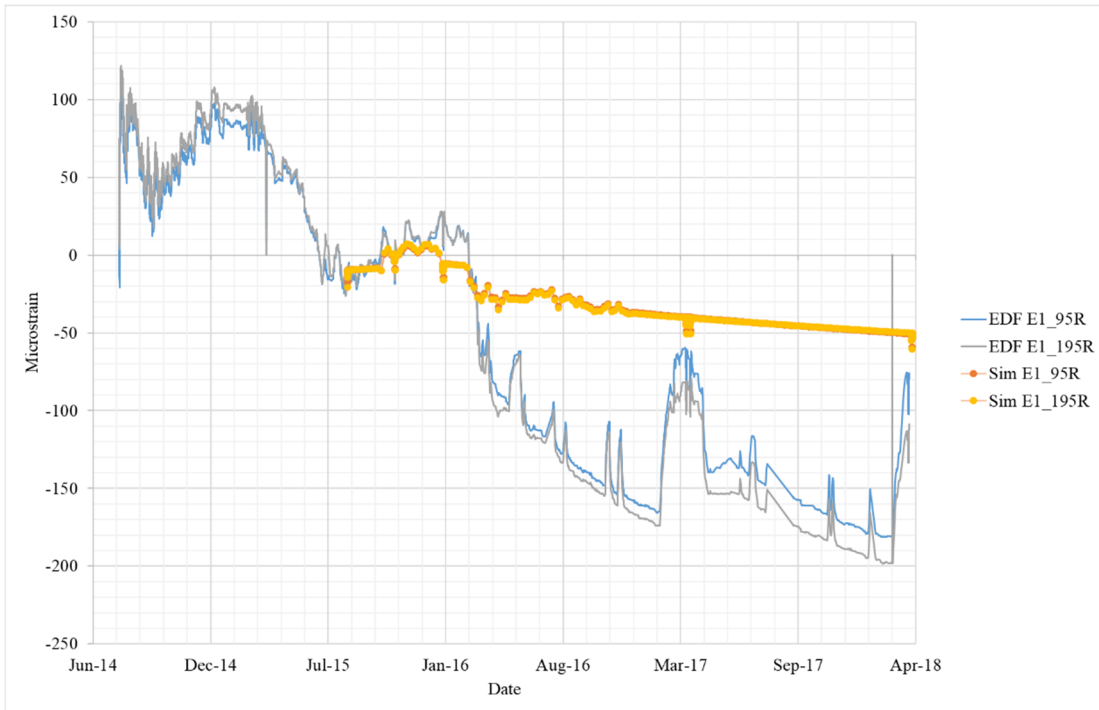
**Figure A-17 Comparison strain gage data for E95R and E195R.**

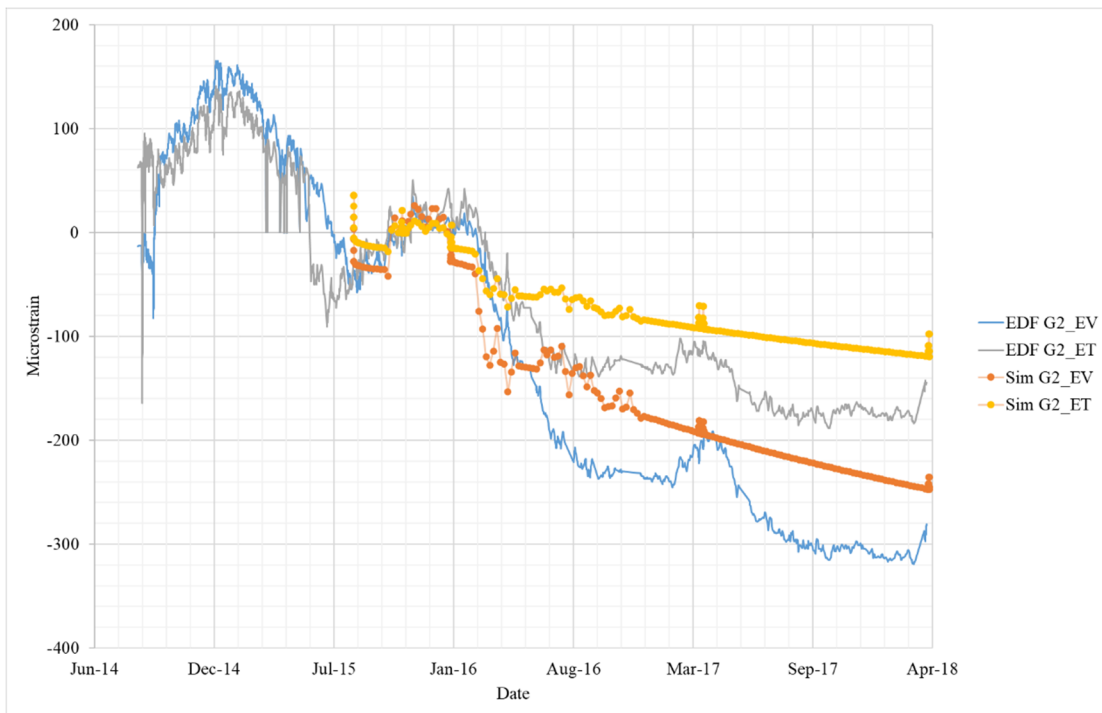
**Figure A-19 Comparison strain gage data for G2EV and G2ET.**

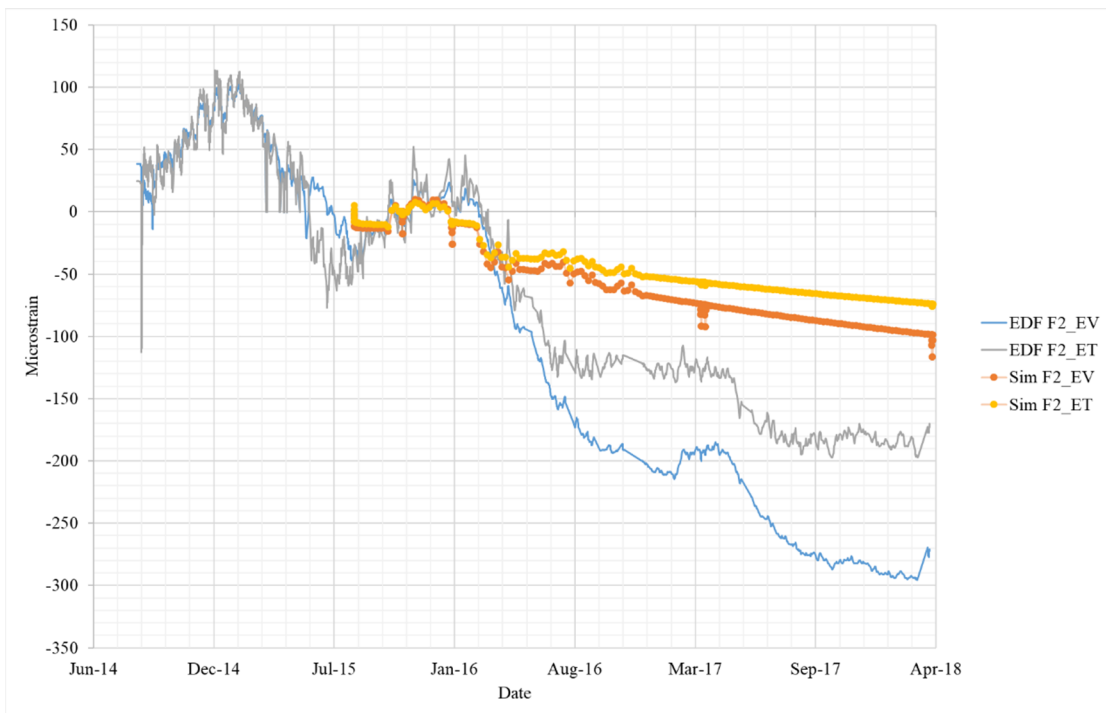
**Figure A-21 Comparison strain gage data for F2EV and F2ET.**

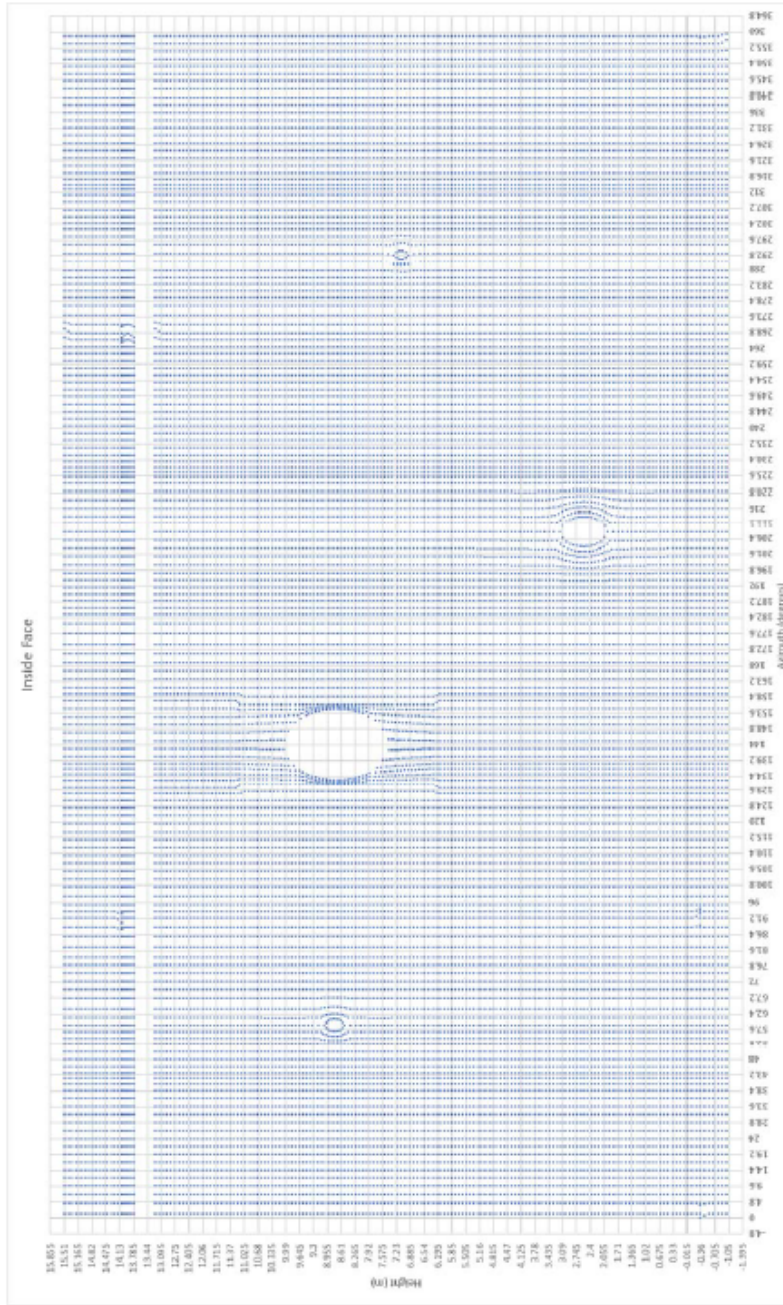
Figure 4. Node Location on Inside Face

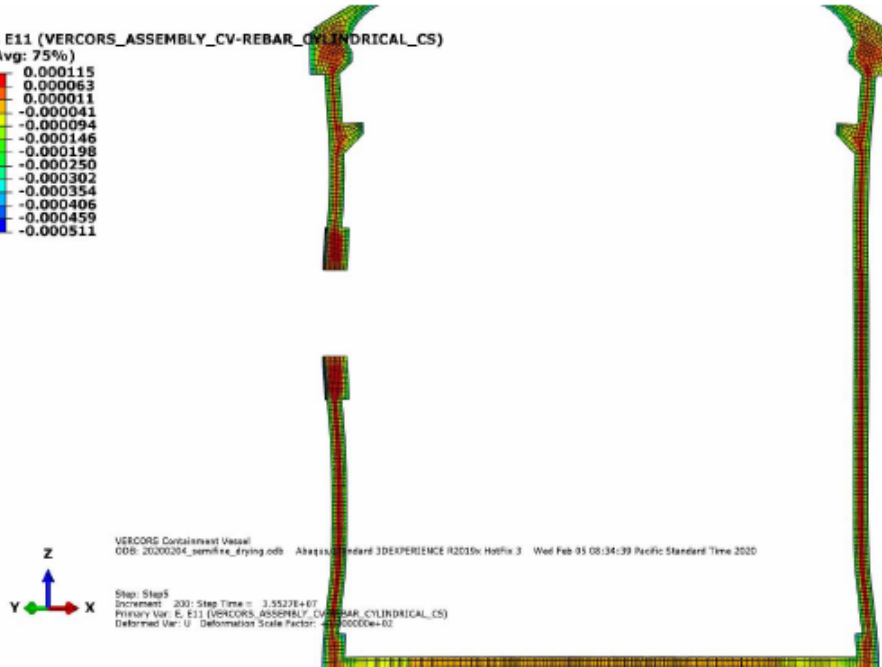
The two figures included show radial strain at horizontal and vertical slices, occurring at the end of Load Step 5. That Load Step represents a time after significant shrinkage has occurred, and after two full pressure cycles have taken place, but at the zero pressure unloaded condition. A few observations and conclusions from studying the radial strain data are as follows:

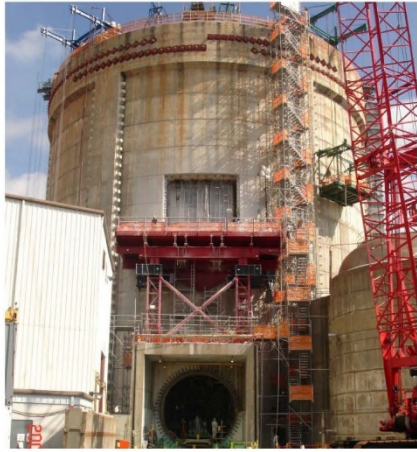
Figure 1-1. Crystal River Structure (Top) and Extent of Delamination (Bottom)

This study is a limited scope to examine the issue of creep in concrete containment vessels and identify any need for further research. This effort is not an attempt to reconstruct all the circumstances that occurred in the Crystal River delamination problem as a kind of “root cause” analysis. Rather, the intent is to consider representative conditions for a situation where a known problem develops in order to show that the modeling employed can provide an indication of potential problems.

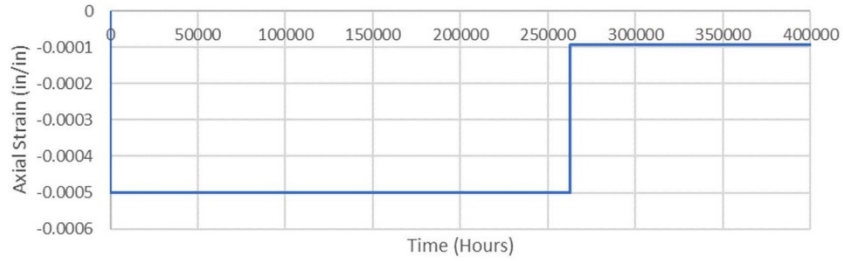
Figure 2-2. Non-Recoverable Displacement

Figure 2-2 shows the axial strain (negative = compression) when a pressure is applied at time zero and then removed after 30 years (note that creep is turned off in this test case). Because the modulus has increased over time the element does not return to a zero-strain state upon unloading.

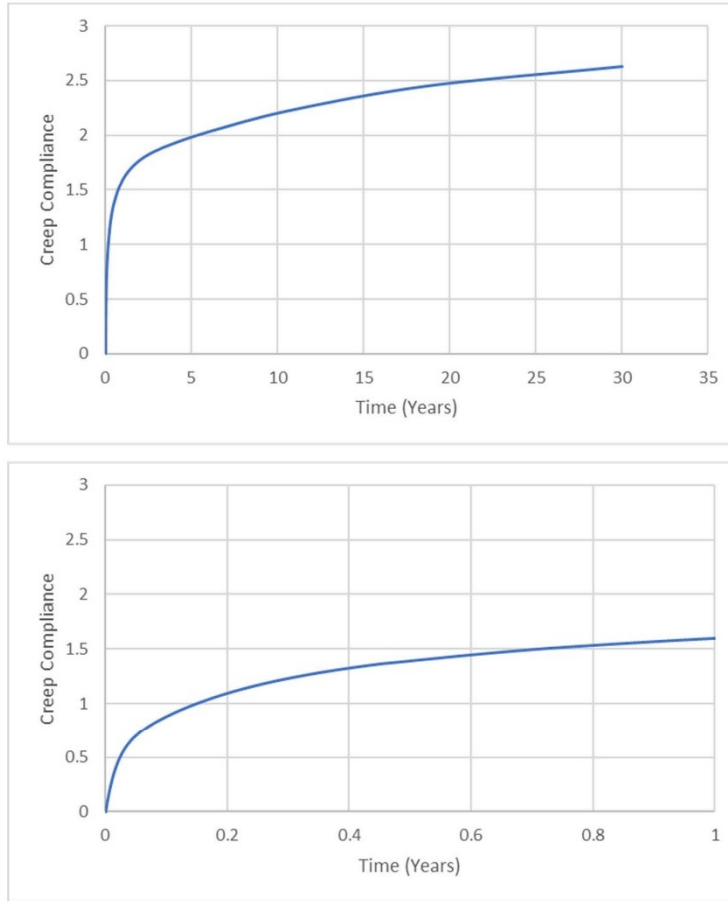
**Figure 3-6. FEM - Creep Compliance (Top=30yr, Bottom=1yr)**

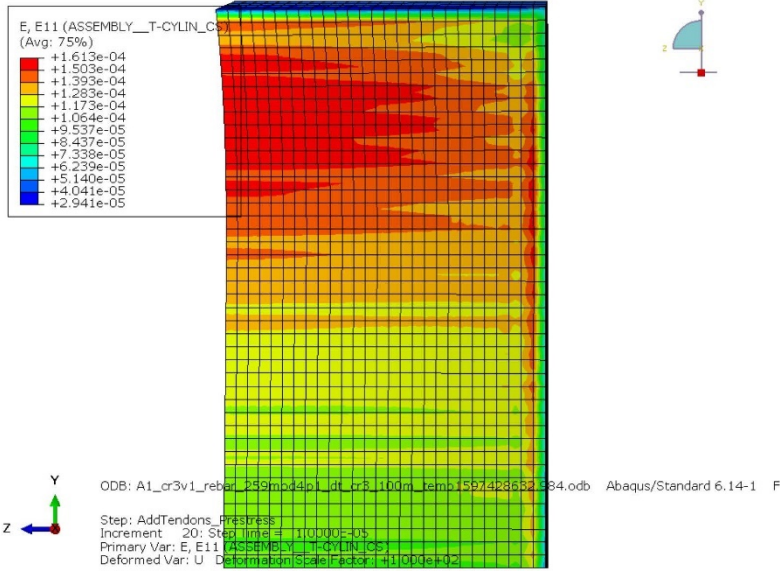
Figure 4-1 Concrete Radial Strain After Initial Stressing [A1]

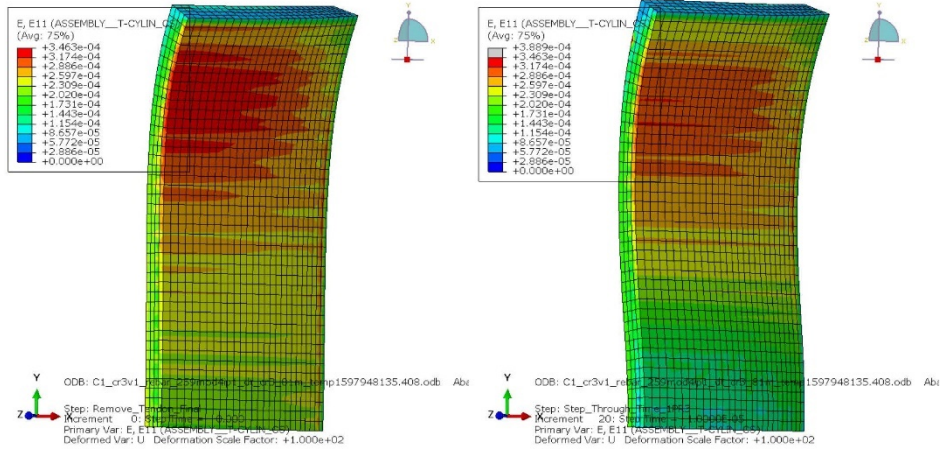
Figure 4-18 Radial Strain Before (Left) and After (Right) Detensioning [C1]

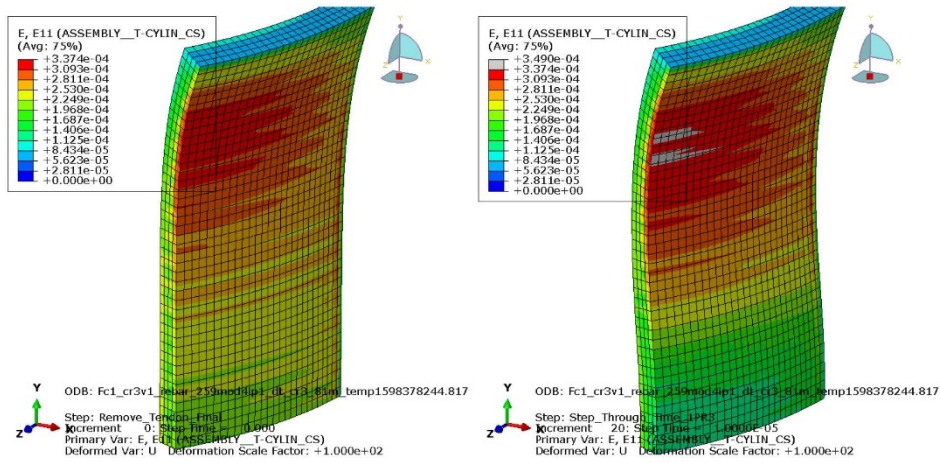
Figure 4-32 Radial Strain Before (Left) and After (Right) Detensioning [Fc1]

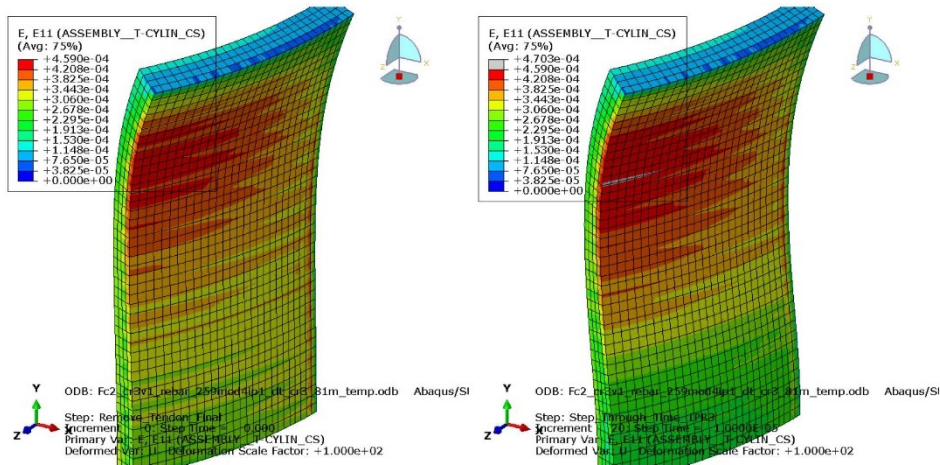
Figure 4-34 Radial Strain Before (Left) and After (Right) Detensioning [Fc2]

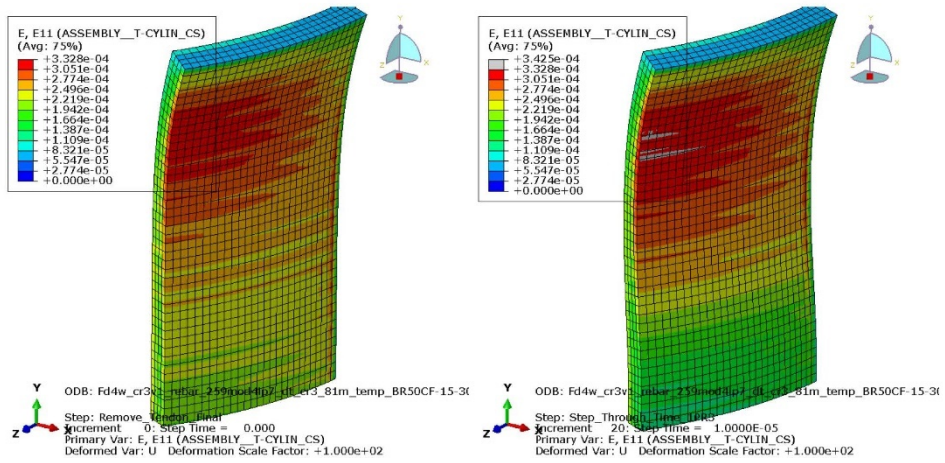
Figure 4-38 Radial Strain Before (Left) and After (Right) Detensioning [Fd4w]

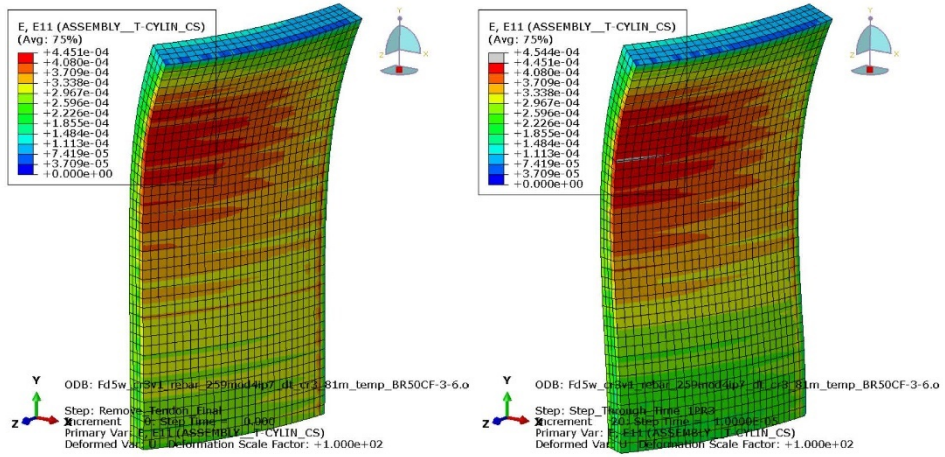
Figure 4-40 Radial Strain Before (Left) and After (Right) Detensioning [Fd5w]
