JAF-RPT-12-00015
Rev. 0

JAF SEISMIC WALKDOWN REPORT FOR RESOLUTION OF FUKUSHIMA NEAR-TERM TASK FORCE RECOMMENDATION 2.3 SEISMIC

NOVEMBER 2012

James A. FitzPatrick (JAF) Nuclear Power Plant Seismic Walkdown Report for Resolution of Fukushima Near-Term Task Force Recommendation 2.3: Seismic

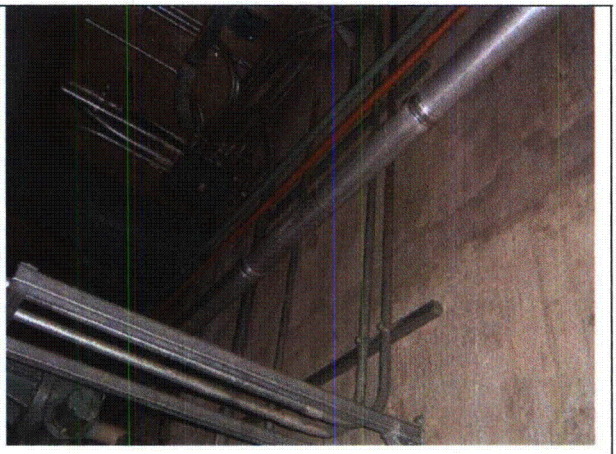
Note: *01-125MOV-14B Valve*

Note: *Unsupported Pipe Spans*

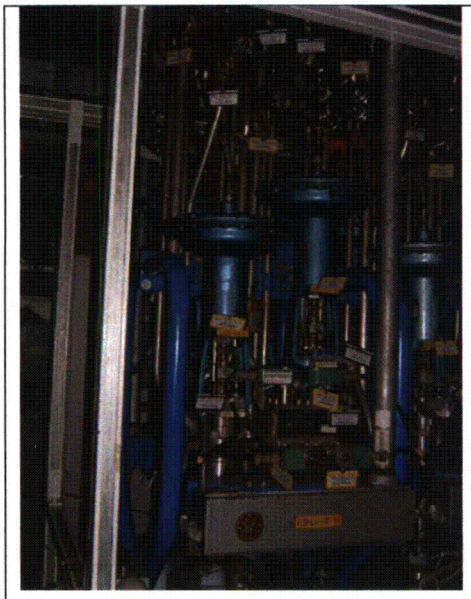
Note: *Picture of equipment 03AOV-126. Valve 03AOV-126 is on the left.*

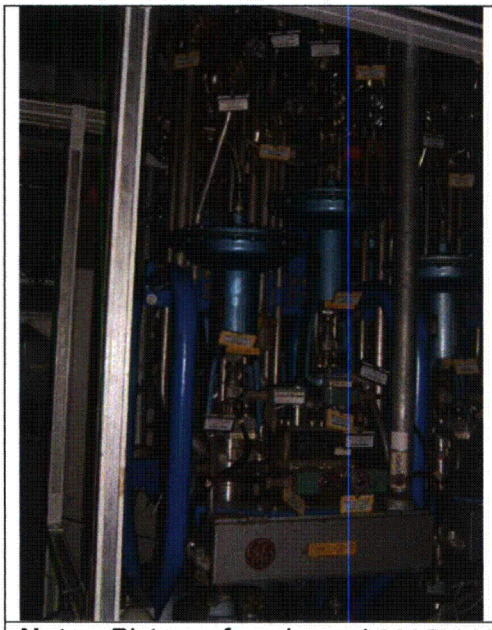
Note: *Picture of equipment 03AOV-127(HCU-02-19). 03AOV-127(HCU-02-19) is the valve on the right.*

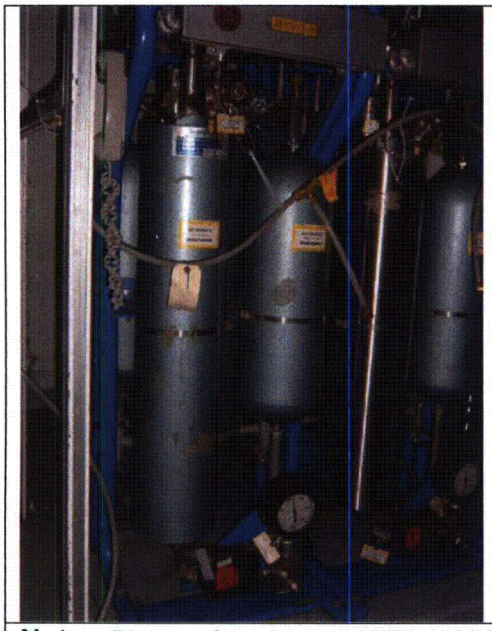
Note: *Picture of equipment 03TK-128(HCU-02-19). 03TK-128(HCU-02-19) is on the left.*

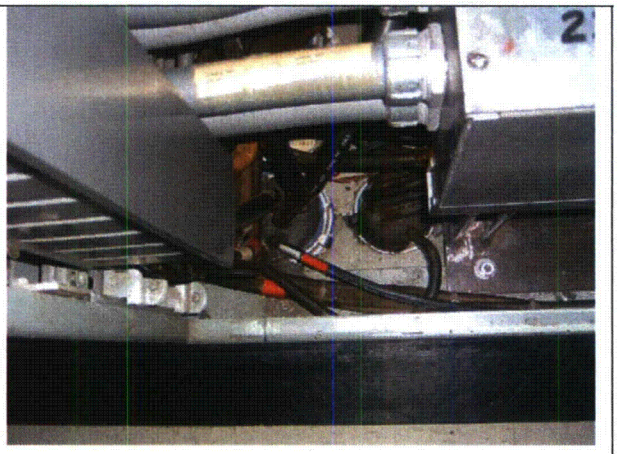
Note: *Cabinet 09-32*

Note: *Cabinet Front Plug Weld*

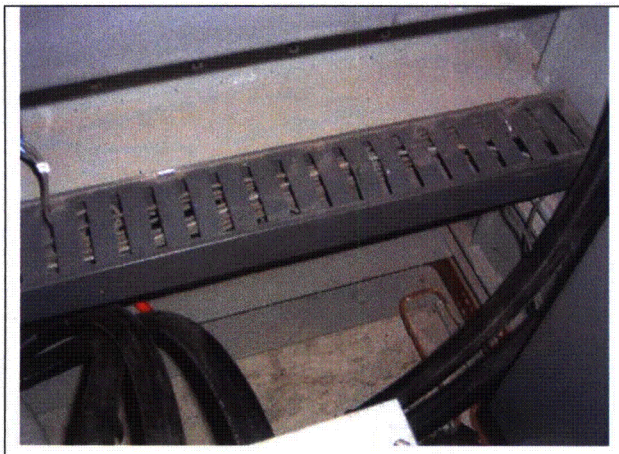
Note: *Spot Welds In The Back Of The Panel.*

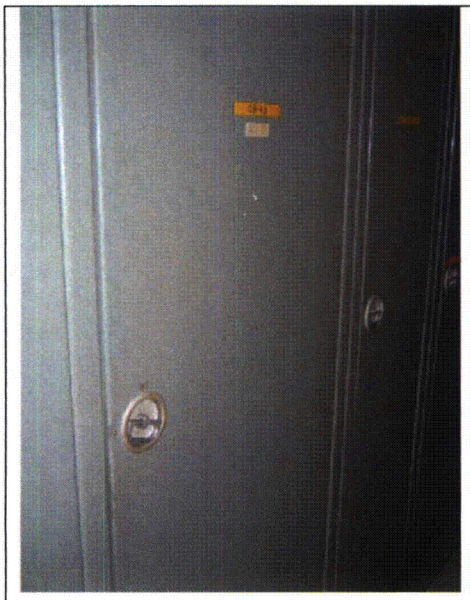
Note: *Cabinet 09-45*

Note: *Cabinet Plug Weld*

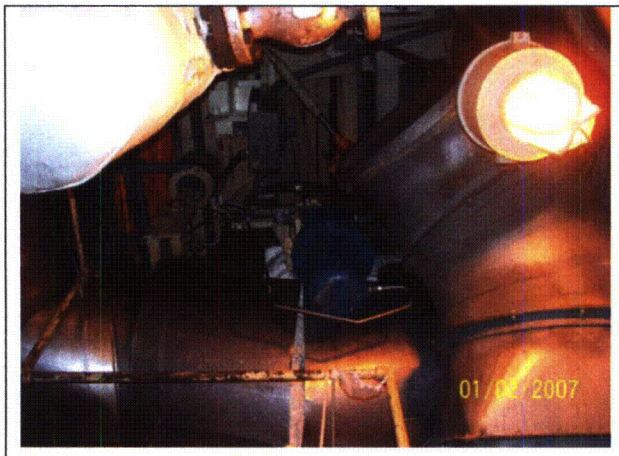
Note: *10AOV-68A (The date provided on the bottom right cornet is not correct the date that the picture was taken. Malfunction with camera setting)*

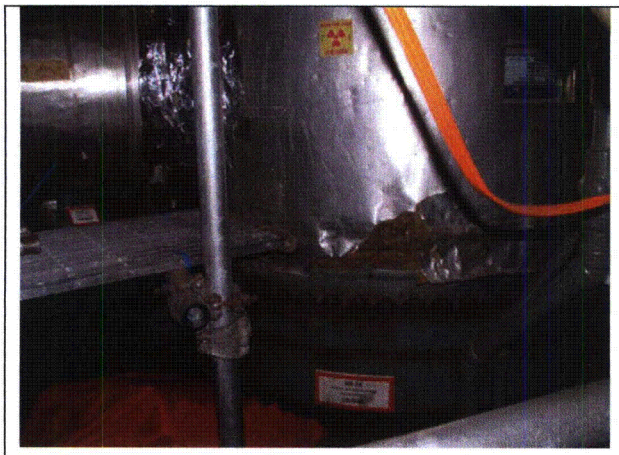
Note: *Picture of equipment 10E-2A.*

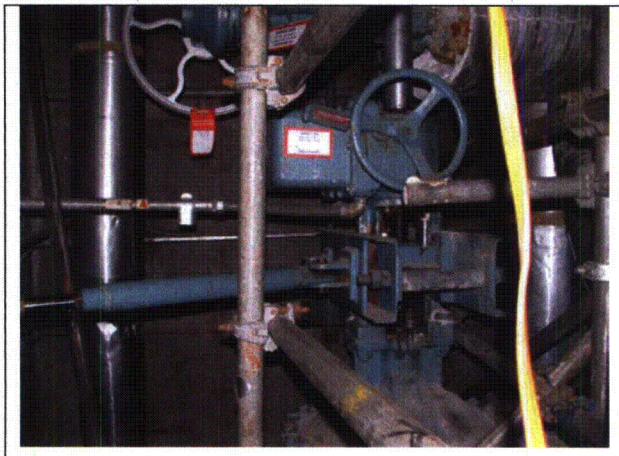
Note: *Picture of equipment 10MOV-12A.*
