# Dry Cask Storage Characterization Project—Phase 1: CASTOR V/21 Cask Opening and Examination

Idaho National Engineering and Environmental Laboratory

U.S. Nuclear Regulatory Commission  
Office of Nuclear Regulatory Research  
Washington, DC 20555-0001

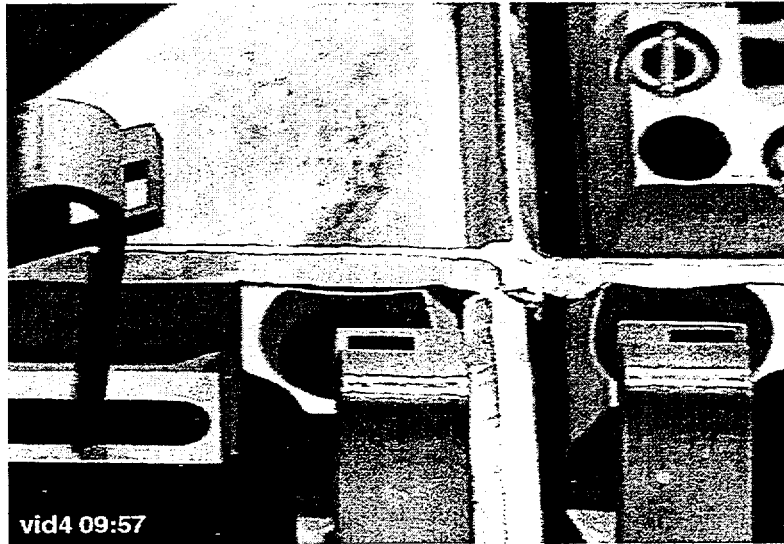
Figure G-2. Existing 1985 weld crack at location No. 2 identified in Figure G-9.
