**NUCLEAR REGULATORY COMMISSION**

Title: Advisory Committee on Reactor Safeguards  
504th Meeting

Date: Friday, July 11, 2003

10 MEMBER SIEBER: You have basically three  
11 documents in front of you, one of which is a drawing  
12 of a bottom penetration and a set of slides for the  
13 South Texas Project, Unit One, bottom-mounted  
14 instrumentation nozzle leakage issue.

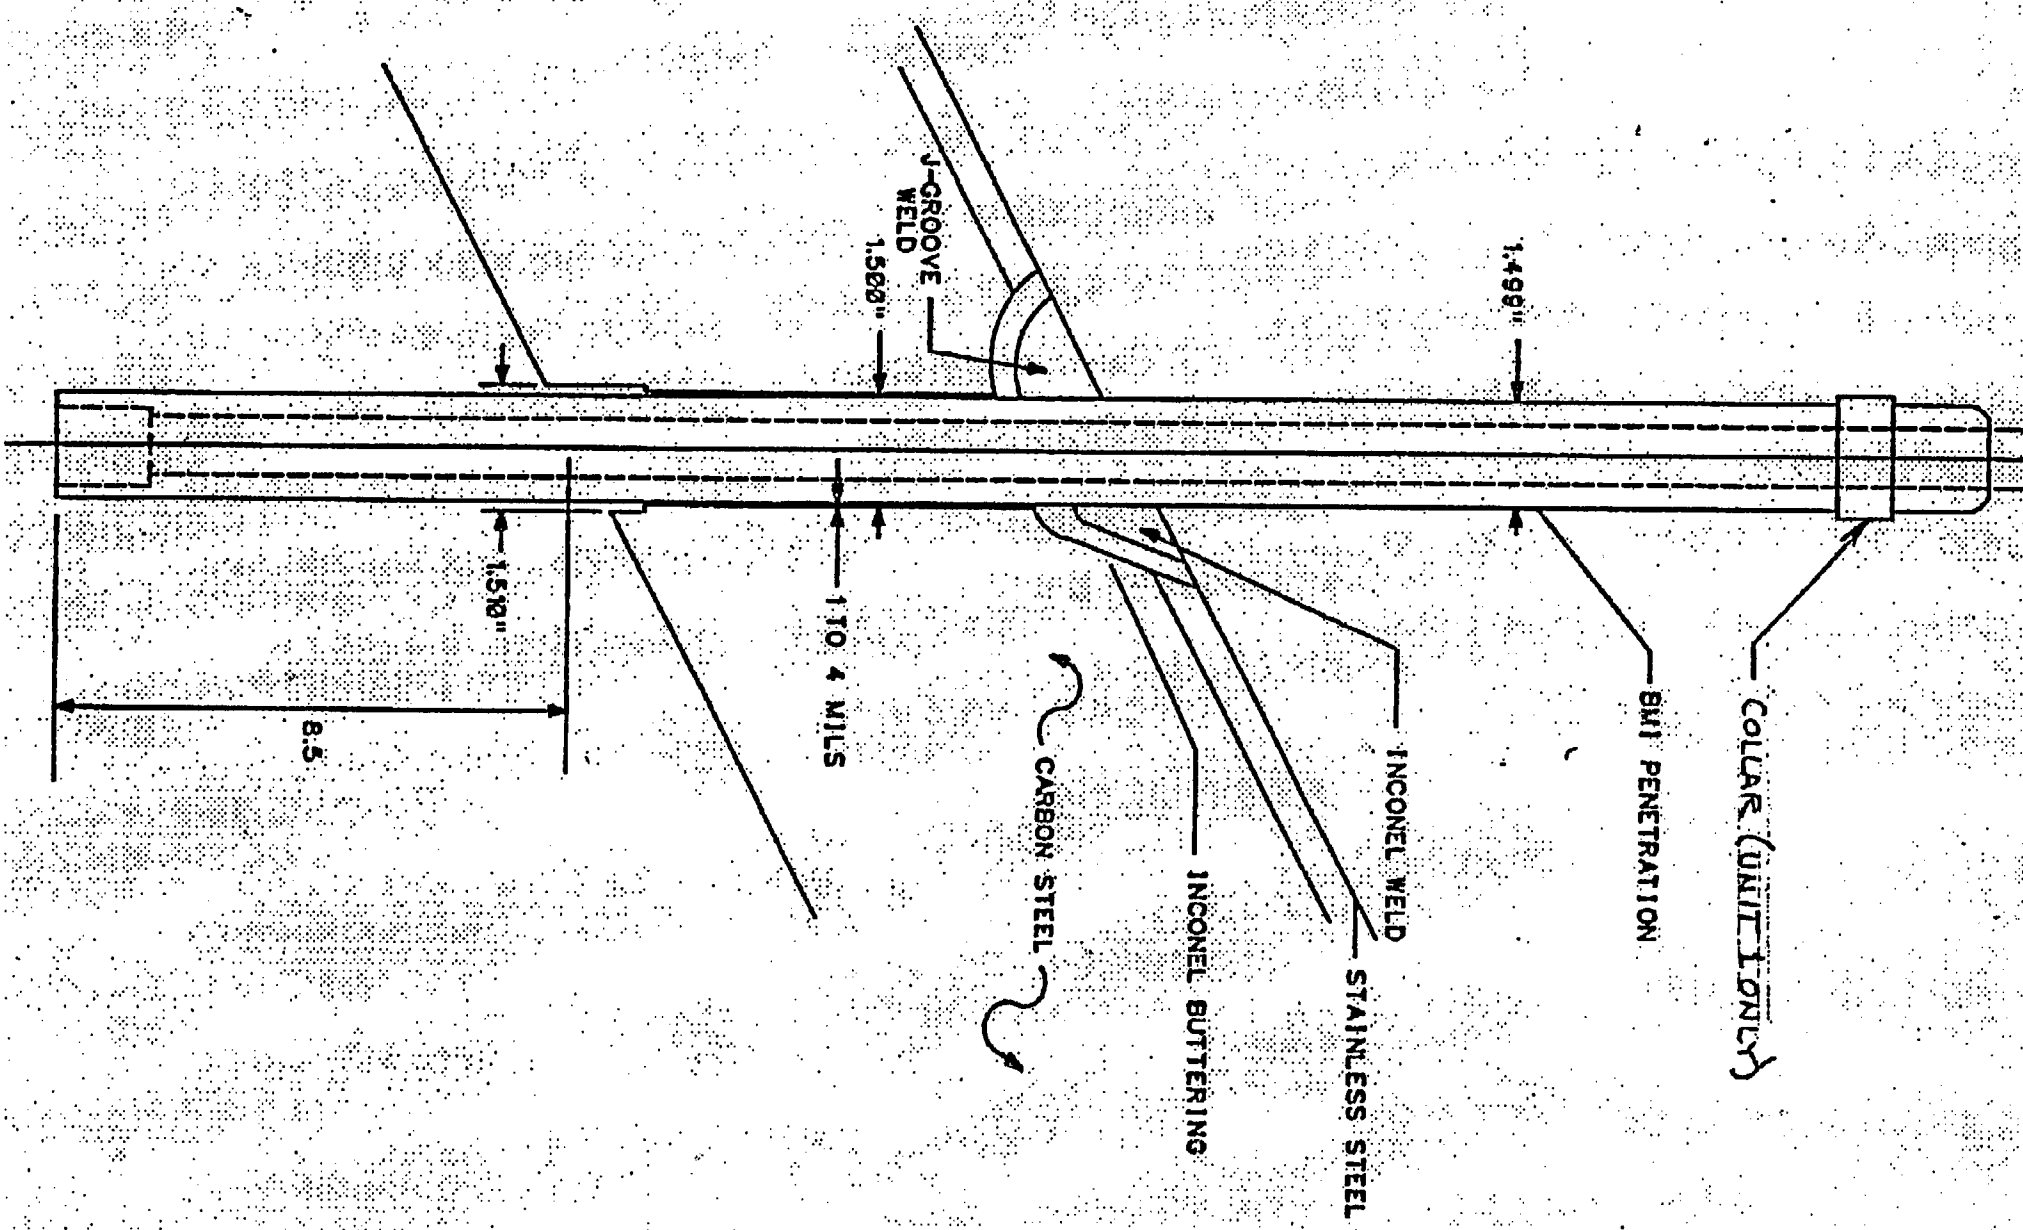
- The licensee performed additional NDE tests on penetrations #1 and #46, including:
  - (1) ECT profilometry on nozzles #1 and #46 to compare as-found nozzle distortions with that predicted from weld finite element modeling to validate predicted weld residual stresses. Preliminary results suggest that the profilometry measurements were consistent with finite element modeling predications.
  - (2) Helium pressurization tests on nozzles #1 and #46 to further investigate potential leakage paths in these penetrations. At 150 psi, bubbles were observed on nozzle #1, but not on nozzle #46.
  - (3) Phased-array UT from the RPV head outside surface to look for evidence of wastage of the ferritic base material of the head. No evidence of wastage was found.

- Based on the information currently available, two principal root cause theories are under consideration by the licensee.
  - (1) The cracking was caused by primary water stress corrosion cracking (PWSCC) which initiated in the nozzle at the toe of the J-groove weld.

- Inconsistent with the fact that no cracking was observed in other penetrations
  - (2) The cracking initiated at “discontinuities” (weld lack of fusion, etc.) at the tube/weld interface and propagated to the tube surface.

- Consistent with observed discontinuities in #1 and #46
    - Consistent with understanding of general fabrication practices/issues
    - Inconsistent with the fact that discontinuities were evident in other penetrations

- The licensee has repaired STP Unit 1 nozzles #1 and #46 using a “half nozzle repair” similar in design to those used to repair other Alloy 600 penetrations.
- The repair was made using Alloy 690 nozzle material and Alloy 52/152 weld material, including the installation of a temper bead weld pad on the outside of the RPV lower head. The RCS pressure boundary weld was moved to the outside surface of the RPV.
- Questions regarding future inspections of the repair, along with inspections of the ferritic base material which will be left exposed to the reactor coolant, are being addressed by the licensee in support of NRC staff review and approval of the repair.
