# **U.S. Plant Experience With Alloy 600 Cracking and Boric Acid Corrosion of Light-Water Reactor Pressure Vessel Materials**

**U.S. Nuclear Regulatory Commission  
Office of Nuclear Regulatory Research  
Washington, DC 20555-0001**

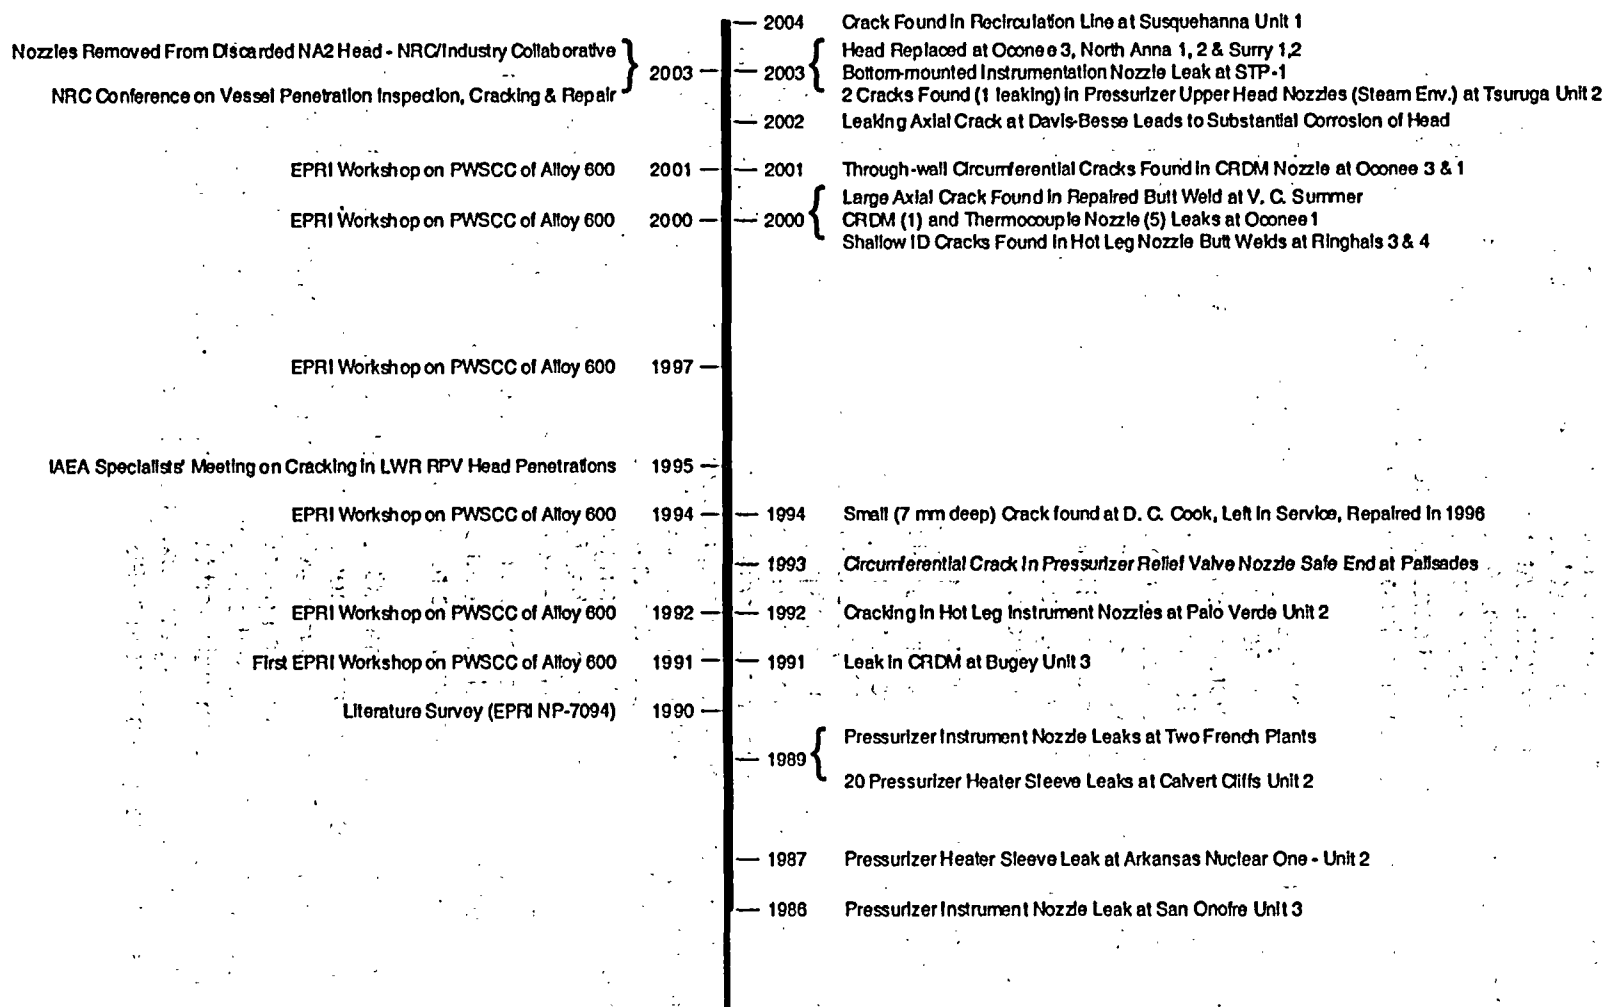
Figure 1. Timeline of findings of significant Alloy 600 cracking in NSSS plants, and important documentation, workshops, and conferences held to discuss this issue.
