Davis-Besse Reactor Pressure Vessel Head Degradation

Overview, Lessons Learned, and
NRC Actions Based on Lessons
Learned

NUREG/BR-0353, Rev. 1
August 2008

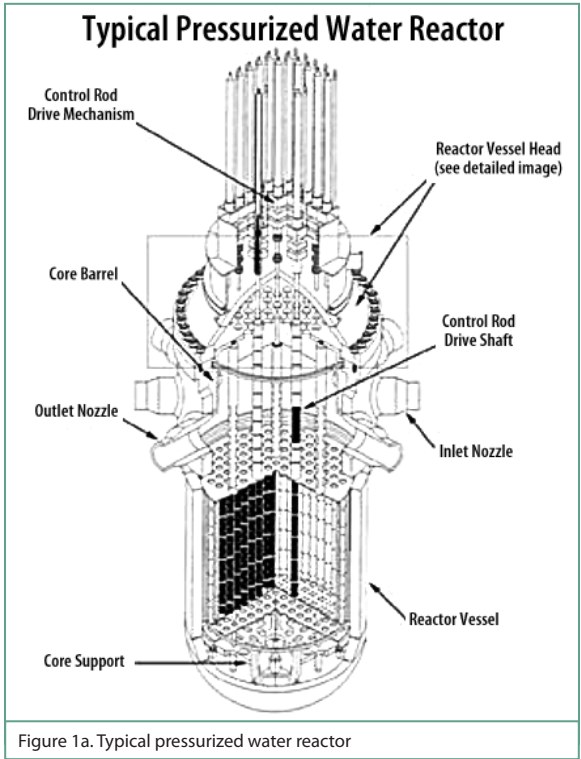
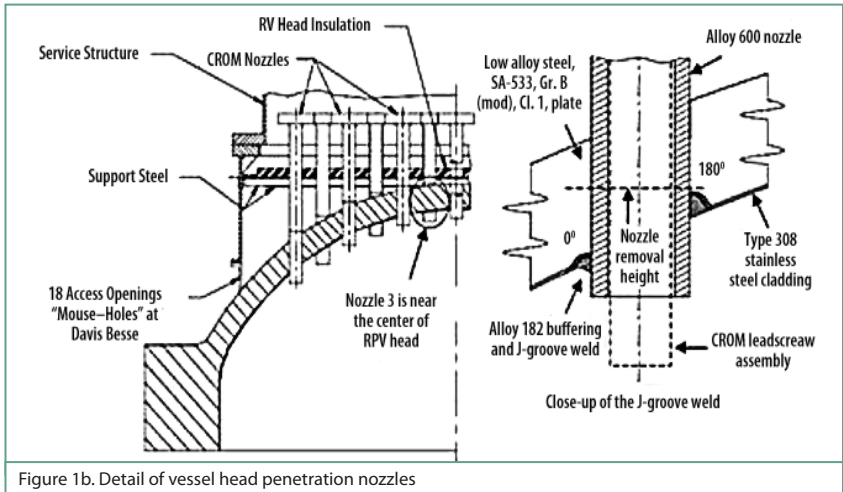
The licensee investigated the condition of the RPV head surrounding CRDM nozzle 3. The investigation included removing the CRDM nozzle and removing boric acid deposits from the top of the RPV head. Upon completing the boric acid removal on March 7, 2002, the licensee conducted a visual examination of the area and identified a large cavity in the RPV head on the downhill side of CRDM nozzle 3 (**Figure 2**). The corrosion was caused by borated water that leaked from the reactor coolant system onto the vessel head (**Figures 3 and 4**) through cracks in the nozzle and the weld that attached nozzle 3 to the RPV head (**Figures 5 and 6**). The remaining thickness of the RPV head in the wastage area was found to be approximately 3/8 inch. This thickness consisted of the thickness of the stainless steel cladding on the inside surface of the RPV head, which is nominally 3/8 inch thick. The stainless steel cladding is resistant to corrosion by boric acid, but it is not intended to provide structural integrity to the vessel. Failure of the stainless steel cladding would have resulted in a loss-of-coolant accident (LOCA). The LOCA would have resulted in actuation of the plant's emergency systems.
