Seismic Walkdown Checklist (SWC)

Equipment ID No.: 1SX01PB

Equipment Description: PUMP,1B ESSENTIAL SER WTR ASMBLY

Project: Braidwood 1 SWEL

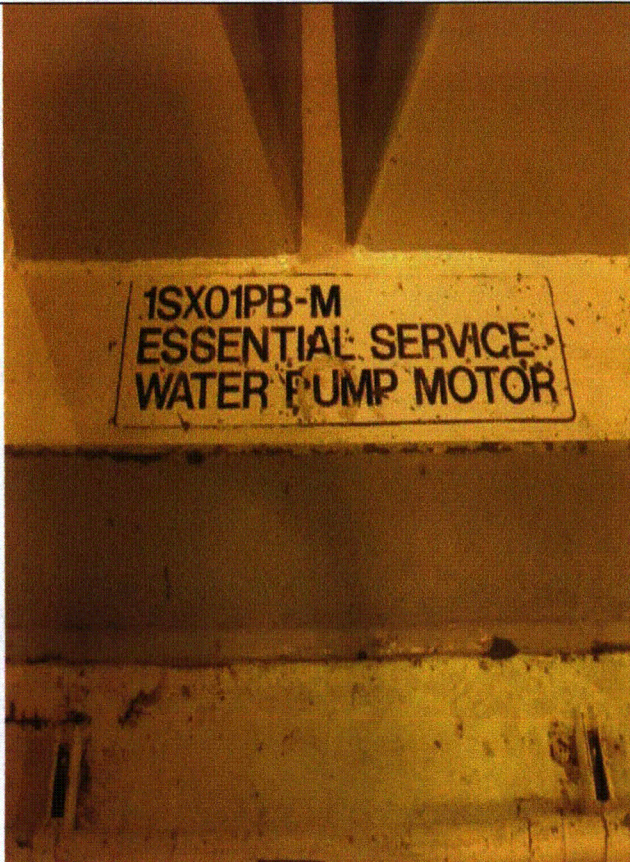
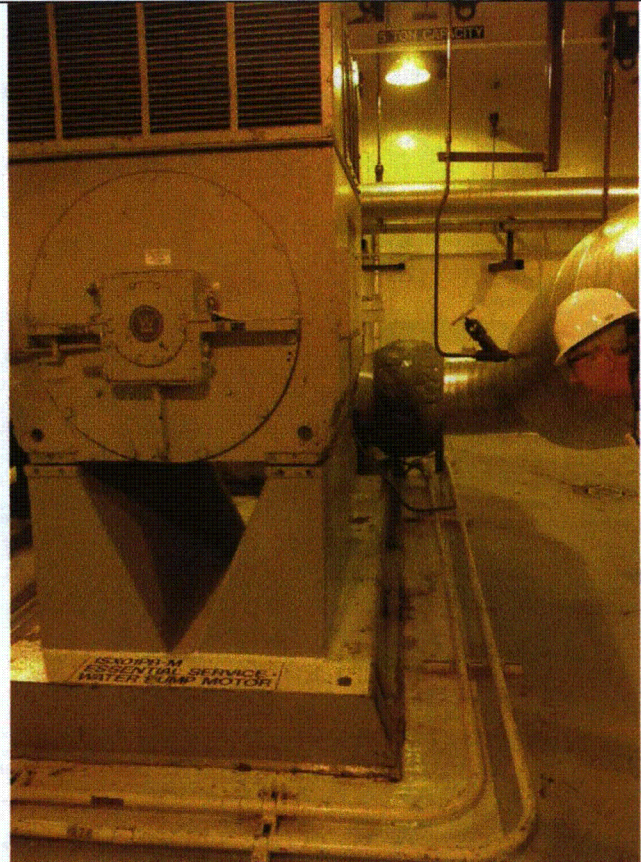
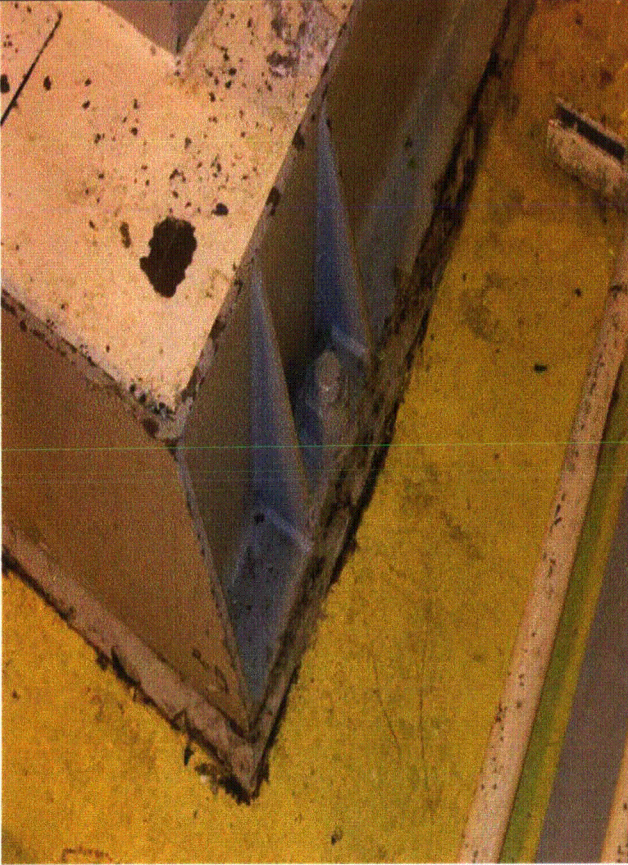
1SX01PB 7-18-12 033

6. Based on the above anchorage evaluations, is the anchorage free of potentially adverse seismic conditions? Yes
Equipment mounted on skid not to structure.
Skid anchorage included with 1SX01PB

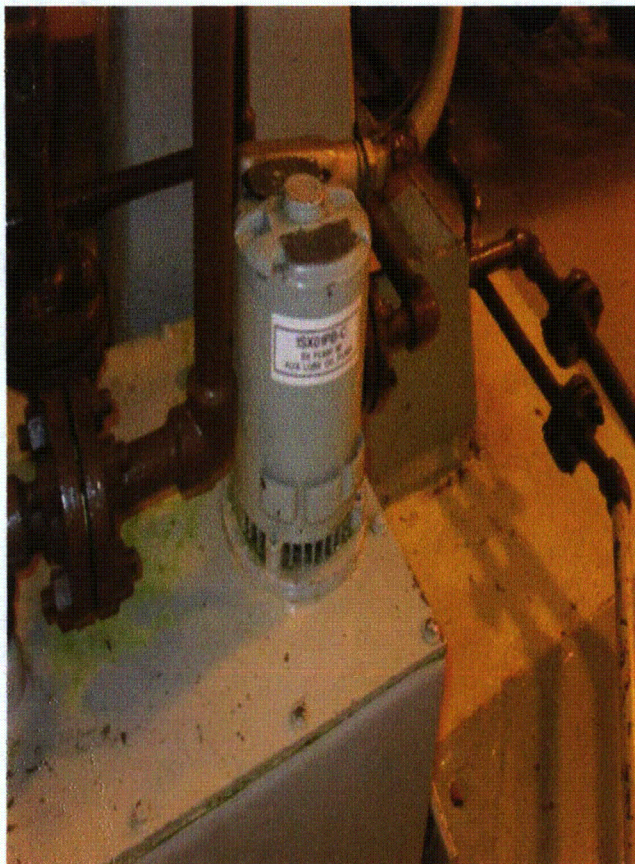
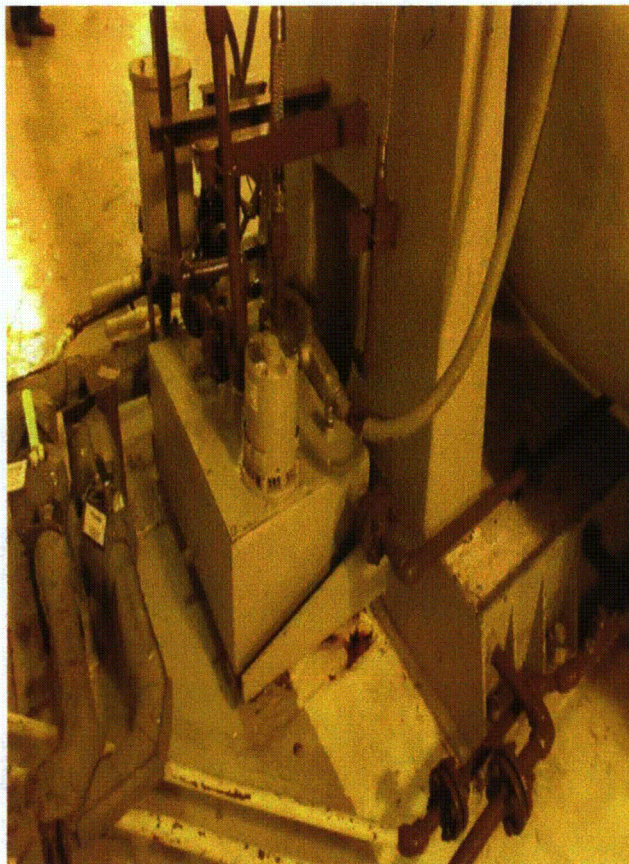
1SX01PB-C 7-18-12 041

11. Have you looked for and found no adverse seismic conditions that could adversely affect the safety functions of the equipment? Yes
Inspected from floor. Adequately supported.

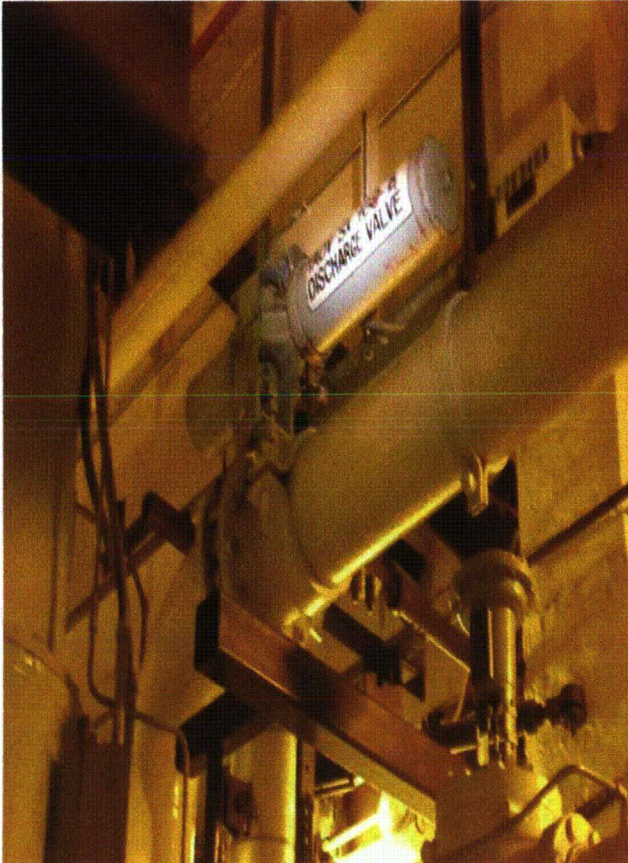
1SX169B 7-16-12 073

11. Have you looked for and found no adverse seismic conditions that could adversely affect the safety functions of the equipment?
well-supported pipe Yes
