ATTACHMENT 4

AREA WALK-BY CHECKLIST

Area Walk-By Checklist (AWC)

Location (Bldg, Elev, Room/Area): Area : AUX, 45, CAL-AB-440

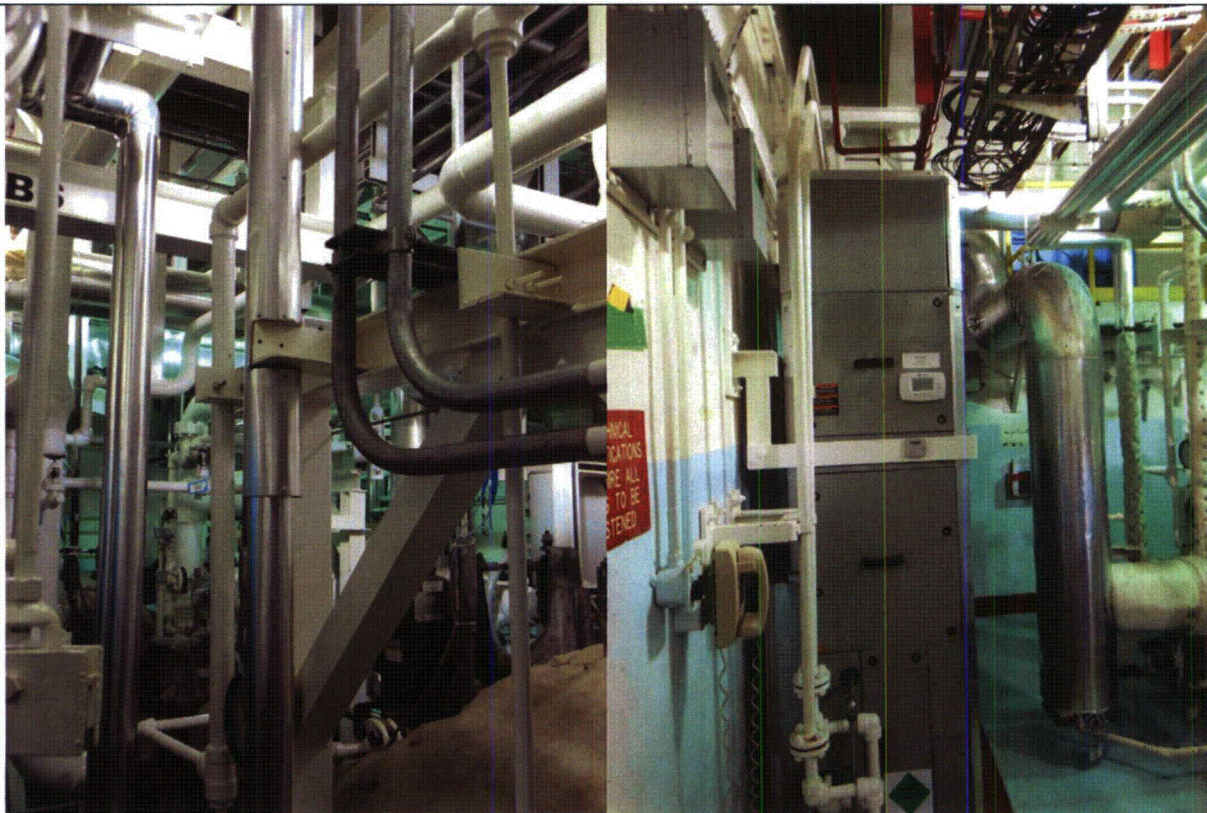
Area # TURB, 12, CAL-AFWPR-605 8-10-12 058 Area # TURB, 12, CAL-AFWPR-605 8-10-12 059

1. Does anchorage of equipment in the area appear to be free of potentially adverse seismic conditions (if visible without necessarily opening cabinets)? Yes
Observed that the 21 AFW PP Discharge pressure gage support is not in contact with wall on right side and the 22 AFWPP Discharge gage is not in contact on the left side. Both condition are judged not to be a seismic concern.

4. Does it appear that the area is free of potentially adverse seismic spatial interactions with other equipment in the area (e.g., ceiling tiles and lighting)? Yes
There is an overhead light over the equipment.
10/3/12 - Overhead lights were deemed not a credible seismic concern due to their lightweight and to typical construction practices. Also, they have been previously evaluated by CCNPP and found seismically acceptable.

5. Does it appear that the area is free of potentially adverse seismic interactions that could cause flooding or spray in the area? Yes
The overhead threaded fire piping is judged to be adequately supported and not a concern for spray or flooding.

8. Have you looked for and found no other seismic conditions that could adversely affect the safety functions of the equipment in the area? Yes
Drain pipe near AFWTD 21 seems to be missing U-Bolt supports, but judged not to be a seismic concern.
