**Seismic Walkdown Checklist (SWC)**

Equipment ID No. C4104F004A Equip. Class<sup>1</sup> 8-Motor Operated and Solenoid Operated Valves

Equipment Description SLC Explosive (SQUIB) Valve

Location: Bldg. RB Floor El. 613'-6" Room, Area A-17, Col C-11

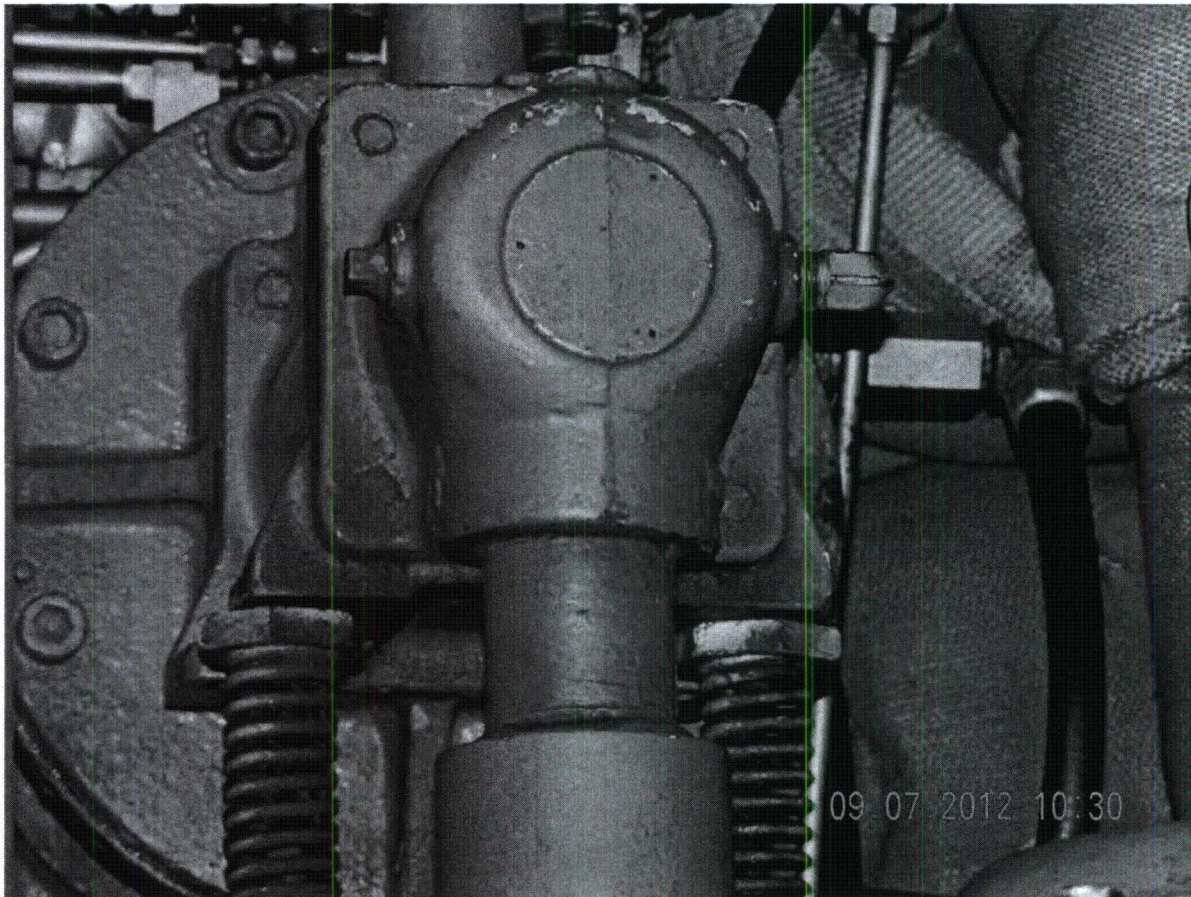
Bolting Configuration for HPCI Turbine Driven Oil Pump  
(Picture 11)

2. Is the anchorage free of bent, broken, missing or loose hardware?  Y  N  U  N/A  
*Anchorage is between flanges. All bolts are present and securely tightened. See pictures 11, 14 & 17.*
3. Is the anchorage free of corrosion that is more than mild surface oxidation?  Y  N  U  N/A  
*Bolts do not exhibit corrosion. See pictures 11, 14 & 17.*

*The pump is securely bolted to the HPCI Turbine outer Casting with one set of feet supported vertically by two springs. See pictures 11, 14, 17 & 19. These springs are referred to as Resilient mounts per the "HPCI Turbine Main Oil Pump Disassembly and Reassembly Procedure 35.202.006" (pages 4 and 11).*

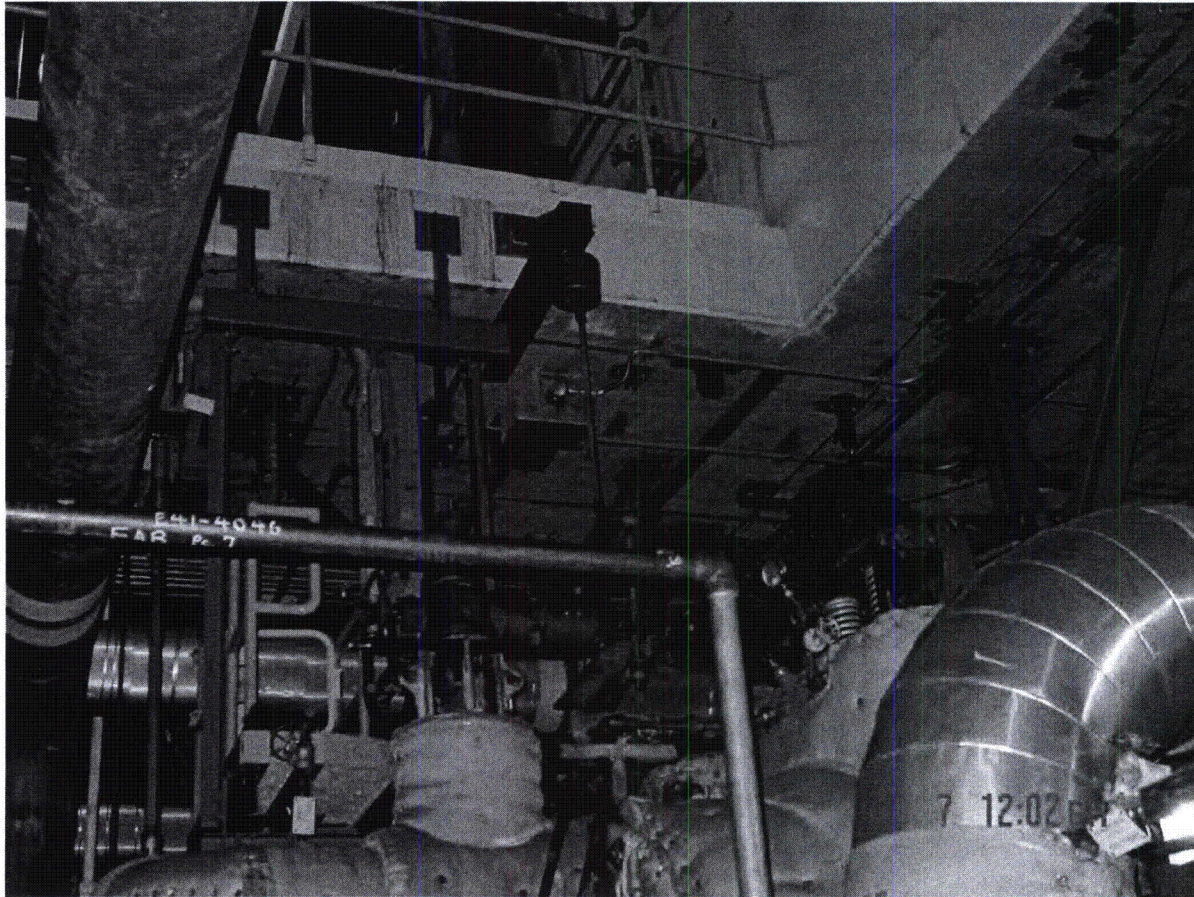
Piping and Supports Overhead the Valve  
(Picture 4)

7. Are soft targets free from impact by nearby equipment or structures?  Y  N  U  N/A  
*There were no potential impact sources observed. (See Pictures 4 and 5.)*
8. Are overhead equipment, distribution systems, ceiling tiles and lighting, and masonry block walls not likely to collapse onto the equipment?  Y  N  U  N/A  
*All overhead equipment/piping was observed to be adequately anchored and restrained. (See pictures 5 and 6.)*
9. Do attached lines have adequate flexibility to avoid damage?  Y  N  U  N/A  
*The attached lines have adequate flexibility. Note the flex conduits in Picture 3.*
10. Based on the above seismic interaction evaluations, is equipment free of potentially adverse seismic interaction effects?  Y  N  U

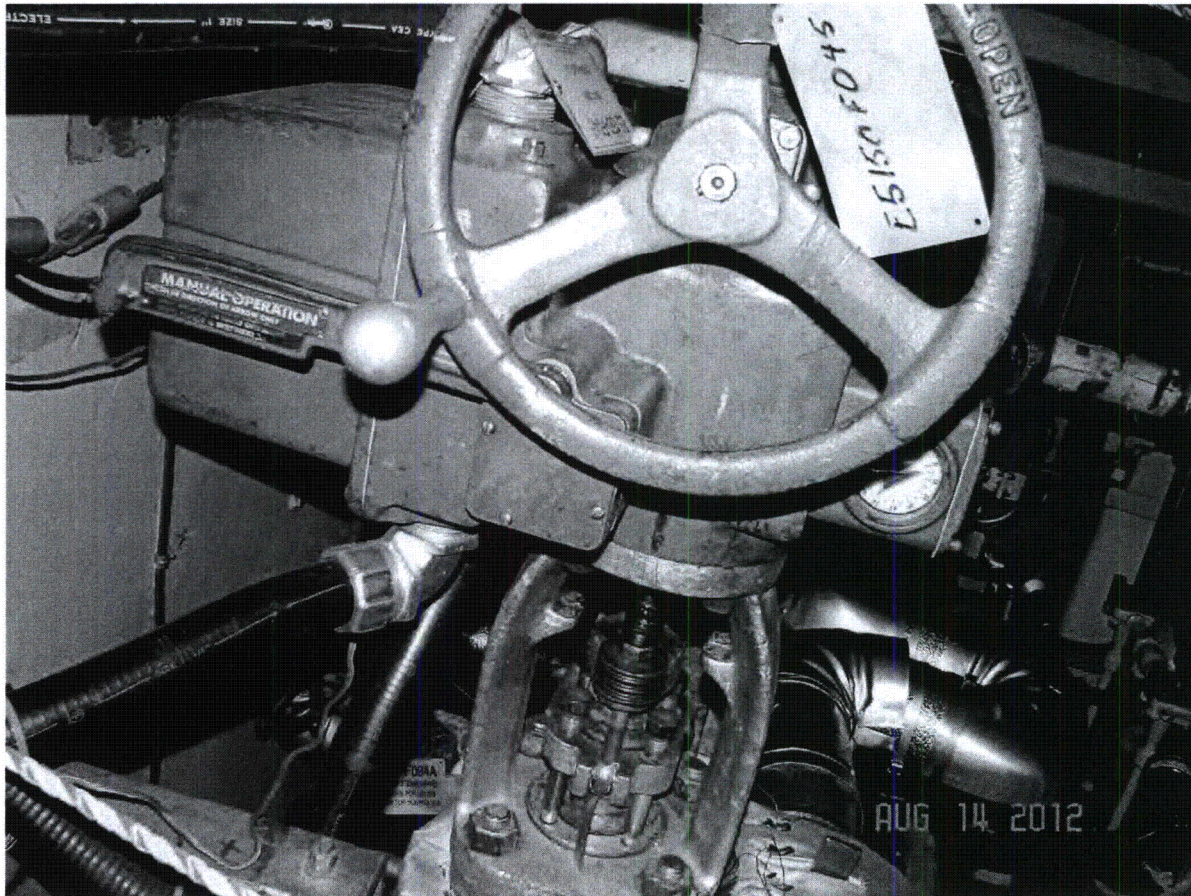
PICTURE #4

9. Do attached lines have adequate flexibility to avoid damage?  Y  N  U  N/A   
*Attached lines are made of a flexible material. (See picture 4.) Attached lines have adequate flexibility.*

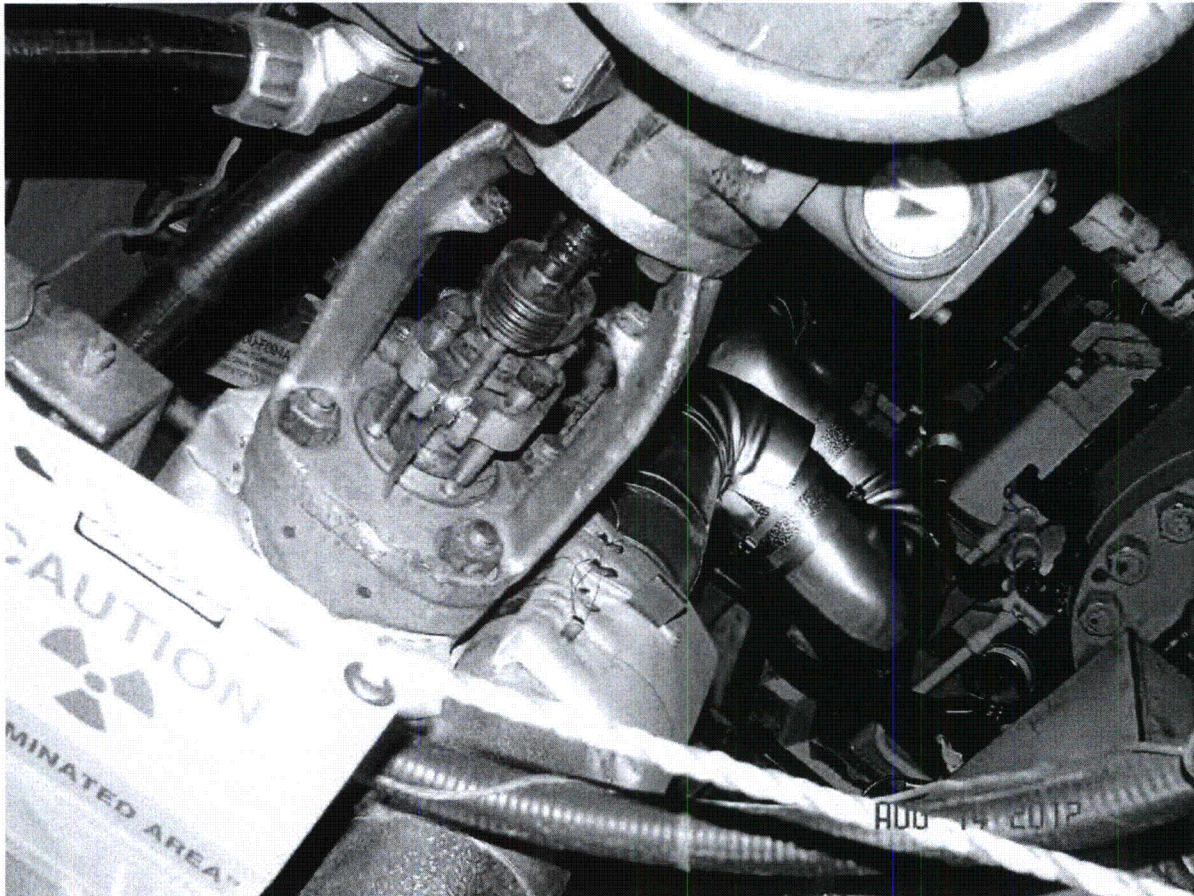
PICTURE #6

2. Is the anchorage free of bent, broken, missing or loose hardware? Y  N  U  N/A   
*All anchors are present and securely tightened. (See picture 6.)*

4. Is the anchorage free of visible cracks in the concrete near the anchors? Y  N  U  N/A   
*Not anchored to concrete. (See picture 6.)*

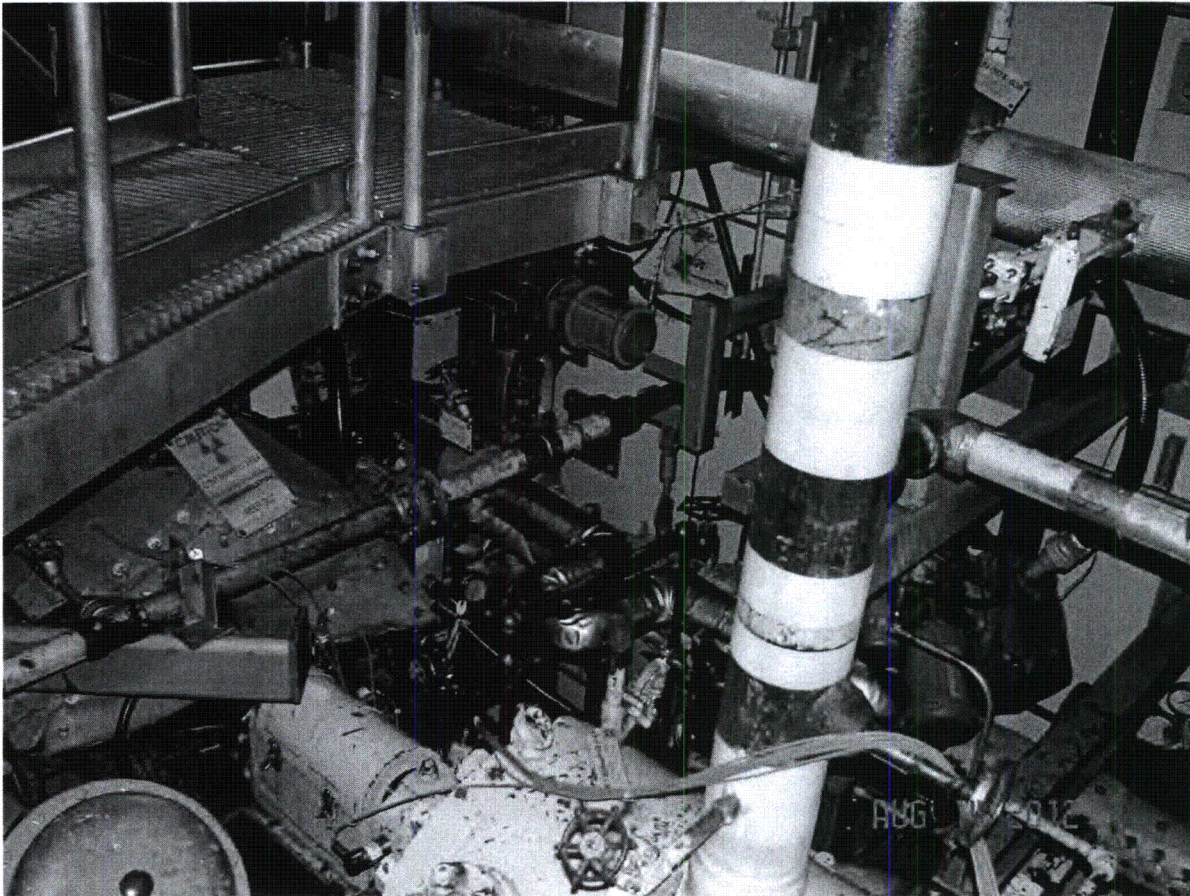
PICTURE #15

8. Are overhead equipment, distribution systems, ceiling tiles and lighting, and masonry block walls not likely to collapse onto the equipment?  Y  N  U  N/A   
*Asset is protected from above by platform. (See picture 15.) Equipment above is well-supported.*

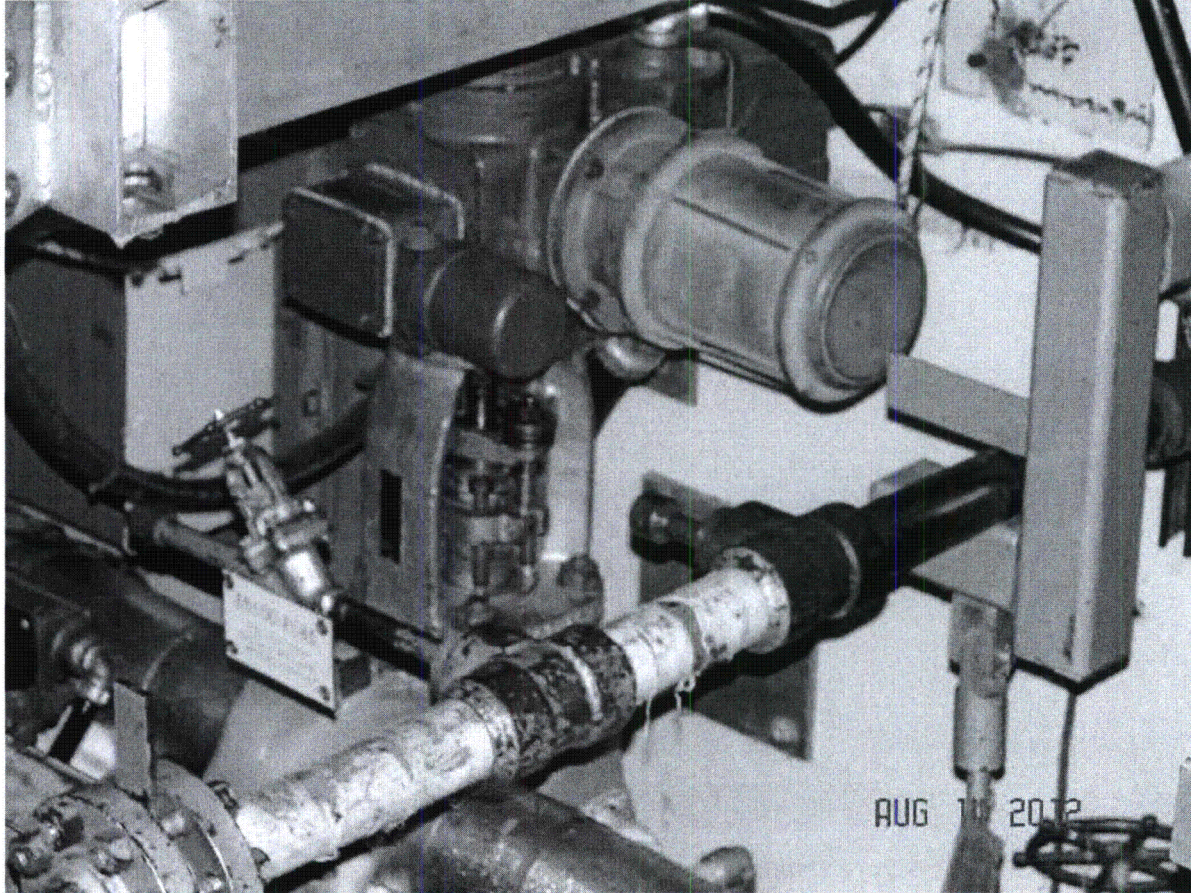
PICTURE #16

10. Based on the above seismic interaction evaluations, is equipment free of potentially adverse seismic interaction effects?  Y  N  U   
*There are no items nearby that are close enough to cause interaction effects. (See picture 16.)*

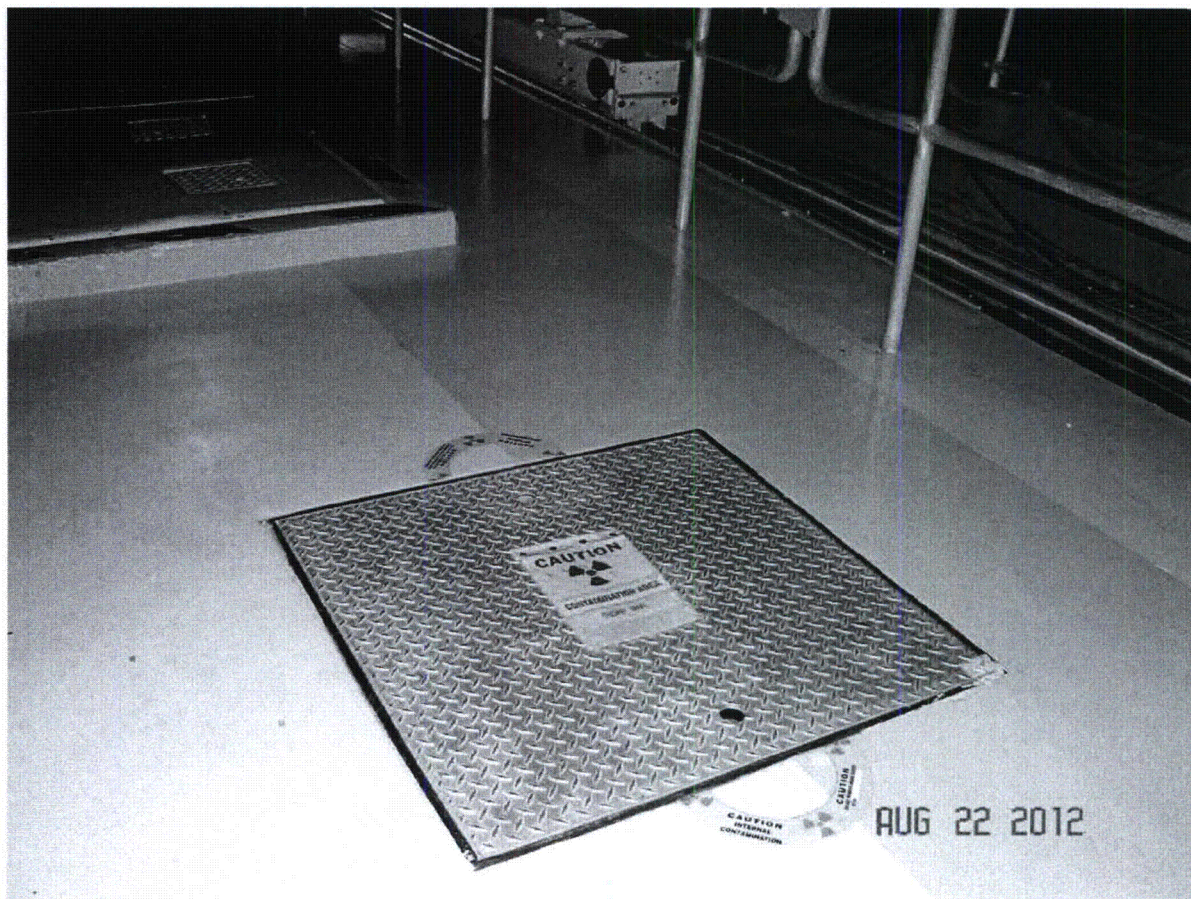
(Picture 2)

7. Are soft targets free from impact by nearby equipment or structures?  Y  N  U  N/A  
*Valve is in a pit and shielded from impact by a checkered cover plate. There are no impact sources. (See Pictures 2 & 3)*

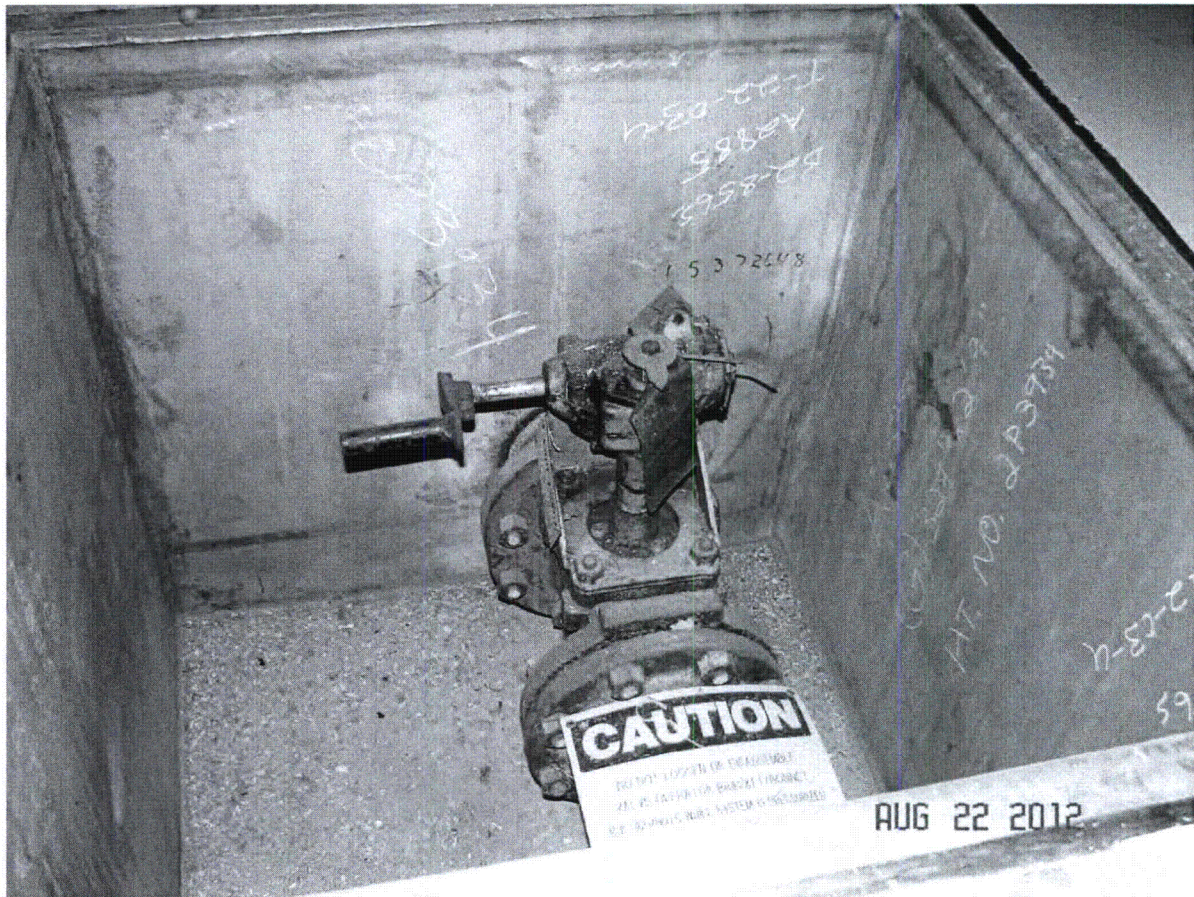
(Picture 4)

9. Do attached lines have adequate flexibility to avoid damage?  Y  N  U  N/A  
*There are no conduit or tubing lines on the valve. (See Picture 4)*

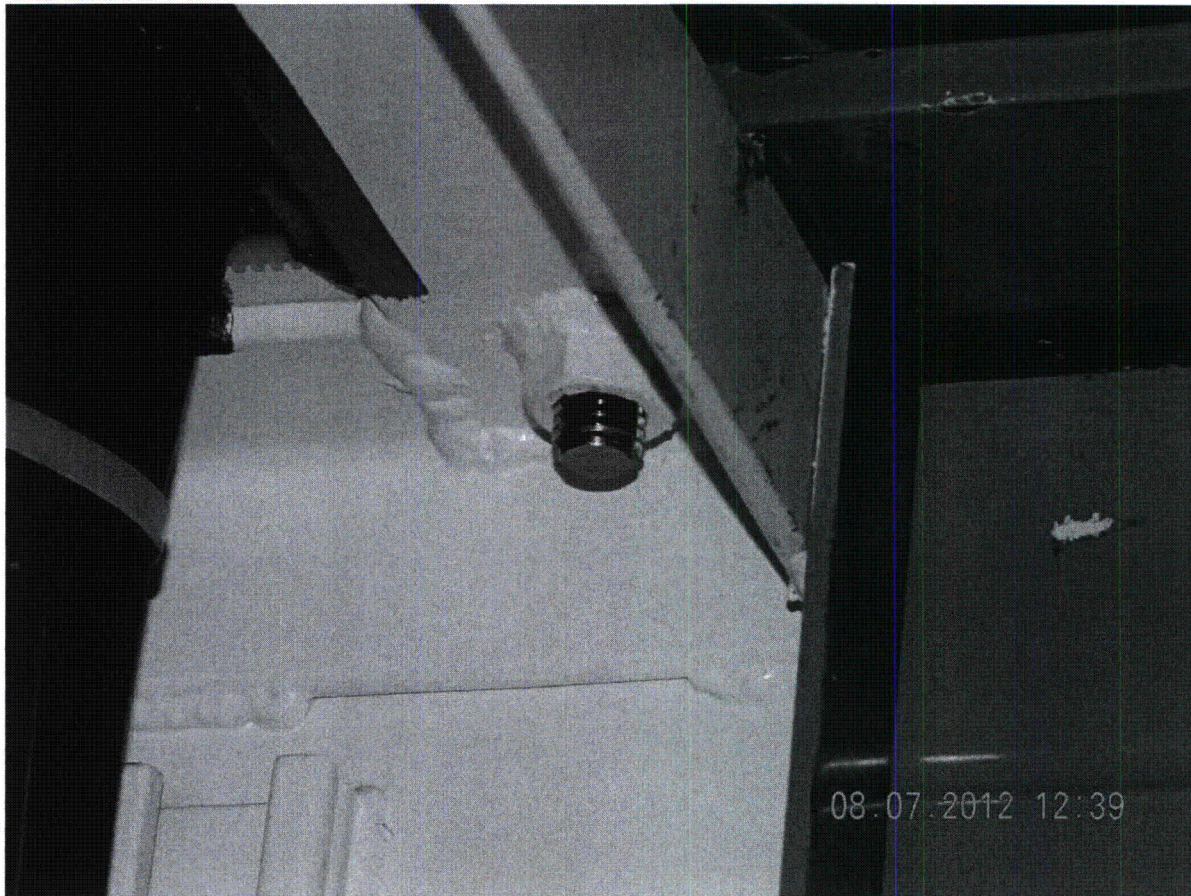
Equipment ID No. H11P612 Equipment Class: 20, Instrumentation and Control Panels

11. Have you looked for and found no other seismic conditions that could adversely affect the safety functions of the equipment?  Y  N  U  
*Note: Bracing per EDP 27108 has been installed properly, per plan, and bolting has been verified.*  
*(SEE PICTURES DSCN0075, DSCN0076) ~ DSK 10/11/12*
