**Area Walk-By Checklist (AWC)**

Fermi 2 Seismic Walkdown Guideline  
Area Walk-By-Checklist

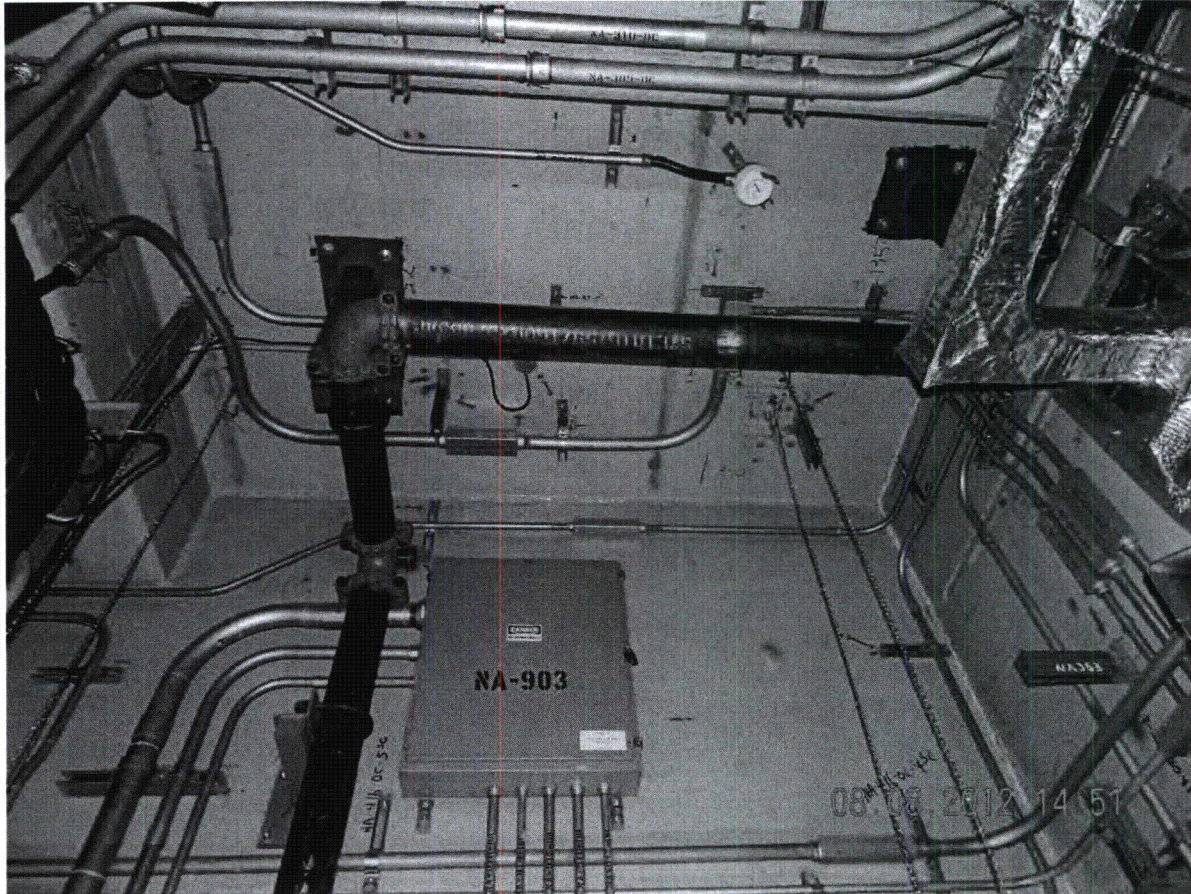
(DSCN0201)

"Halon Piping above, Ref. Dwg. M-5327"

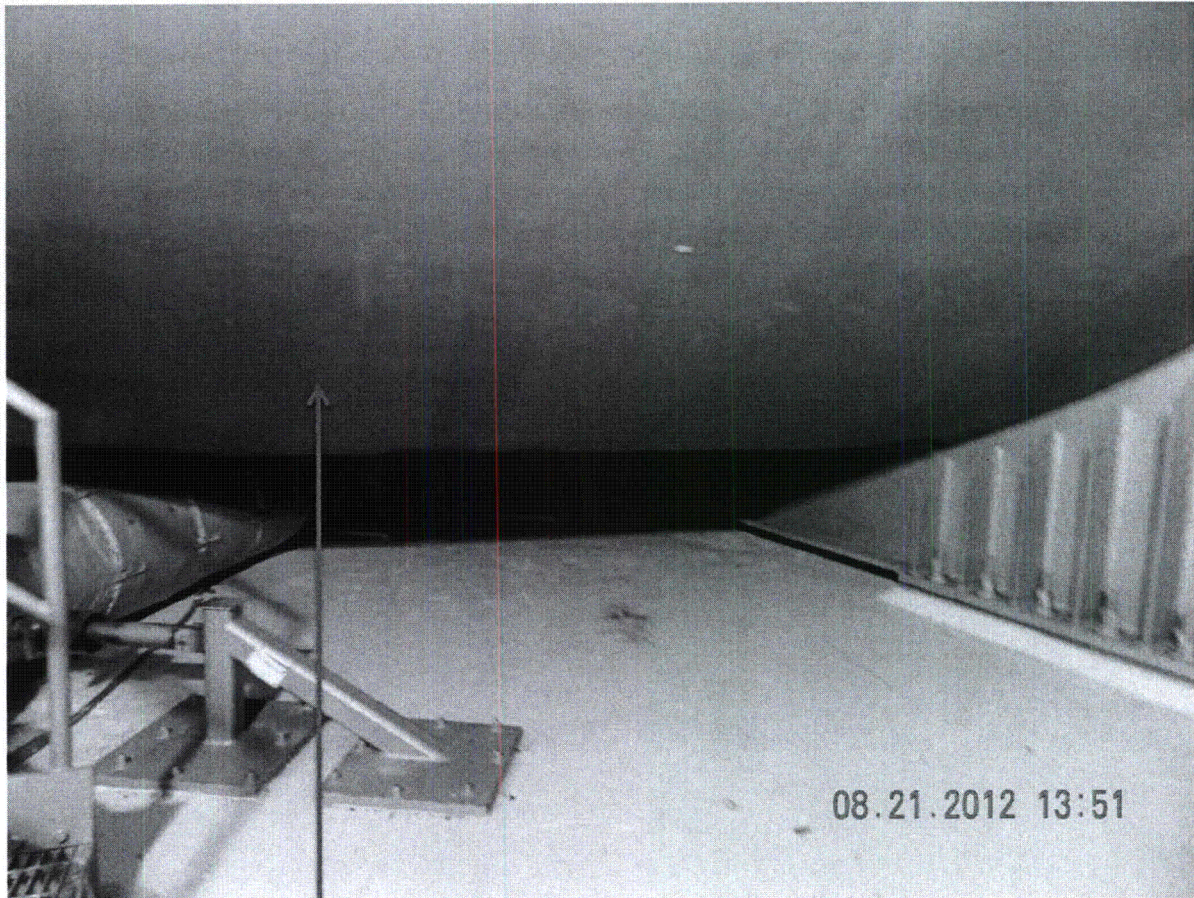
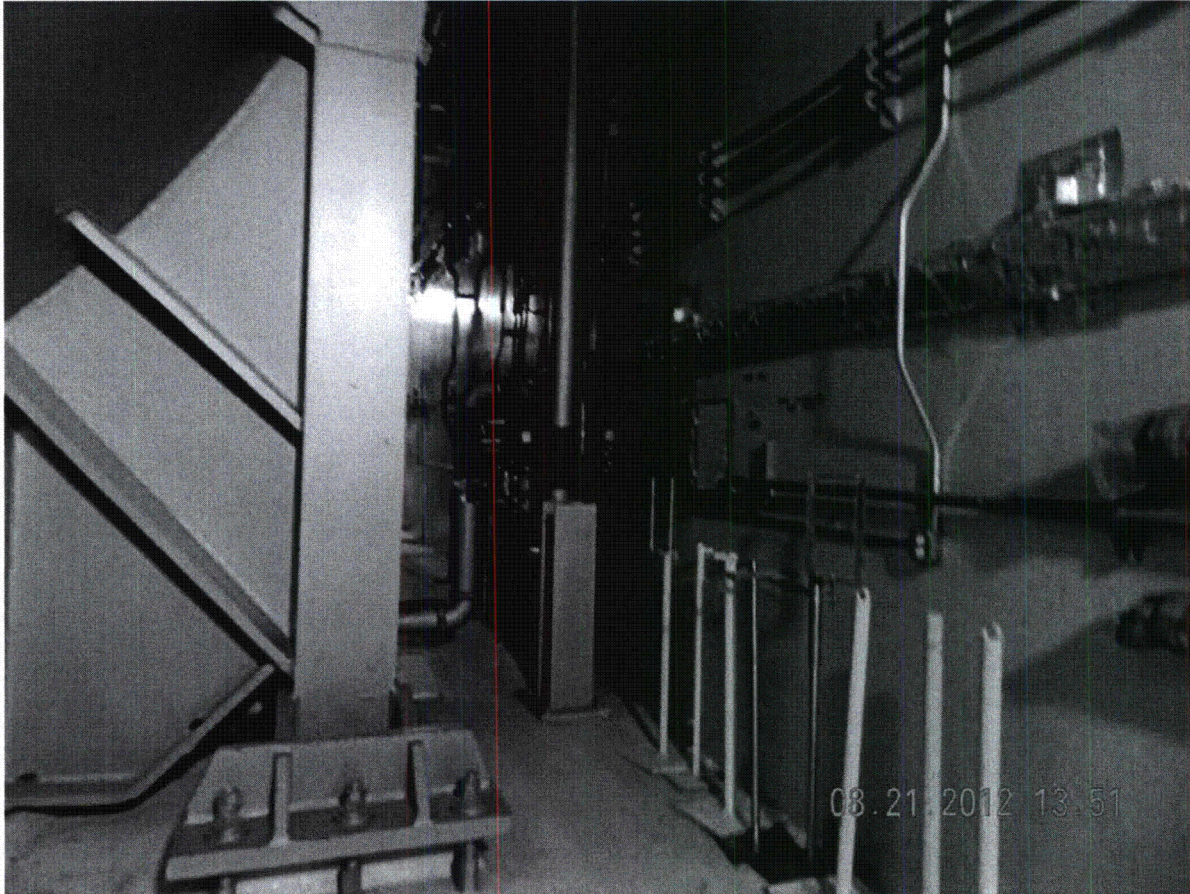
(Picture 7)

*All anchorage in the area was observed to be intact and securely tightened. See pictures 7 & 8 for typical conditions.*

*No anchorage in the area was observed to be degraded. See pictures 7 & 8 for typical conditions.*

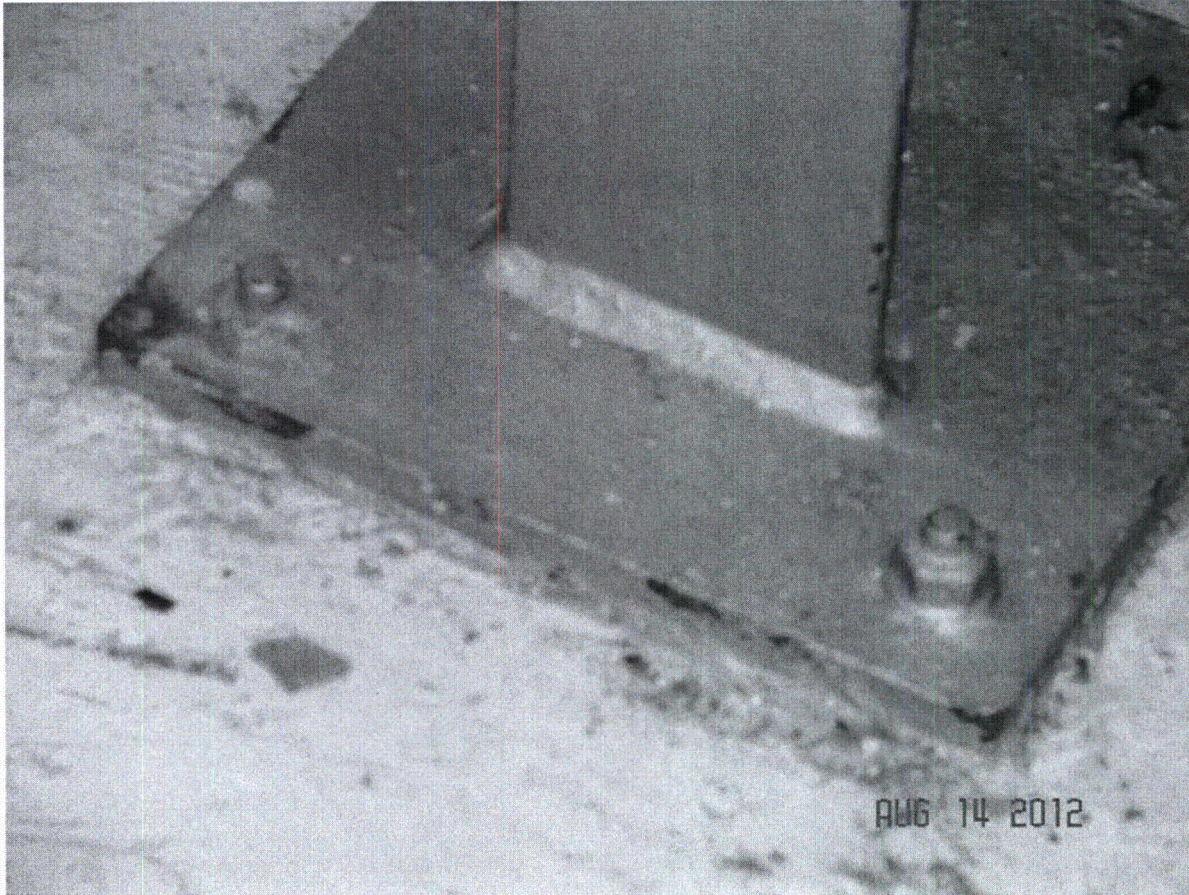
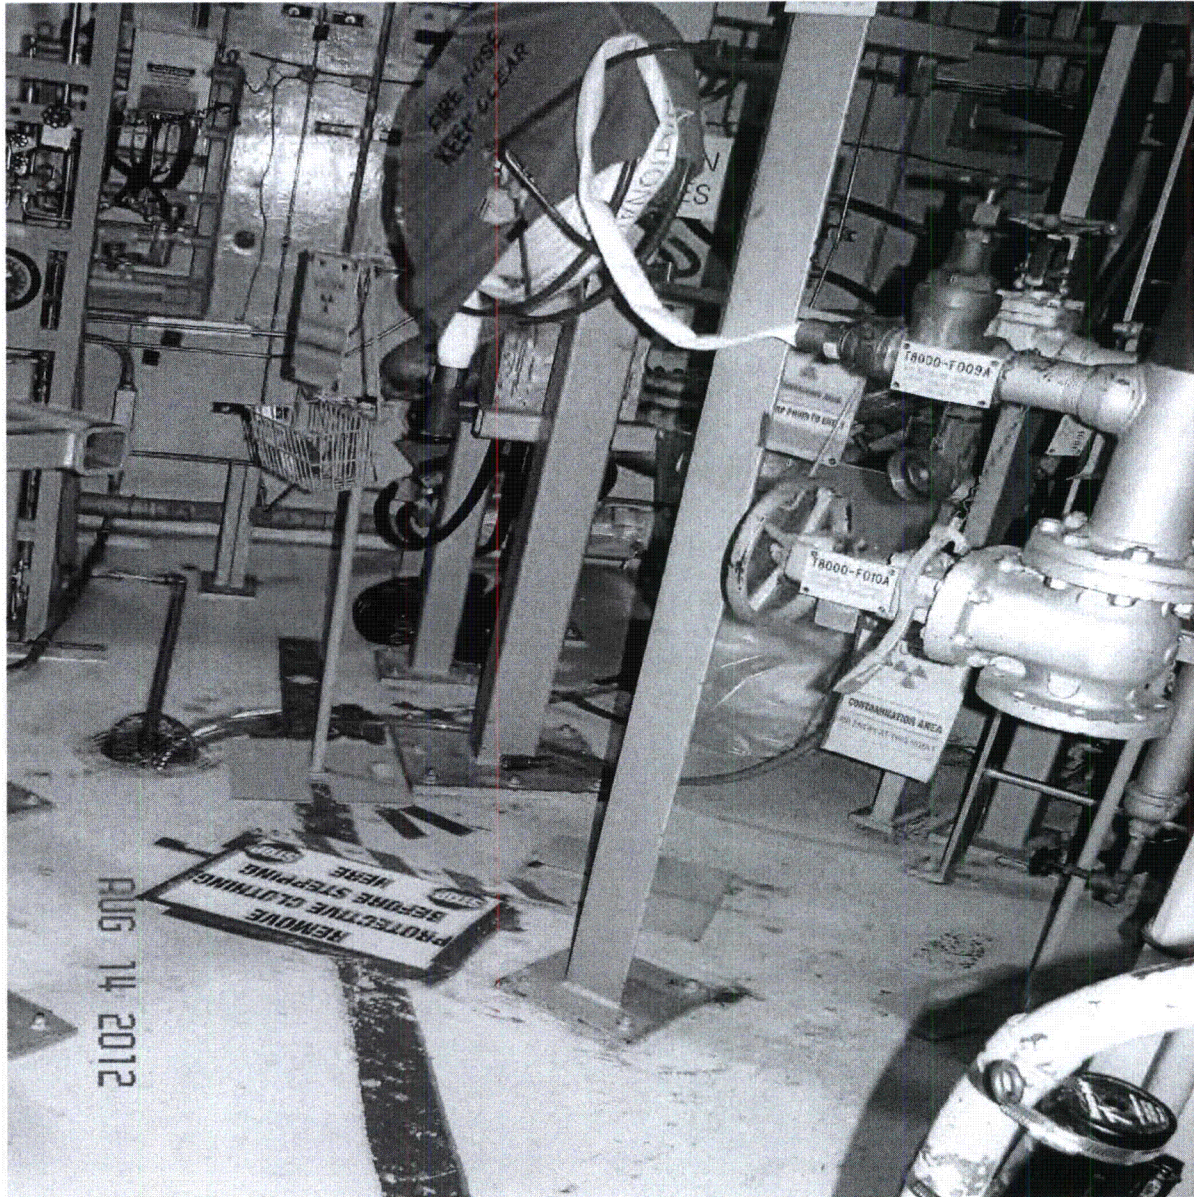
(Picture 19)

*Hose reel support is missing a nut, however it is not close enough to E5150F045 or E2101C001C to pose any realistic hazard. (See Pictures 19 and 20.) CARD 12-26957 has been written (8/21/12) for the missing nut on the hose reel support baseplate. The other equipment in the area has adequate anchorage.*
