Area Walk-By Checklist (AWC)

Assets: *H21P614B*

Location: Bldg. RB Floor El. 540'-0" Room, Area¹ A-02, Col. B-9

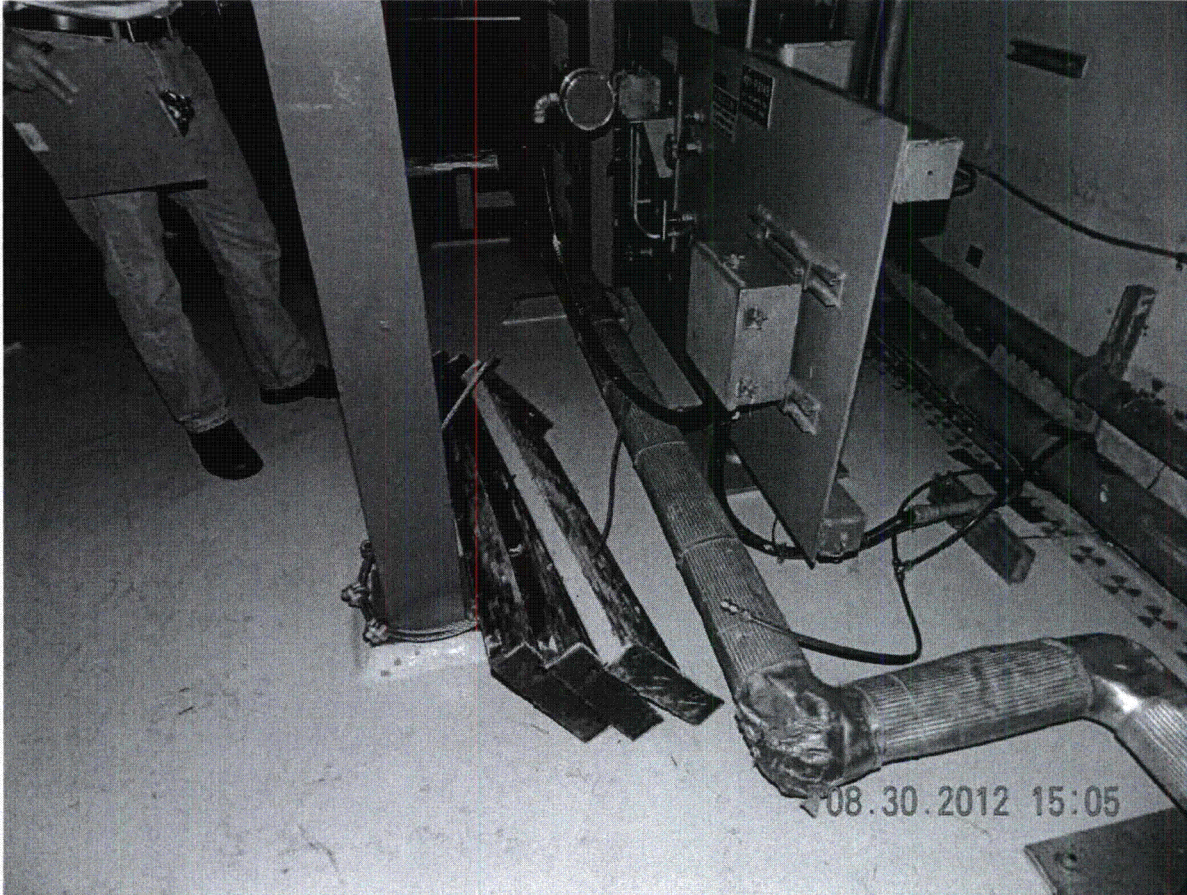
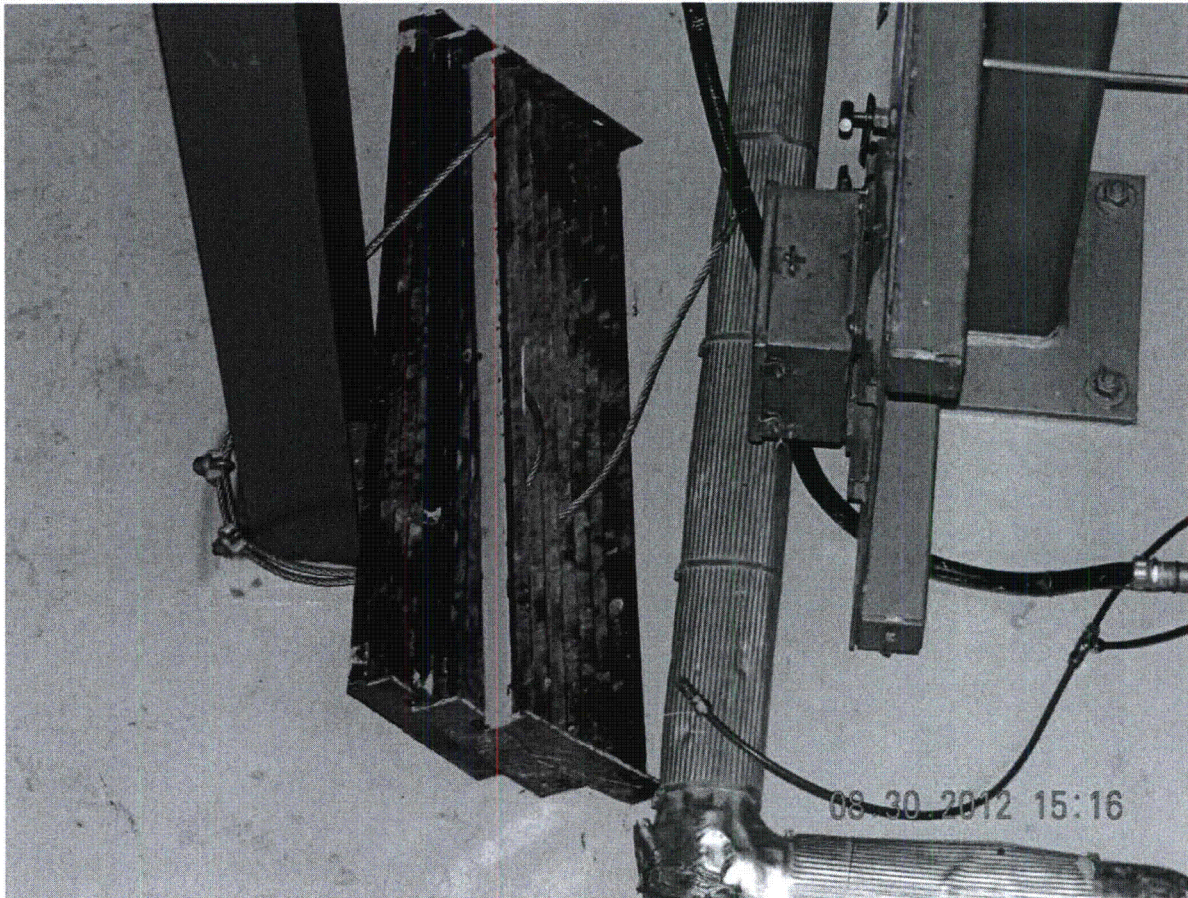
Near the base of the asset, there are some grates that are tied off to a nearby column by a cable. These grates are part of the ISFSI project and will not impact any safety related equipment. The E1102C002B pump casing drain pipe nearby is not safety-related. (See Pictures 58 and 82.)

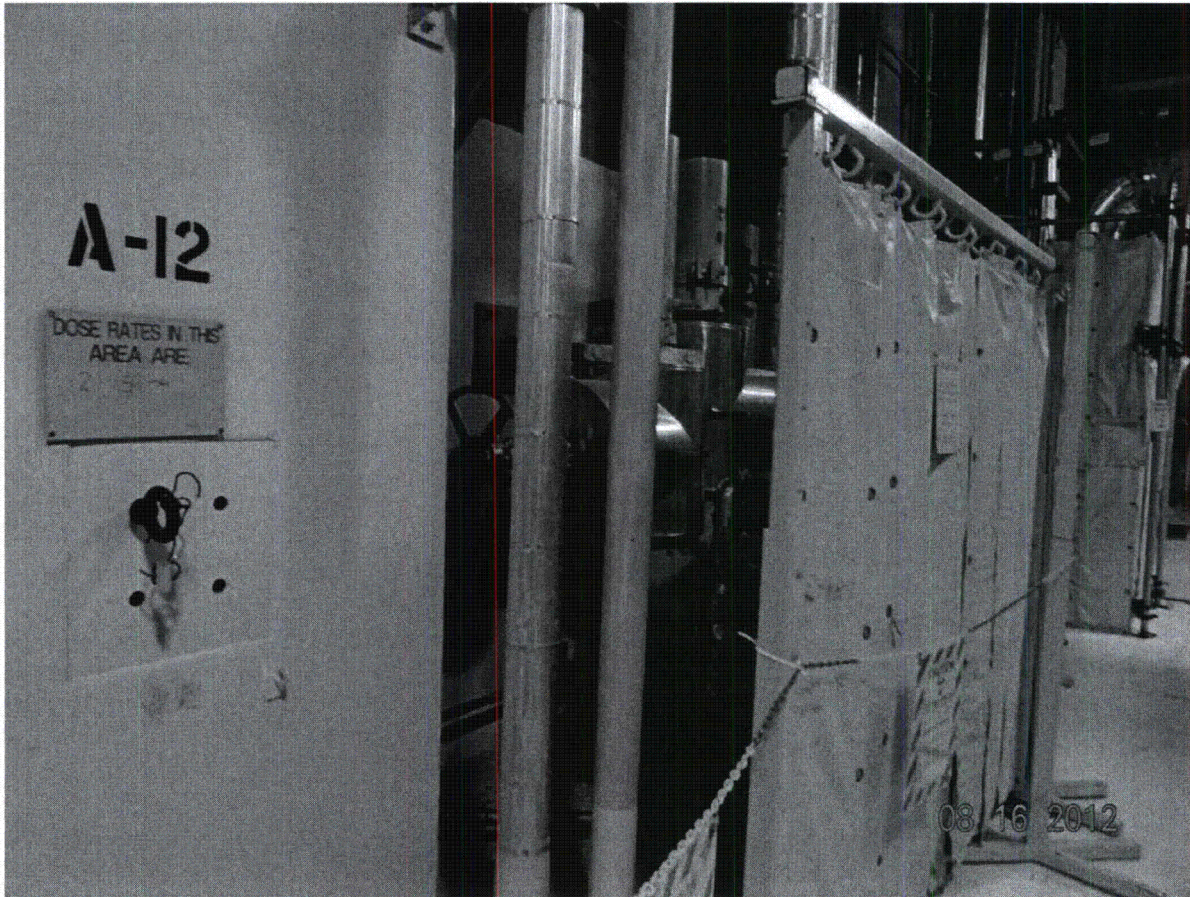
(Picture 1)

The asset is surrounded by lead blankets and radiation caution signs. The latter are chained to the lead blanket supports and to each other, so they are appropriately restrained. (See Picture 1.)

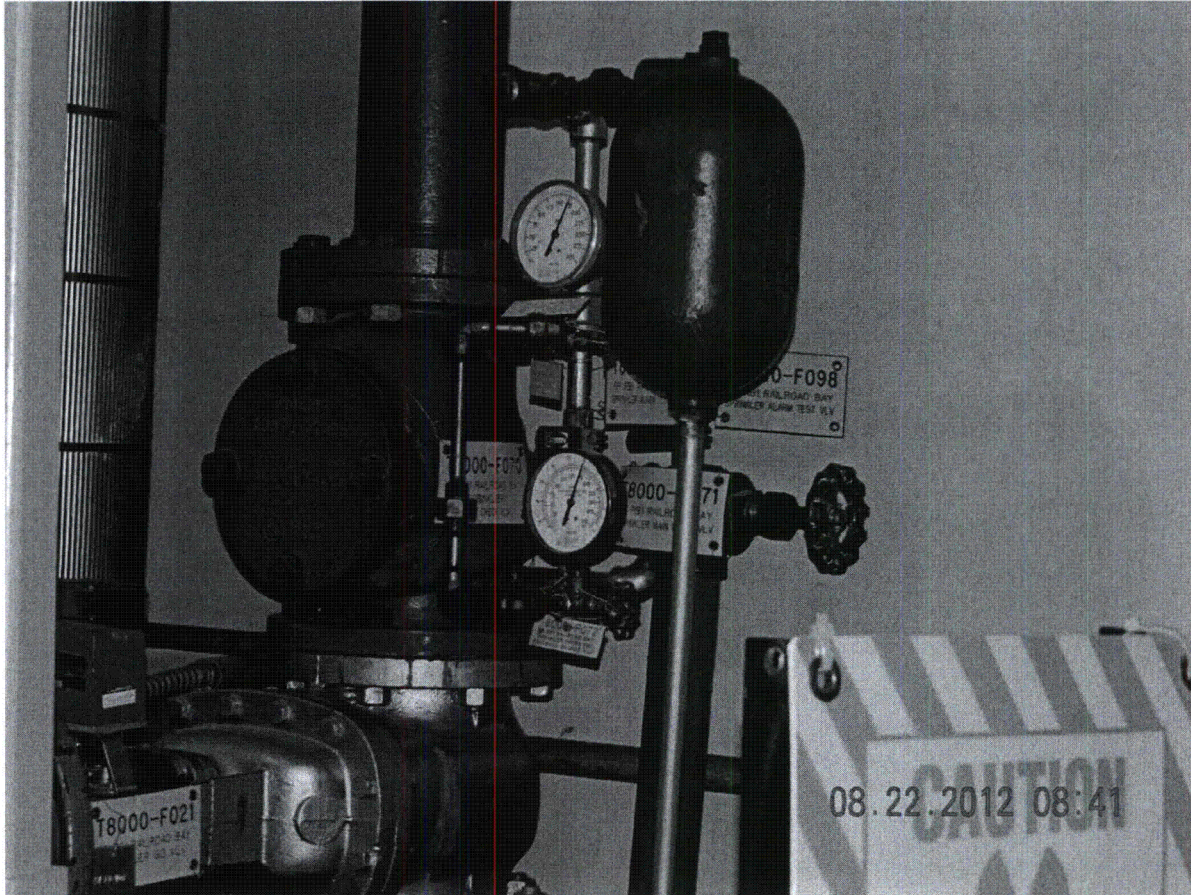
(Picture 44)

There is a bulb valve in the vicinity, with a rod inserted into the bottom that is adjacent to T8000F098, and it is attached to its piping system via a fairly thin valve connection. The bulb valve is I/I and is not an impact source for the asset or any other equipment in the area. (See picture 44.)

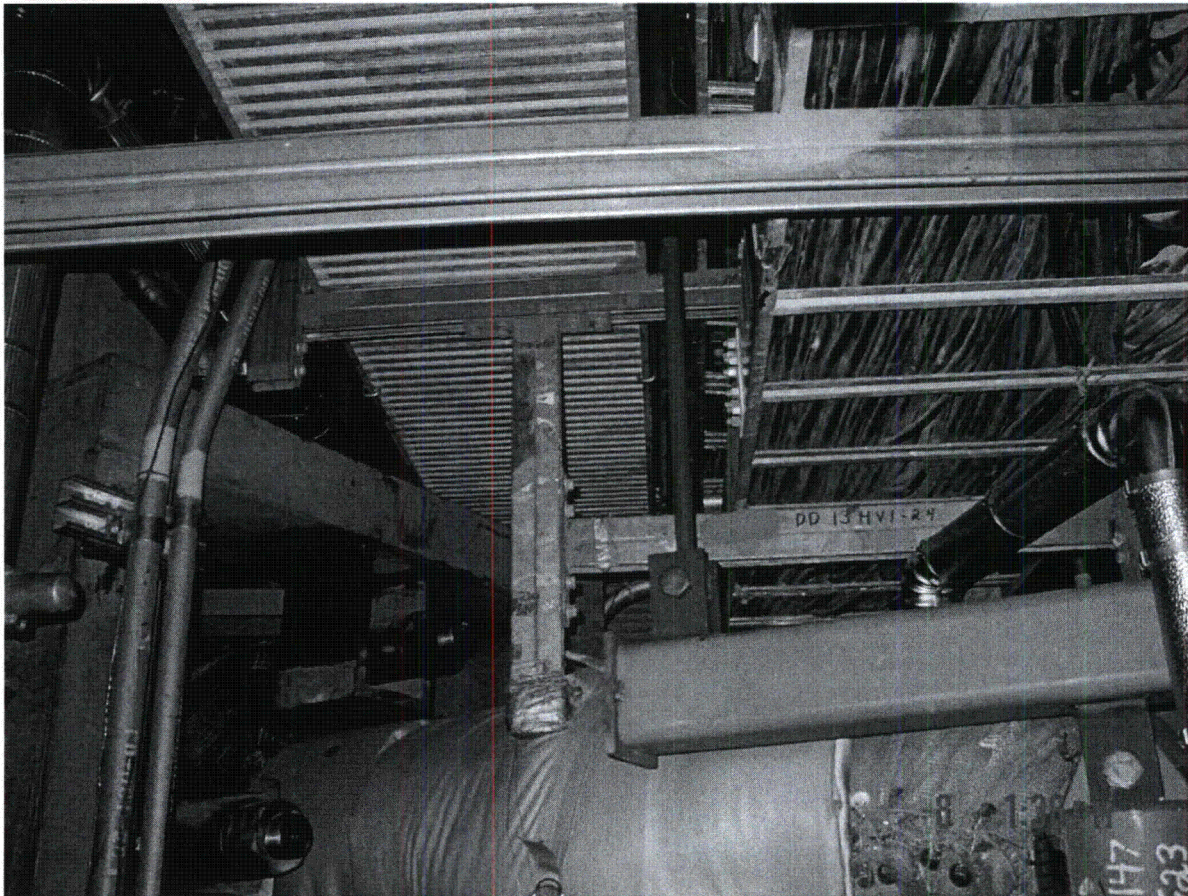
(Picture 4)

Raceways were evaluated from the catwalk (See picture 4).

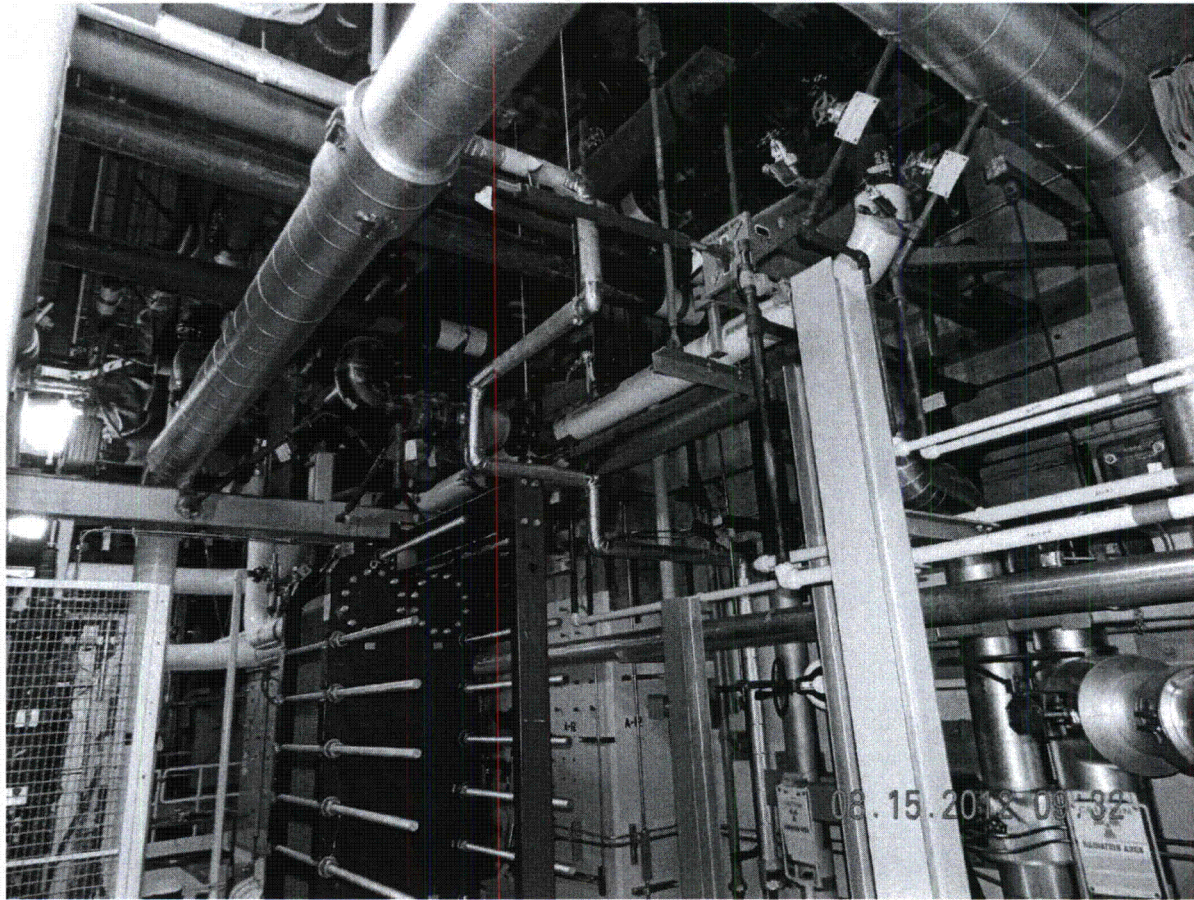
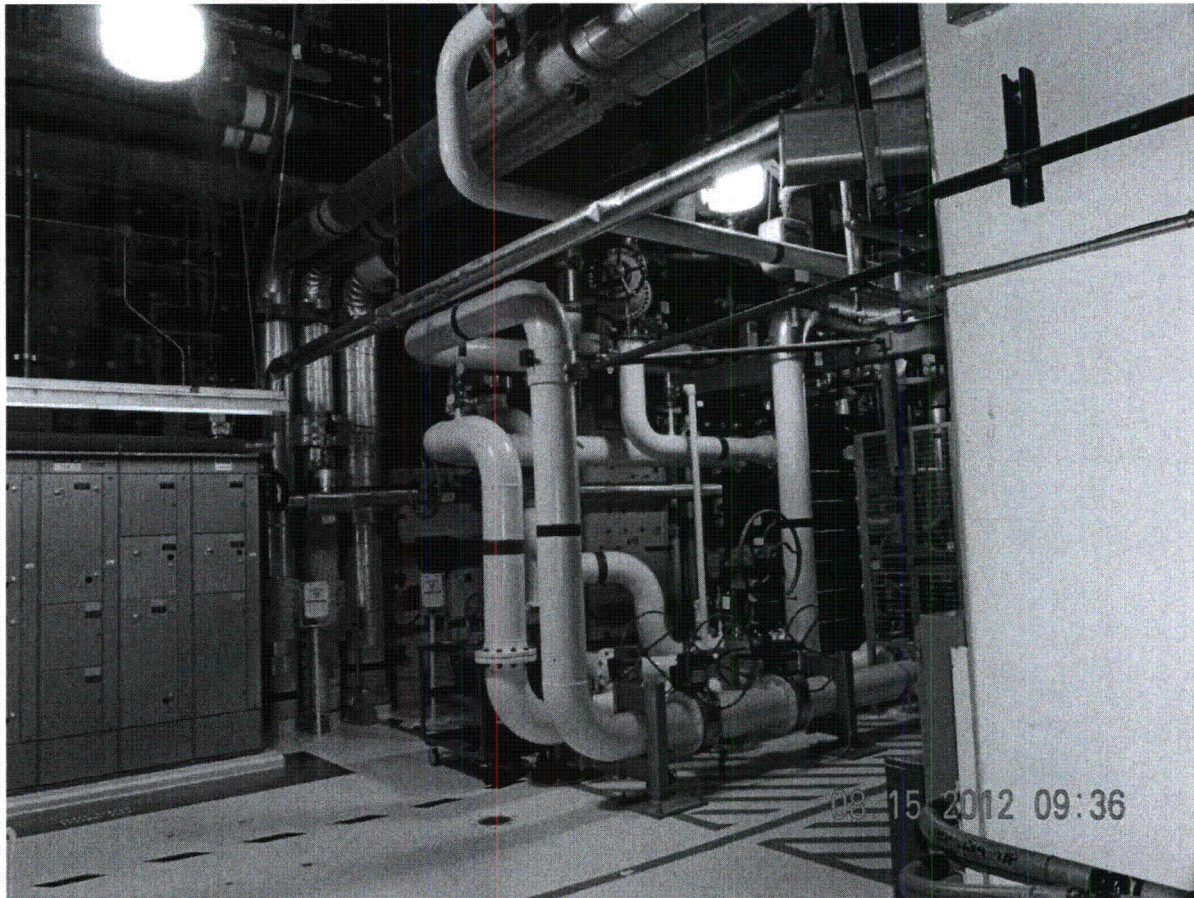
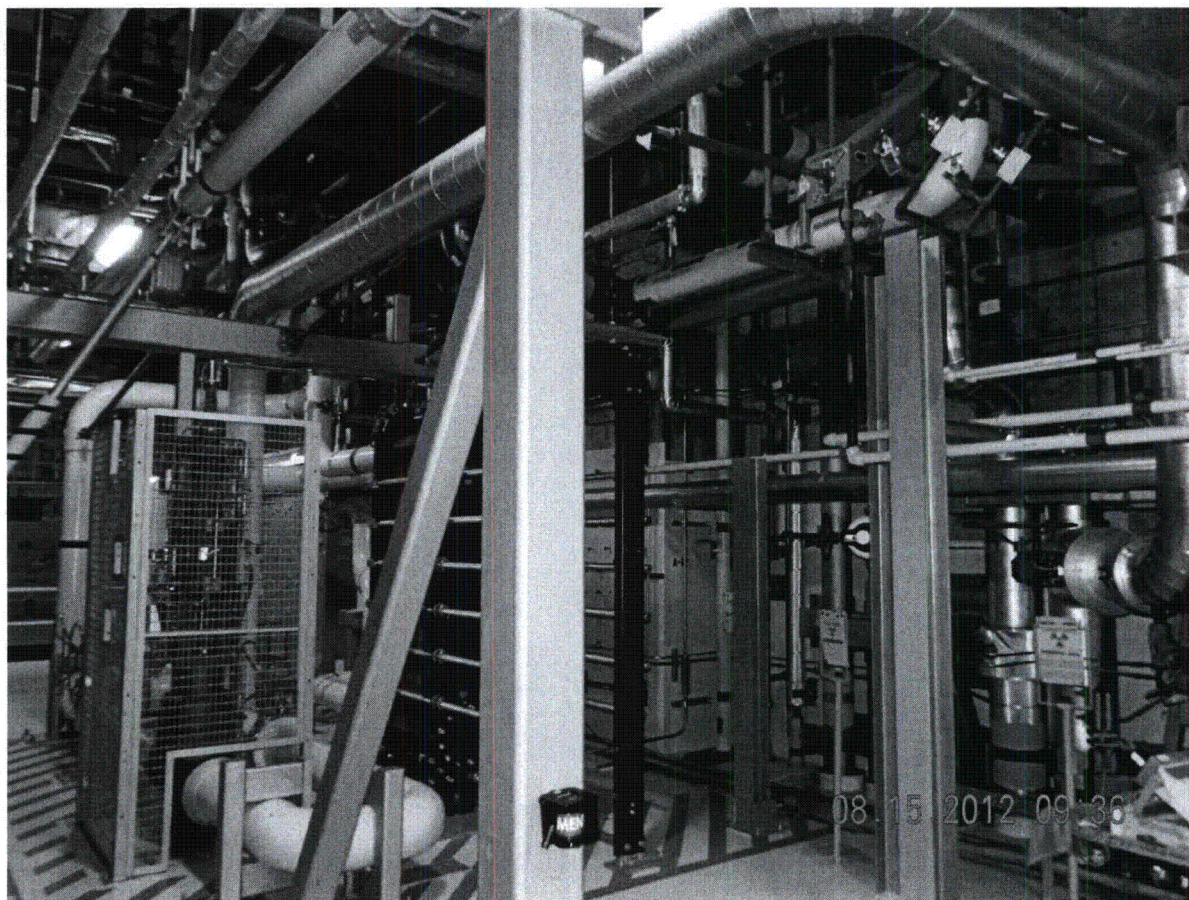
Anchorage of equipment in the area is free of adverse seismic conditions. See photo 006, 007 & 009 of the area.

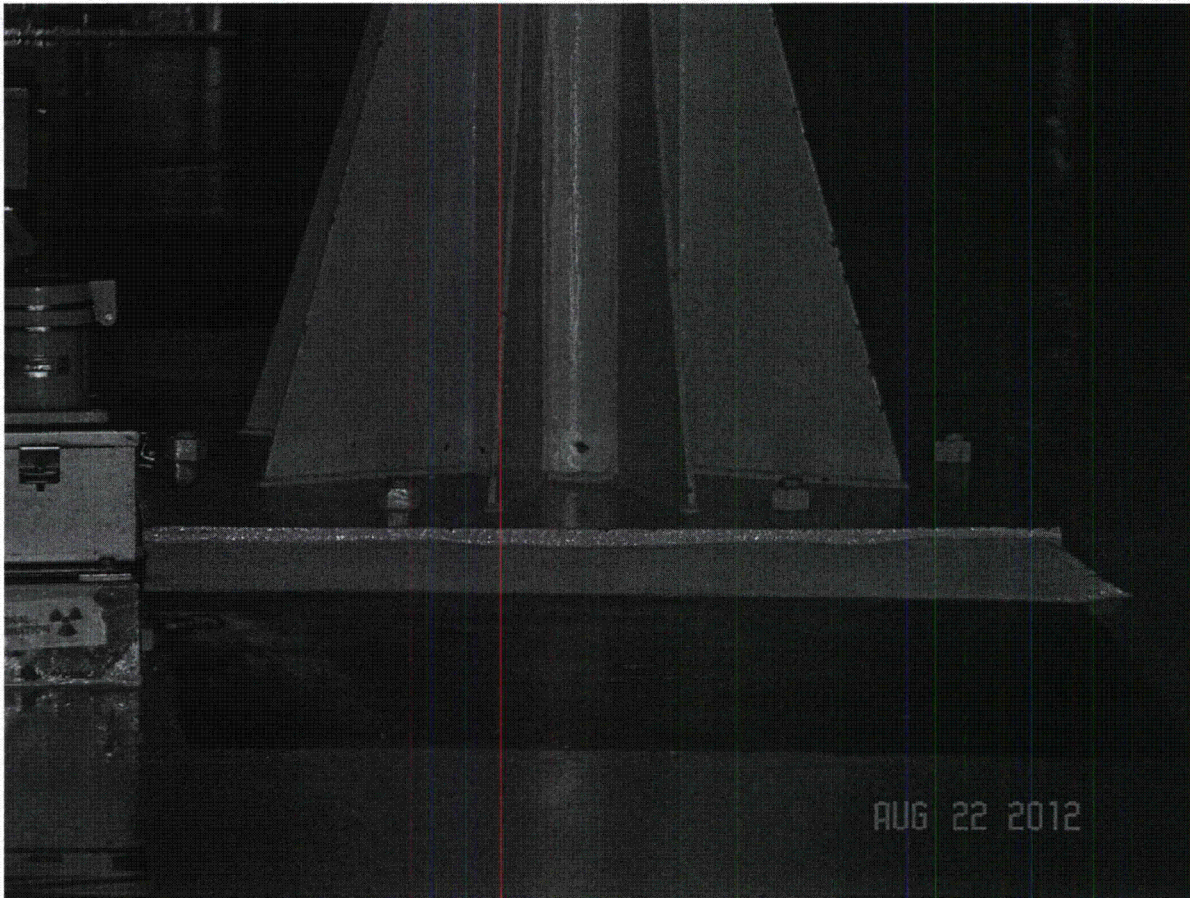
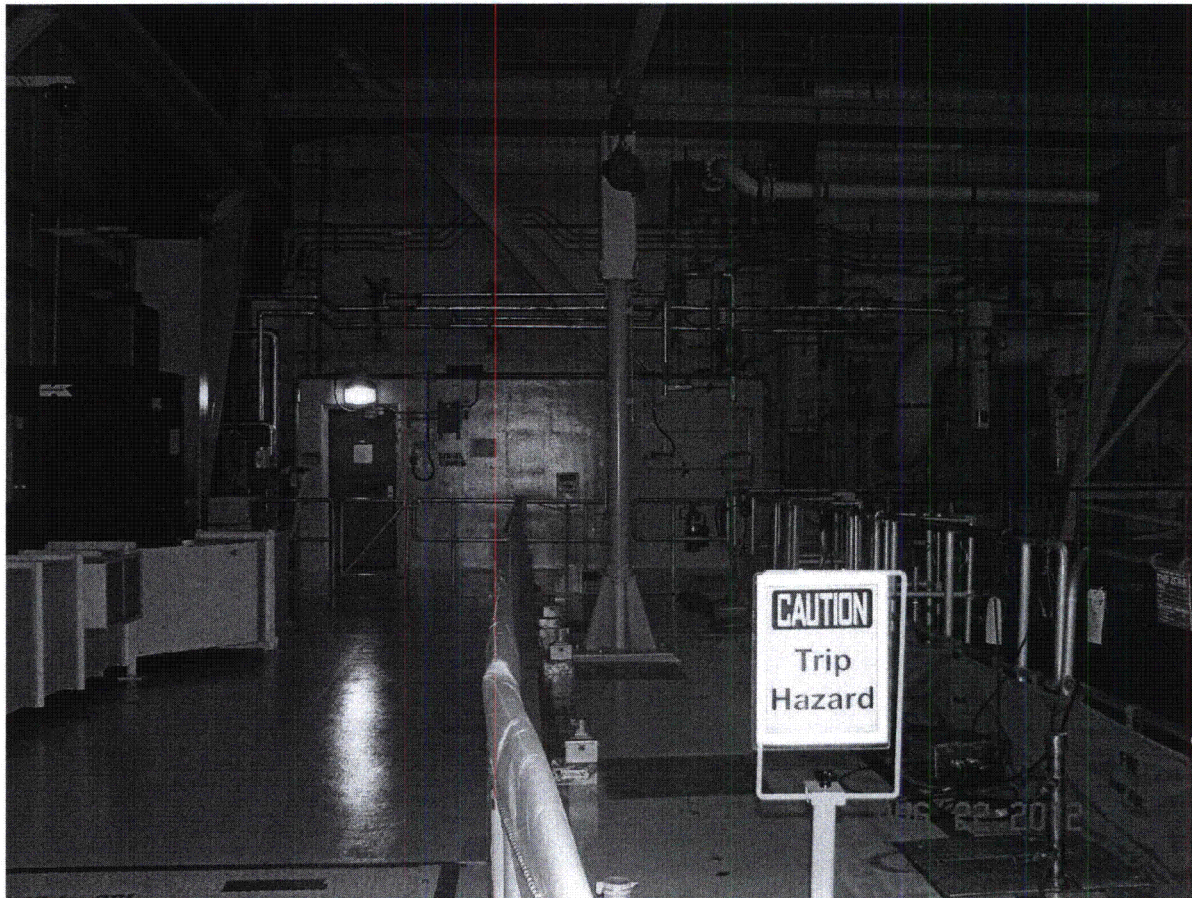
Anchorage on a nearby floor-mounted crane and other local supports are free from adverse conditions. (See Pictures 1 & 2)

Anchorage in the area is free from degraded conditions. (See Pictures 1 & 2)
