## SEISMIC WALKDOWN CHECKLIST FORM

Status: Y  N  U Seismic Walkdown Checklist (SWC) SWEL2-008Equipment ID No. 19P-1A Equip. Class 5. Horizontal pumpsEquipment Description: Fuel pool cooling recirc pump ALocation: Bldg. RB Floor El. 326 Room, Area Col 3 line T

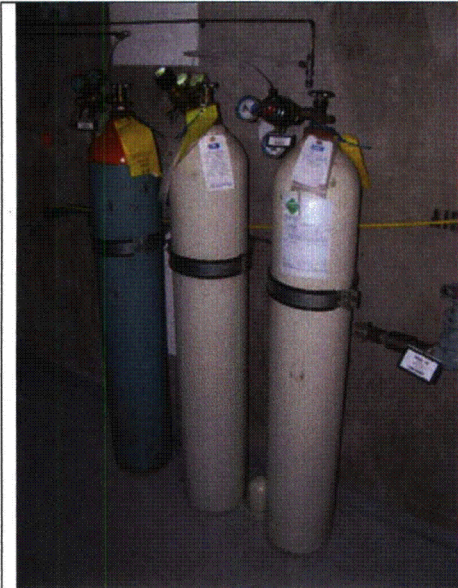
**Note:** *Picture of the compressed gas cylinder tanks.*
