Status: Y N U **Seismic Walkdown Checklist (SWC) SWEL1-065**Equipment ID No. F-52B Equip. Class¹ 17 – ENGINE GENERATORSEquipment Description DG2 ENGINE MOUNTED TURBO FILTERLocation: Bldg. RAB Floor El. 369 Room, Area 86Manufacturer, Model, Etc. (optional but recommended) Electro-Motive**Instructions for Completing Checklist**

Seismic Walkdown Checklist (SWC) SWEL1-065

Equipment Description DG2 ENGINE MOUNTED TURBO FILTER

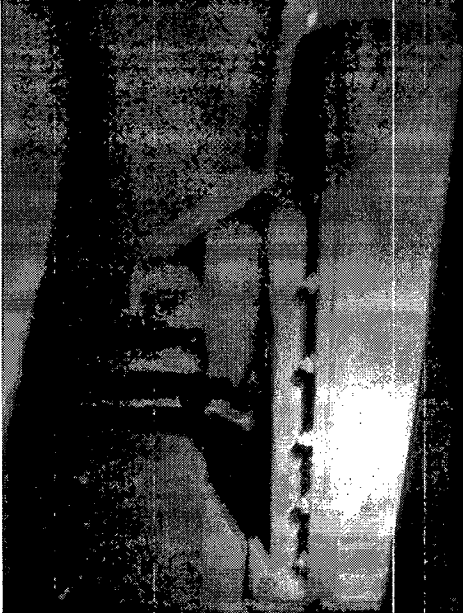
Note: Close up of Component from underside

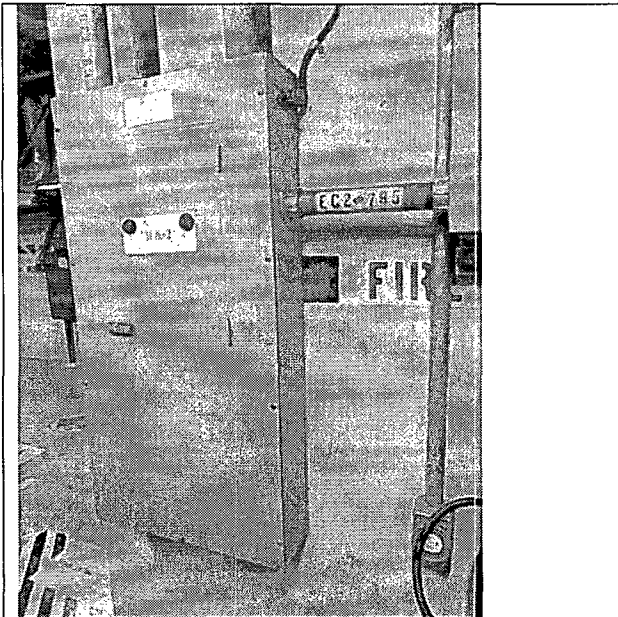
Note: View of panel RA-2 in Room 95.

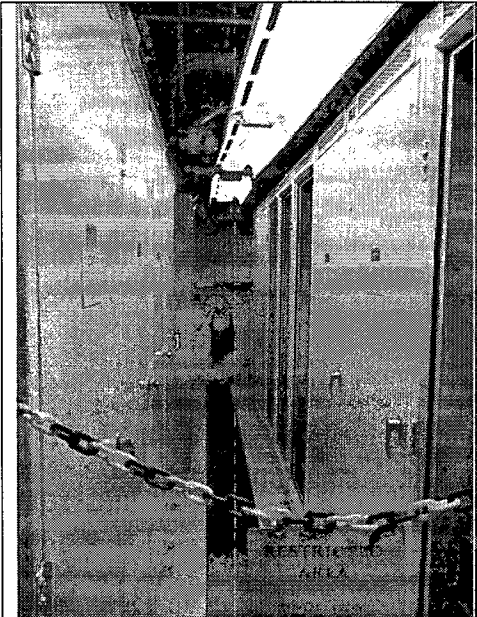
Note: Row of cabinets in Room 96.
