AREA WALK-BY CHECKLIST

Area Walk-By Checklist (AWC) AWC-013

Location: Bldg. SWSTR PIT Floor El. 5'-9" Room, Area¹ Zem Strainer Pit

ATTACHMENT E – POTENTIALLY ADVERSE SEISMIC CONDITIONS

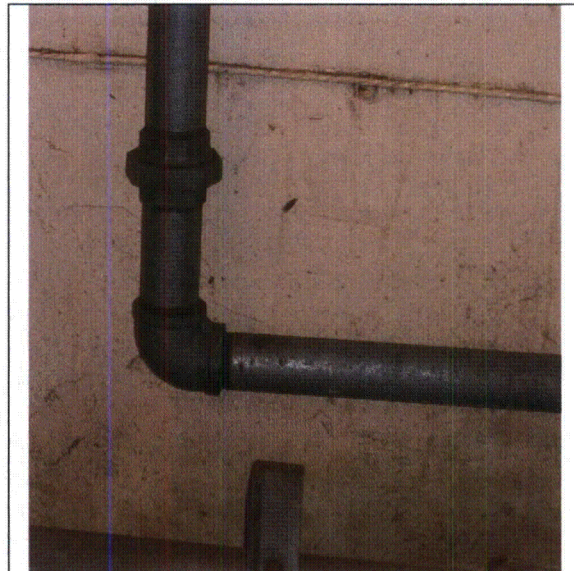
Note: Threaded pipe for the 26 sump pump discharge.

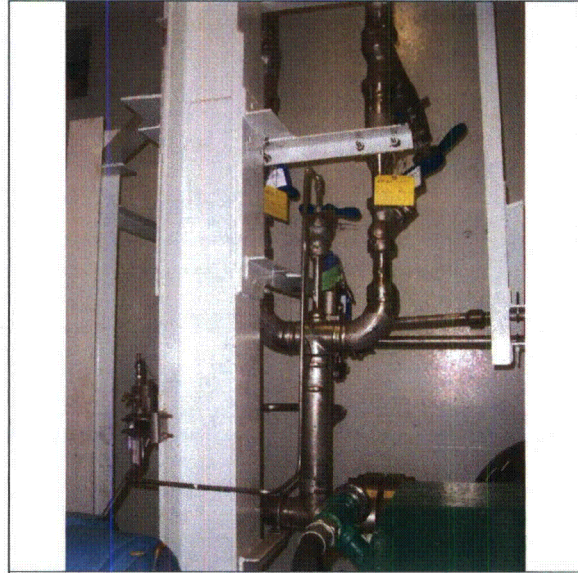
Note: Pipes coming off of the 23 charging pump.

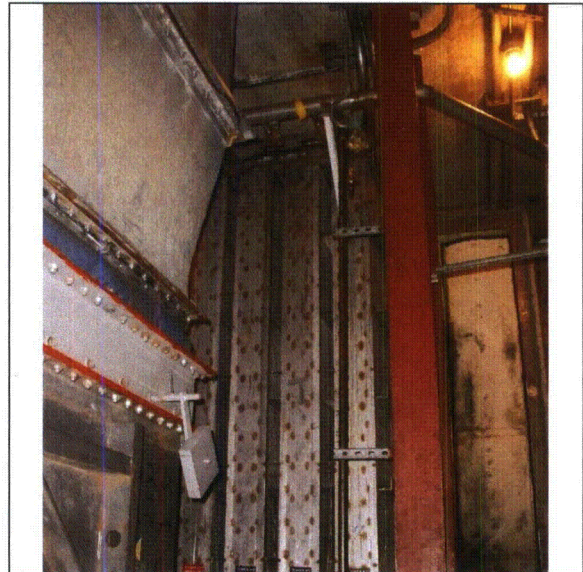
Note: HEPA filters behind fan 22.

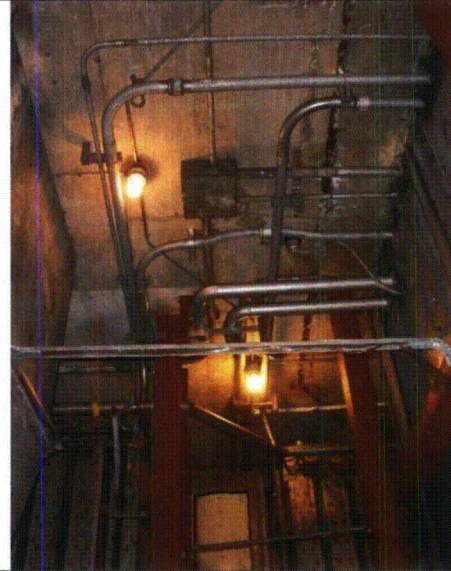
Note: Overhead area with 22 fan on left.

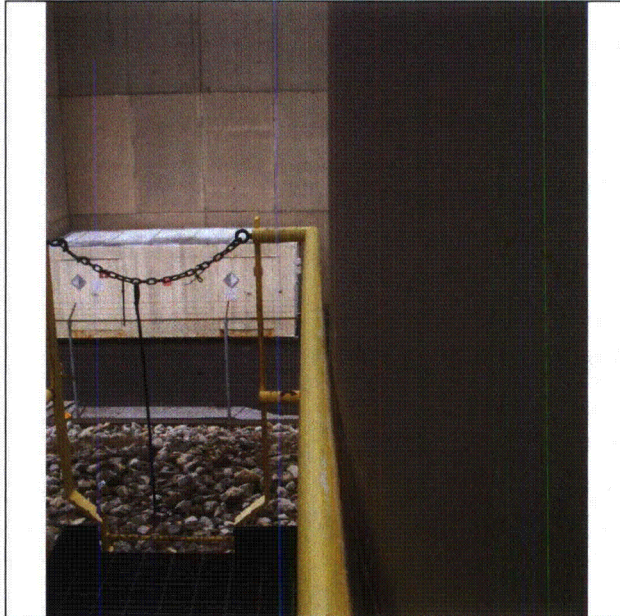
Note: Very small gap between platform and RWST.

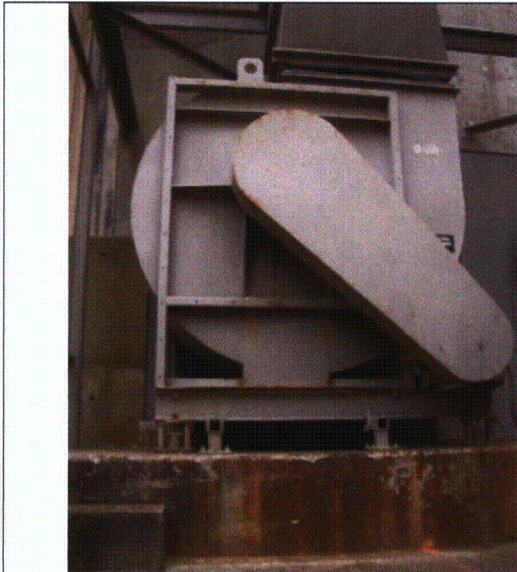
Note: 21 Electrical Tunnel Exhaust Fan

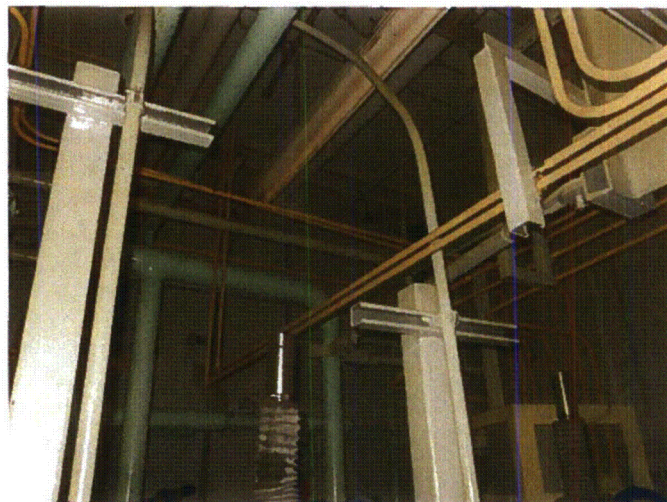
Tubing with excessive distance between supports at entry to room.

A subsequent walkdown of the tubing locations by members of the IPEC Design Engineering Department certified for performance of the Seismic Walkdowns, was performed. Approximations of the tubing spans made by the original walkdown team that prepared AWC-35 were reviewed against the tubing layouts. The new inspections established that:
