Seismic Walkdown Checklist (SWC) SWEL1-074

SEISMIC WALKDOWN CHECKLIST FORM

IP2

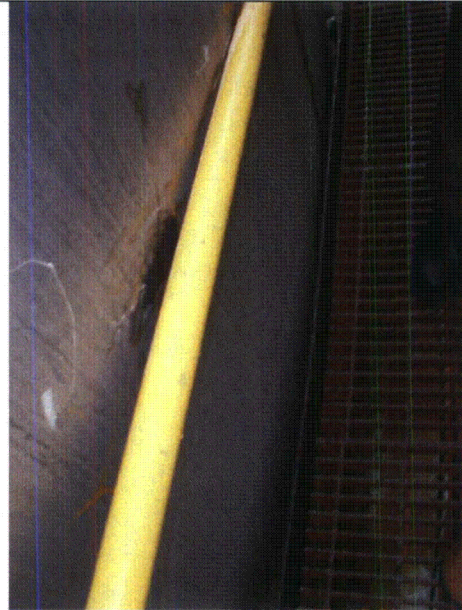
Note: The tank too close to the platform railing

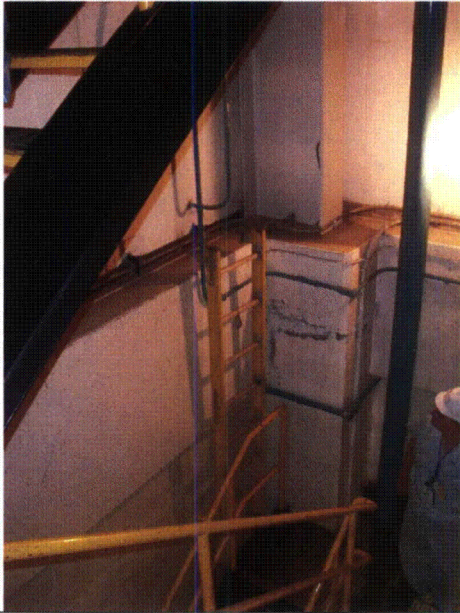
Note: Unsecured ladder next to stair way.

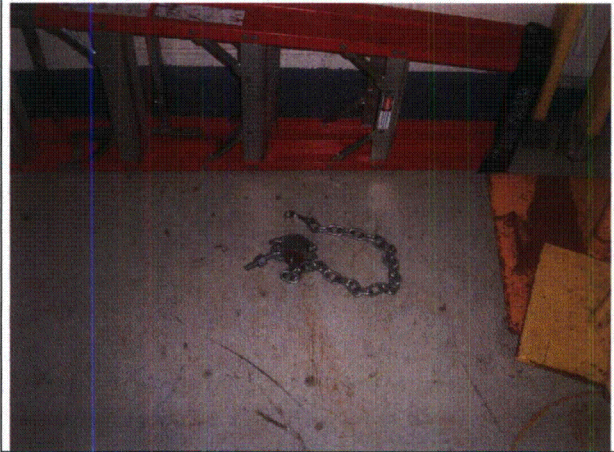
Note: Numerous unsecured items under stair way.

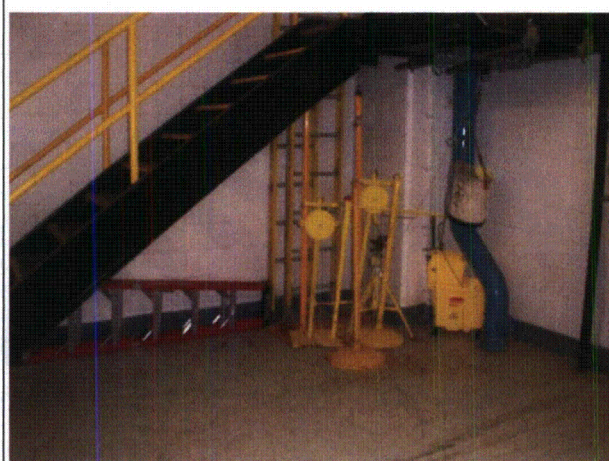
Note: Numerous unsecured items under stair way.
