# **Attachment D**

## ***AREA WALK-BY CHECKLISTS (AWCs)***

Status: Y  N  U **Area Walk-By Checklist (AWC) AWC- 001**Location: Bldg. AB Floor El. 93 Room, Area<sup>1</sup> 1A102,07**SWEL Components: SWEL1- 024,030****Instructions for Completing Checklist**

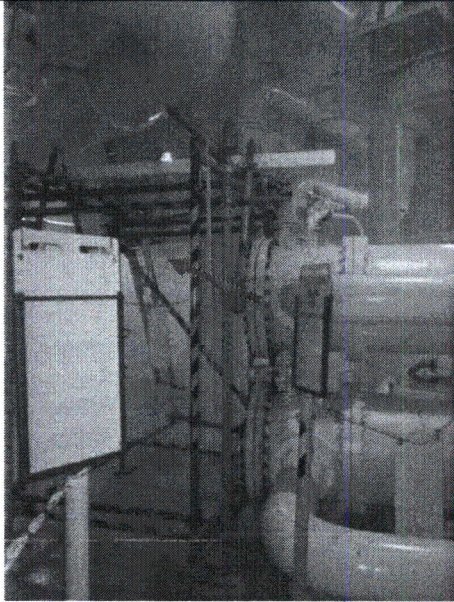
**Note:** *Ladder in the area*

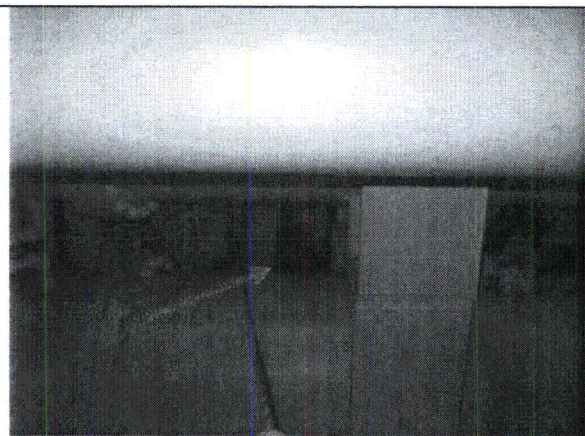
**Note:** *Hose on the floor*

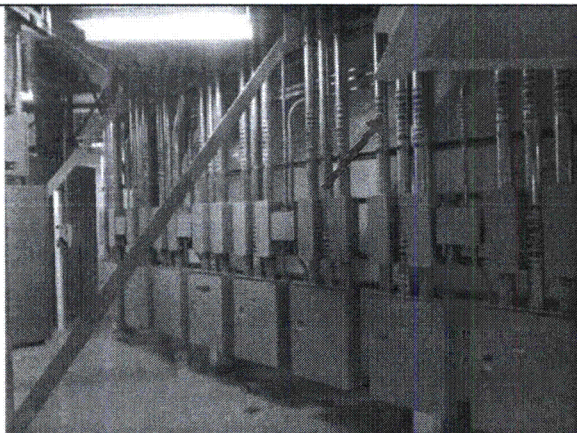
**Note:** *Conduits from cable tray*

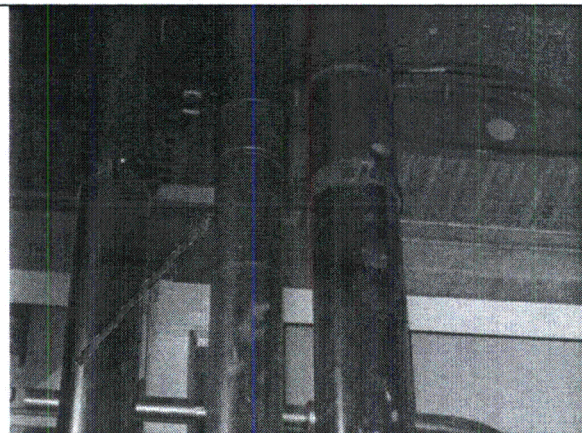
**Note:** *Only conduit without unistrut support clamp at this location*

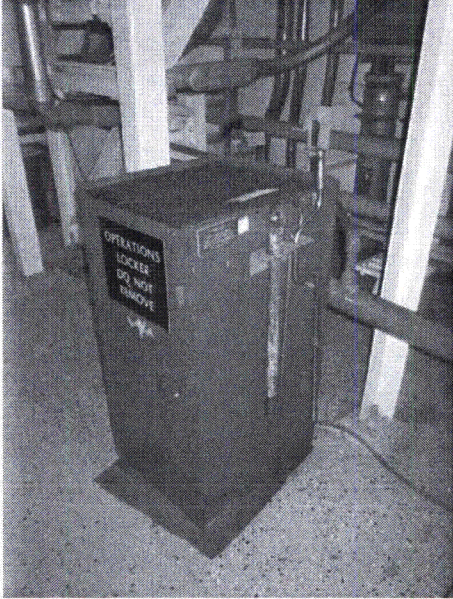
**Note:** *Operations Locker on floor*

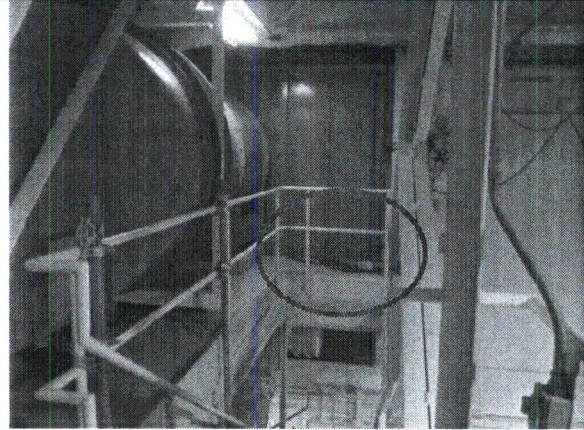
*Temporary stand frame found; however it's tied-off to the handrail using wire rope. Temporary scaffolding (connected to the permanent platform structure) and control for the overhead hoist (see photo) found in this area doesn't pose a seismic concern.*

**Note:** *Controls for the overhead hoist.*
