Seismic Walkdown Checklist (SWC)	
Equipment ID No. 2X41-C010A Equip. Class 9	and the second s
Equipment Description DG 2C ROOM FAN 2A	
Location: Bldg. DIESEL Floor El. 150 Room, Area ROOF	
Manufacturer, Model, Etc. (optional but recommended)	
Instructions for Completing Checklist	
This checklist may be used to document the results of the Seismic Walkdown of SWEL. The space below each of the following questions may be used to record findings. Additional space is provided at the end of this checklist for documenting the space is provided at the end of this checklist for documenting the space is provided at the end of this checklist for documenting the space is provided at the end of this checklist for documenting the space is provided at the end of this checklist for documenting the space is provided at the end of this checklist for documenting the space is provided at the end of this checklist for documenting the space is provided at the end of this checklist for documenting the space is provided at the end of this checklist for documenting the space is provided at the end of this checklist for documenting the space is provided at the end of this checklist for documenting the space

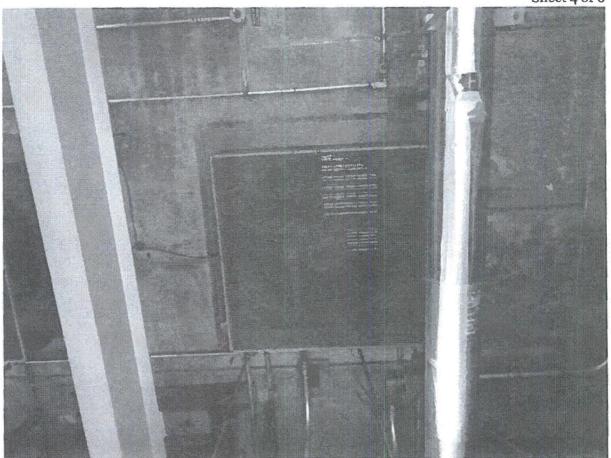
2: Equipment from Below Roof (2X41-C010A)

Anchorage	
1. Is the anchorage configuration verification required (i.e., is the item one of the 50% of SWEL items requiring such verification)?	Y⊠ N□
2. Is the anchorage free of bent, broken, missing or loose hardware? Viewed anchorage from underside of roof slab and on the roof.	Y⊠ N□ Ü□ N/A□

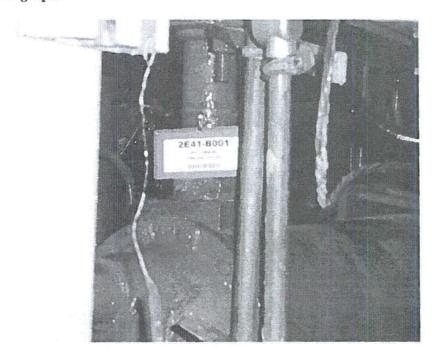
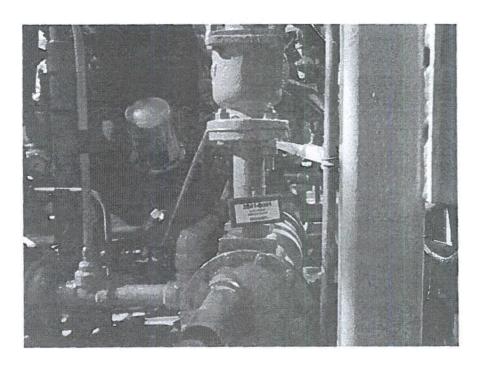
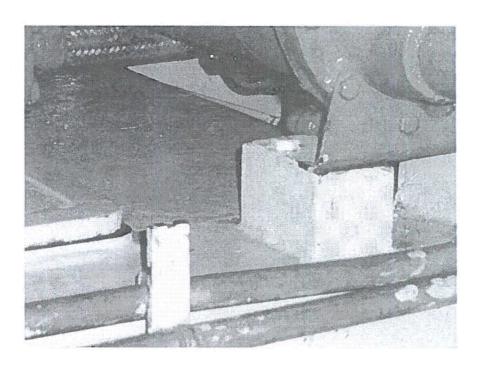
11. Have you looked for and found no other seismic conditions that could adversely affect the safety functions of the equipment?	Y⊠ "עֹם "עֹם
Comments (Additional pages may be added as necessary)	
No washers are found for 2 of the 4 bolts in the anchorage. However, SV seismic concern since the washers are not critical anchorage items w oversized. Area walkby was performed within the package for 2E21-C001B.	
Evaluated by: KURSAT KINALI	Date: <u>9/24/2012</u>
WESLEY WILLIAMS Wisley A pullian	9/24/2012

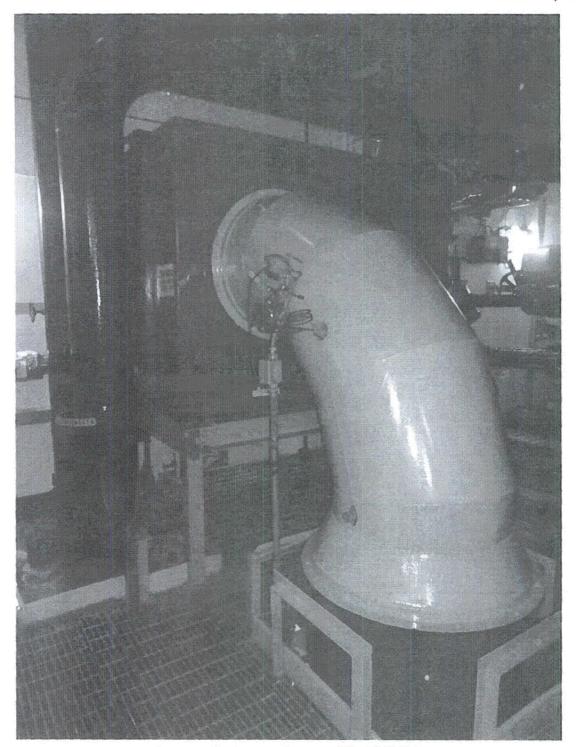
Figure 2 - Equipment Elevation (2T41-B003B)

11. Have you looked for and found no other seismic conditions that could adversely affect the safety functions of the equipment?	Y⊠ N□ U□
Comments (Additional pages may be added as necessary)	
There is a small section of grating broken near the corner of the 2T41-BC Cooler. The section of grating is extremely small and is welded to the kid going through the grating at that location. The grating is not in immedia becoming an impact hazard and does not affect the larger grating panel's Therefore, it has been judged to be seismically adequate.	ck plate around the pipe te danger of separating and
See Component 2E11-B001A for the Area Walk-by Checklist.	<u></u>
Evaluated by: John McFarland	Date: 09/12/2012
Jeff Horton Il Korton	09/12/2012

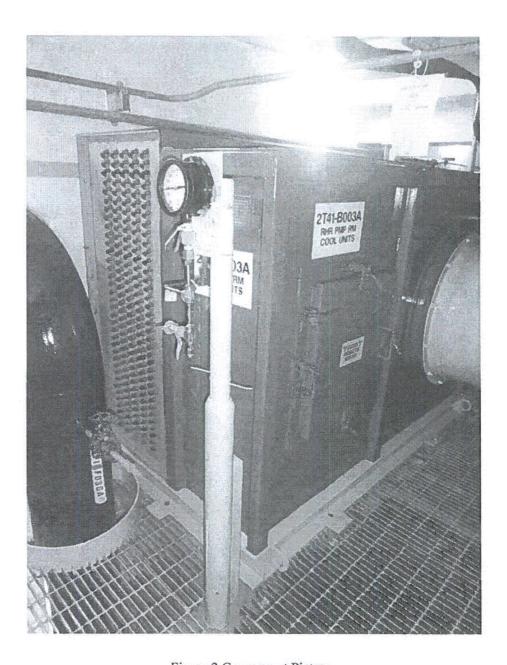
Figure 2 Component Picture

Anchorage 1. Is the anchorage configuration verification required (i.e., is the item one of the 50% of SWEL items requiring such verification)?	Y⊠ N□
2. Is the anchorage free of bent, broken, missing or loose hardware? Holes with missing anchors but replaced with tabs and new anchors. SWE's have determined that this configuration is acceptable and consistent with anchorage shown in SQUG package based on referenced SEWS package and Calculation	Y⊠ N□ U□ N/A□
