Status: Y  N  U **Seismic Walkdown Checklist (SWC)**Equipment ID No. 2R43-B002A Equip. Class<sup>1</sup> 21Equipment Description DG 2A LUBE OIL HEAT EXCHLocation: Bldg. DIESEL Floor El. 130 Room, Area 2A

**Seismic Walkdown Checklist (SWC)**

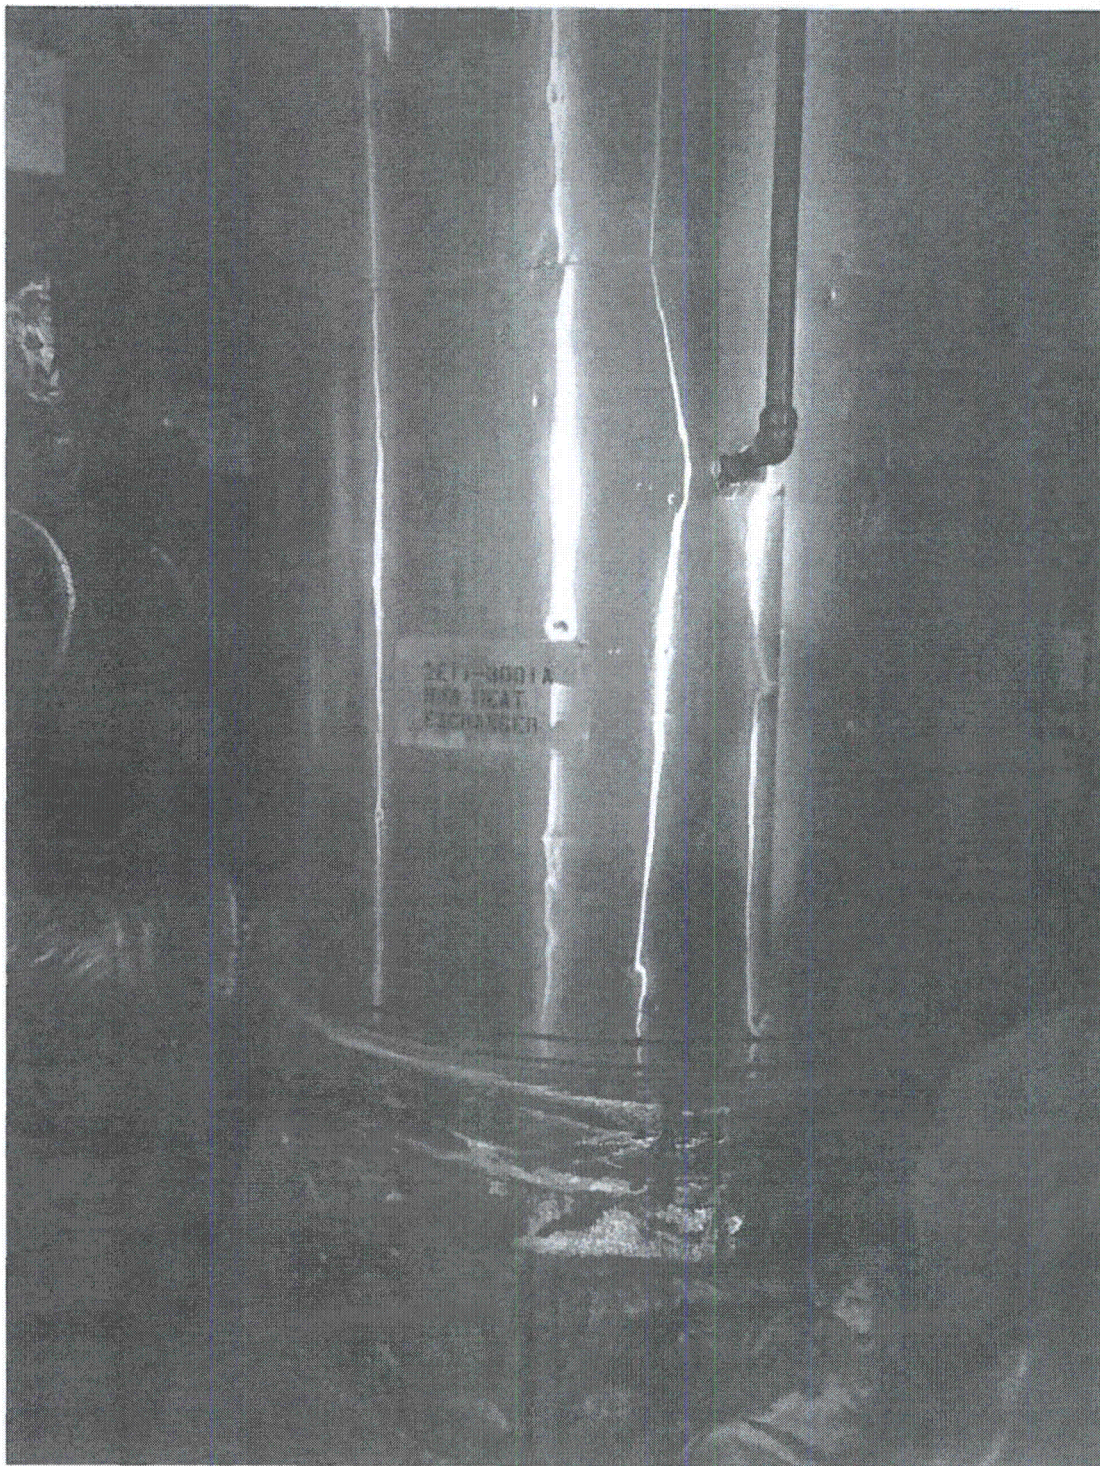
Figure 2 – Equipment Elevation (2E11-B001A)

2. Is the anchorage free of bent, broken, missing or loose hardware? Y  N  U  N/A   
*There are eight anchors attached to the steel frame in four mounting chairs. Two of the bolts have full thread engagement but do not have the required minimum of two threads above the nut; an additional two bolts have bolts approximately 1/4" below the nuts and so do not have full thread engagement (CR 516593). The bolts are welded to the steel frame, providing additional support for the connection. In addition, the heat exchanger is also supported by four sway struts below the roof above to prevent overturning of the equipment. The shear strength is not impacted, overturning is restrained, and the center of gravity of the equipment is below the bolts and the vertical seismic acceleration at that level will not exceed 1.0, so the largest tension load the bolts will see is the preload, which is already applied. Therefore, the bolts are judged to be acceptable and do not create a potentially adverse seismic condition.*

- 10. Based on the above seismic interaction evaluations, is equipment free of potentially adverse seismic interaction effects? Y N U  
*The cable raceway support impinges on the RHR Heat Exchanger insulation, and the insulation has been cut away from the member. The raceway support only impacts the insulation, but is at least one inch from the body of the heat exchanger, so there will be no impact between the two components. Therefore, it is judged that there is no potentially adverse seismic condition.*

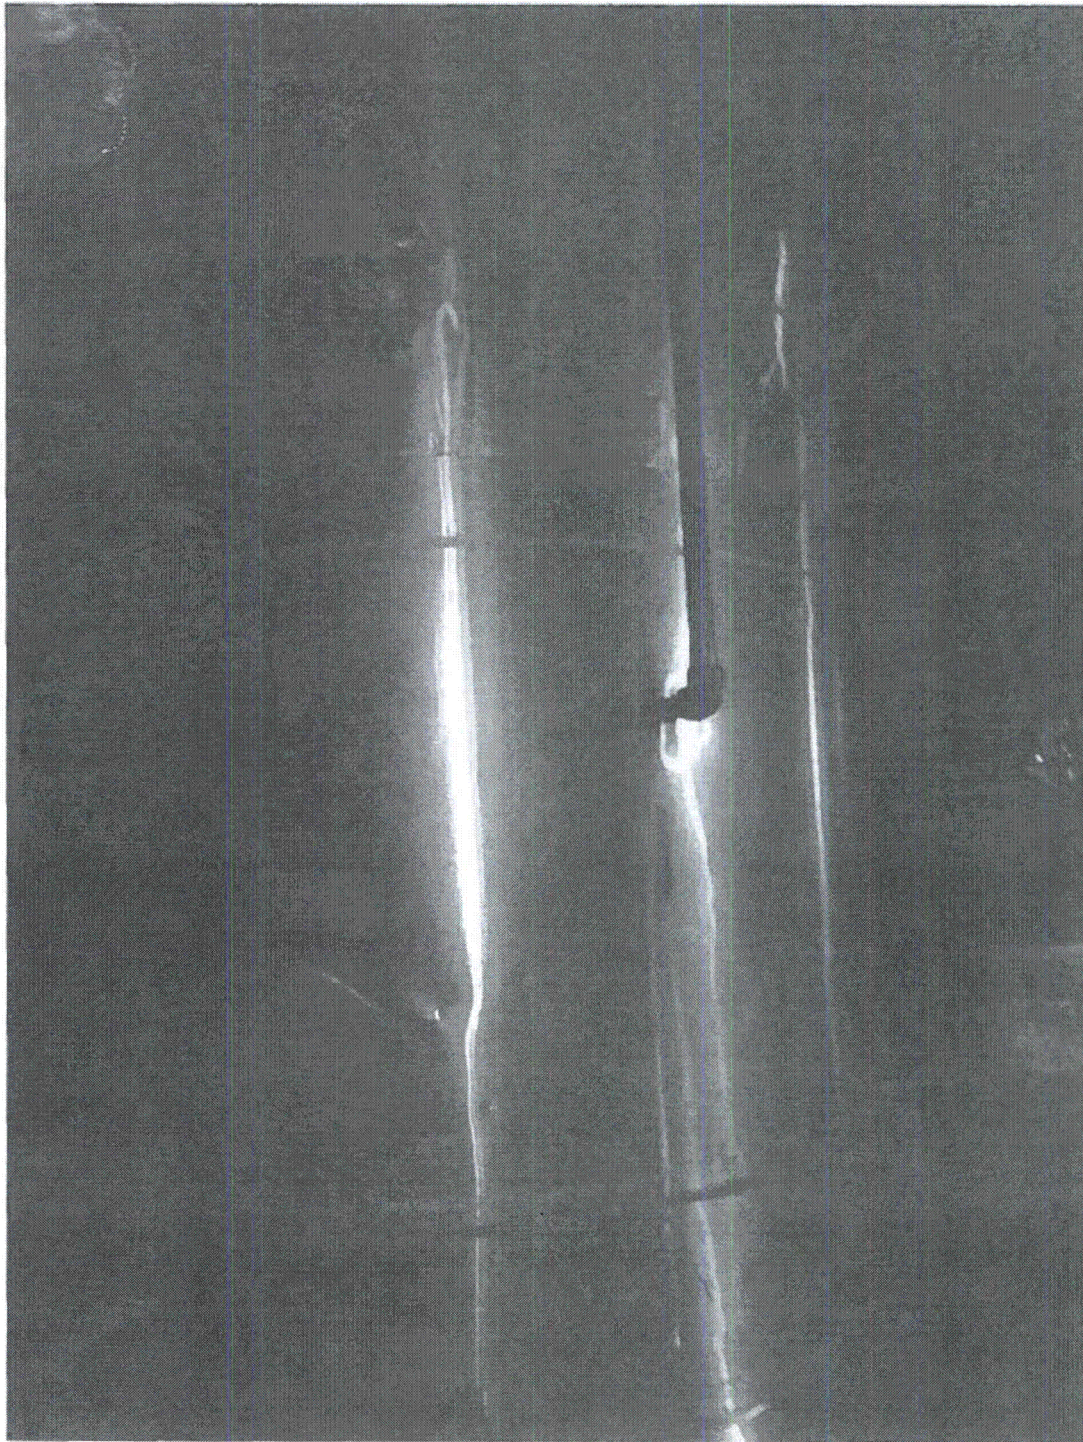
Figure 2 – Equipment Elevation (2E11-B001B)

2. Is the anchorage free of bent, broken, missing or loose hardware? Y  N  U  N/A   
*There are eight anchor connections to the steel frame in four mounting chairs. Two of the bolts have full thread engagement but do not have the required minimum of two threads above the nut (CR 516595). The bolts are welded to the steel frame, providing additional support for the connection. Also, each of the HX anchoring chairs have two additional holes drilled in them. These bolt holes appear to be the original holes for the installation of the RHR HX. Bolts installed in these holes would not be able to reach the structural steel flanges in the existing building structure. Therefore, new mounting holes have been provided for installing the RHR HX on the existing building structure. The current bolts used for the anchorage of this component are judged by the SWE's to be the same size and strength as the original connections for the holes on the bolting chairs for this component.*

*In addition, the heat exchanger is also supported by four sway struts below the roof above to prevent overturning of the equipment. The shear strength is not impacted, overturning is restrained, and the center of gravity of the equipment is below the bolts and the vertical seismic acceleration at that level will not exceed 1.0, so the largest tension load the bolts will see is the preload, which is already applied. Therefore, the bolts are judged to be acceptable and do not create a potentially adverse seismic condition.*

3. Is the anchorage free of corrosion that is more than mild surface oxidation? Y  N  U  N/A   
*The bolt paint chipped off in several places, resulting in mild surface oxidation. Since oxidation is only on the surface, the anchors are not degraded. Therefore, the anchors are judged not be a seismic concern.*

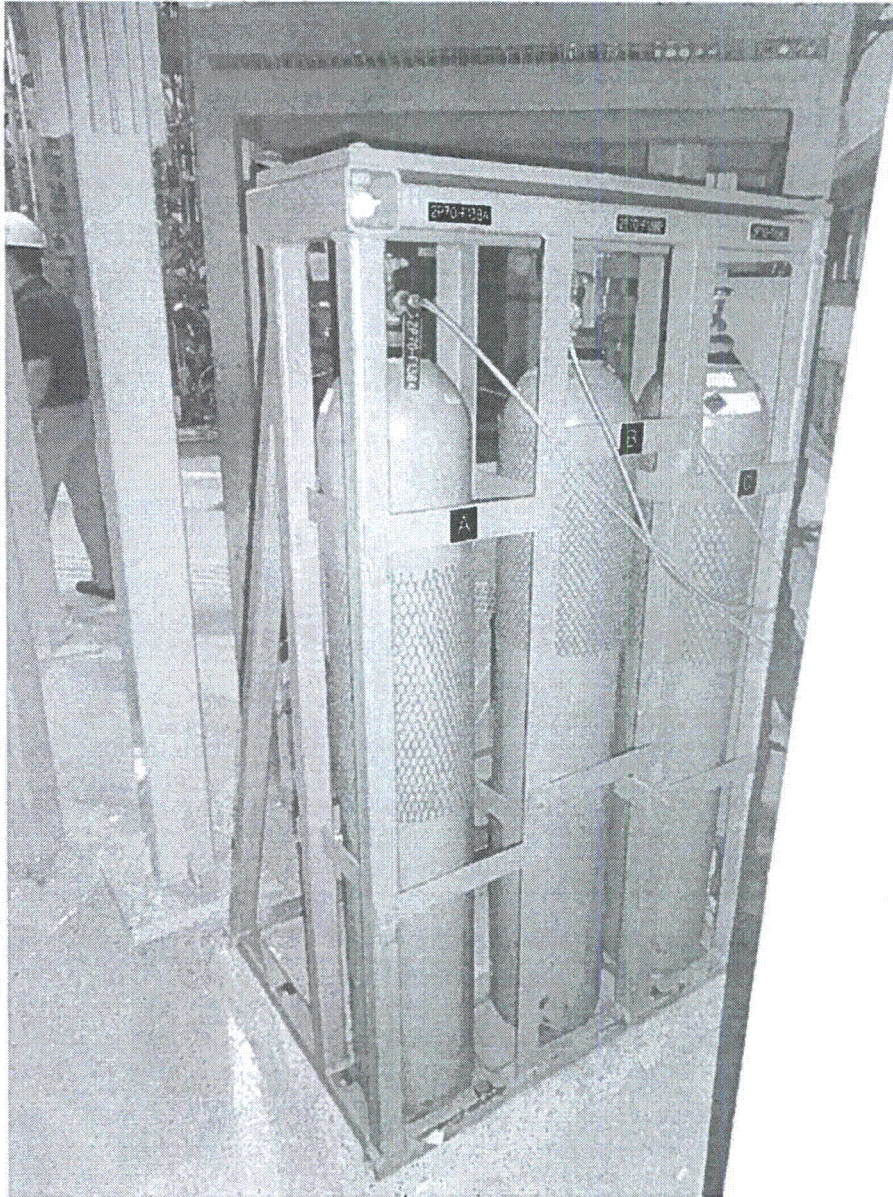
Figure 1 Equipment ID (2P70-A002B) No Equipment ID Tag
