Seismic Walkdown Checklist (SWC)	
Equipment ID No. <u>2H21-P021</u> Equip. Class ¹ <u>18</u>	
Equipment Description RHR Instrument Rack	- and the first and a second
Location: Bldg. <u>REACTOR</u> Floor El. <u>87</u> Room, Area <u>SE Diagonal</u>	Úniť 2
Manufacturer, Model, Etc. (optional but recommended)	una per de la companya de la company
Instructions for Completing Checklist This checklist may be used to document the results of the Seismic Walkdown of SWEL. The space below each of the following questions may be used to record findings. Additional space is provided at the end of this checklist for documentin	the results of judgments and
Anchorage

NO. SNCH082-RPT-02, VERSION 1.0 Sheet 4 of 5

ATTACHMENT 3: SEISMIC WALKDOWN CHECKLISTS

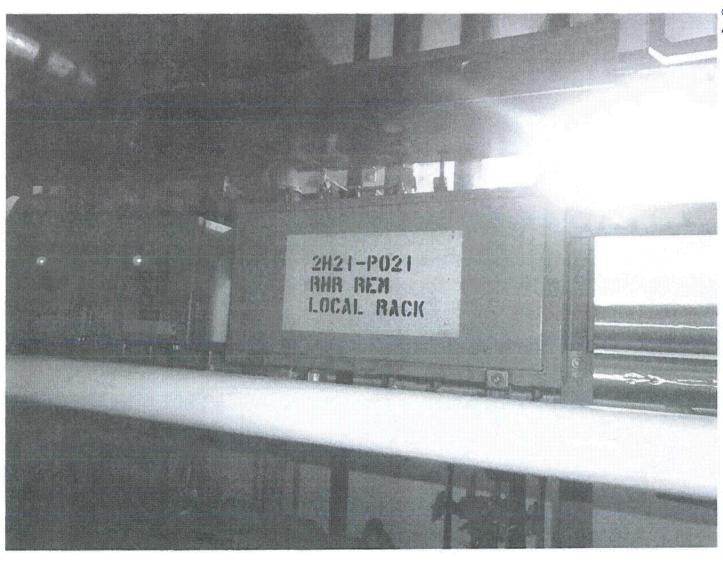
Figure 1 - Equipment ID No (2H21-P021)

1. Is the anchorage configuration verification required (i.e., is the item one of the 50% of SWEL items requiring such verification)?	Y
2. Is the anchorage free of bent, broken, missing or loose hardware? There is one anchor missing on the south side of the support for Instrument Rack 2H21-P021 (CR 515727). There is a good deal of debris in the hole, so it is unsure whether the anchor is broken off, removed or was never installed. There are seven other anchors in good condition, and the rack frame is very stiff.	Y_ N⊠ U_ N/A_

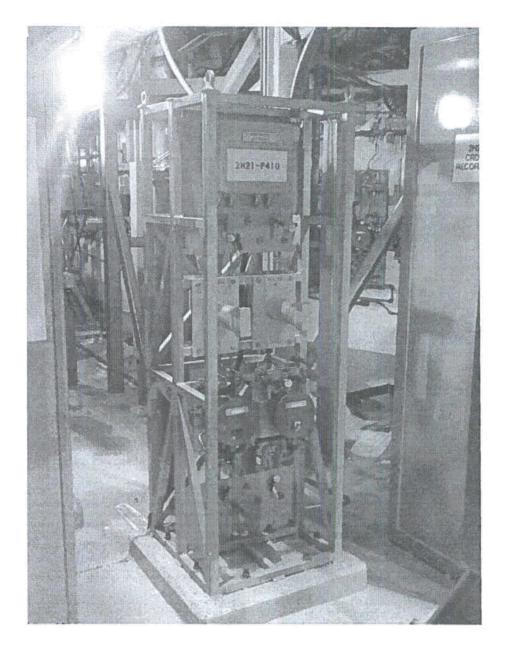
Figure 2 Picture of Full Rack

nch	orage	
1.	Is the anchorage configuration verification required (i.e., is the item one of the 50% of SWEL items requiring such verification)?	Y□ N⊠
2.	Is the anchorage free of bent, broken, missing or loose hardware? There are four anchors of the 10 anchors that have cut washers. The cutting of these washers has no affect on the ability of these four anchors to carry the seismic loads applied to them during a seismic event. Therefore, the anchorage is seismically acceptable.	Y⊠ N□ U□ N/A□

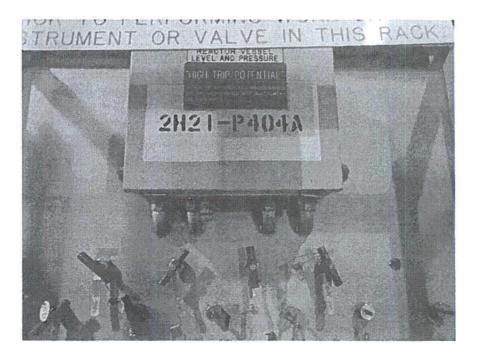
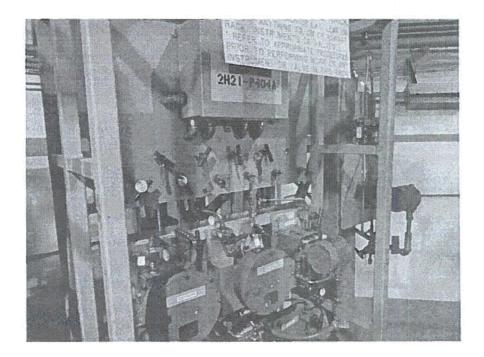
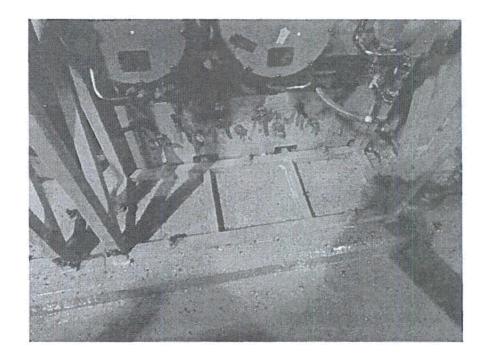
9. Do attached lines have adequate flexibility to avoid damage? One hole clamp behind the rack is missing for one of the cables. However, this is judged not to be a seismic concern since this is rather a thick cable and the span is short.	Y⊠ N□ U□ N/A□

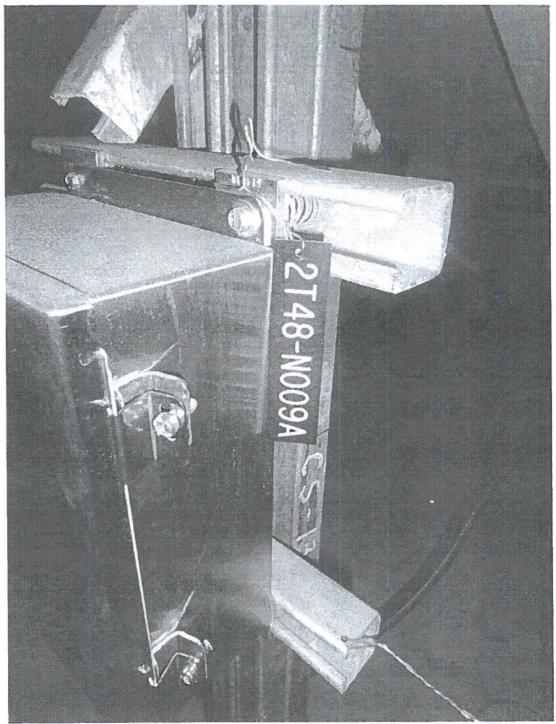
Figure 1 - Equipment ID No (2T48-N009A)

7. Are soft targets free from impact by nearby equipment or structures? There is a conduit running past the component to the wall that passes approximately 1" from the equipment. The conduit is attached to the same support as the temperature element, so the two components will move together. Since there will be no differential seismic motion between them, there is no potentially adverse seismic condition.	YN NO UO N/AO
