Area Walk-By Checklists (AWCs)

Table D-1. Summary of Area Walk-By Checklists

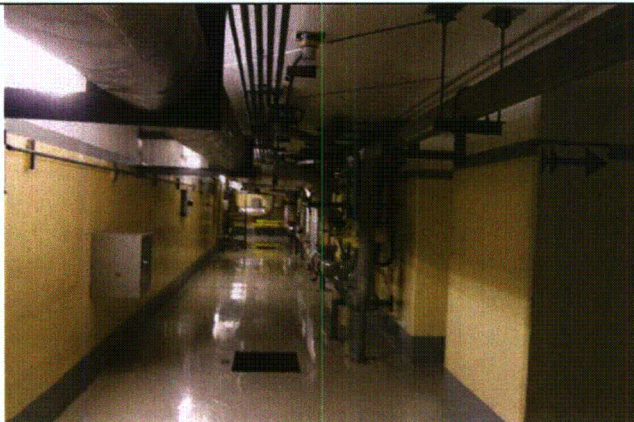
100_3358

Vertical linear indications (Cracking) on wall, adjacent to 620 EQ, judged not to be a potential seismic concern.

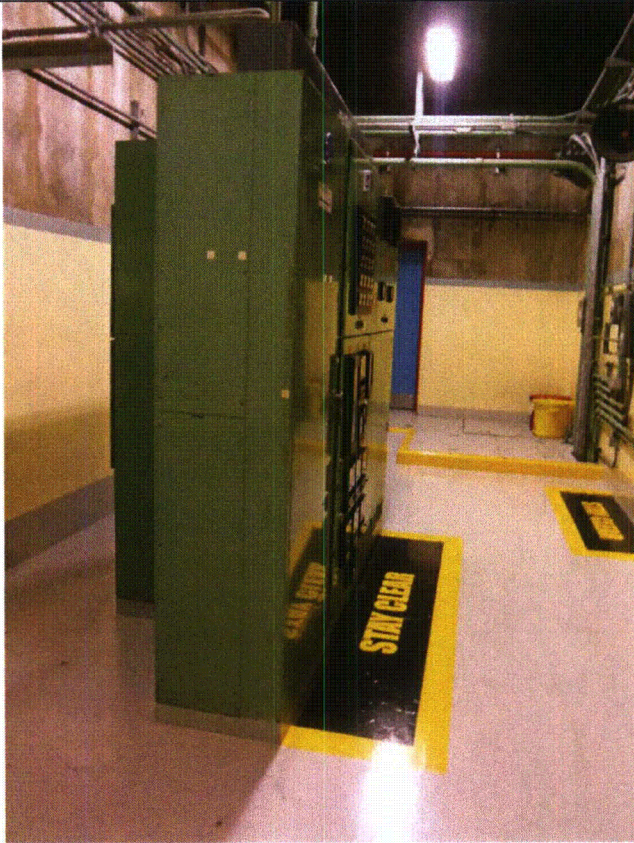
100_3014

Surface spalling on South Wall is previously documented under Maintenance Rule Inspection R2151812. R2151812 tracks completion of the walkdown and updates the topical report with its results.
