**ATTACHMENT 9.6****SEISMIC WALKDOWN CHECKLIST FORM**

Status: Y  N  U **Seismic Walkdown Checklist (SWC) SWEL2- 004**Equipment ID No. PS-19-80A Equip. Class<sup>1</sup> 18 - INSTRUMENTS ON RACKSEquipment Description PRESSURE SWITCH (RK-10AA)Location: Bldg. RB Floor El. 303 Room, Area \_\_\_\_\_

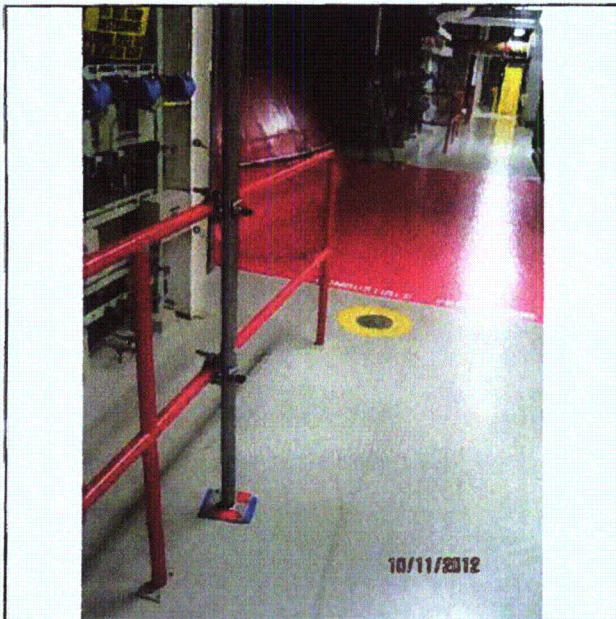
**Note:** Railing near RK25-6A/B

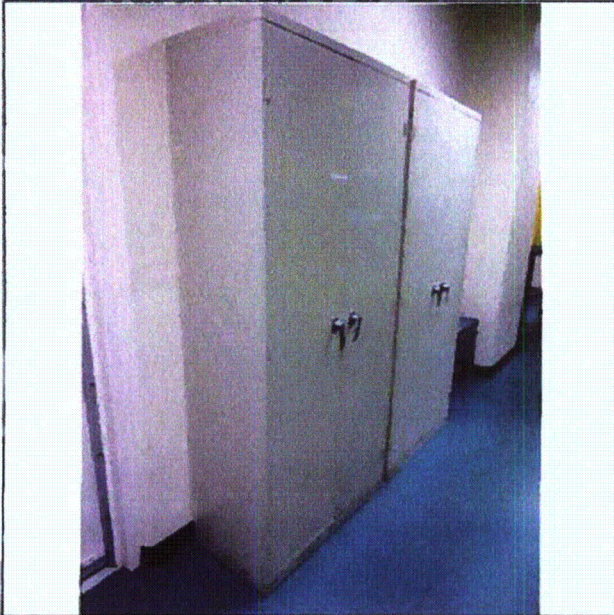
Note: Storage cabinets in SW area of room
