Seismic Walkdown Checklist (SWC)

Equipment ID No. ODG012 Equip. Class¹² (17) Engine Generators

Equipment Description E4 Standby Diesel Generator

Peach Bottom Atomic Power Station Unit 3
MPR-3812, Revision 3
Correspondence No. RS-12-173

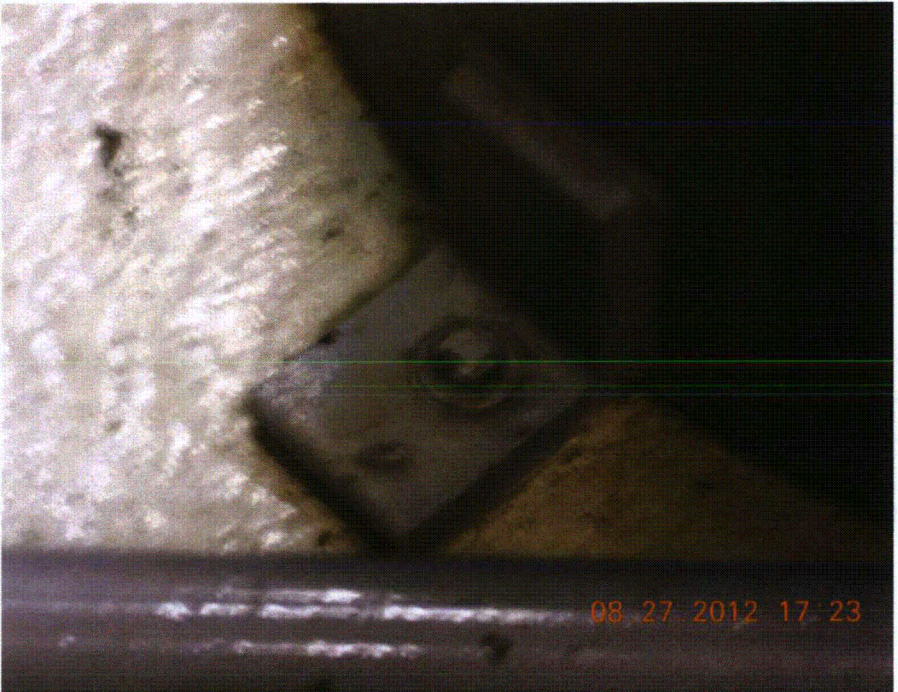
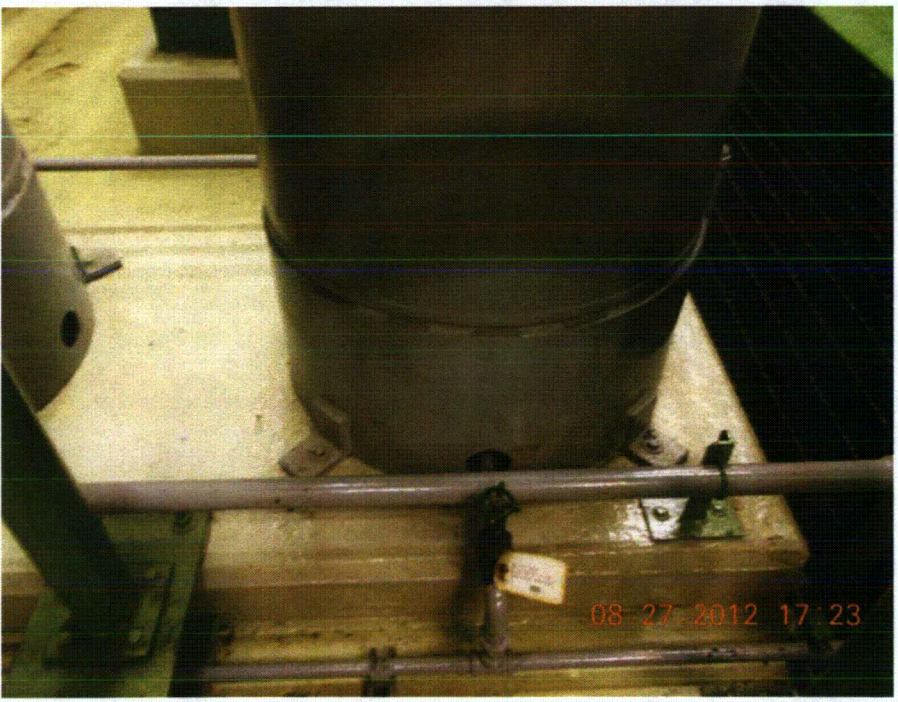
Equipment ID: OHT095

DISCREPANCY WAS EVALUATED PER NCR P900140 AND FOUND TO BE ACCEPTABLE. KE 11/5/12

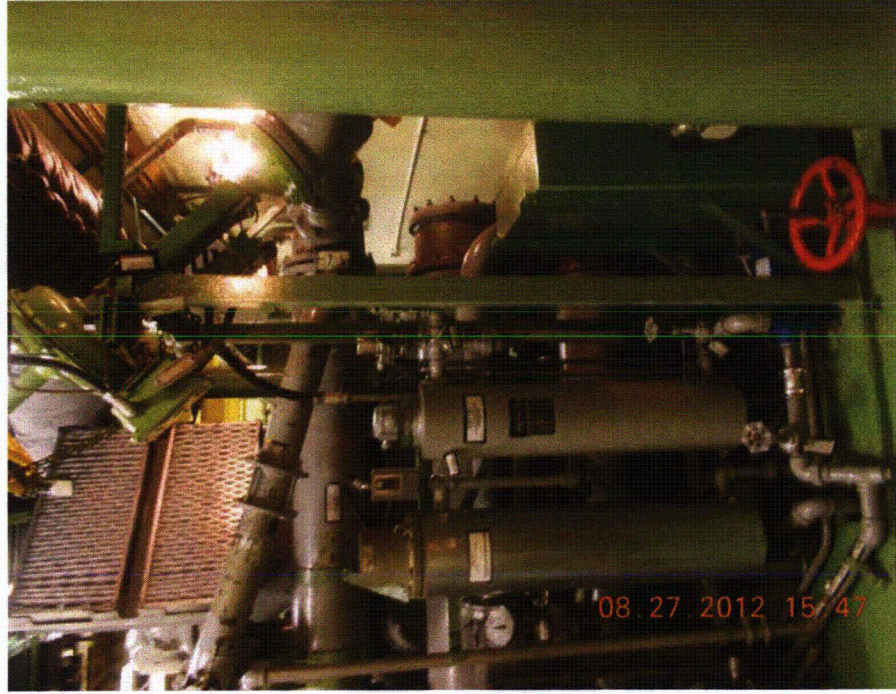
Equipment ID: AO-0-33-0241D

6. Based on the above anchorage evaluations, is the anchorage free of potentially adverse seismic conditions? Y N U
 See attached evaluation for acceptance of independent anchorage for air operator

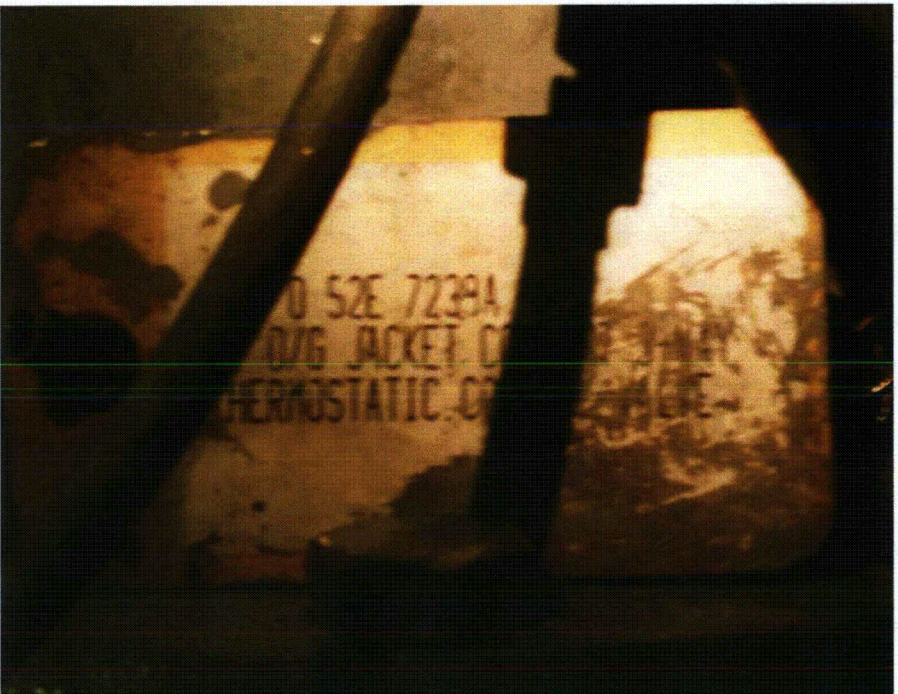
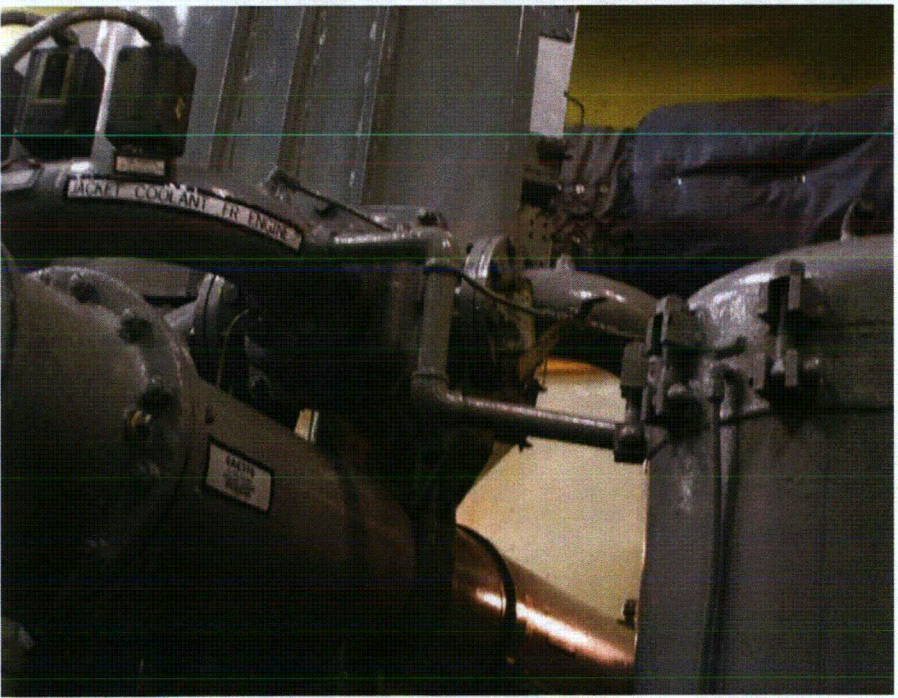
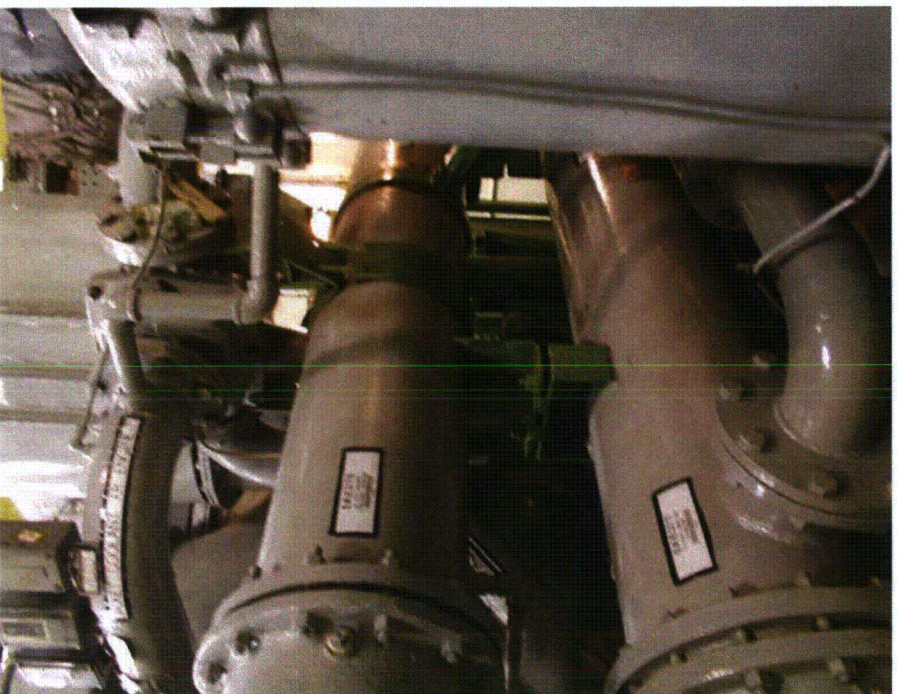
Equipment ID: TCV-0-52E-7239A

4. Is the anchorage free of visible cracks in the concrete near the anchors? Y N U N/A
 Anchored to OAE376 E1 D/G Jacket Coolant cooler underneath valve.

Falling light bulbs during seismic will not have credible damage.

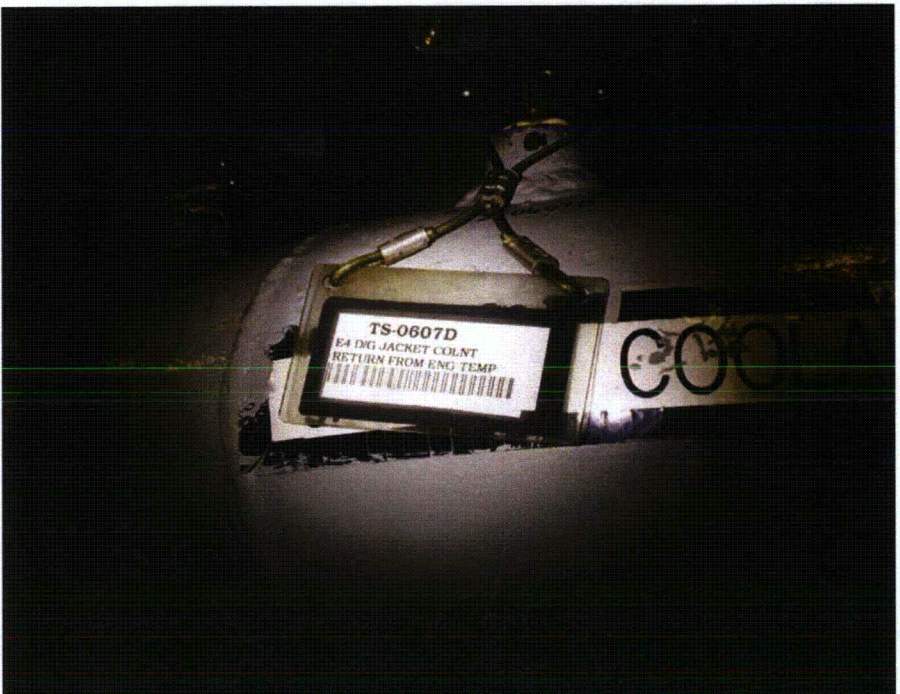
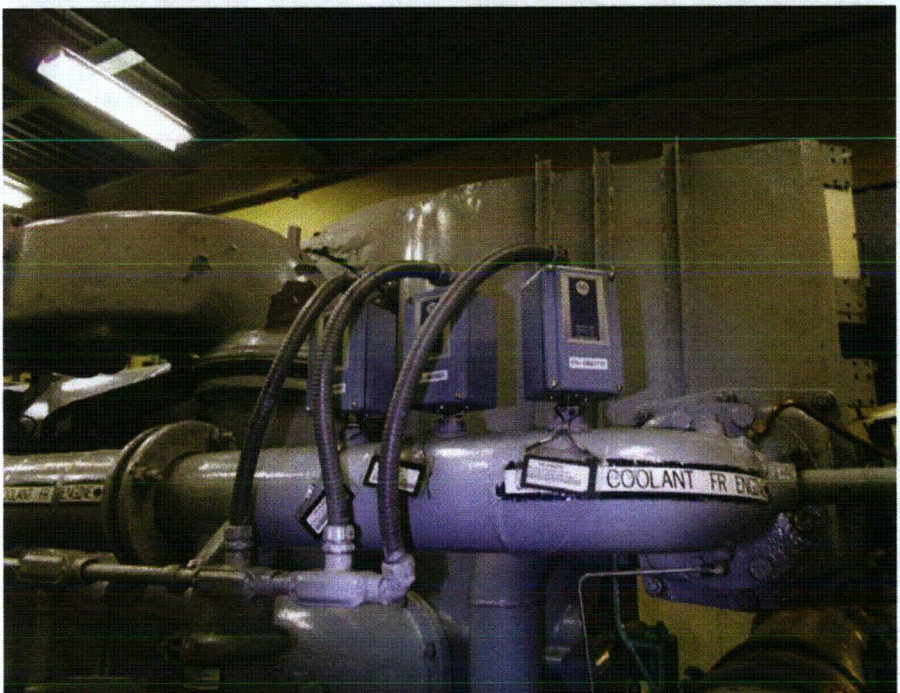
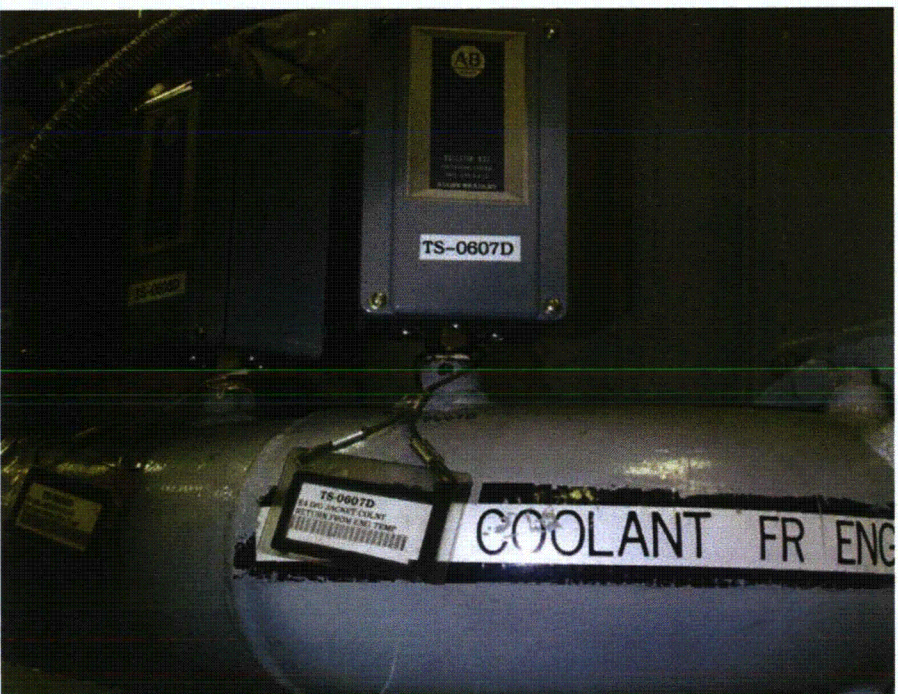
Equipment ID: TS-0607D

1. Is the anchorage configuration verification required (i.e., is the item one of the 50% of SWEL items requiring such verification)? Y N
Line mounted component
2. Is the anchorage free of bent, broken, missing or loose hardware? Y N U N/A
3. Is the anchorage free of corrosion that is more than mild surface oxidation? Y N U N/A
4. Is the anchorage free of visible cracks in the concrete near the anchors? Y N U N/A
5. Is the anchorage configuration consistent with plant documentation? Y N U N/A
 (Note: This question only applies if the item is one of the 50% for which an anchorage configuration verification is required.)
6. Based on the above anchorage evaluations, is the anchorage free of potentially adverse seismic conditions? Y N U
