Seismic Walkdown Checklist (SWC)

Peach Bottom Atomic Power Station Unit 2
MPR-3815, Revision 3
Correspondence No. RS-12-173

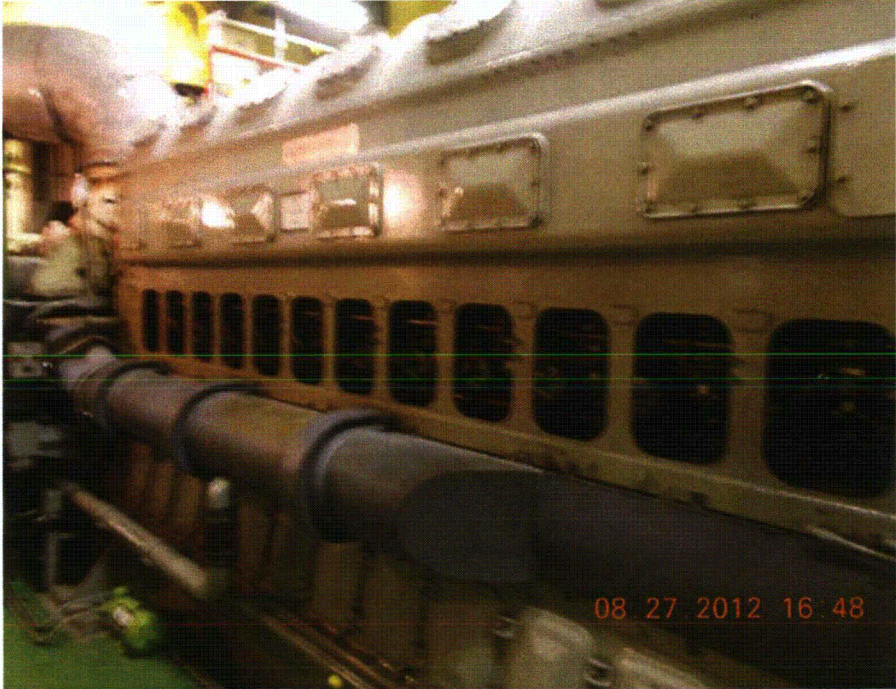
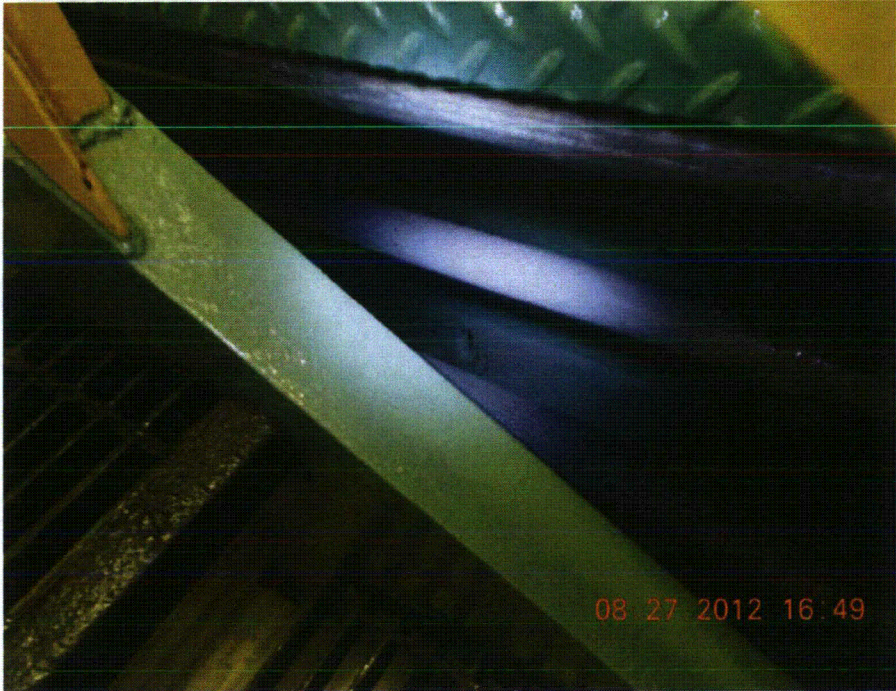
Equipment ID: ODG012

Does not match configuration evaluated in Calculation No. 6280-E5-155-1 (Rev. 1); as-built configuration has 1" anchor bolts securing skid to foundation instead of evaluated 1 1/4" anchor bolts. Judged acceptable for anticipated seismic loads per attached evaluation.

7. Are soft targets free from impact by nearby equipment or structures? YES NO U N/A
 TEMPERATURE GAUGE ON SCAVENGING AIR COOLER INLET COULD CONTACT
 ADJACENT LINE AND HOUSING COULD CRACK. WILL NOT AFFECT SAFETY FUNCTION
8. Are overhead equipment, distribution systems, ceiling tiles and lighting, YES NO U N/A
 and masonry block walls not likely to collapse onto the equipment?
 FLUORESCENT LIGHT TUBES FALLING JUDGED CREDIBLE, BUT
 NOT SIGNIFICANT
9. Do attached lines have adequate flexibility to avoid damage? YES NO U N/A
10. Based on the above seismic interaction evaluations, is equipment free YES NO U
 of potentially adverse seismic interaction effects?

AS FOUND $1" \text{ } \emptyset$ BOLTS

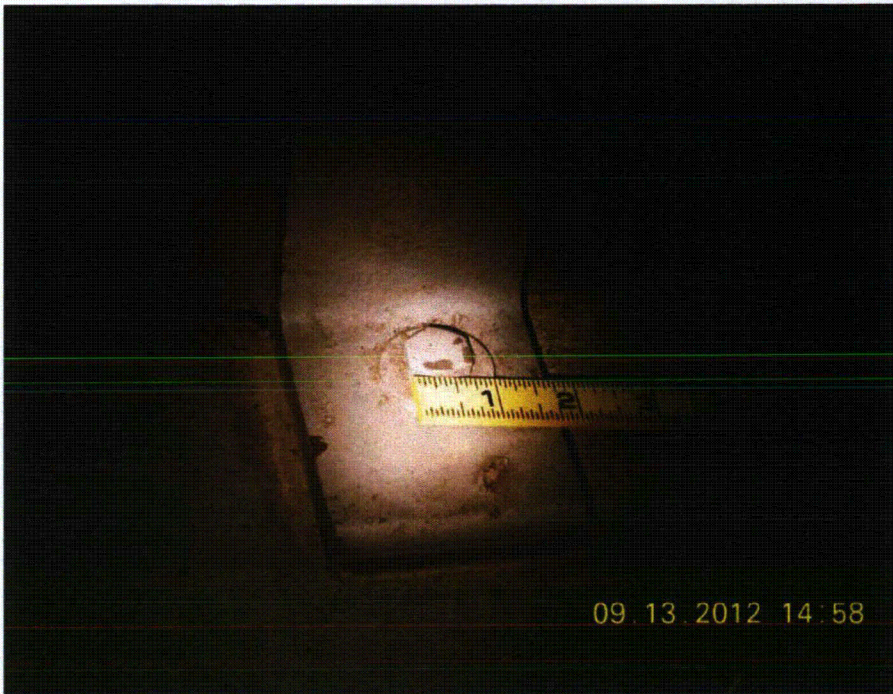
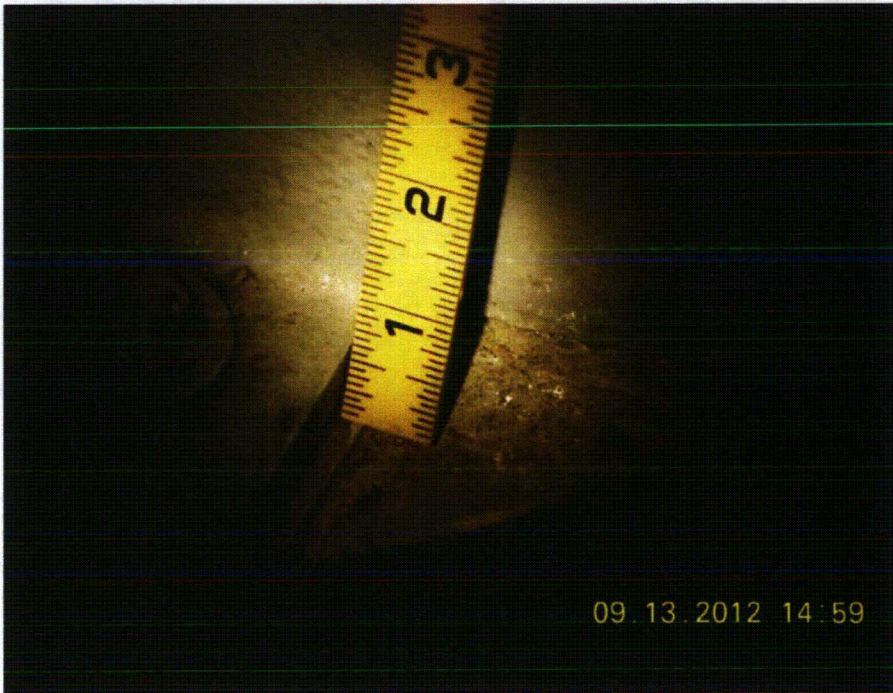
Equipment ID: OHT095

DISCREPANCY WAS EVALUATED PER NCR P900140 AND FOUND TO BE ACCEPTABLE. KC 11/5/12

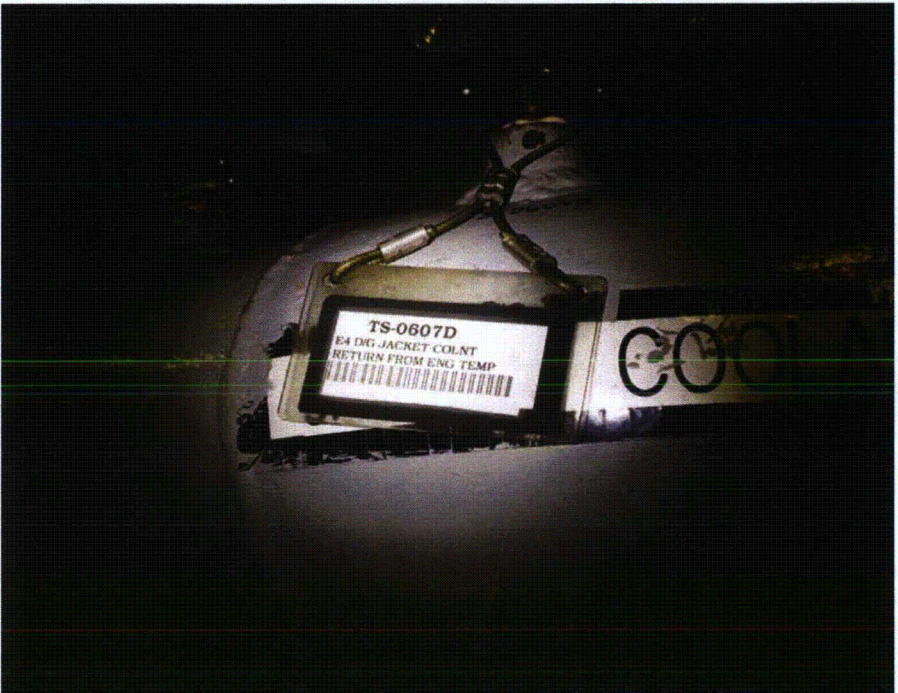
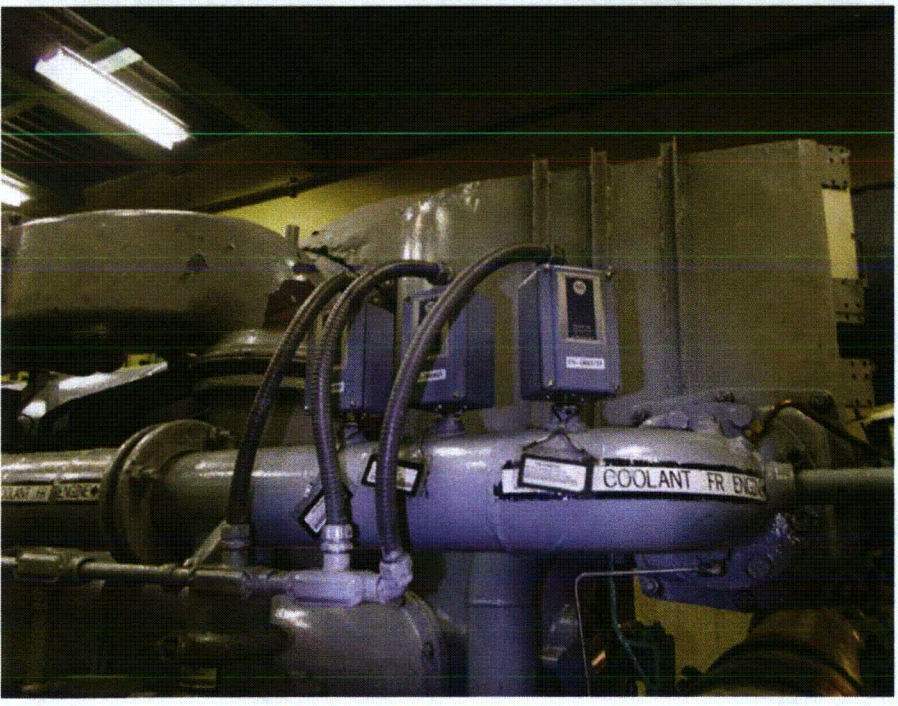
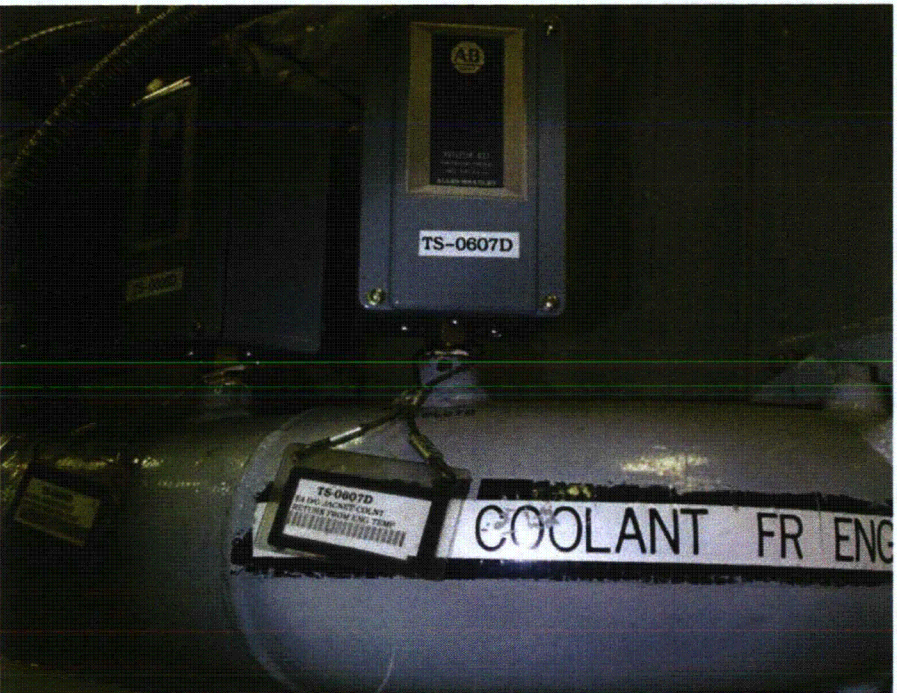
Equipment ID: TS-0607D

Equipment ID No. TS-0607D Equip. Class¹² (19) Temperature sensors
 Equipment Description E4 D/G Sacket Coolant Temperature sensor
 Location: Bldg. EDG Floor El. 112 Room, Area D/G-9
 Manufacturer, Model, Etc. (optional but recommended) 127 ^{Mo} 10/31/12

1. Is the anchorage configuration verification required (i.e., is the item one of the 50% of SWEL items requiring such verification)? Y N
Line mounted component
2. Is the anchorage free of bent, broken, missing or loose hardware? Y N U N/A
3. Is the anchorage free of corrosion that is more than mild surface oxidation? Y N U N/A
4. Is the anchorage free of visible cracks in the concrete near the anchors? Y N U N/A
5. Is the anchorage configuration consistent with plant documentation?
 (Note: This question only applies if the item is one of the 50% for which an anchorage configuration verification is required.) Y N U N/A
6. Based on the above anchorage evaluations, is the anchorage free of potentially adverse seismic conditions? Y N U
