APPENDIX C: AREA WALK-BY CHECKLISTS (AWCs)

PERRY NUCLEAR POWER PLANT

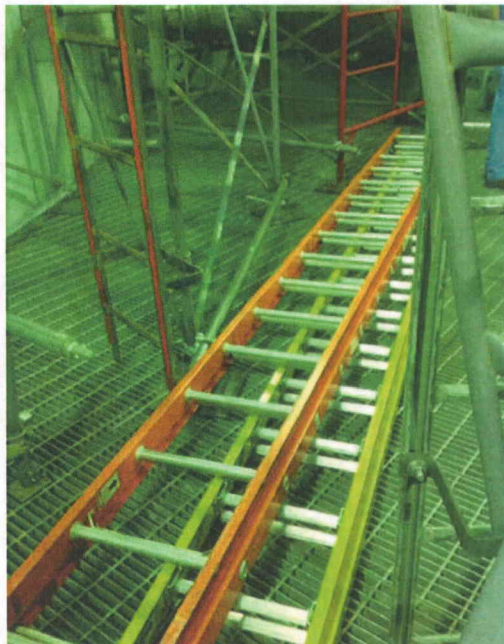
Scaffold found properly restrained. Ladders are unrestrained but judged not likely to impact components.

File Name: 1-60-1-1-19.jpeg
Description: View of unrestrained ladders not likely to impact components

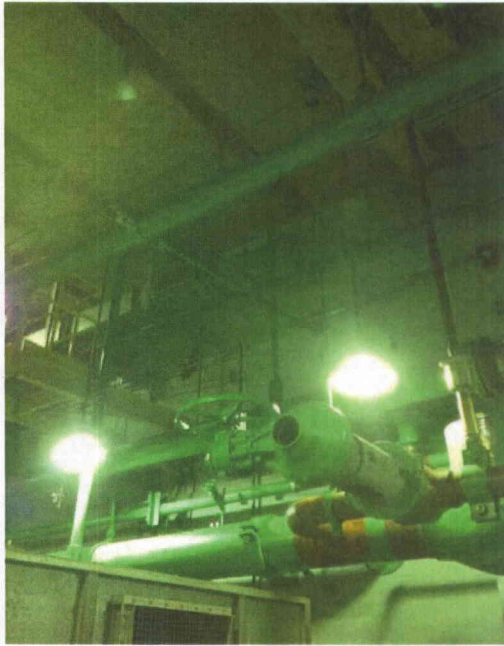
File Name: 1-65-5-1-18.jpeg
Description: View of piping in the area

3. Based on a visual inspection from the floor, do the cable/conduit raceways and HVAC ducting appear to be free of potentially adverse seismic conditions (e.g., condition of supports is adequate and fill conditions of cable trays appear to be inside acceptable limits)?
HVAC ducts and piping in the area were identified to be rigidly supported.

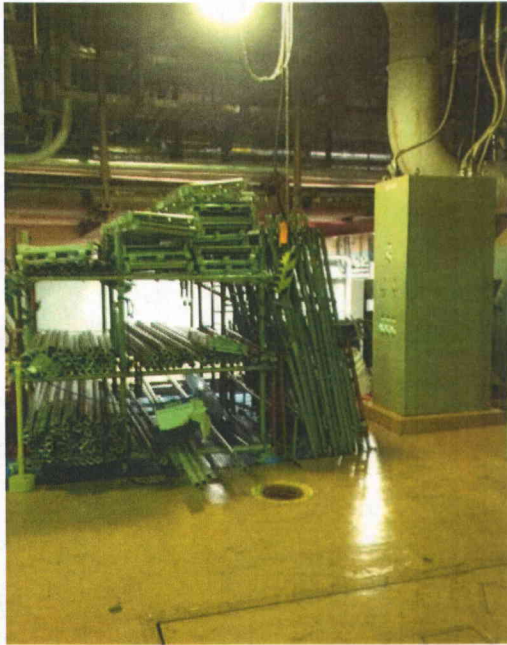
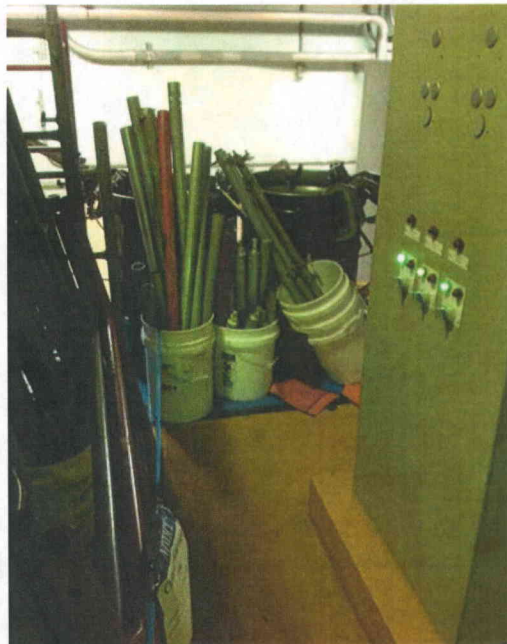
File Name: 1-59-3-1-20.jpeg
Description: View of scaffold staging area

File Name: 1-66-3-1-20.jpeg
Description: View of scaffold staging area

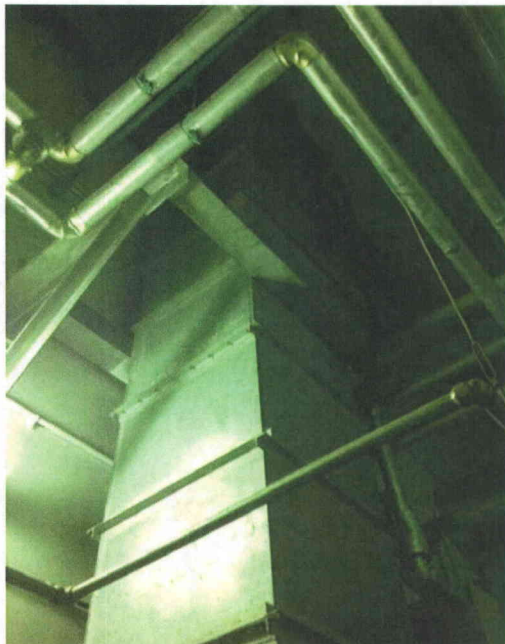
File Name: 1-60-2-1-15.jpeg
Description: View of HVAC support

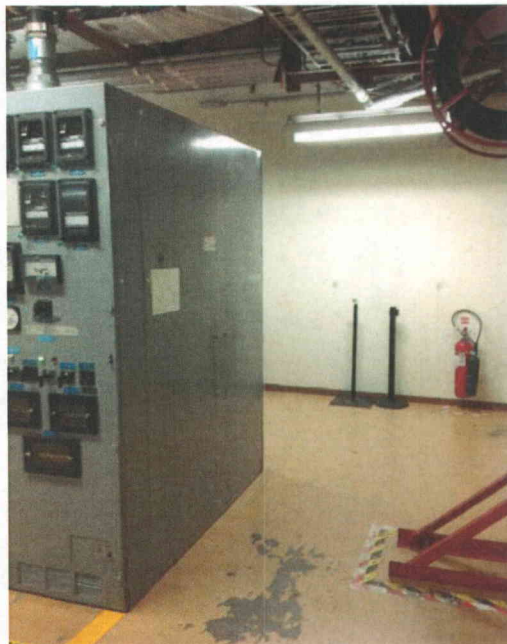
File Name: 1-72-1-1-06.jpeg
Description: View of area where tool locker was located

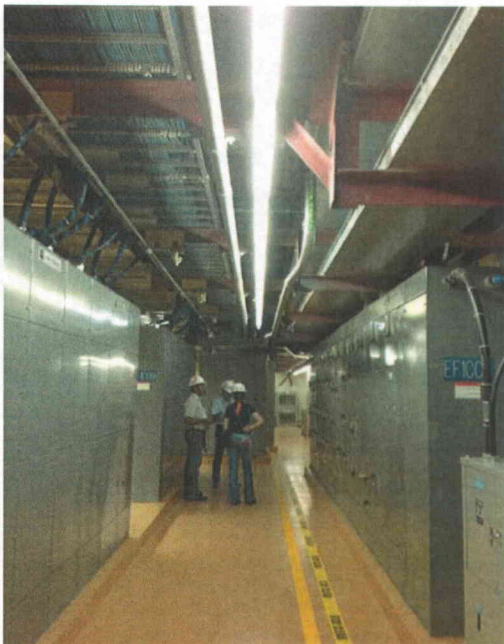
File Name: 1-75-1-1-06.jpeg
Description: View of single row of fluorescent lights

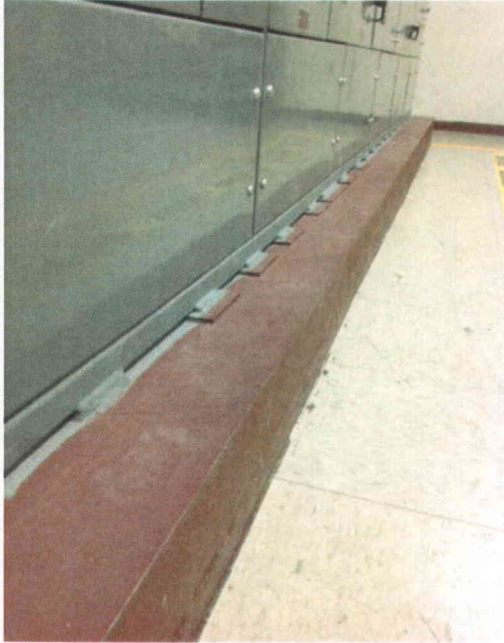
File Name: 1-65-2-1-06.jpeg
Description: View of 1R24-S0029 welded shims

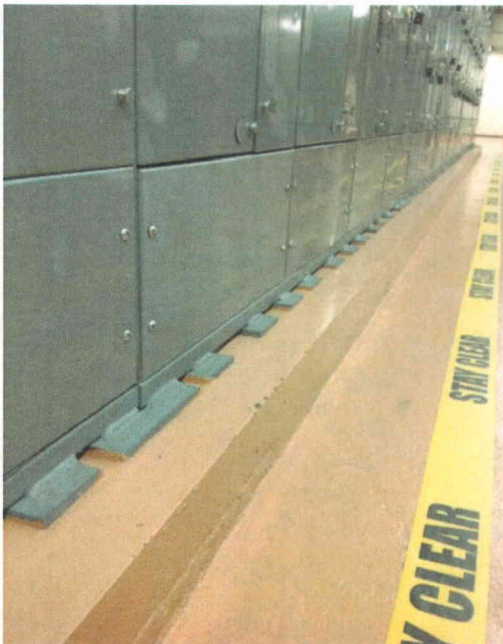
File Name: 1-60-3-1-06.jpeg
Description: View of 1R24-S0021 welded to shims

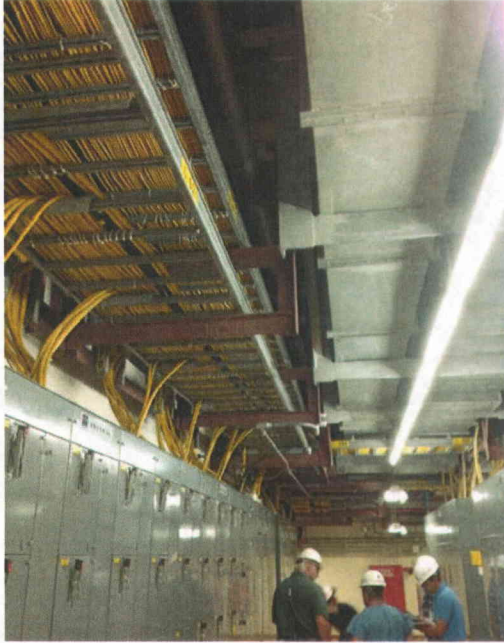
File Name: 1-65-3-1-06.jpeg
Description: View of supports for cable trays

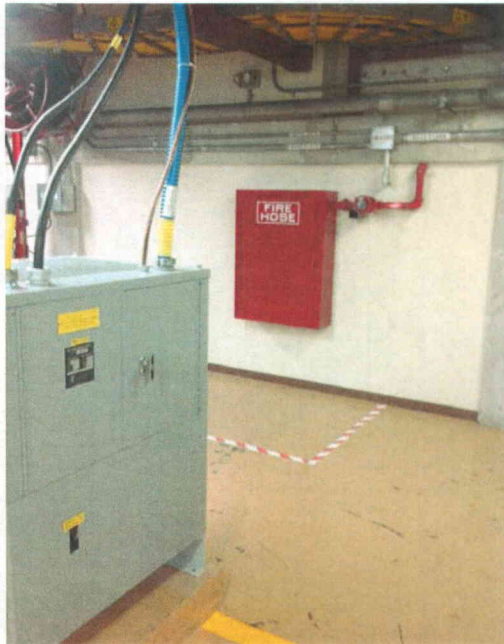
File Name: 1-67-3-1-06.jpeg
Description: Fire protection valve near transformer judged to be adequately supported

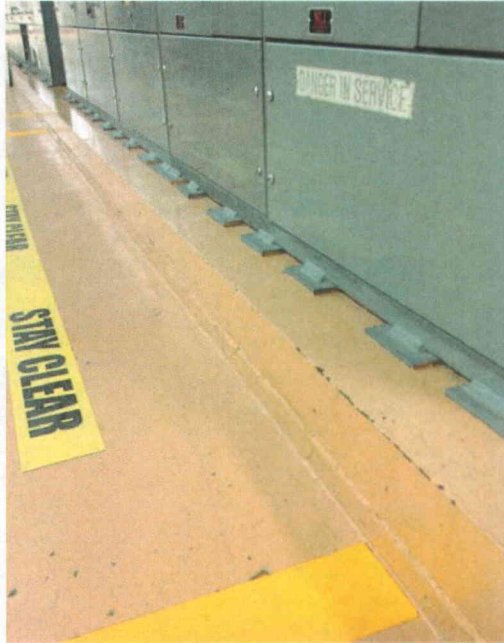
File Name: 1-69-3-1-06.jpeg
Description: Welded shims for 1R21-S0019

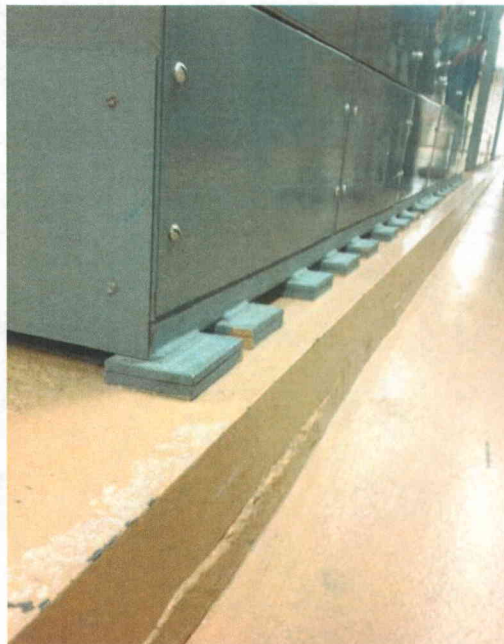
File Name: 1-70-3-1-06.jpeg
Description: Welded shims for 0R24-S0035

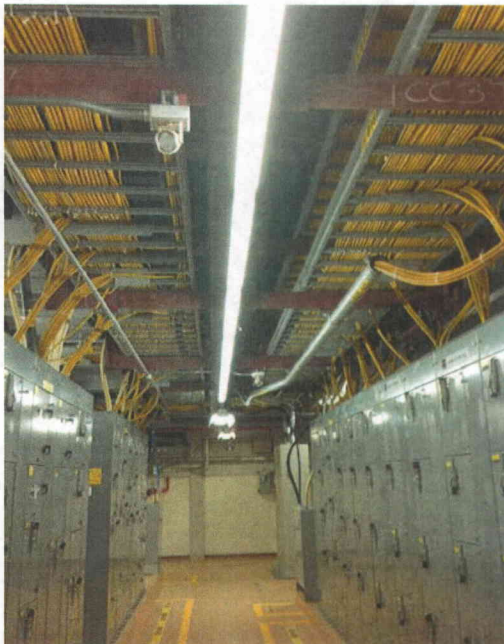
File Name: 1-72-3-1-06.jpeg
Description: View of single row of fluorescent lights

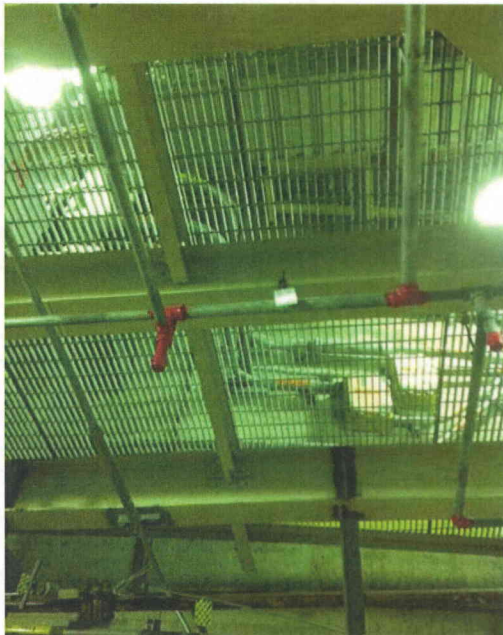
File Name: 1-60-2-1-16.jpeg
Description: Friction clip on fire protection piping

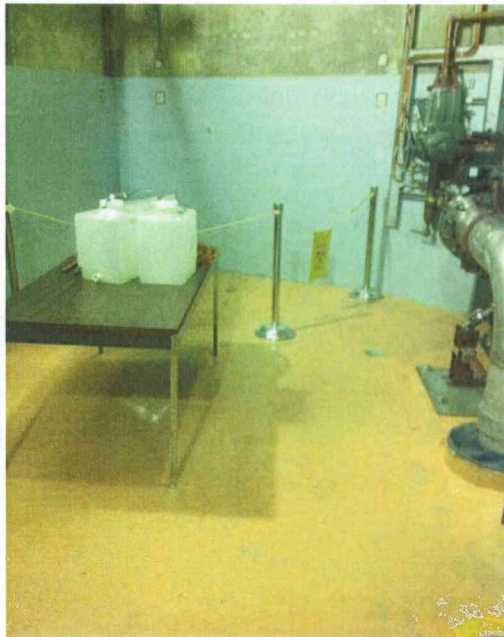
File Name: 1-66-2-1-16.jpeg
Description: Potential impact from table judged not to be significant

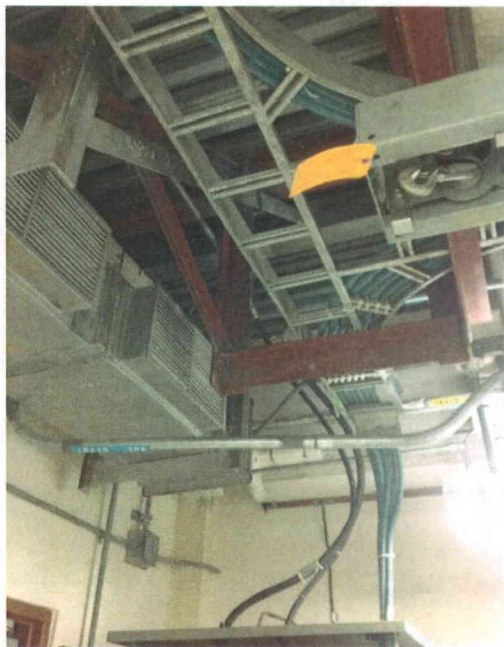
File Name: 1-60-1-1-02.jpeg
Description: Rigid support cable tray and HVAC

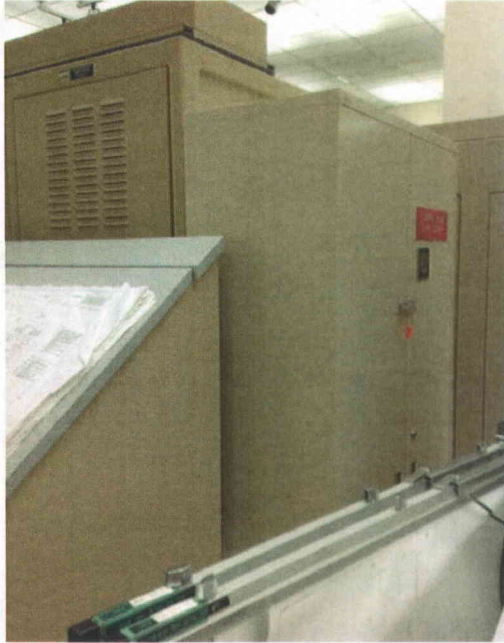
File Name: 1-59-1-1-03.jpeg
Description: Supply locker not anchored

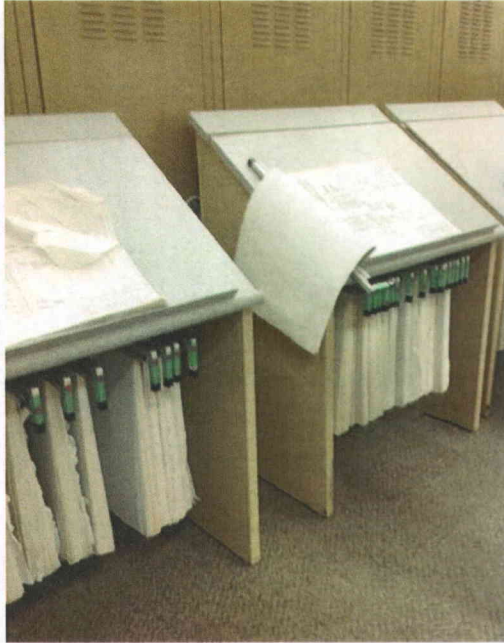
File Name: 1-65-1-1-03.jpeg
Description: Desks adjacent to reactivity control cabinets

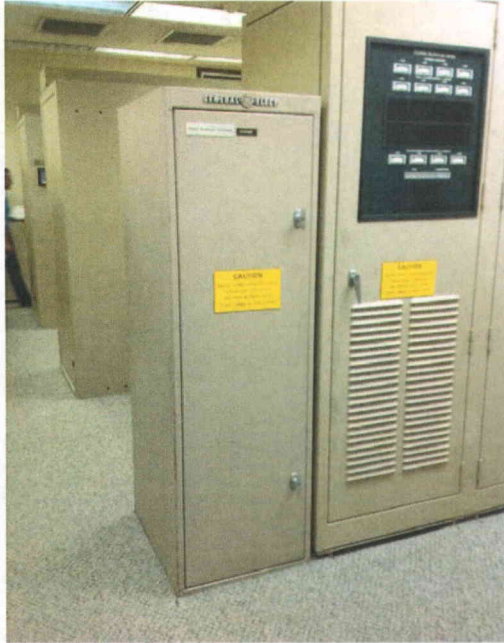
File Name: 1-67-1-1-03.jpeg
Description: Cabinet not anchored

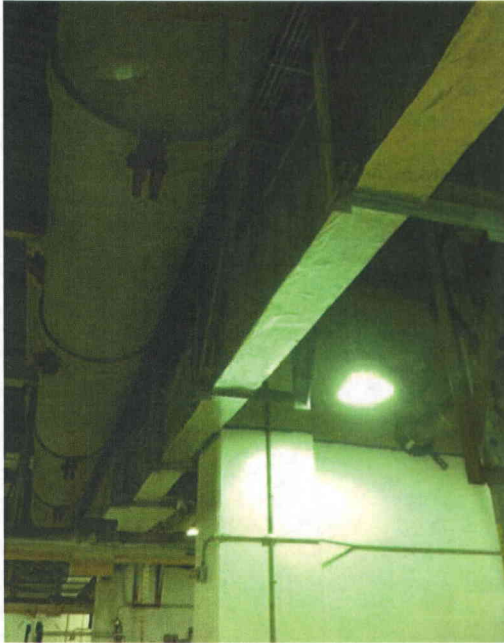
File Name: 1-65-1-1-01.jpeg
Description: HVAC rigidly supported

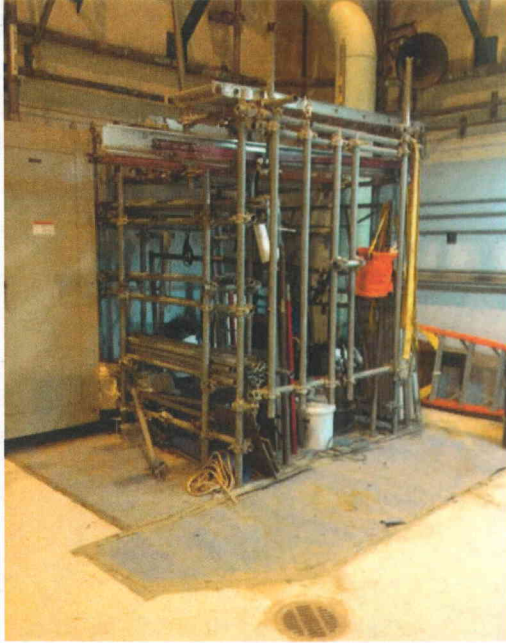
Very tall temporary scaffolding noted in area. Temporary unrestrained storage container observed adjacent to H51-P010A. Items judged OK due to temporary nature.

File Name: 1-67-1-1-05.jpeg
Description: Scaffolding staging area

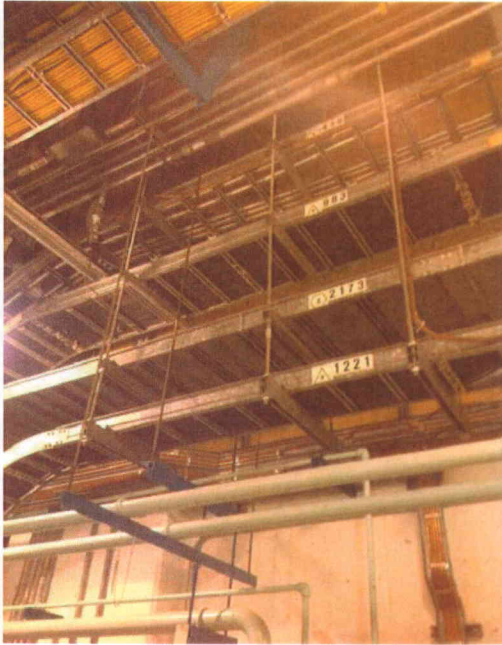
File Name: 1-65-2-1-14.jpeg
Description: View of cable trays in the area

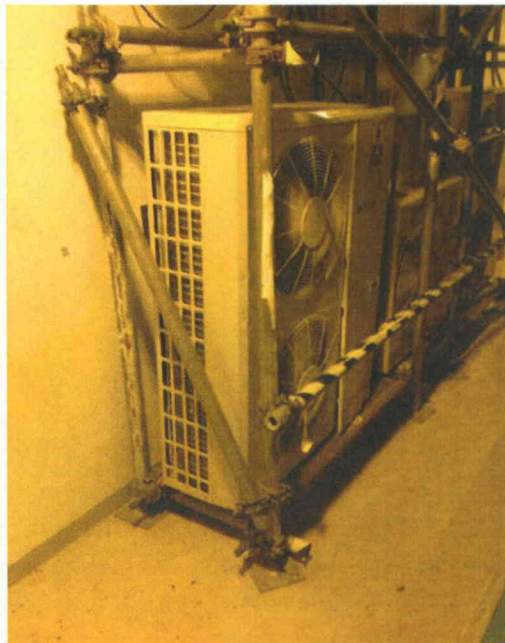
File Name: 1-60-3-1-14.jpeg
Description: Scaffold structure for chiller unit

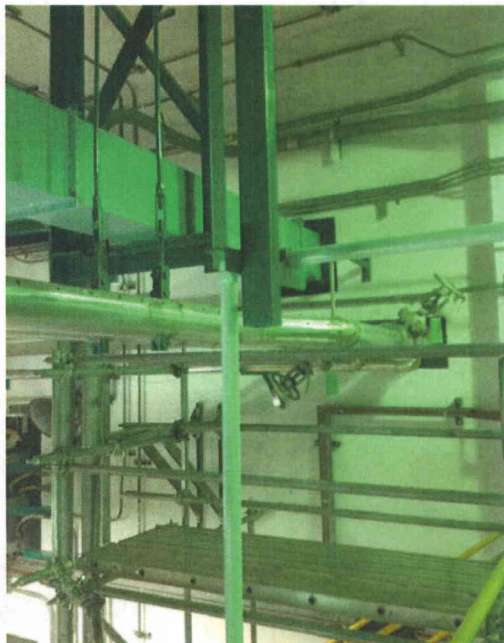
File Name: 1-60-1-1-11.jpeg
Description: View of HVAC duct wall penetration
