Seismic Walkdown Checklist (SWC)

Equipment ID No. MCC-1-E7 Equip. Class 1. Motor Control Center

Equipment Description 480V Motor Control Center FED From 480V Substation 1-8Bus 1N(8N14)

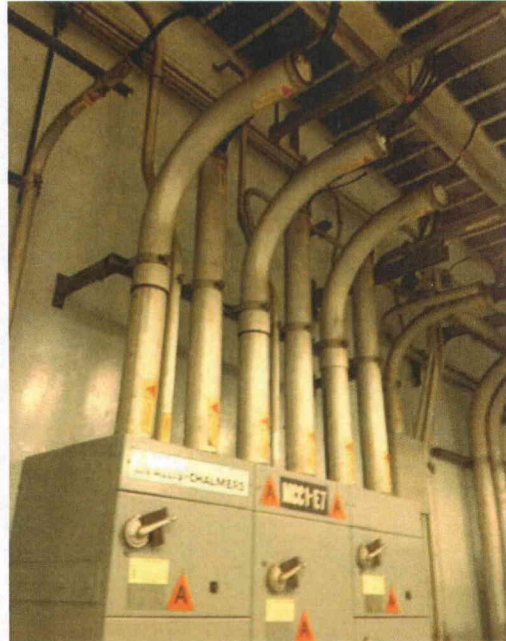
1. Is the anchorage configuration verification required (i.e., is the item one of the 50% of SWEL items requiring such verification)?
MCC composed of 3 sections. Component is close to wall but it is top braced by top entry conduit as well as separate top bracing mechanism.

File Name: 2-63-7-1-20.jpeg
Description: View of top entry conduits

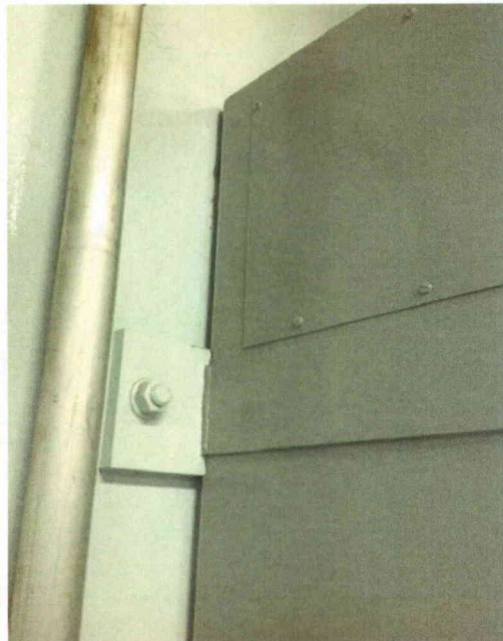
File Name: 2-64-7-1-20.jpeg
Description: View of wall mounted lateral support

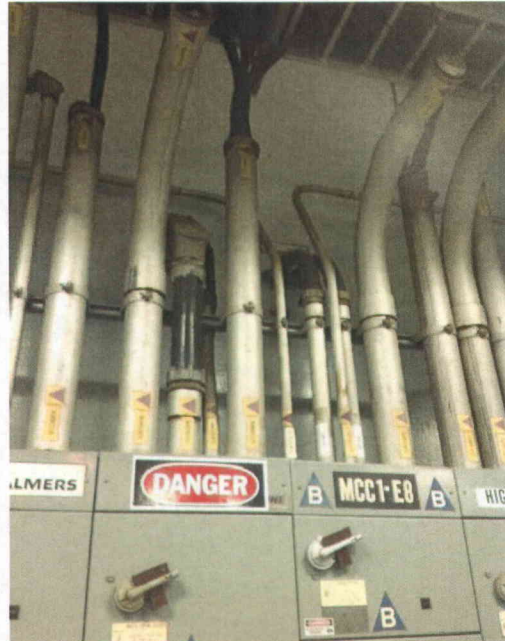
File Name: 2-63-1-1-22.jpeg
Description: View of top entry conduits

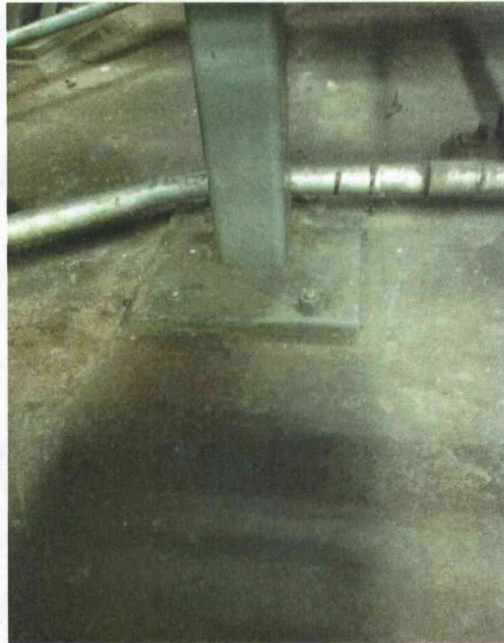
File Name: 2-63-7-1-32.jpeg
Description: View of base anchorage configuration

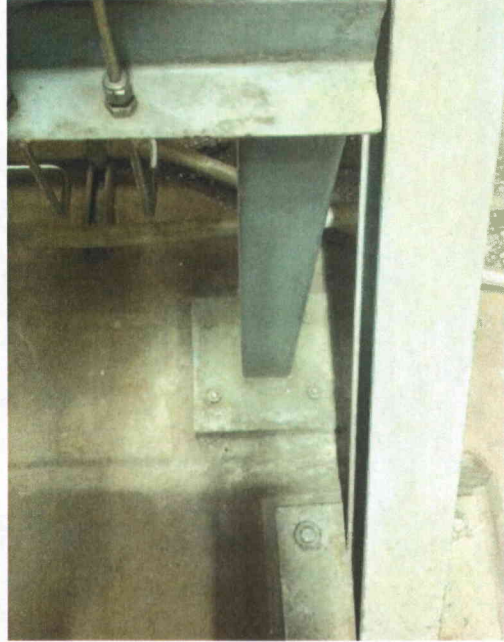
File Name: 2-63-8-1-32.jpeg
Description: View of base anchorage configuration

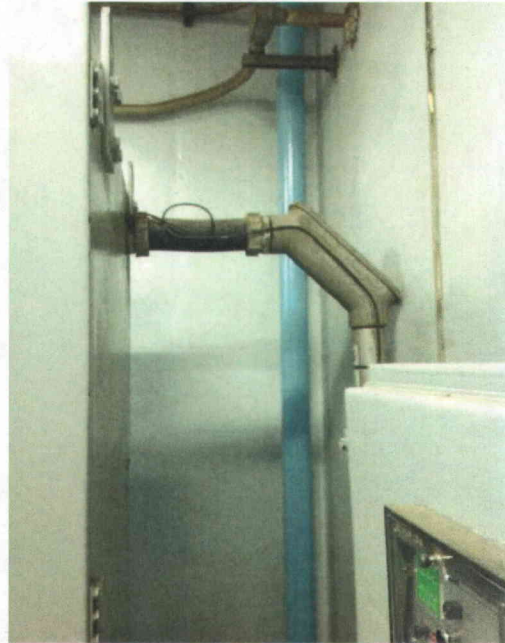
File Name: 2-63-2-1-21.jpeg
Description: View of flexible attached line

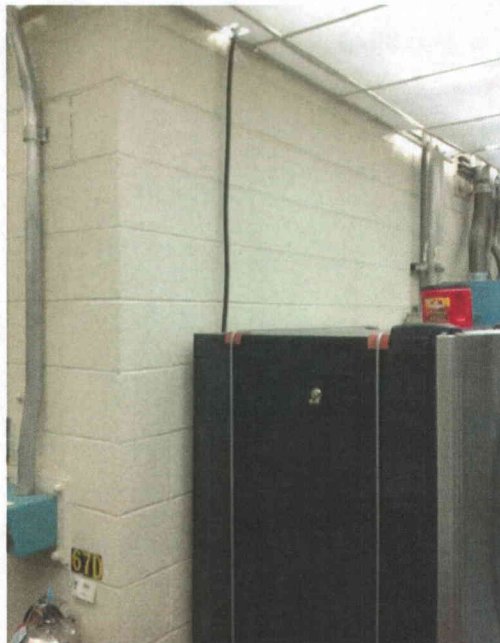
File Name: 2-64-1-1-18.jpeg
Description: Block wall identified in the vicinity of the component

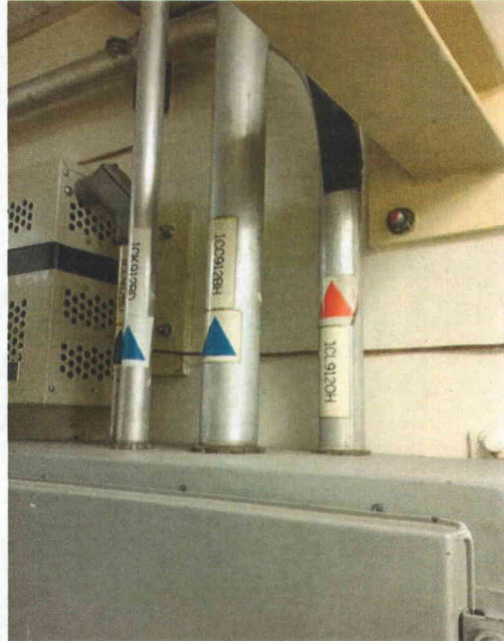
File Name: 2-63-2-1-18.jpeg
Description: View of top entry conduits

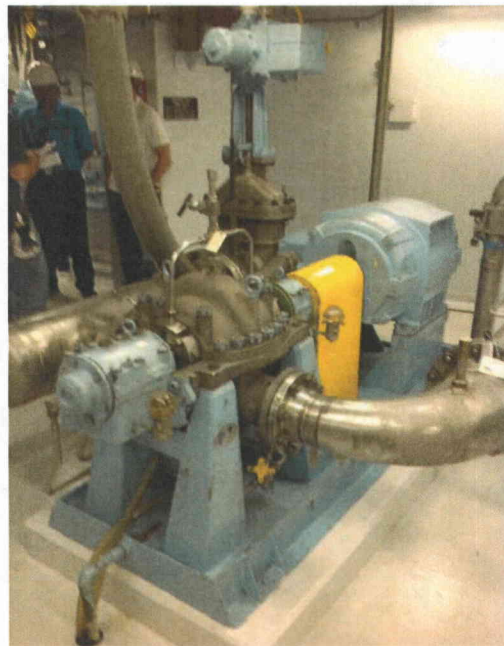
File Name: 2-62-7-1-50.jpeg
Description: General view of component

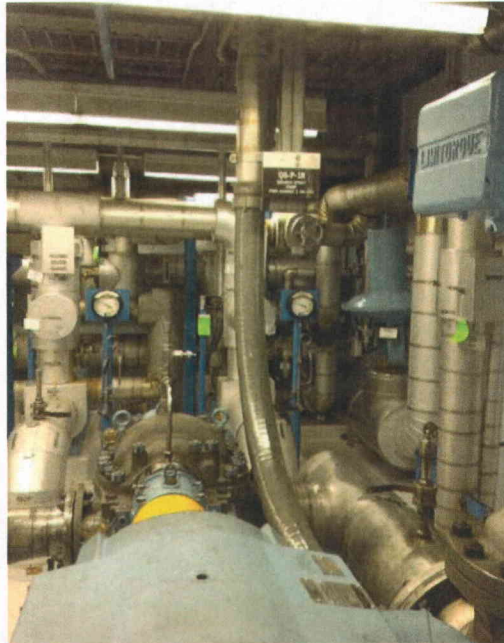
File Name: 2-63-7-1-50.jpeg
Description: View of flexible attached lines

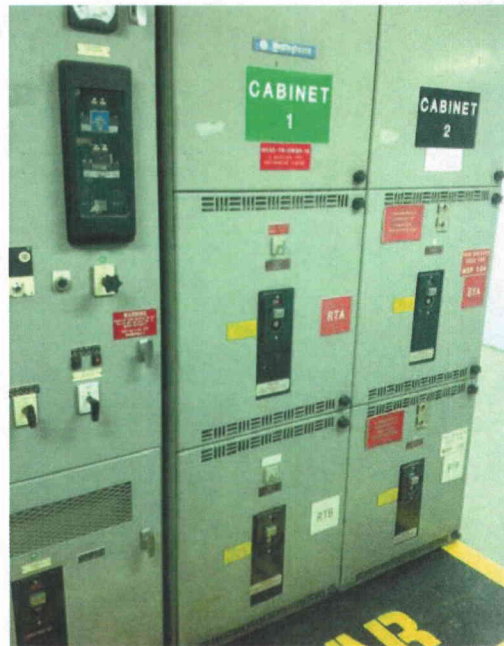
File Name: 2-62-1-1-33.jpeg
Description: General view of component

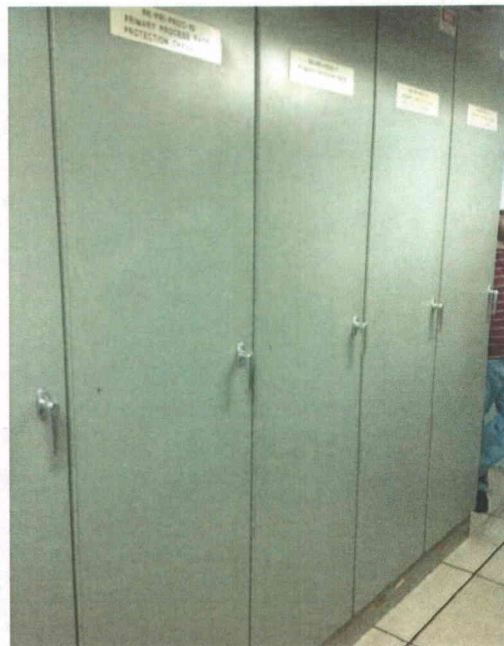
File Name: 2-62-2-1-49.jpeg
Description: General view of component

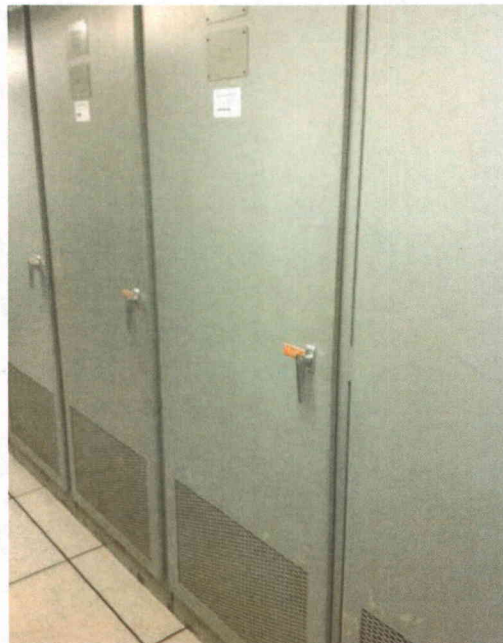
File Name: 2-62-1-1-49.jpeg
Description: General view of component

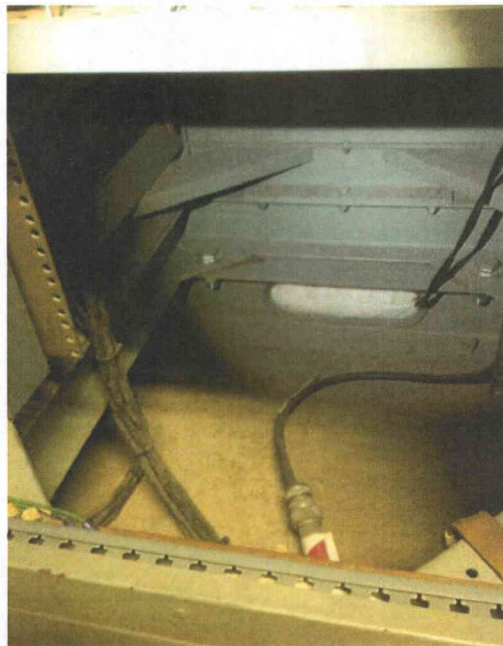
File Name: 2-64-1-1-49.jpeg
Description: View of base frame connection to floor wide flange beams

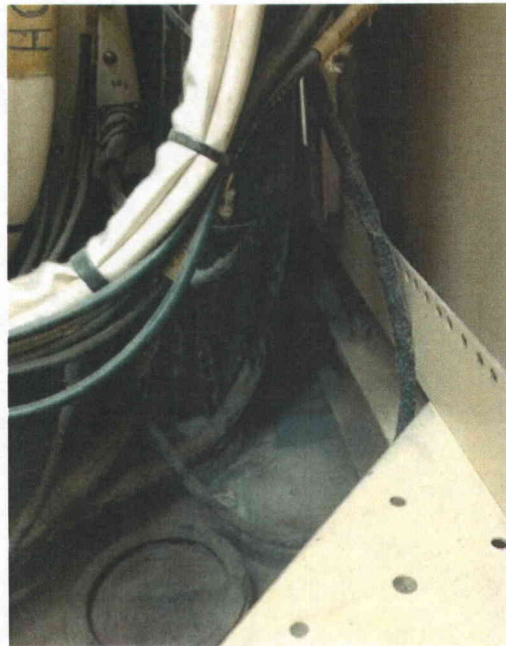
File Name: 2-64-4-1-18.jpeg
Description: View of anchorage between cabinet housing and base frame

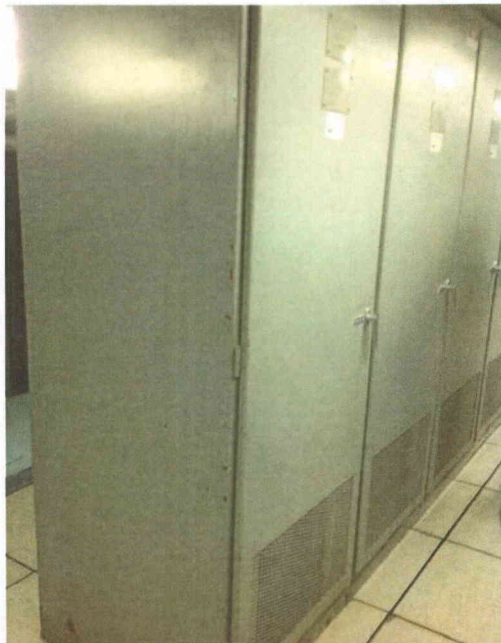
File Name: 2-62-3-1-49.jpeg
Description: General view of component

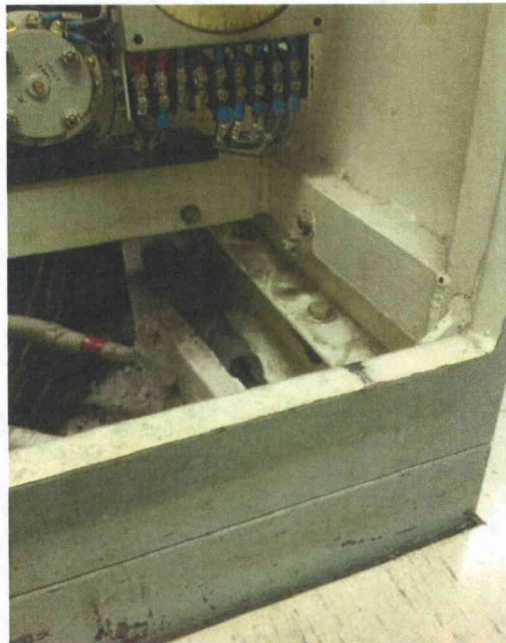
File Name: 2-64-3-1-49.jpeg
Description: View of anchorage between cabinet housing and base frame

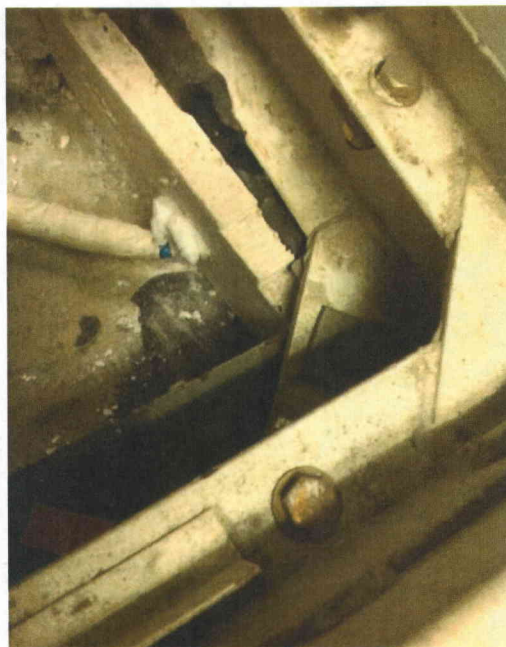
File Name: 2-73-3-1-49.jpeg
Description: View of anchorage between base frame and floor beam

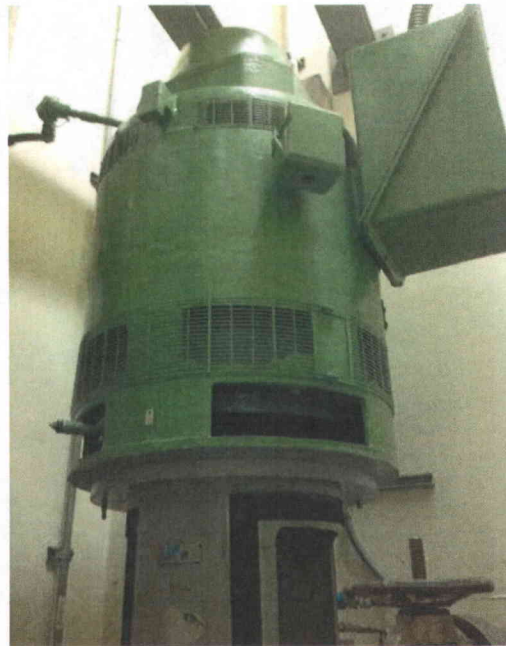
File Name: 2-61-1-1-10.jpeg
Description: General view of component

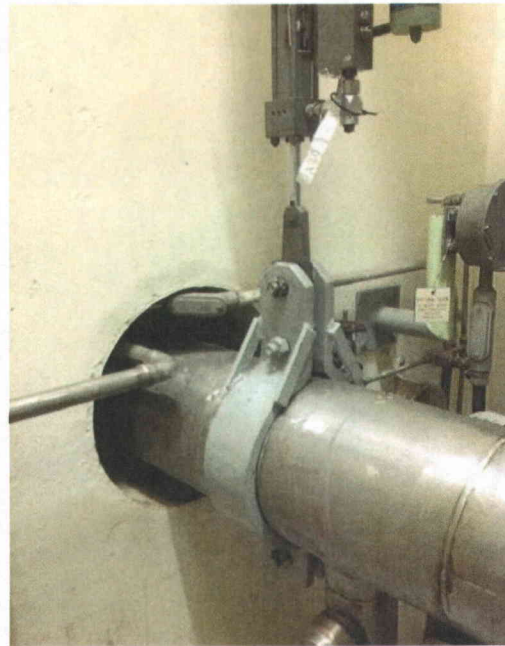
File Name: 2-63-1-1-10.jpeg
Description: View of hung support for attached pipe line

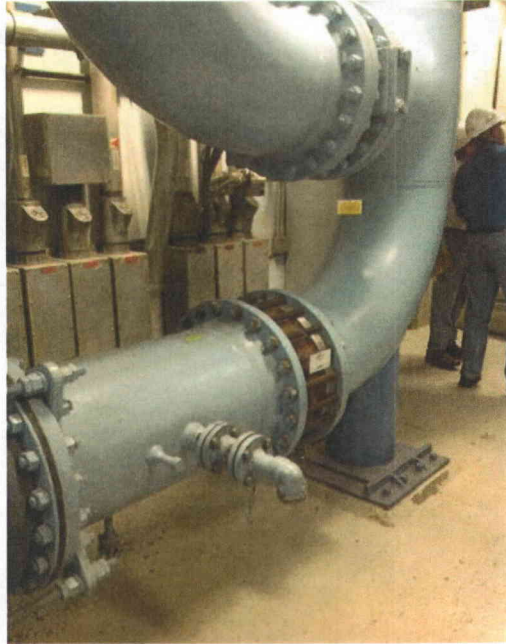
File Name: 2-63-4-1-27.jpeg
Description: View of valve location on main line

1. Is the anchorage configuration verification required (i.e., is the item one of the 50% of SWEL items requiring such verification)?
Inline check valve on ~24" diam pipe line. No degraded condition identified.

3. Is the anchorage free of corrosion that is more than mild surface oxidation?
Mild surface corrosion identified on bolts. Judged not a concern.

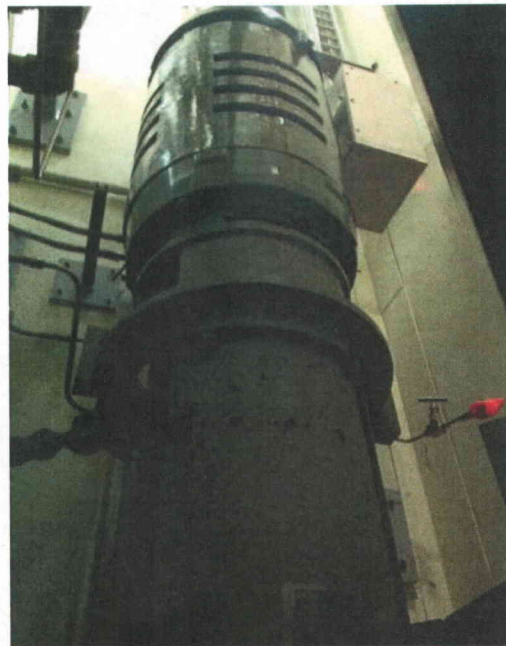
File Name: 2-61-1-1-31.jpeg
Description: General view of component

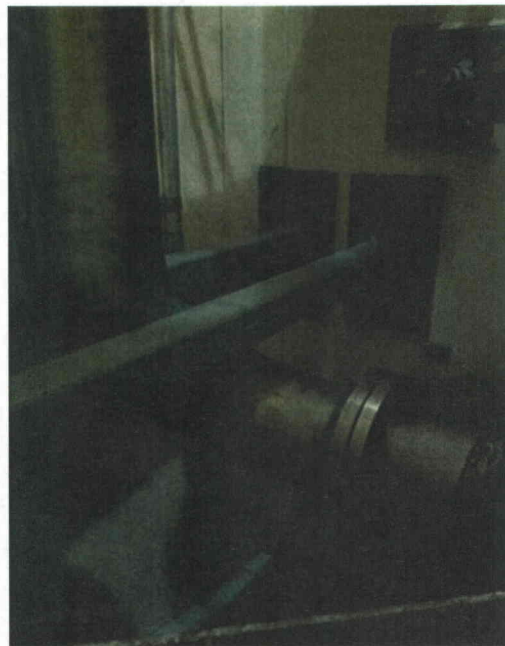
File Name: 2-94-1-1-31.jpeg
Description: View of pipe line restraining tube section members

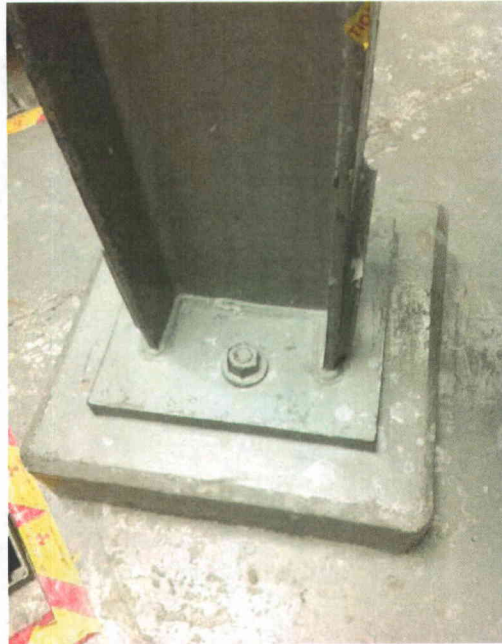
File Name: 2-63-1-1-42.jpeg
Description: Typical view of base anchorage configuration for each leg support

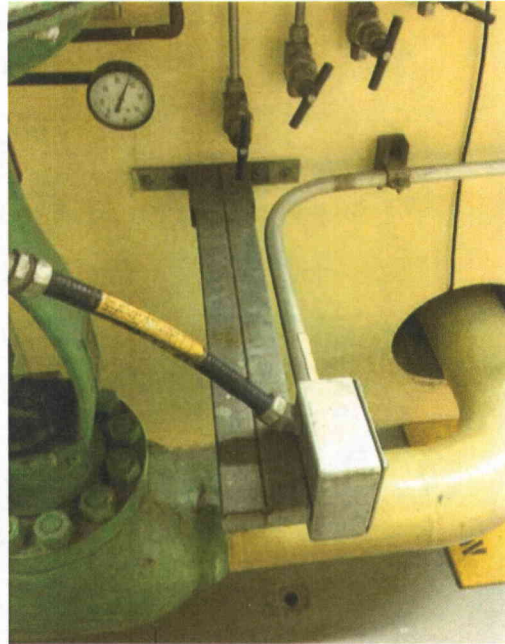
File Name: 2-63-1-1-41.jpeg
Description: View of flexible attached lines

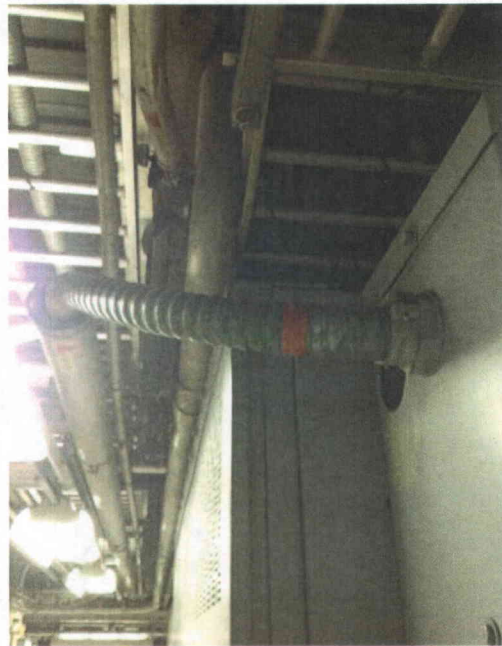
File Name: 2-64-12-1-25.jpeg
Description: View of flexible attached line

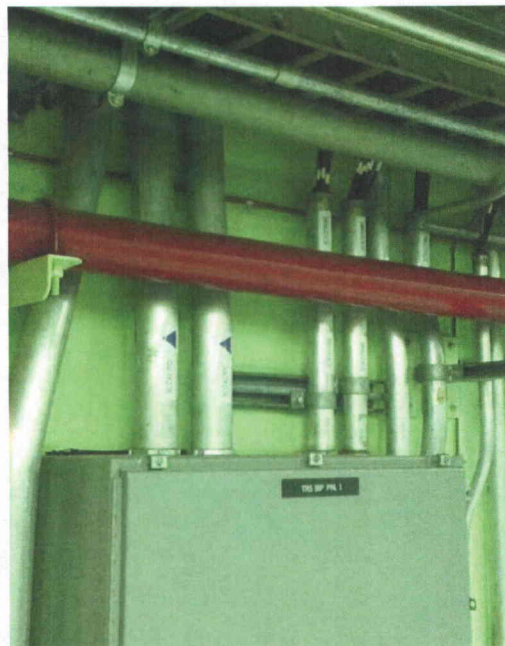
File Name: 2-64-1-1-23.jpeg
Description: View of top entry conduits

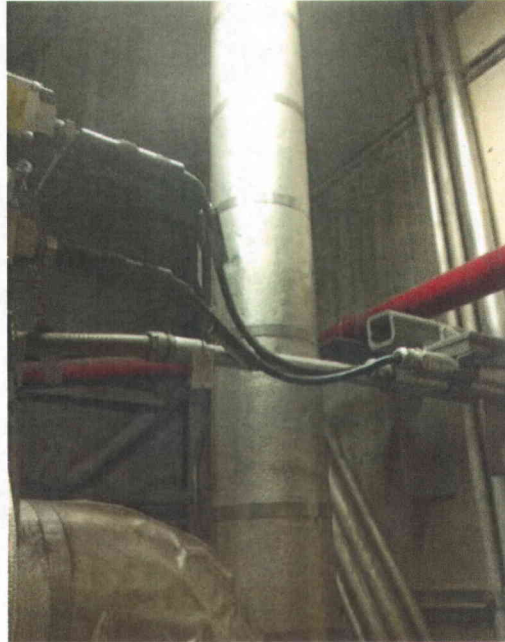
File Name: 2-63-6-1-32.jpeg
Description: View of flexible attached lines

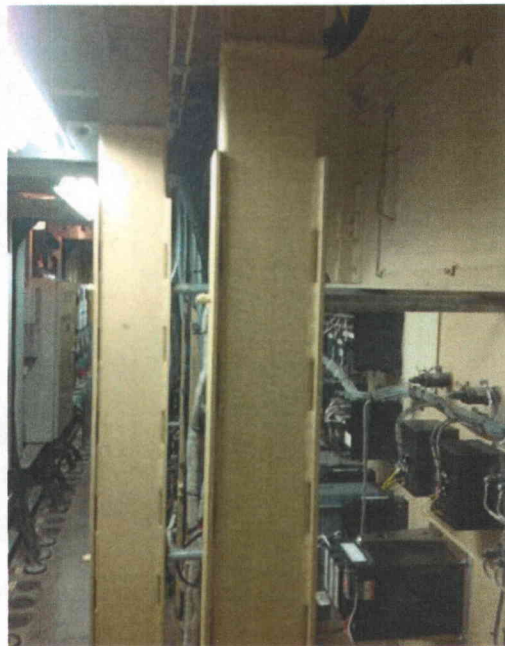
File Name: 2-64-6-1-18.jpeg
Description: View of mid posts inside panel providing support to front mounting panel

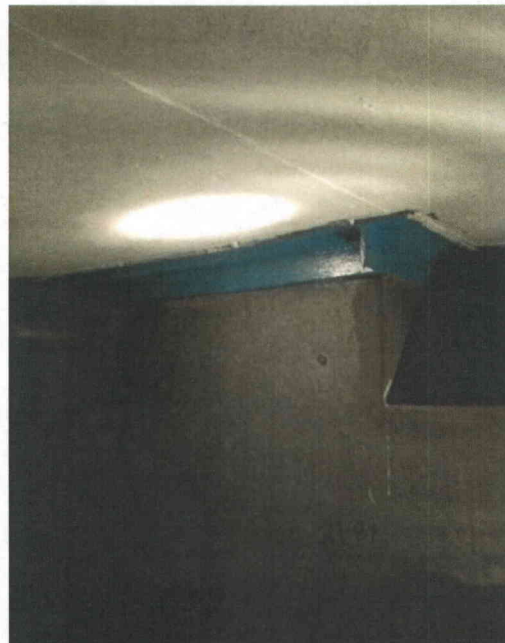
File Name: 2-63-1-1-29.jpeg
Description: View of angle framing connected to ceiling

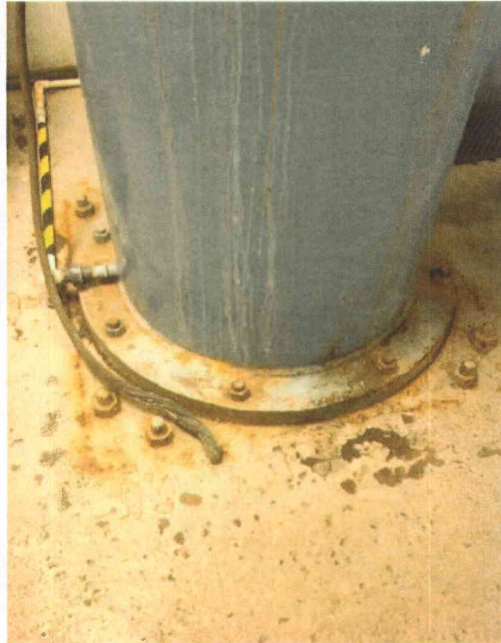
File Name: 2-63-2-1-28.jpeg
Description: View of anchorage configuration
