## APPENDIX C AREA WALK-BY CHECKLISTS (AWCs)

**Area Walk-By Checklist (AWC)**

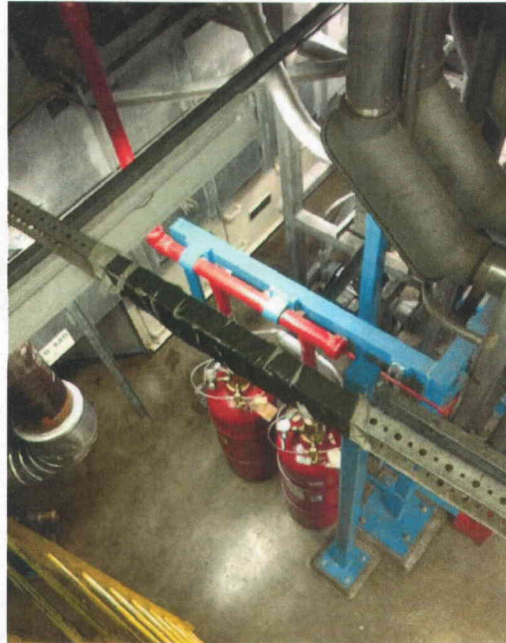
File Name: 1-65-1-4-06.jpeg  
Description: Fire suppression system rugged

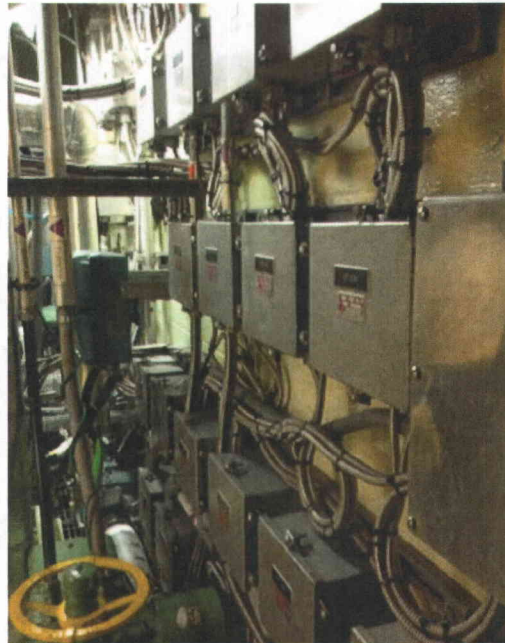
File Name: 1-65-1-4-12.jpeg  
Description: Block wall right to room entrance. East wall

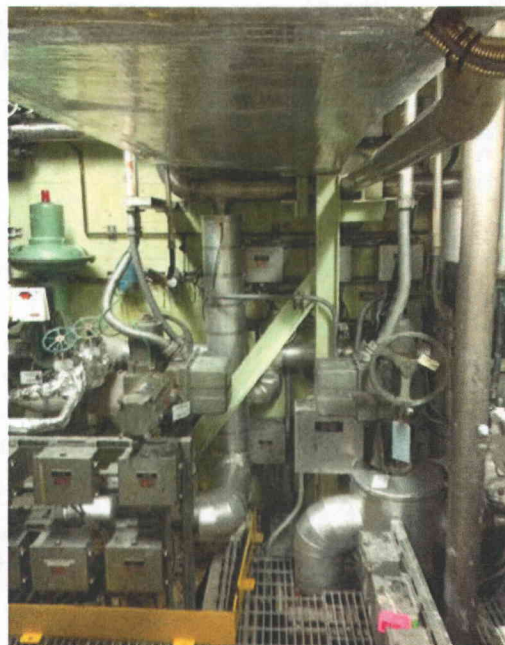
File Name: 1-66-1-4-12.jpeg  
Description: Block wall located front of entrance. North wall

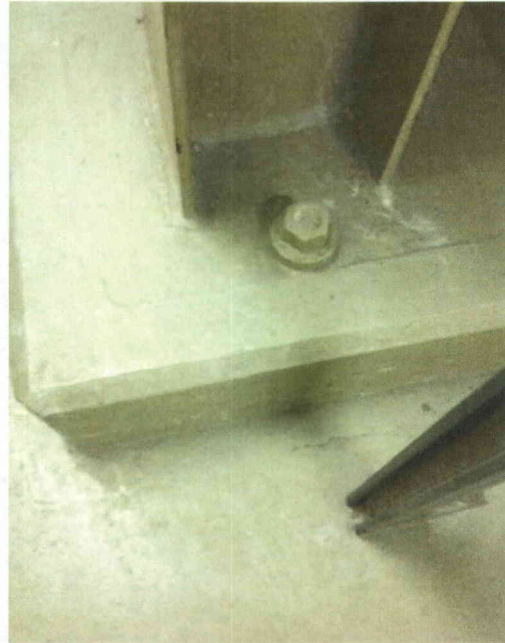
File Name: 1-65-1-4-14.jpeg  
Description: One anchor bolt not fully engaged on north post by half a thread.

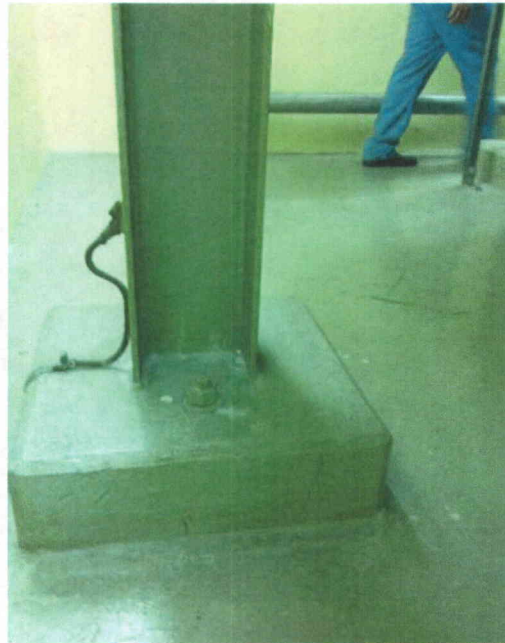
File Name: 1-66-1-4-14.jpeg  
Description: Gap between nut and base on west post

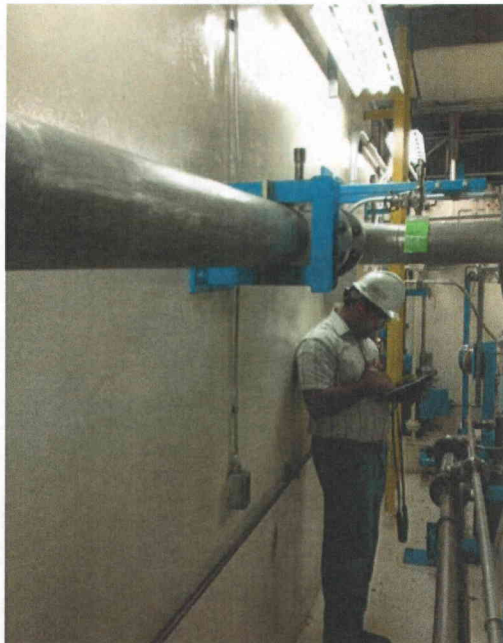
File Name: 1-60-1-4-17.jpeg  
Description: Pipe is not restrained in the longitudinal direction

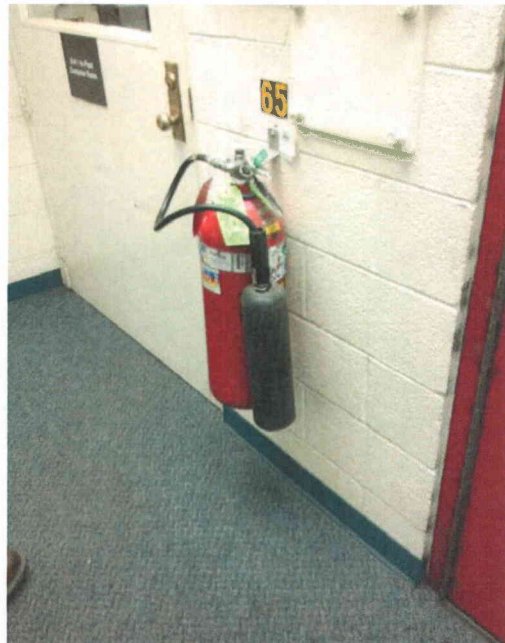
File Name: 1-60-1-4-18.jpeg  
Description: Fire extinguisher near computer room

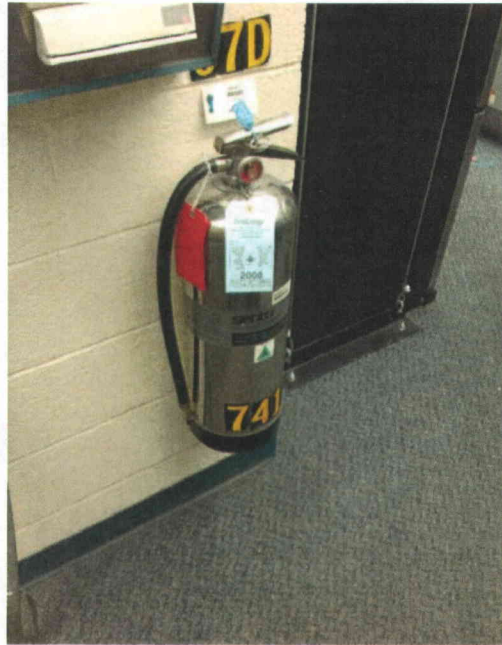
File Name: 1-65-1-4-18.jpeg  
Description: Fire extinguisher near computer room

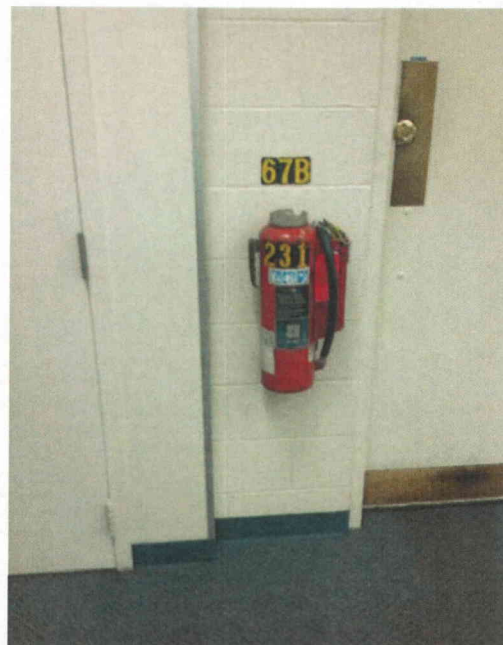
File Name: 1-68-1-4-18.jpeg  
Description: Fire extinguisher near computer room

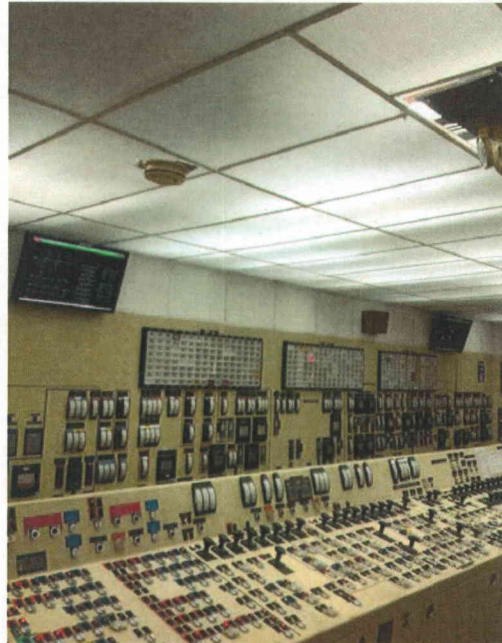
File Name: 1-71-1-4-18.jpeg  
Description: Several LCD screens are secure and are not a falling concern

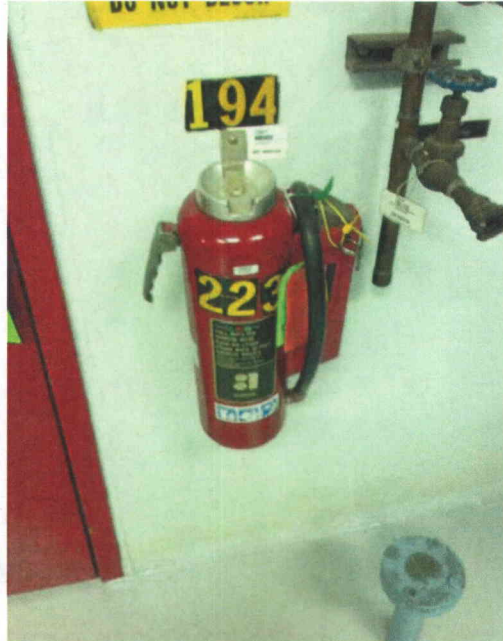
File Name: 1-65-1-4-20.jpeg  
Description: View of nearby fire extinguisher

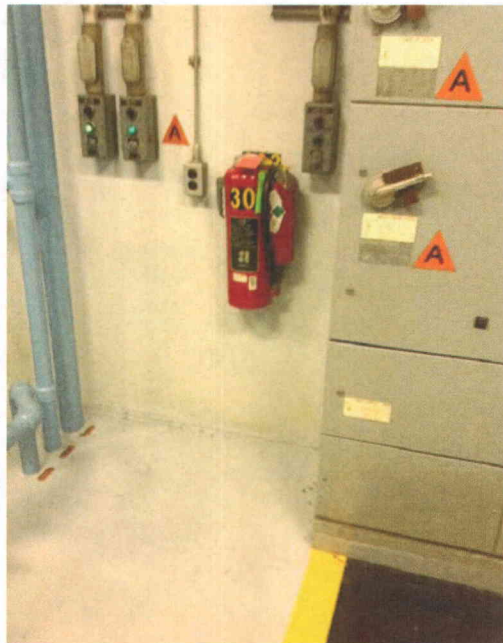
File Name: 1-66-1-4-20.jpeg  
Description: View of nearby fire extinguisher

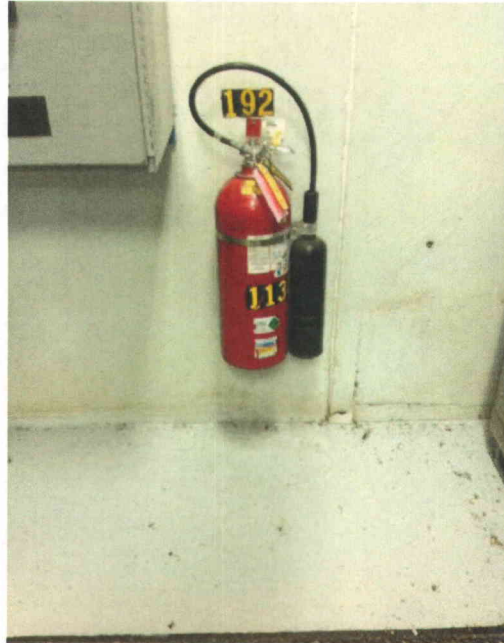
File Name: 1-67-1-4-20.jpeg  
Description: View of nearby fire extinguisher

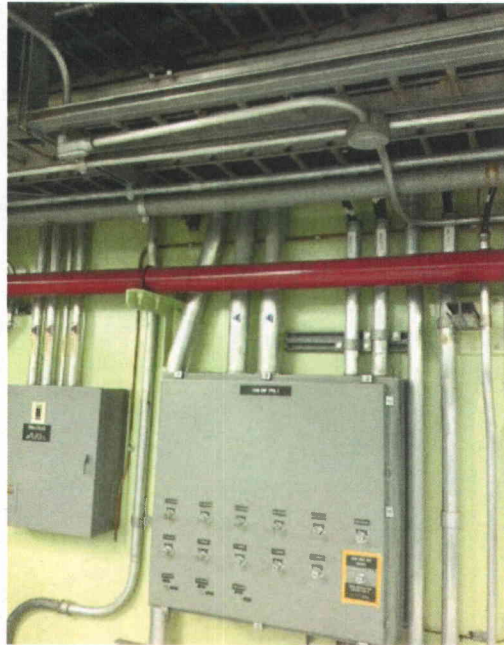
5. Does it appear that the area is free of potentially adverse seismic interactions that could cause flooding or spray in the area?  
*Fire protection pipe above TRS BIP PNL 1 judged to be rigidly supported.*

File Name: 1-65-1-4-23.jpeg  
Description: Fire pipe over panel is rigidly supported

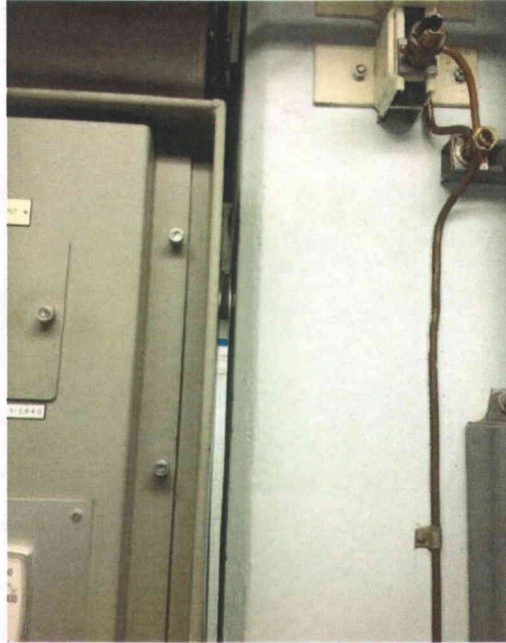
*INV-VITBUS 1 panel has a gap of 1" to a wall. It is judged that this gap is adequate and there will be no impact to the wall. HVAC grill over INV-Vitbus1-3 is held with small screws, but appears to be rugged, it is not a credible fall hazard. Block wall SB1-11 and SB1-12 are adequate under calculation DSC-0090 and DSC-0091, respectively. Block wall SB1-15 is adequate under calculation DSC-0093. These calculations are part of a follow-up seismic analysis in support of IE80-11 calculations.*

File Name: 1-67-1-4-25.jpeg  
Description: Gap of 1" between VITBUS 1 and wall judged adequate

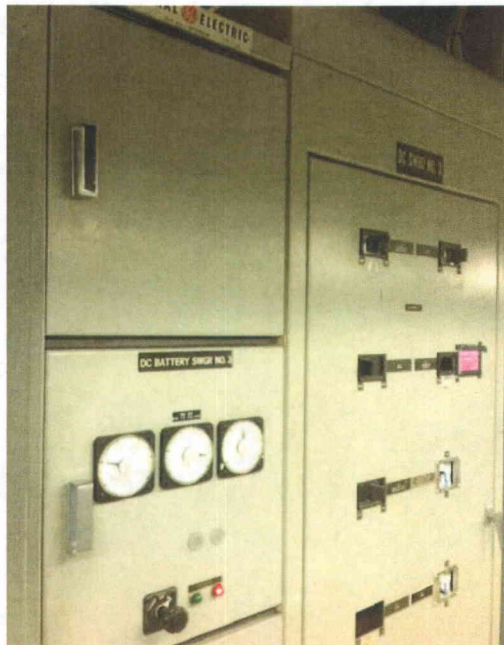
File Name: 1-70-1-4-25.jpeg  
Description: DC-SWGR-3 and DC-SWBD-3 are bolted together,

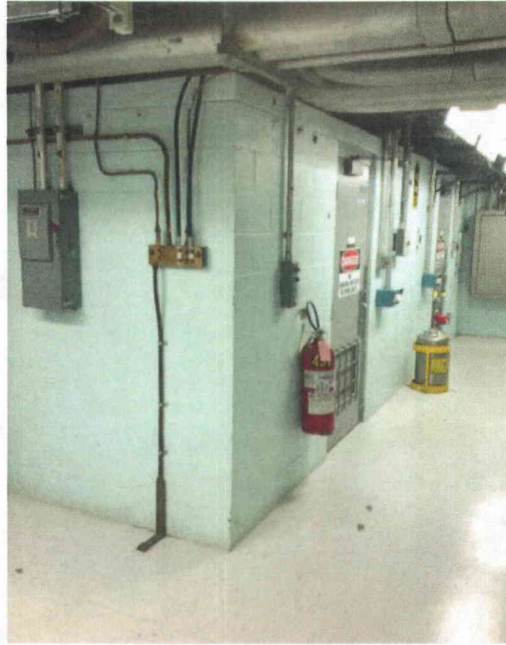
File Name: 1-65-1-4-26.jpeg  
Description: Block wall, fire ext, fire danger sign

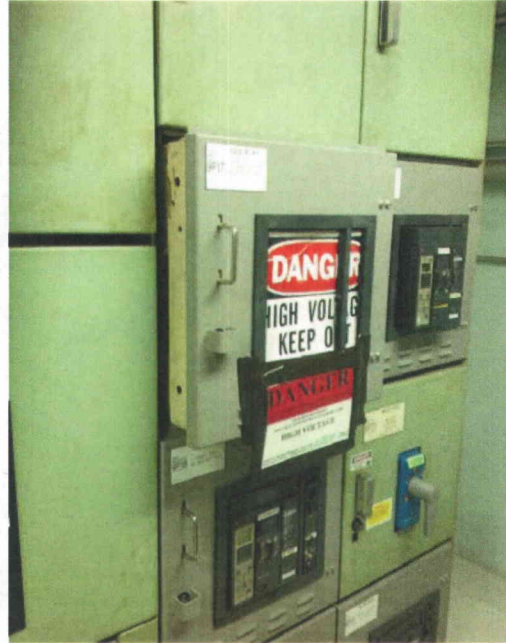
File Name: 1-67-1-4-26.jpeg  
Description: SUB STA 1-9 BUS 1P, with un-racked breaker

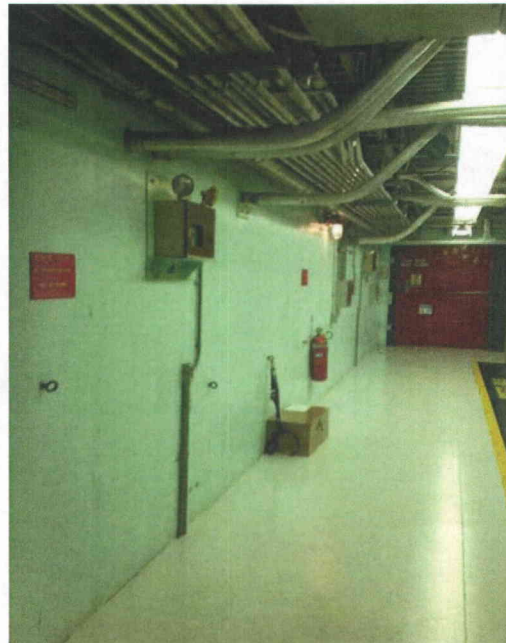
File Name: 1-69-1-4-26.jpeg  
Description: View of unrestrained fire extinguisher, and properly secured box.

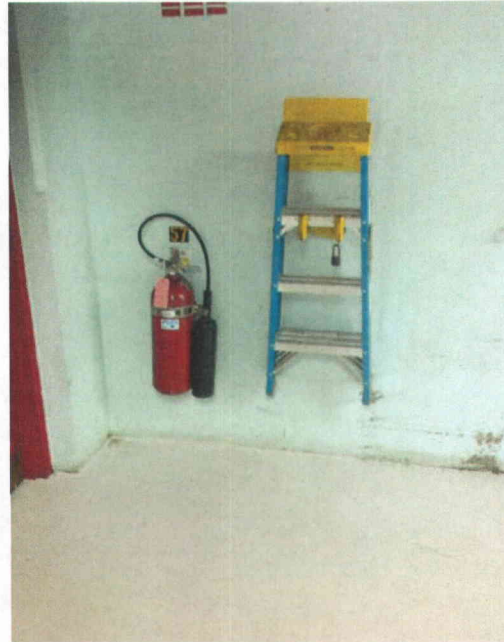
File Name: 1-70-1-4-26.jpeg  
Description: View of unrestrained fire ext, ladder is properly secured.

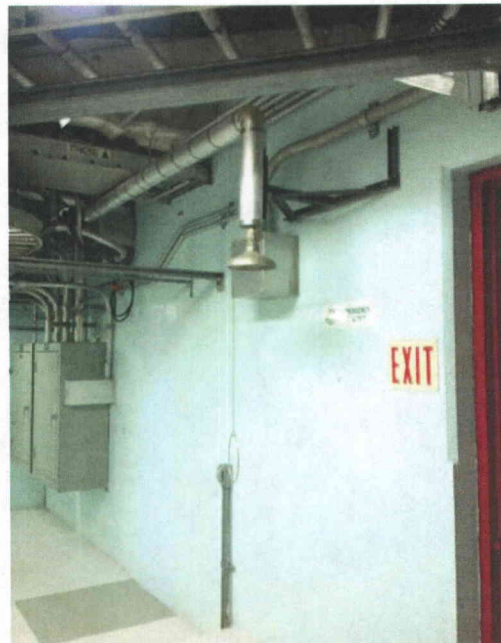
*Shower in area judged rugged and not a spray hazard.*

File Name: 1-71-1-4-26.jpeg  
Description: Emergency shower is rugged, judged not a spray concern

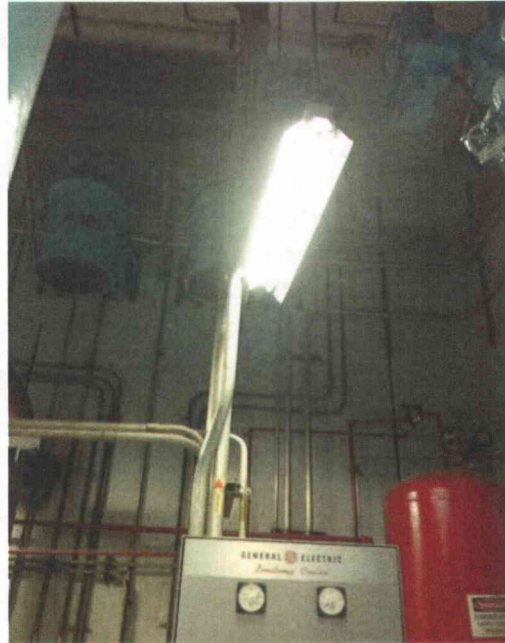
File Name: 1-65-1-4-27.jpeg  
Description: Light above Cabinet PNL 1FP1. Judged non-damaging.

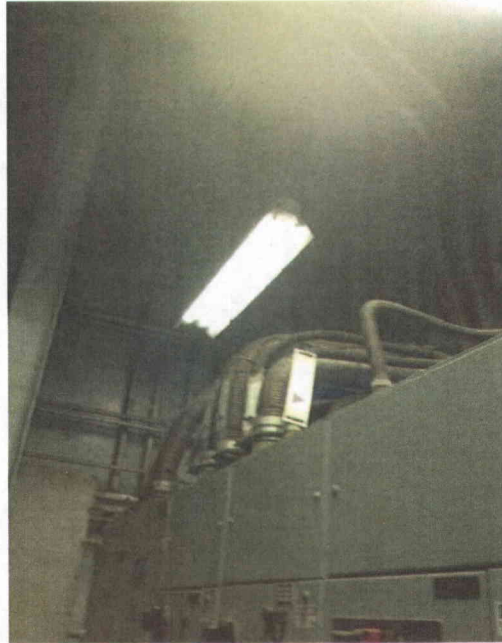
File Name: 1-65-1-4-29.jpeg  
Description: View of light above feed breaker. Judged not a concern.

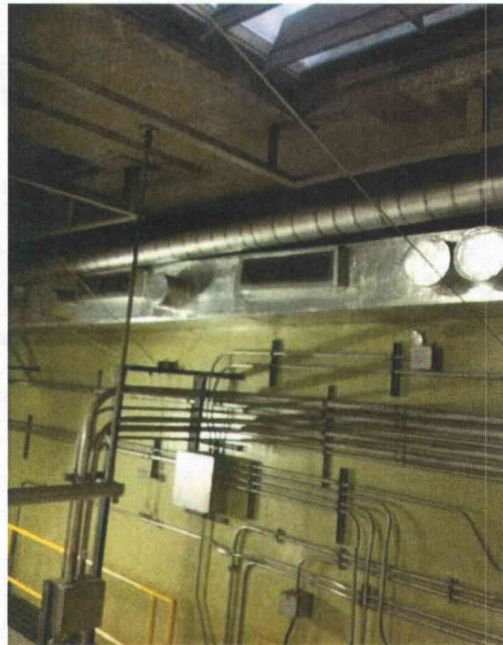
File Name: 1-65-1-4-32.jpeg  
Description: Ducting in area adequately supported

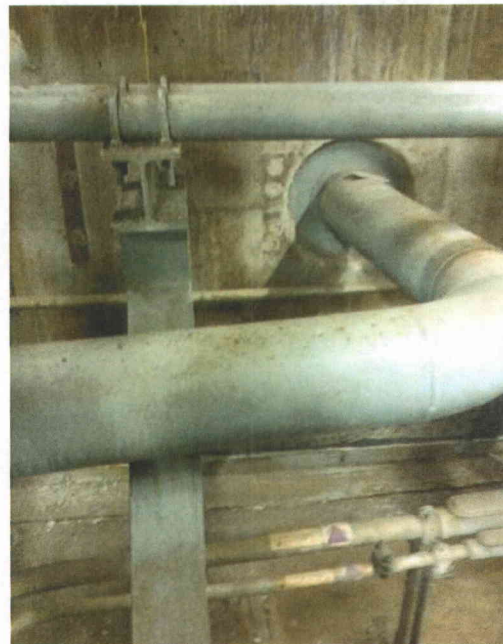
File Name: 1-75-1-4-32.jpeg  
Description: View of pipe going into containment building with nearby knee brace located on the floor of Safeguards Building. Interaction due to differential motion judged not a concern.

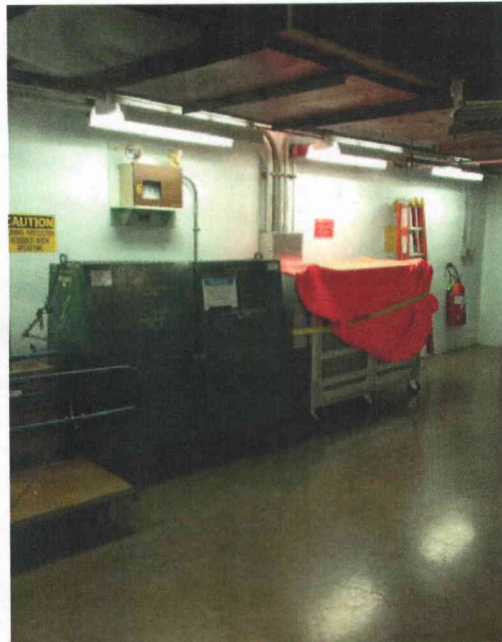
File Name: 1-65-1-4-33.jpeg  
Description: View of carts, ladders and fire extinguisher in the area

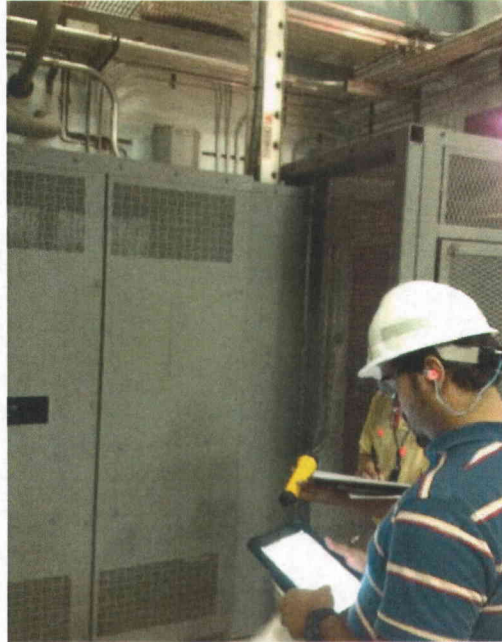
File Name: 1-66-1-4-34.jpeg  
Description: No connection between cage and transformer, approx 2 in gap, judged a non issue.

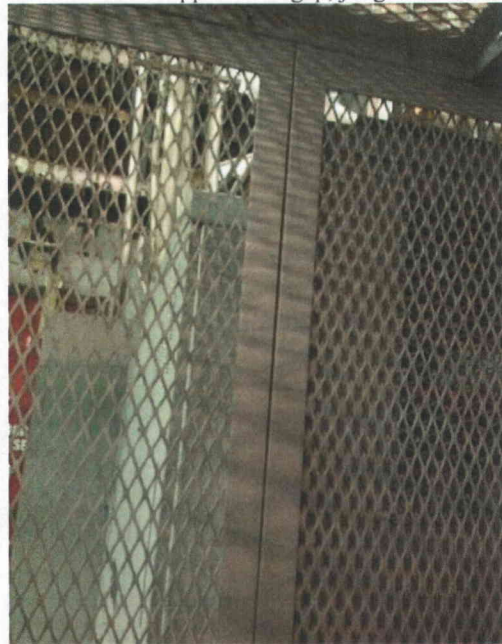
File Name: 1-67-1-4-34.jpeg  
Description: No connection between cage and transformer, approx 2 in gap, judged a non issue.

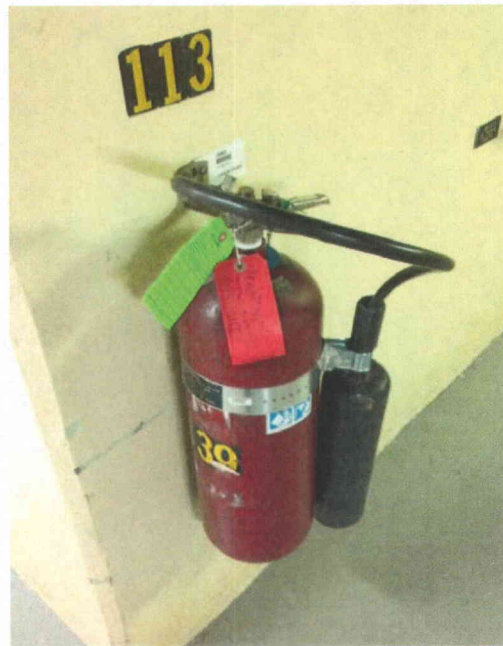
*Unsecured pole and fire extinguisher in the area considered not to cause unacceptable interactions.*

File Name: 1-60-1-4-41.jpeg  
Description: Fire extinguisher in area

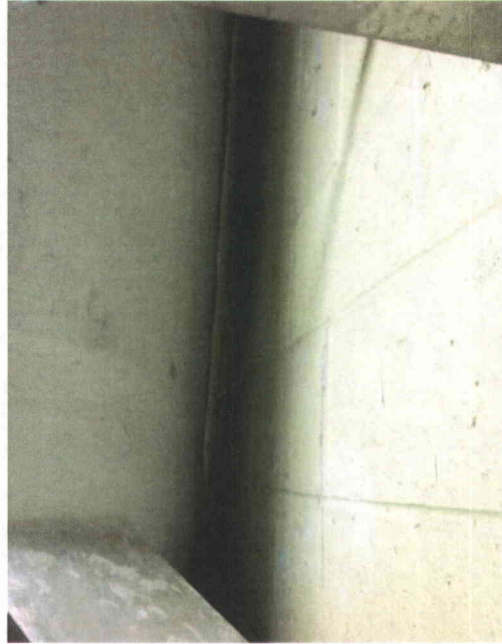
File Name: 1-65-1-4-42.jpeg  
Description: SI TK 2 approximately 3 inches from block wall.  
Judged not a concern.

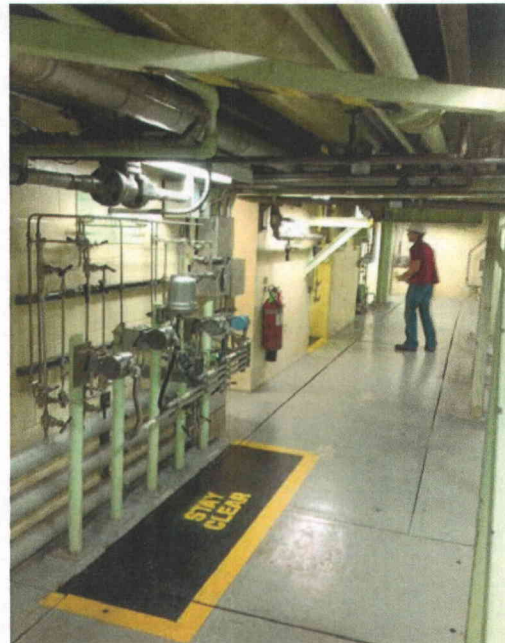
File Name: 1-68-1-4-43.jpeg  
Description: Block walls, South

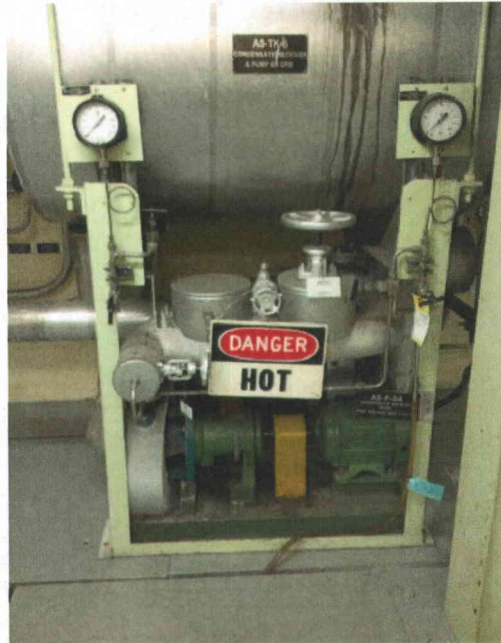
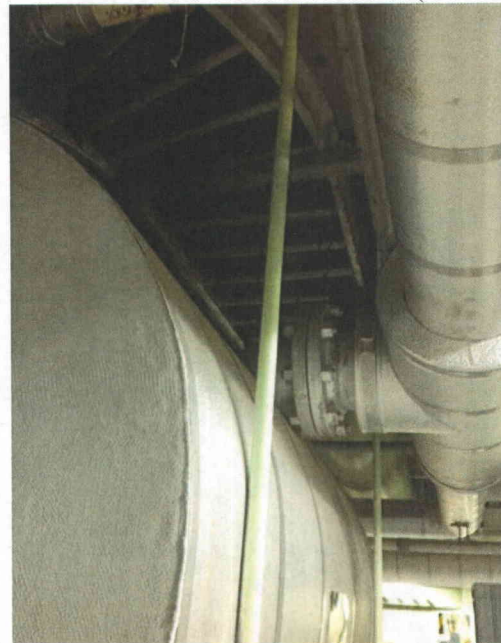
File Name: 1-74-1-4-43.jpeg  
Description: Unanchored tank, but rod hung.  
No interaction concern. (The tank is not Cat I)

File Name: 1-75-1-4-43.jpeg  
Description: Unanchored tank, but rod hung.  
No interaction concern. (The tank is not Cat I)

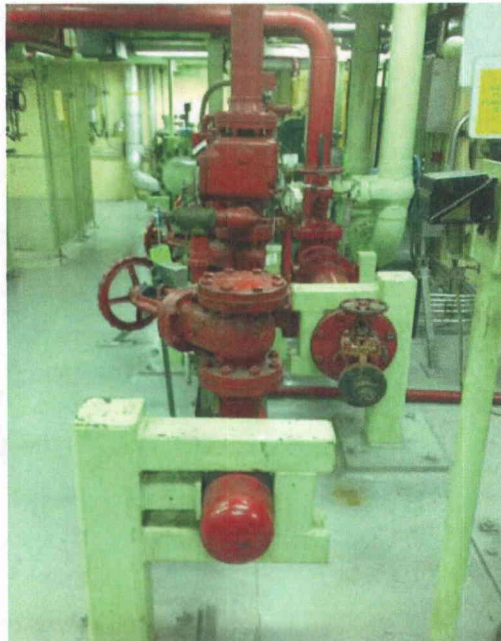
File Name: 1-60-1-4-45.jpeg  
Description: Fire system identified to be adequately supported.

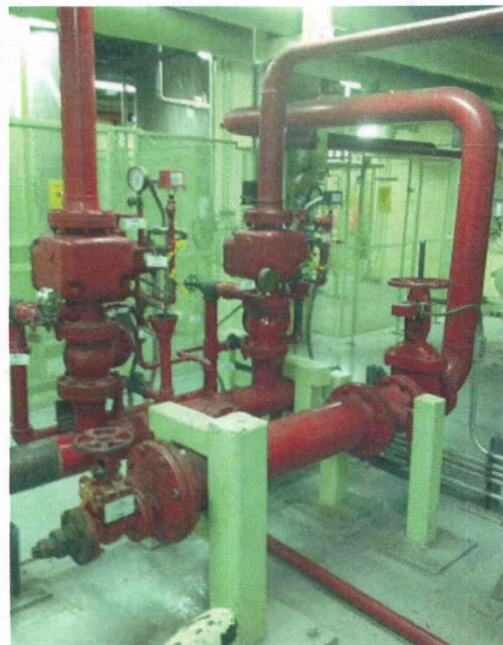
File Name: 1-60-1-4-46.jpeg  
Description: Fire system is rugged.

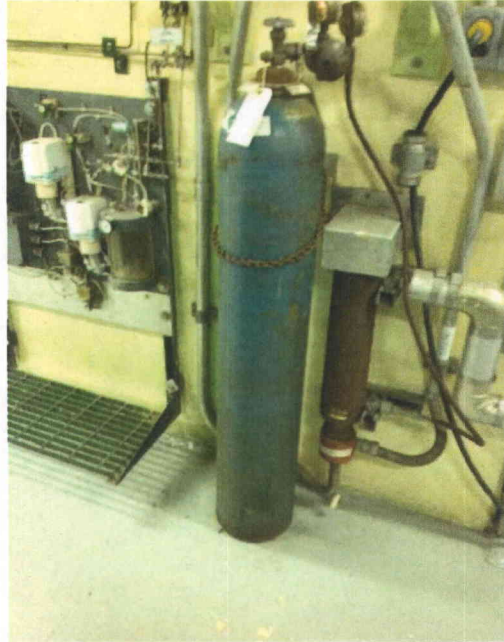
File Name: 1-67-1-4-46.jpeg  
Description: Gas bottle with only one chain at top near Post Accident Sampling panel PA5C1 judged OK.

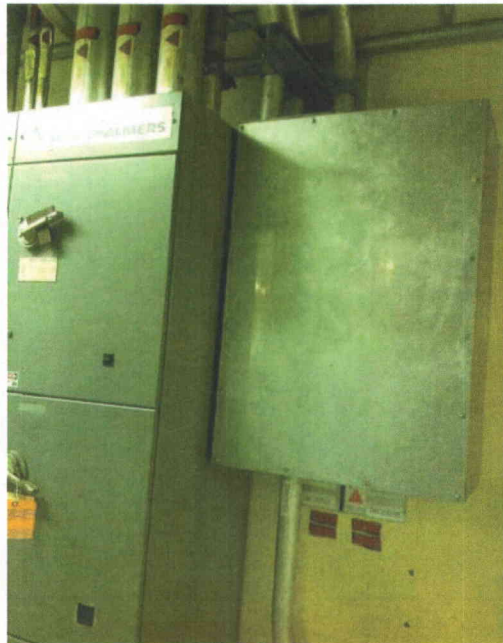
File Name: 1-60-1-4-47.jpeg  
Description: MCC 1-E4 approximately 1 in from panel  
judged to have no interaction

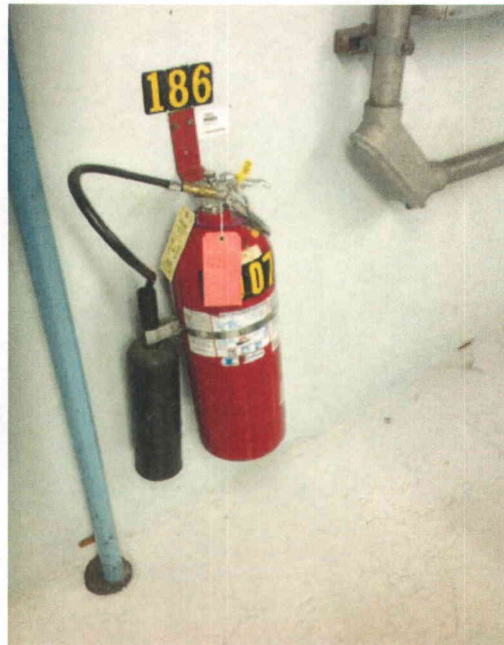
File Name: 1-65-1-4-50.jpeg  
Description: View of fire extinguisher located in the area

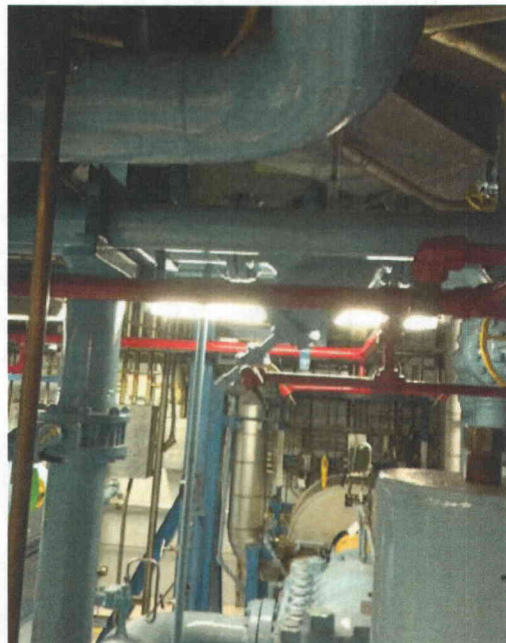
File Name: 1-72-1-4-50.jpeg  
Description: Fire pipe system appears secure, no risk identified.

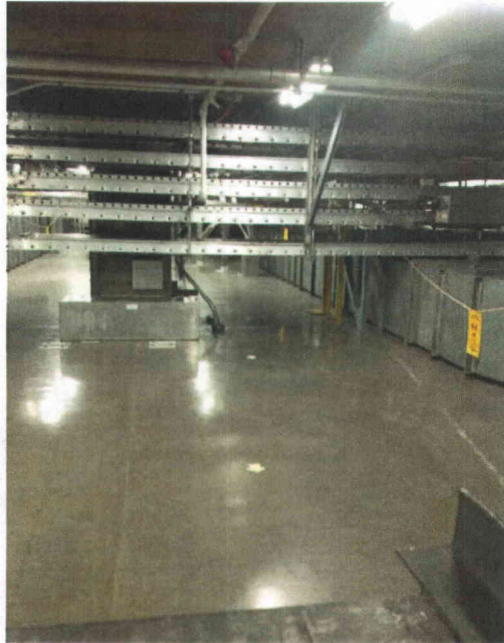
File Name: 1-65-1-4-56.jpeg  
Description: General view of cable trays in the area

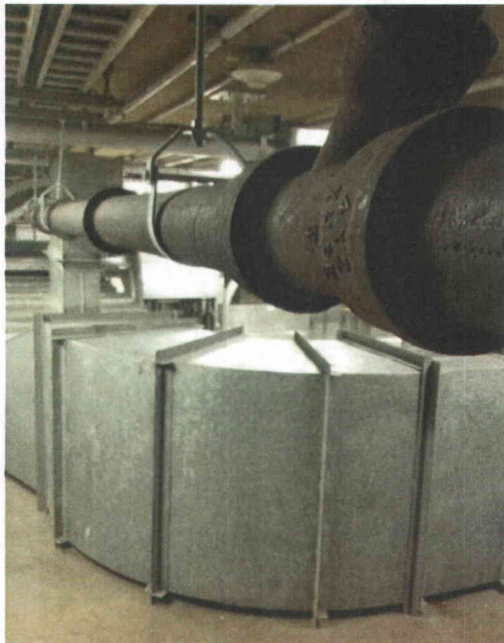
File Name: 1-66-1-4-56.jpeg  
Description: View of cast iron pipe located in the area.

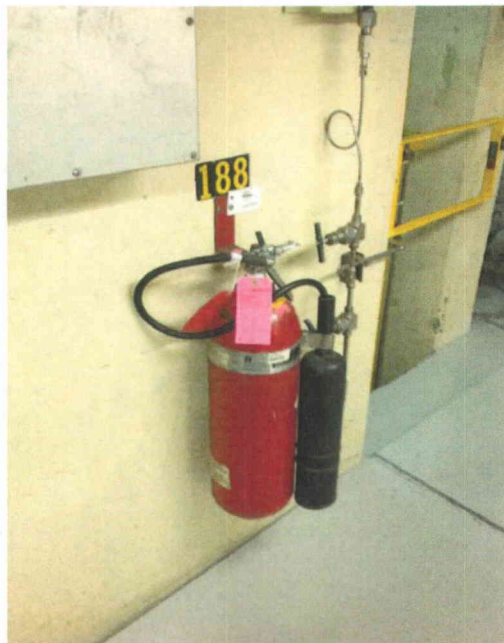
*Unsecured fire extinguishers are not considered significant. Unsecured lifting crane hook judged not to cause unacceptable interactions.*

File Name: 1-66-1-4-58.jpeg  
Description: Fire extinguisher

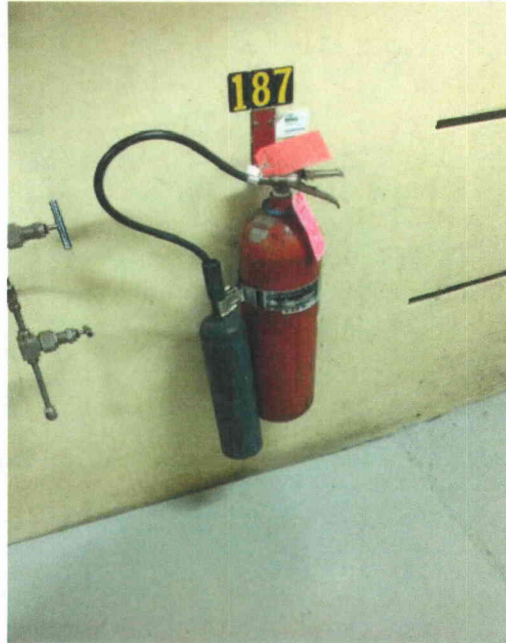
File Name: 1-67-1-4-58.jpeg  
Description: Fire extinguisher

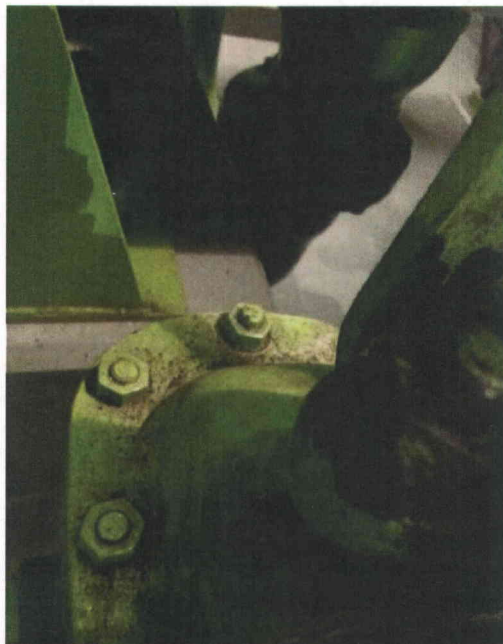
*One of ten bolts connecting the bonnet of manual valve ICCR-106 to its body does not have full thread engagement (approximately one-half thread is not engaged). Judged acceptable, as the valve is very light and has a very low moment arm. Similar thread engagement issue observed at Valve FC-E-1B and judged acceptable as-is.*

File Name: 1-65-3-4-60.jpeg  
Description: Nut at 12 o'clock not engaged on underside. Judged acceptable.

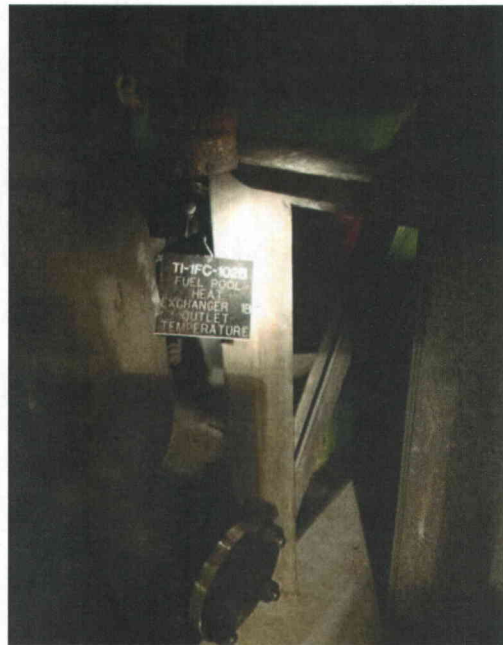
File Name: 1-70-3-4-60.jpeg  
Description: Temperature gage near HVAC supports judged acceptable

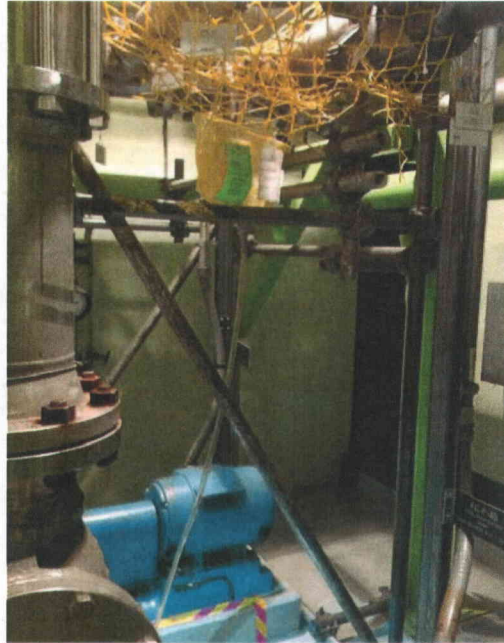
File Name: 1-72-3-4-60.jpeg  
Description: Scaffold in area is adequately braced.

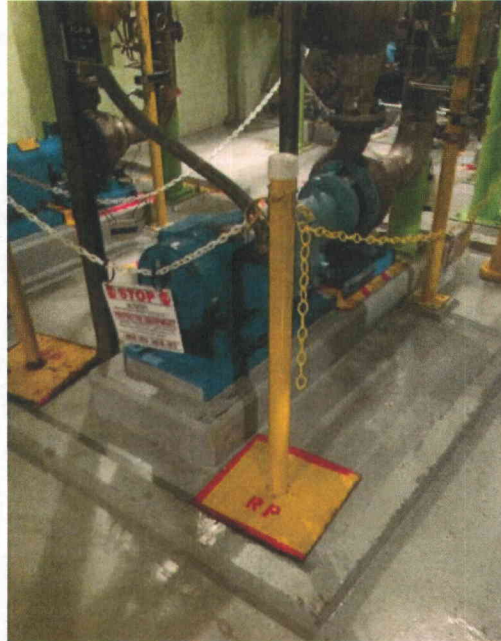
File Name: 1-74-3-4-60.jpeg  
Description: Posts located near component. Judged not a significant seismic concern.

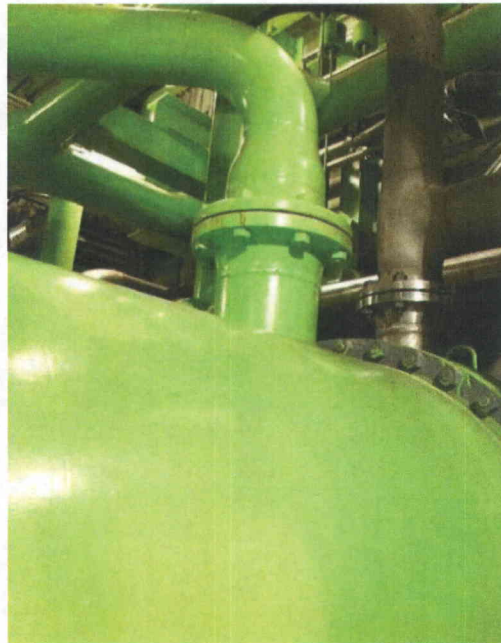
File Name: 1-75-3-4-60.jpeg  
Description: Thread engagement at heat exchanger FC-E-1B nozzle is judged acceptable.

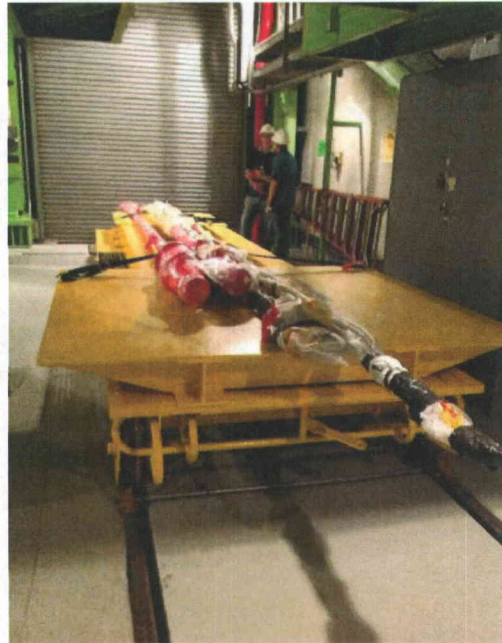
File Name: 1-76-3-4-60.jpeg  
Description: Cart, ladder, and fire pipe, all secured, judged a non issue.

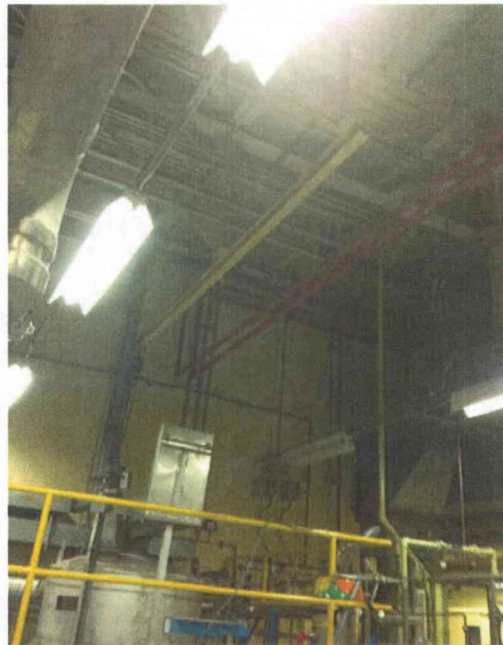
File Name: 1-60-4-4-60.jpeg  
Description: Fire pipe looks secured judged a non issue

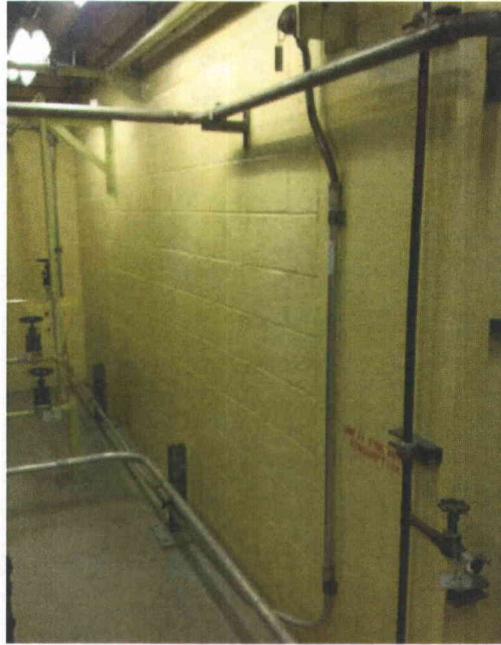
File Name: 1-67-4-4-60.jpeg  
Description: Block wall in area

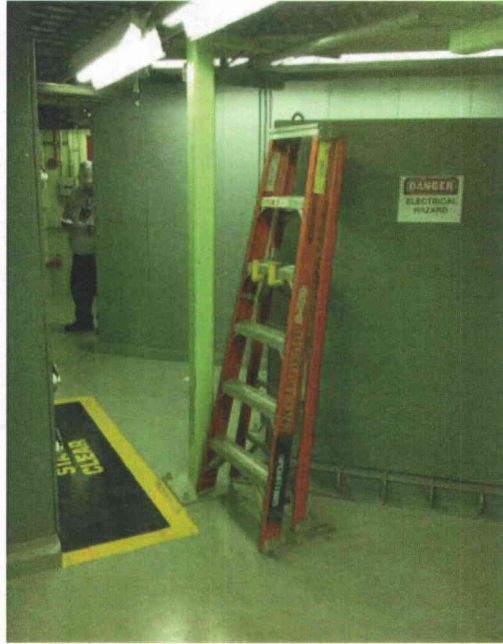
File Name: 1-65-1-4-60.jpeg  
Description: Poorly secured ladder at ladder station 34

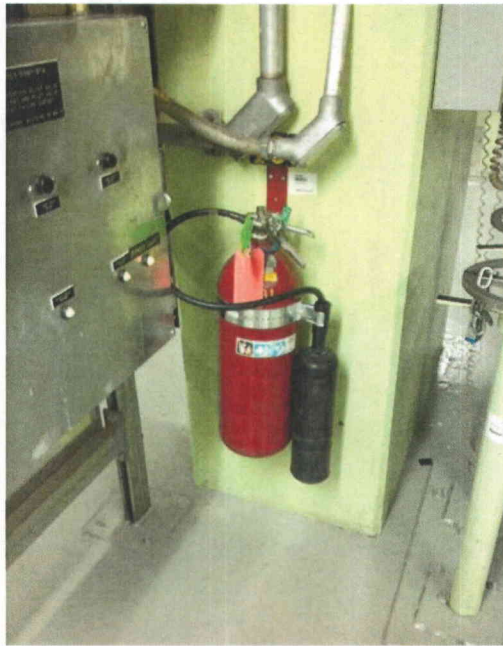
File Name: 1-66-1-4-60.jpeg  
Description: Fire extinguisher unsecured in area

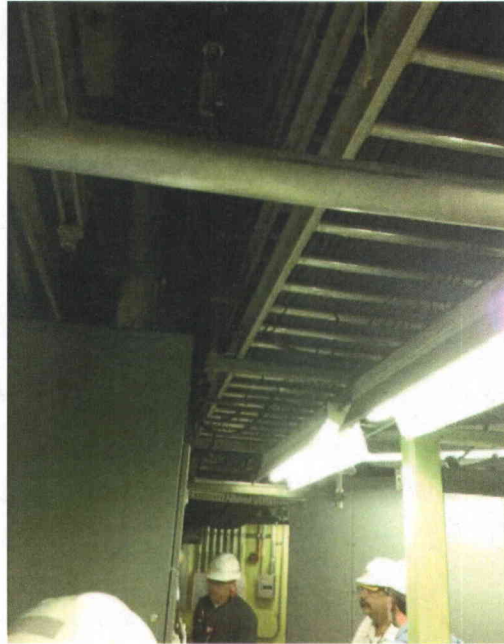
File Name: 1-67-1-4-60.jpeg  
Description: Cable tray is rod hung with minimal lateral support.

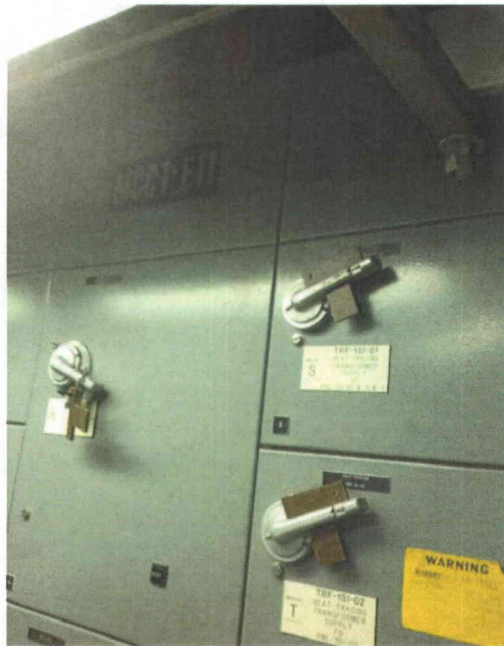
File Name: 1-68-1-4-60.jpeg  
Description: MCC-E11 and nearby cable tray

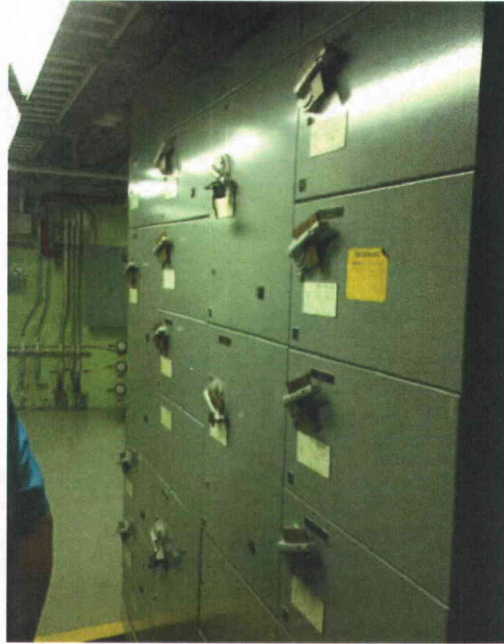
File Name: 1-69-1-4-60.jpeg  
Description: MCC-E11 and nearby cable tray

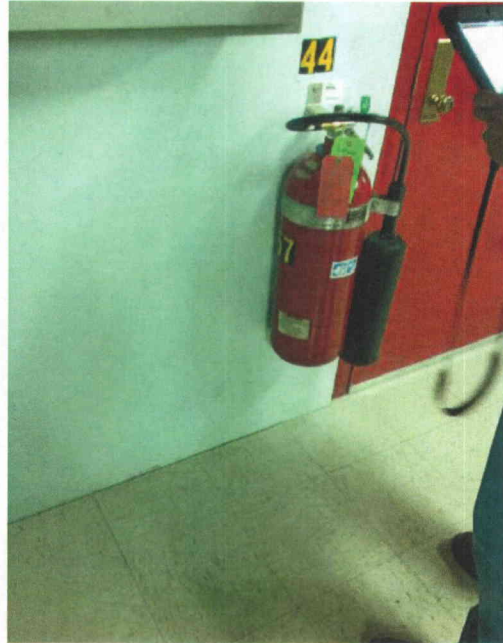
File Name: 1-65-5-4-60.jpeg  
Description: Fire extinguisher

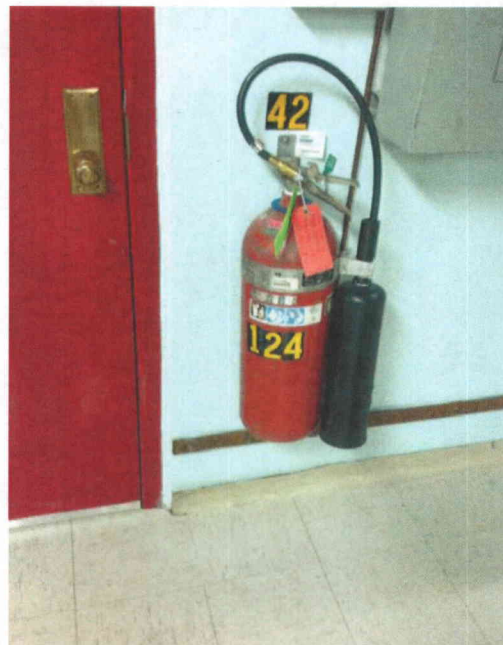
File Name: 1-66-5-4-60.jpeg  
Description: Fire extinguisher
