APPENDIX B: SEISMIC WALKDOWN CHECKLISTS (SWCs)

Seismic Walkdown Checklist (SWC)

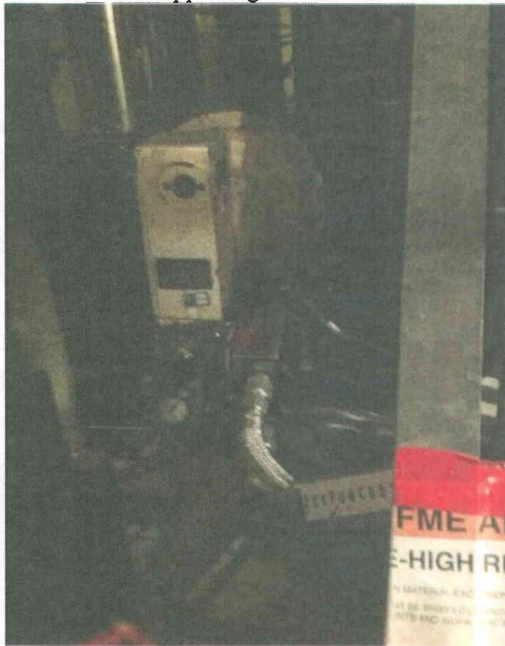
File Name: 2-61-6-2-19.jpeg
Description: General View of Component

AOV found in good condition on ~3" line. Line is supported within ~1' on one side and ~12' on other side.

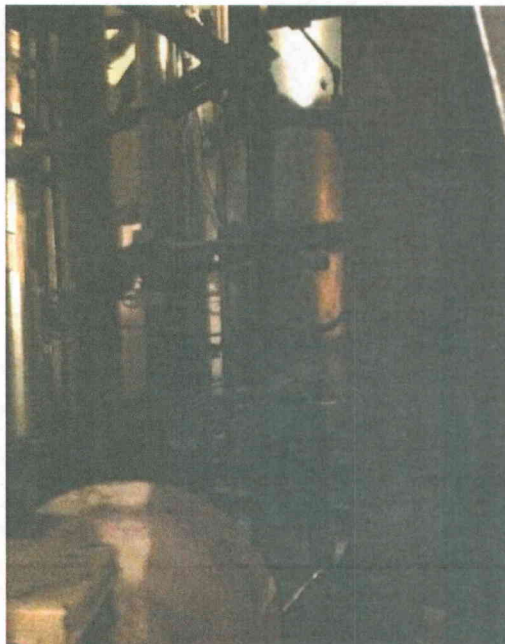
File Name: 2-62-6-2-19.jpeg
Description: View of Piping Support

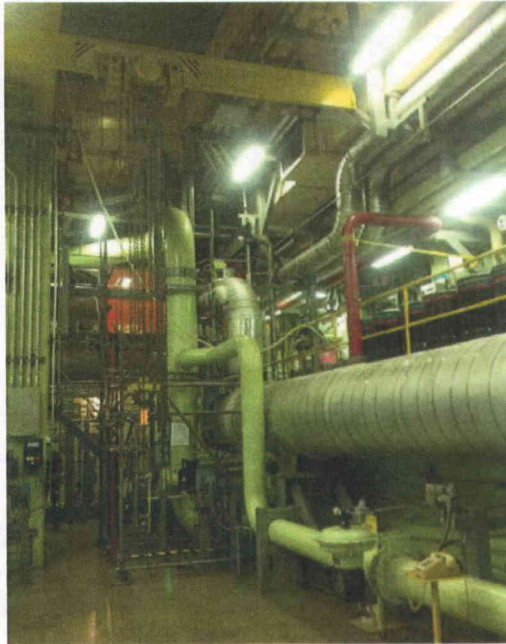
File Name: 2-94-4-2-01.jpeg
Description: View of Monorail Crane in Area

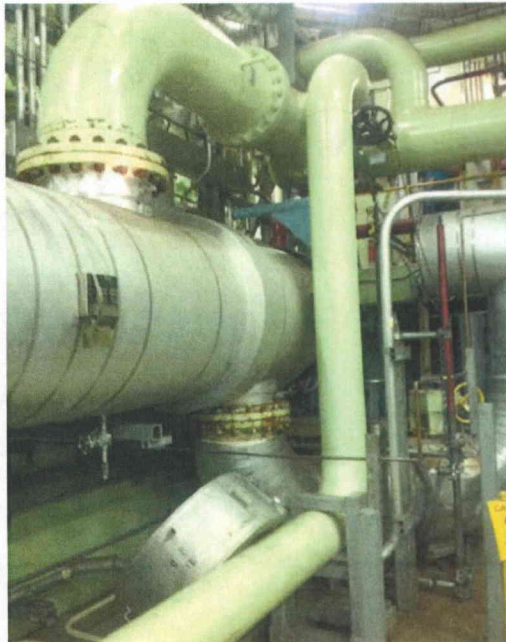
File Name: 2-95-4-2-01.jpeg
Description: View of Attached Piping

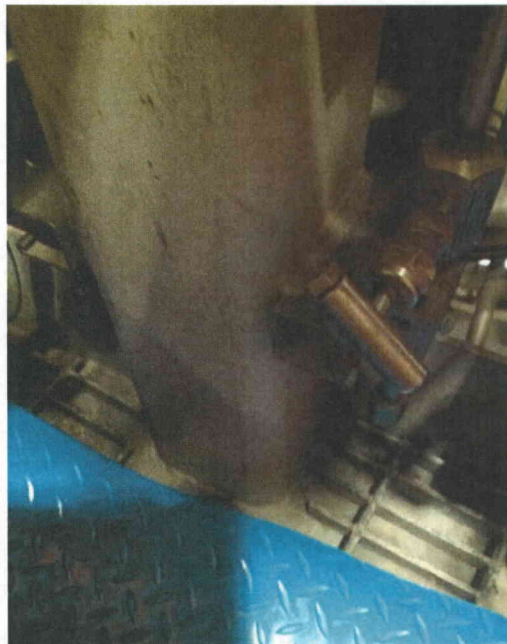
File Name: 2-64-7-2-19.jpeg
Description: View of Base Weld

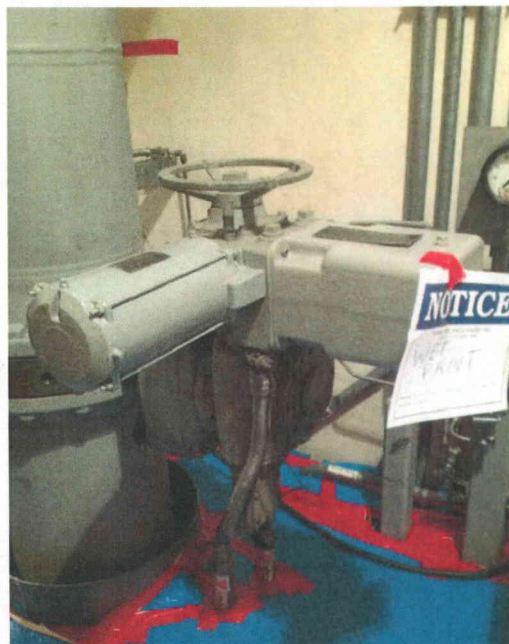
File Name: 2-62-3-2-19.jpeg
Description: General View of Component

MOV mounted on 24" diam pipe line. Pipe found to be well supported.

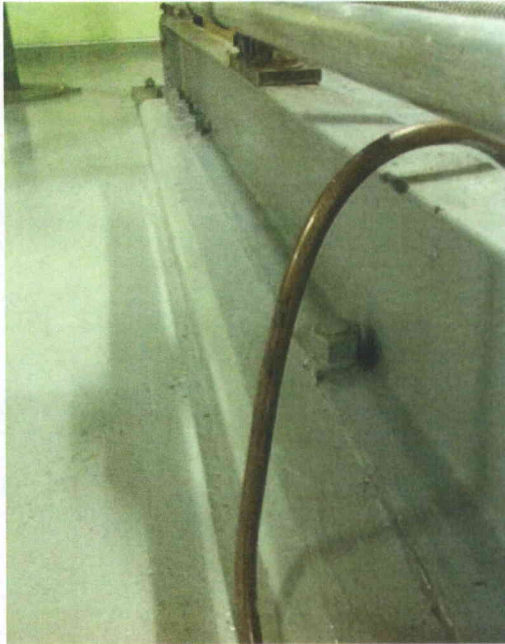
File Name: 2-63-2-2-03.jpeg
Description: Close Up View of Anchorage

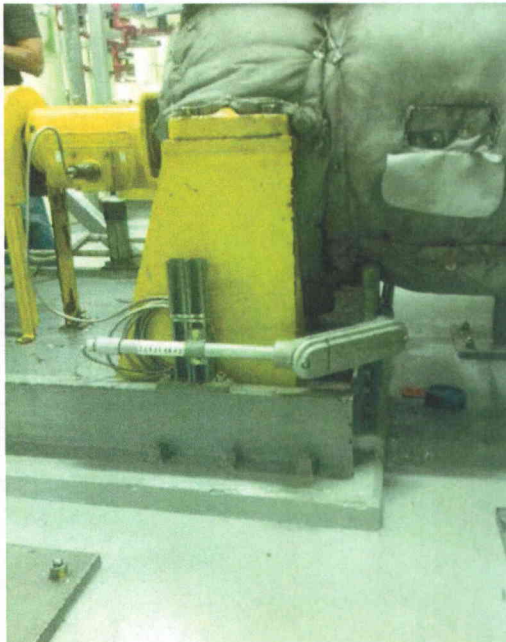
File Name: 2-64-2-2-03.jpeg
Description: Close Up View of Anchorage

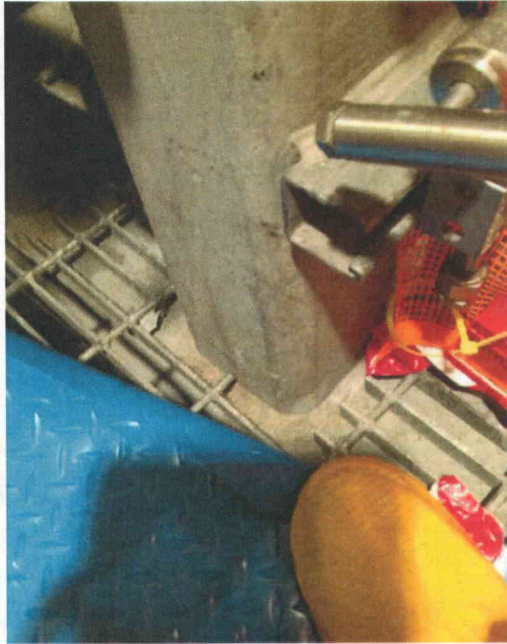
File Name: 2-64-8-2-19.jpeg
Description: View of Base Weld

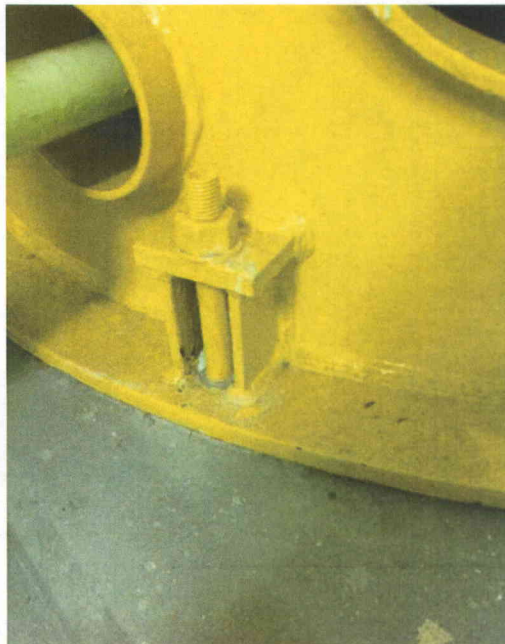
Tank and anchorage found in good condition.

File Name: 2-62-1-2-05.jpeg
Description: Close Up View of Anchorage

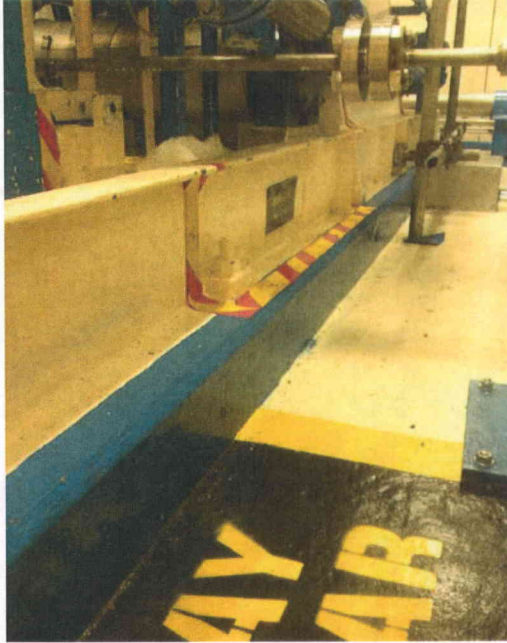
File Name: 2-63-3-2-03.jpeg
Description: Close Up View of Anchorage

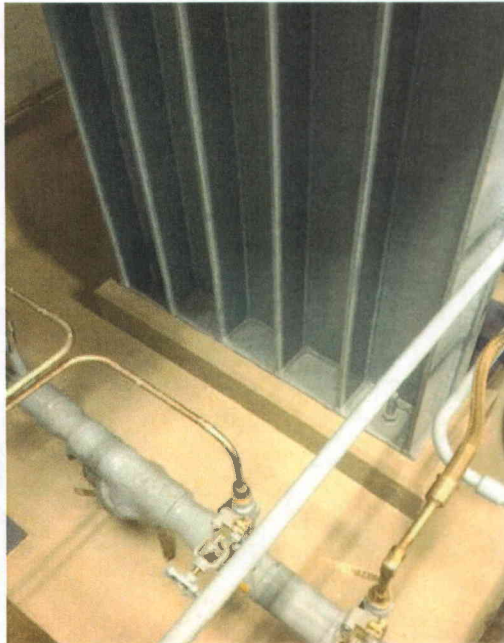
File Name: 2EGF-TK22A(3).jpg
Description: View of Anchor Bolts

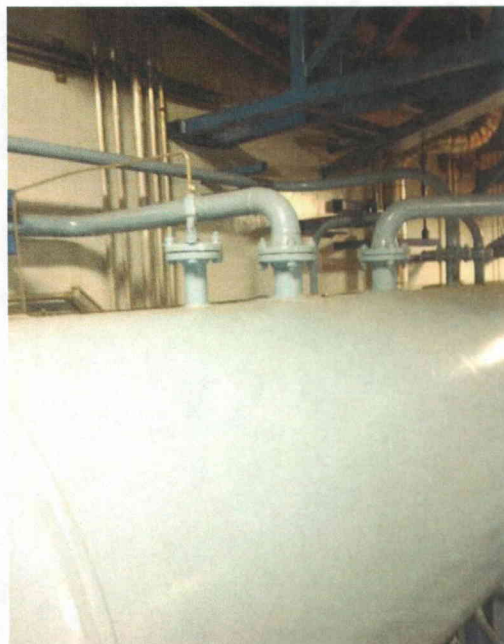
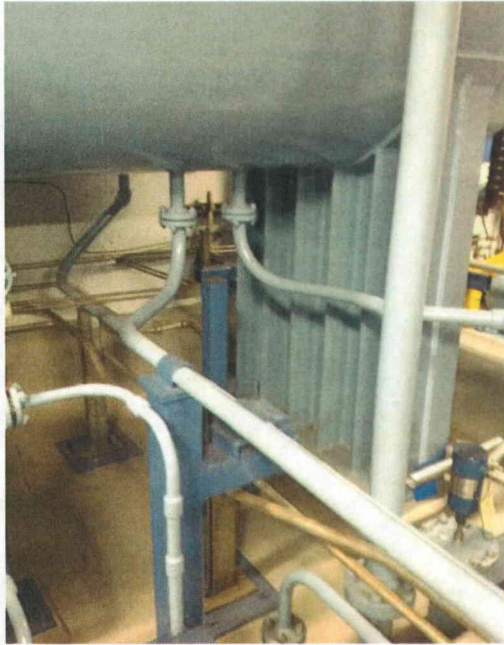
File Name: 2EGF-TK22A(4).jpg
Description: View of Attached Lines

File Name: 2EGF-TK22A(5).jpg
Description: View of Attached Lines

9. Do attached lines have adequate flexibility to avoid damage?
Attached lines have adequate flexibility.

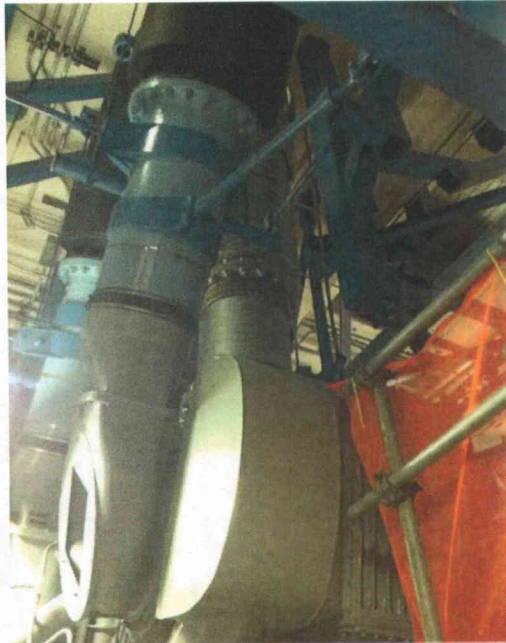
File Name: 2EGS-EG2-1(3).jpg
Description: View of Exhaust Pipe Bracing

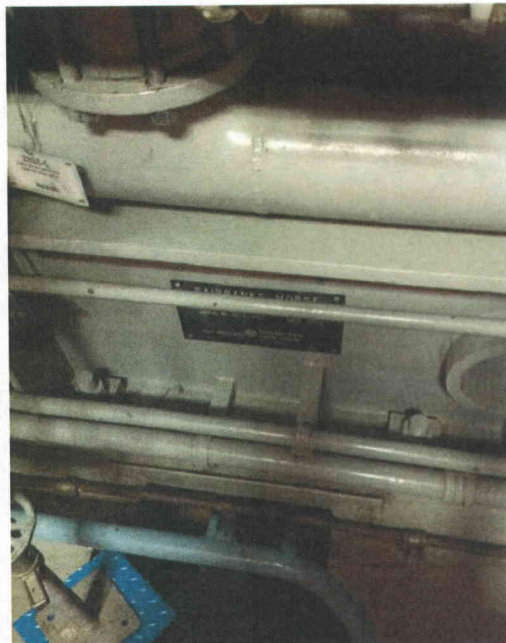
File Name: 2EGS-EG2-1(4).jpg
Description: View of Typical Anchor Bolts

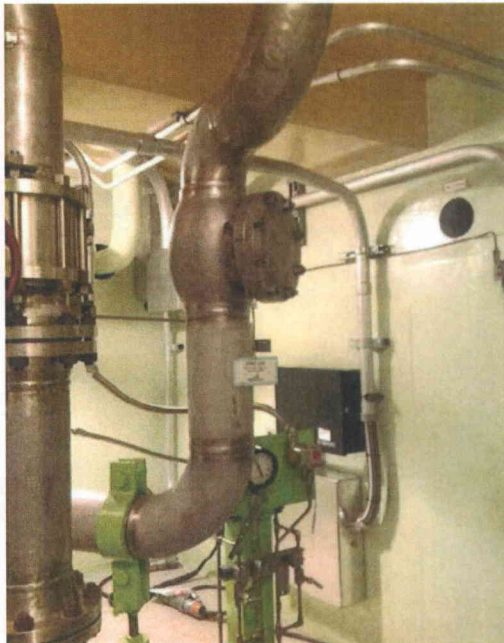
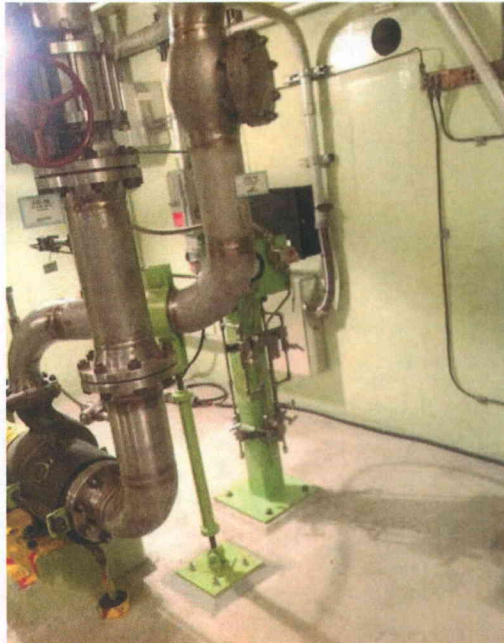
File Name: 2-62-6-2-29.jpeg
Description: General View of Component

File Name: 2-63-6-2-29.jpeg
Description: General View of Component

Piping from pump 2FNC-P21A to heat exchanger 2FNC-E21A spans ~50' and was observed to have minimal lateral support. Nozzle load/pipe stress calculation was checked to verify that pump was designed for nozzle loads, and the configuration was judged to be adequate. See also SWC for 2FNC-P21A (Sheet 124 of 513).

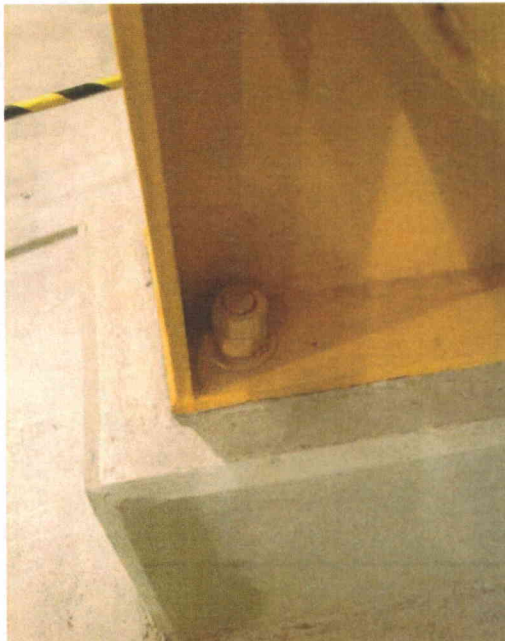
File Name: 2-64-2-2-29.jpeg
Description: Close Up View of Anchorage

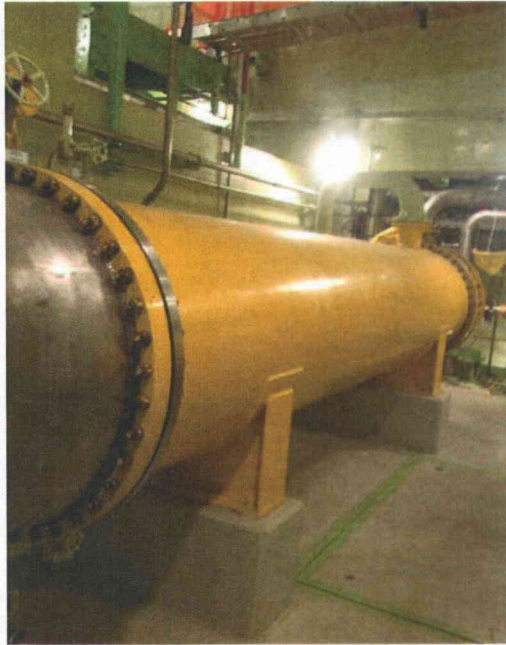
File Name: 2-73-2-2-29.jpeg
Description: General View of Component

Piping from pump 2FNC-P21A to heat exchanger 2FNC-E21A spans ~50' and was observed to have minimal lateral support. Nozzle load/pipe stress calculation was checked to verify that pump was designed for nozzle loads, and the configuration was judged to be adequate. See also SWC for 2FNC-P21A (Sheet 124 of 513).

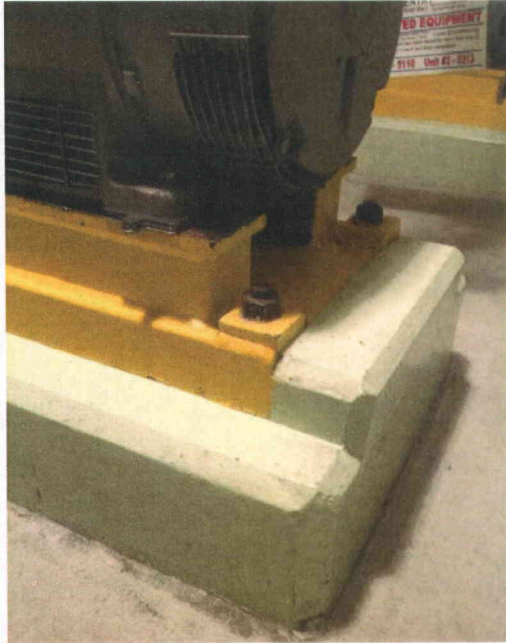
File Name: 2-63-7-2-29.jpeg
Description: Close Up View of Anchorage

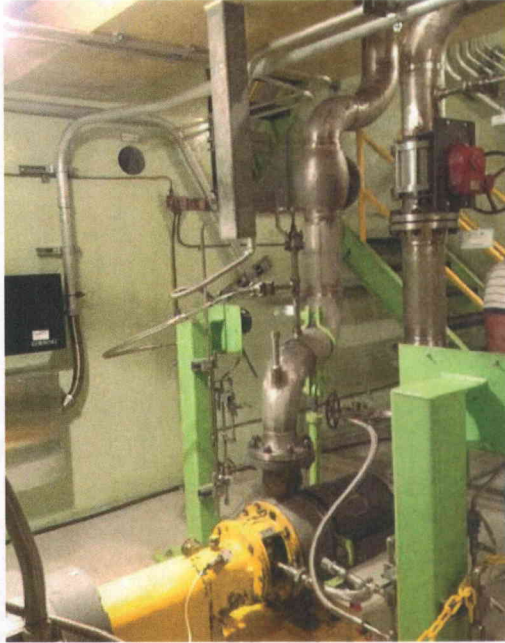
File Name: 2-73-7-2-29.jpeg
Description: View of Attached Lines

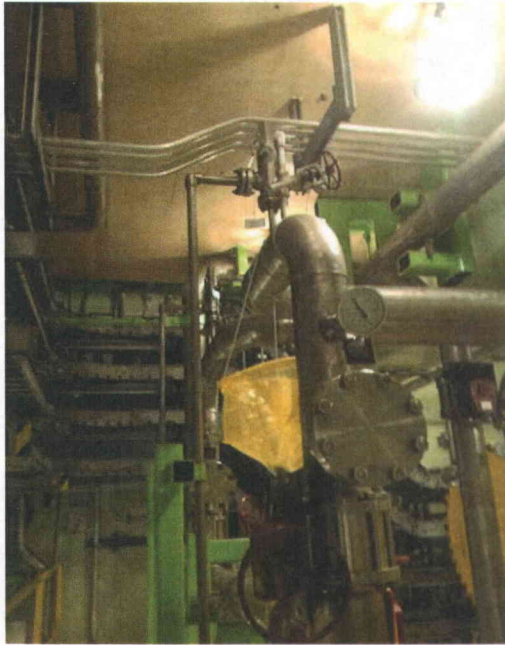
File Name: 2-63-5-2-29.jpeg
Description: General View of Component and Main Line

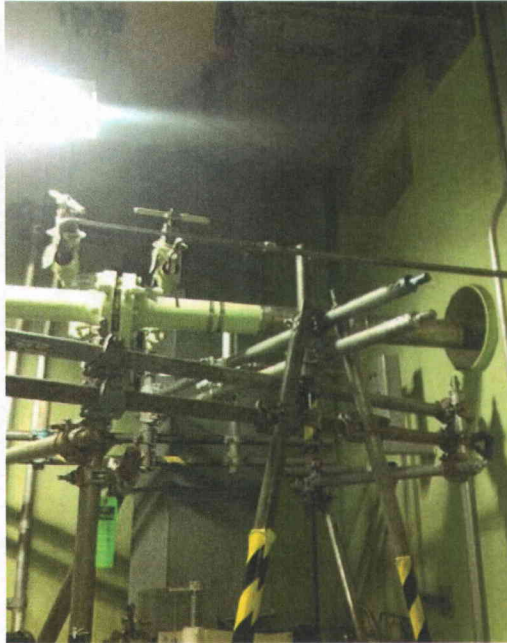
File Name: 2-63-3-2-25.jpeg
Description: View of Component Area

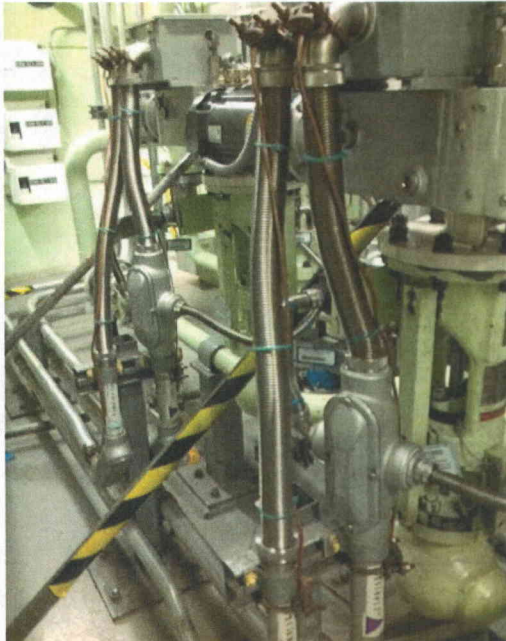
File Name: 2-64-1-2-25.jpeg
Description: View of Attached Lines

9. Do attached lines have adequate flexibility to avoid damage?
Attached lines found with adequate flexibility. Nozzles are well supported.

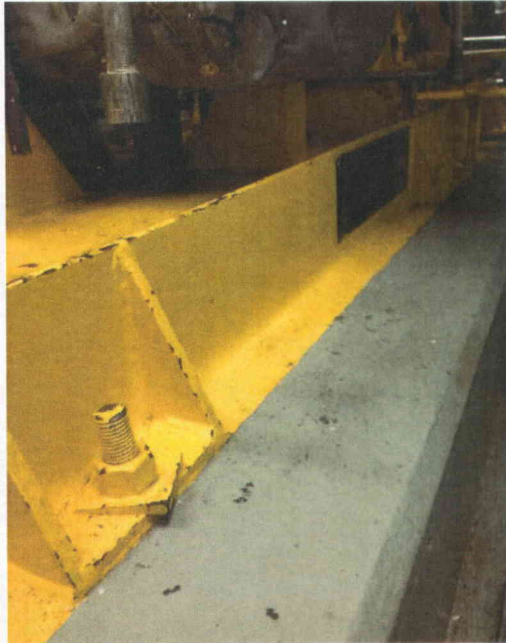
File Name: 2-63-3-2-23.jpeg
Description: Close Up View of Anchorage

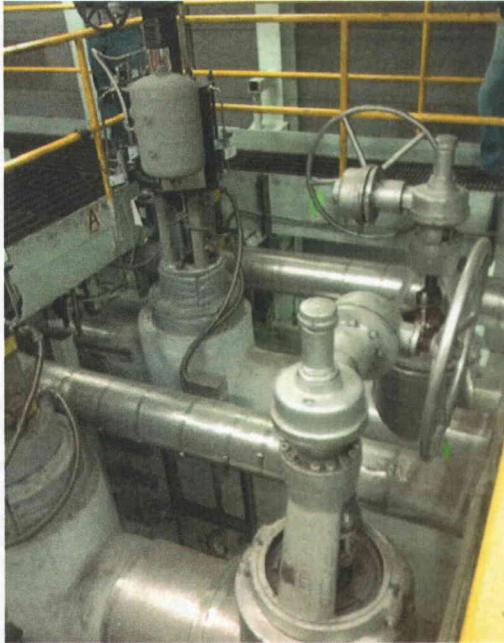
File Name: 2-63-2-2-27.jpeg
Description: View of Component Area

Surface rust at yoke bottom plate judged acceptable.

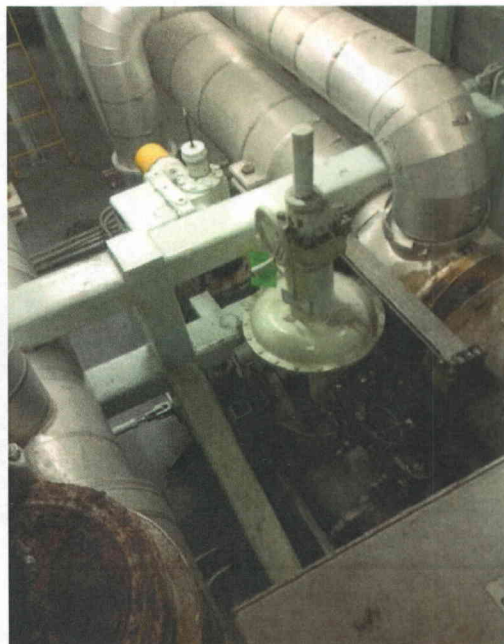
File Name: 2-62-1-2-27.jpeg
Description: View of Component Area

Valve found in good condition.

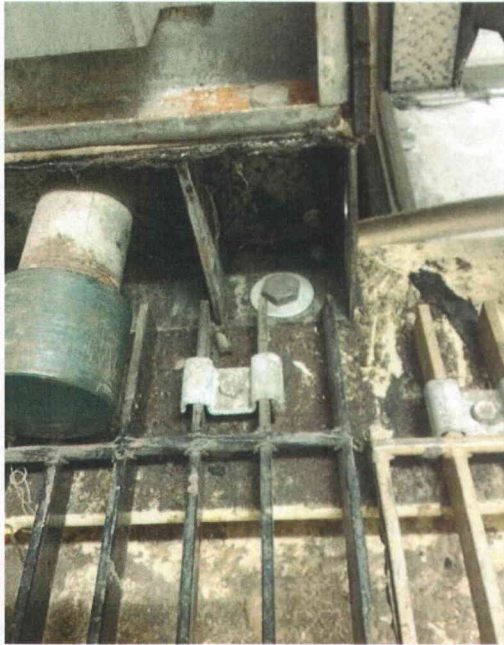
File Name: 2-62-2-2-07.jpeg
Description: Close Up View of Anchorage

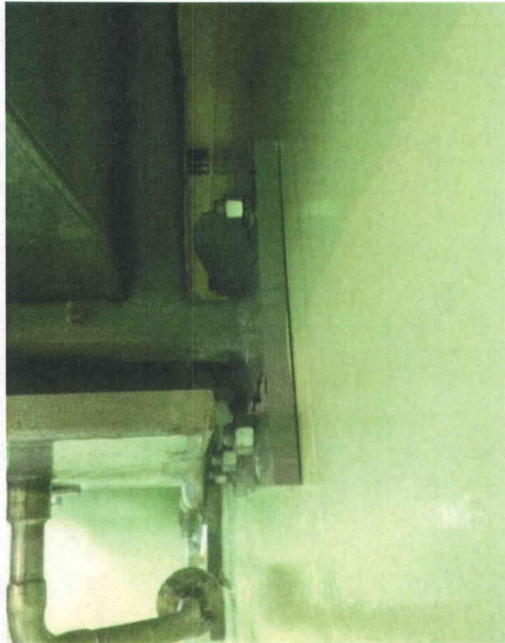
File Name: 2-64-2-2-04.jpeg
Description: View of Anchorage to Wall

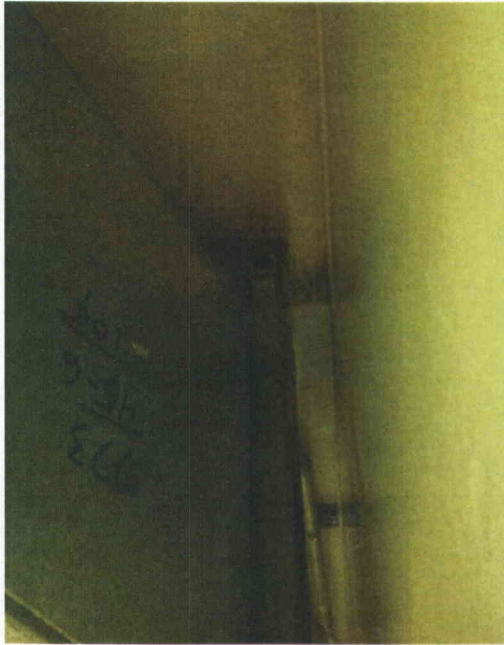
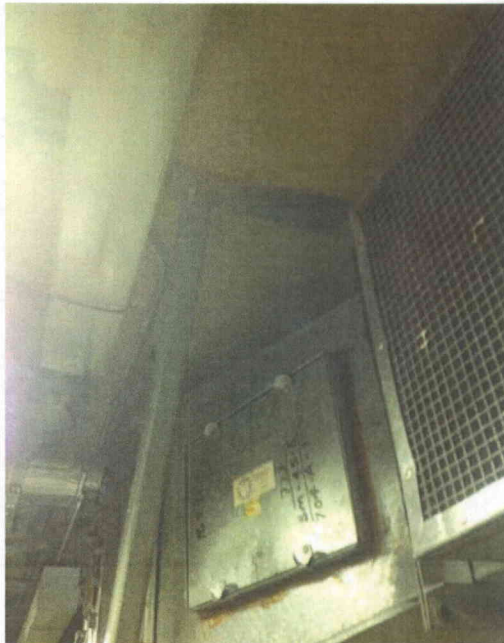
File Name: 2-94-2-2-04.jpeg
Description: View of Anchorage to Ceiling

File Name: 2-95-2-2-04.jpeg
Description: View of Anchorage to Ceiling

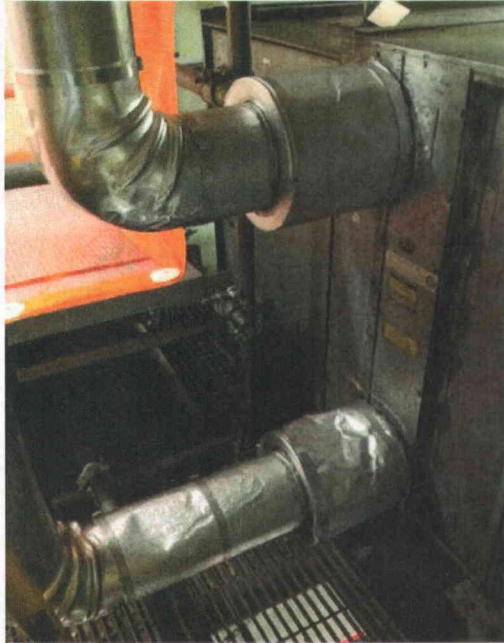
File Name: 2-63-2-2-25.jpeg
Description: View of Attached Piping

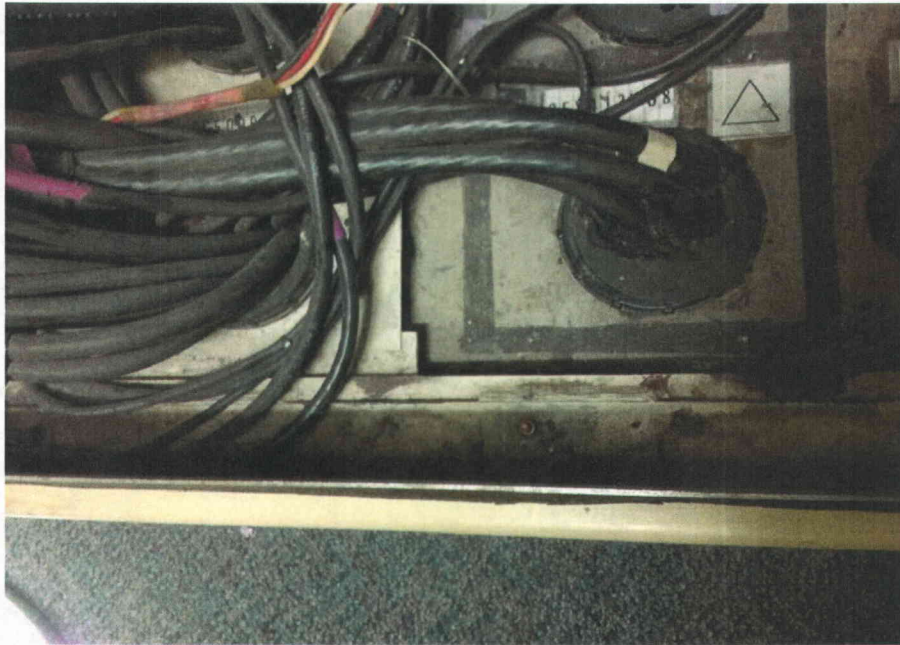
File Name: 2HVR-TI228-1(3).jpg
Description: View of Cabinet Anchorage

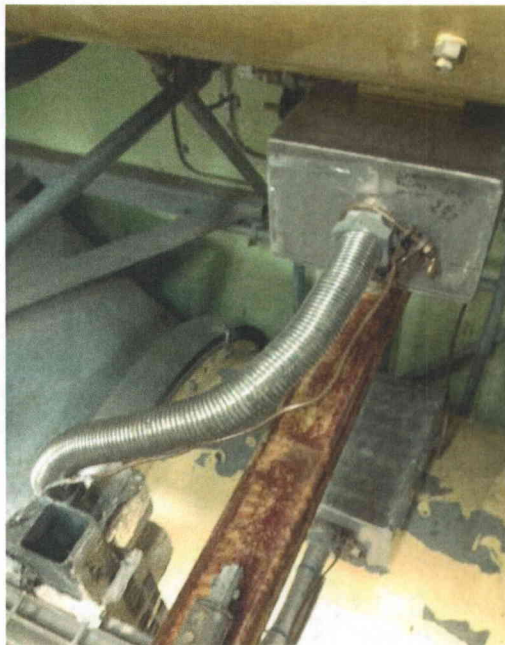
File Name: 2-64-9-2-16.jpeg
Description: View of Attached Lines

Expansion joints on either side of the fan are found in good condition and with adequate flexibility.

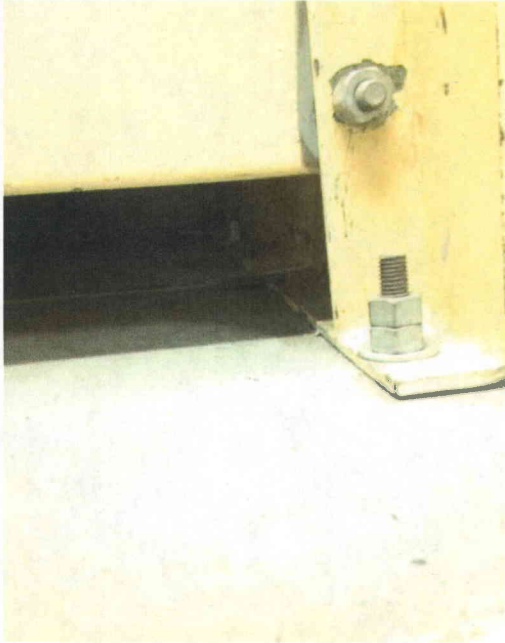
File Name: 2-63-10-2-16.jpeg
Description: View of Fan Support Bolts

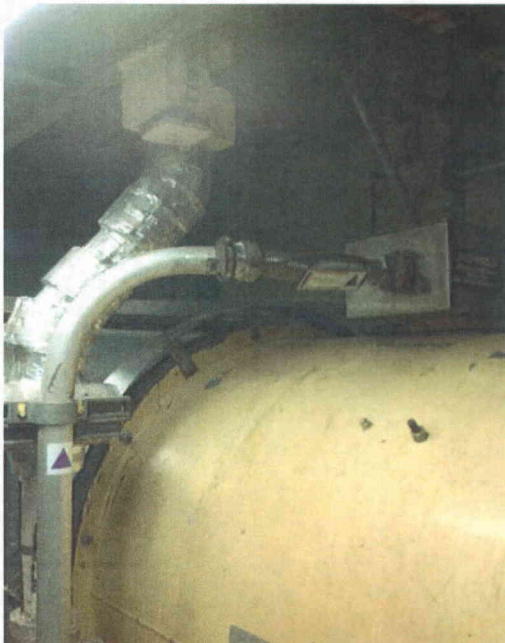
File Name: 2-64-10-2-16.jpeg
Description: View of Attached Lines

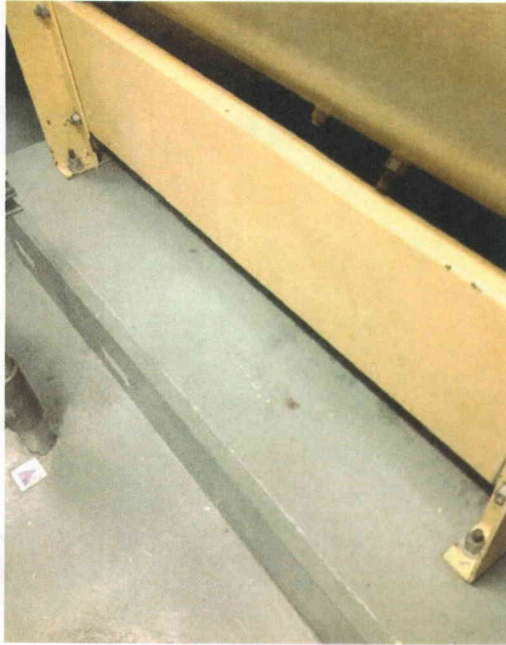
File Name: 2-73-10-2-16.jpeg
Description: View of Fan Anchorage

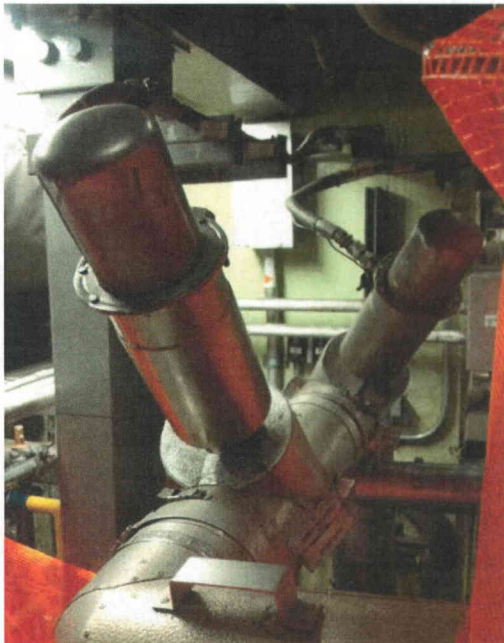
A deficiency tag was observed on component regarding corrosion of attached drain tube. Judged that the deficiency identified will not affect the component's intended design function.

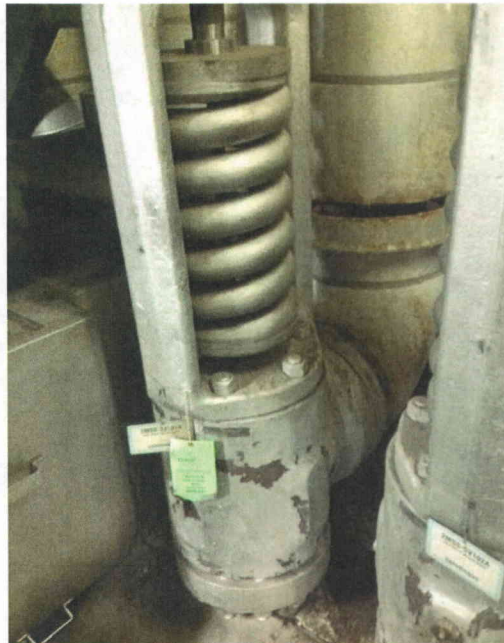
3. Is the anchorage free of corrosion that is more than mild surface oxidation?
Corrosion identified at base where valve connects to pipe. CR-2012-14749 generated to document this condition..

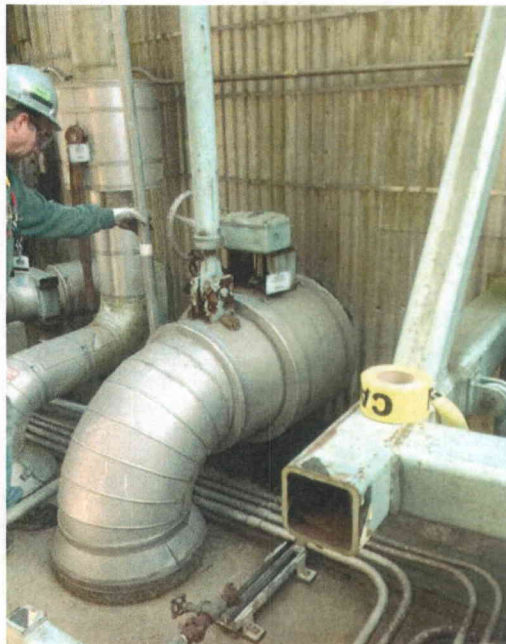
Corrosion is identified in anchor bolts. CR-2012-14744 generated to document this condition.
