Seismic Walkdown Checklist (SWC)

Equipment ID No. 2SIS-MOV867A Equip. Class 8A. Motor Operated Valve

Equipment Description HHSI Isol to Cold Leg Injection

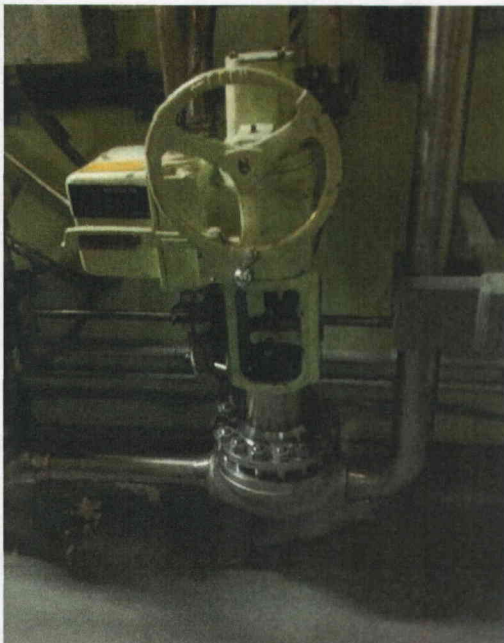
Valve found in very good condition.

File Name: 2-62-1-2-01.jpeg
Description: General View of Component

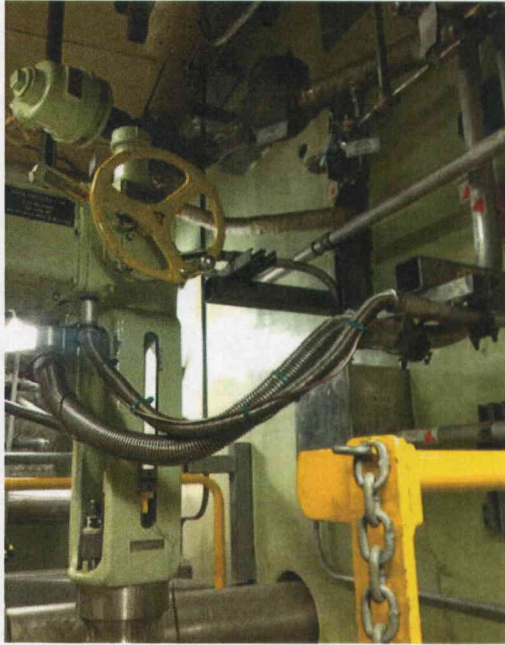
File Name: 2-63-8-2-23.jpeg
Description: View of Attached Lines

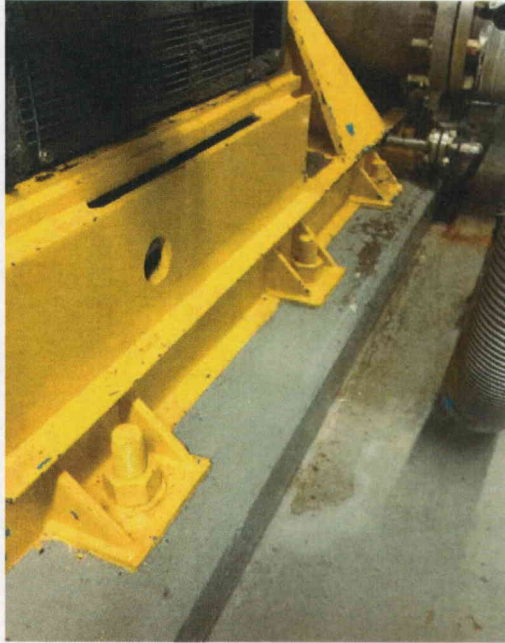
File Name: 2-63-5-2-23.jpeg
Description: Close Up View of Anchorage

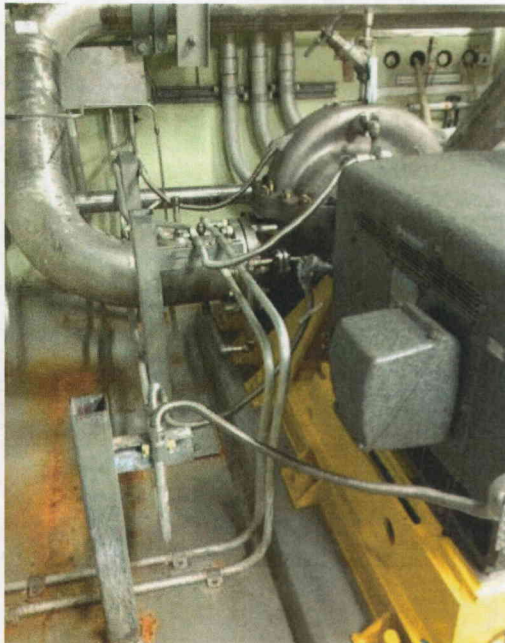
File Name: 2-64-5-2-23.jpeg
Description: View of Attached Lines

9. Do attached lines have adequate flexibility to avoid damage?
Attached lines found with adequate flexibility.

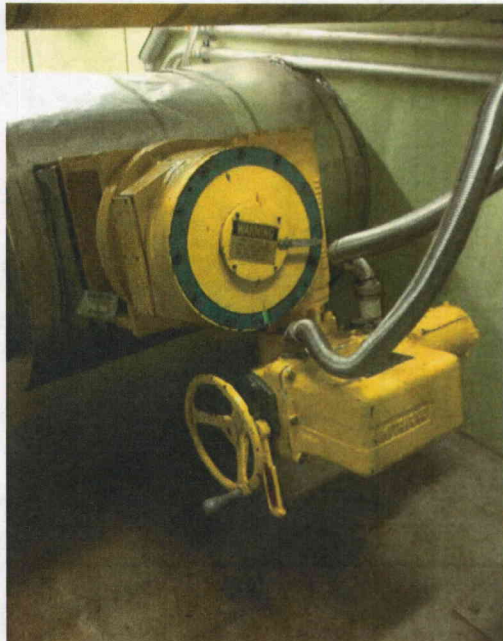
File Name: 2SWS-MOV106A(2).jpg
Description: General View of Component

Both packing nuts observed to have moderate corrosion. CR-2012-14409 written to document this condition.

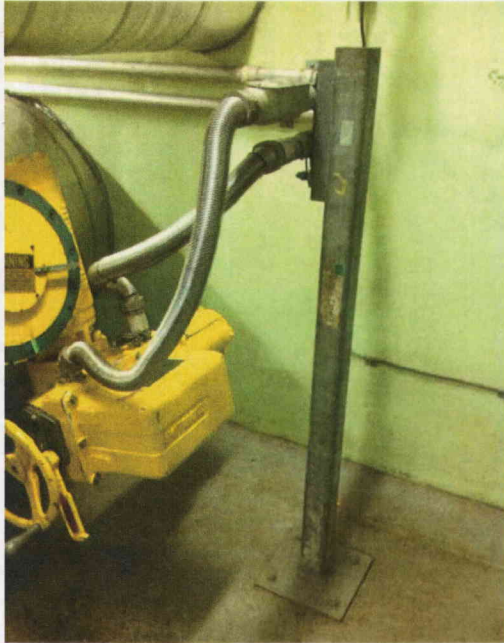
File Name: 2SWS-MOV106A(3).jpg
Description: View of Attached Lines

9. Do attached lines have adequate flexibility to avoid damage?
Attached lines have adequate flexibility.

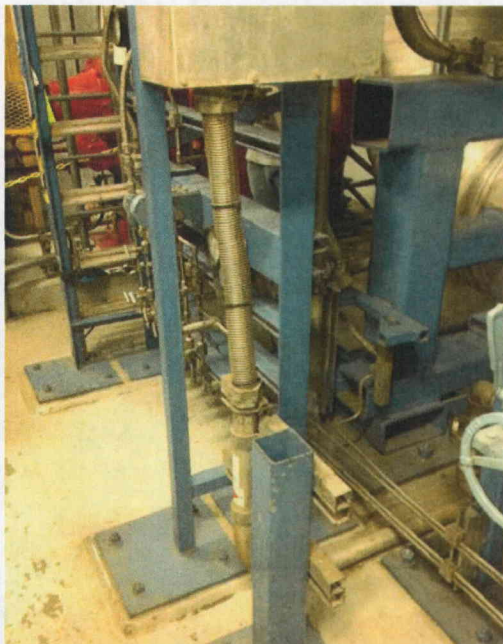
File Name: 2SWS-PT-117A(6).jpg
Description: General View of Rack

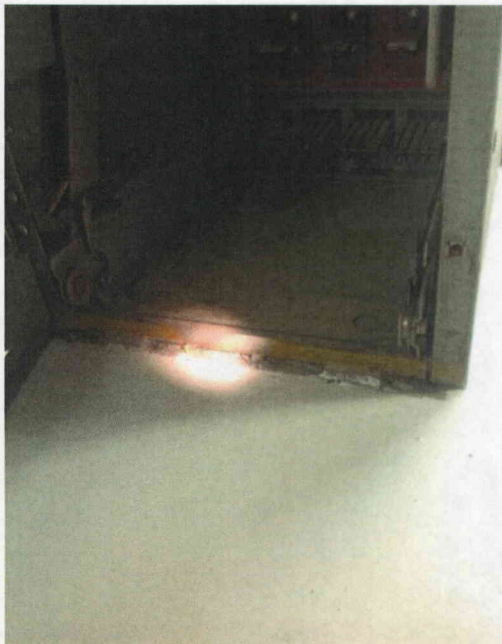
File Name: 2-61-9-2-26.jpeg
Description: View of Anchor Welds

Presence of embedded sill channels indicates that the unit is welded to the embed and therefore no missing or broken anchorage is expected.

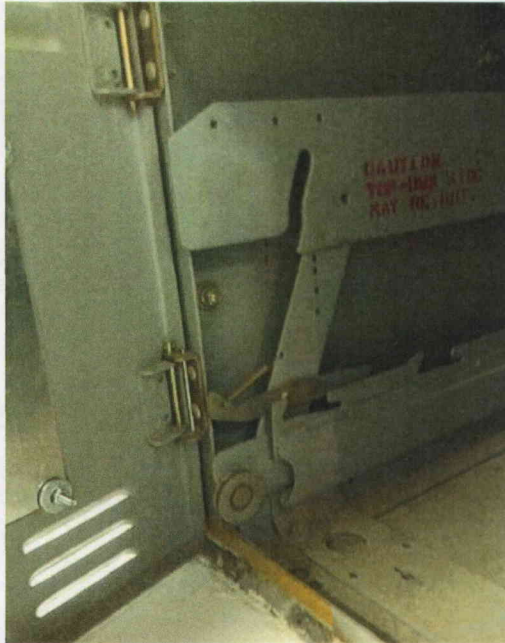
File Name: 2-62-9-2-26.jpeg
Description: Adjacent Cabinets Bolted Together

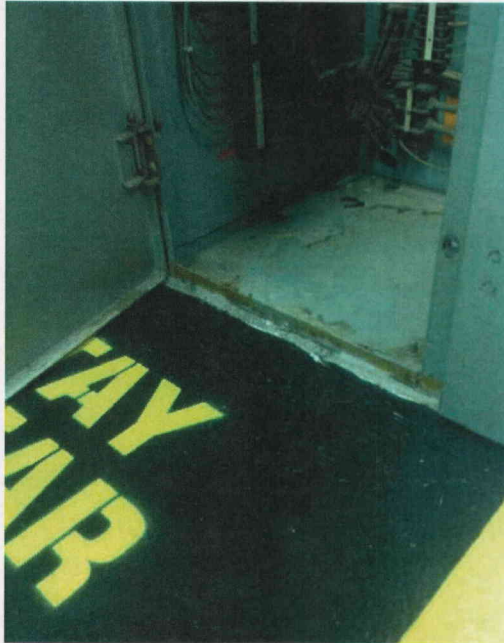
File Name: 2-95-9-2-26.jpeg
Description: View of Welds at Component Base

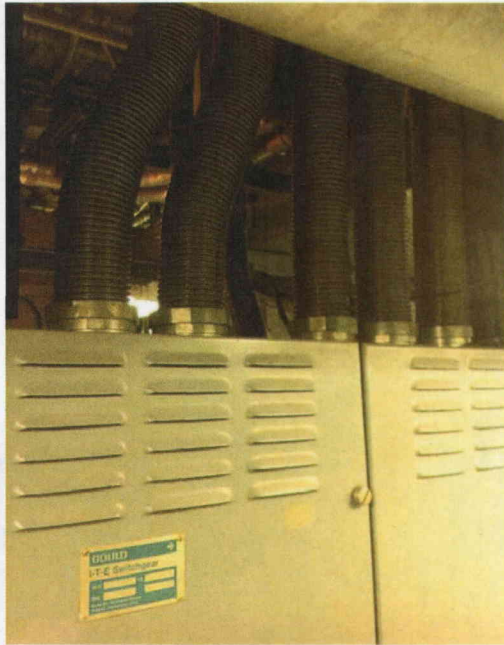
File Name: 480VUS-2-9(3).jpg
Description: View of Flexible Top Conduit

9. Do attached lines have adequate flexibility to avoid damage?
Attached top conduit is adequately flexible.

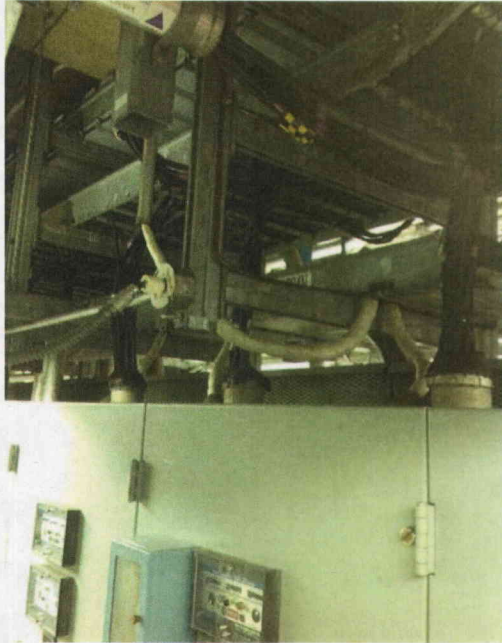
File Name: 4KVS-2-DF(3).jpg
Description: View of Flexible Top Conduit

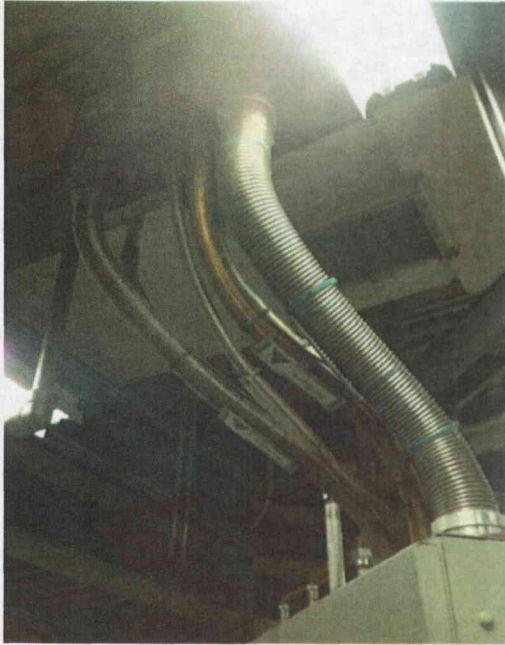
File Name: 2-63-2-2-15.jpeg
Description: View of Flexible Top Lines

9. Do attached lines have adequate flexibility to avoid damage?
Attached lines have adequate flexibility.

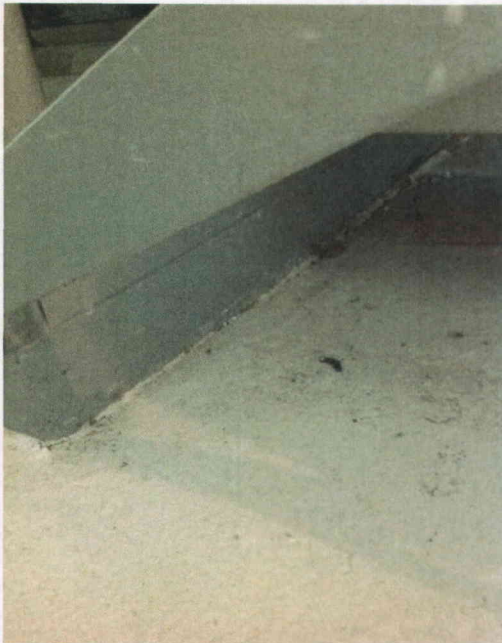
File Name: BAT-2-1(2).jpg
Description: View of Anchor Welds

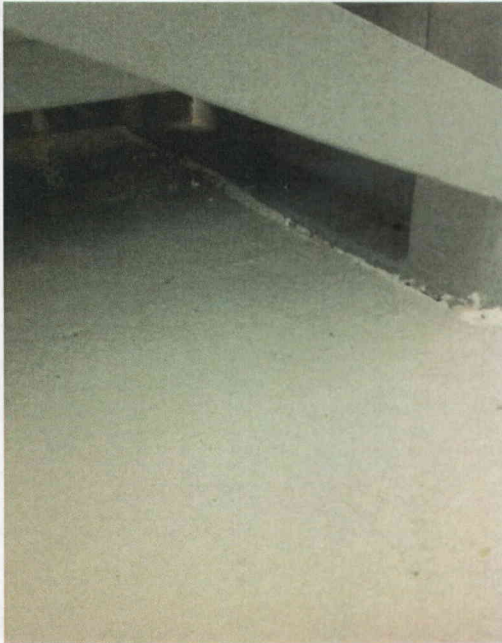
File Name: BAT-2-1(3).jpg
Description: View of Anchor Welds

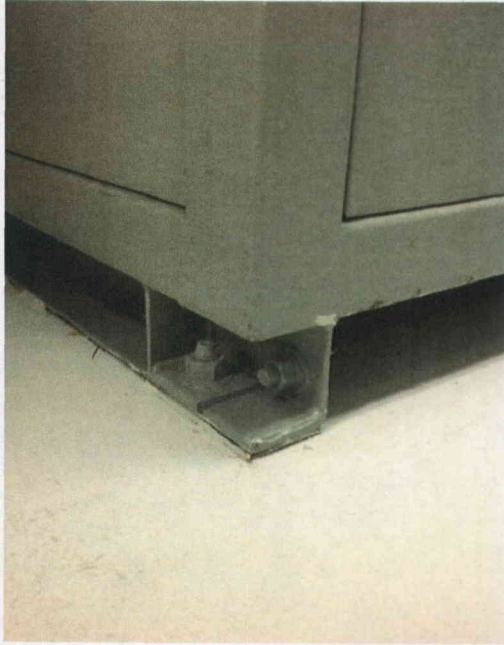
File Name: BAT-CHG2-1(1).jpg
Description: View of Anchor Bolts in Rear of Component

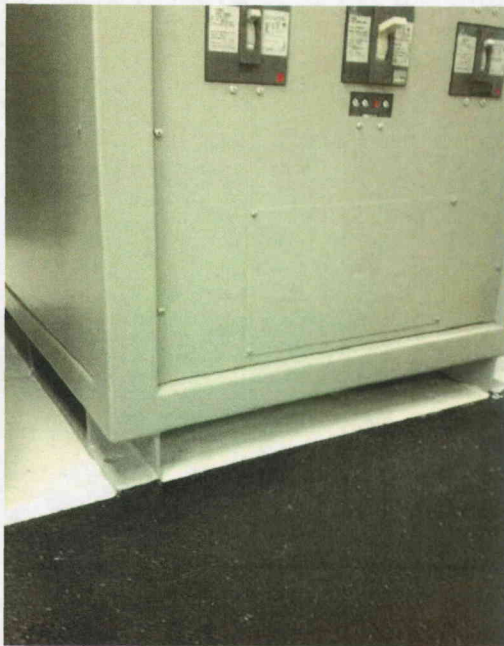
File Name: BAT-CHG2-1(4).jpg
Description: View of Welded Channel at Front of Component

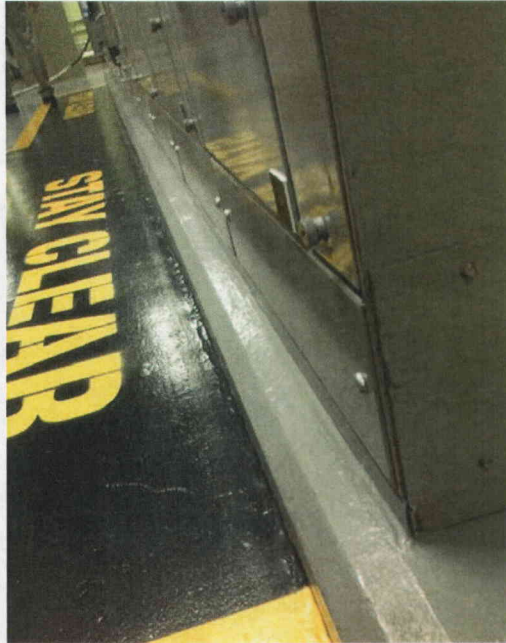
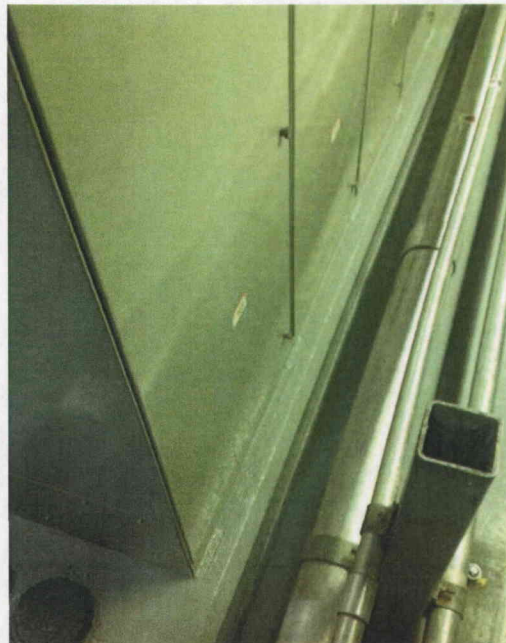
File Name: 2-63-1-2-13.jpeg
Description: View of Front Anchorage

File Name: 2-64-1-2-13.jpeg
Description: View of Back Anchorage

Calculation 12241-NM(B)-468-CZC confirms anchorage configuration as total of eight 3" long fillet welds at both front and back of the MCC. The welds are specified to be placed at each corner of MCC sections. The required weld length per the referenced calculation is 48" vs. ~84" observed during walkdown. The configuration is adequate.

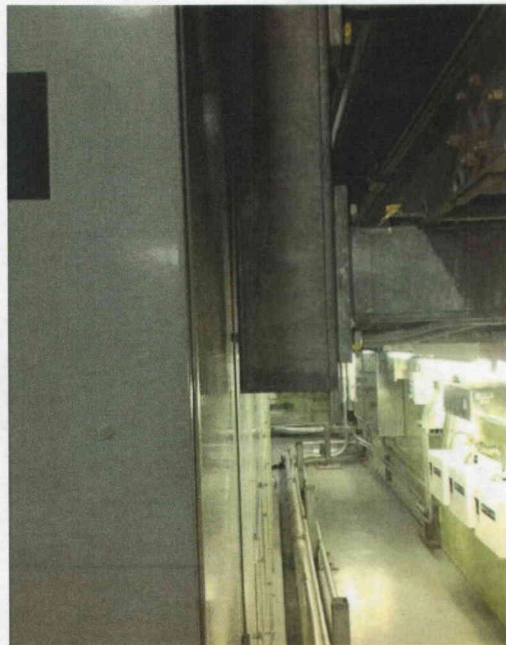
File Name: 2-94-1-2-13.jpeg
Description: Space Between MCC and Cable Tray Support

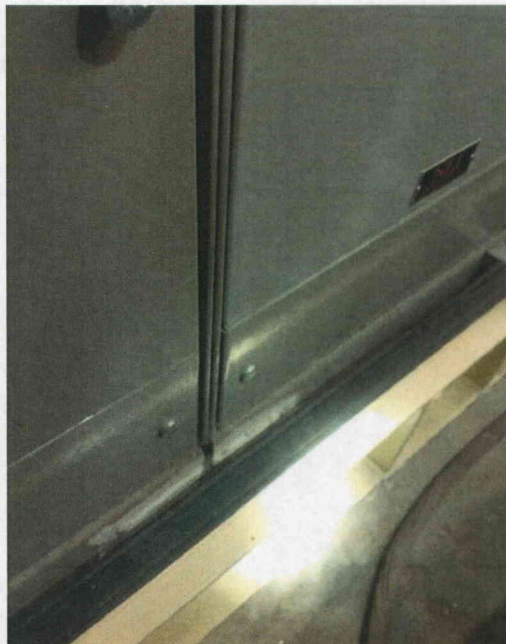
File Name: 2-73-1-2-06.jpeg
Description: View of Welds at Component Base

- Calculation 12241-NM(B)-468-CZC confirms anchorage configuration as 24- 3" long fillet welds at corners of MCC sections for a total of 36" of weld at front and 36" of weld at the back of the MCC. The required welds at each side of the MCC is 36" vs. the 49.5" observed during walkdown. The configuration is adequate.*
-

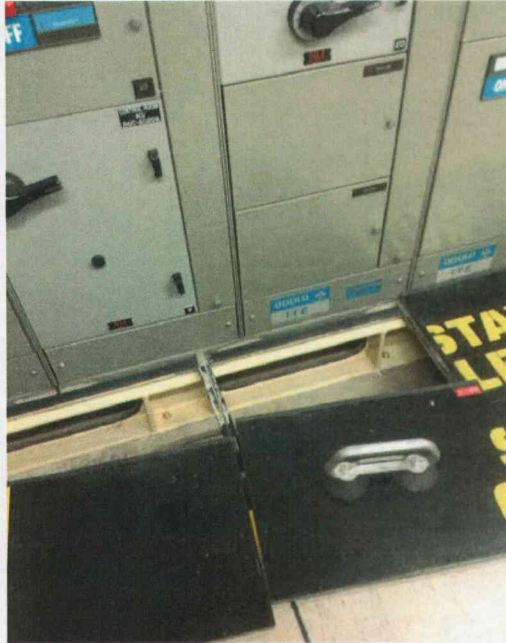
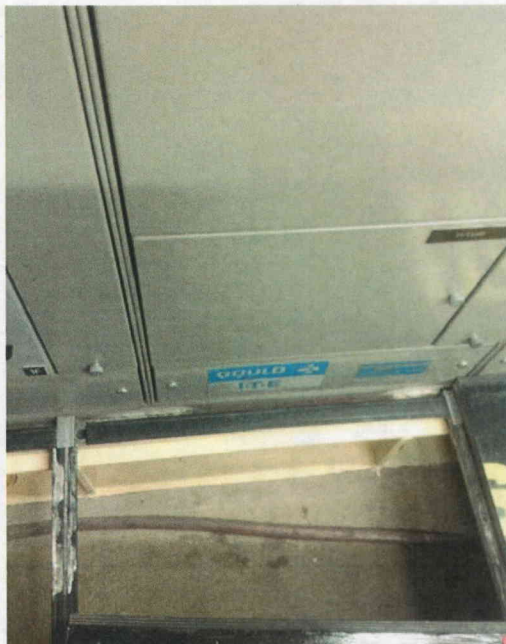
File Name: 2-94-1-2-06.jpeg
Description: View of Welds at Component Base

File Name: 2-95-1-2-06.jpeg
Description: View of Welds at Component Base

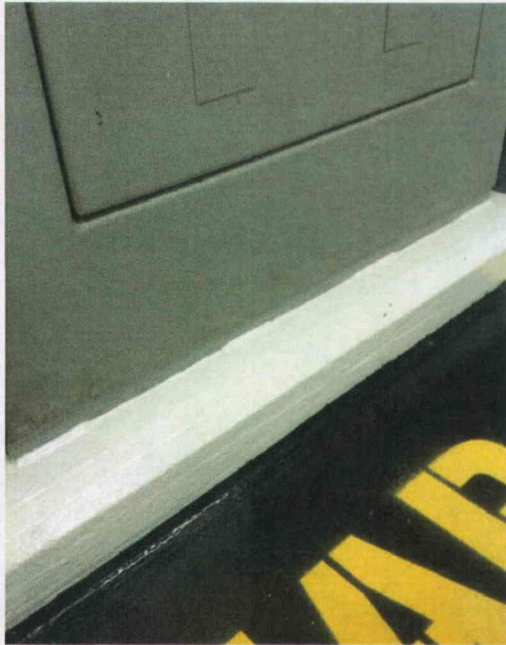
File Name: 2-63-17-2-26.jpeg
Description: View of Anchor Welds

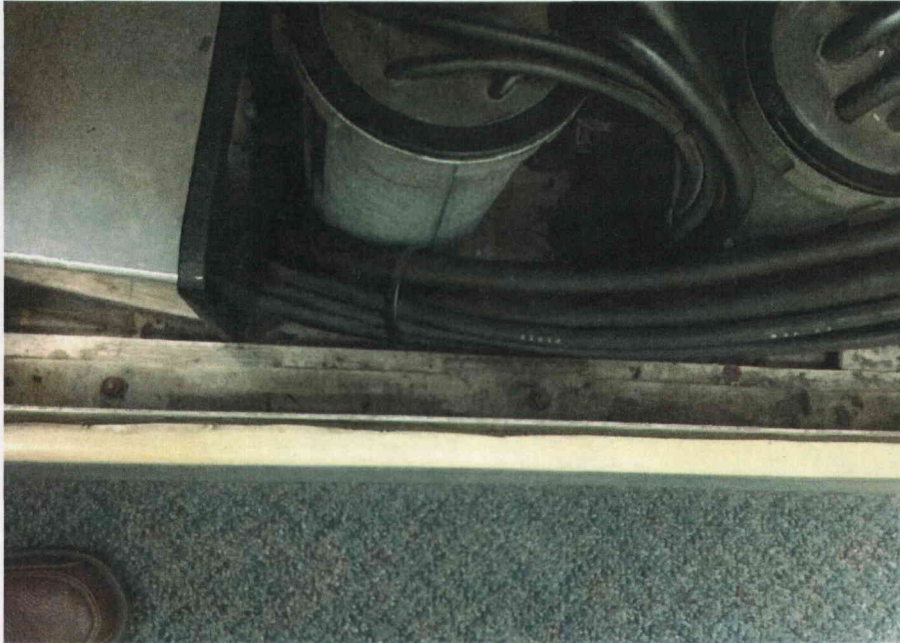
File Name: 2HVR-TI228(1).jpg
Description: View of Cabinet Anchorage

File Name: 2HVR-TI228-1(3).jpg
Description: View of Cabinet Anchorage

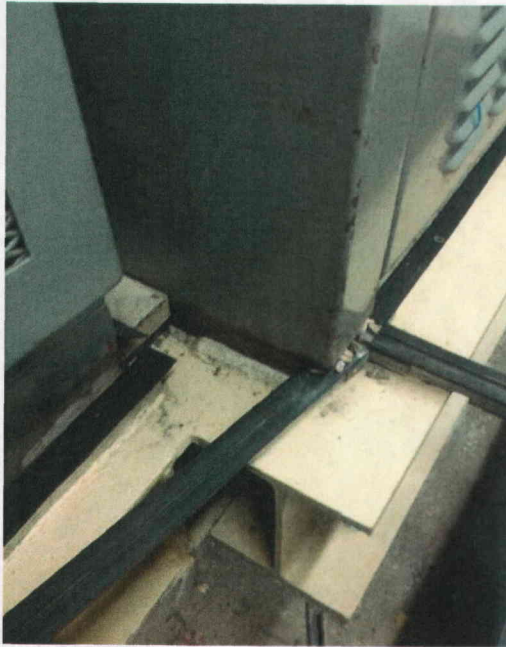
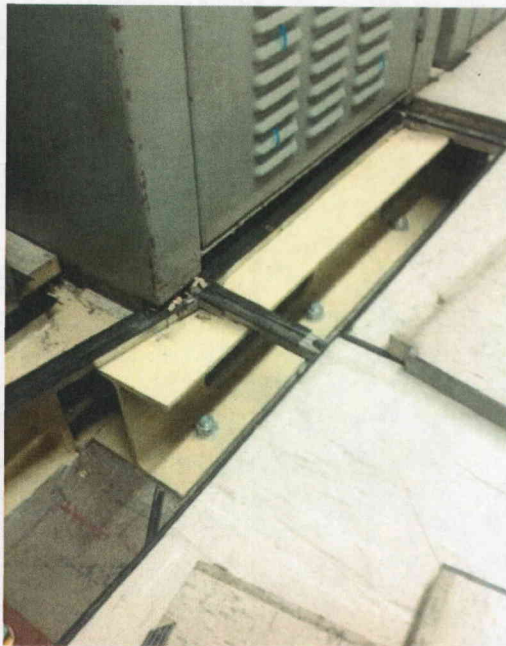
File Name: 2-63-6-2-06.jpeg
Description: View of Anchor Welds

File Name: 2-64-6-2-06.jpeg
Description: View of Anchor Welds

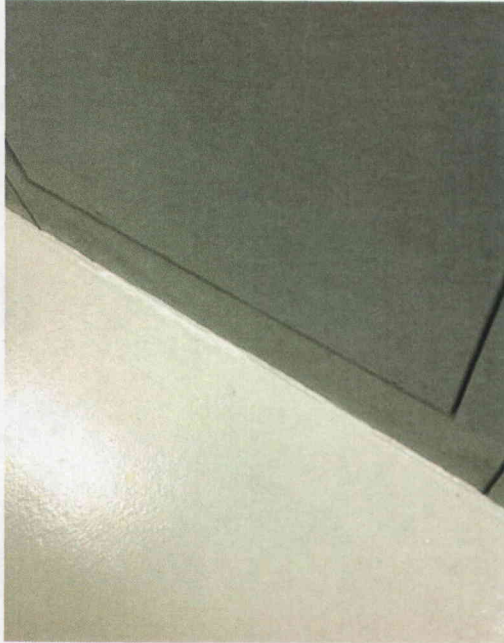
File Name: PNL-SEQ-244(3).jpg
Description: View of Anchor Weld

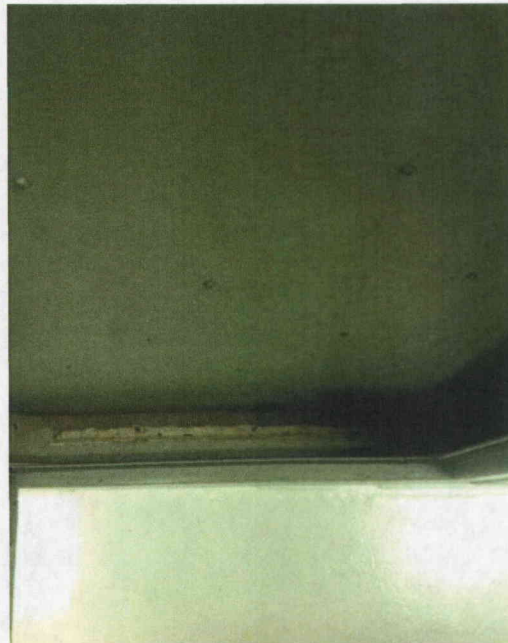
File Name: 2-62-14-2-26.jpeg
Description: View of Internal Welding in Front of Cabinet

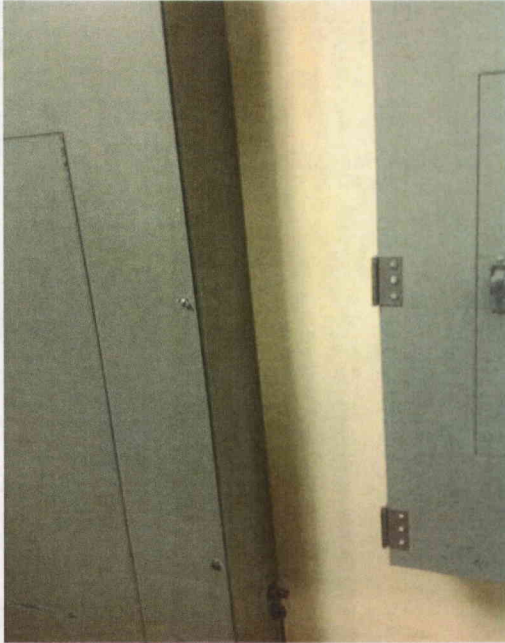
File Name: 2-63-2-2-06.jpeg
Description: Anchorage Inaccessible

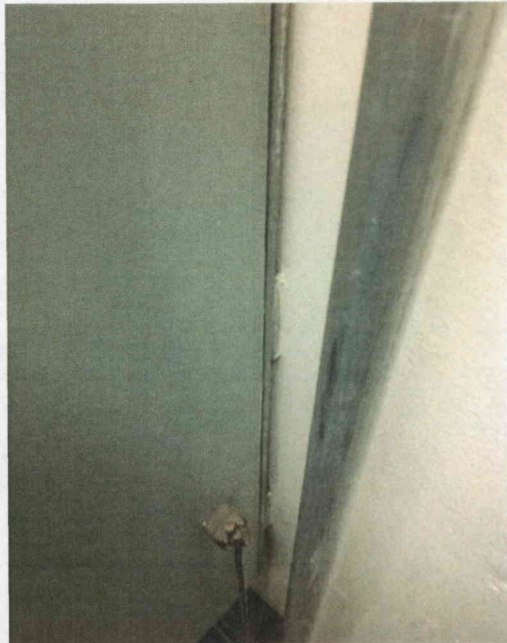
File Name: PNL-VITBS2-2C(4).jpg
Description: View of Anchorage to Wall

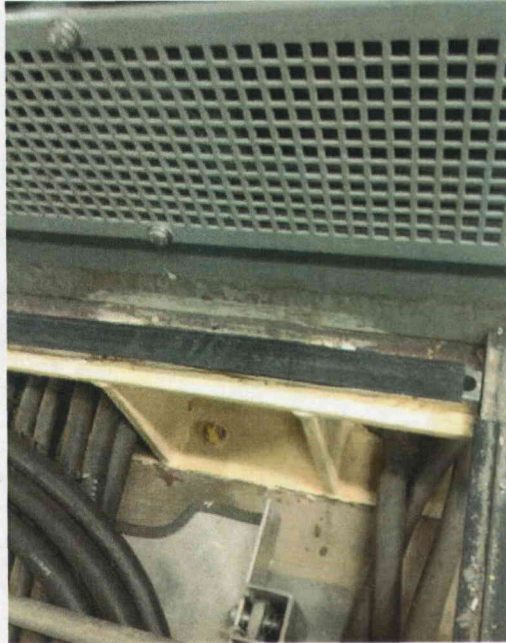
File Name: 2-95-3-2-06.jpeg
Description: View of Anchor Weld and Wide Flange Anchor Bolt

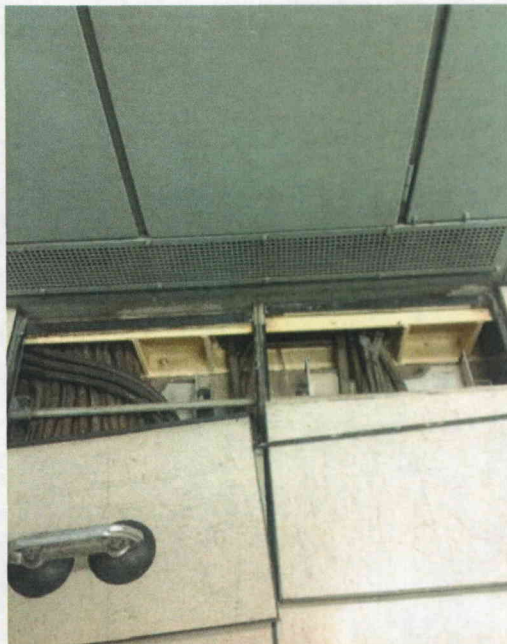
File Name: 2-96-3-2-06.jpeg
Description: View of Anchor Welds

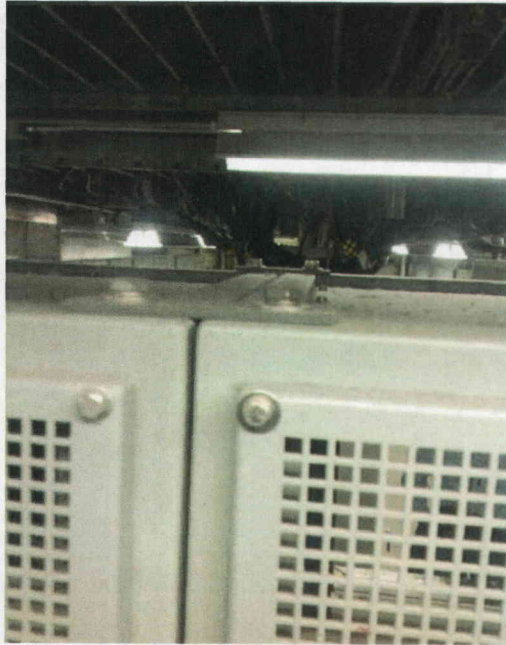
File Name: 2-95-4-2-06.jpeg
Description: Adjacent Cabinets are Bolted Together

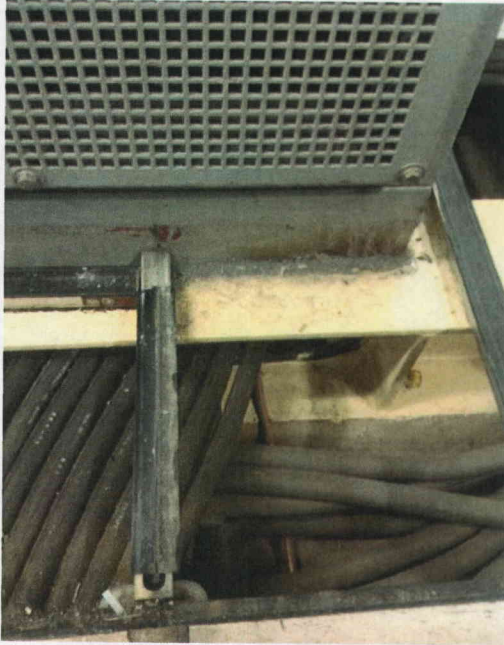
File Name: 2-97-4-2-06.jpeg
Description: View of Base Weld

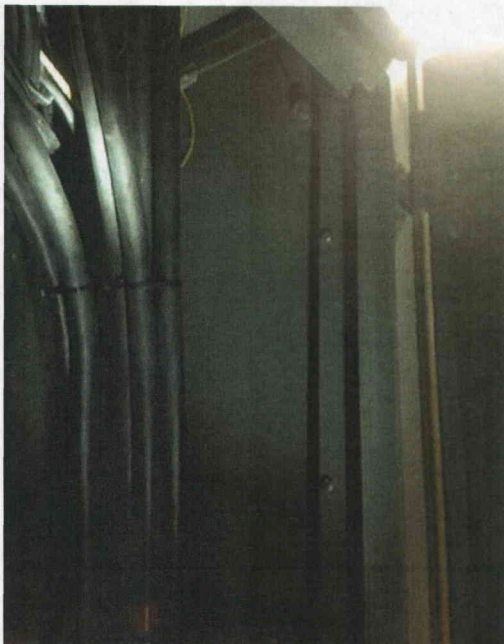
File Name: 2-62-5-2-06.jpeg
Description: Adjacent Cabinets are Bolted Together

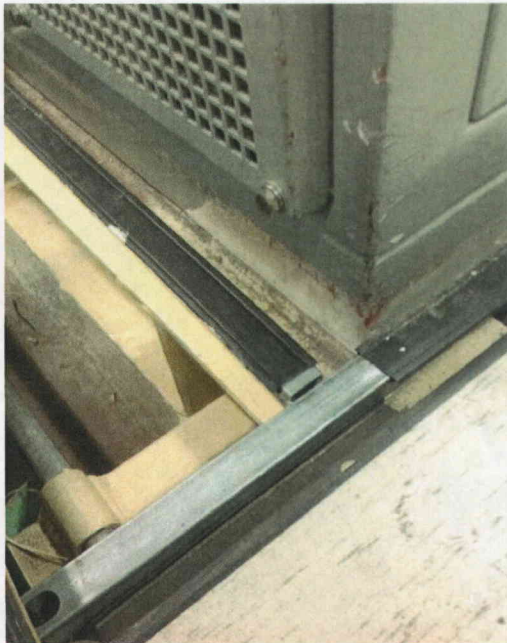
File Name: 2-95-5-2-06.jpeg
Description: View of Base Weld

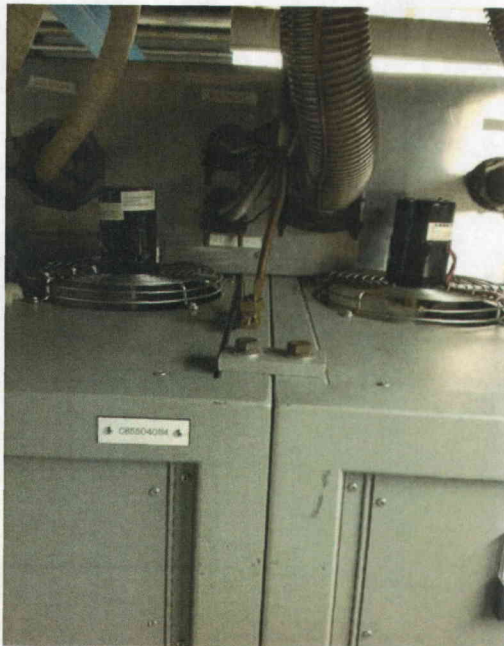
File Name: UPS-VITBS2-1-REG(1).jpg
Description: View of Top Bolting of Cabinets

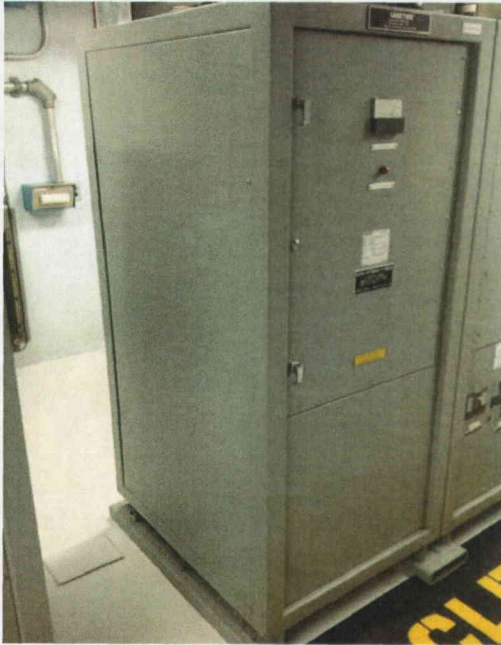
File Name: UPS-VITBS2-1-REG(3).jpg
Description: General View of Component
