APPENDIX C: AREA WALK-BY CHECKLISTS (AWCs)

Area Walk-By Checklist (AWC)

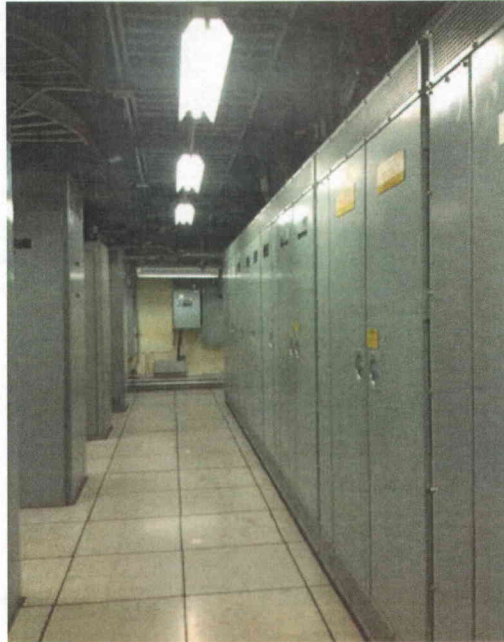
File Name: 1-65-4-3-06.jpeg
Description: View of cart with locked wheels located near cabinets

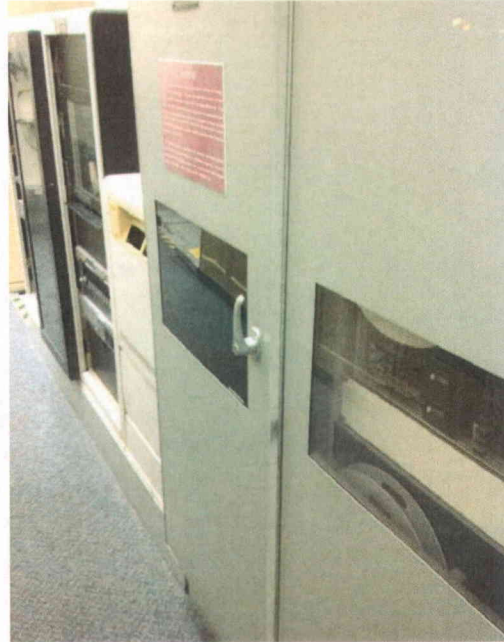
File Name: Control_Rm(1).jpg
Description: View of panel PNL-2FAL-REC was not positively latched.

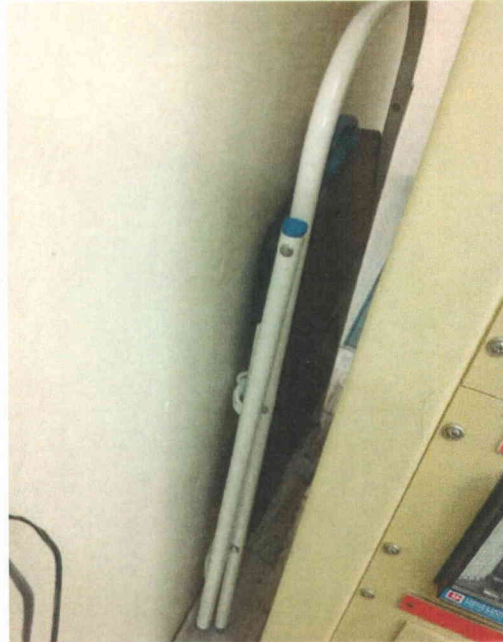
File Name: Control_Rm(3).jpg
Description: Step ladder located next to cabinet

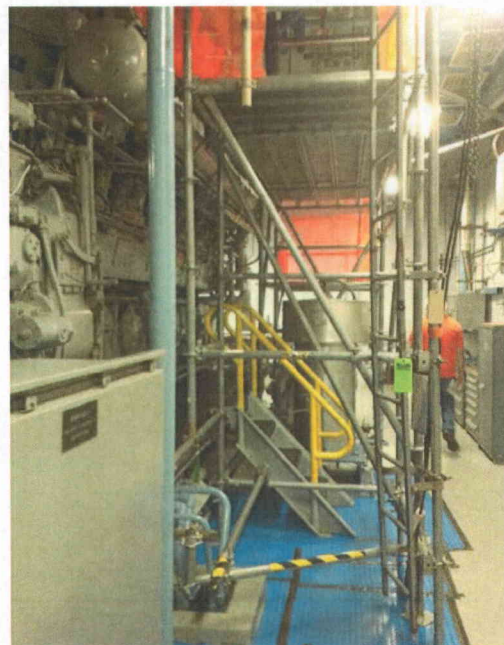
File Name: EDG2-1(6).jpg
Description: View of scaffold located next to Diesel Generator

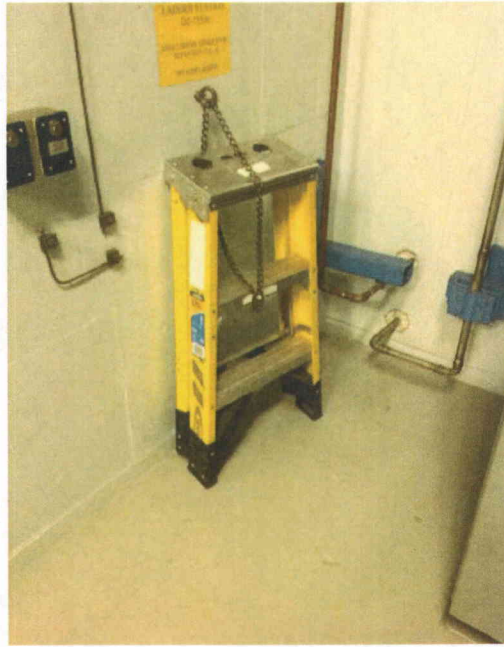
File Name: EDG2-1(7).jpg
Description: View of restrained ladder in the area

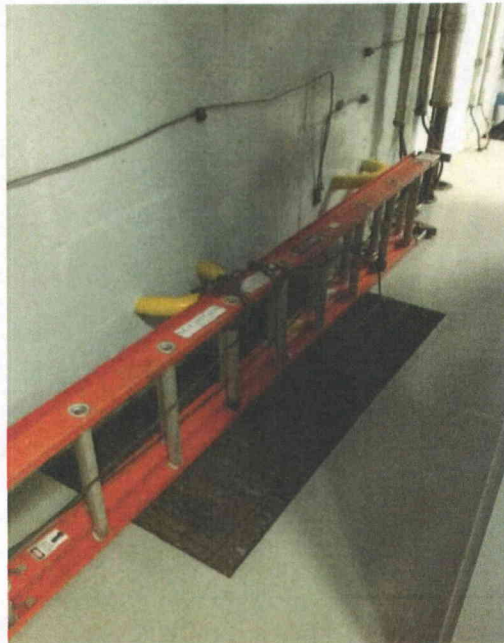
File Name: EDG2-1(8).jpg
Description: View of restrained ladder in the area

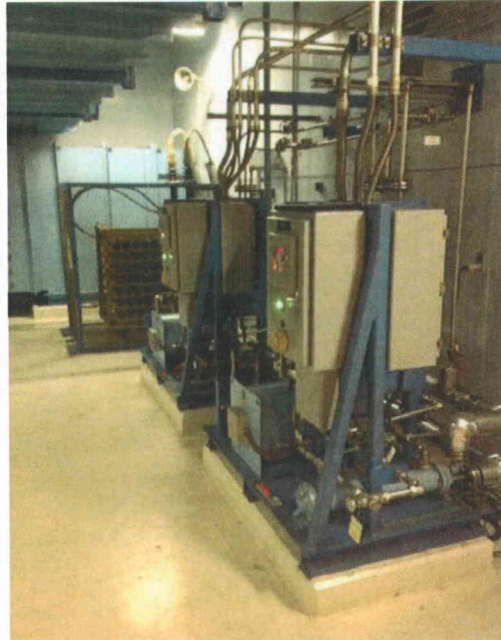
File Name: EDG2-1_Up(1).jpg
Description: View of electrical equipment properly braced in the area

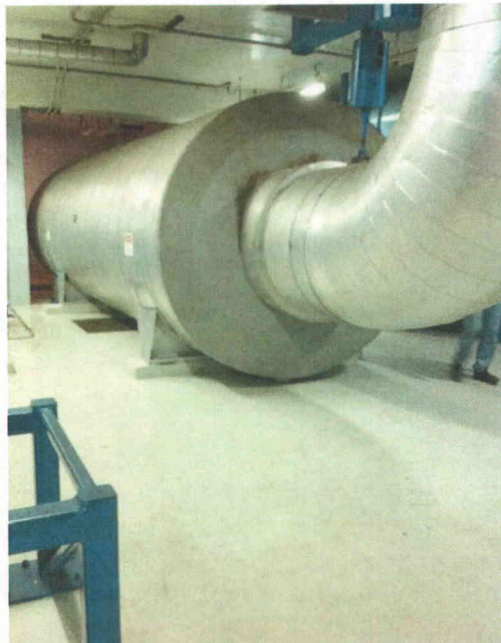
File Name: EDG2-1_Up(2).jpg
Description: General view of DG exhaust muffler

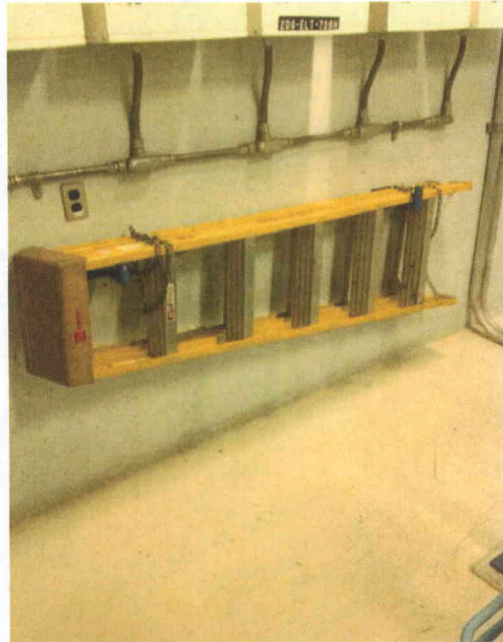
File Name: EDG2-1_Up(5).jpg
Description: Properly restrained ladder identified in the area

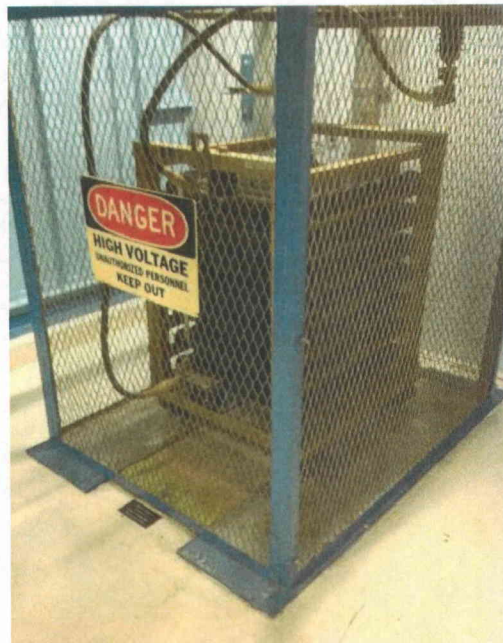
File Name: EDG2-1_Up(6).jpg
Description: View of DG ground resistor

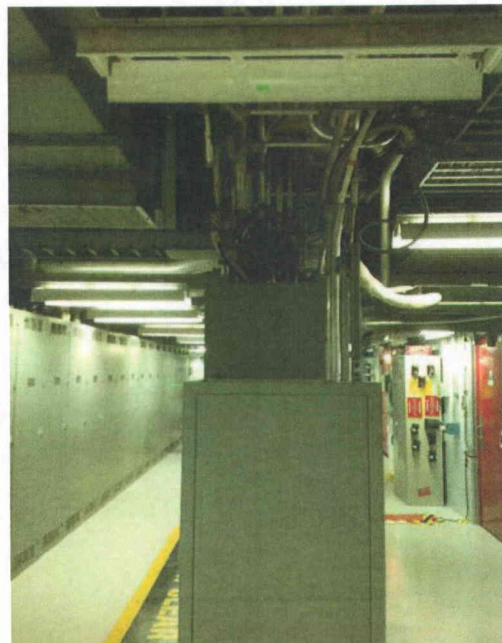
File Name: SWGR AE(2).jpg
Description: General view of lighting fixtures and top cabinet conduits

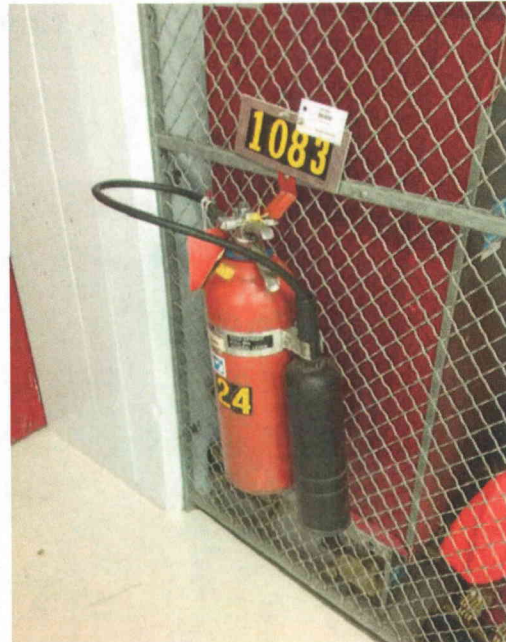
File Name: SWGR AE(3).jpg
Description: Fire extinguisher located in the area

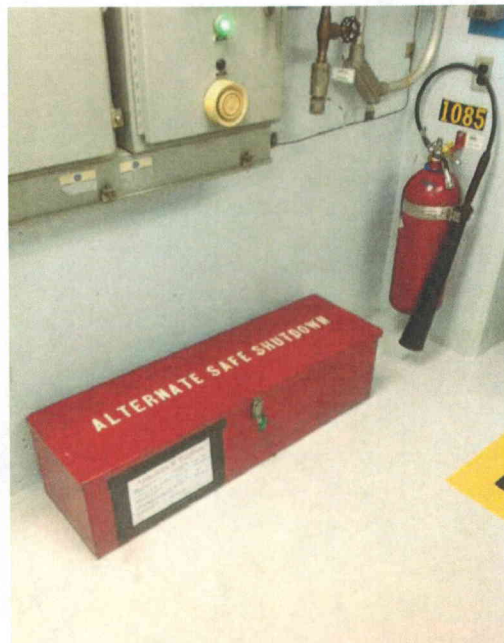
File Name: SWGR AE(4).jpg
Description: Storage box located in the area.

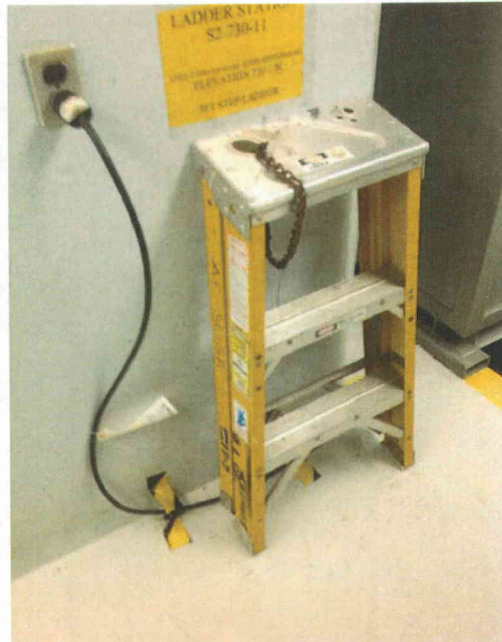
File Name: SWGR AE(5).jpg
Description: Properly restrained ladder identified in the area

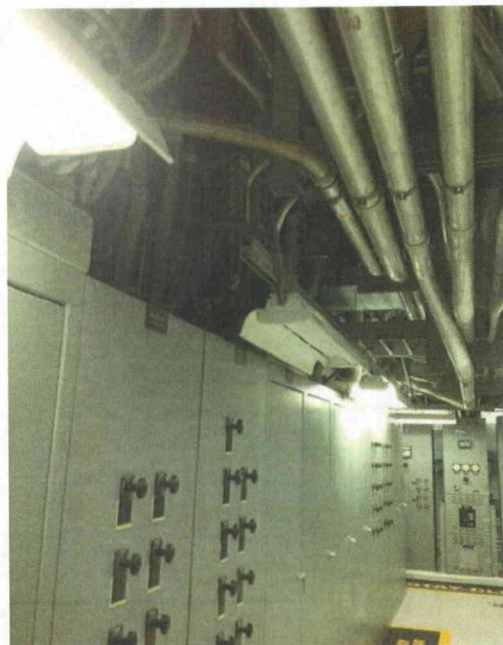
File Name: SWGR AE(6).jpg
Description: View of ceiling conduits and lighting fixtures

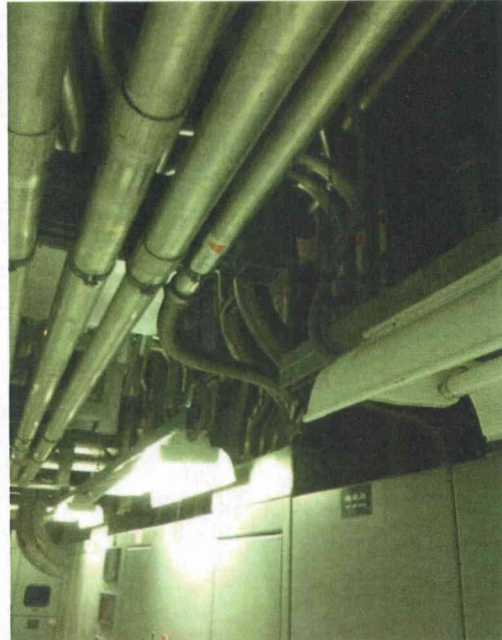
File Name: SWGR AE(7).jpg
Description: Hanging light located close to cabinet.
Interaction addressed in CR-2012-14463

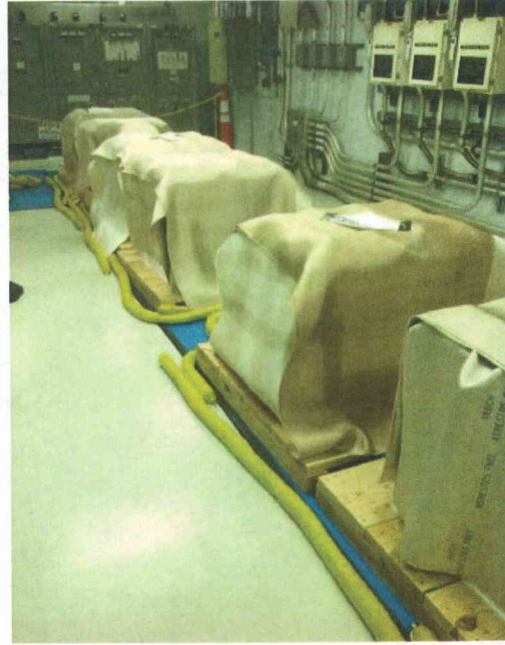
File Name: SWGR_DF(1).jpg
Description: General view of electrical equipment in the area

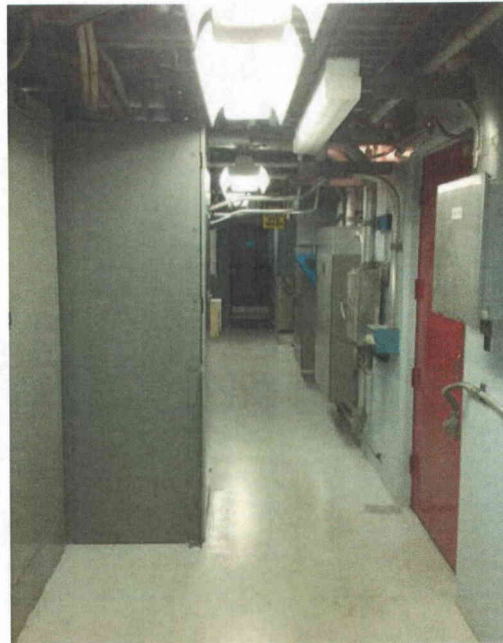
File Name: SWGR_DF(2).jpg
Description: General view of cabinets and lighting fixtures

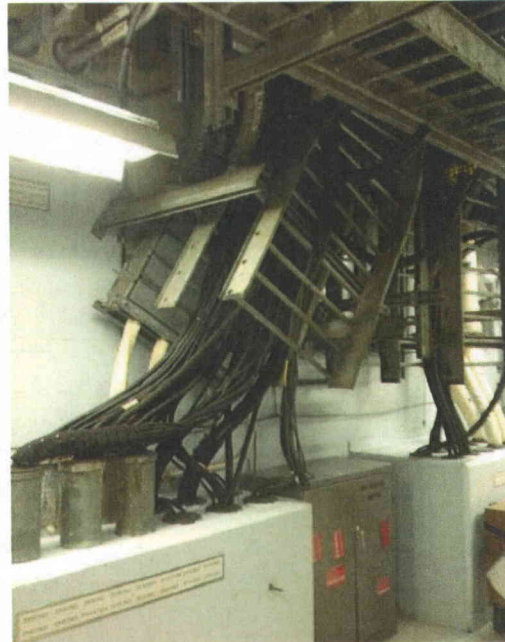
File Name: SWGR_DF(3).jpg
Description: View of cable trays above electrical cabinets

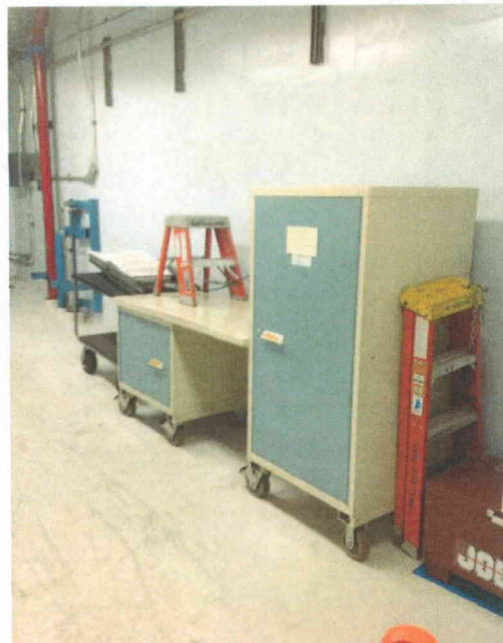
File Name: SWGR_DF(4).jpg
Description: Storage carts and ladders located in the area identified to be properly secured.

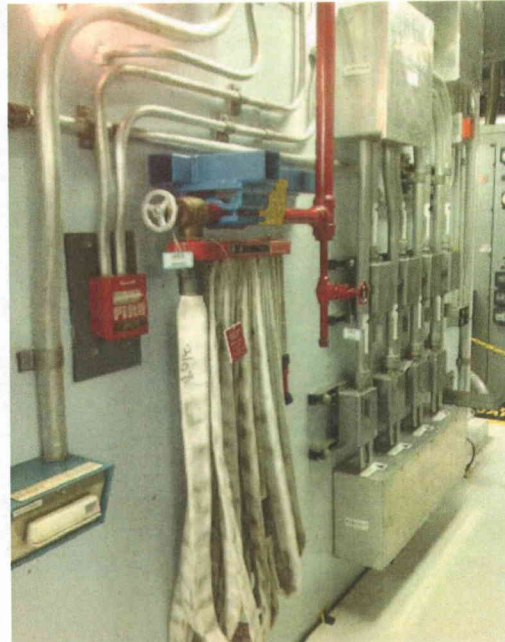
File Name: SWGR_DF(5).jpg
Description: Fire hose located in the area

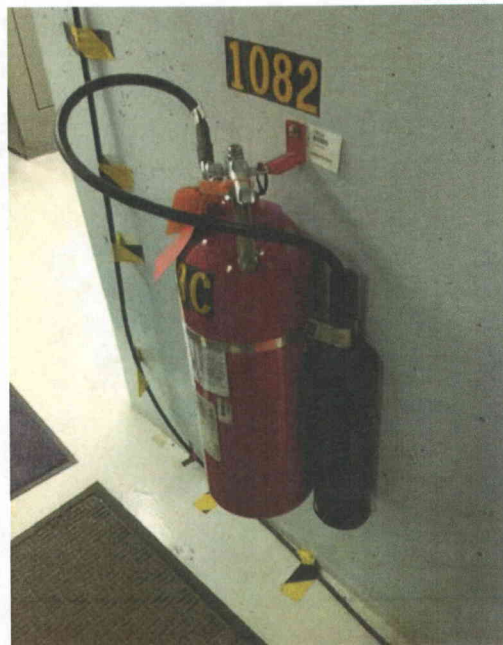
File Name: SWGR_DF(6).jpg
Description: Fire extinguisher located in the area

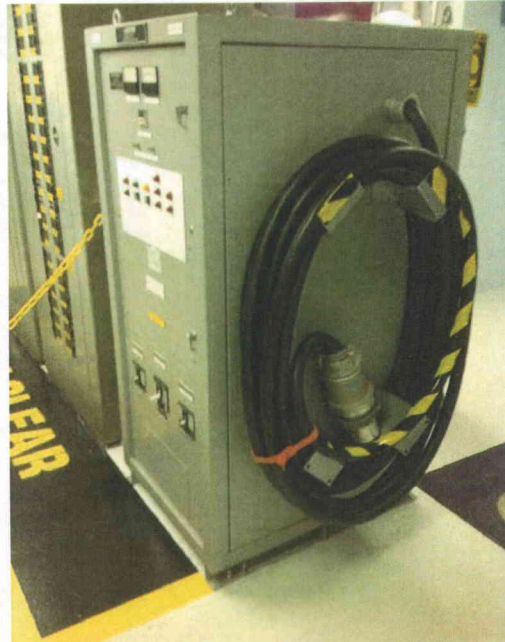
File Name: SWGR_DF(7).jpg
Description: View of 1.5" diameter loops of cable mounted on the side of BAT-CHG2-9

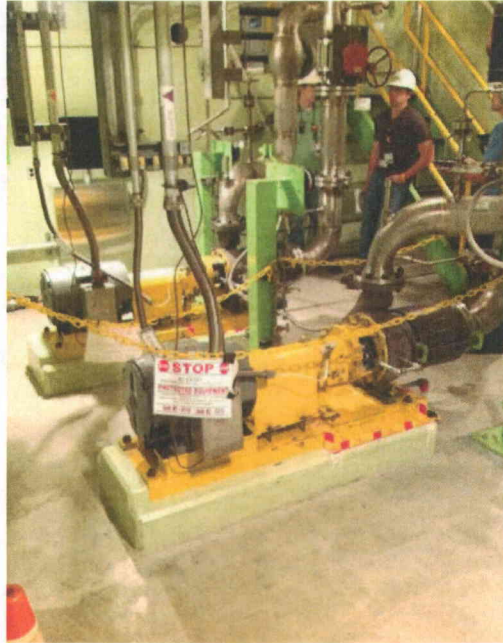
File Name: 1-59-3-3-29.jpeg
Description: Overall view of pumps in the area

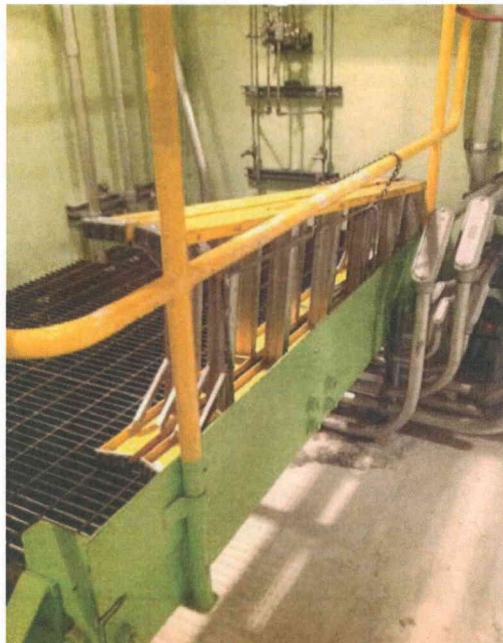
File Name: 1-60-3-3-29.jpeg
Description: Ladder in the area identified to be properly restrained.

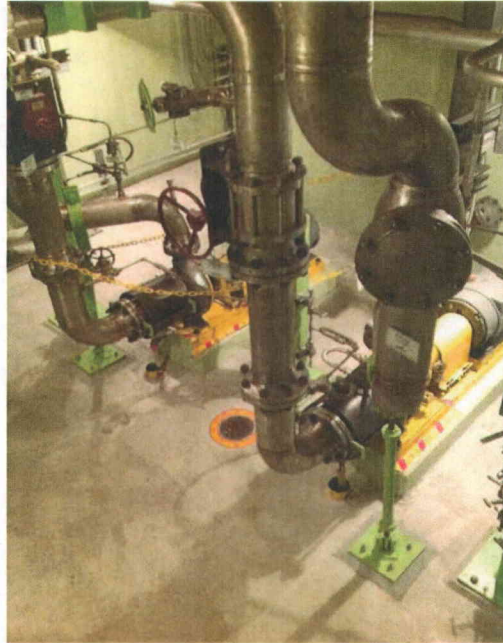
File Name: 1-65-3-3-29.jpeg
Description: View of pipe lines attached to pumps in the area

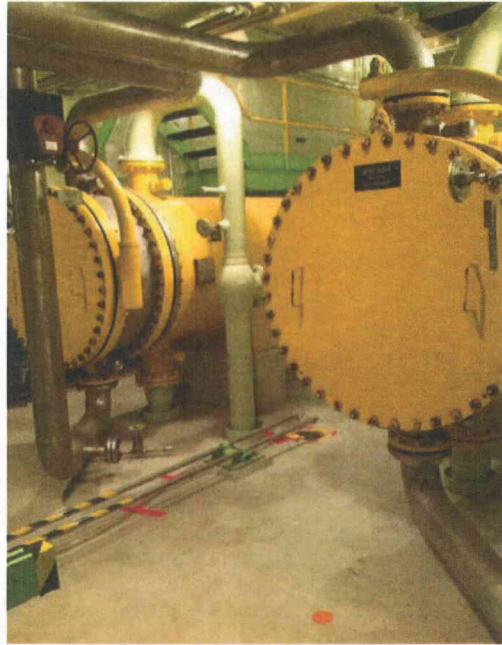
File Name: 1-59-2-3-29.jpeg
Description: General view of Heat Exchangers

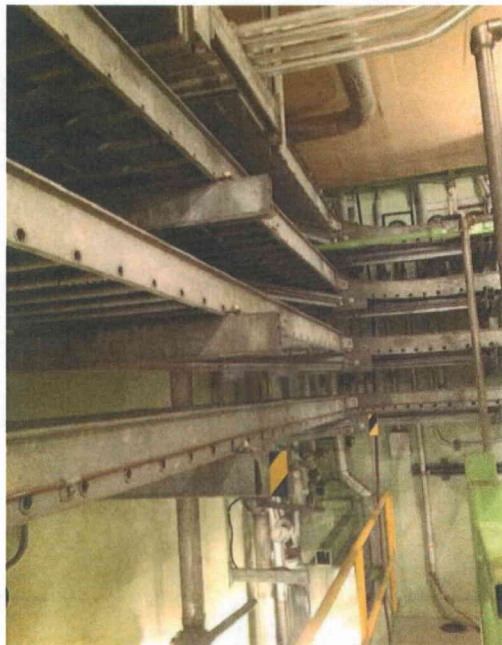
File Name: 1-60-2-3-29.jpeg
Description: View of cable trays in the area

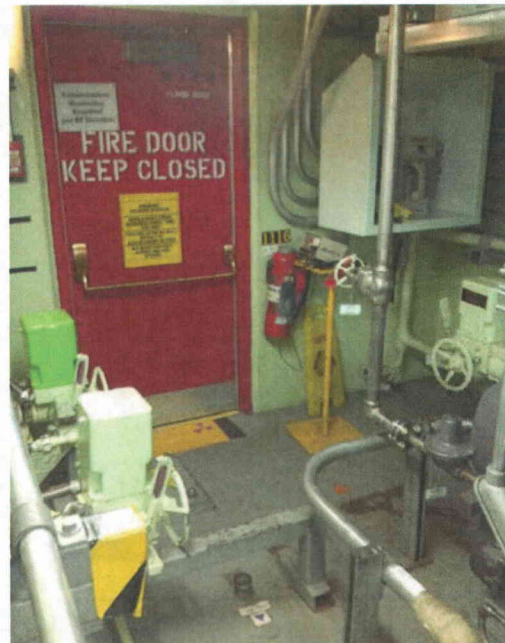
File Name: 1-60-5-3-16.jpeg
Description: Fire extinguisher and floor mounted supports for room pipe lines.

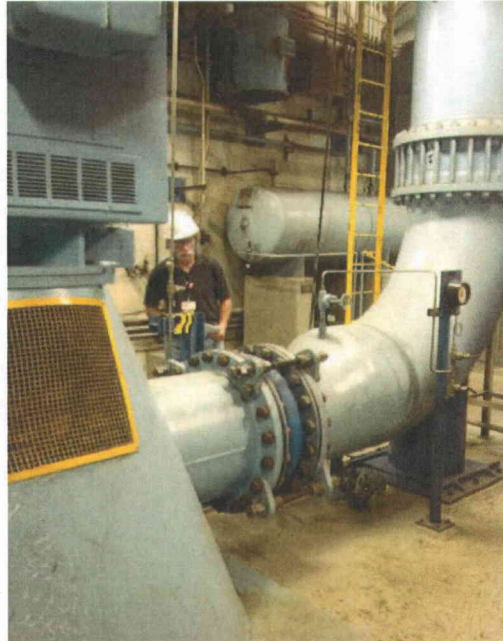
File Name: INTK_CUB_D(1).jpg
Description: View of expansion joint located on pipe attached to vertical Pump 2SWS-P21A.

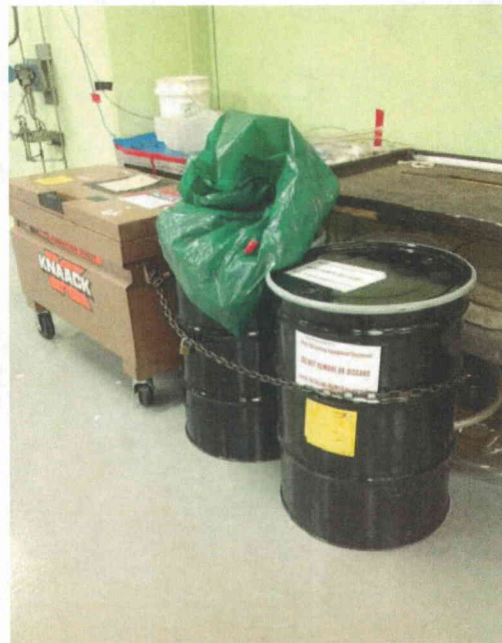
File Name: 1-60-2-3-12.jpeg
Description: View of storage cart and waste drums in the area.
These were identified to be properly secured.

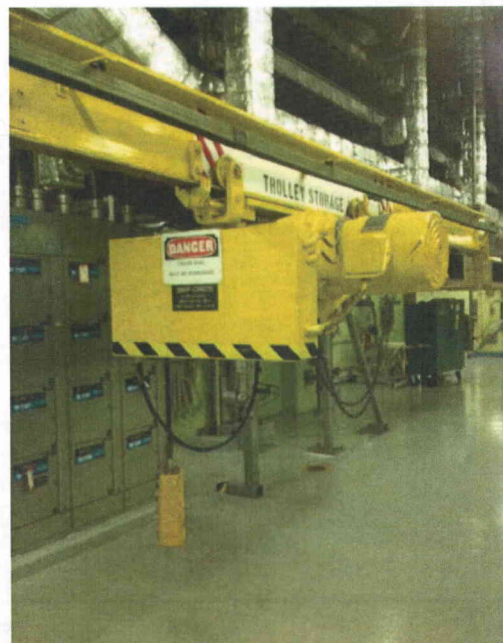
File Name: 1-66-5-3-03.jpeg
Description: Trolley identified in the area to be securely restrained

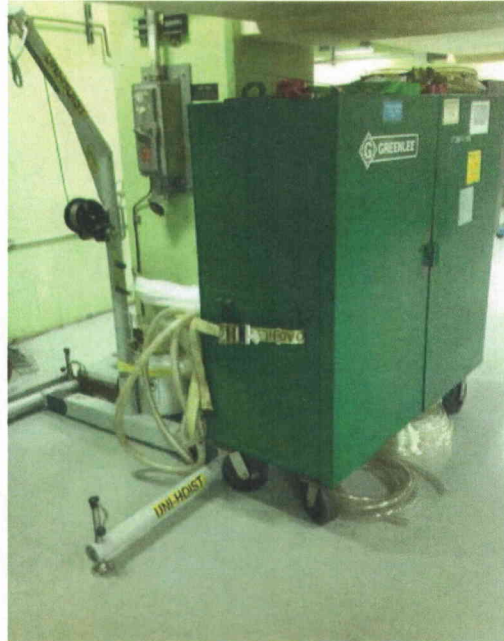
File Name: 1-69-5-3-03.jpeg
Description: Restrained storage cart located in the area

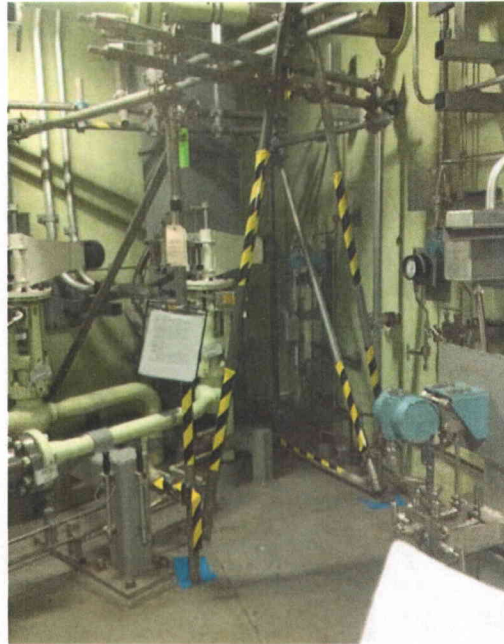
File Name: 1-60-3-3-25.jpeg
Description: Scaffold identified in the area

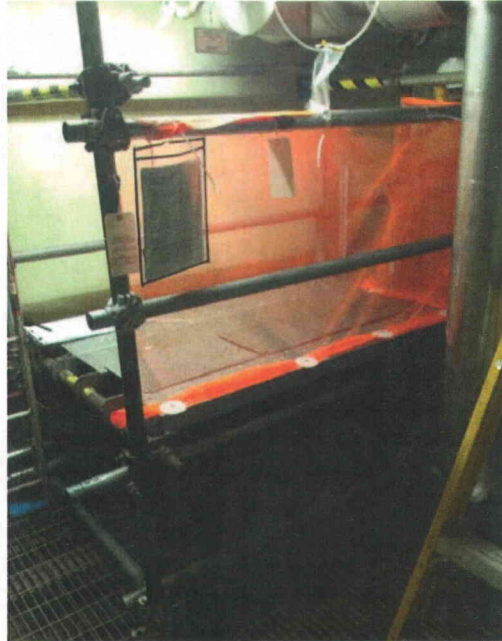
File Name: 1-59-2-3-25.jpeg
Description: Scaffold located in the area

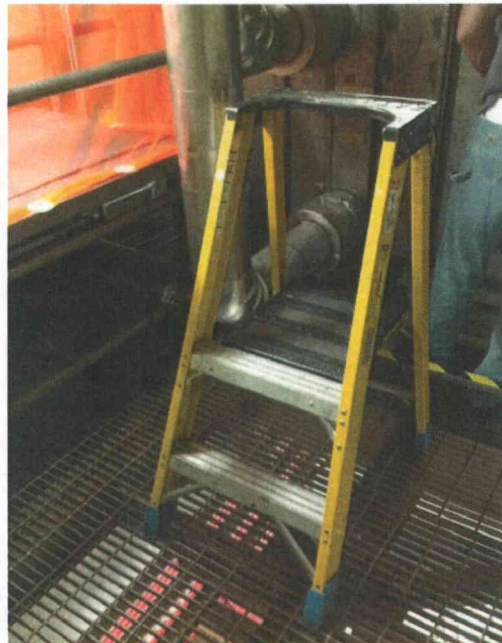
File Name: 1-60-2-3-25.jpeg
Description: Unrestrained ladder identified in the area.
Judged not a seismic concern for nearby equipment.

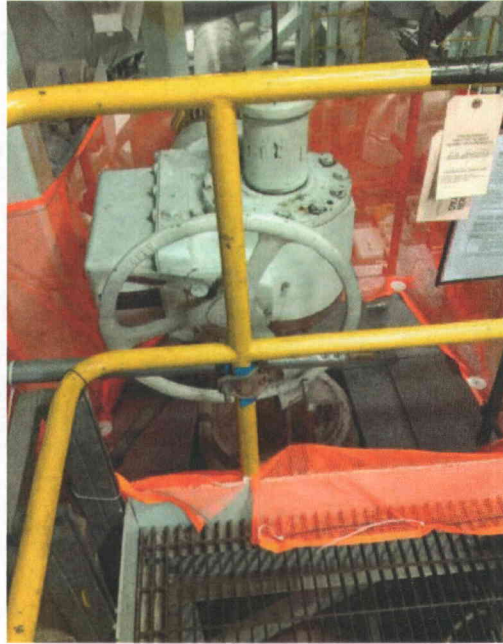
File Name: 1-65-2-3-27.jpeg
Description: Scaffold identified in the area

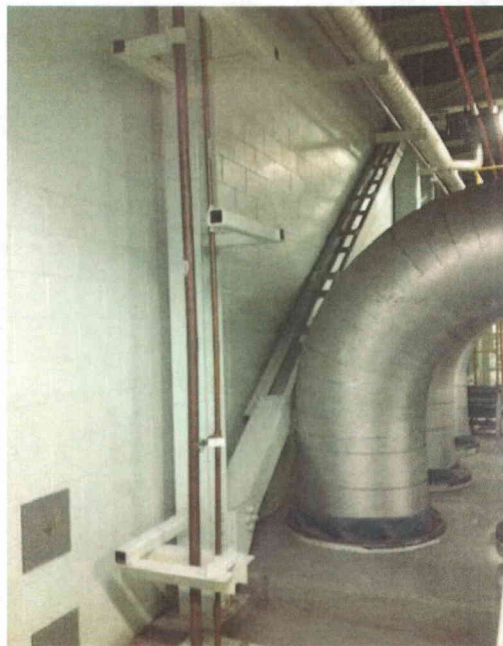
File Name: 1-68-2-3-27.jpeg
Description: Block wall identified in the area

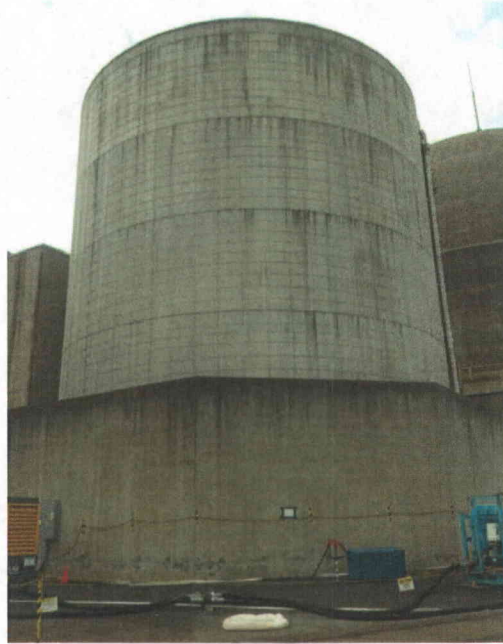
Mild surface corrosion identified on several locations around tank 2QSS-TK21. This is mostly due to humidity in the area. CR-2012-14744 and CR-2012-14749 were issued to address moderate corrosion identified on valves.

File Name: 1-65-4-3-29.jpeg
Description: View of Tank 2QSS-TK21.

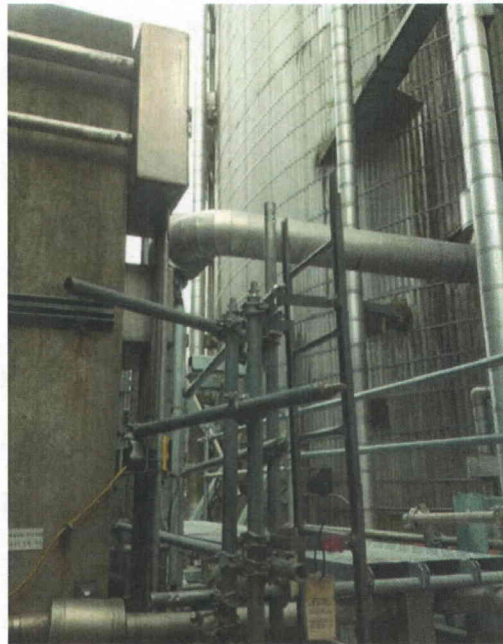
File Name: 1-60-4-3-29.jpeg
Description: Scaffold located in the area.

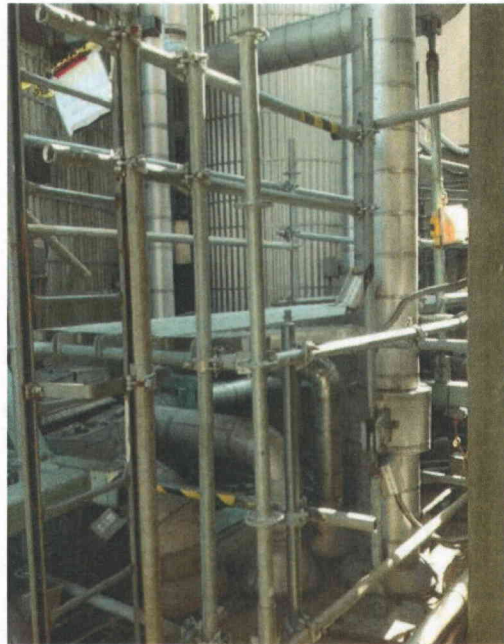
File Name: 1-67-4-3-29.jpeg
Description: Scaffold located in the area.

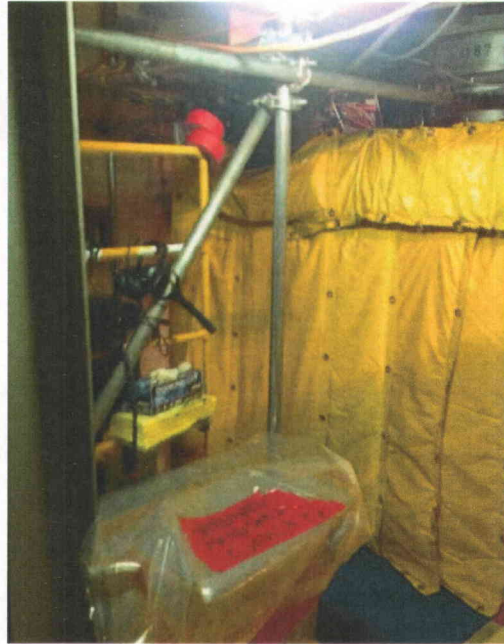
File Name: 1-59-6-3-19.jpeg
Description: View of scaffold in the area

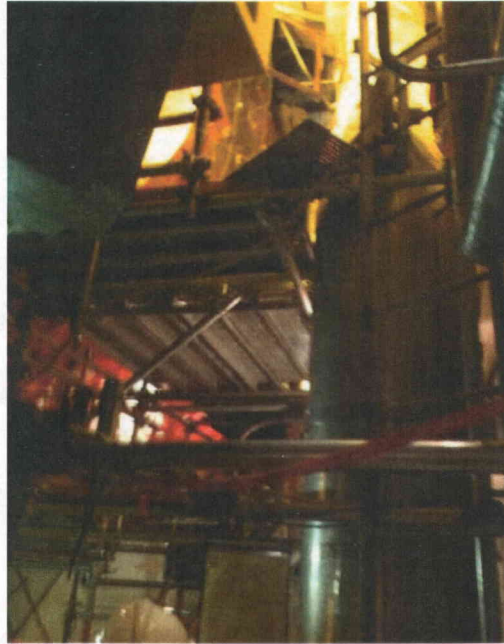
File Name: 1-65-6-3-19.jpeg
Description: View of scaffold in the area

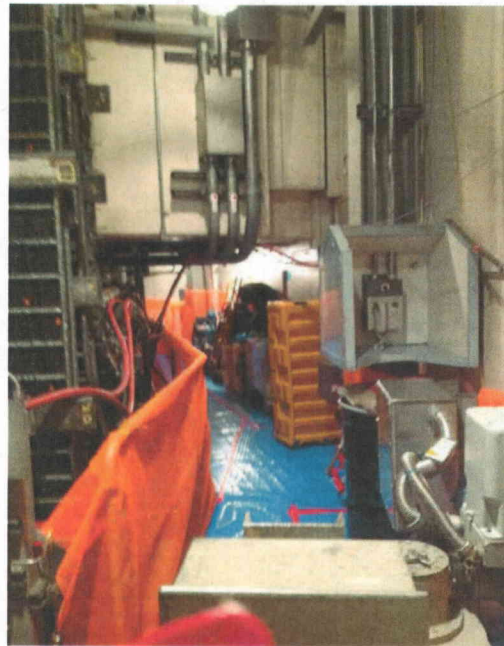
Maintenance equipment found in the area to be properly restrained.

File Name: 1-60-2-3-19.jpeg
Description: View of maintenance equipment in the area

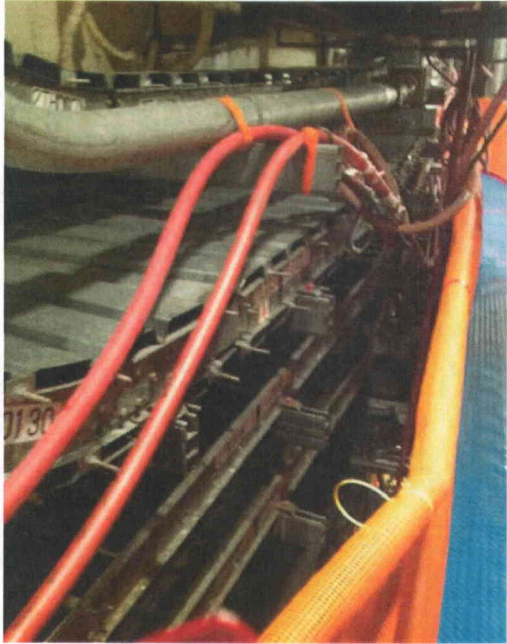
File Name: 1-65-2-3-19.jpeg
Description: View of cable trays in the area.

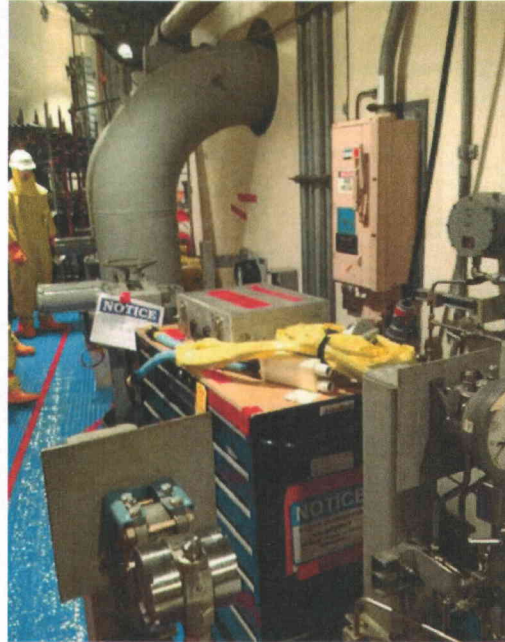
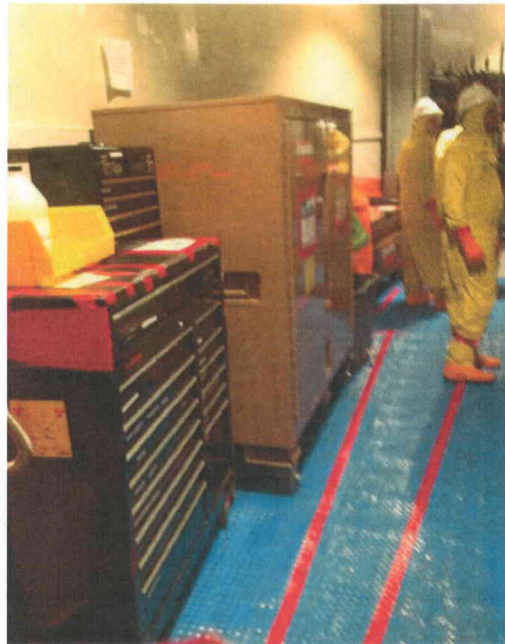
File Name: 1-59-4-3-19.jpeg
Description: Temporary outage related maintenance equipment

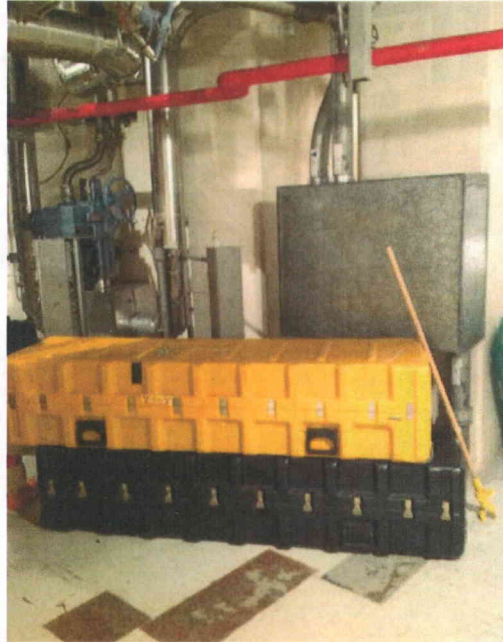
File Name: 1-59-4-3-17.jpeg
Description: View of heavy storage boxes in the area.

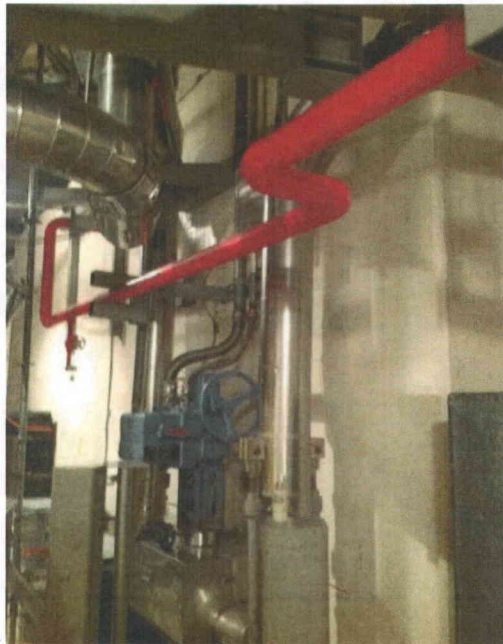
File Name: 1-60-4-3-17.jpeg
Description: Fire line located above 2CHS-MOV310

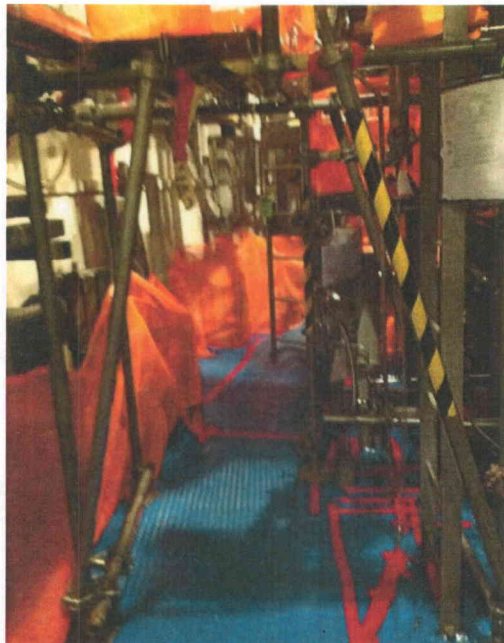
File Name: 1-67-7-3-19.jpeg
Description: View of scaffold in the area

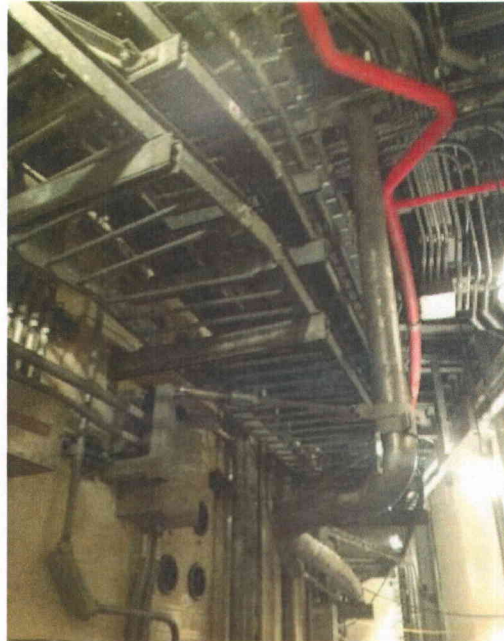
File Name: 1-59-5-3-19.jpeg
Description: General view of cable trays and fire line in the area

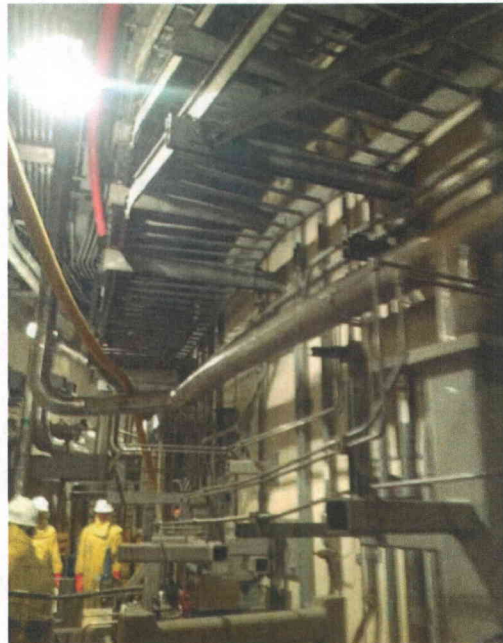
File Name: 1-66-5-3-19.jpeg
Description: View of wall mounted supports for piping and cable trays.
