**APPENDIX C**  
**AREA WALK-BY CHECKLISTS (AWCs)**

**Area Walk-By Checklist (AWC)**

Room 105 Floor El. 545 Bldg. AUXB

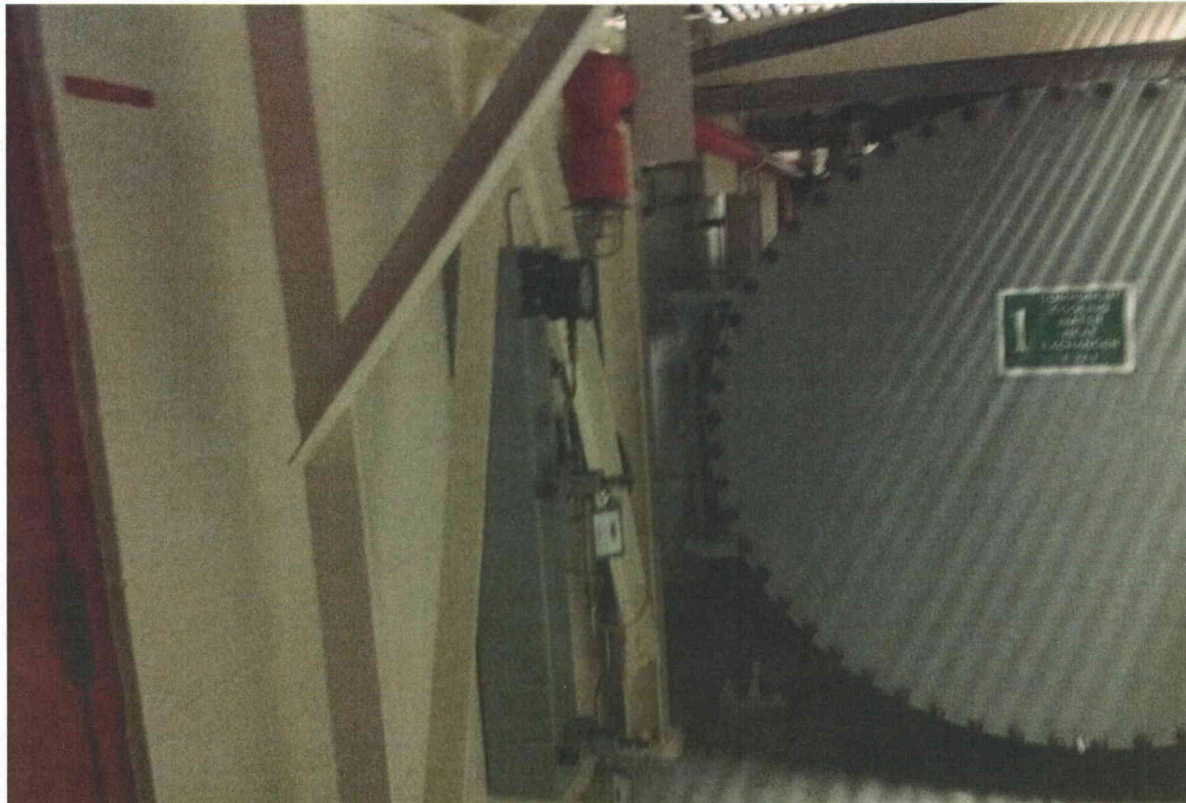
**Photo 1**  
**General View of Room 328**  
**Masonry Wall Adjacent to Heat Exchange E22-1**

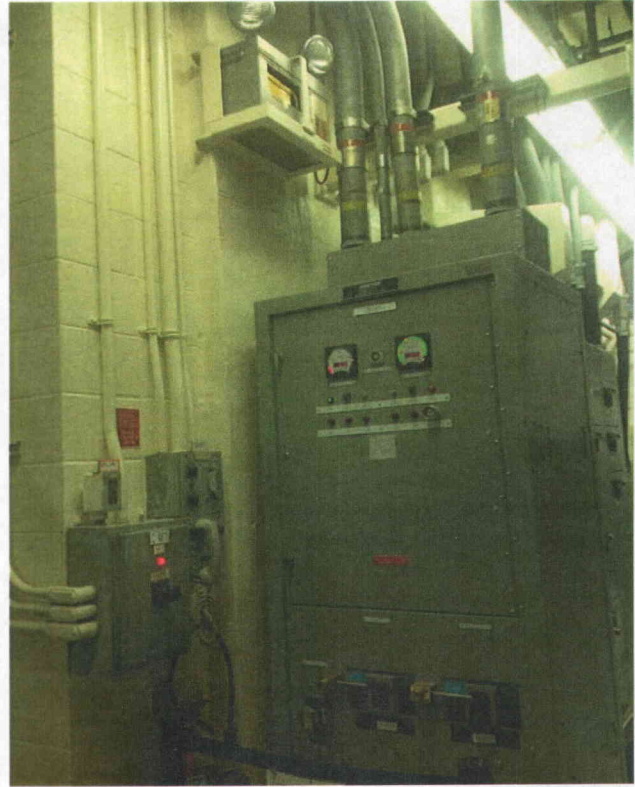
**Photo 2**  
**Masonry Wall Adjacent to Components**

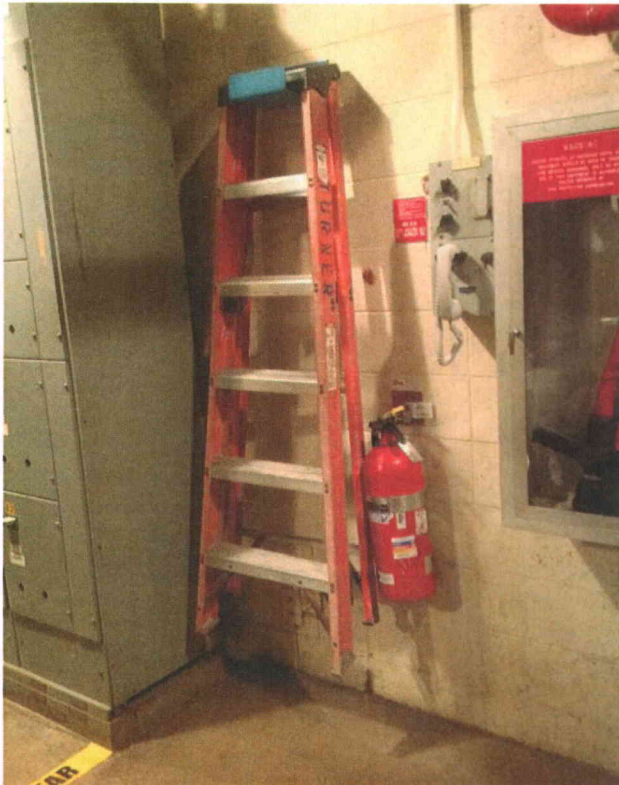
**Photo 1**  
**Fire Extinguisher not Restrained**  
**and Masonry Wall**

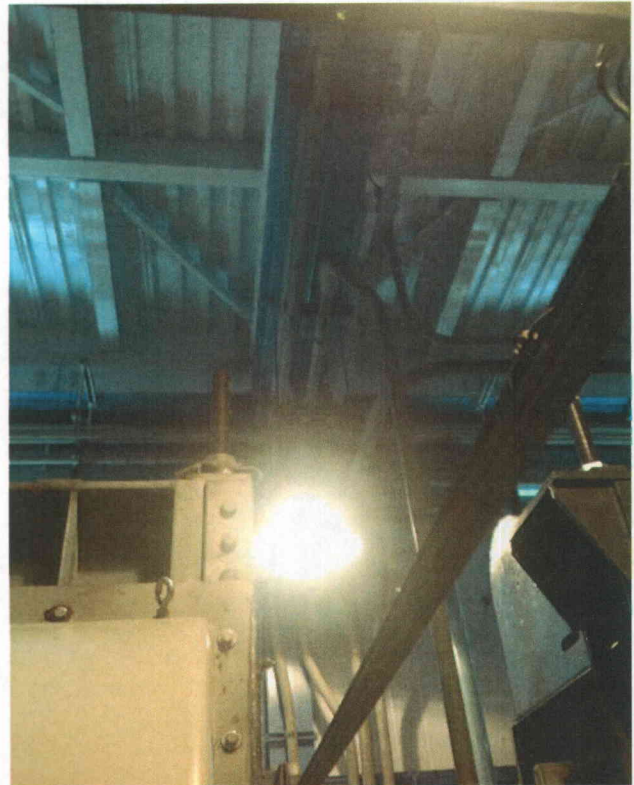
**Photo 2**  
**Rod Hung Pipes**
