APPENDIX B: SEISMIC WALK-DOWN CHECKLISTS (SWCs)

Seismic Walkdown Checklist (SWC)

Equipment ID No. 0G41A0002A Equip. Class 21. Tanks and Heat Exchangers

Equipment Description FPCC Surge Tank

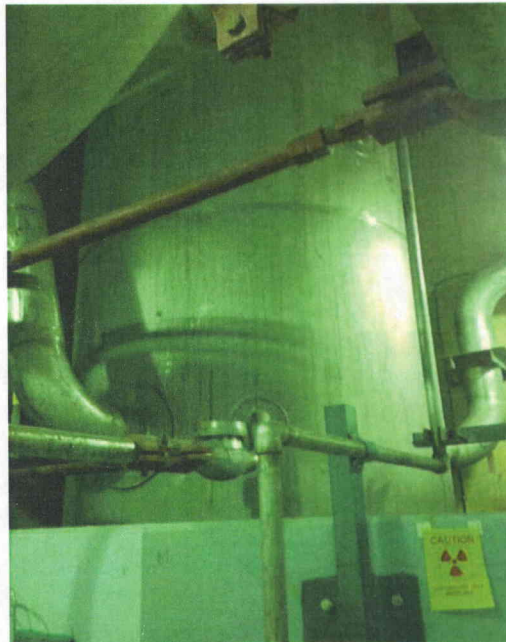
File Name: 2-62-1-4-22.jpeg
Description: General view of component

Tall vertical tank. At top penetrates ceiling at elevation 620. Top bracing provided by floor slab.

Surrounding area found in adequate condition.

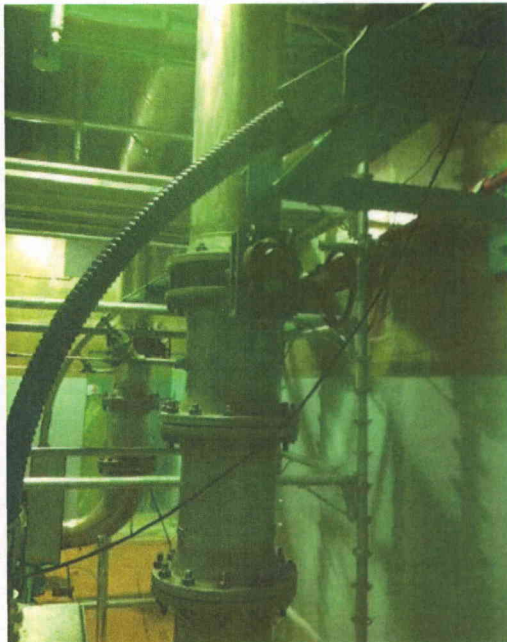
File Name: 2-62-7-1-21.jpeg
Description: General view of component

Inline check valve on ~14" diam pipe line. Pipe line shows adequate support. No degraded condition identified.

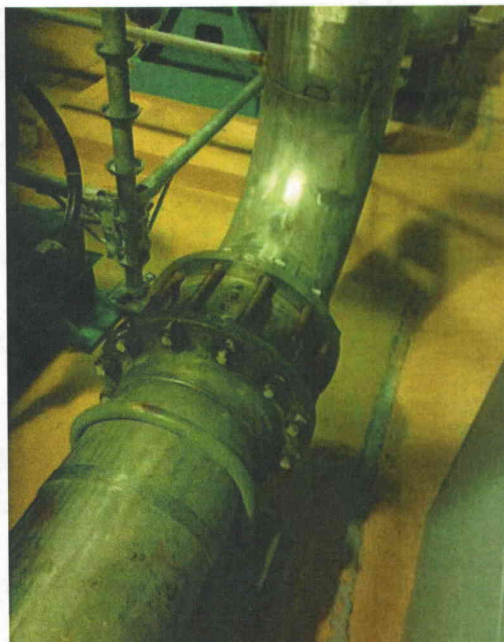
File Name: 2-62-3-4-21.jpeg
Description: View of valve location in pipe main line

Inline check valve on ~14" diam pipe line. Pipe line shows adequate support. No degraded condition identified.

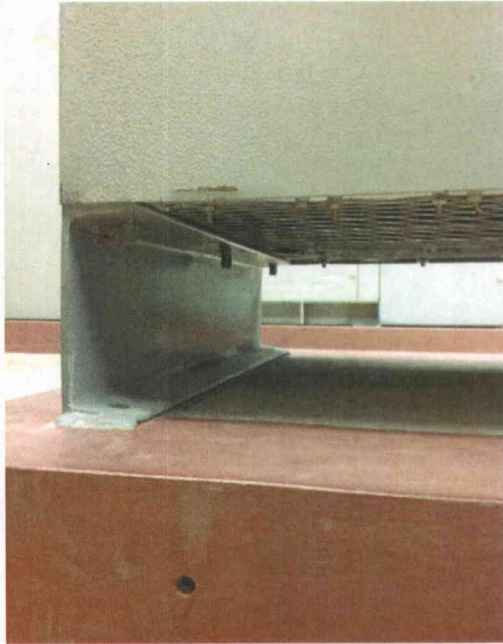
Slight surface corrosion identified but judged not a concern.

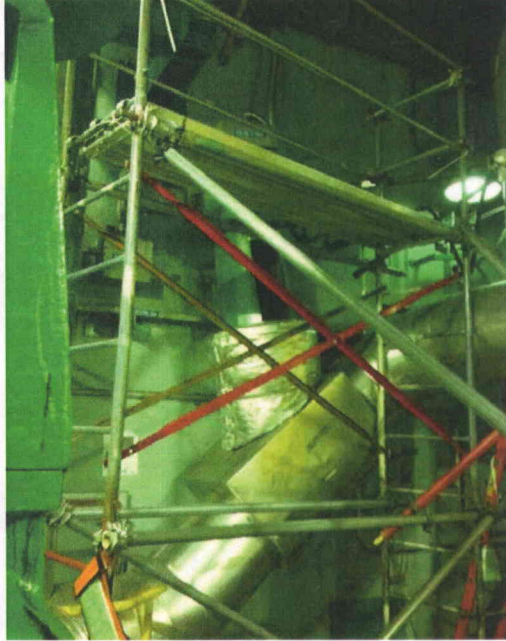
File Name: 2-61-3-4-20.jpeg
Description: Scaffolding located in the area

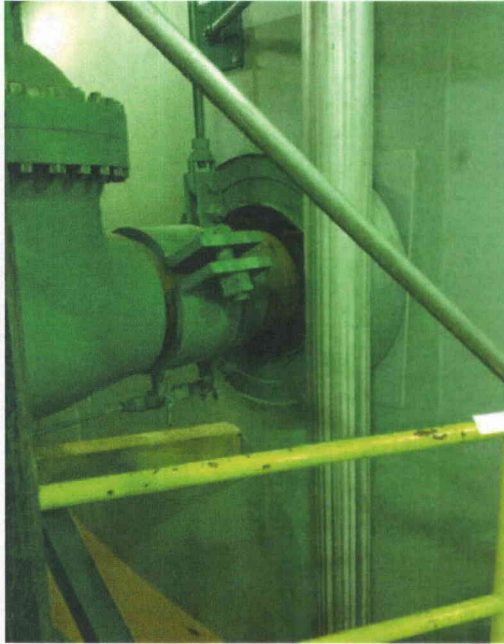
File Name: 2-63-8-4-18.jpeg
Description: View of main pipe line run through shield building

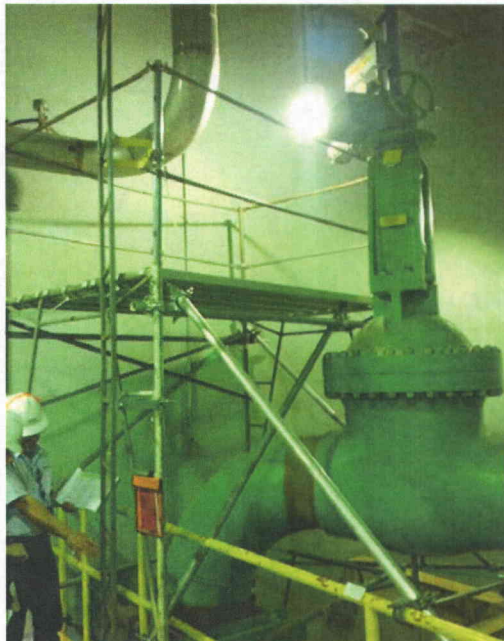
File Name: 2-64-8-4-18.jpeg
Description: Scaffolding located in the area

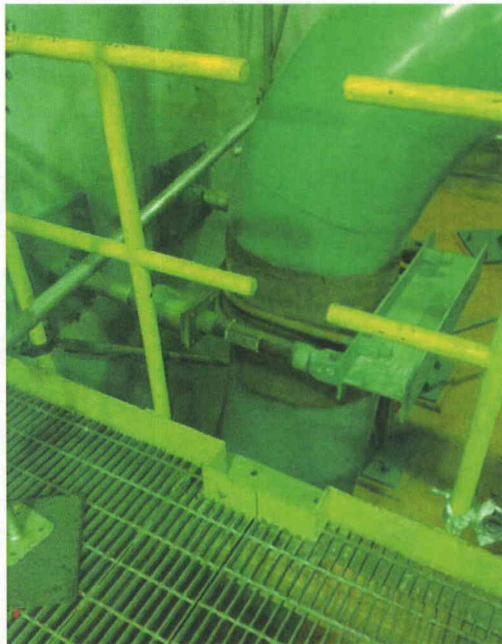
File Name: 2-94-8-4-18.jpeg
Description: View of main pipe line support configuration

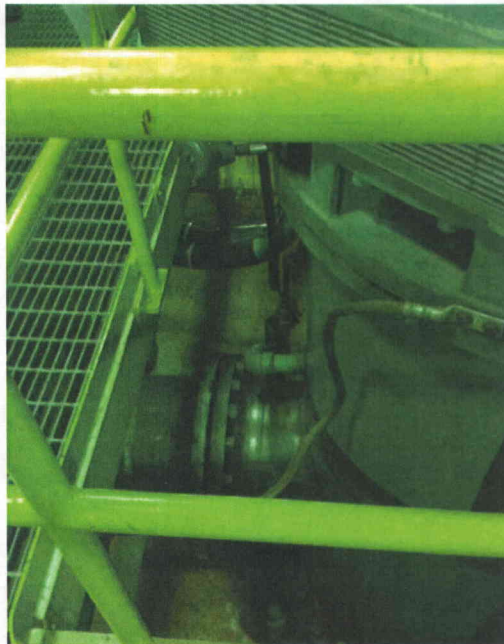
File Name: 2-64-14-4-18.jpeg
Description: View of attached lines to component

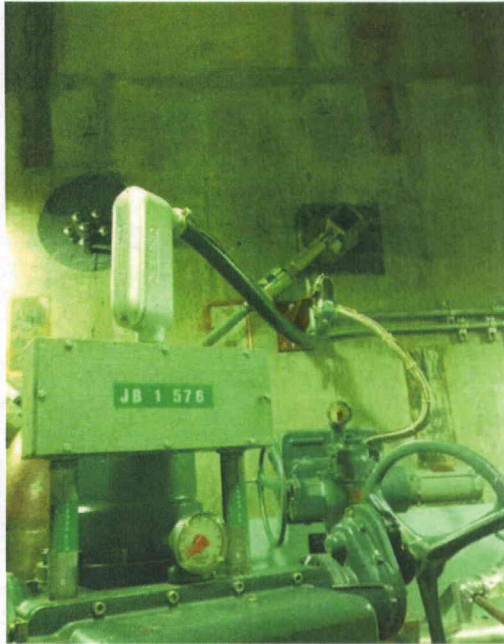
File Name: 2-63-1-4-10.jpeg
Description: View of attached lines

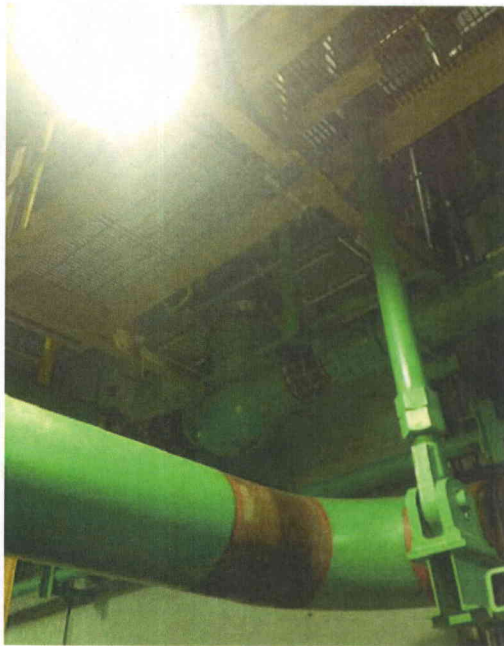
File Name: 2-62-12-4-18.jpeg
Description: General view of Component

Slight corrosion identified but judged not significant.

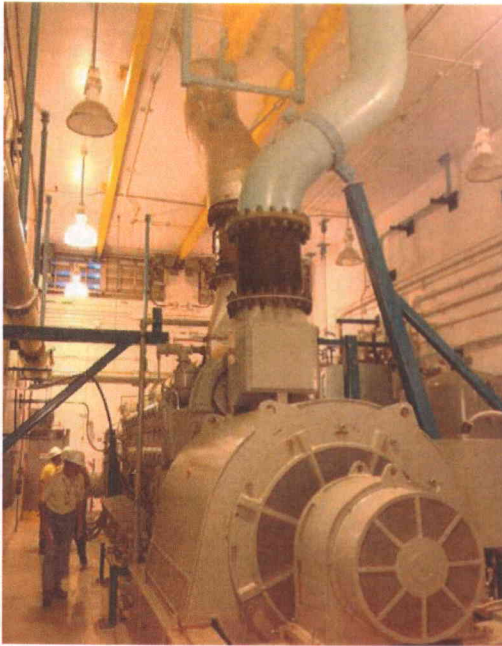
File Name: 2-63-12-4-08.jpeg
Description: View of top conduits
