Loss of an Iridium-192 Source and  
Therapy Misadministration at  
Indiana Regional Cancer Center  
Indiana, Pennsylvania, on  
November 16, 1992

Manuscript Completed: February 1993  
Date Published: February 1993

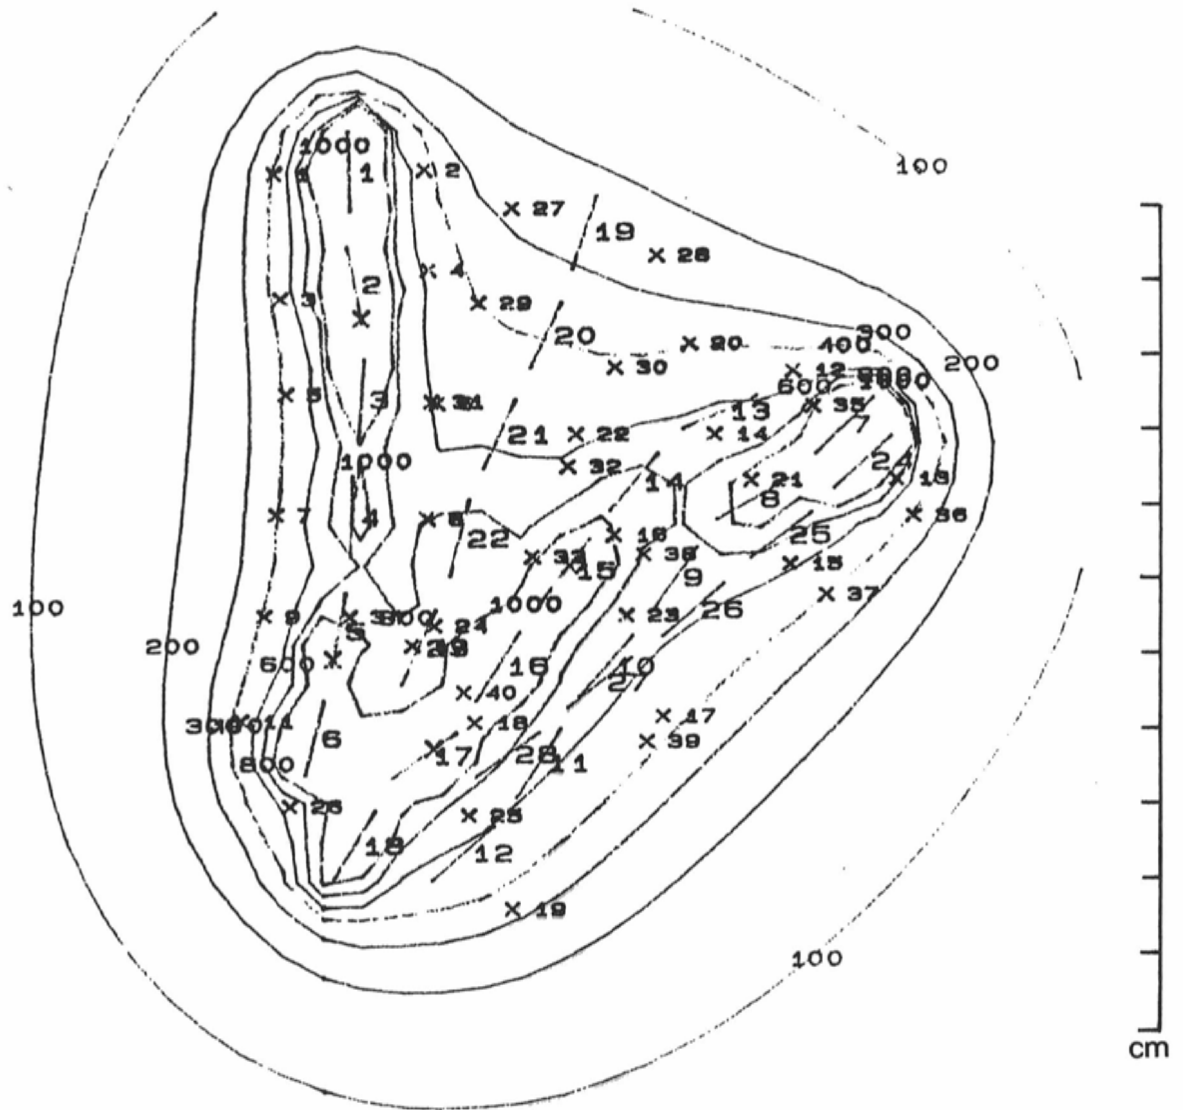
Figure 2.1 Isodose Graph for Initial High Dose Rate Patient Treatment Plan

On November 16, 1992, before the patient was treated, Medical Physicist A generated an Omnitron HDR dosimetry drawing with 40 dosimetric points (Figure 2.1). The calculated source strength upon initiating the treatment was  $1.56 \text{ E}+11 \text{ Bq}$  (4.219 Ci). The dwell time calculations for the five implanted catheters were generated by computer (Figure 2.2). On November 16, 1992, at 9:35 a.m., the implanted catheters were connected to the HDR afterloader connecting catheters\* and patient treatment was initiated. Difficulties were encountered during the source wire insertion into implanted Catheter 5, and Physician A directed termination of treatment without treating the patient through implanted Catheter 5. The patient was disconnected from the HDR afterloader (Figures 2.3 and 2.4). After the patient was removed from the treatment room, one loose catheter was removed, and the other four catheters were left in the patient for subsequent treatments.

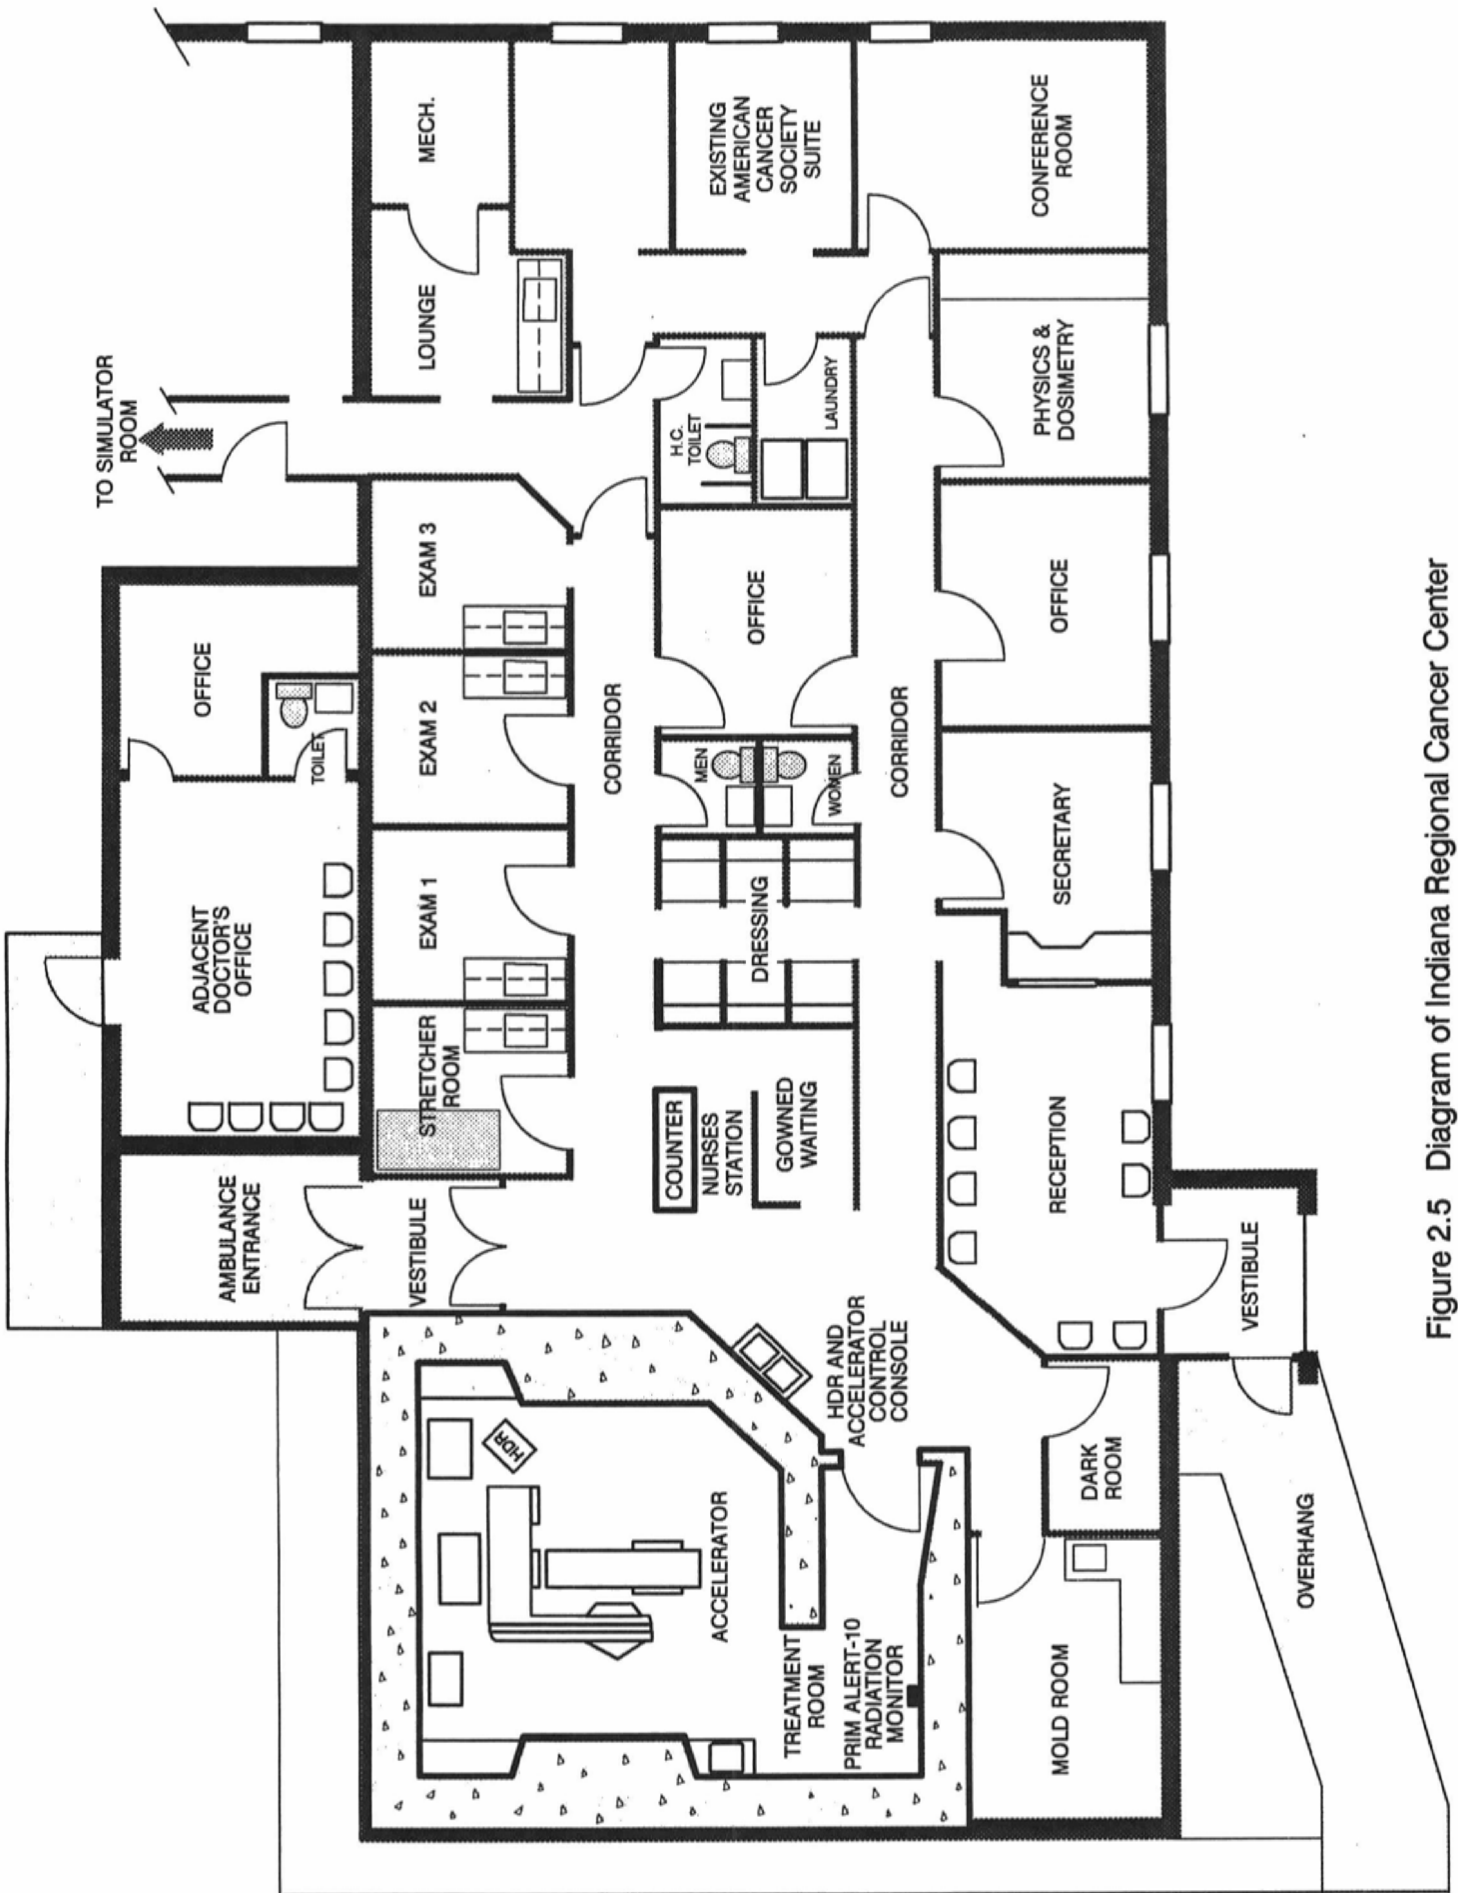
Figure 2.5 Diagram of Indiana Regional Cancer Center

10:20 a.m. RTT-A disconnected the patient's implanted catheters from the HDR afterloader. RTT-A removed the patient from the HDR treatment room, and the patient was taken to the stretcher room (see Figure 2.5).

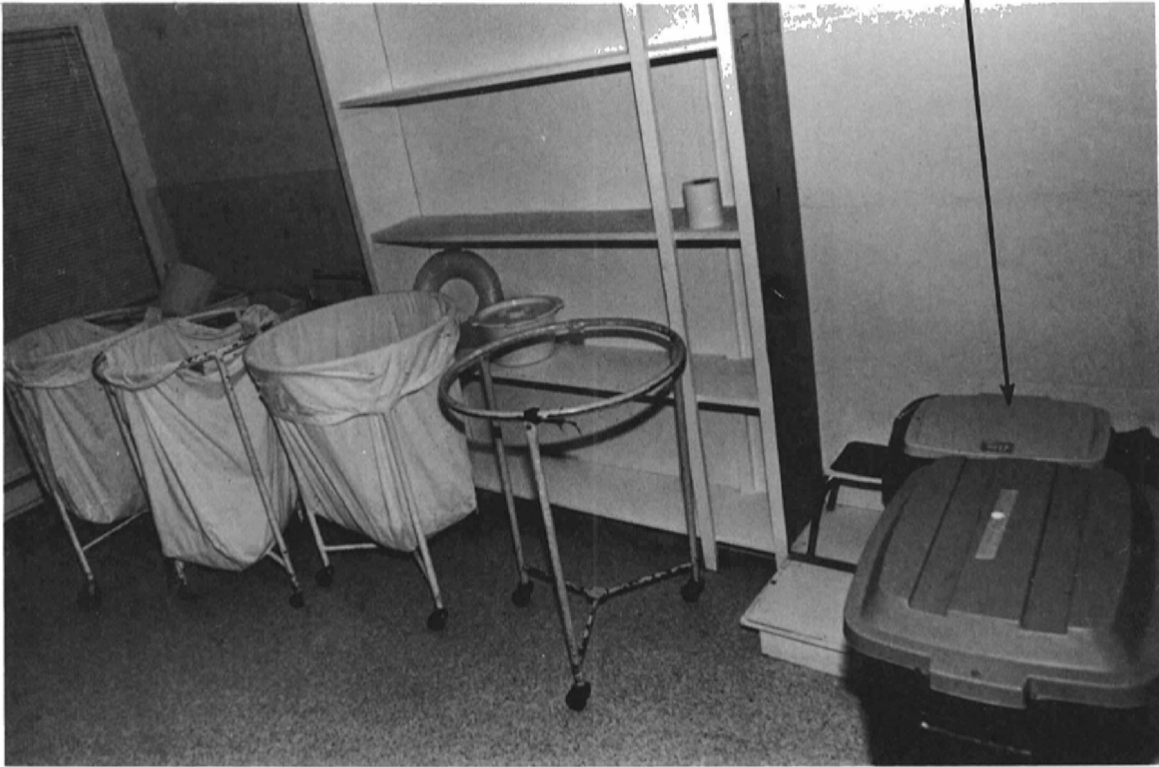
Figure 2.7 Soiled Utility Room with Biohazard Waste Container

LPN-B picked up the catheter containing the source, placed it in a red bag, which the nursing home uses for medical and biohazardous waste (typically referred to as "red-bag" waste), and transferred this small, red bag to a larger container for medical waste in the soiled utility room where red-bag waste is stored daily (Figure 2.7). LPN-B was unaware the catheter contained the iridium-192 source.

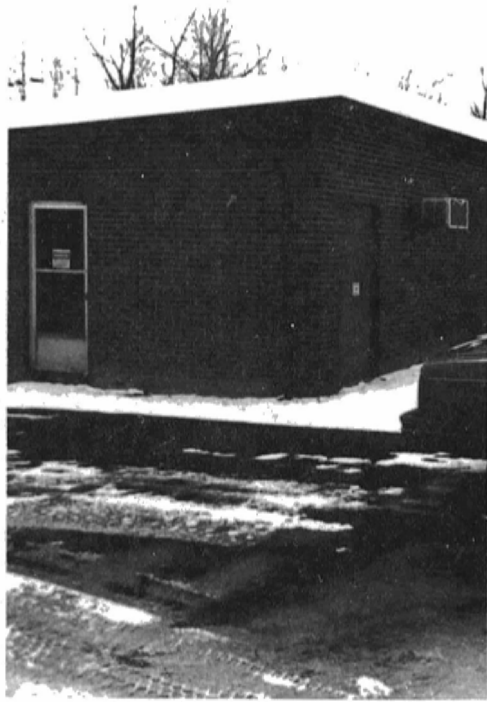
Figure 2.8 Waste Storage Room at Scenery Hill Manor Nursing Home

After discussing the situation with the IRCC, RN-D instructed Maintenance Man A to remove the large red bag of waste from the soiled utility room, which he normally does at 7:30 a.m., and transfer it to the outside waste storage room (see Figure 2.8).

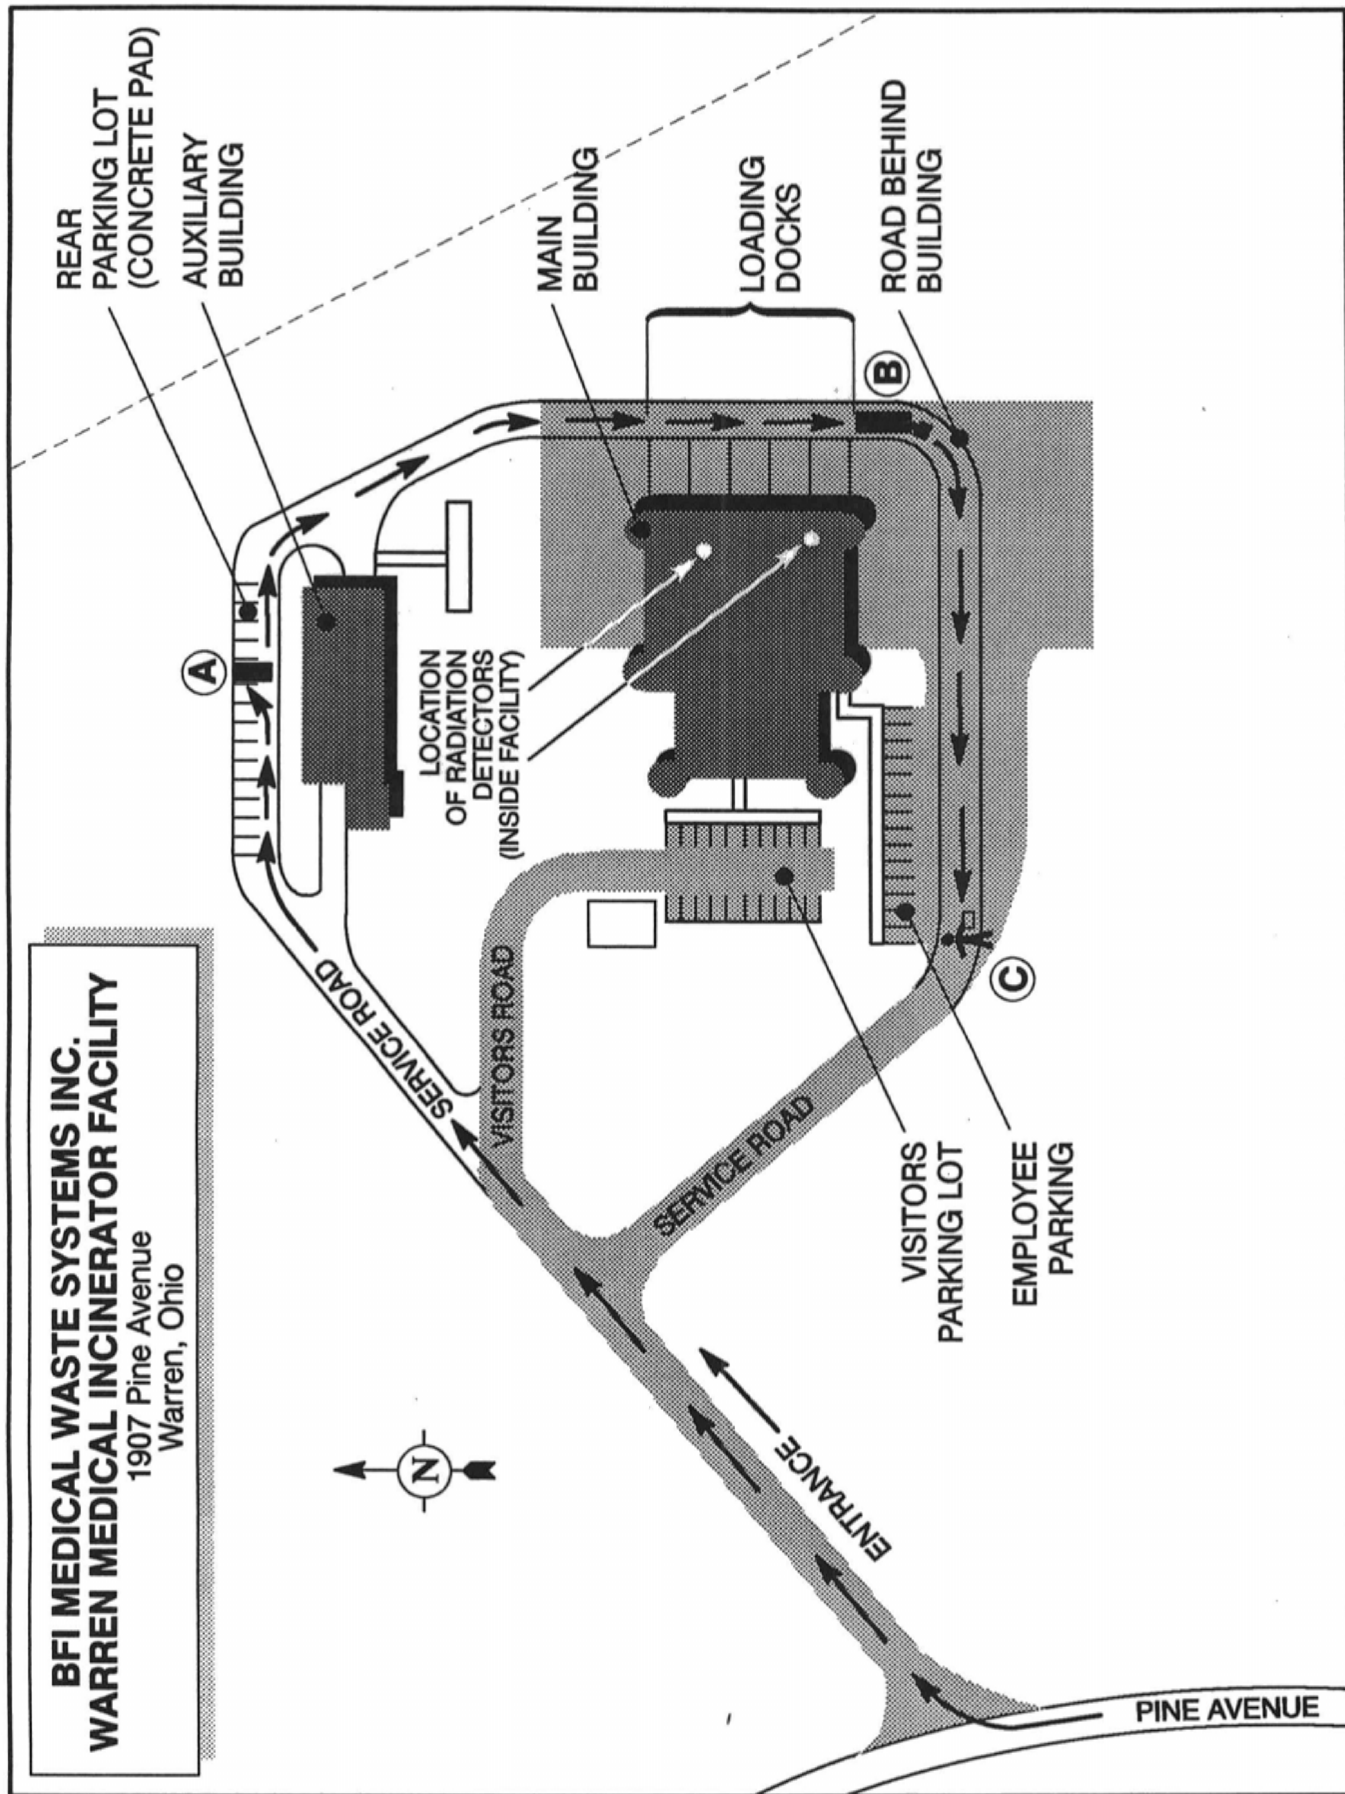
Figure 2.13 Diagram of Tractor-Trailer Route Carrying Iridium-192 Source at BFI-Warren on November 25, 1992

- 8:30 a.m. Driver B arrived at BFI-Warren, drove over to the unloading area (see Position A, Figure 2.13), disconnected Trailer 808, hooked up his cab to an empty trailer, drove to the front office, completed the paperwork for this shipment, and left BFI-Warren. Two fixed radiation monitors inside the facility alarmed, reading above their normal limits of 0.2  $\mu\text{Sv}$  (20  $\mu\text{rem}$ ) per hour. Employees working that shift began trying to locate the cause of the radiation alarms.

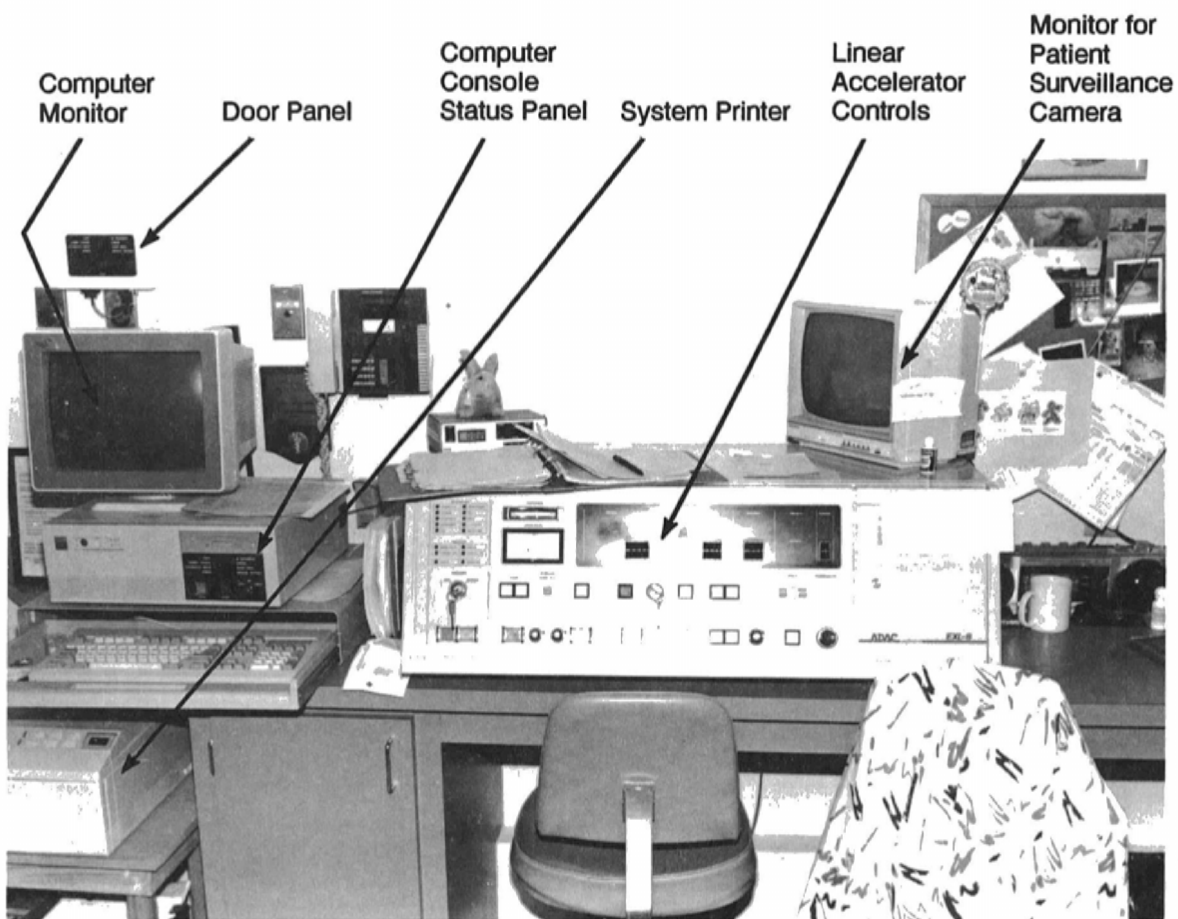
Figure 3.5 Arrangement of the Computer Console Status Panel, Door Panel System Printer, Linear Accelerator Controls, Computer Monitor, and Monitor for Patient Surveillance Camera

Owing to the placement of the computer console and the patient surveillance camera monitor (Figure 3.5), it was difficult for one operator to watch both simultaneously. Additionally, the PrimAlert-10 was located inside the treatment room and was visible through a window in the treatment room door. Therefore, the operator would have to look away from the console and monitor to observe any alarm on the PrimAlert-10. Physician A was not present at the computer console during the treatment, and Medical Physicist A was off the site. In contrast, at the GPCC, Medical Physicist B was watching the computer console and Physician E was watching the patient surveillance camera monitor.

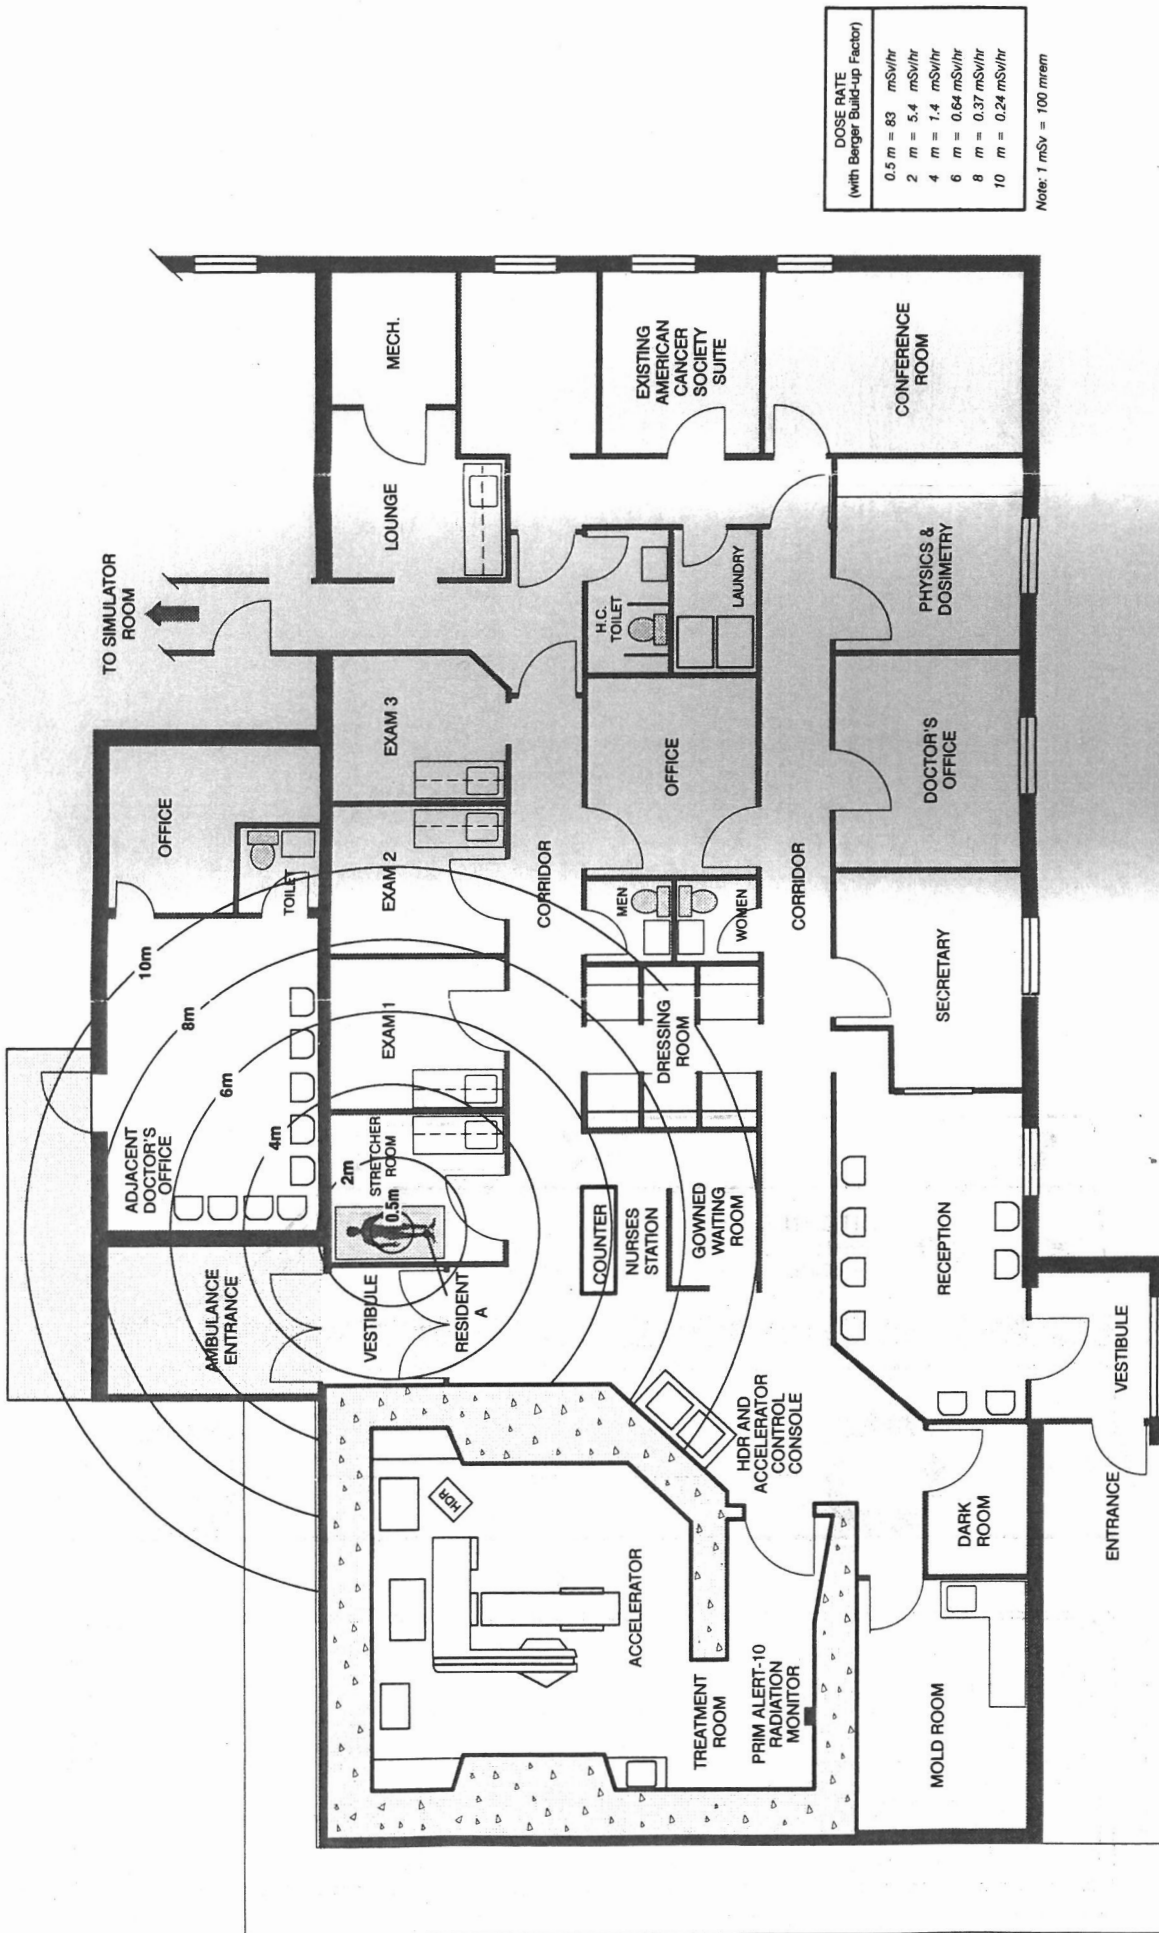
Figure 6.1 Diagram of the Indiana Regional Cancer Center Showing Isodose Curves from the Iridium-192 Source on November 16, 1992.

During the treatment, Patient A was in a shielded treatment room. After the IRCC staff experienced difficulty using the HDR afterloader to insert the source wire into the last catheter, Patient A was moved from the shielded room to the stretcher room (see Figure 6.1). Patient A remained in this room for 10 minutes awaiting the arrival of the ambulance service employees to transport Patient A to SHM nursing home. For this 10-minute period, all nonoccupational workers and visitors to IRCC were potentially exposed to the source. Table 6.4 depicts their range of distances from the source location in the stretcher room and,

hence, the range of potential doses received by those individuals who received nonoccupational exposures at IRCC. Depending on the estimated distance from the source, the calculated doses to these individuals ranged from as low as 0.04 mSv (4.0 mrem) to as high as 13.9 mSv (1.39 rem). Figure 6.1 shows isodose curves at the IRCC on November 16, 1992.

The team found that three employees of the adjacent doctor's office (ADO) and two patients visiting the ADO were potentially exposed to the source on November 16, 1992. The ADO is located southwest and adjacent to the IRCC stretcher room (see Figure 6.1). Using conservative estimates, the team estimated the exposure time for these individuals to be 10 minutes (the time Patient A spent in the IRCC stretcher room). The team estimated the distance the ADO employees and visitors spent near the source from the office's layout plan, which was supplied by the staff in the ADO, and the IRCC's blueprint of the building. As shown in Table 6.5, the maximum estimated exposure that these persons received was 4.3 mSv (430 mrem).

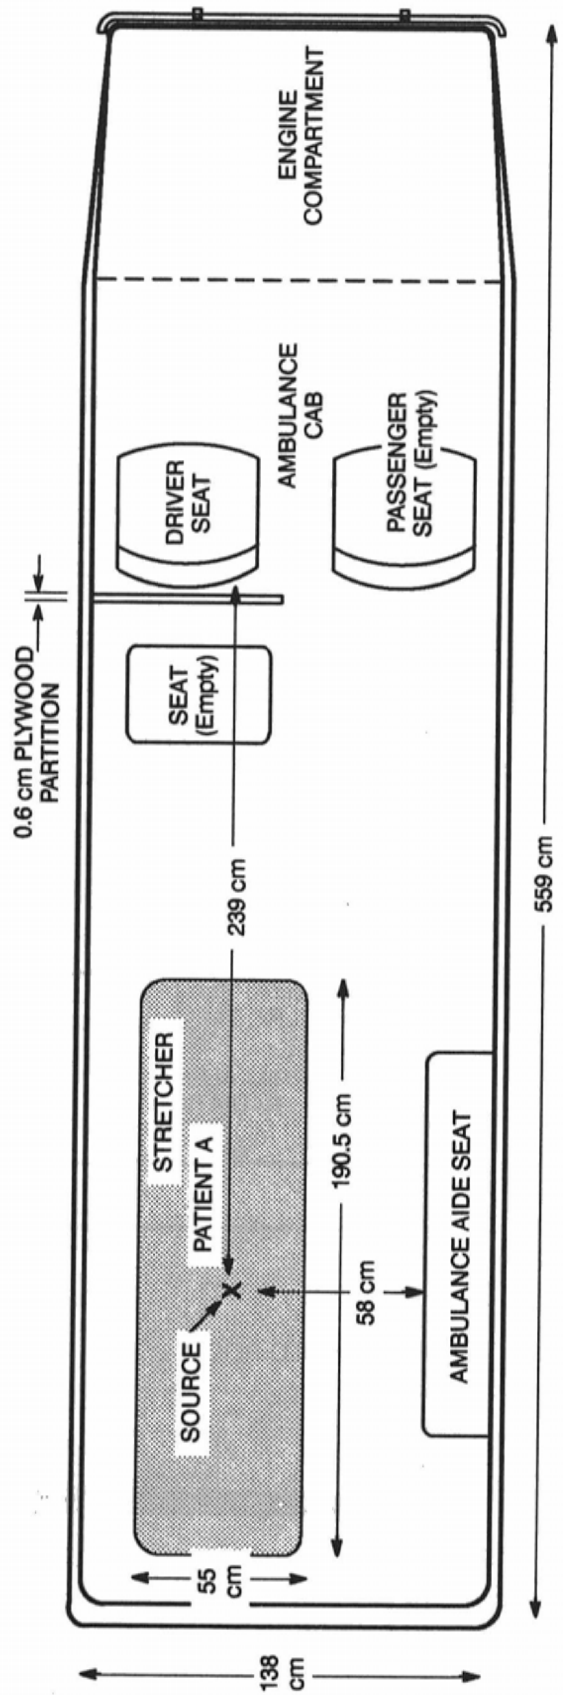
Figure 6.2 Location of Ambulance Staff and Patient A in Citizen's Ambulance

Two ambulance service employees were exposed to the iridium-192 source during transport of Patient A after Patient A received HDR treatment on November 16, 1992. The team measured probable distances that the ambulance service employees maintained from the source in Patient A and estimated the time spent at each distance based on the ambulance service's dispatch log. The team estimates that the ambulance aide received a dose in the range of 13.3 mSv (1.3 rem) to 25.7 mSv (2.6 rem), while the ambulance driver received from 4.8 mSv (0.48 rem) to 8.4 mSv (0.84 rem) (Table 6.6). The estimated dose range for the ambulance aide is higher because he spent the time in transit to SHM nursing home sitting across from Patient A approximately 58 cm (22.8 inches) away (Figure 6.2).

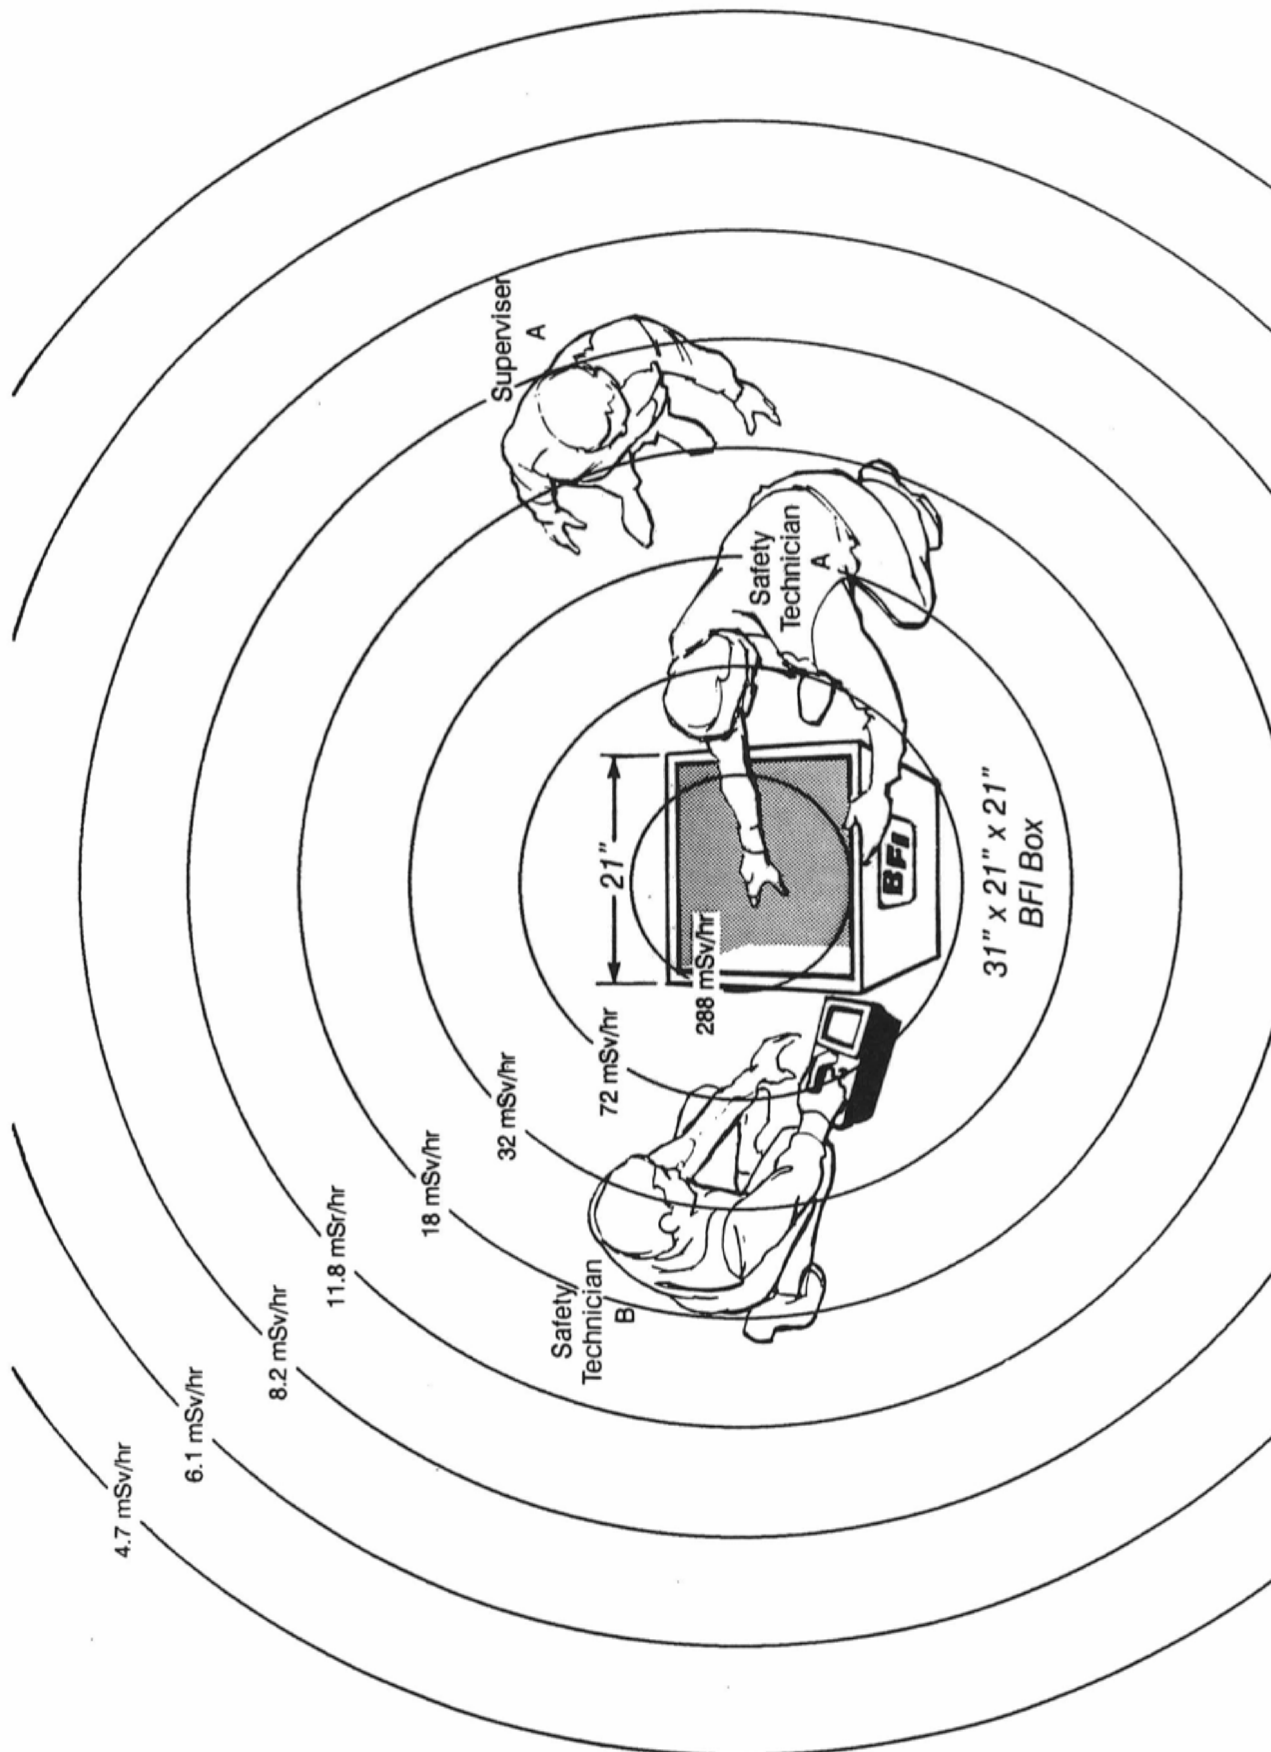
Figure 6.8 shows the position of Supervisor A, Safety Technician A, and Safety Technician B around the box [78.7 cm by 53.3 cm by 53.3 cm (31 inches by 21 inches by 21 inches)] showing isodose curves in mSv per hour.

Figure 6.8 Aerial View of the Positions of Supervisor A, Safety Technician A, and Safety Technician B Around the Box Containing the Iridium-192 Source on December 1, 1992, Showing Isodose Curves in mSv per Hour
