Common-Cause Failure Event Insights

Motor-Operated Valves

Idaho National Engineering and Environmental Laboratory

**U.S. Nuclear Regulatory Commission
Office of Nuclear Regulatory Research
Washington, DC 20555-0001**

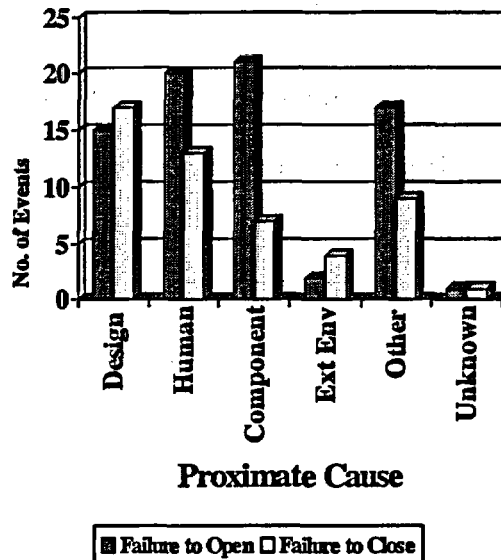
One hundred and twenty-seven CCF events affected the actuator sub-component (see Table B-1 in Appendix B, items 1–127). Of these 127 events, 76 were fail-to-open and 51 were fail-to-close. Table 4-3 contains a summary of these events by proximate cause group and failure. Figure 4-1 shows that the most likely proximate cause groups are Design, Construction and Manufacture Inadequacies, Operational/Human Actions, and Internal to the Component. Twenty actuator MOV CCF events were Complete CCF events (see Table 4-4).

Figure 4-1. Distribution of proximate causes for the actuator sub-component.

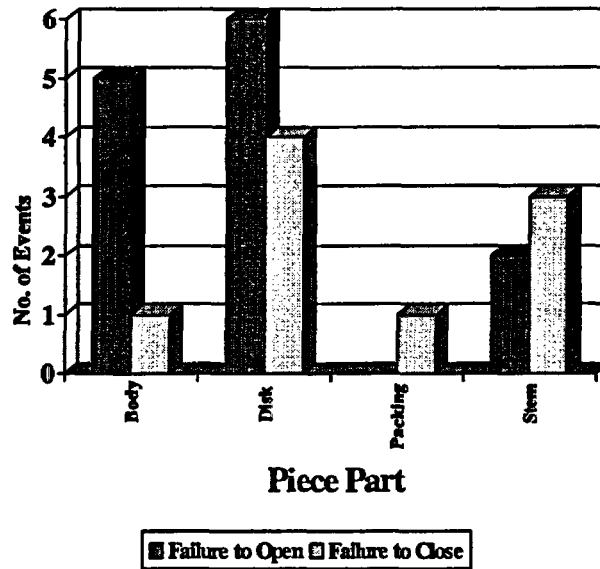
Demand and Testing were the most likely methods of discovery for the valve sub-component MOV events (17 out of the 22 events) as shown in Figure 4-5. The most likely piece parts involved in CCF events were the disk, stem, and body as shown in Figure 4-6.

Figure 4-6. Distribution of the affected piece parts for the valve sub-component.

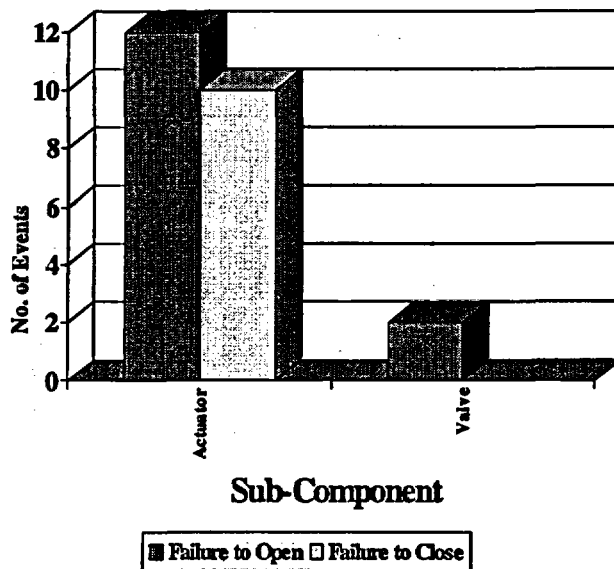
Figure 5-9. Proximate cause distribution for the AFW system.

Figure 5-10. Method of discovery distribution for the AFW system.

Figure 5-11. Piece part distribution for the AFW system.

Figure 5-12. Sub-component distribution for the AFW system.

Twenty-four events affected the AFW system (see Table C-1 in Appendix C, items 1–24). Figure 5-9 through Figure 5-12 show selected distributions graphically. There were two Complete CCF events in the AFW system. The most likely proximate causes for the AFW system events were Operational/Human Error (38 percent), Design/ Construction/Installation/Manufacture Inadequacy (29 percent), and Internal to Component (25 percent). Specifically, most events were coupled by maintenance staff errors and maintenance/test schedules. The most likely discovery method was Demands; however, all these events except one occurred prior to 1990. None of these events were determined to be unique to the AFW system. The distribution of proximate causes and coupling factors indicates that there is no single mechanism driving the CCF of AFW MOVs.
