# Common-Cause Failure Event Insights

## Circuit Breakers

**U.S. Nuclear Regulatory Commission  
Office of Nuclear Regulatory Research  
Washington, DC 20555-0001**

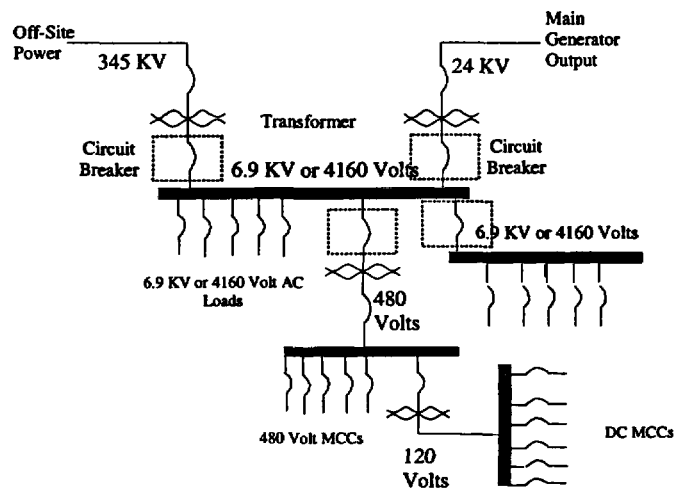
Included within the 480 Vac circuit breaker type are the circuit breakers located at the motor control centers (MCC) and the associated power boards that supply power specifically to any 480-volt equipment. The MCCs and the power boards are not included except for the load shedding and load sequencing circuitry/devices, which are, in some cases, physically located within the MCCs. Load shedding of the safety bus and subsequent load sequencing onto the bus of vital electrical loads is considered integral to the 480 Vac circuit breakers function and is therefore considered within the bounds of this study. All instrumentation, control logic, and the attendant process detectors for system initiations, trips, and operational control are included. Batteries were included if failures impacted 480 Vac circuit breakers functional operability. Figure 2-1 shows a typical 480 Vac circuit breaker arrangement.

Figure 2-1. Generic distribution system.

The Medium Voltage circuit breakers considered here are feeder circuit breakers to smaller electrical distribution centers (480 Vac motor control centers), circuit breakers between two 4160 volts-ac (Vac) busses, and the feeder circuit breakers from off-site power. Circuit breakers, which supply power to 4160 Vac and 6.9 kVac busses, as well as circuit breakers supplying loads from the 4160 Vac and 6.9 kVac busses, were also considered. Circuit breakers that supply individual components (e.g., safety injection pumps) are not included in this study, but are included in the component studies as a part of the individual component. Circuit breakers used to supply power from an emergency diesel generator to a 4160-volt bus are specifically excluded and are considered under the separate study of emergency diesel generators. Figure 2-1 shows a typical simplified ac power distribution system. The circuit breakers considered in this study are shown in boxes.

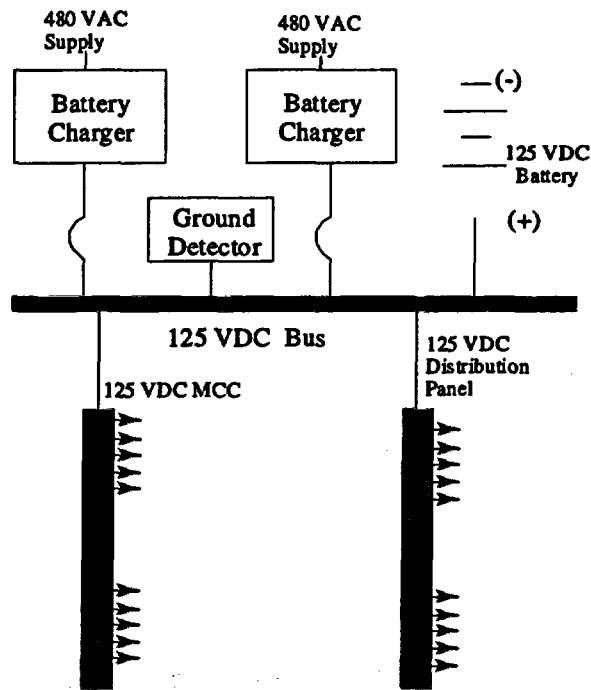
Most dc loads are supplied from 125 volt-dc (Vdc) panels through individual distribution circuit breakers, though some plants may have 250 Vdc distribution systems to support dc-powered motor-operated valves or other relatively large dc-powered loads. Multiple trains or divisions are available to ensure dc power is supplied to redundant components. These dc distribution divisions typically number from as few as two to as many as eight depending on the design of the plant. The dc power is normally distributed to the loads from a battery charger in parallel with a battery. The battery charger is usually powered from a Class 1E 480 Vac bus, supplied from off-site power or the emergency diesel generators. In the event power is not available from the normal source, dedicated station batteries supply dc power to the distribution system. A simplified schematic for a typical train or division of dc-power distribution is presented in Figure 2-2.

Figure 2-2. Dc power distribution configuration.

The dc distribution circuit breakers are normally in the closed position regardless of whether the plant is at power or shutdown. Most of the dc distribution circuit breakers are manipulated locally with only instrumentation available to the control room operator.

The dc circuit breakers have overcurrent protection that is a built-in part of a circuit breaker unit. Most circuit breakers, especially for safety-related equipment applications, provide additional protection by monitoring parameters such as undervoltage, ground faults, and other protection schemes as required for circuit breaker/system protection or the specific safety application. This additional application hardware is generally located external to the circuit breaker and merely utilizes the remote operating features of the circuit breaker. This hardware, as well as the remote operating hardware, is considered integral to the function of the circuit breaker and part of the breaker for failure analysis. It includes all sensing devices, cabling, and components necessary to process the signals and provide control signals to the individual circuit breaker.
